ROCKI-237-H Dan River Primary Ash Basin Failure Pictures from 02-03-2014

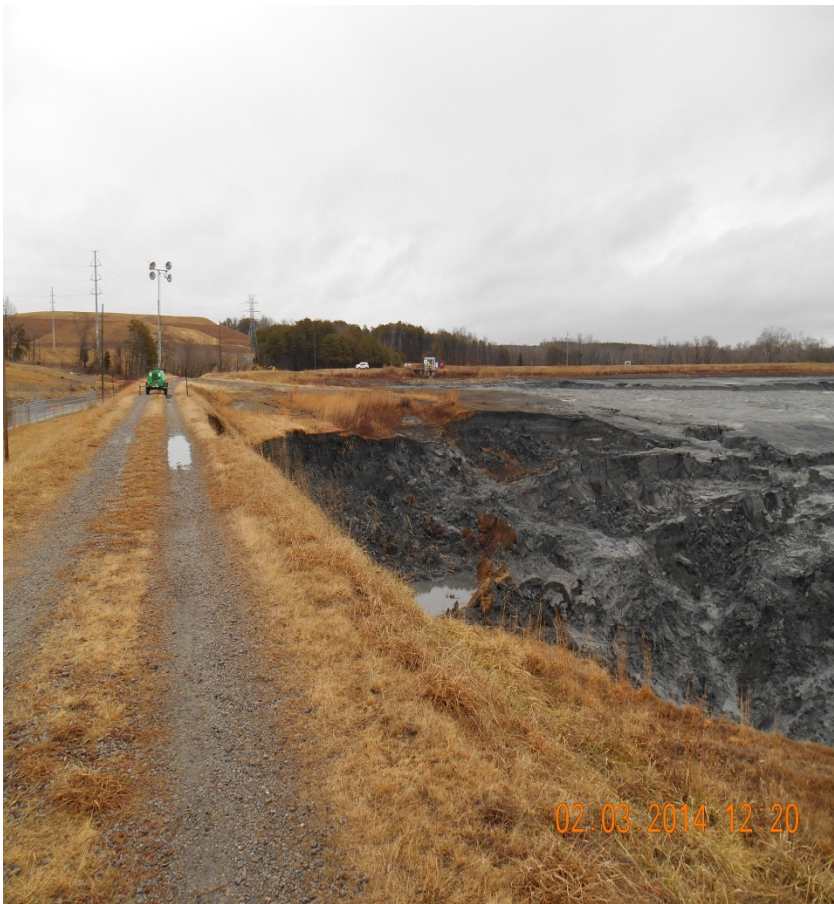
Looking at upstream slope failure on west side of dam. Slope is vertical back to crest of dam. Picture taken on west side of dam looking toward northeast direction.

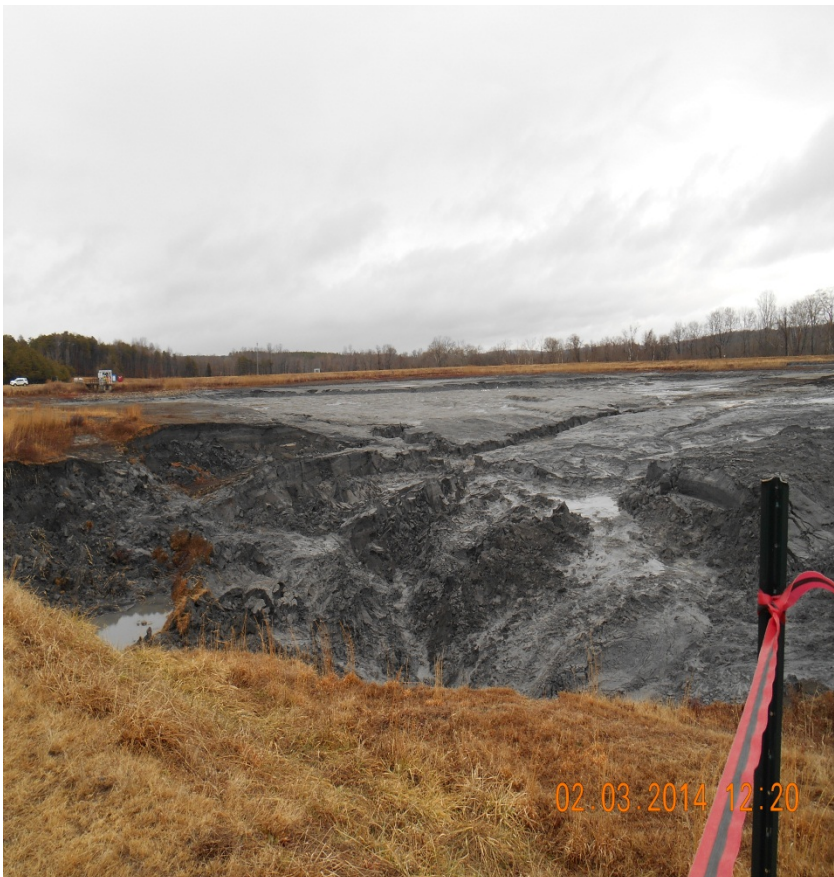
Looking across impoundment area. Picture taken on west side of dam looking toward northeast corner of dam.

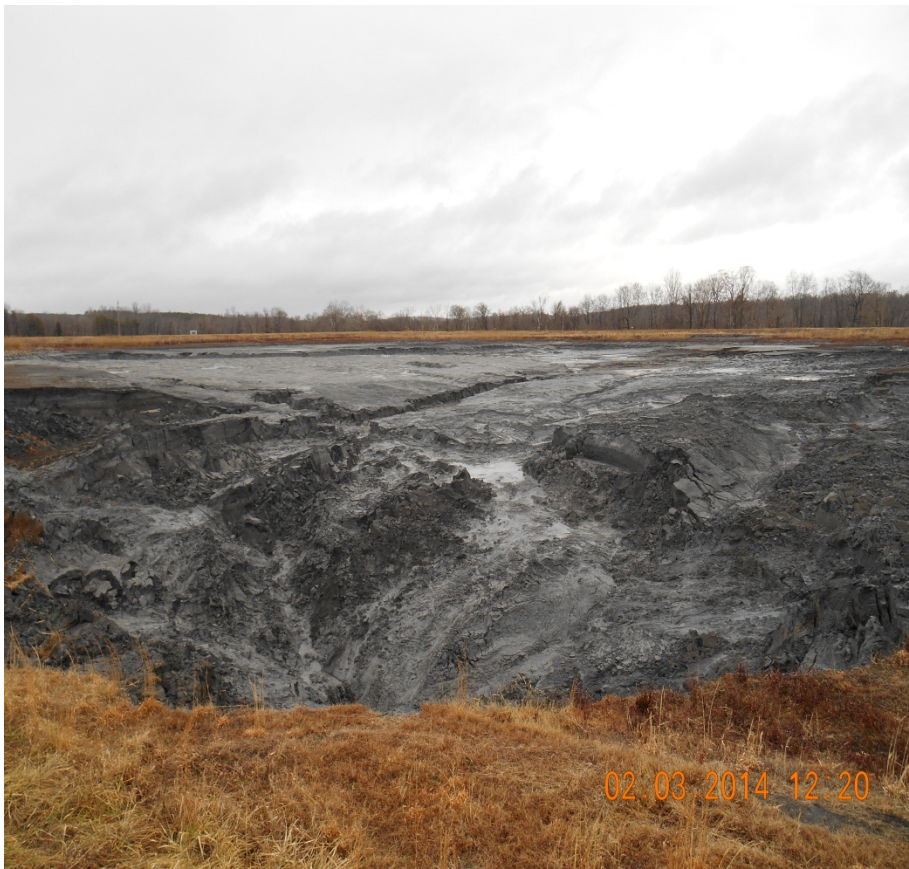
Looking across impoundment area. Picture taken on west side of dam looking toward northeast corner of dam.

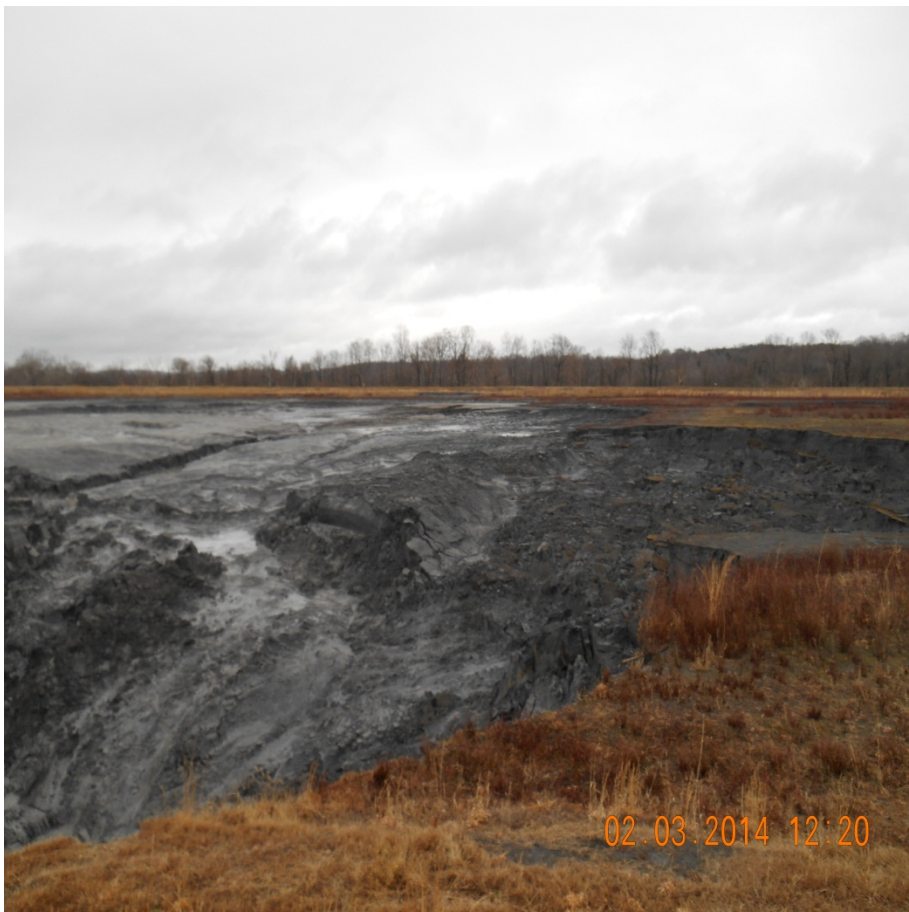
Looking across impoundment area. Picture taken on west side of dam looking toward eastern side of dam.

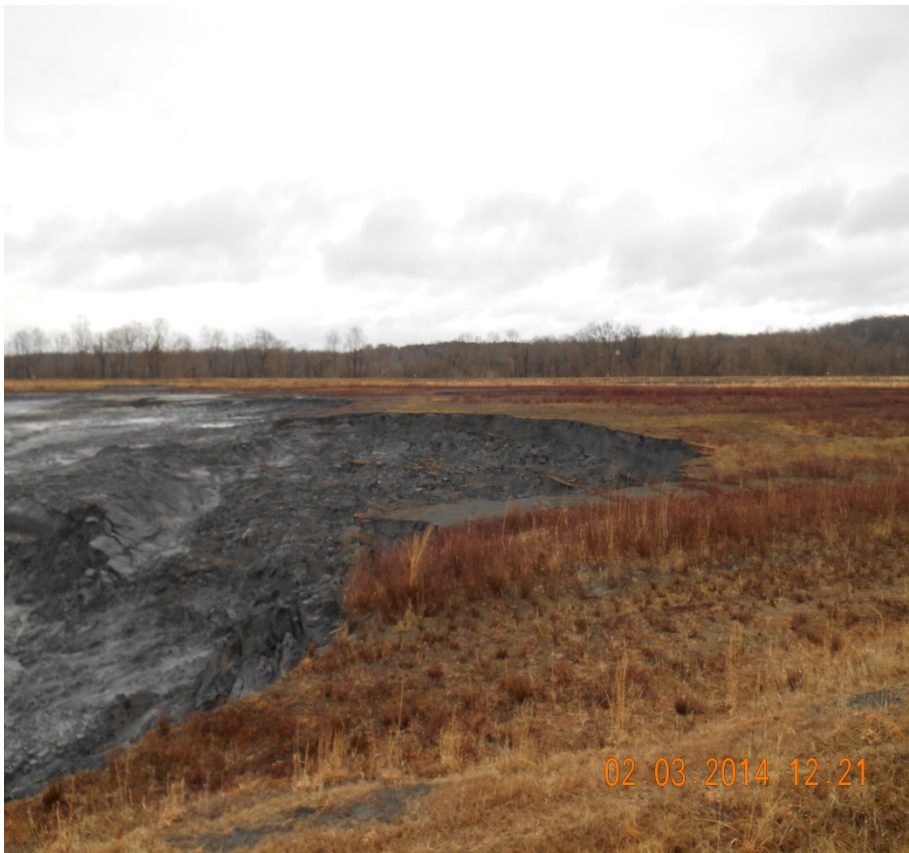
Looking across impoundment area. Picture taken on west side of dam looking toward south side of dam.

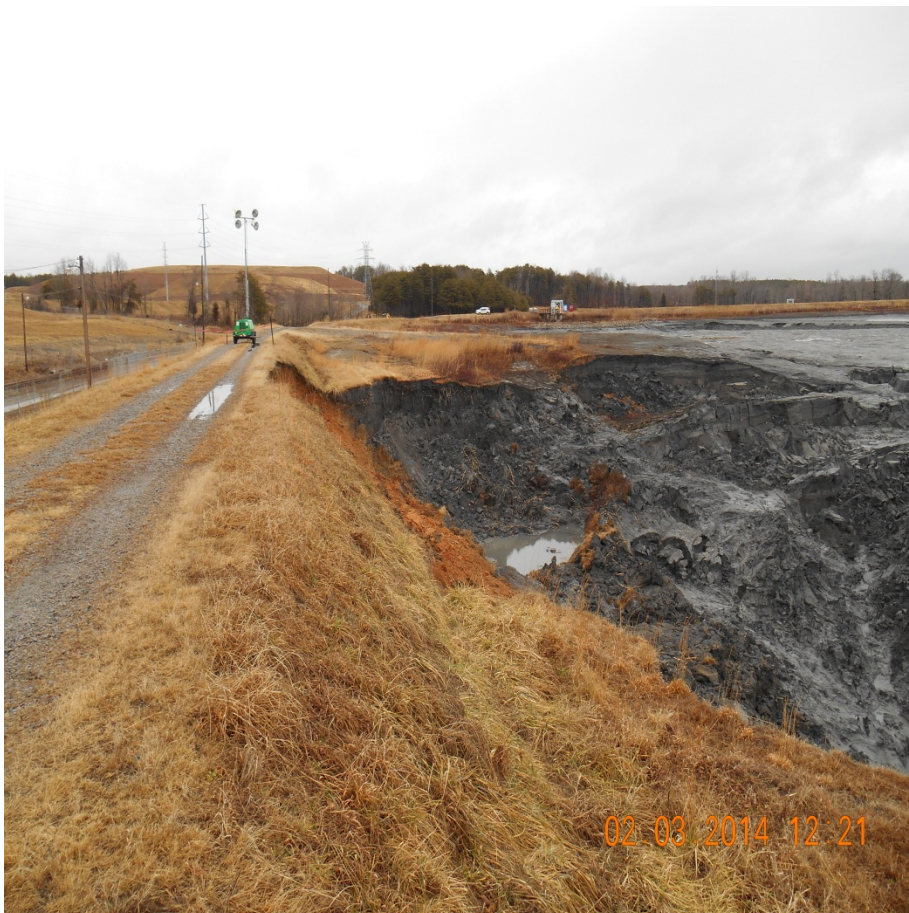
Looking at upstream slope failure on west side of dam. Slope is vertical back to crest of dam. Picture taken on west side of dam looking toward northeast direction.

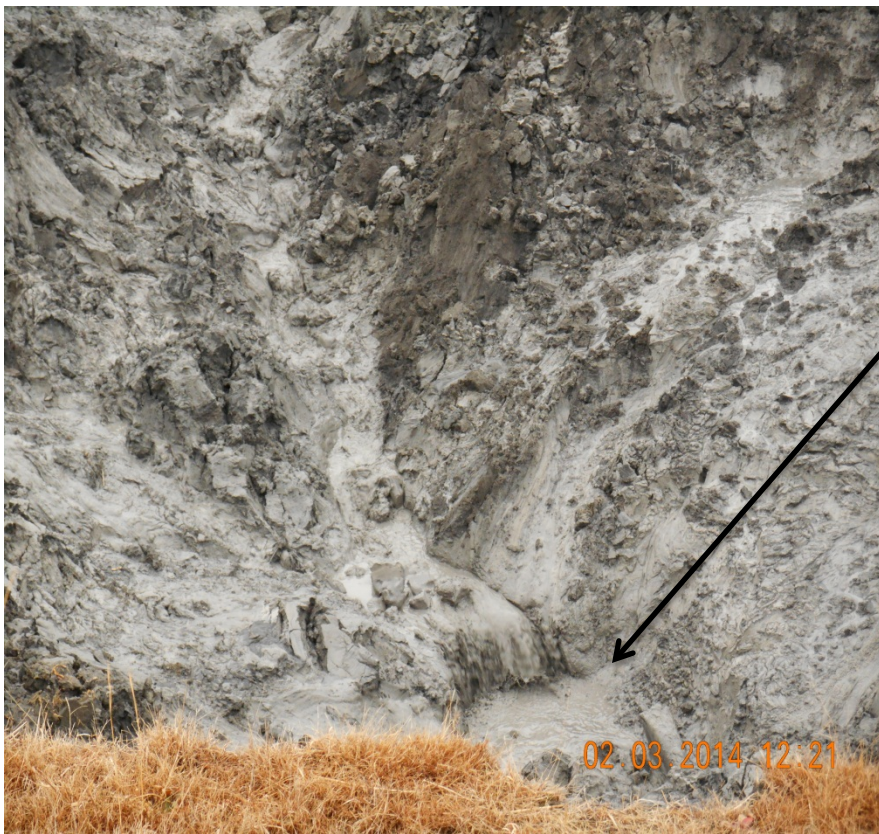
Looking at area where collapsed pipe is thought to be located. Water & ash were entering 48" RCP in this area.

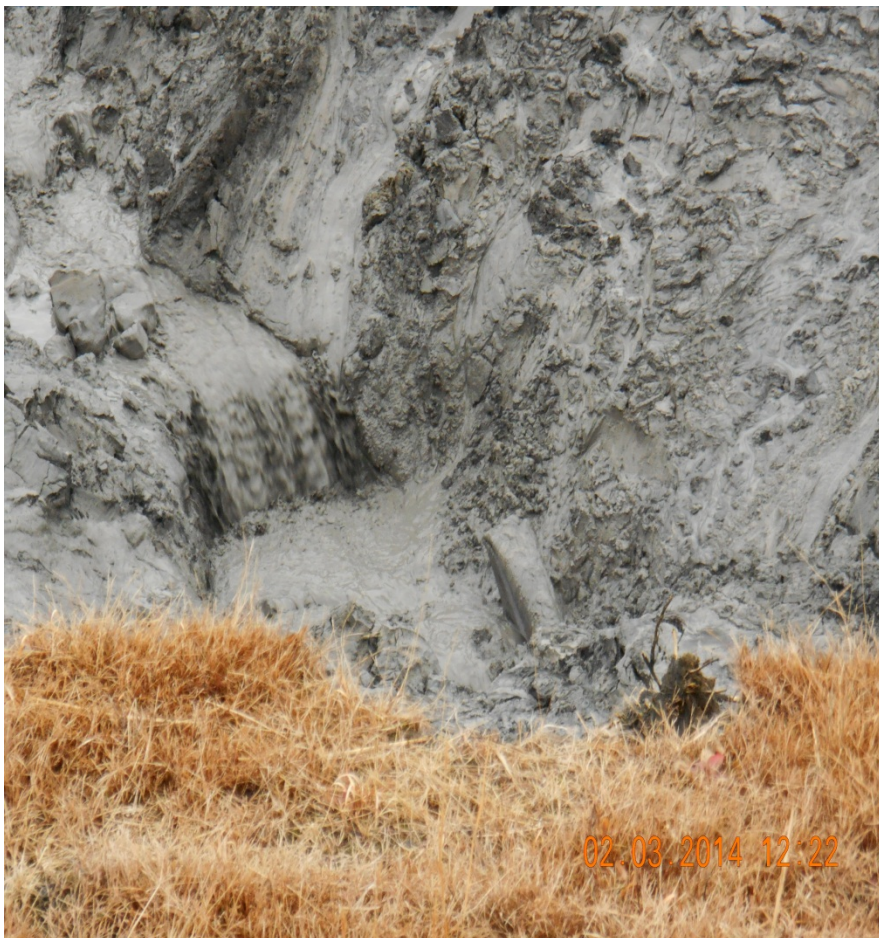
Close-up of area where collapsed pipe is thought to be located. Water & ash were entering 48" RCP in this area.

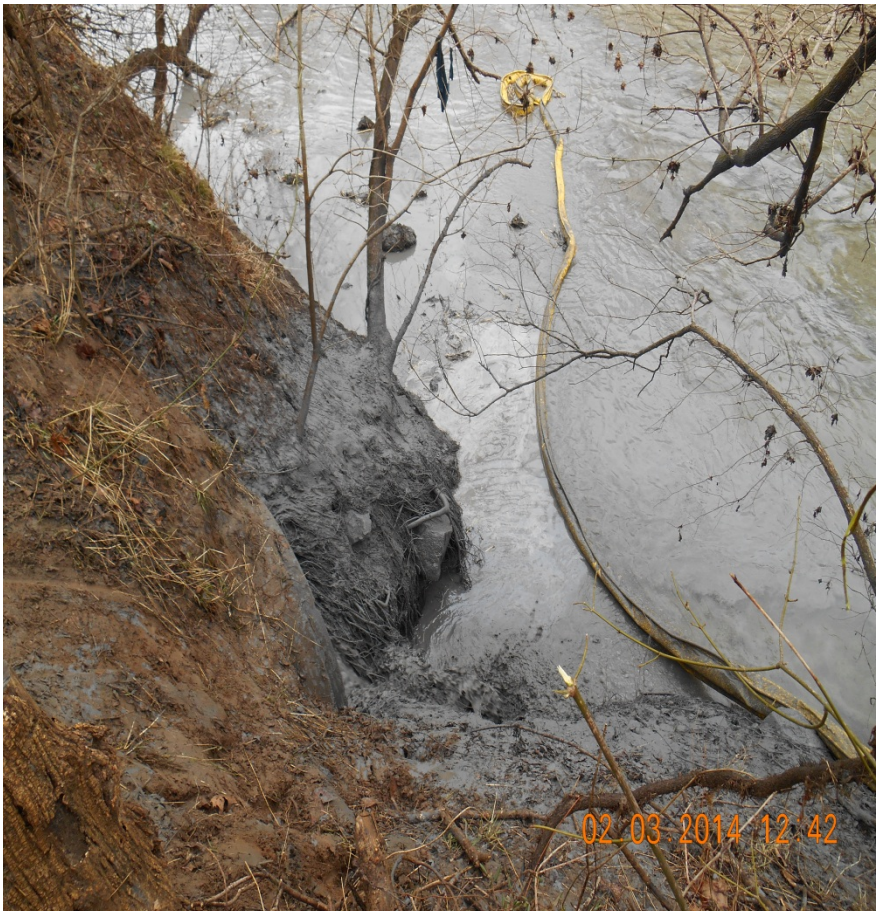
02.03.2014 12:42

Looking at outlet of 48" RCP
where it empties into the Dan
River.

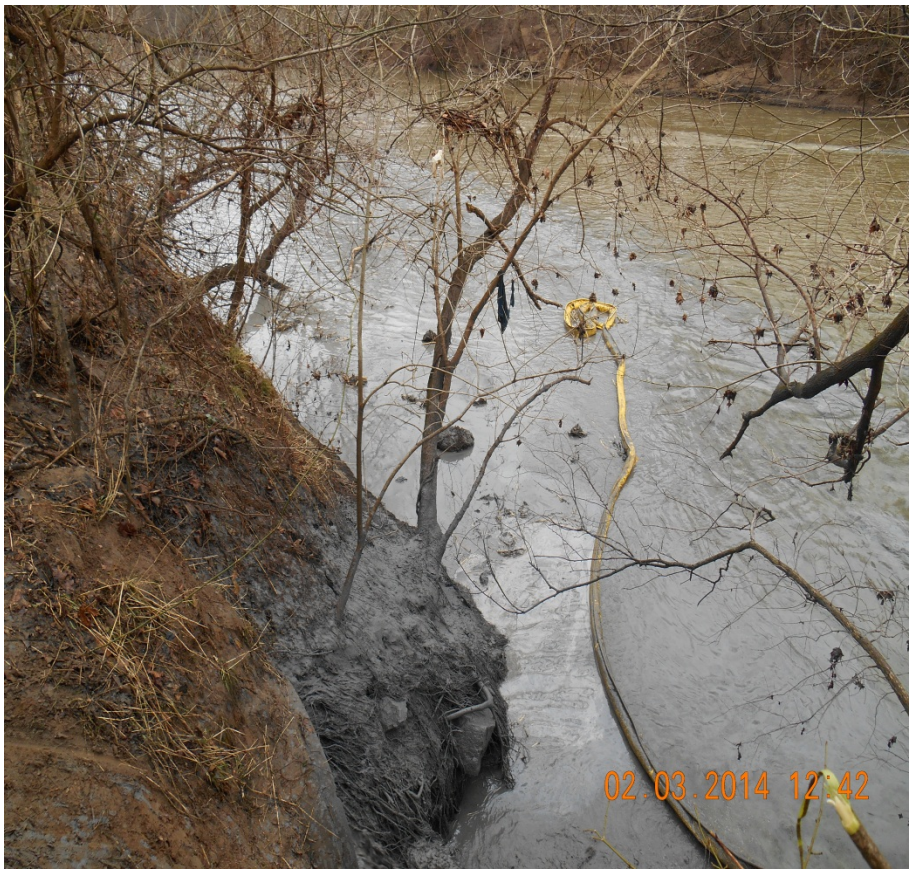
Looking at outlet of 48" RCP where it empties into the Dan River. You can visibly see the ash plume in the river.

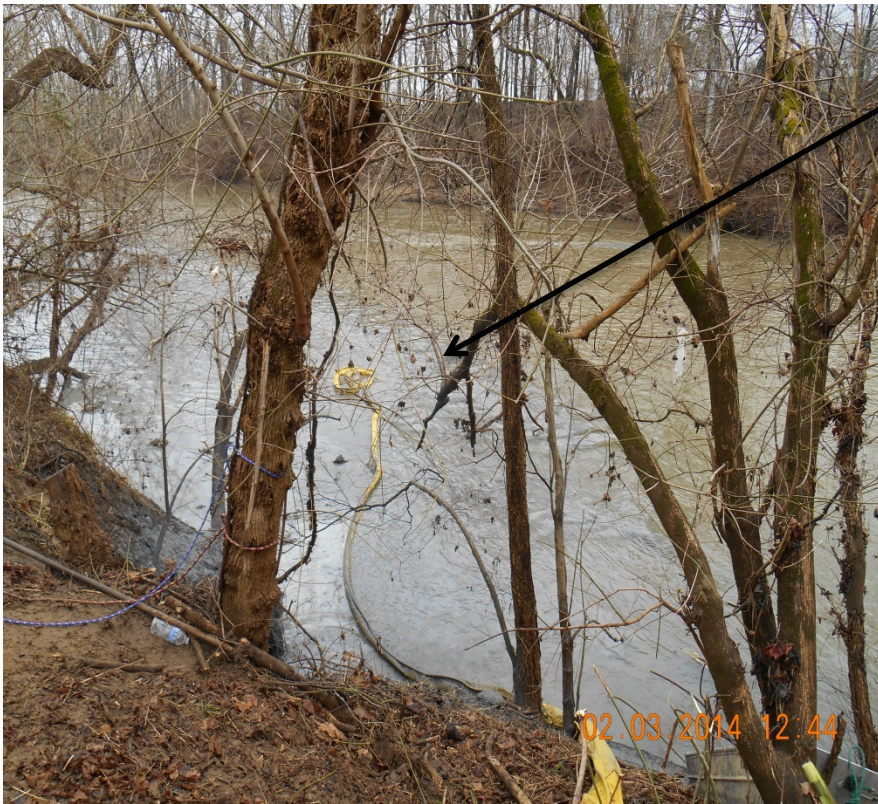
Visible ash plume in the river.

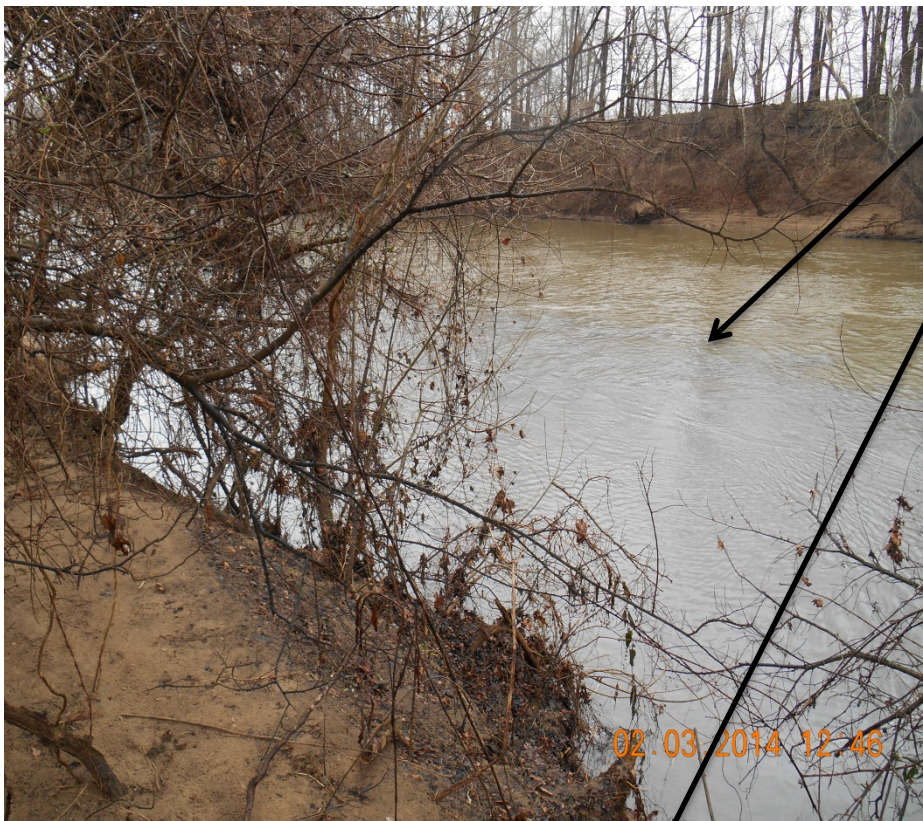
Visible ash plume in the river.

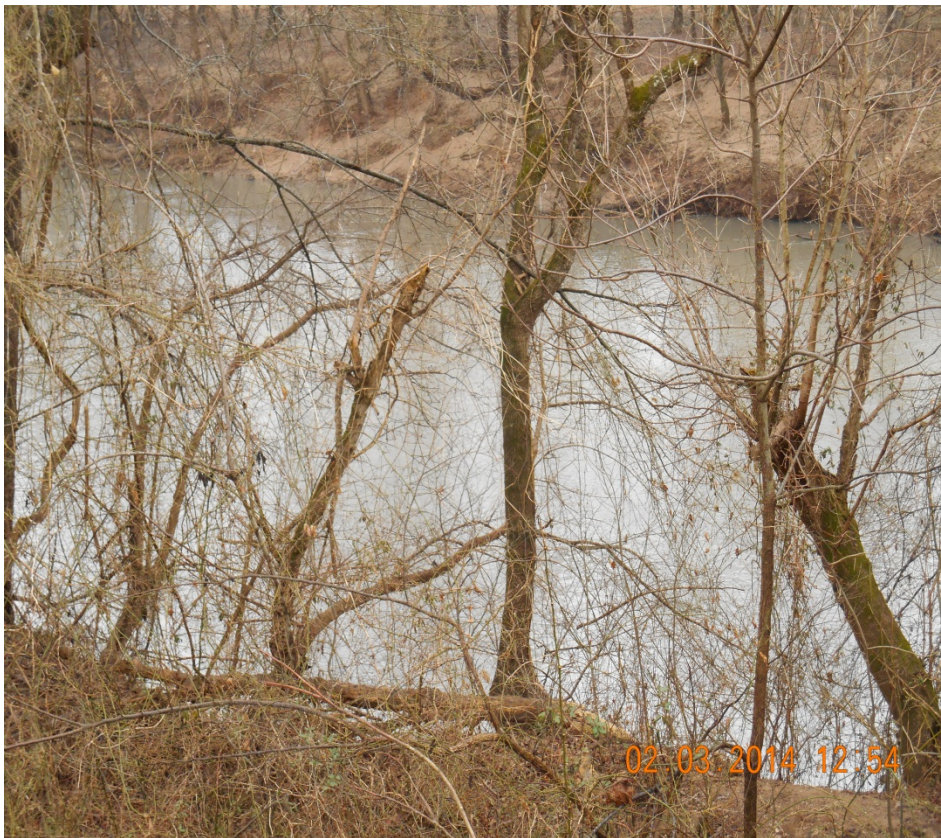
Farther downstream of 48'' RCP outlet. Entire river is completely discolored.

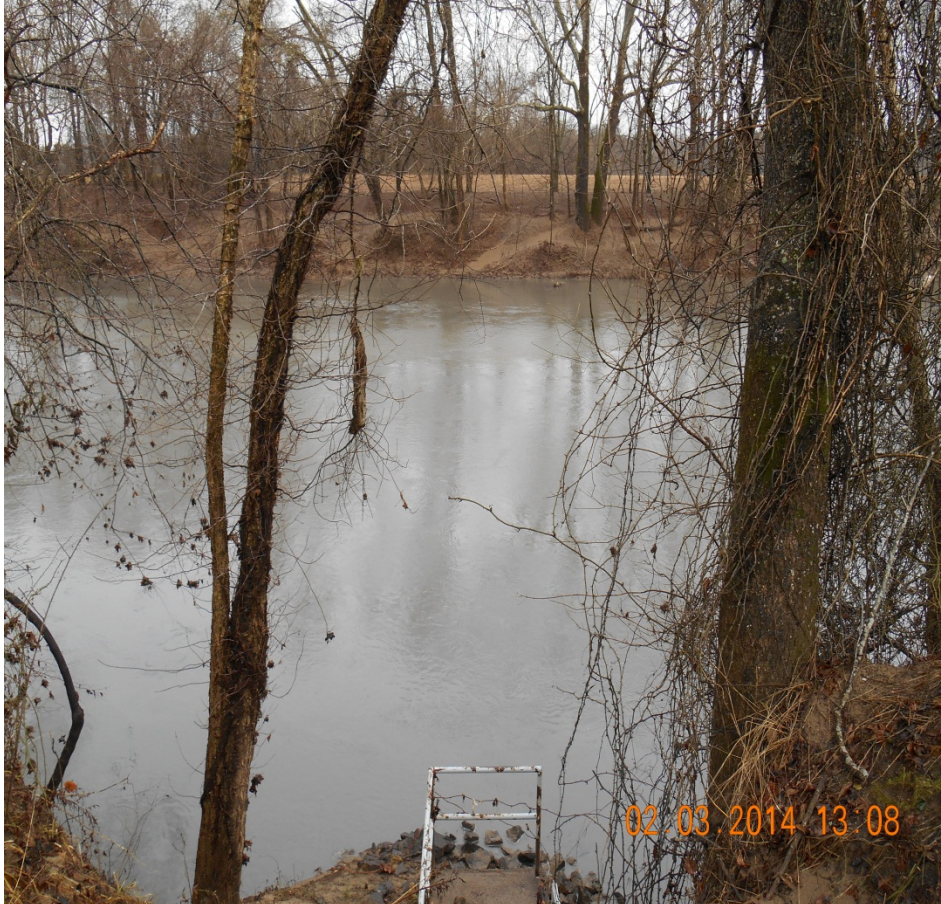
Farther downstream of 48'' RCP outlet. Entire river is completely discolored.

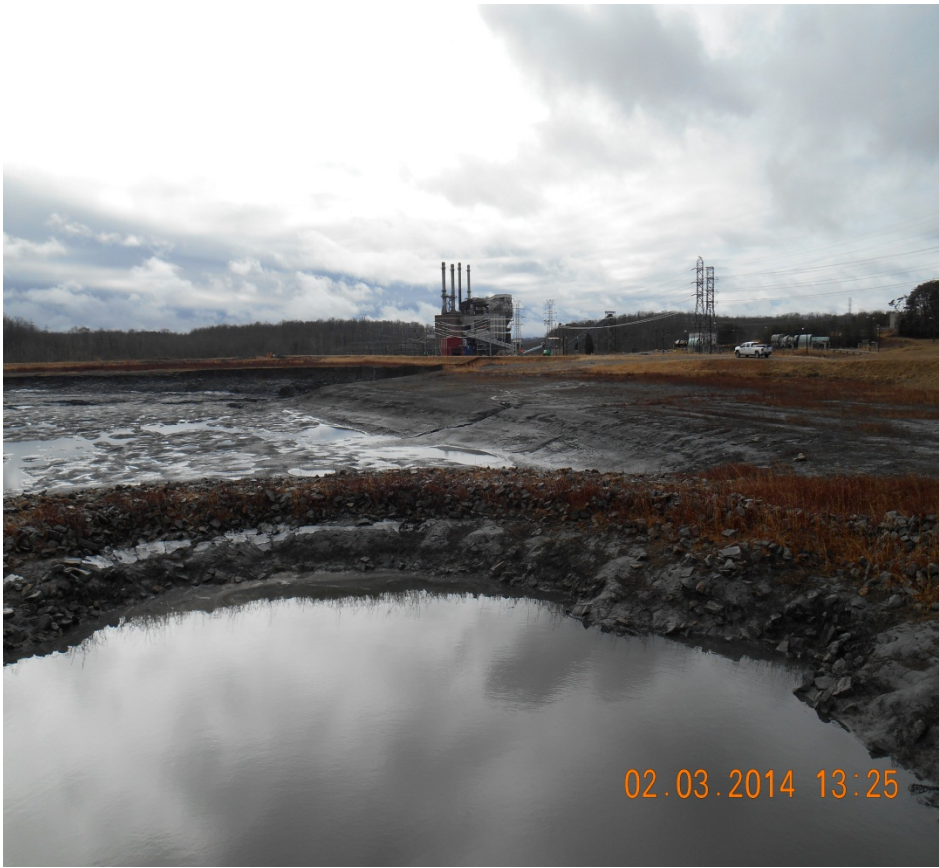
Standing on riser intake structure looking toward pipe failure area and upstream slope of the west side of dam.

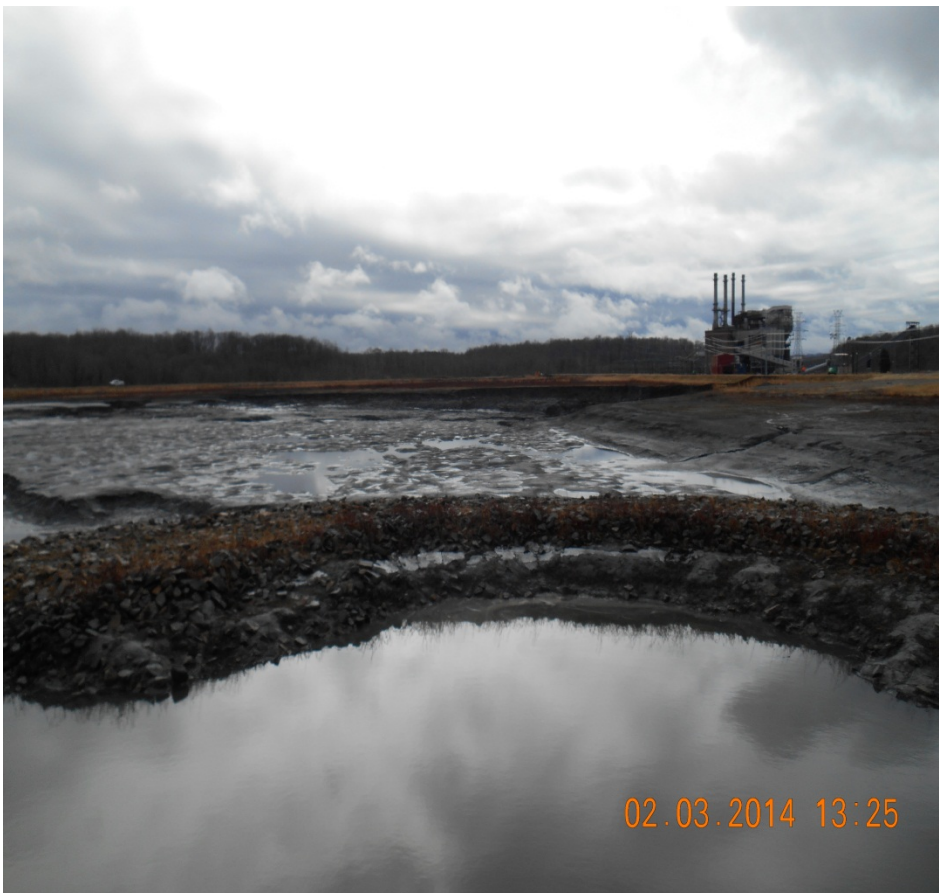
Standing on riser intake structure looking toward pipe failure area and upstream slope of the west side of dam.

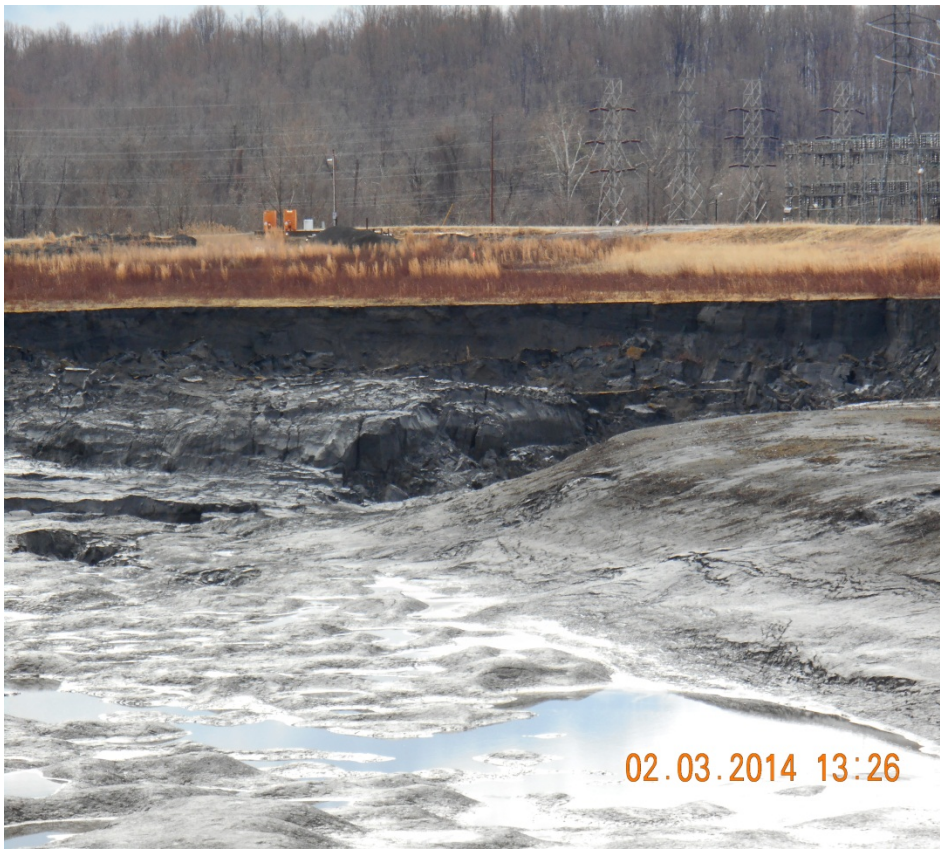
Standing on riser intake structure looking across impoundment area. Close-up of ash impoundment area.

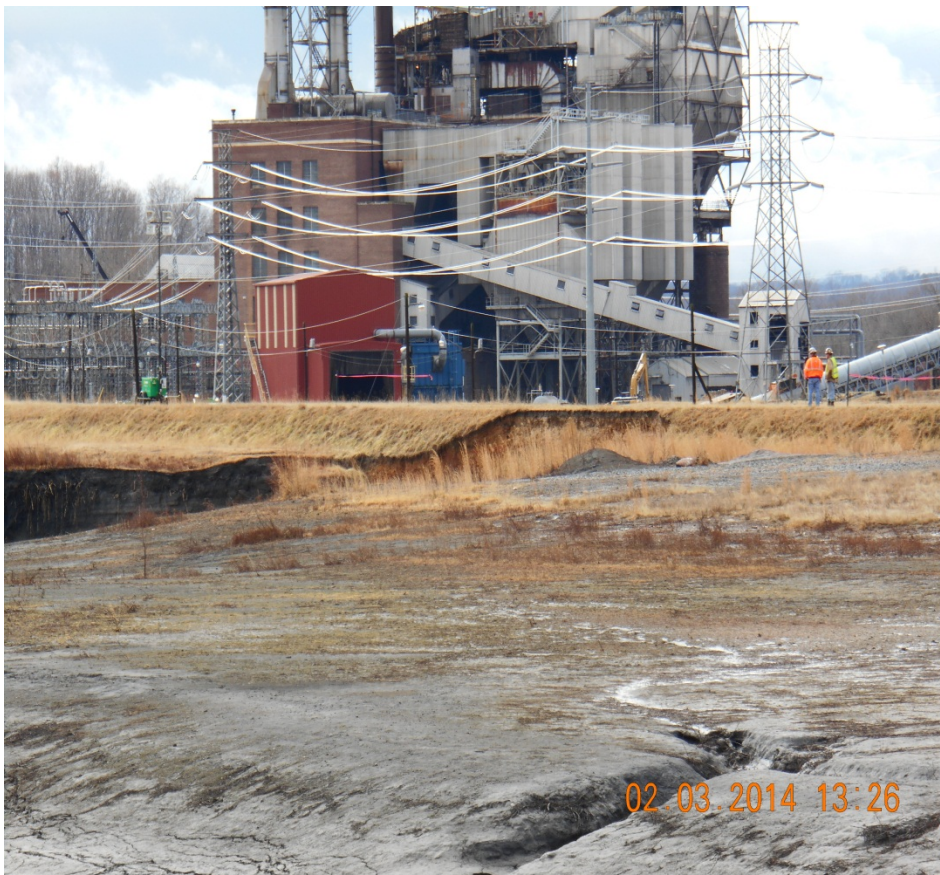
Standing on riser intake structure looking across impoundment area. Close-up of upstream slope failure.

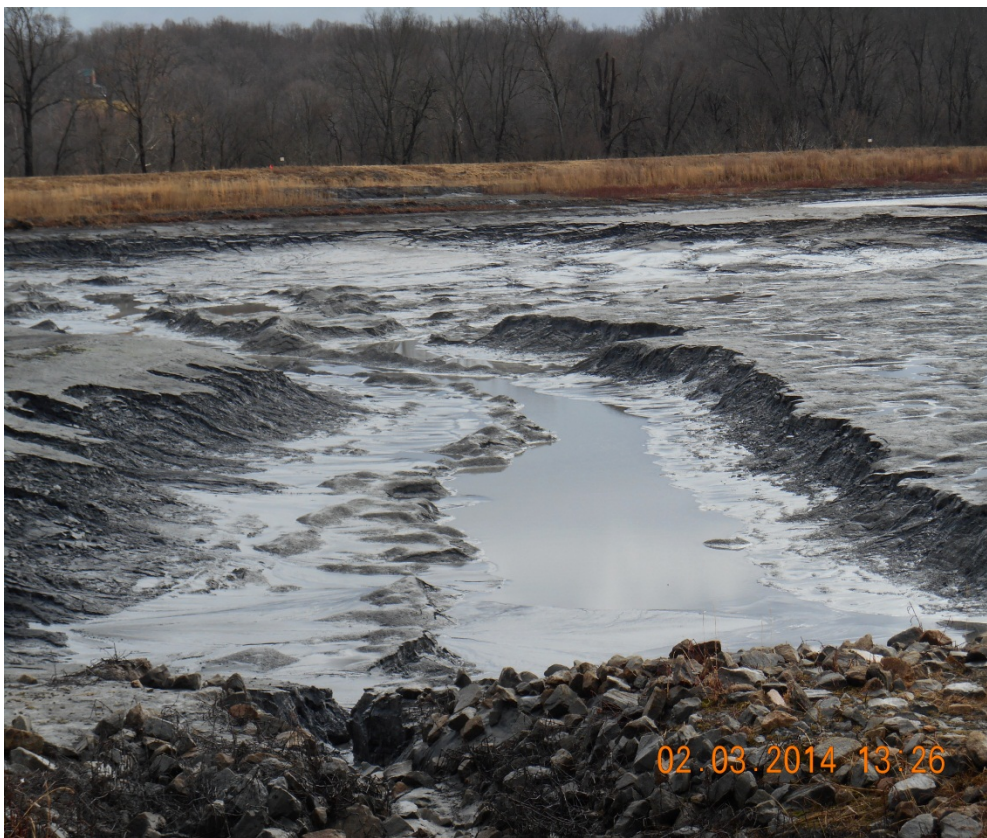
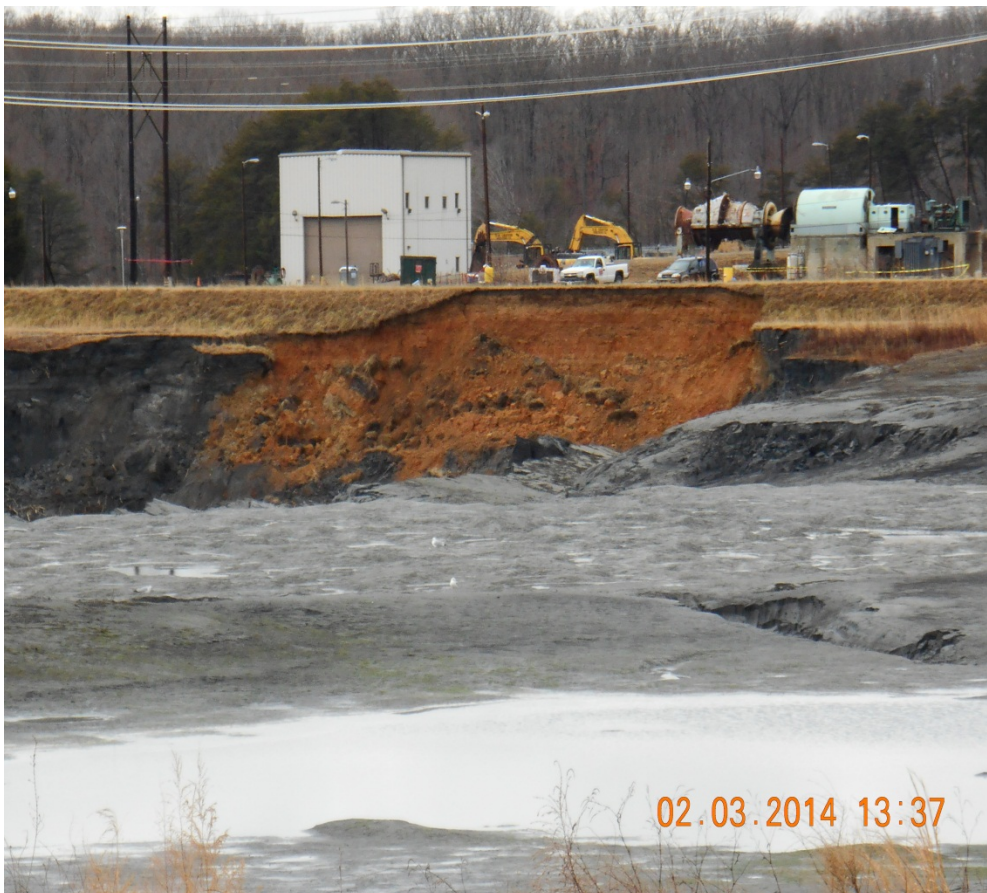
Standing on northeastern embankment looking across impoundment area to west embankment. Close-up of upstream slope failure.

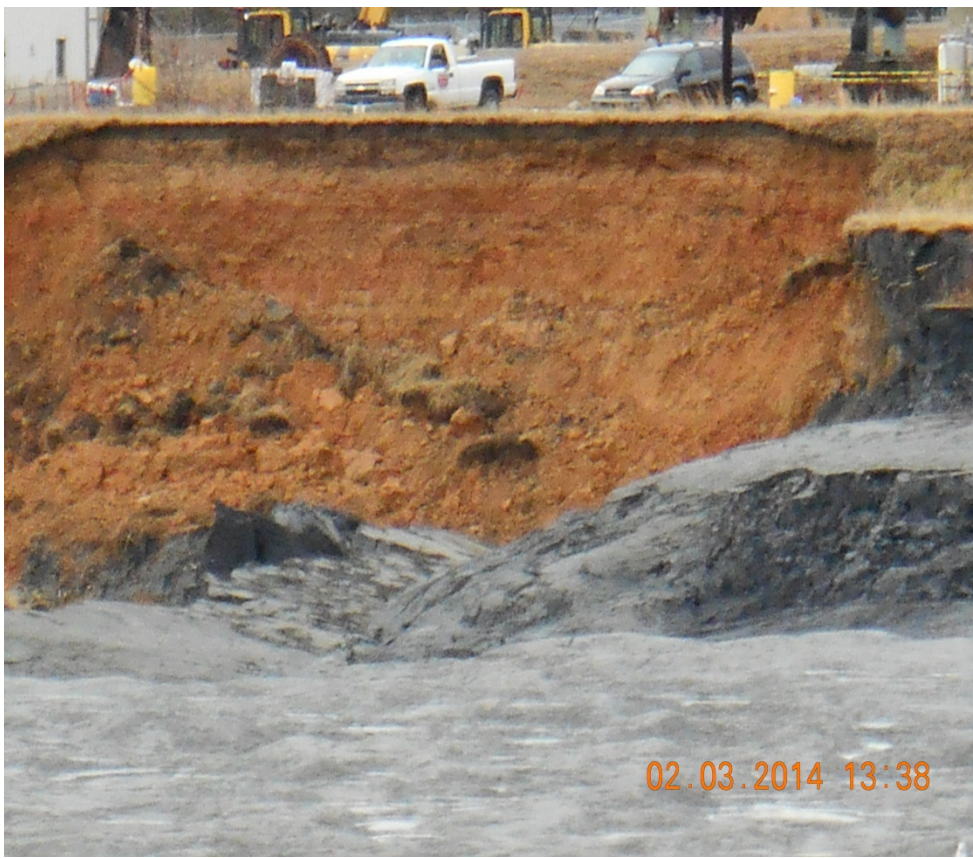
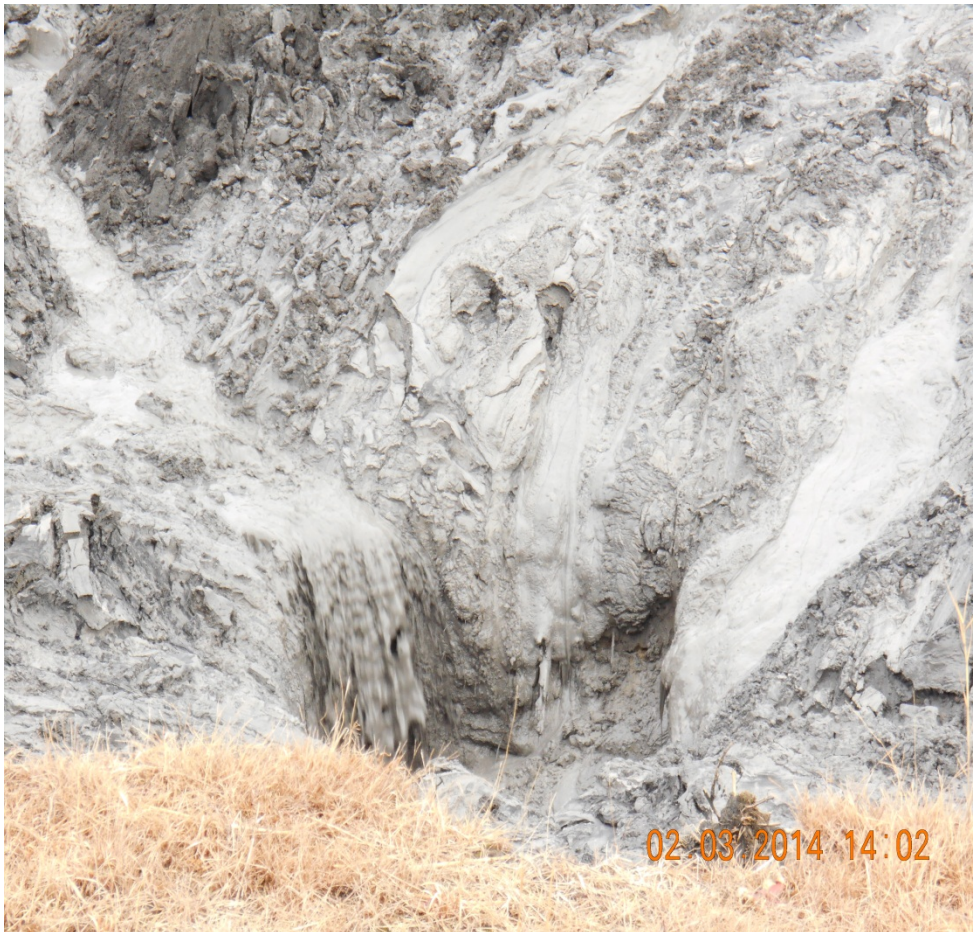
Close-up of 48" RCP failure area.

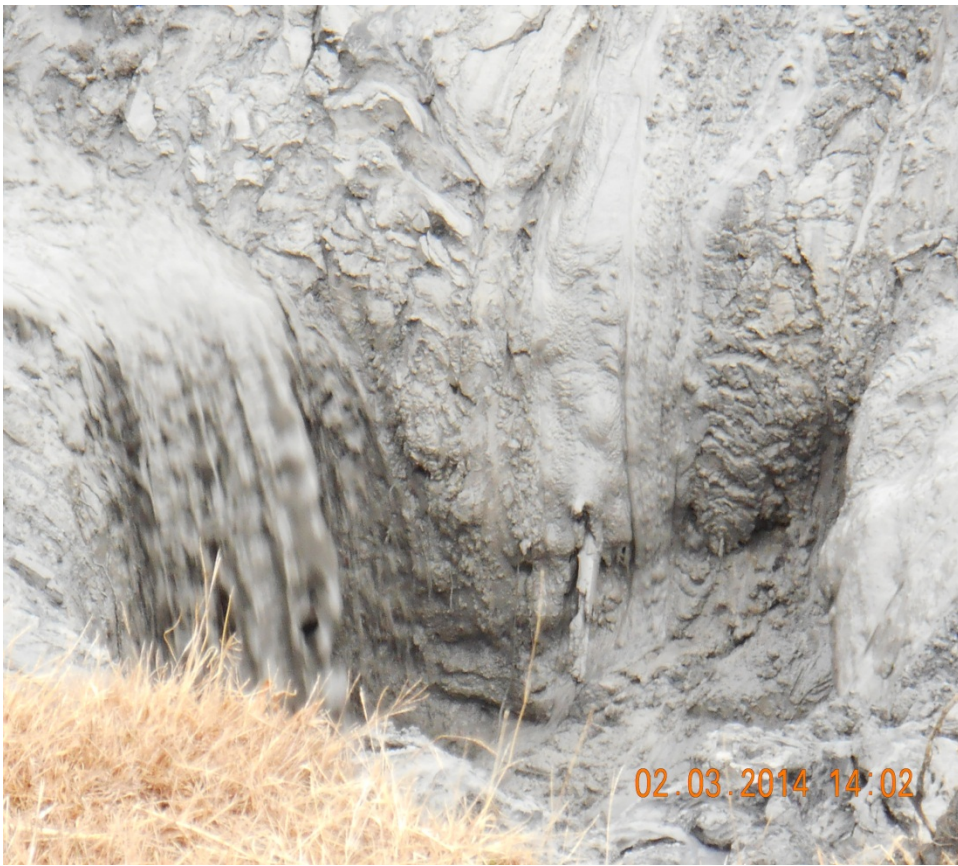
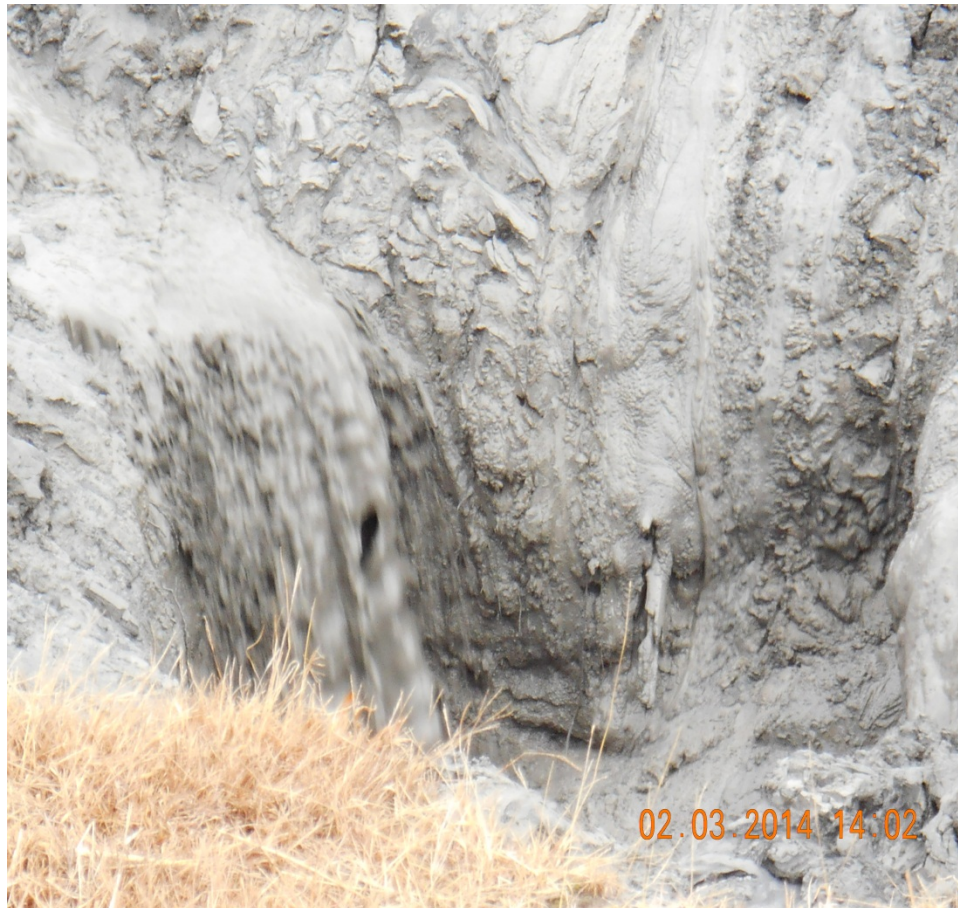
Close-up of 48" RCP
failure area.
