August 11, 2016

RE: Results of Borehole Geophysical Logging: ERT-44-S
Site: Crown Cleaners Superfund Site, Village of Herrings, NY

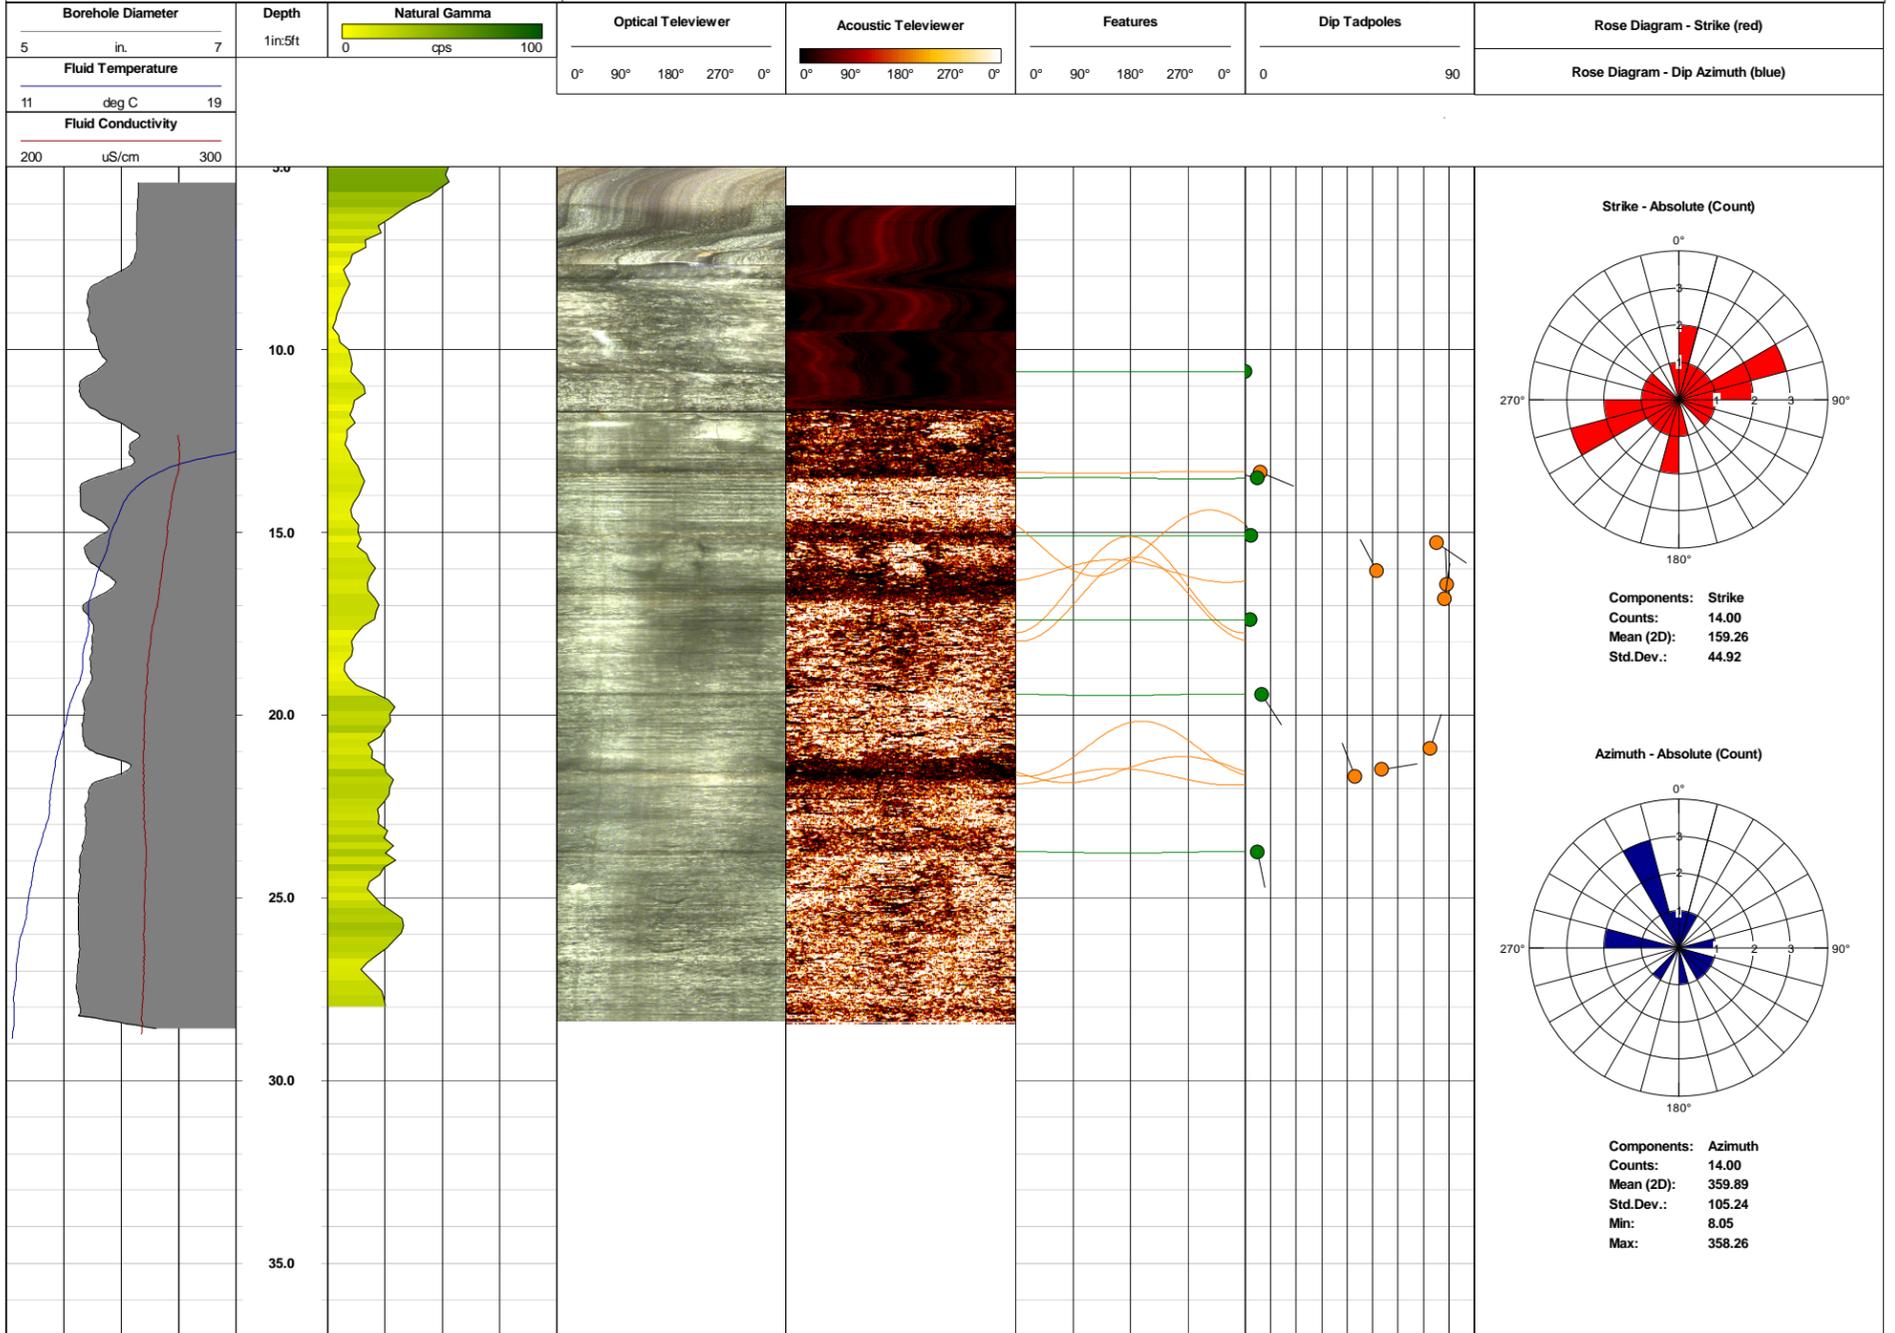
- Hairline features observed near 13', 15', 16.5', & 21.5'
- Relatively uniform lithology throughout open borehole.

ATV & OTV features: 14 (see attached summary table and graphical presentation)

Apparent strike: East-Northeast – West-Southwest

Apparent dip: North-Northwest
