RE: Results of Borehole Geophysical Logging: ERT-45-S
Site: Crown Cleaners Superfund Site, Village of Herrings, NY

ERT-45-S

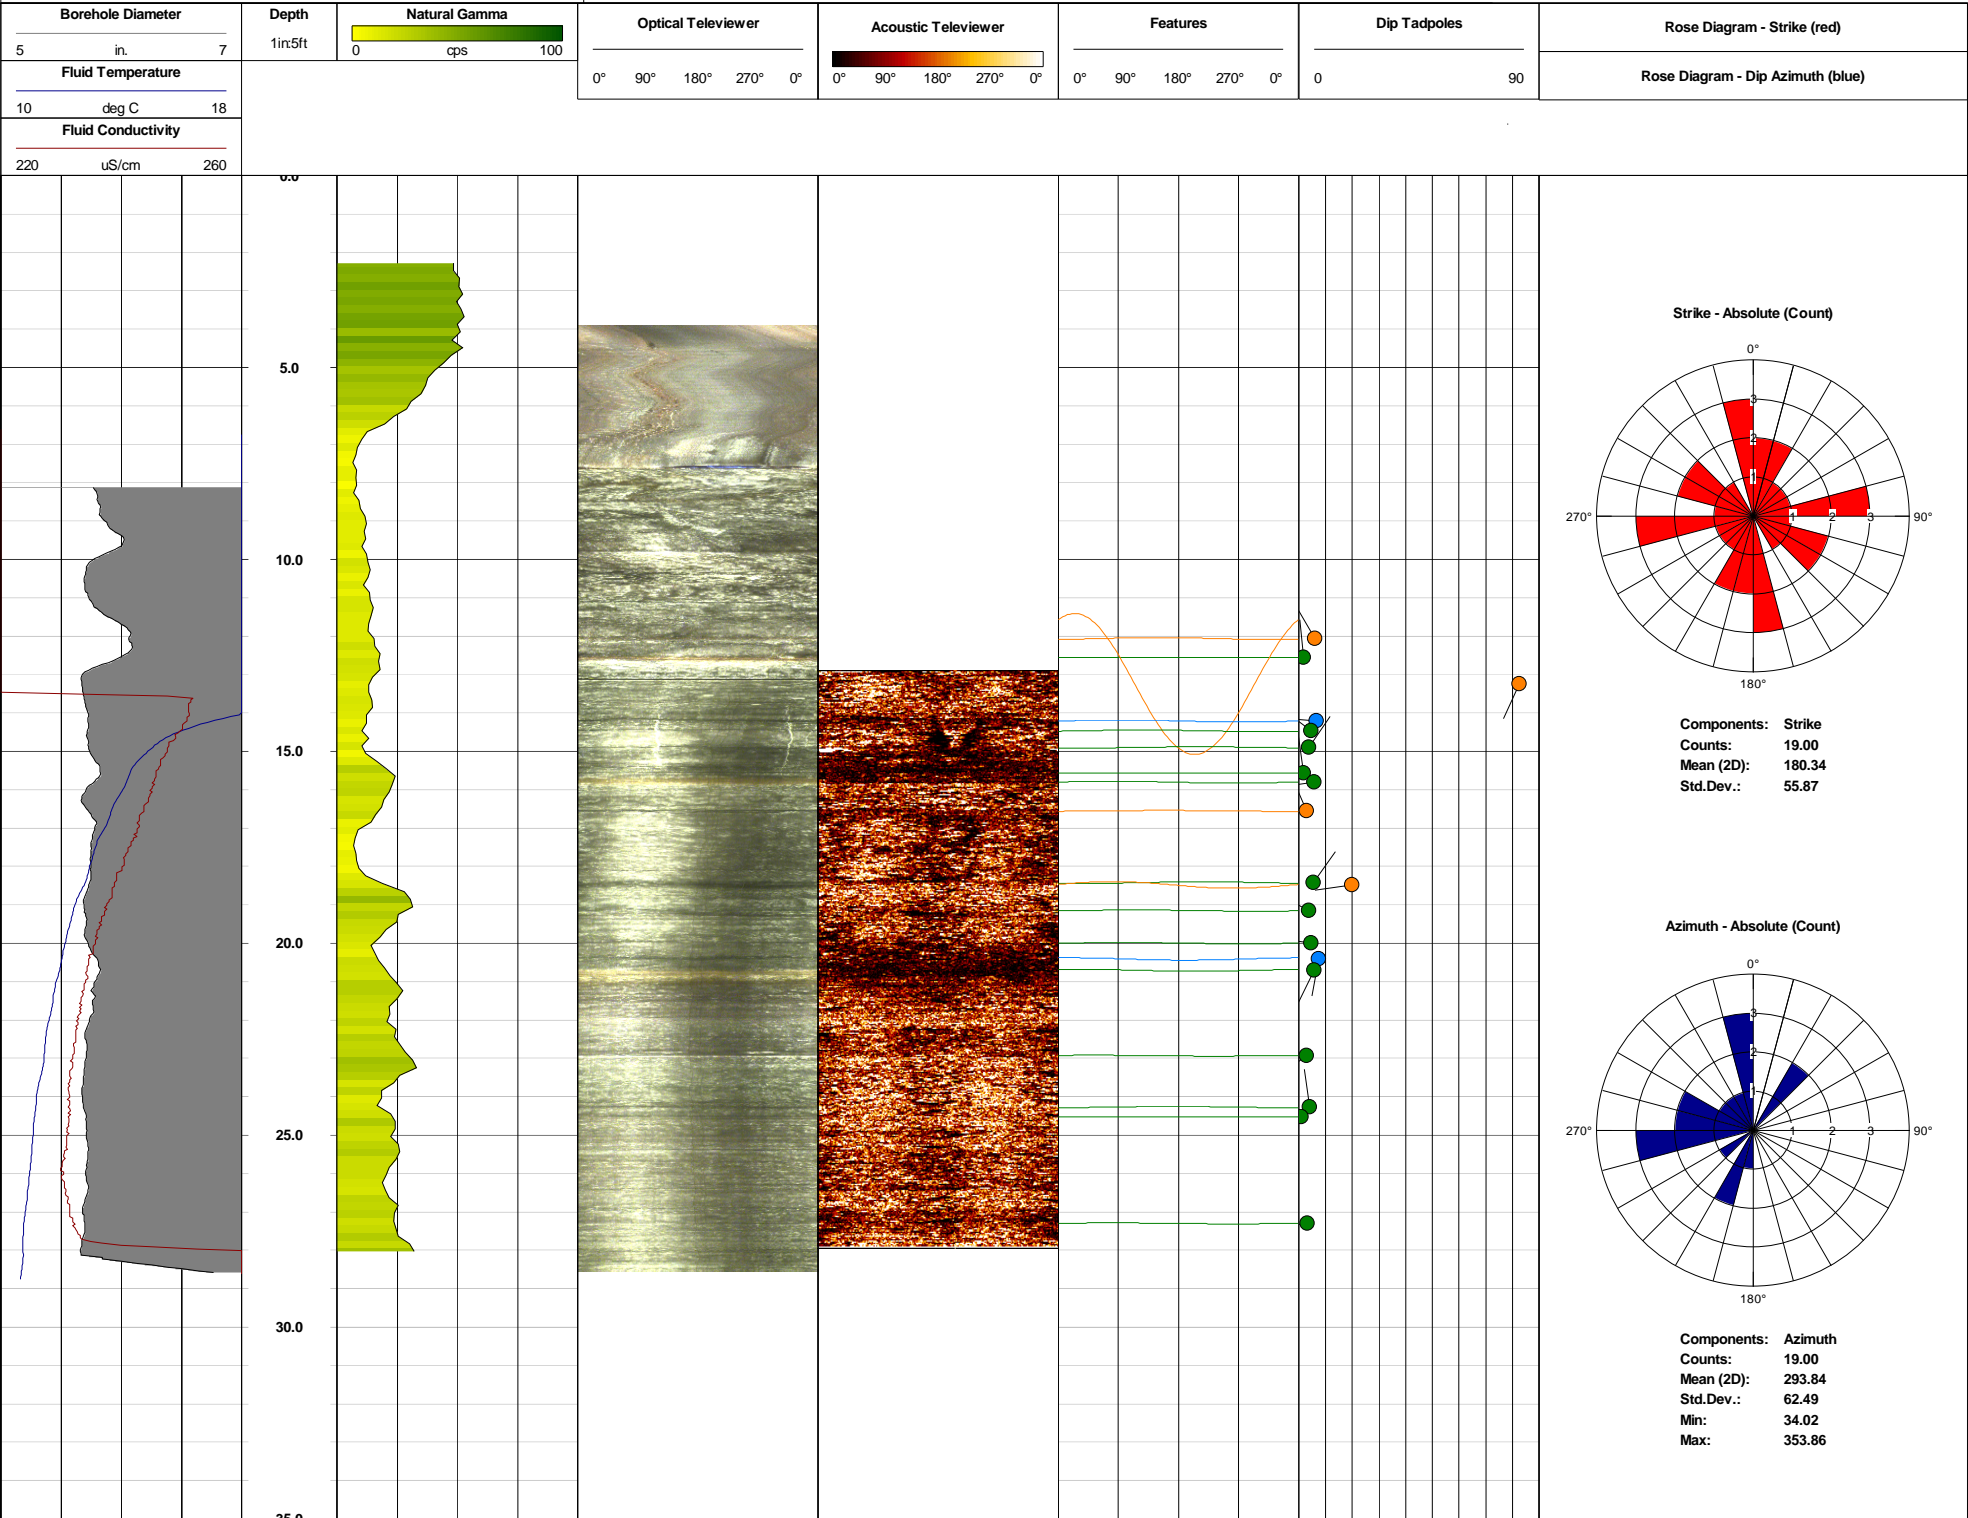
- Slight changes in the slope of the fluid temperature log at 16'. Gradual decrease in fluid temperature with depth.
- Fluid temp at the bottom of the borehole: 10.7°C
- Slight changes in the slope of the fluid conductivity log at 24'-26'. Sharp increase in conductivity at 28' may be due to sediment accumulation at the bottom of the well.

- Hairline features observed between 14'-16', 18.5', & 20.5'
- Relatively uniform lithology throughout open borehole.

ATV & OTV features: 19 (see attached summary table and graphical presentation)

Apparent strike: varies; North- – South & East – West

Apparent dip: varies; West & North
