August 11, 2016

RE: Results of Borehole Geophysical Logging: ERT-47
Site: Crown Cleaners Superfund Site, Village of Herrings, NY

ERT-47

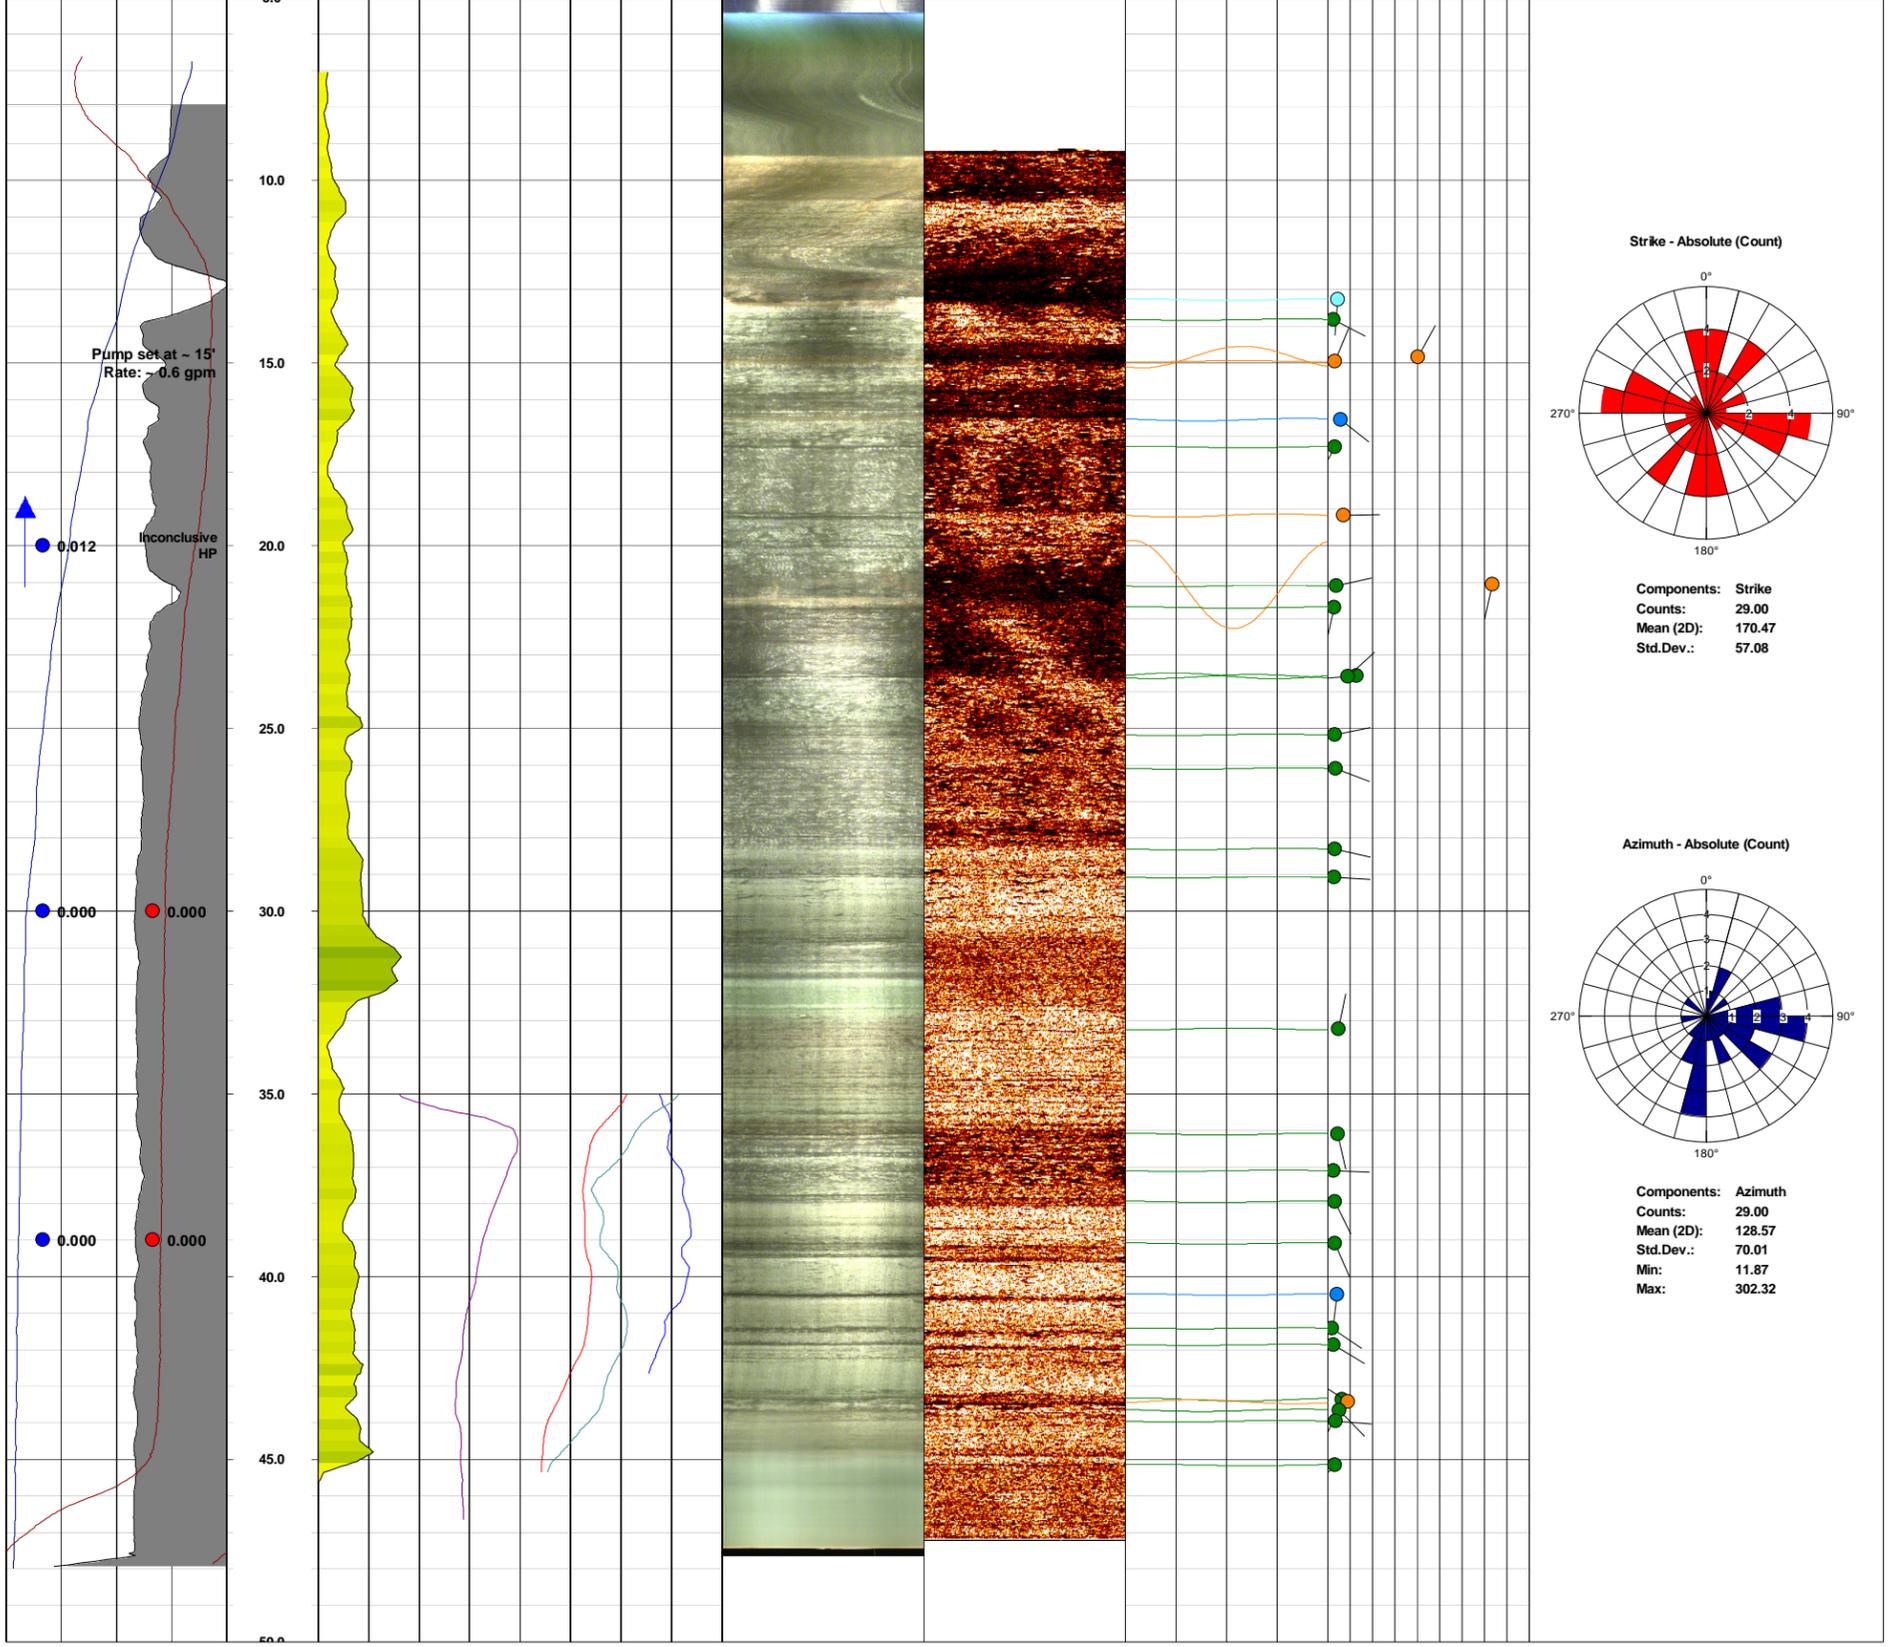
<p><i>Fluid characteristics:</i></p> <ul style="list-style-type: none"> - Slight changes in fluid temperature log slope at 14’, 16’, 23’, 27’, & 30’. - Fluid temp at the bottom of the borehole: 10.4°C - Changes in the slope of the fluid conductivity log between 13’, 18’, 22’, 25’, & 45’ <p><i>Rock characteristics:</i></p> <ul style="list-style-type: none"> - Larger feature/fracture observed between 12’-14’ - Smaller fractures observed at 10.5’, 15’-17’, 21.5’, & 40.5’ - Relatively uniform lithology throughout open borehole. Slight increase in natural gamma between 31’-32’.

ATV & OTV features: 29 (see attached summary table and graphical presentation)
 Apparent strike: East-Southeast – West-Northwest & North-Northeast – South-Southwest
 Apparent dip: South-Southwest & East-Southeast

- The operating range of the heat pulse probe is 0.03 gpm to 1.0 gpm. Values less than 0.03 gpm are provided for qualitative purposes only.
- Inflow zones (water flowing into the borehole) are generally observed where flow directions diverge from an area/feature within the borehole or increase in strength while moving in the same direction. The largest *increase* in upward flow was observed between 20’-30’ (potential inflow zone) under ambient conditions.

- Outflow zones (water flowing out of the borehole and into the formation) are generally observed where flow directions converge on an area/feature or decrease in strength while moving in the same direction. An outflow zone may exist above 20’.
- During the pumping portion of the heat pulse testing (lasting approximately 30 minutes), a total of 2.5’ of drawdown was observed, at a pumping rate of approximately 0.6 gpm.
- The accuracy and reliability of the heat pulse flowmeter are dependent on borehole conditions. If the borehole fluid is turbulent or heavily impacted with particulates, the log may be unintelligible and/or produce inconclusive results.
- It is important to note that the open borehole creates a conduit for water to flow between fractures. Therefore, flow patterns may not be indicative of the natural conditions that existed prior to the commencement of drilling operations.
