August 11, 2016

RE: Results of Borehole Geophysical Logging: ERT-48-S
Site: Crown Cleaners Superfund Site, Village of Herrings, NY

ERT-48-S

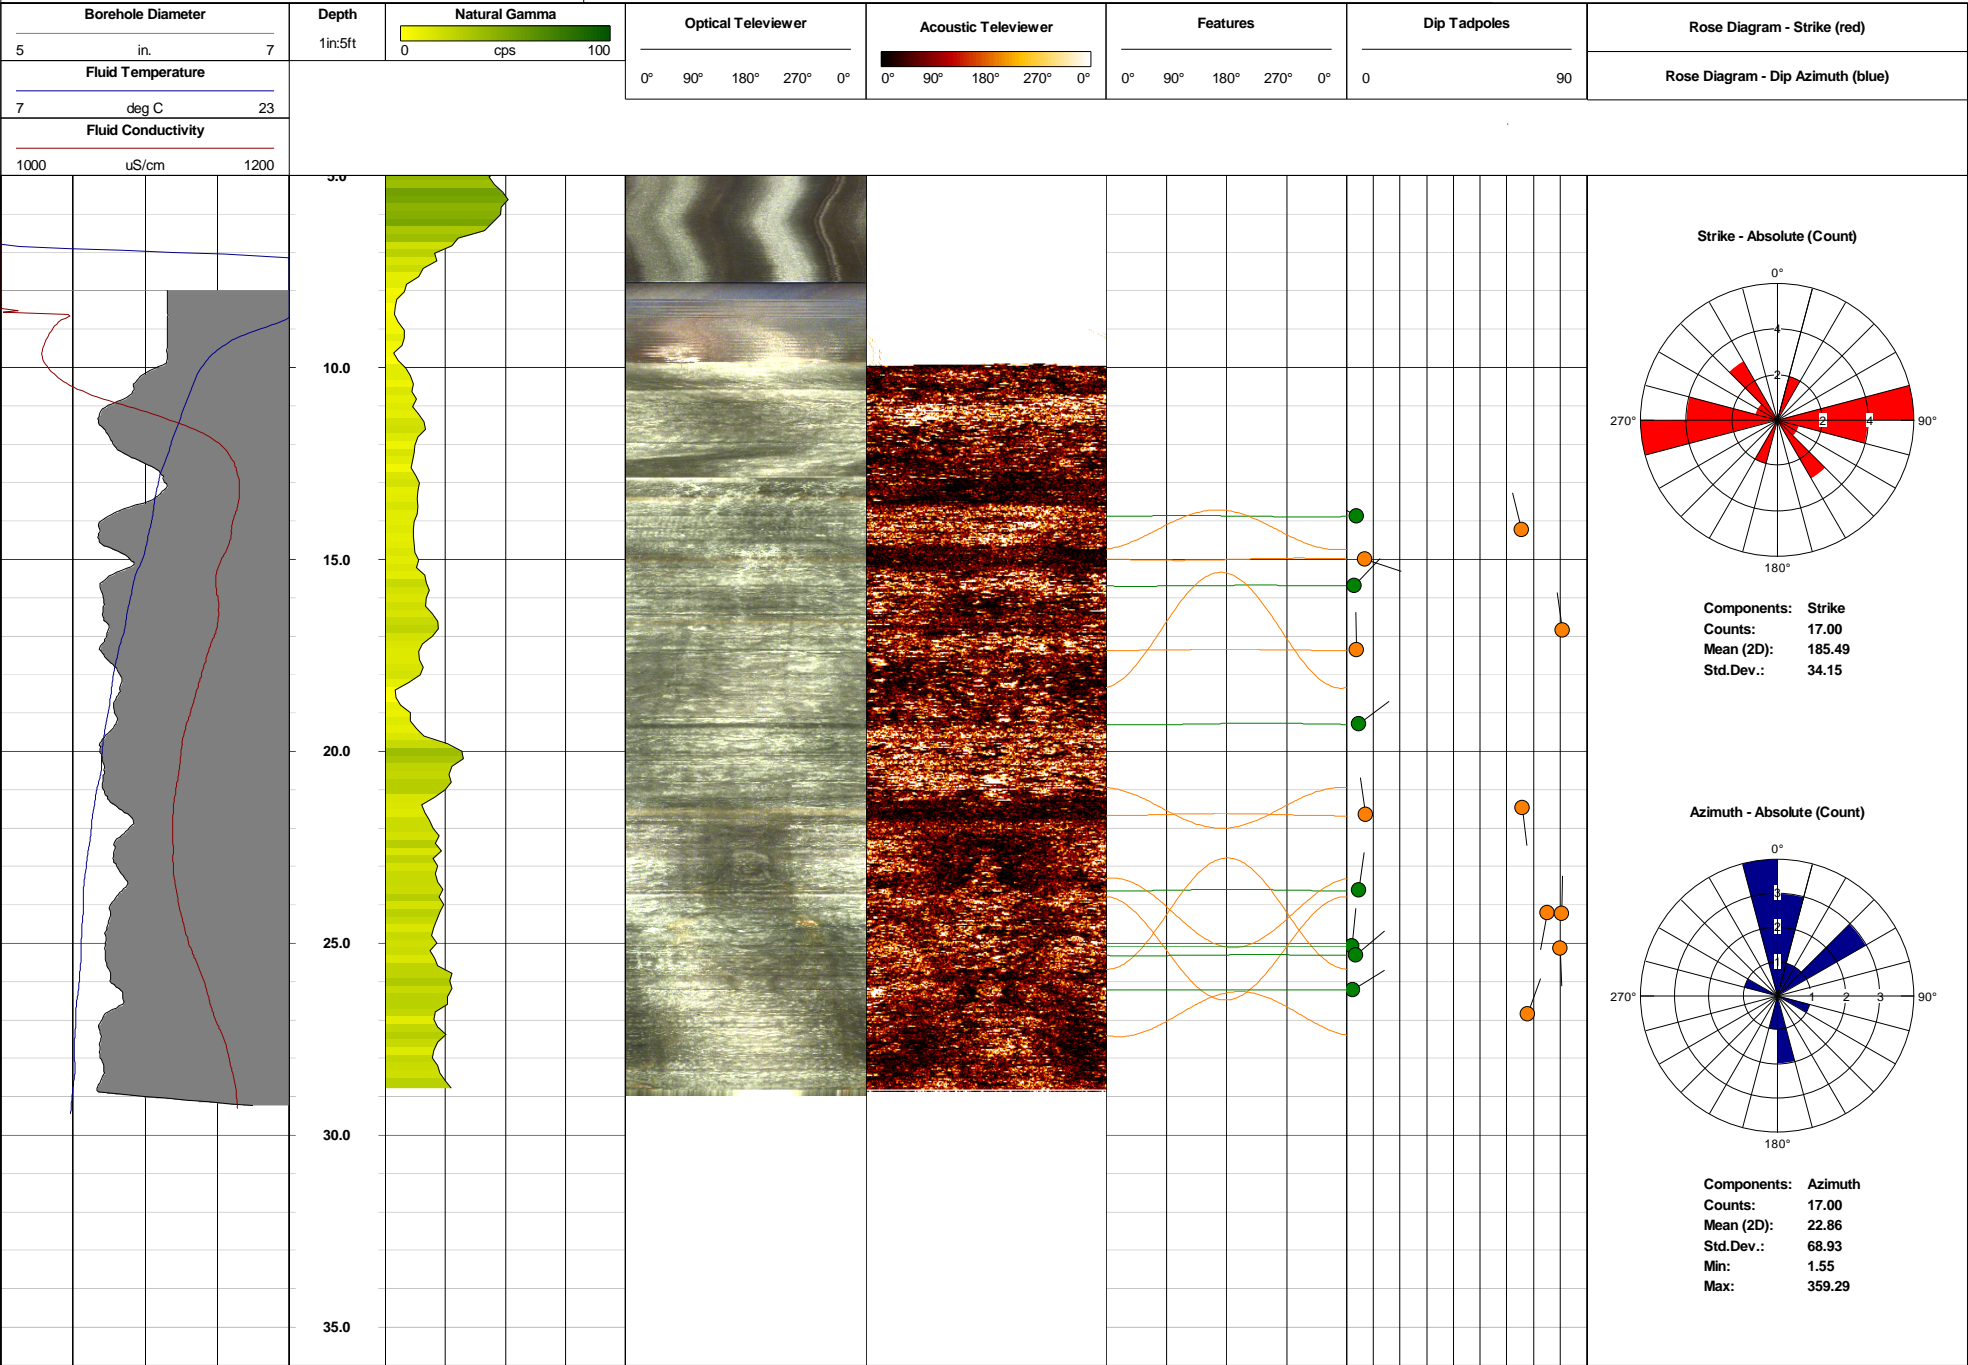
- Gradual decrease in fluid temperature from 10' to depth. Slight changes in log slope at 13', 15', 20', & 26'.
- Fluid temp at the bottom of the borehole: 10.9°C
- Changes in the slope of the fluid conductivity log at 10', 13', 15.5', & 23'

- Larger feature observed between 12'-14'
- Smaller features observed at 15', 18'-19', 22', 23.5', & 26.5'
- Relatively uniform lithology throughout open borehole. Slight increase in natural gamma at 20'.

ATV & OTV features: 17 (see attached summary table and graphical presentation)

Apparent strike: East – West

Apparent dip: North
