Lessons Learned LOUDONVILLE, OH

February 3, 2018 Loudonville, Ohio

INITIAL NS ICS 201

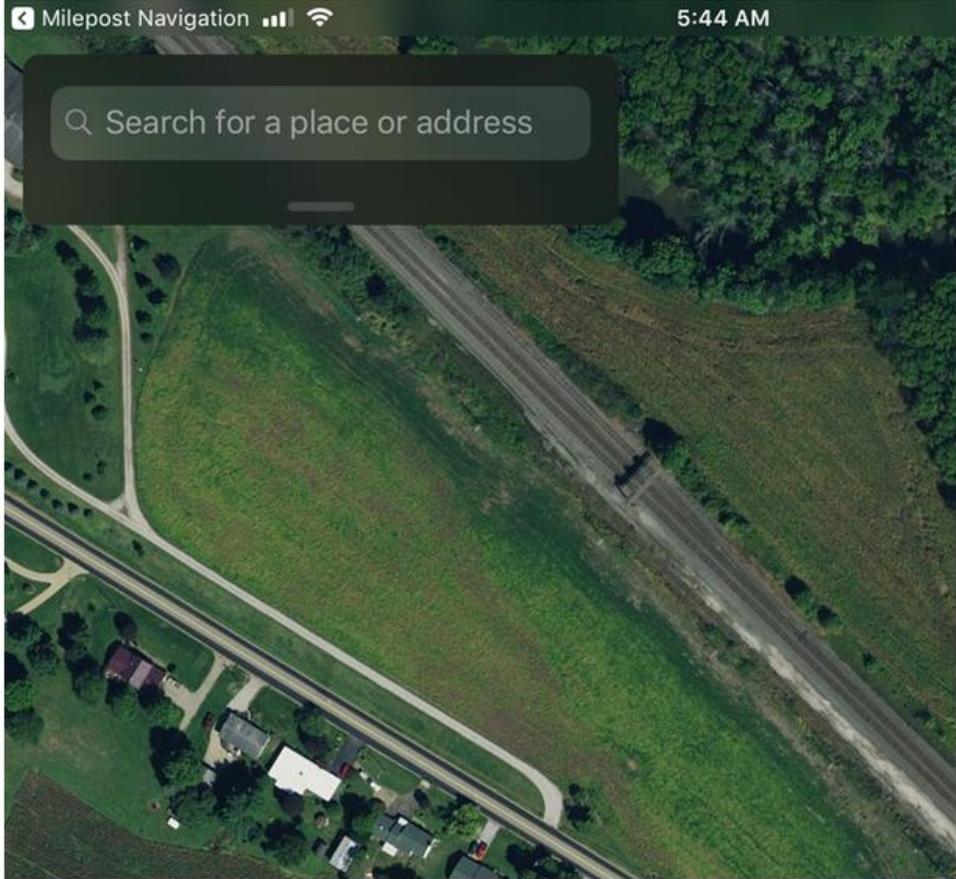
3. Map/Sketch (include sketch, showing the total area of operations, the incident site/area, overflight results, trajectories, impacted shorelines, or other graphics depicting situational and response status)

12V.02, 210am, CP-Mohican, OH mp-PC157.4 (Loudonville, OH) derailed 15+ cars starting at the 95th head car.

The derailment contains at least 4 hazmat cars.

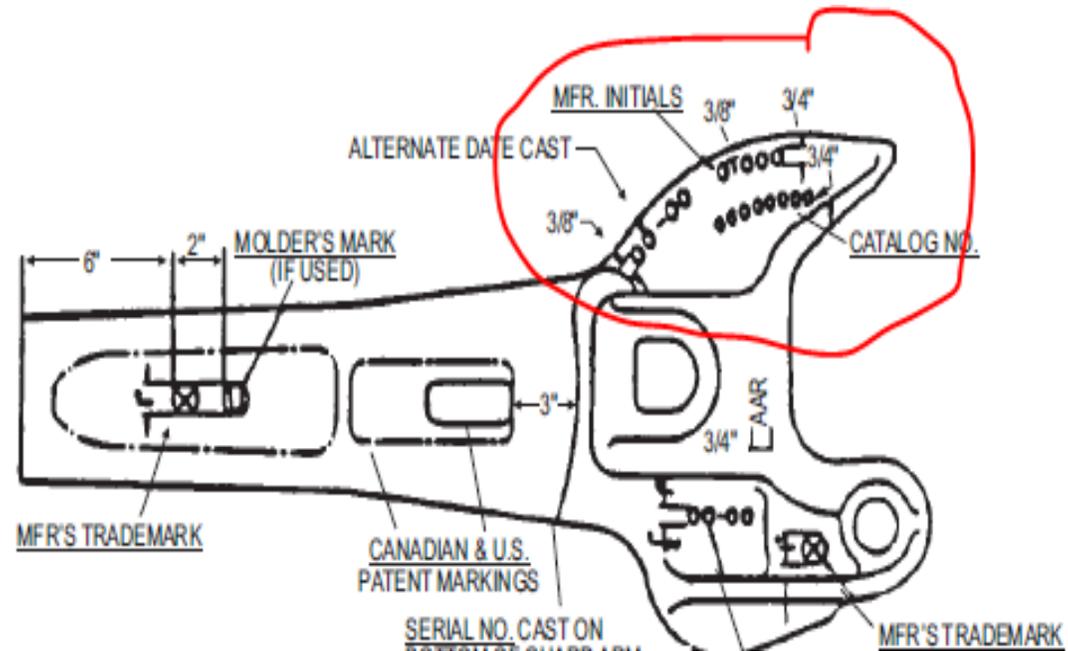
The section of the coupler circled in red below is called the “guard arm”.
