**Otsego Township Dam Area
Time Critical Removal Action**

**DRAFT
Final Maintenance and Monitoring Report**

Prepared by:
**Wood Environment & Infrastructure Solutions, Inc.
Novi, Michigan**

November 15, 2019

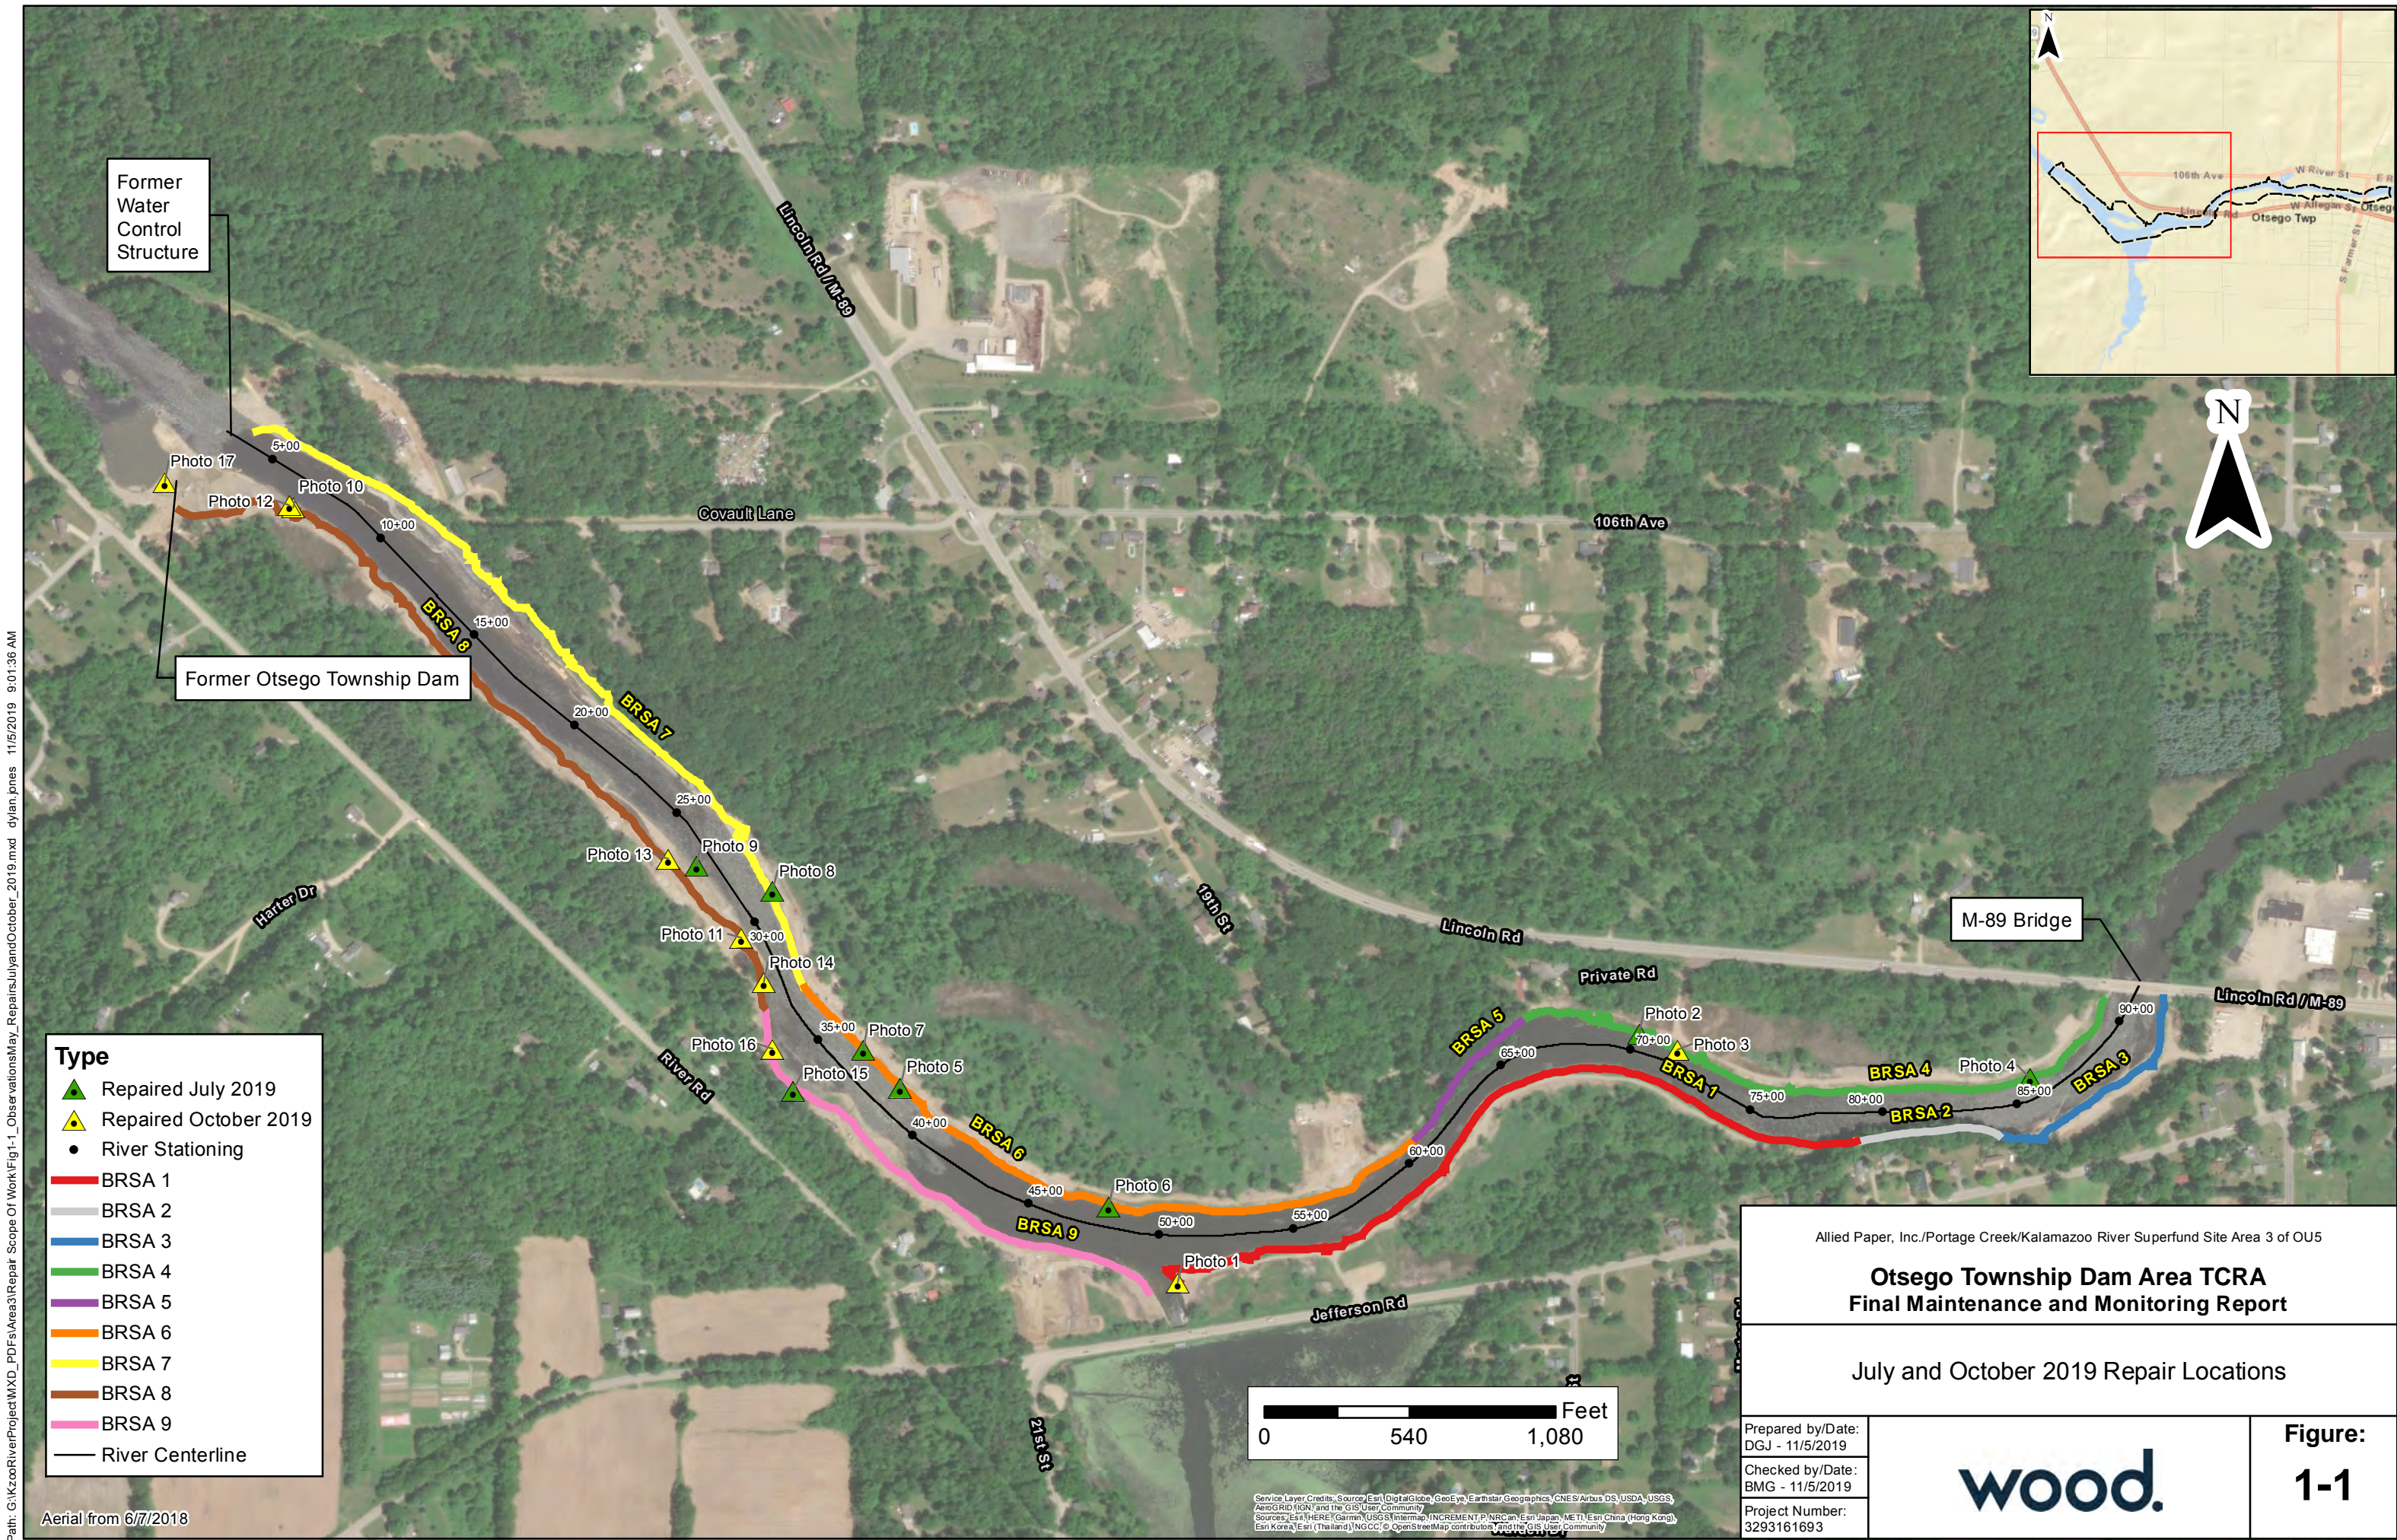
The completed repairs are described below, and were completed consistent with previously issued technical memoranda, design drawings, and restoration details. Repair locations are shown on Figure 1-1 and a photo log of the repairs is included as Attachment B. It should be noted that while Wood was on-Site to confirm completion of the repairs in October 2019, an MDNR contractor was observed using small equipment to plant trees in bank treatment areas, resulting in disturbance (e.g. ruts and tracks) in some of the restoration areas.

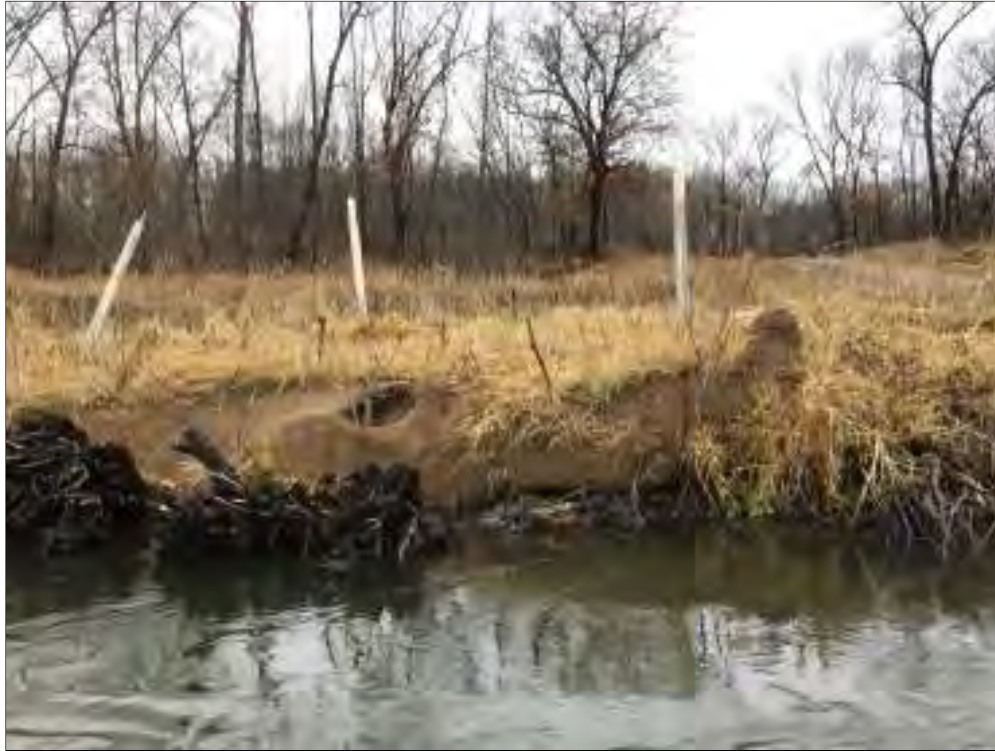
Photo 7: Area of settling observed along approx. 32 lineal feet of BRSA 4 bank, downstream of staging area.

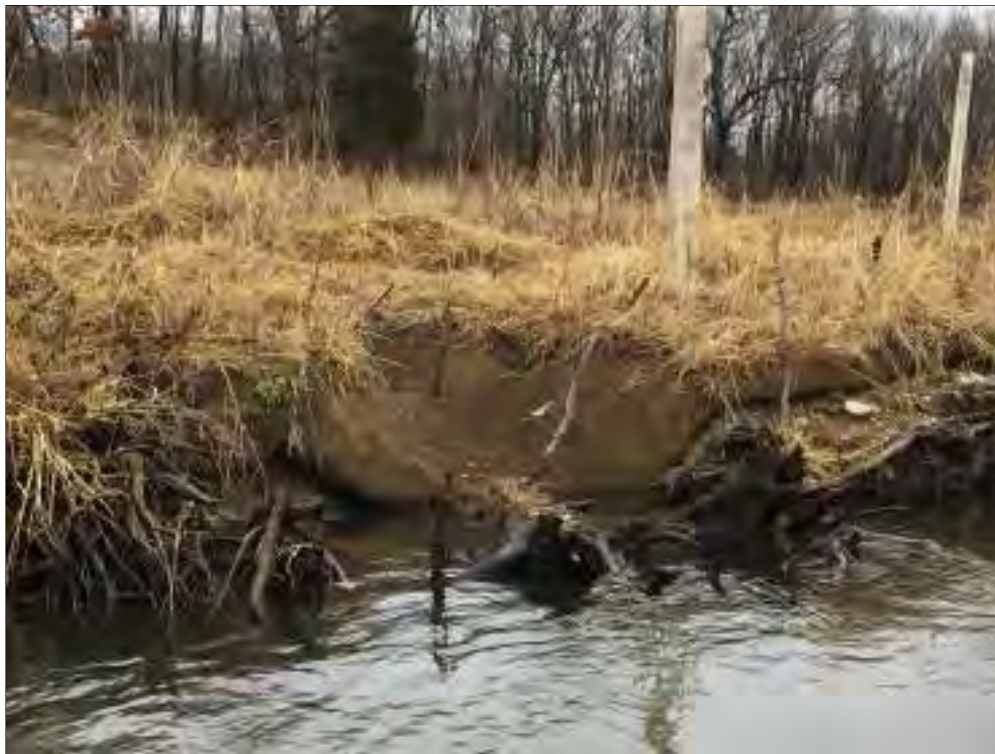
Photo 8: Area of settling observed on BRSA 4 bank, downstream of staging area (approx. 120 feet upstream of location in Photo 7).

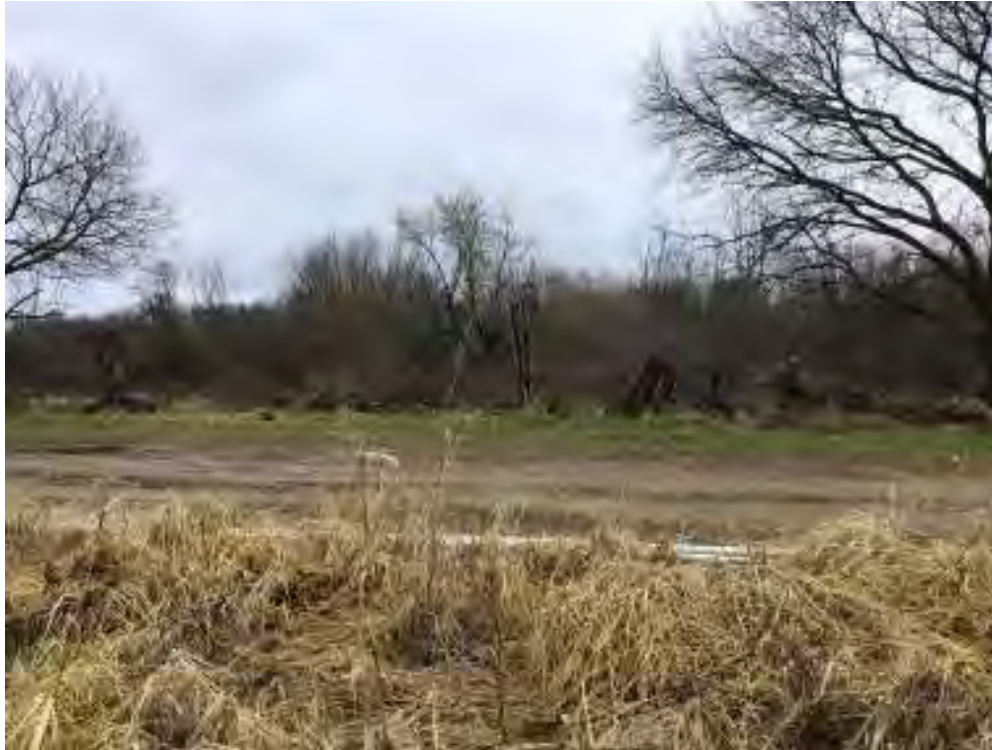
Photo 13: BRSA 6 root wad trees left vertical in turnaround area.

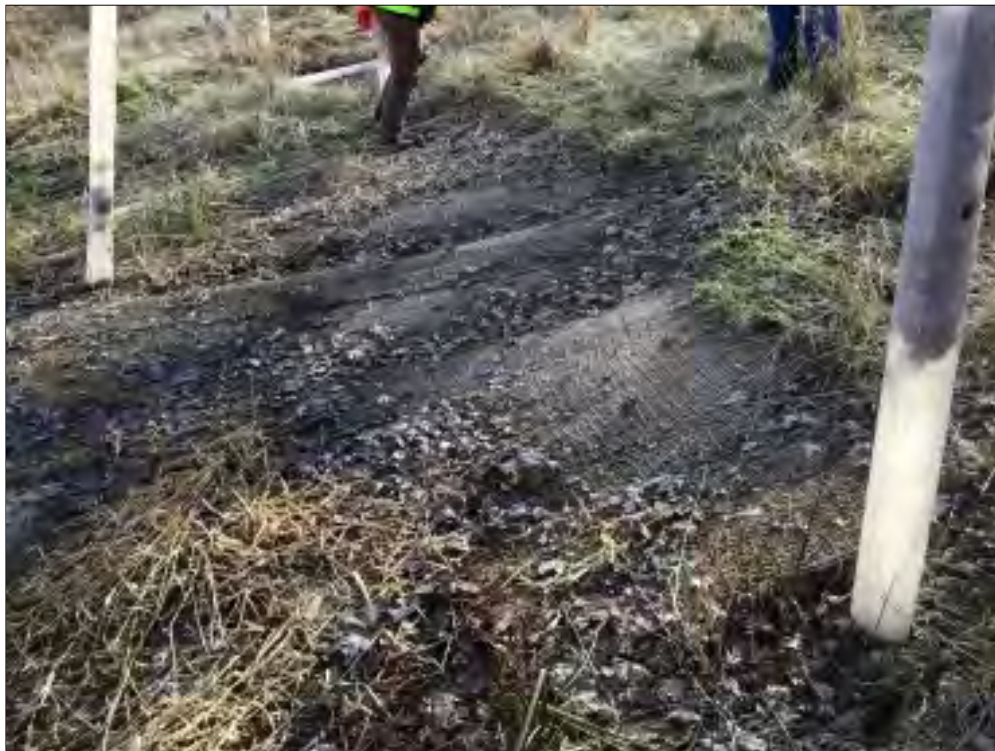
Photo 22: BRSA 9 approaching transition to BRSA 8, coir fabric not secure.

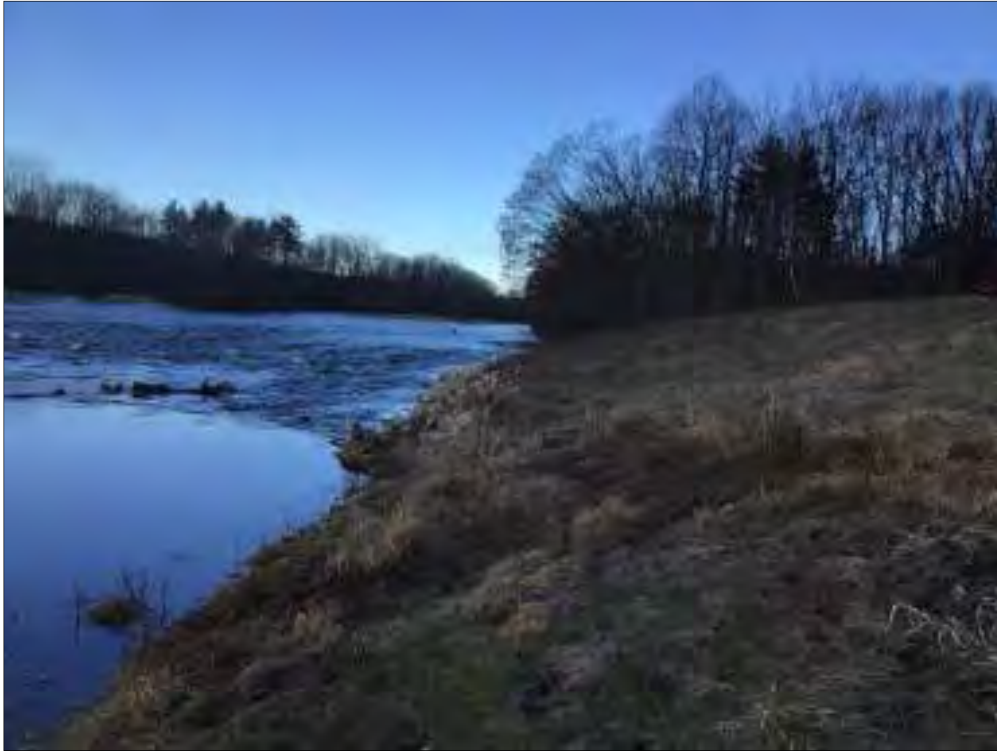
Photo 28: Approx. 8 lineal feet (perpendicular to river) of erosion observed at drainage area on RDB of former water control structure (WCS) corridor.

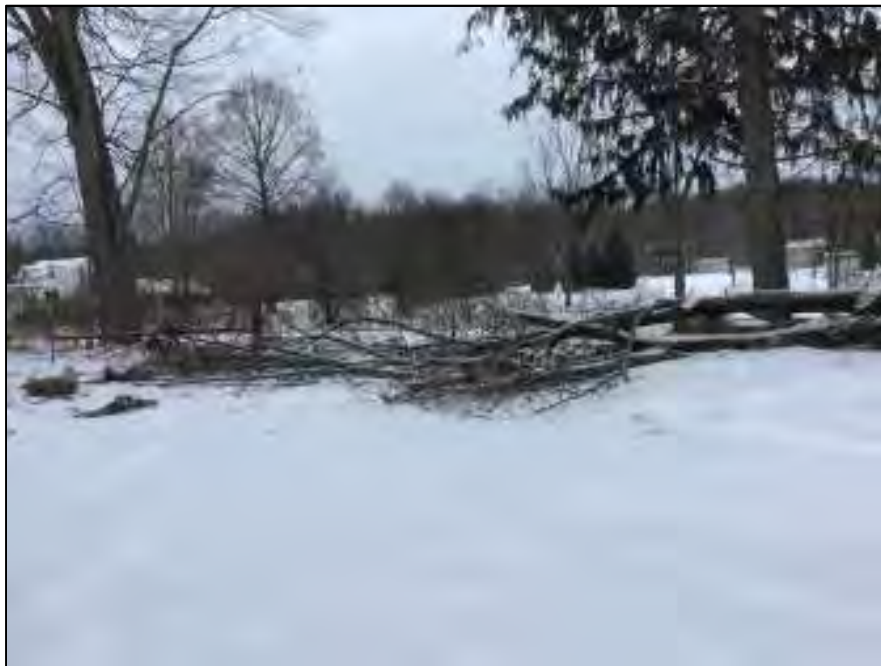
Photo 14: Fallen tree blocking BRSA 8 east access gate; notify the landowner (MDNR).

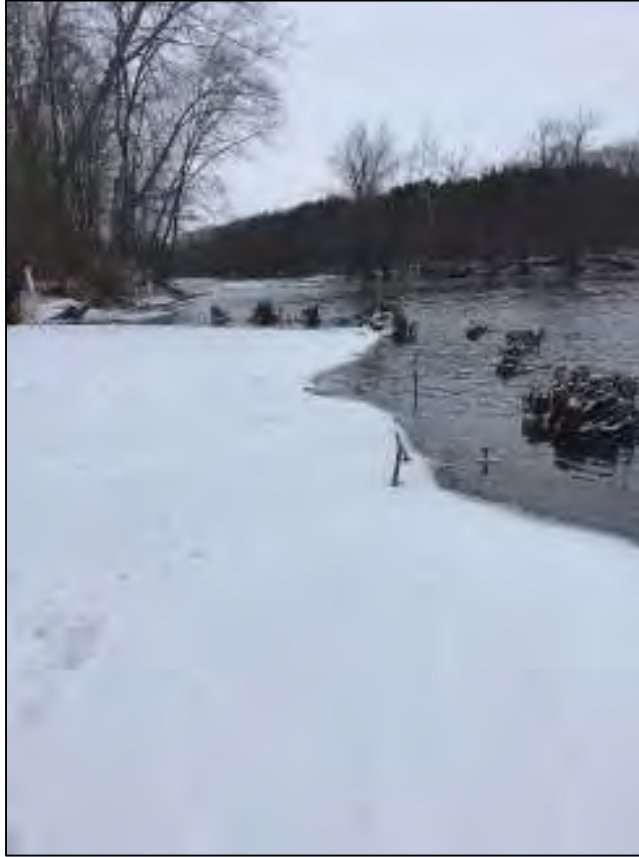
Photo 19: Live stakes appear to have been broken/dislodged on left-descending bank (LDB) of plunge pool area.

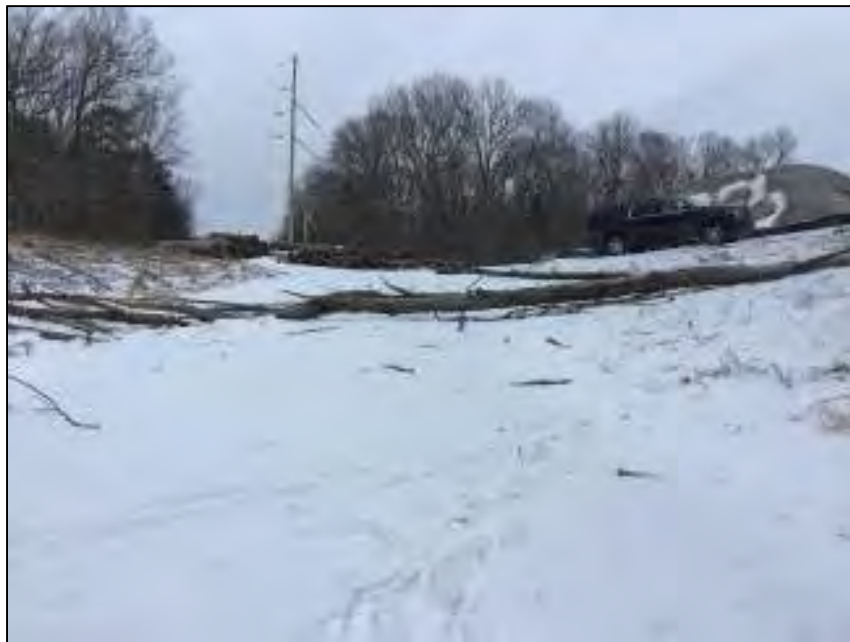
Photo 20: Fallen tree blocking access road to former WCS area; notify the landowner (MDNR).

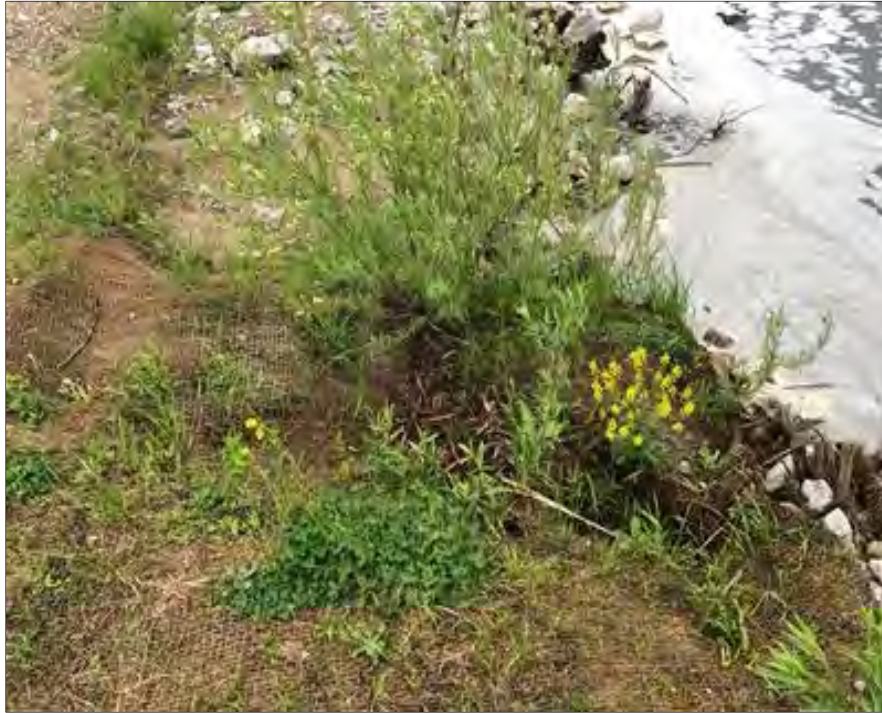
Photo 1: BRSA 1 along right-descending bank (RDB) of Pine Creek confluence. Void observed below coir fabric at rootwad/joint planting transition. No significant changes observed since first quarterly inspection.

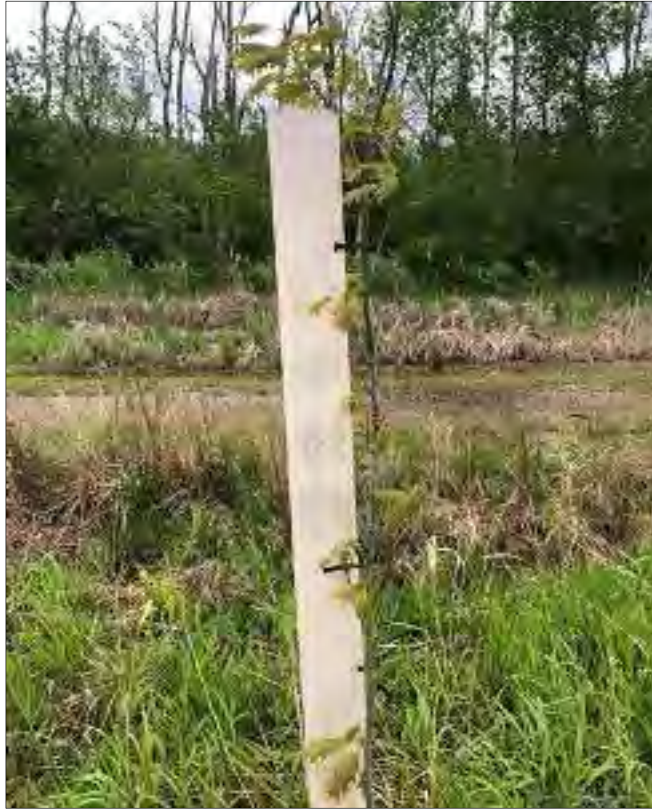
Photo 5: BRSA 1 grow tubes tied to outside of trees. Approx. 7-9 trees along approx. 300 ft. of bank.

During the May 2019 inspection, tree tubes near river station (RS) 60+00 were observed to have been removed (by trespassers [or vandals]) from trees and tied to the outside of the trees. These tubes were removed and properly disposed.

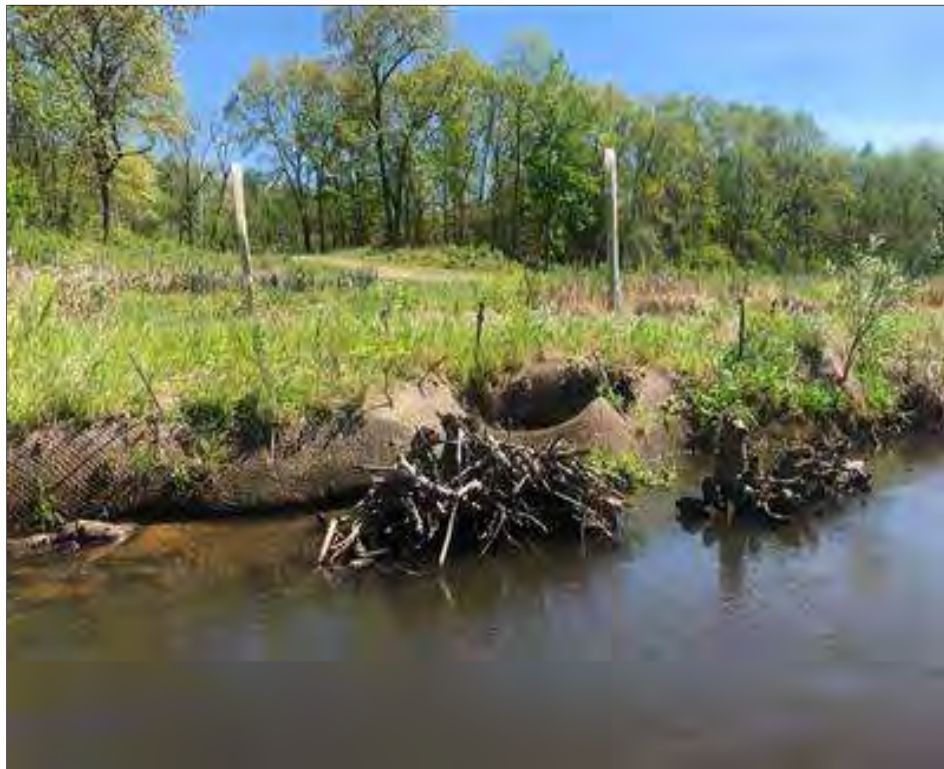
Photo 12: Boat-based view of BRSA 4 area of sloughing observed during 1st and 2nd Quarterly Inspections.

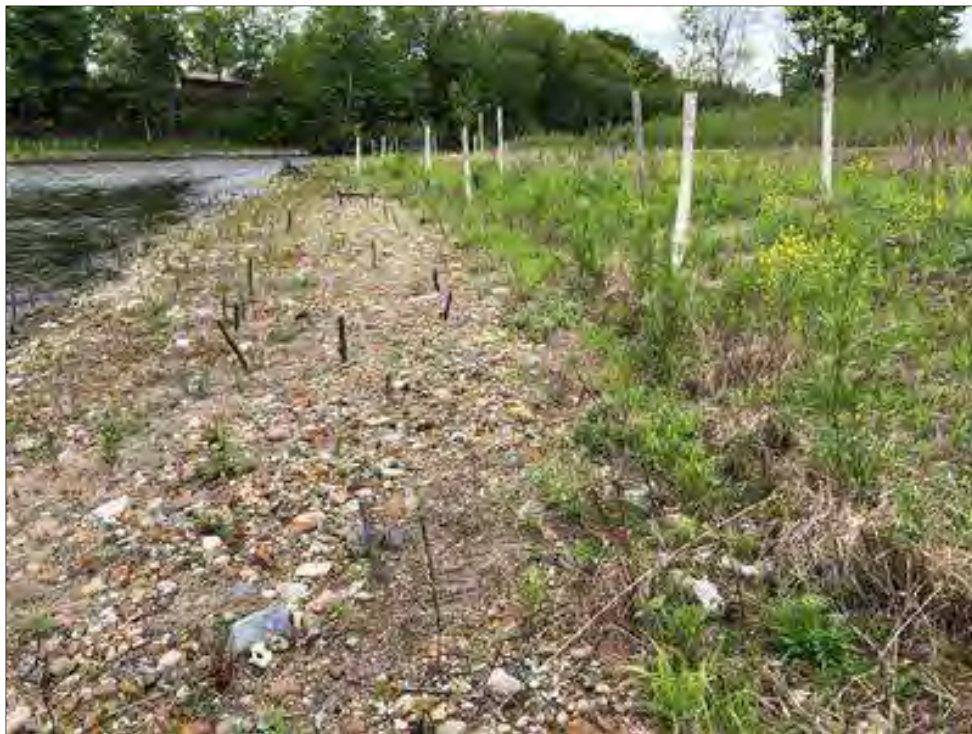
Photo 14: BRSA 4 live stakes do not appear to be growing in area where mid-channel bar material was placed; live stakes are growing higher on bank.

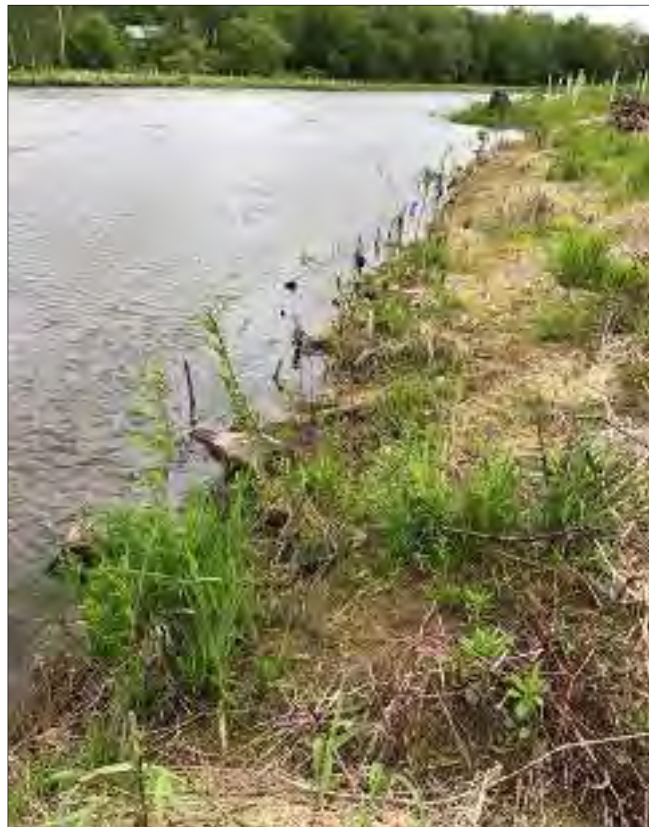
Photo 16: Approx. 50 ft. of BRSA 6 with low-growth on live stakes. Previously identified, no new issues observed.

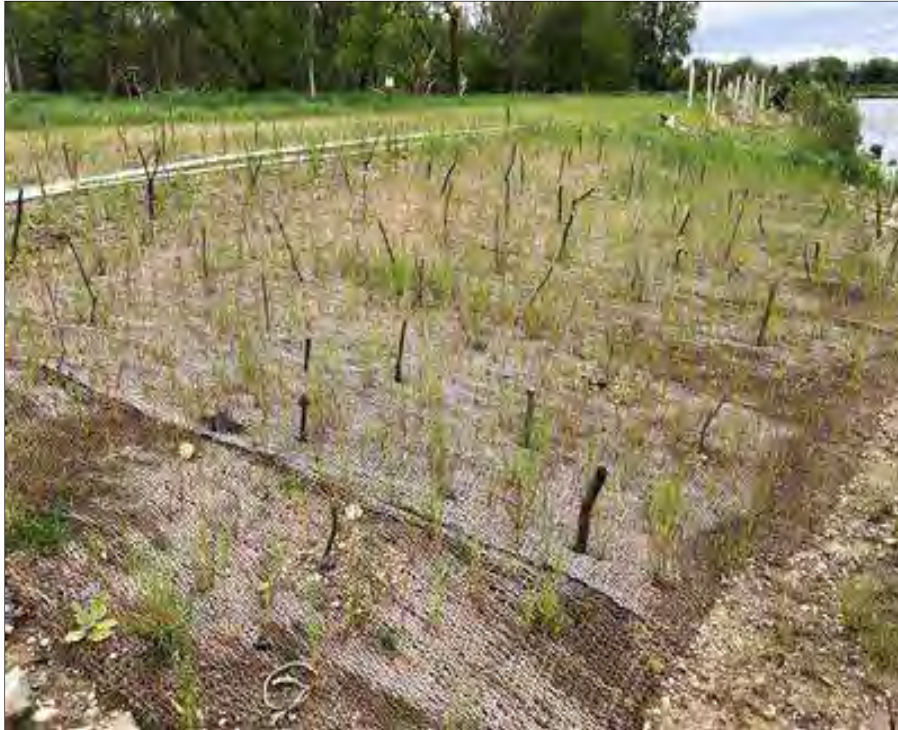
Photo 17: BRSA 6 oxbow discharge area – live stakes not showing signs of growth.

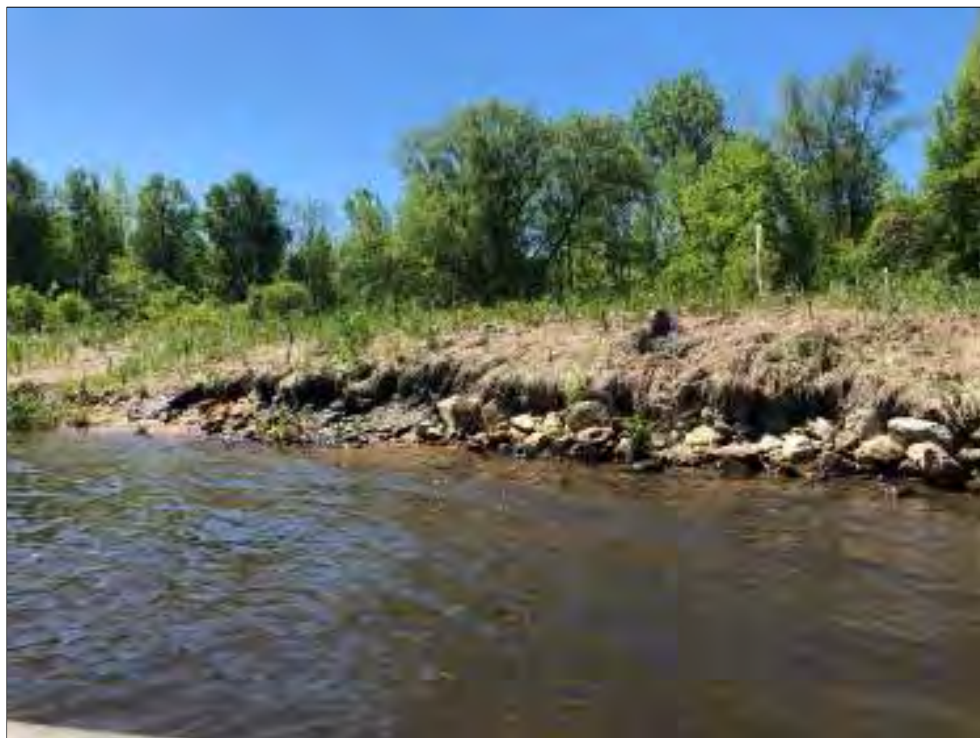
Photo 26: Boat-based view of BRSA 8 scour shown in Photo 25.

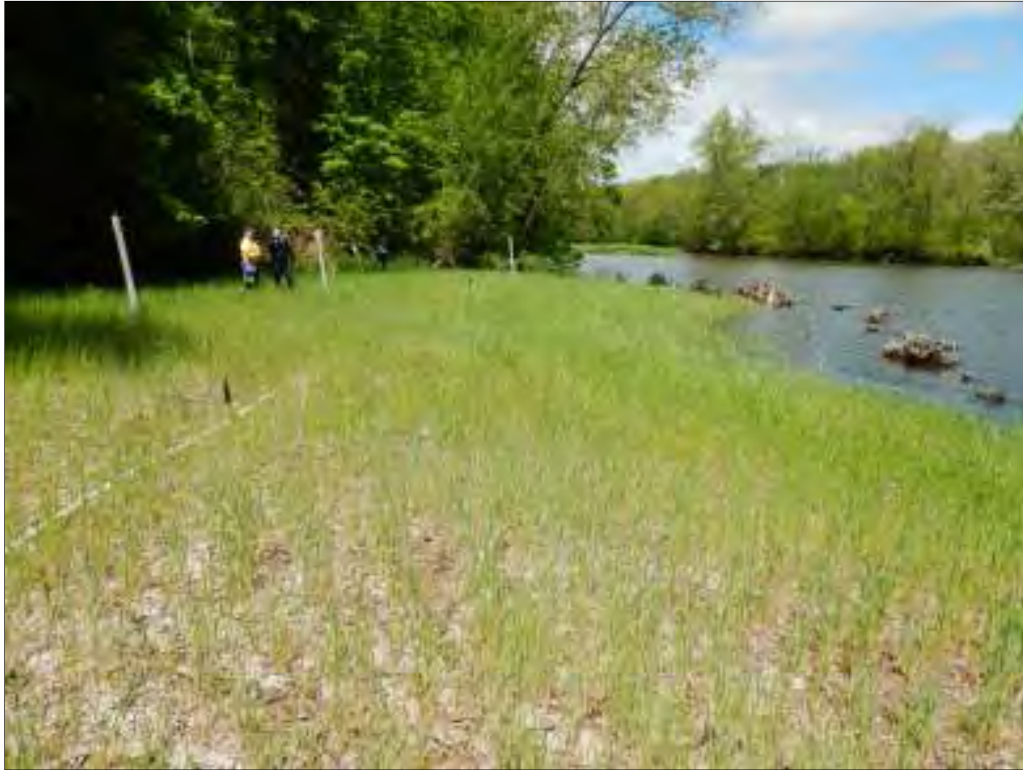
Photo 33: Plunge Pool Study Plot. Note that live stakes appear to have been removed by passersby.

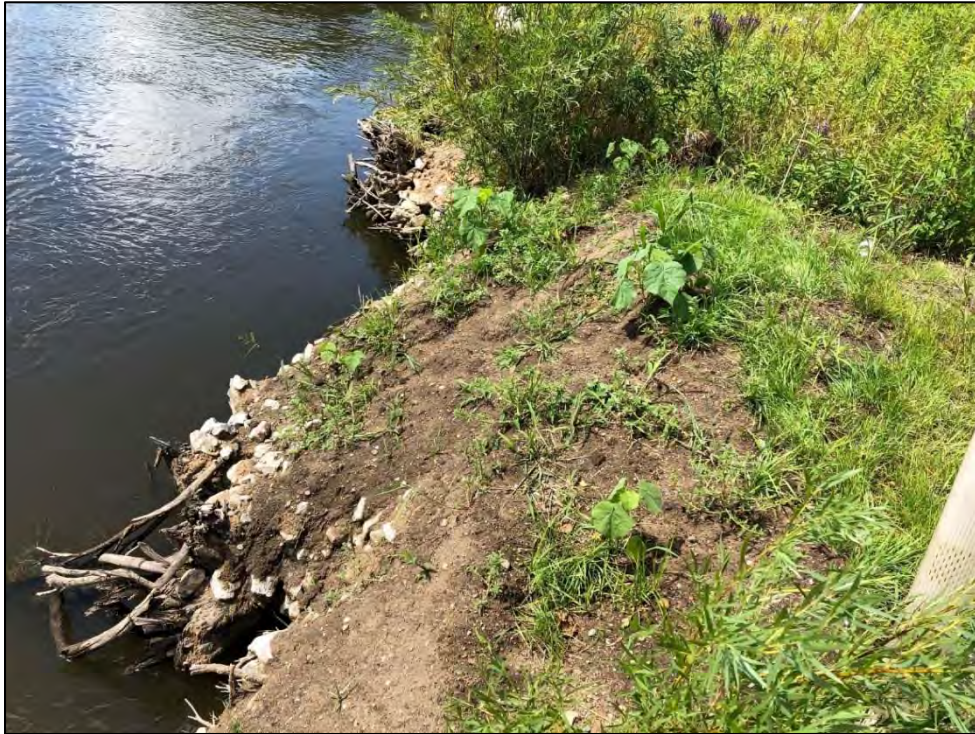
Photo 9: BRSA 4 bank repair area (repair completed July 2019), no live stakes were installed as part of the repair.

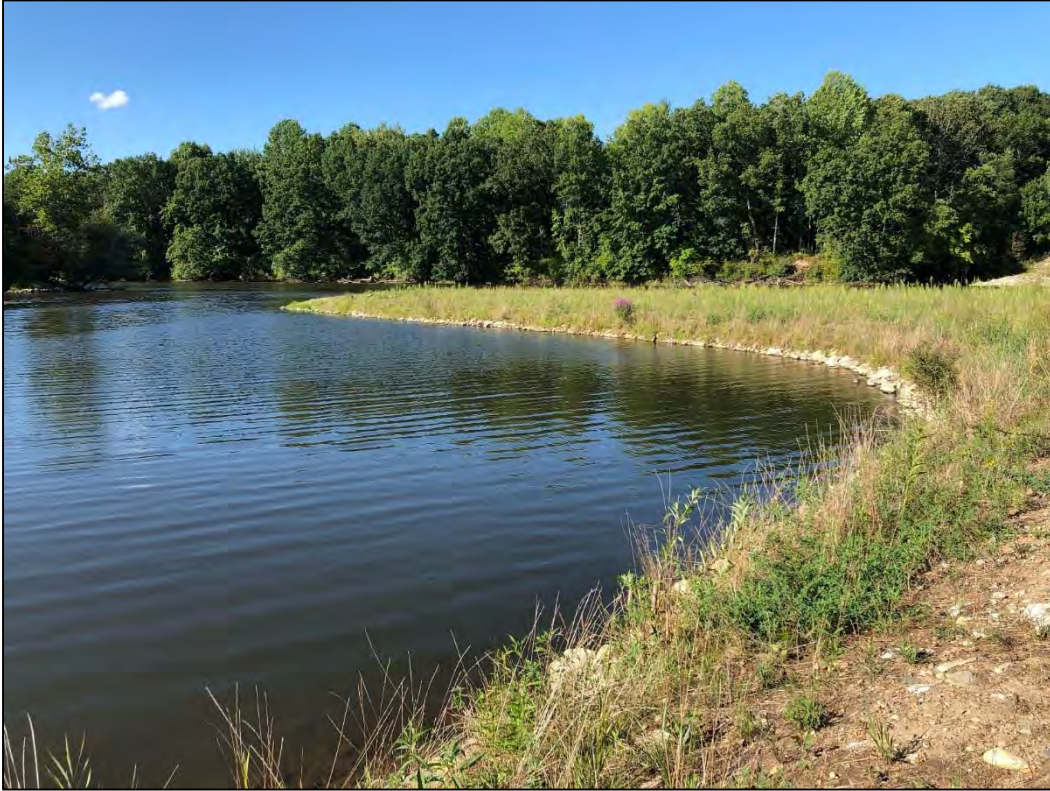
Photo 21: Plunge Pool general view. Sparse vegetation observed on peninsula.

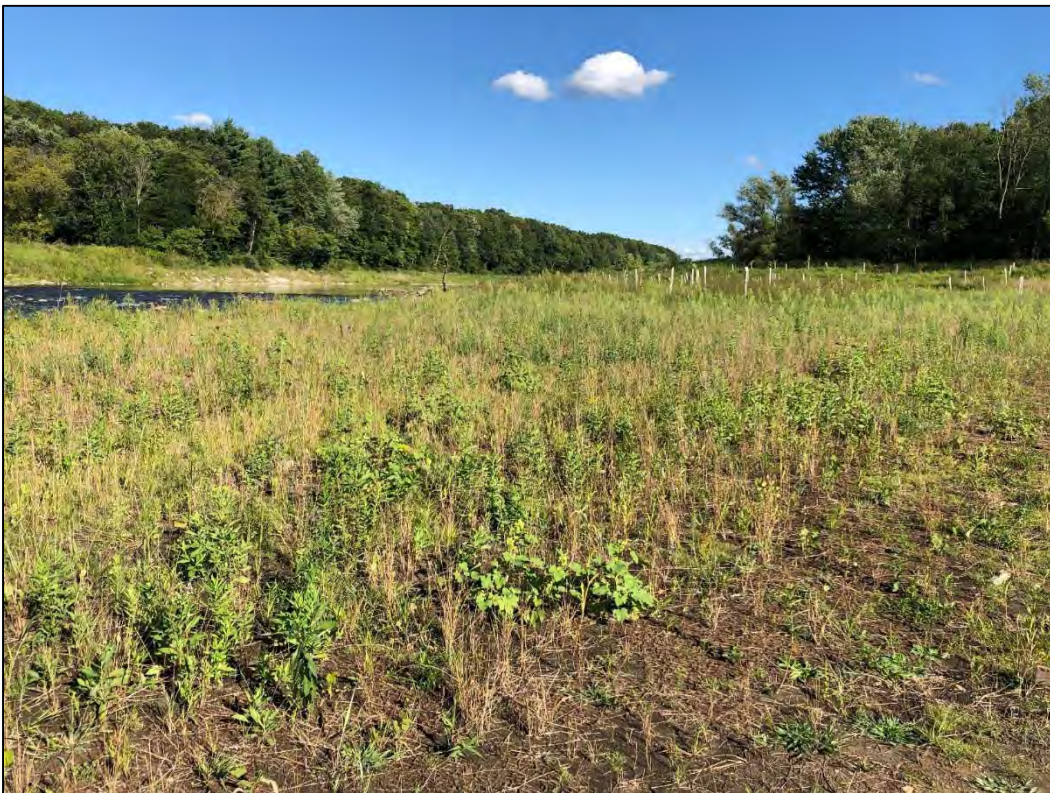
Photo 22: Peninsula general view. Sparse vegetation observed.

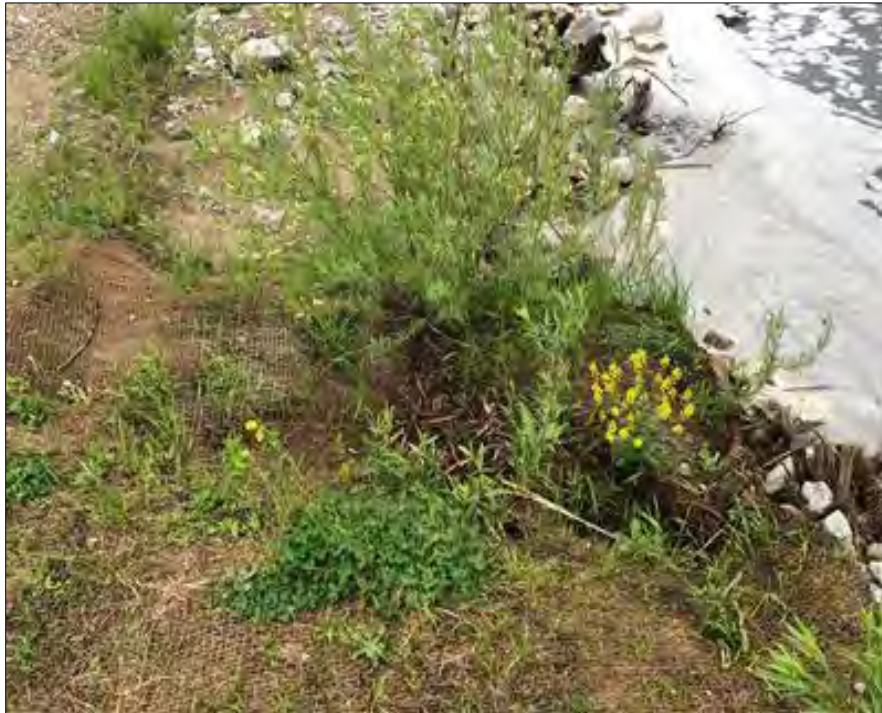
A hole along the right-descending bank of the Pine Creek confluence with the Kalamazoo River (RS 50+00) developed at the rootwad/joint planting transition. This was first observed during the December 2018 inspection and monitored during subsequent inspections. In October 2019, the hole was filled with MDOT plain riprap. (Photos 1a and 1b)

Photo 1A (Before): BRSA 1 near RS 50+00, along the right-descending bank (RDB) of the Pine Creek confluence. Void observed below coir fabric at rootwad/joint planting transition (May 2019).

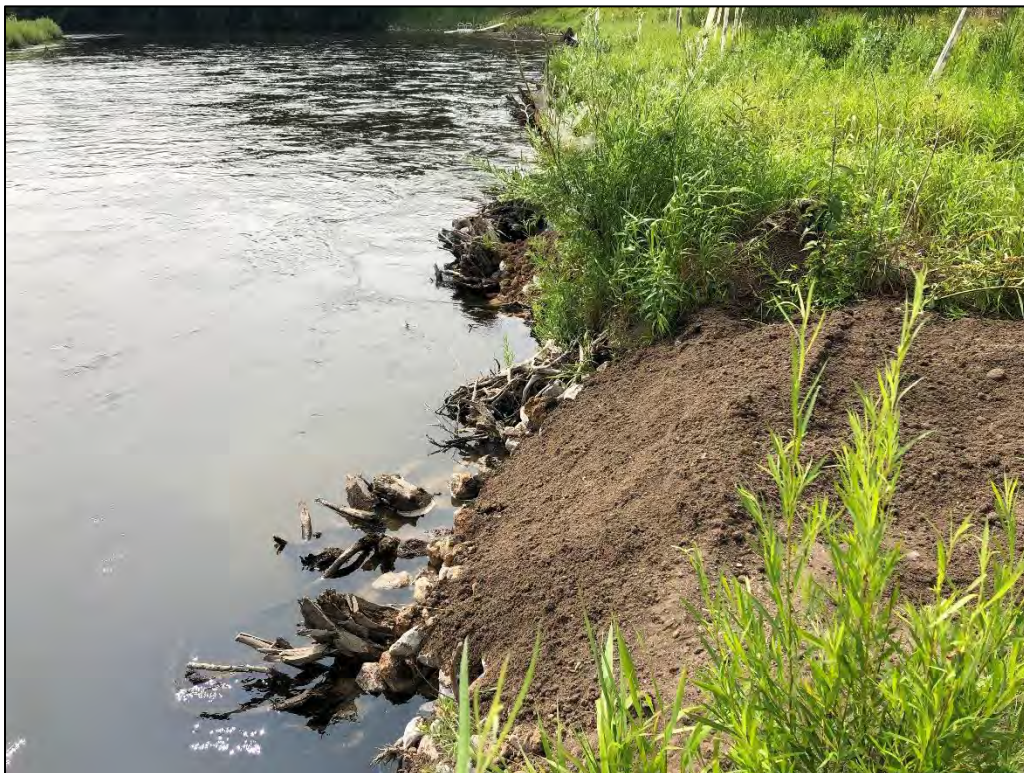
Photo 2B (After): BRSA 4 near RS 70+00, area of sloughing bank repair (July 2019).

Approximately 50 linear feet (LF) of rootwad restoration settled into the soft, muddy subgrade near RS 70+00. This was observed during the first quarterly inspection and monitored during subsequent inspections. In July 2019, the area was stabilized by installing 4-inch x 8-inch riprap mixed with common fill over the existing restoration to secure the rootwads. The area was then covered with approximately 6 inches of topsoil and seeded. Live stakes were subsequently harvested and planted in this area in October 2019. (Photos 2a and 2b). During the August 2019 inspection, an area of minor erosion was observed approximately 25 to 50 feet upstream

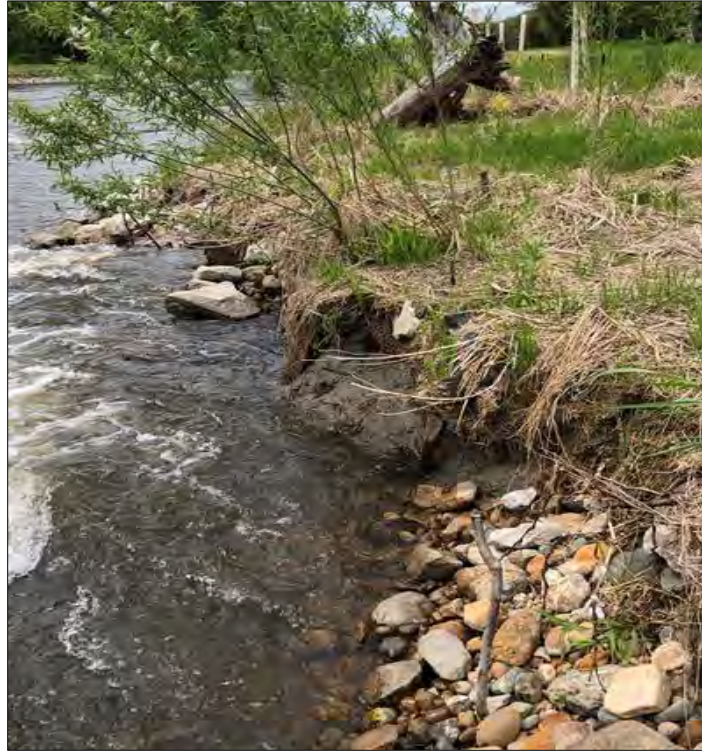
Photo5A (Before): BRSA 6 near RS 38+50, bank scour along approximately 75-100 linear feet (LF) of bank (May 2019).

During the May 2019, three areas totaling approximately 75-100 LF near RS 38+50 where ice and high near shore water velocities had scoured the bank were observed. The bank was repaired in July 2019 by installing Michigan Department of Transportation (MDOT) heavy riprap (36-inch thickness at D-50 of 18.5 inches), common fill, topsoil, seed (riparian seed mix) and live stakes over the existing grade (Photos 5a and 5b).

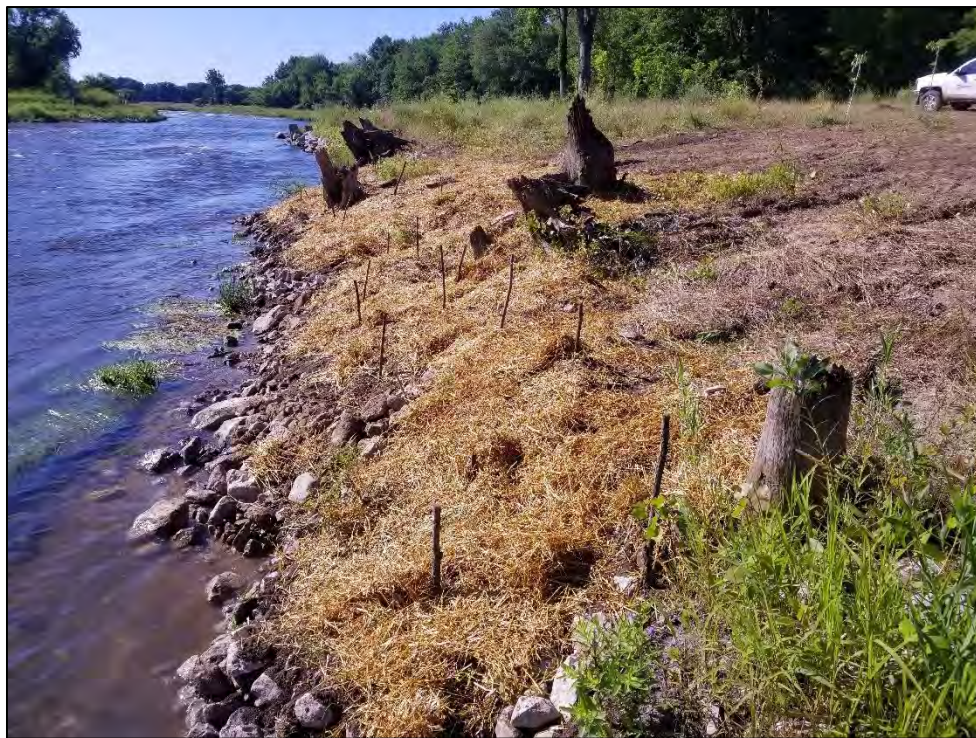
Photo 9B (After): BRSA 8 near RS 27+00, area of scouring bank repair (July 2019).

During the May 2019 inspection, an area of erosion along approximately 100-150 LF of bank was observed starting near RS 24+75. The erosion was likely due to high flows (before vegetative establishment) and/or ice scour of the common fill placed over the joint planting (at the toe of the slope). In July 2019, this area was hand graded, seeded, and additional live stakes were installed (Photos 9a and 9b).

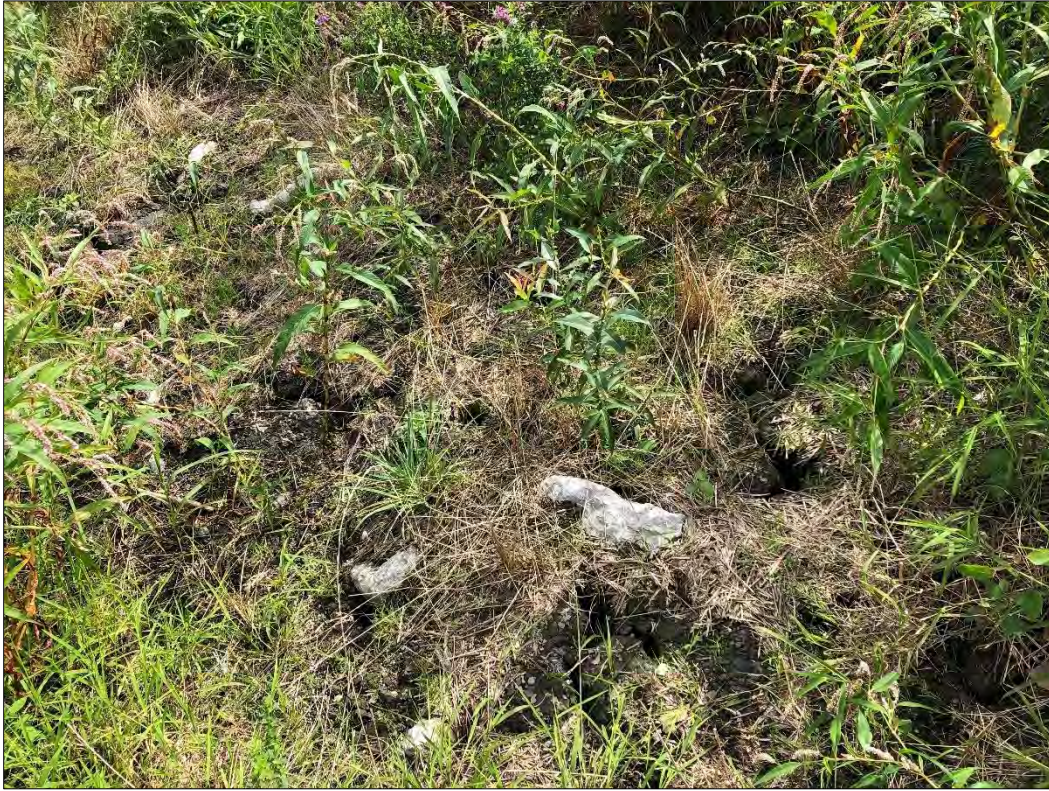
Photo 12A (Before): BRSA 8 near RS 7+00, third area of minor erosion (Erosion Area 3, August 2019).

During the August 2019 inspection, three minor erosion areas were repaired. According to the Final Repair SOW (Wood 2019b), following repair, these areas were to be covered with topsoil and seeded; however, after discussion with USEPA, it was decided to install additional live stakes, rather than re-seed. In October 2019, the three erosion areas were repaired as follows:

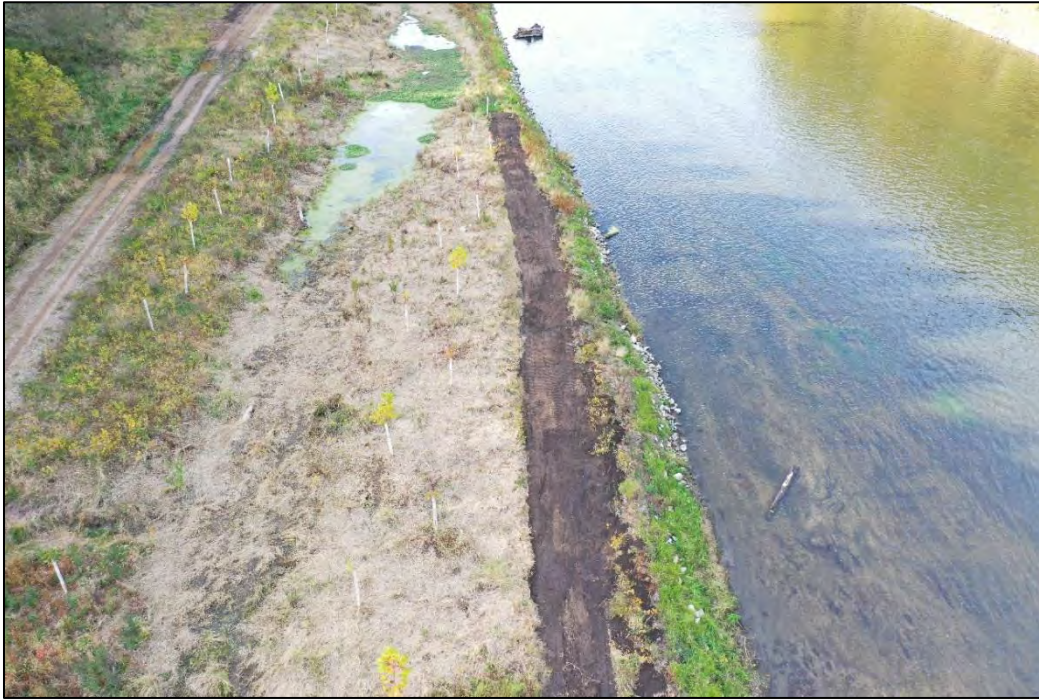
Photo 13: BRSA 8 near RS 26+50, topsoil, seed, and straw placed at top of bank in area of sparse vegetation. Repaired at the request of MDNR during October repair activities (October 2019).

Several small areas of sparse vegetation were observed between RS 7+00 and RS 25+00 during the August 2019 inspection. Per the Final Repair SOW these areas were to be re-seeded. However, based on discussions with USEPA, it was decided to install additional live stakes rather than re-seed. A larger area of sparse vegetation was also observed during the August 2019 inspection. This area extended along approximately 150-200 LF at the top of bank near RS 26+50, and was repaired by installing additional topsoil, seed, and straw in October 2019 (Photo 13).
