**Otsego Township Dam Area
Time Critical Removal Action**

**DRAFT
Final Maintenance and Monitoring Report**

Prepared by:
**Wood Environment & Infrastructure Solutions, Inc.
Novi, Michigan**

November 15, 2019

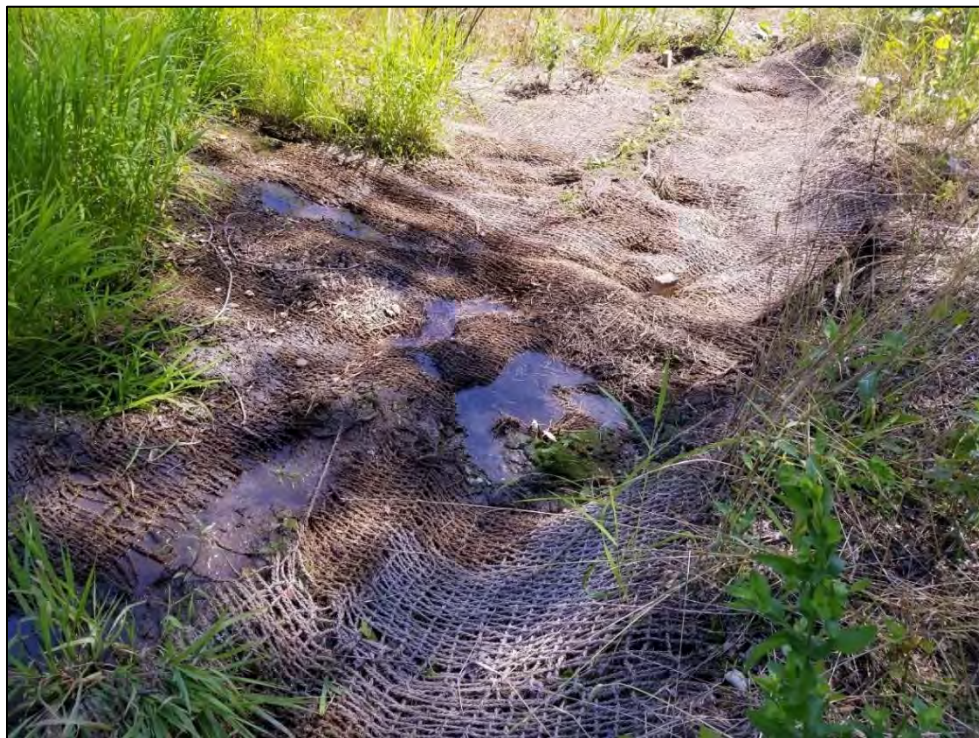
Photo 15B (After): BRSA 9 near RS 36+00, area of coir fabric repair (July 2019).

During the December 2018 inspection, an area of soil at the top of slope was observed to have settled beneath the coir fabric creating an approximately 6-inch to 9-inch void space beneath the coir fabric near RS 36+00. In July 2019, the coir fabric was cut, secured with stout wood stakes, and additional upland seed mix was installed (Photos 15a and 15b).

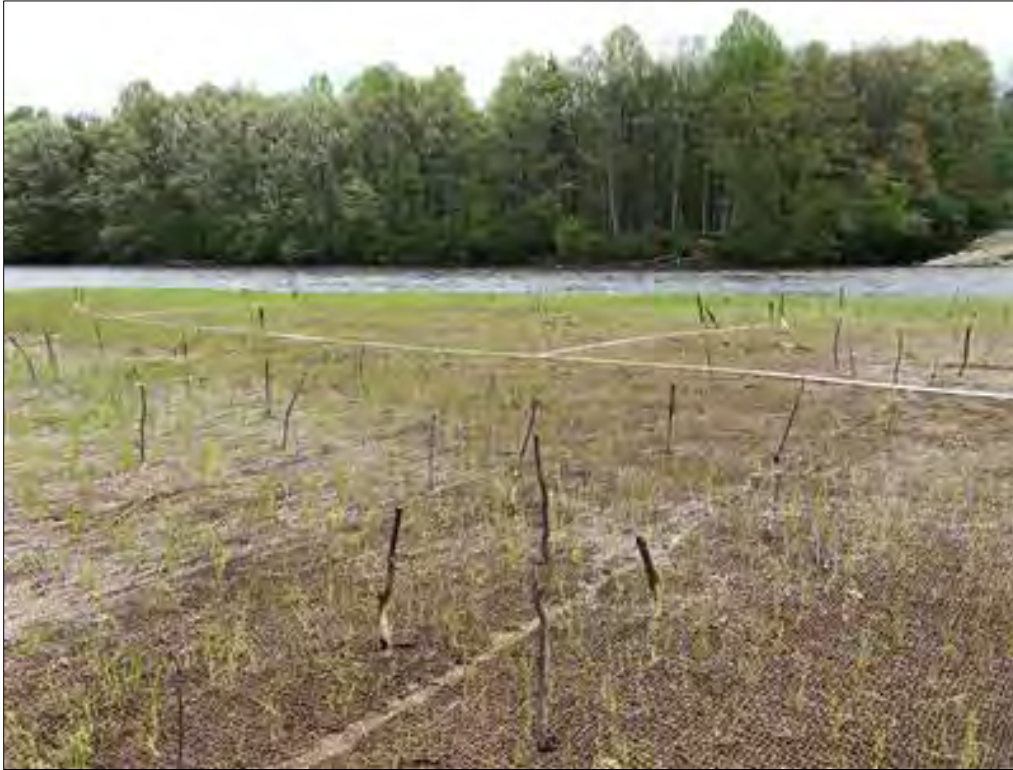
Photo 17A (Before): Plunge Pool near 0+00, general view of peninsula. Limited grass and live stake growth observed (May 2019).

During the four quarterly M&M inspections, vegetation in the plunge pool area was observed to be sparse. In October 2019, the existing vegetation was mowed, new top soil placed, and the area was re-seeded and strawed (Photos 17a and 17b). This repair was not included in either Repair SOW but was repaired after submittal and approval of the Final Repair SOW based on discussions with USEPA and MDNR.

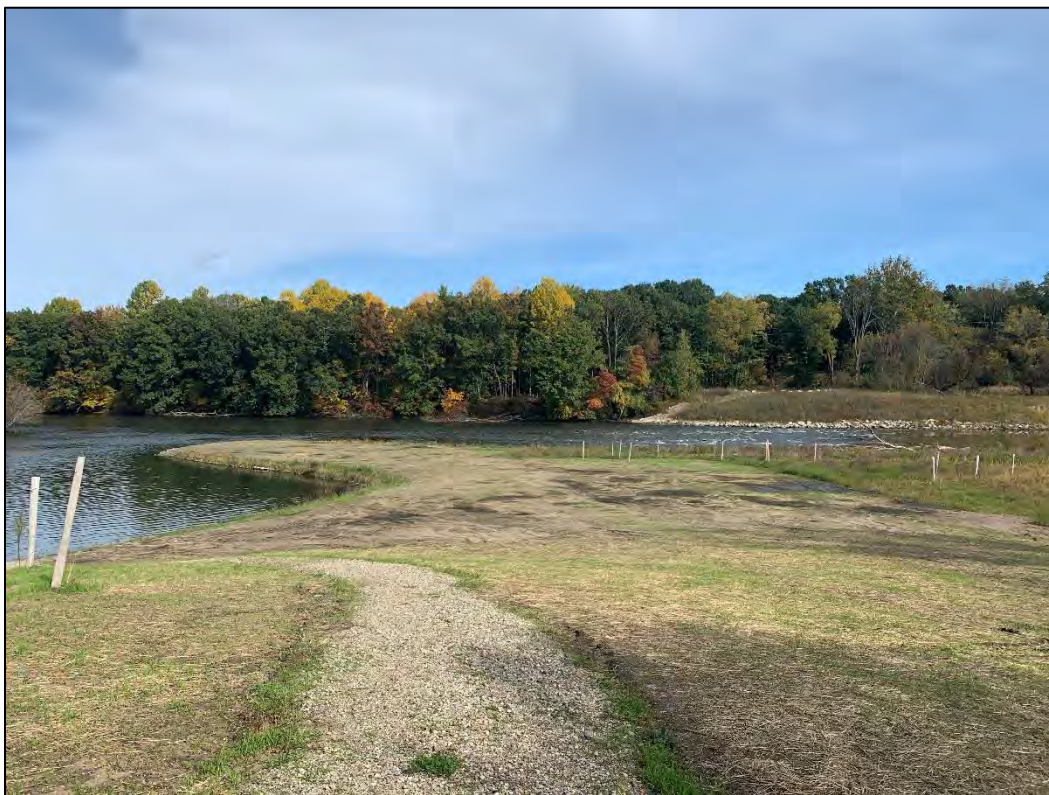
Photo 17B (After): Plunge Pool near 0+00, new topsoil and seed installed (October 2019).
