# **SITE INSPECTION REPORT**

Globe-Union Battery  
Garland, Dallas County, Texas  
TXD980626642

**May 2020**

Globe Union Battery  
1111 S. Shiloh Rd  
Dallas, Dallas County, Texas  
TXD980626642

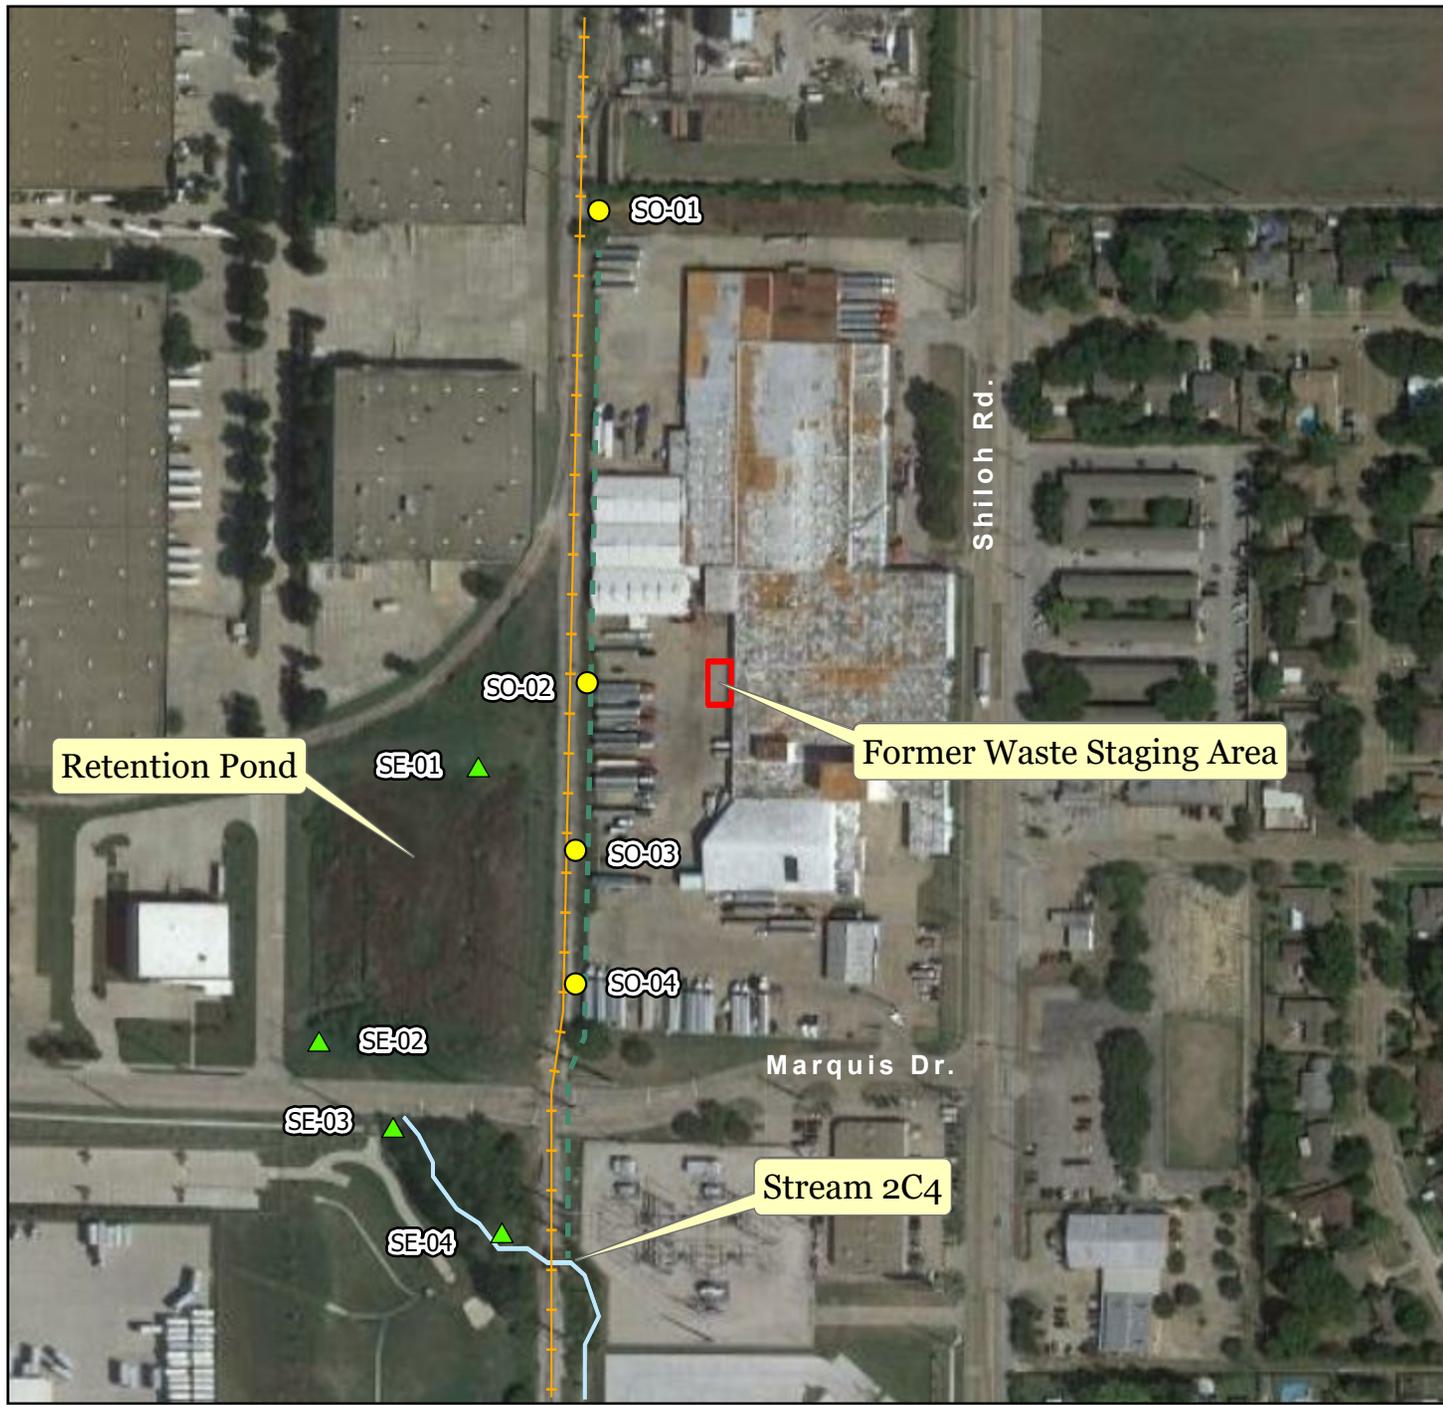
# Figure 2: Site Vicinity Sample Location Map

A total of twenty-one soil and five sediment samples were collected from the surface water migration pathway TDL from the site to Duck Creek. Two sediment samples (SE-03 and SE-04) and ten soil samples (SO-06 through SO-16) were collected along Stream 2C4, comprising approximately the first 1.8 miles of the pathway. The remainder of the samples (SO-17 through SO-21) were collected along Ruppards Branch and Duck Creek.

Sample results were reviewed and evaluated based on the EPA RSL for lead of 400 mg/kg for residential properties and 800 mg/kg for commercial/industrial properties (Ref. 29, p. 3). Nine soil sample locations exceeded their applicable value, including SO-03, SO-06, SO-08, and SO-11 through SO-16 (Ref. 27, pp. 9, 10, 16, 25, 26, 33). The highest detections were recorded in results from samples SO-11 through SO-13, which were sampled along the bank of Stream 2C4 adjacent to a residential yard (Ref. 27, pp. 28, 33). Table 7-1 details sample results for lead in the surface water migration pathway.

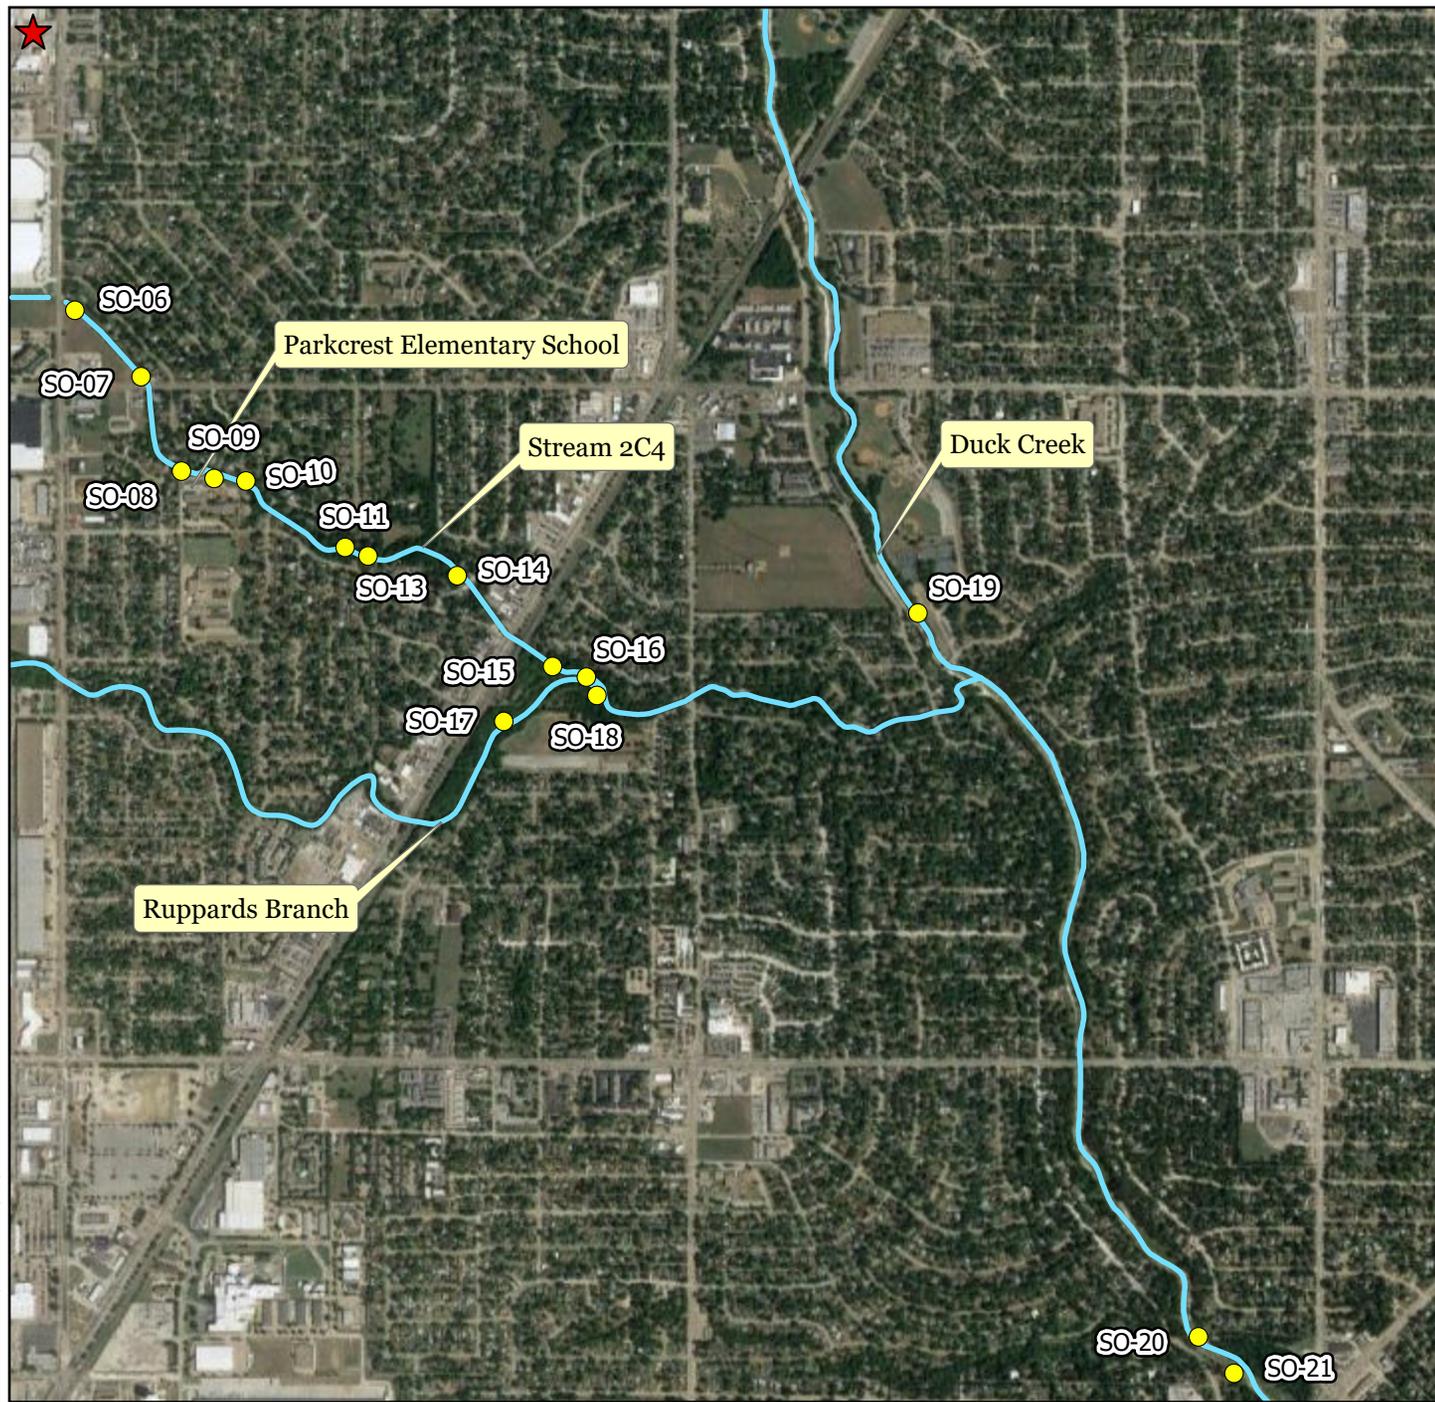
# Figure 3: Off-Site Sample Location Map

Background soil samples were collected to represent the soil types located in the site vicinity and upgradient of any suspected contamination. Background soil sample SO-01 was collected upgradient of the suspected potential contamination area for the site, though the sample location was still in an industrial area and could potentially be contaminated by other industrial runoff unrelated to on-site activities. Background soil sample SO-17 was collected on the bank of Ruppards Branch upstream of the intersection with Stream 2C4, and background soil sample SO-19 was collected on the bank of Duck Creek upstream of the intersection with Ruppards Branch to represent soil unimpacted by potential runoff from on-site contamination (Figure 3).
