**UNITED STATES ENVIRONMENTAL PROTECTION AGENCY
REGION 8
RESOURCE CONSERVATION AND RECOVERY ACT**

Facility Name: Lodge Grass Drum Site
RCRA ID: MTR000211649

Date of Inspection: May 15, 2019

Type and Purpose of Inspection: Compliance Evaluation Inspection
RCRA Section 7003 Inspection

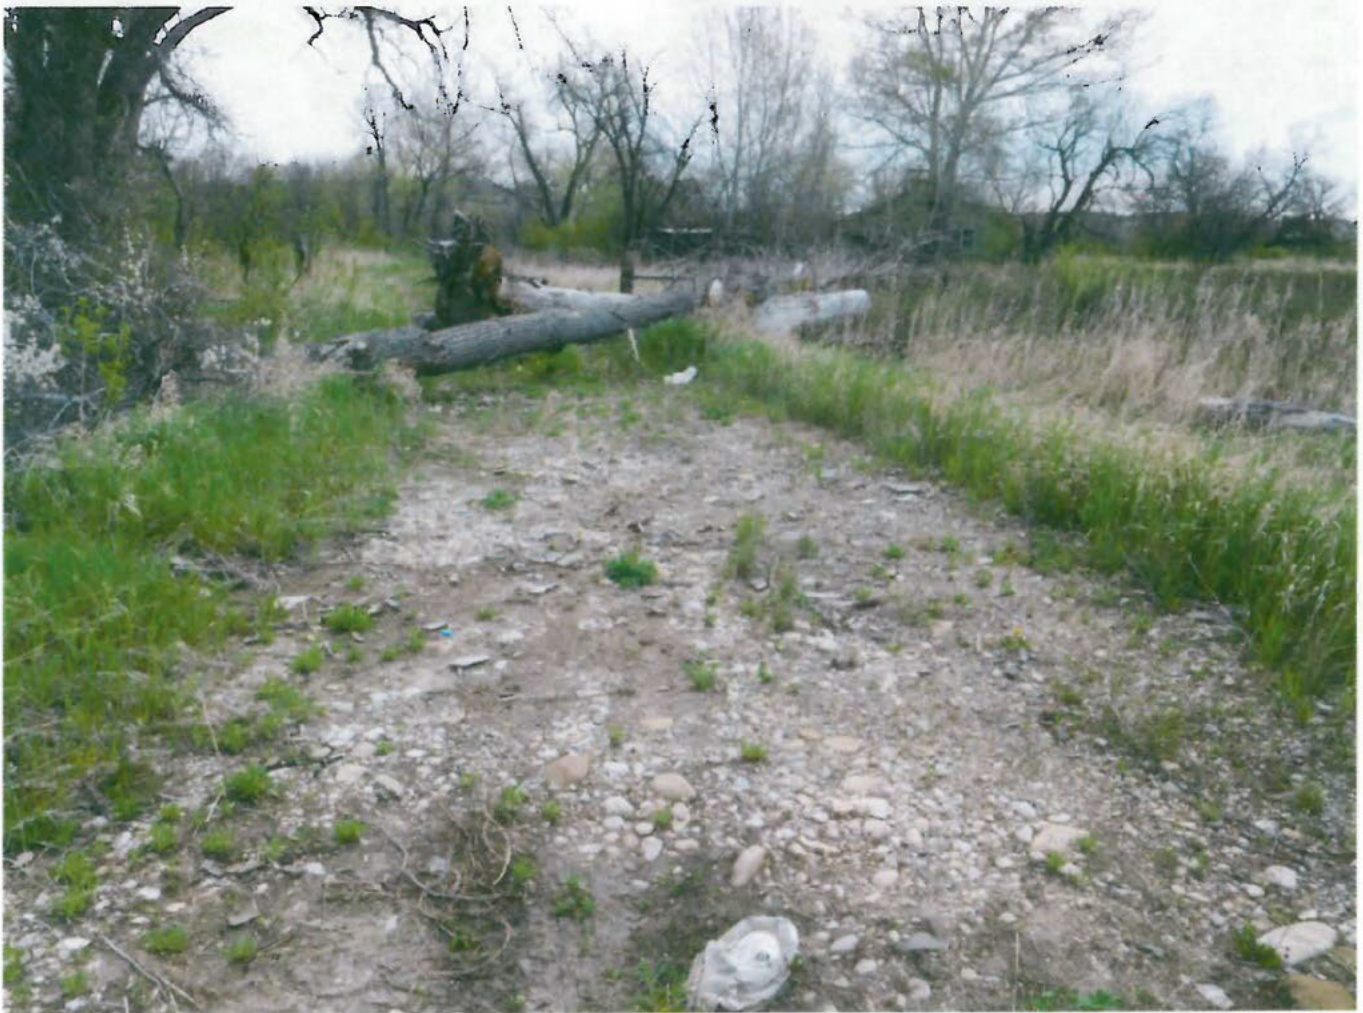
Photo 1159, DSCN1159.jpg, 5/15/2019 9:37 am, photo of driveway leading to area where drums are located. A fallen tree blocks vehicle access to the site. Photo taken facing east.

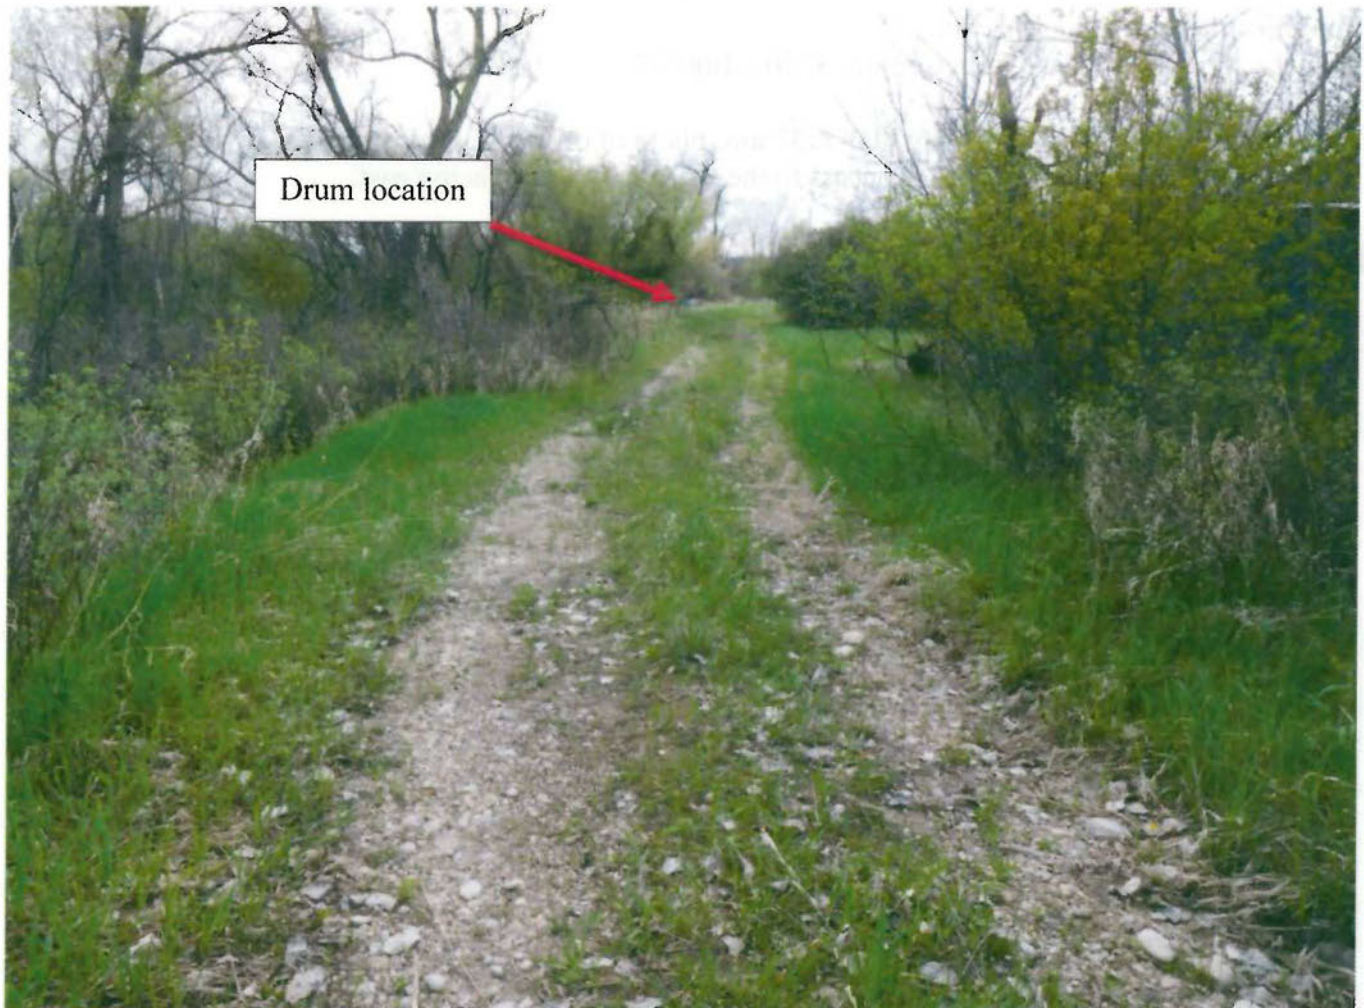
Photo 1160, DSCN1160.jpg, 5/15/2019 9:38 am, photo of driveway beyond (east of) the fallen tree with drums visible in background.

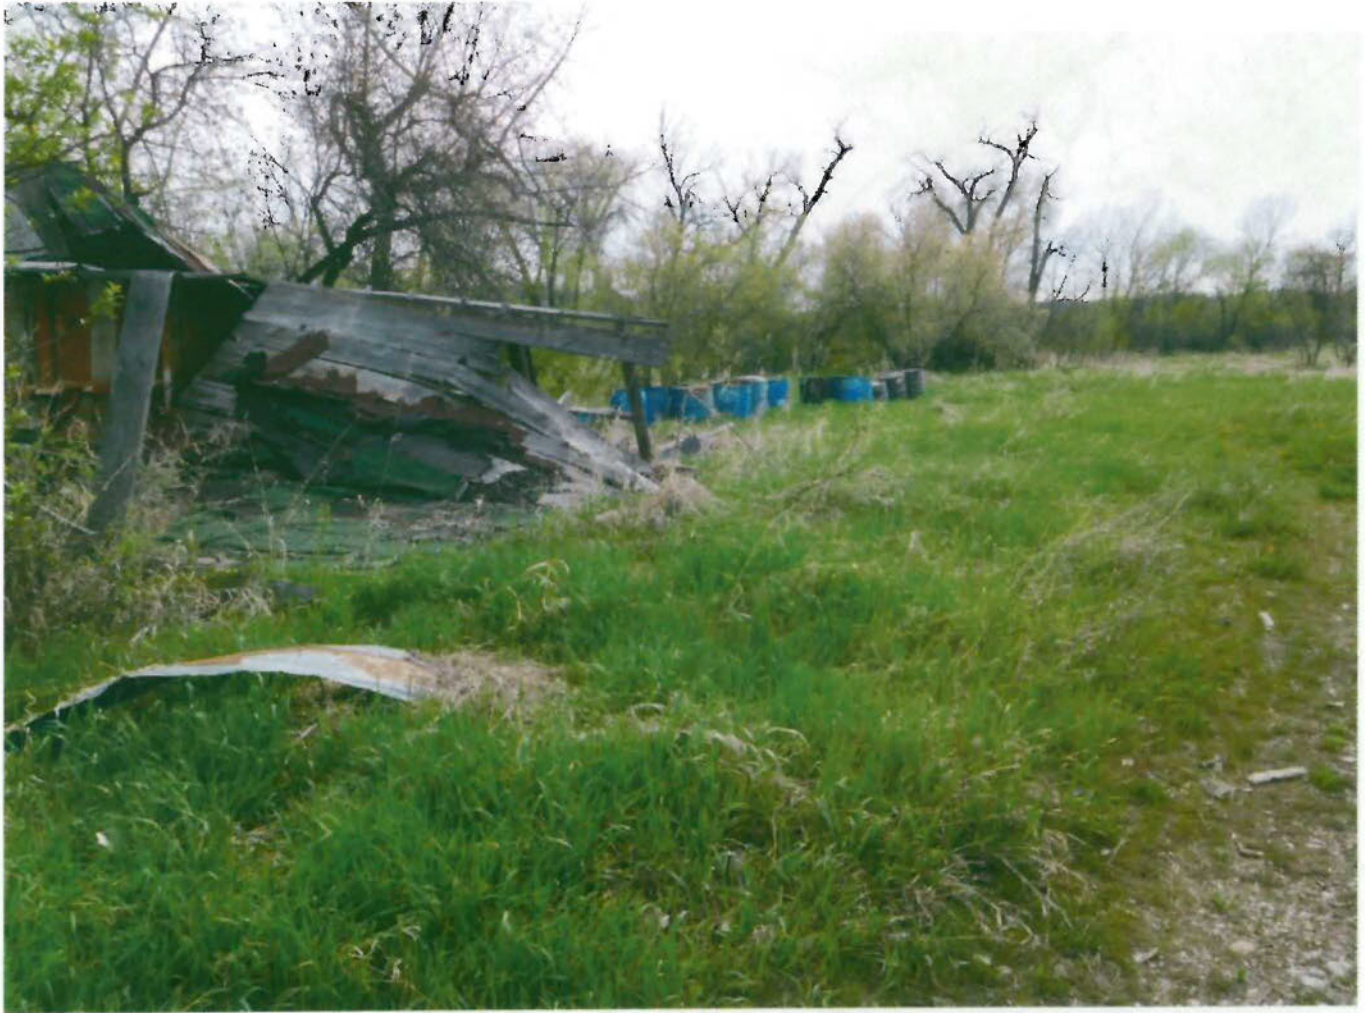
Photo 1161, DSCN1161.jpg, 5/15/2019 9:39 am, photo of drums near eastern end of driveway.

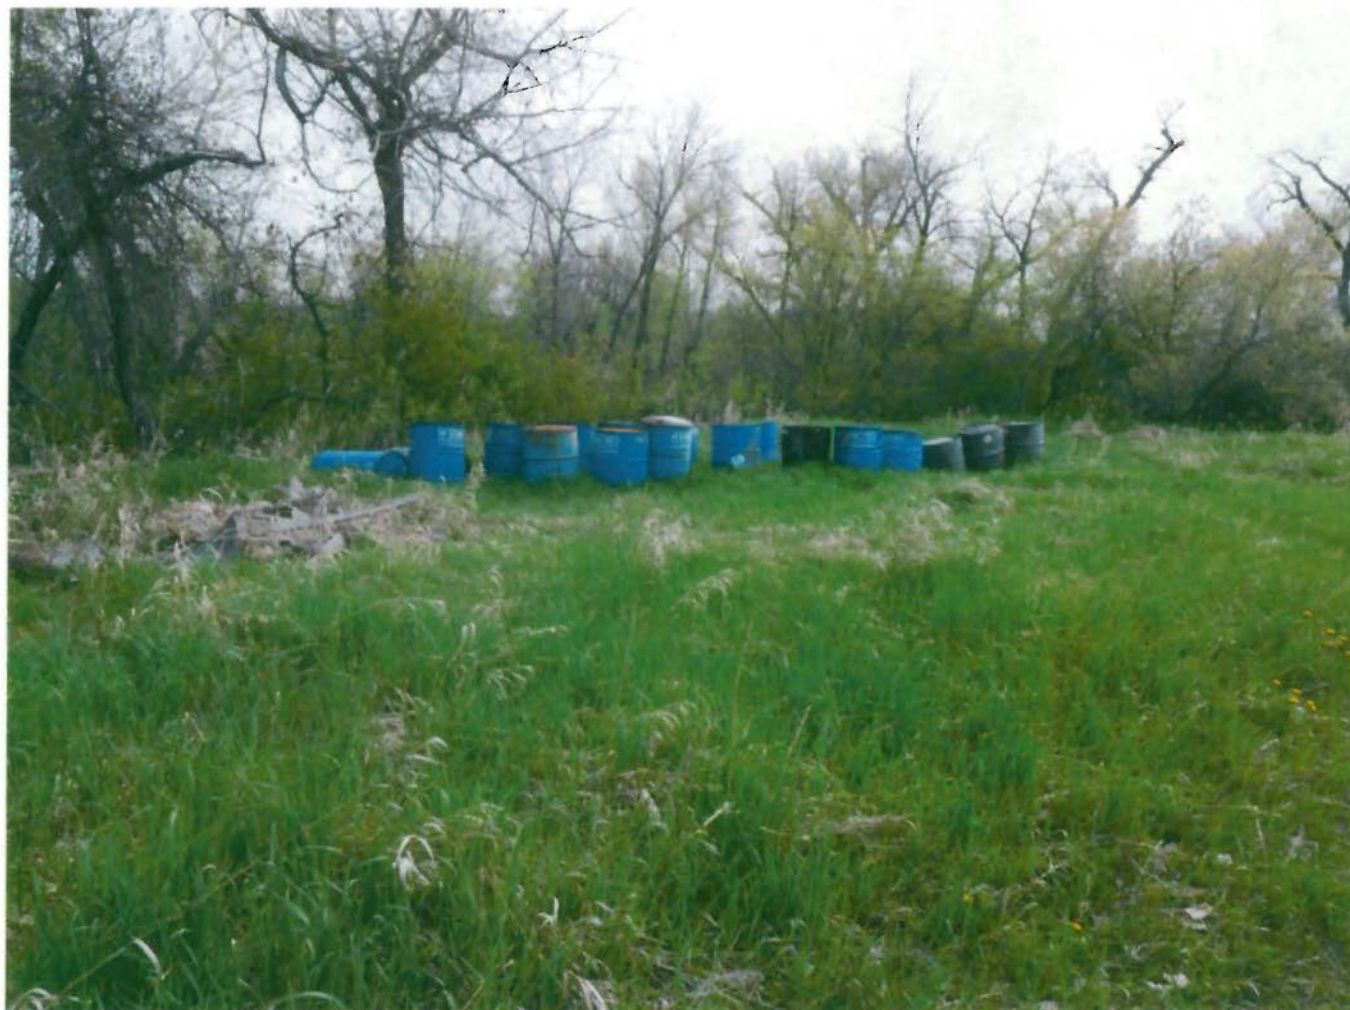
Photo 1162, DSCN1162.jpg, 5/15/2019 9:39 am, photo of drums, showing all 20 drums. Photo taken facing north/northeast.

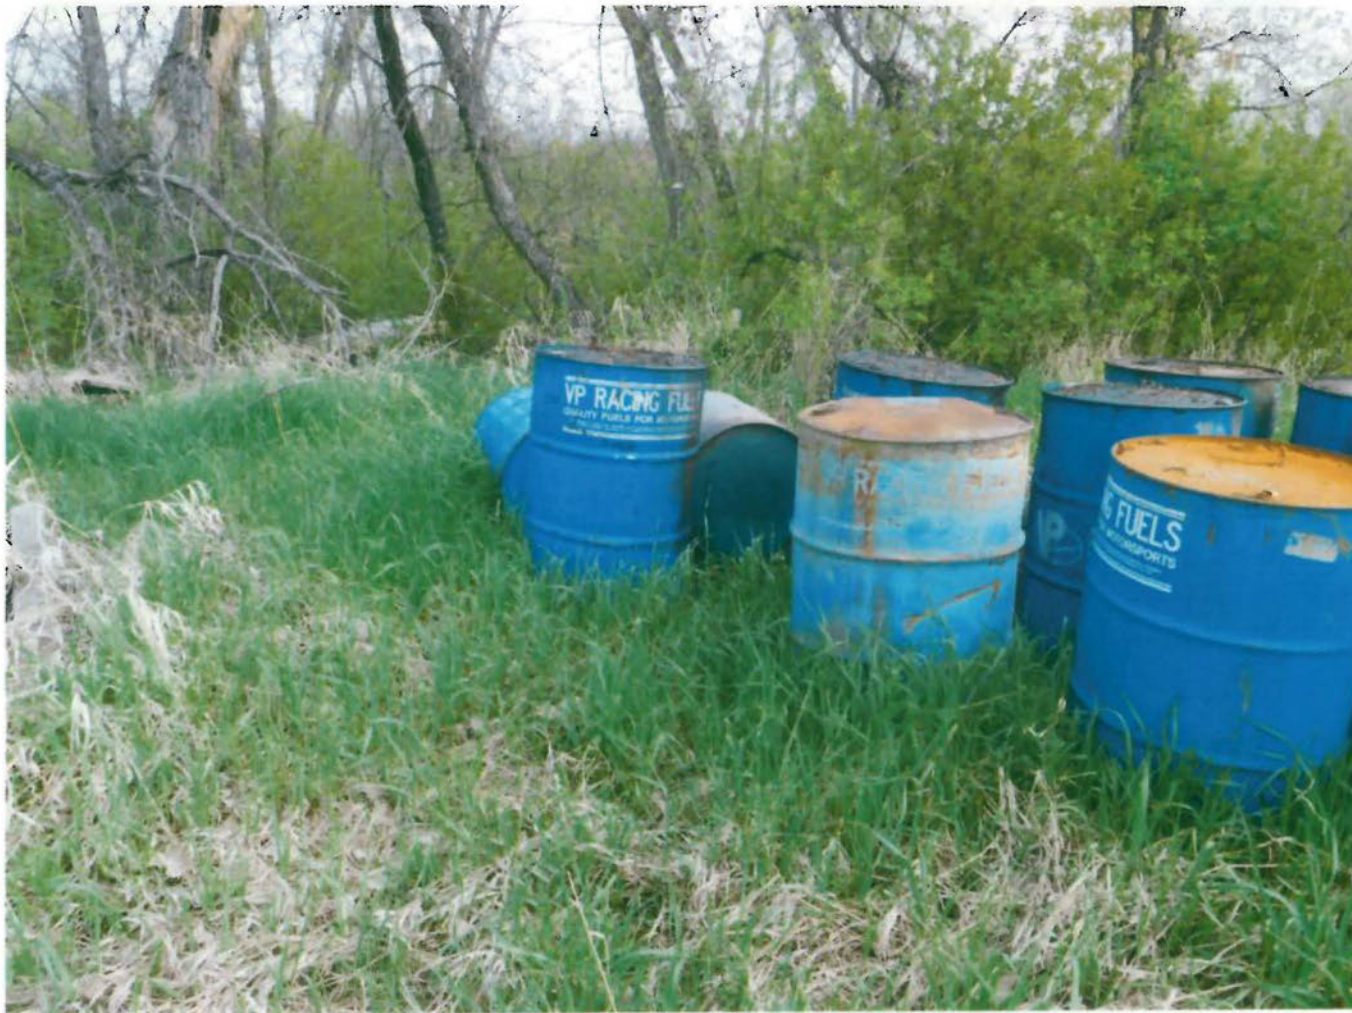
Photo 1163, DSCN1163.jpg, 5/15/2019 9:40 am, photo of westernmost section of drums. Photo includes two drums on their sides and one drum with a bulging top.

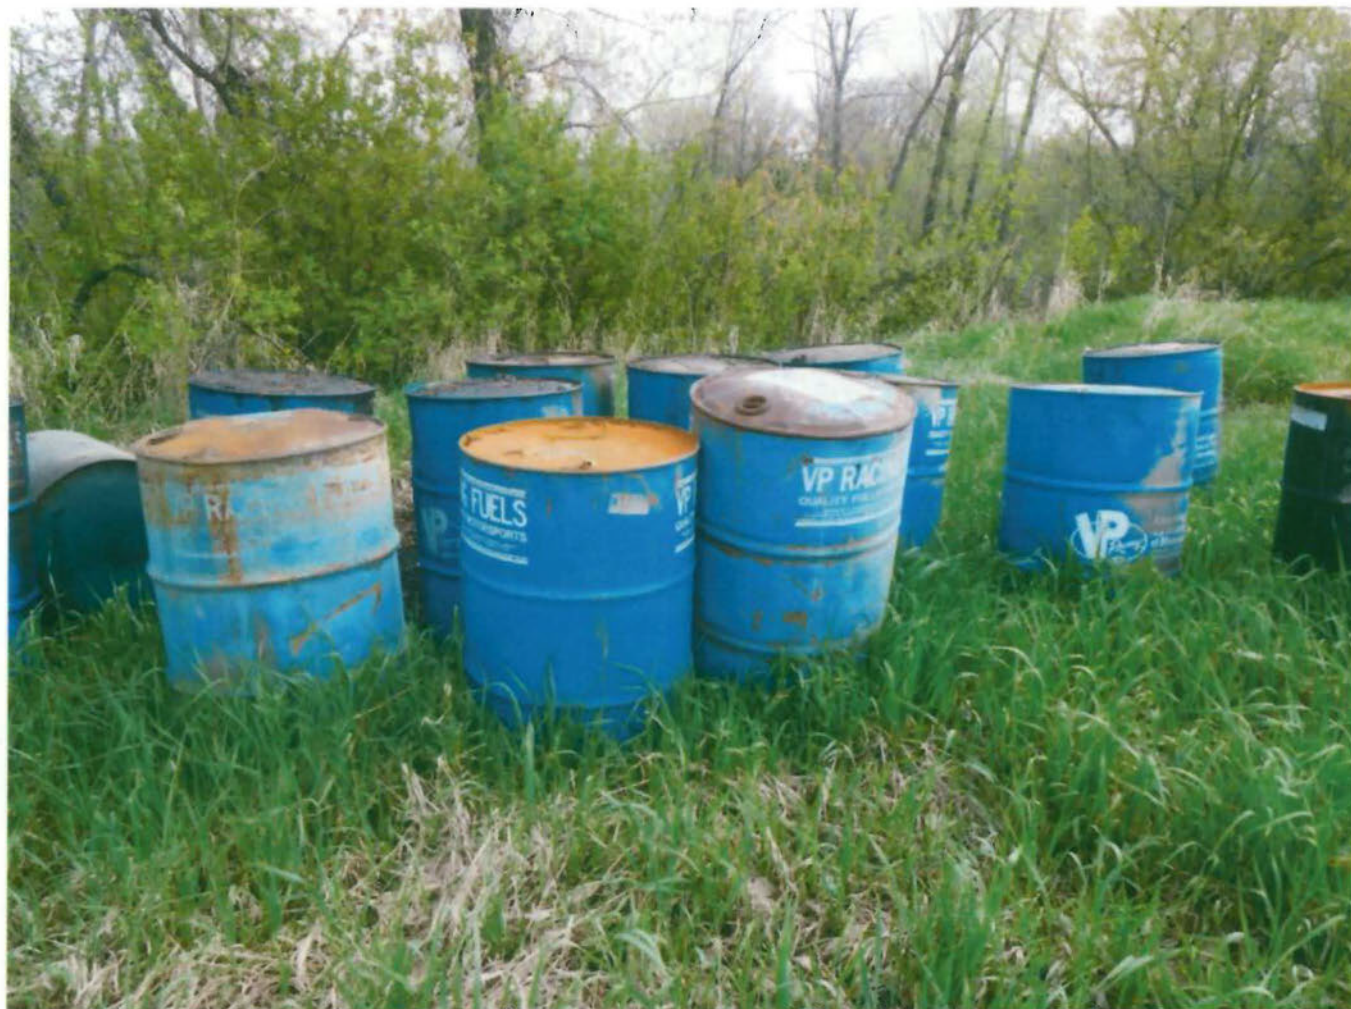
Photo 1164, DSCN1164.jpg, 5/15/2019 9:40 am, photo central section of drums, including two drums with bulging tops (one of which was also shown in photo 1163).

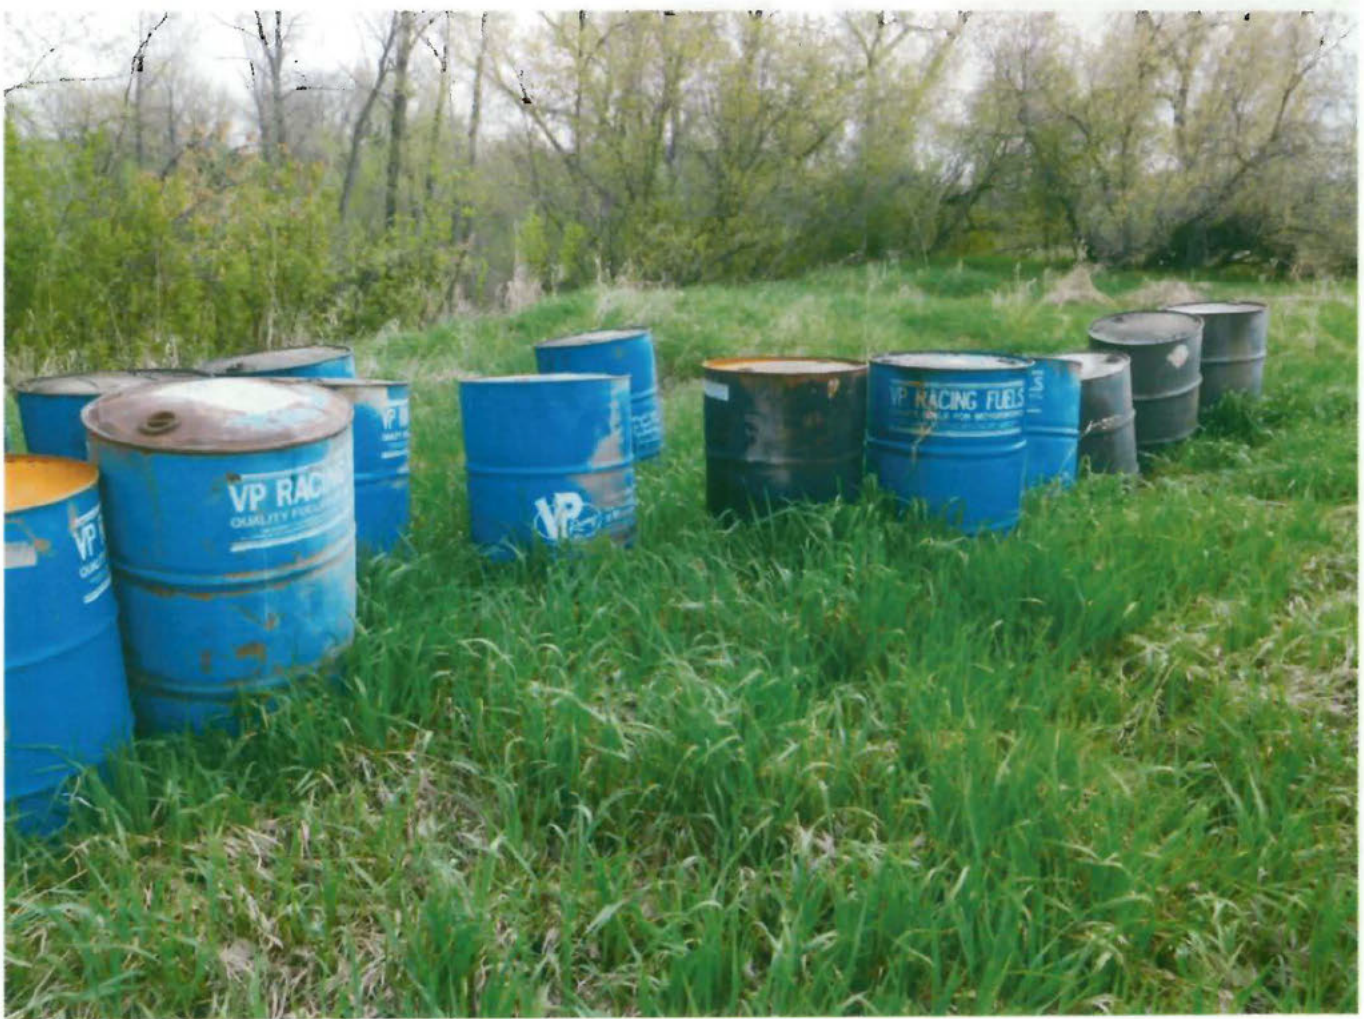
Photo 1165, DSCN1165.jpg, 5/15/2019 9:40 am, photo of easternmost section of drums.

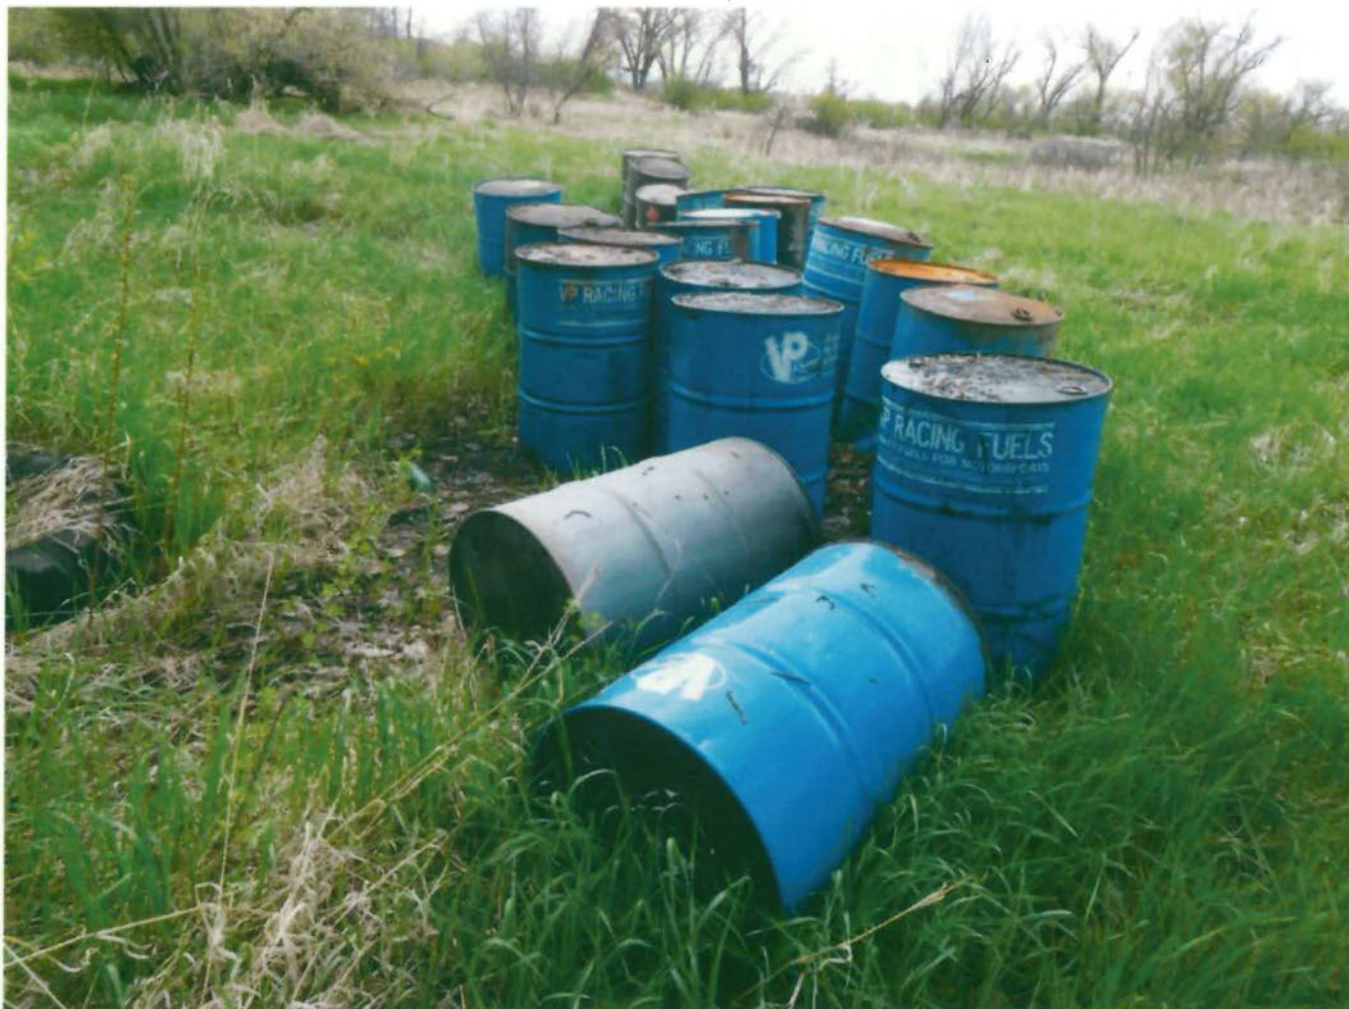
Photo 1166, DSCN1166.jpg, 5/15/2019 9:40 am, photo of all 20 drums, taken facing south.

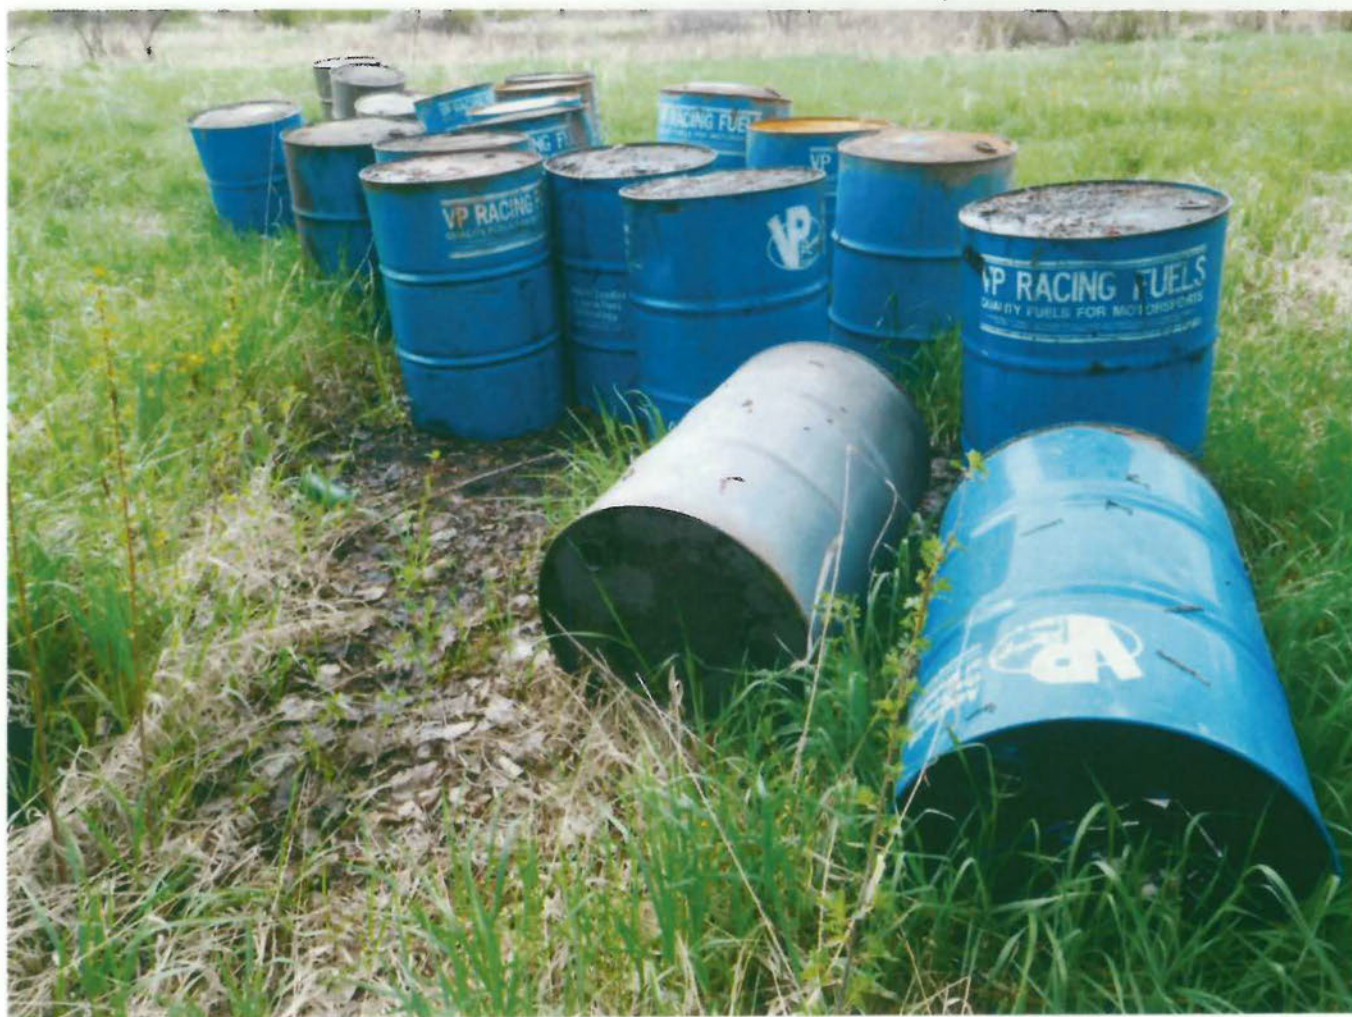
Photo 1167, DSCN1167.jpg, 5/15/2019 9:41 am, photo of all 20 drums, taken facing southeast.

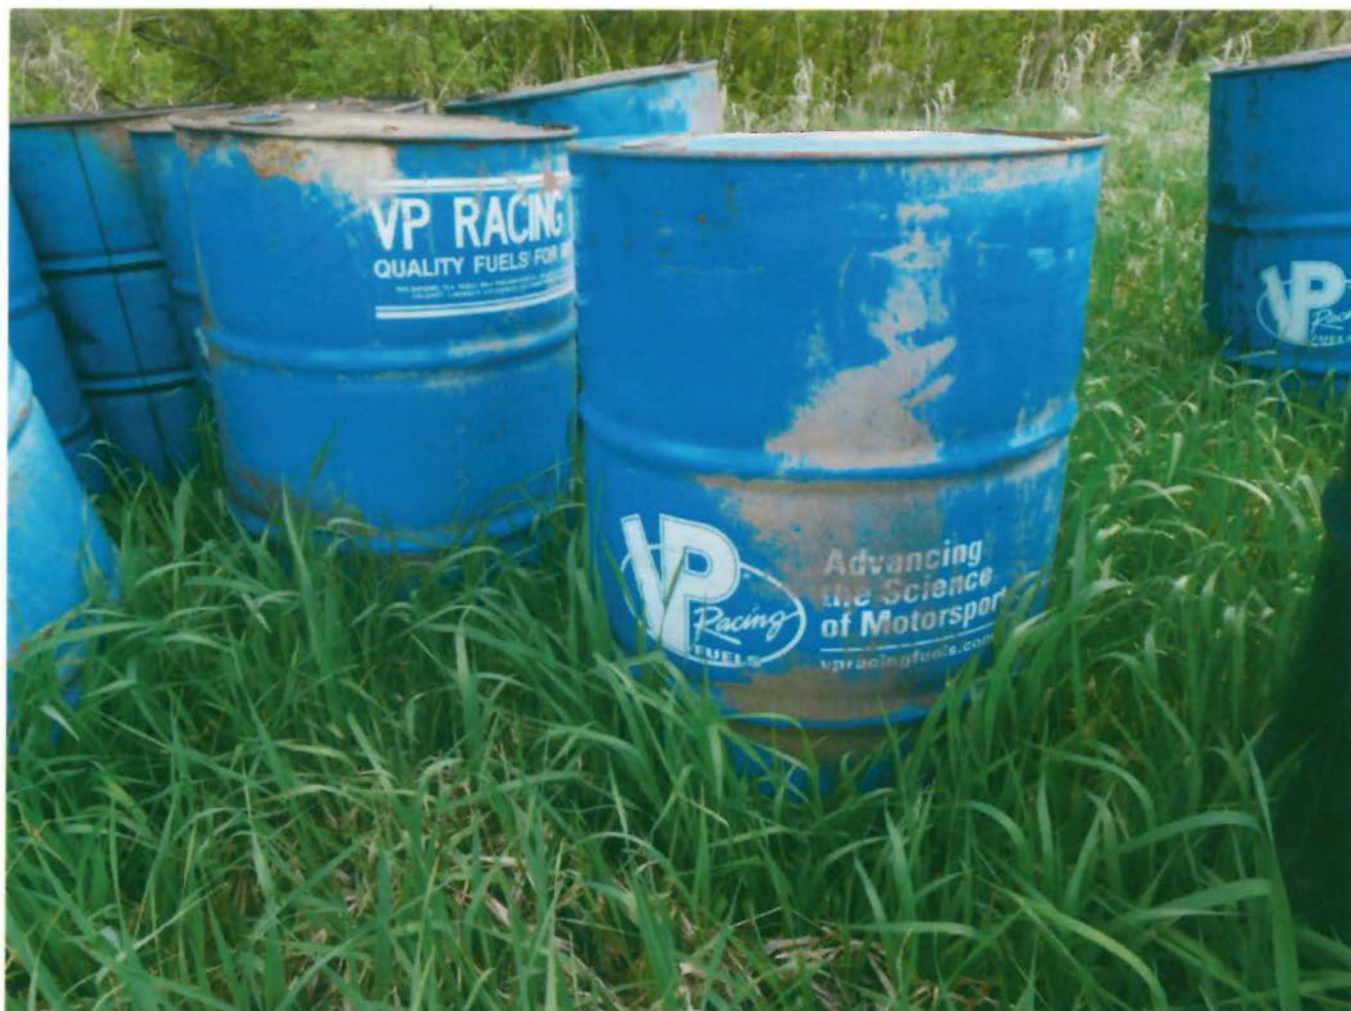
Photo 1168, DSCN1168.jpg, 5/15/2019 9:41 am, photo of drum labeling.

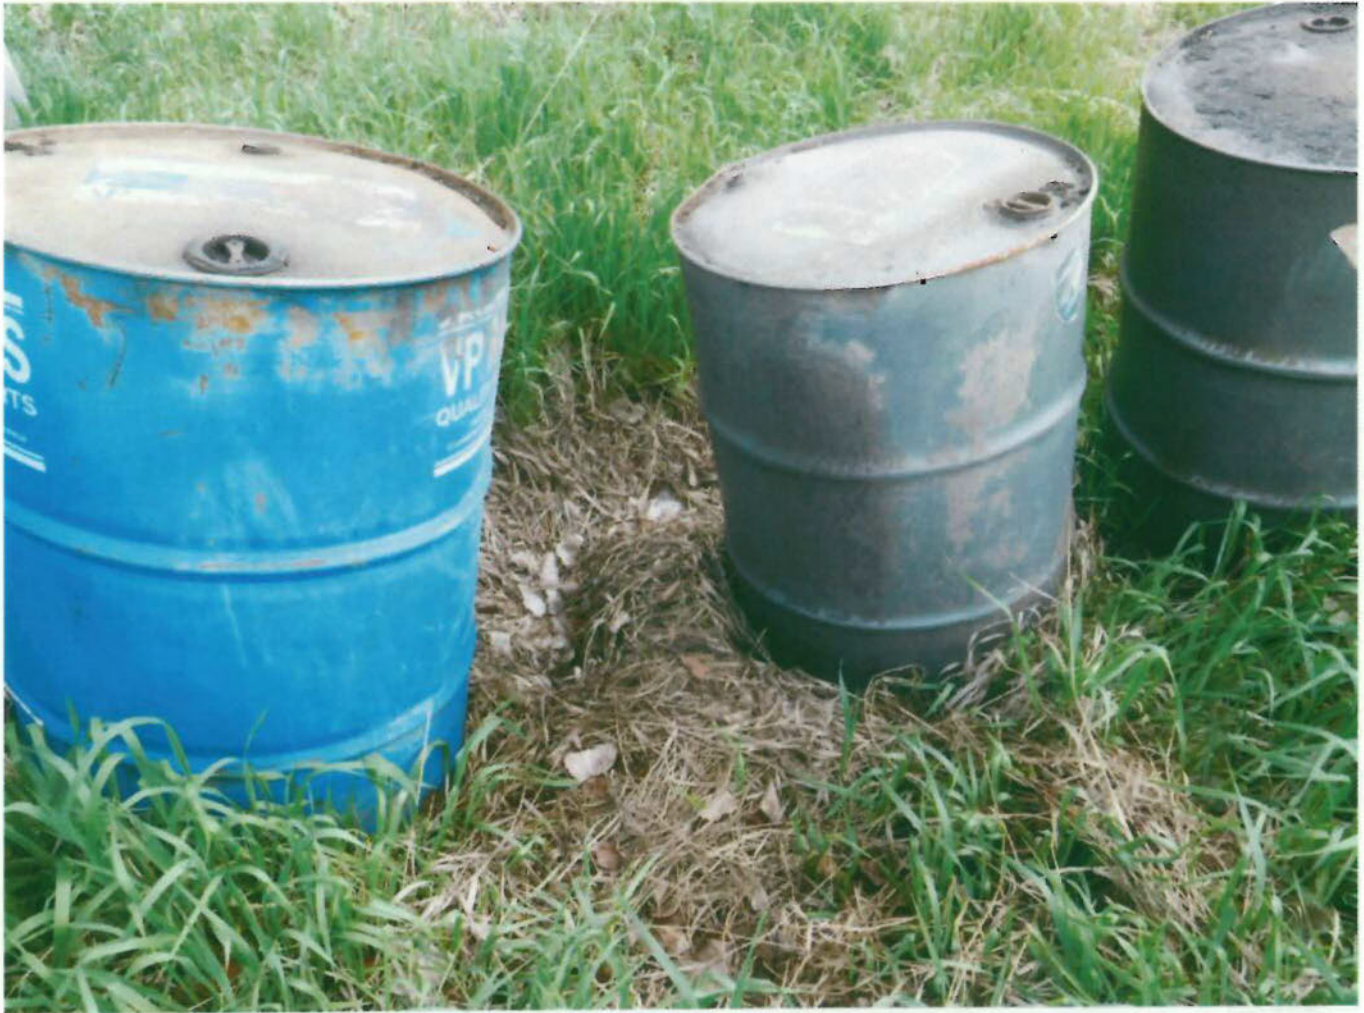
Photo 1169, DSCN1169.jpg, 5/15/2019 9:41 am, photo of stressed vegetation in between drums.

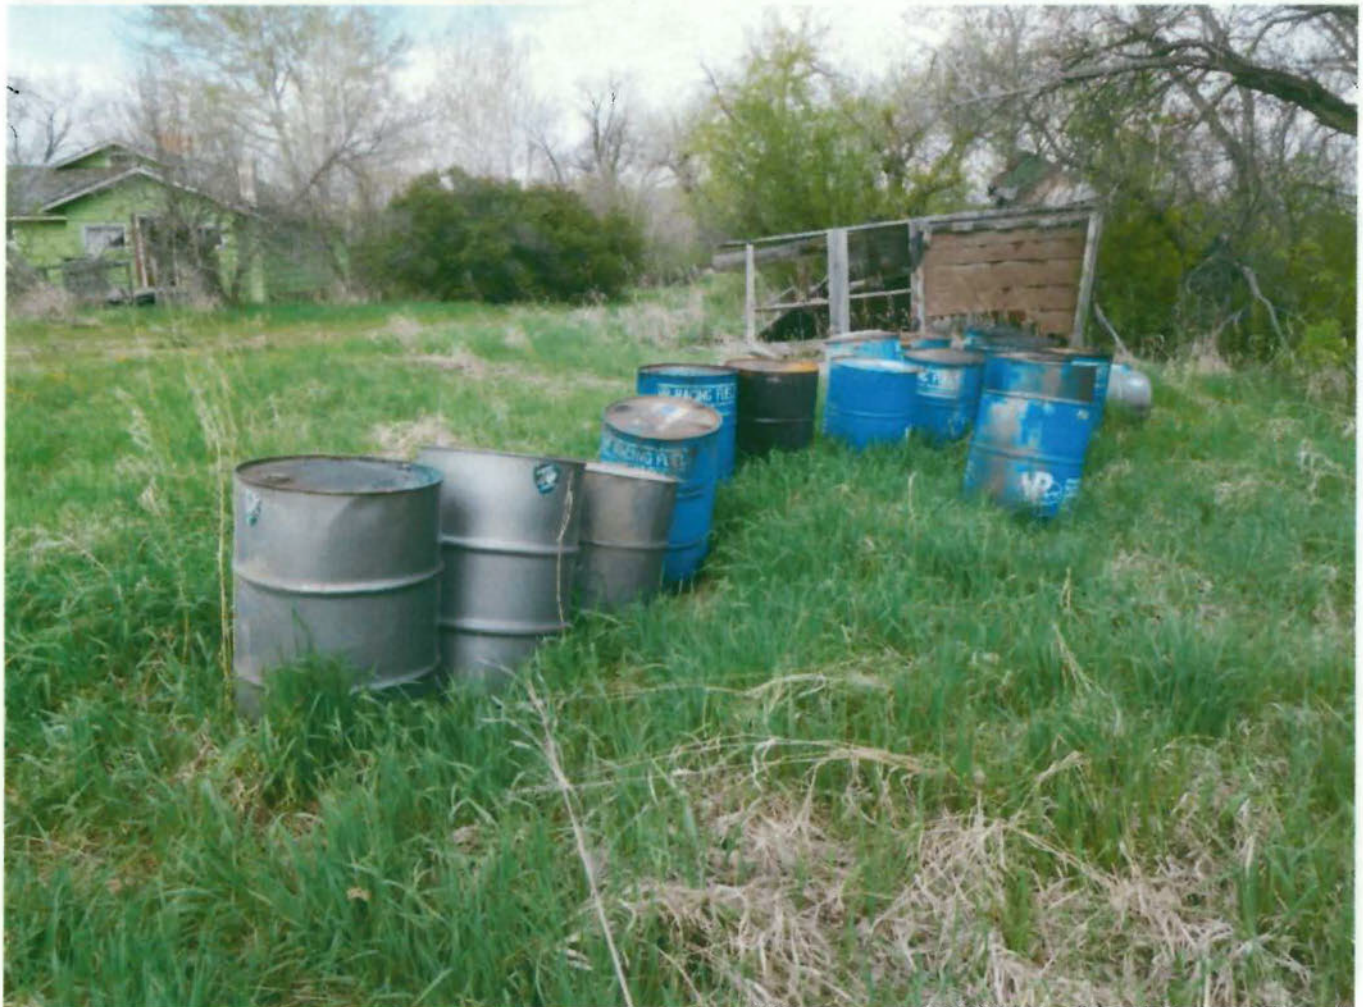
Photo 1170, DSCN1170.jpg, 5/15/2019 9:42 am, photo of all 20 drums, taken facing west. Uninhabited green residential structure and partially fallen-down additional structure included in photo background.

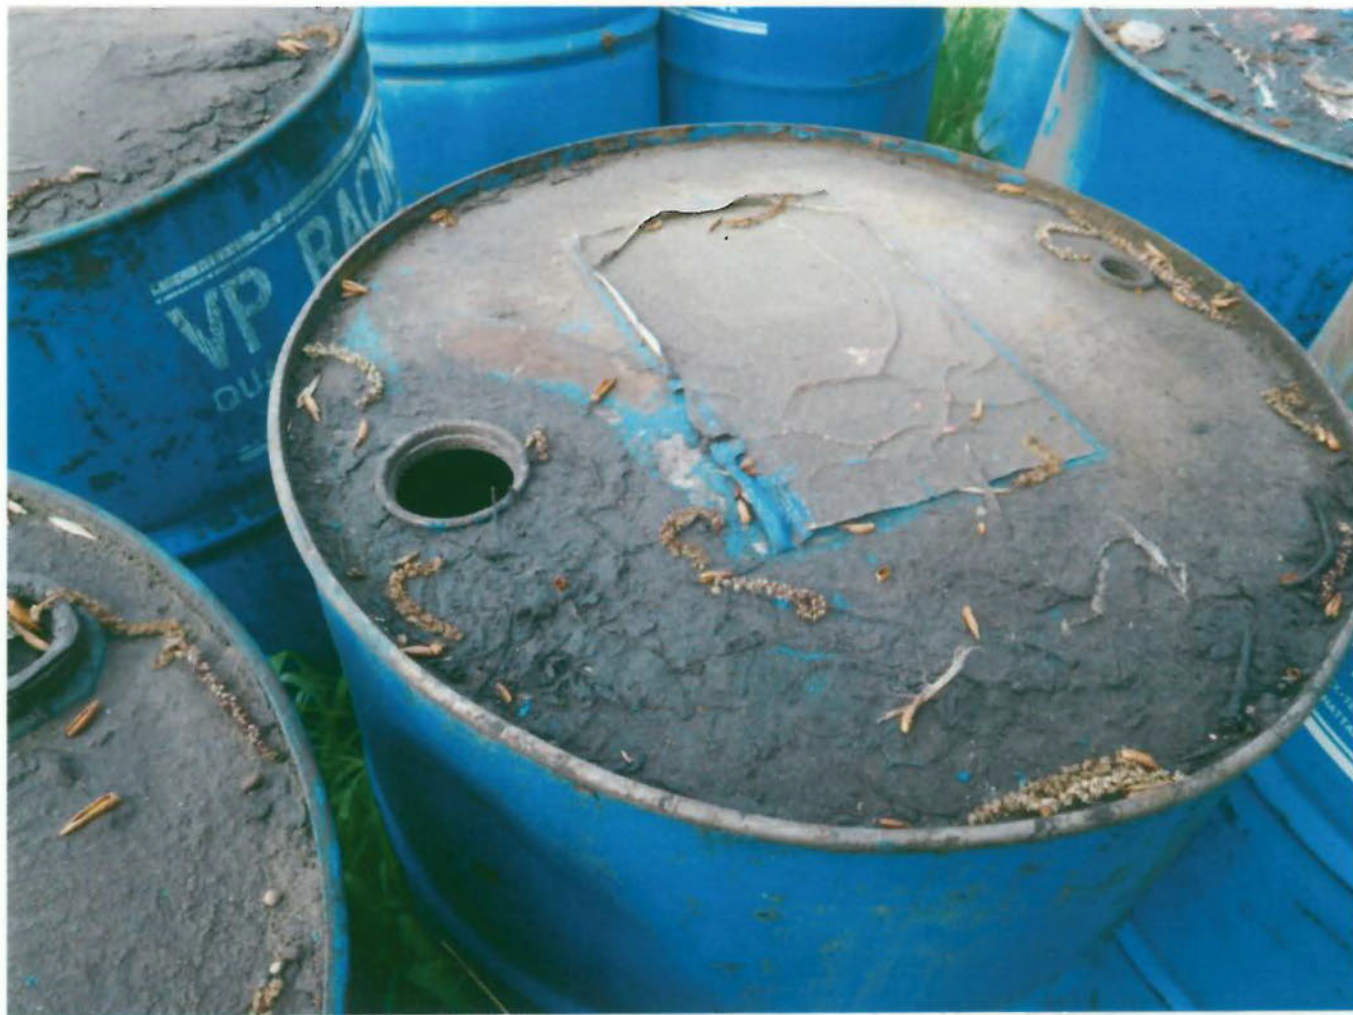
Photo 1171, DSCN1171.jpg, 5/15/2019 9:42 am, photo of an open drum.

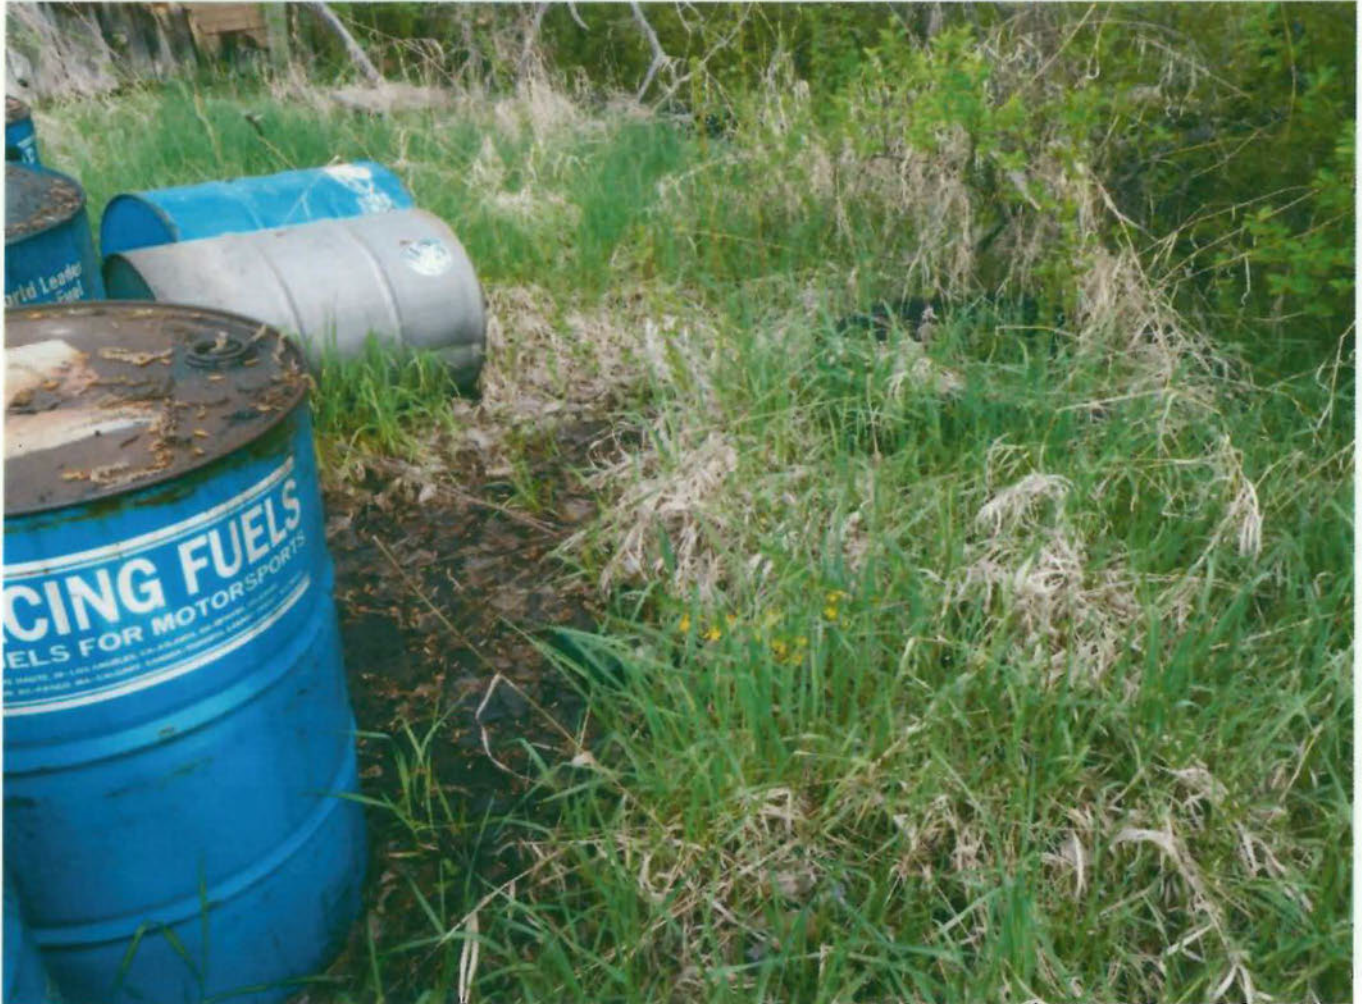
Photo 1172, DSCN1172.jpg, 5/15/2019 9:42 am, photo of spilled or leaked oily-looking waste on ground on north side of drum area.

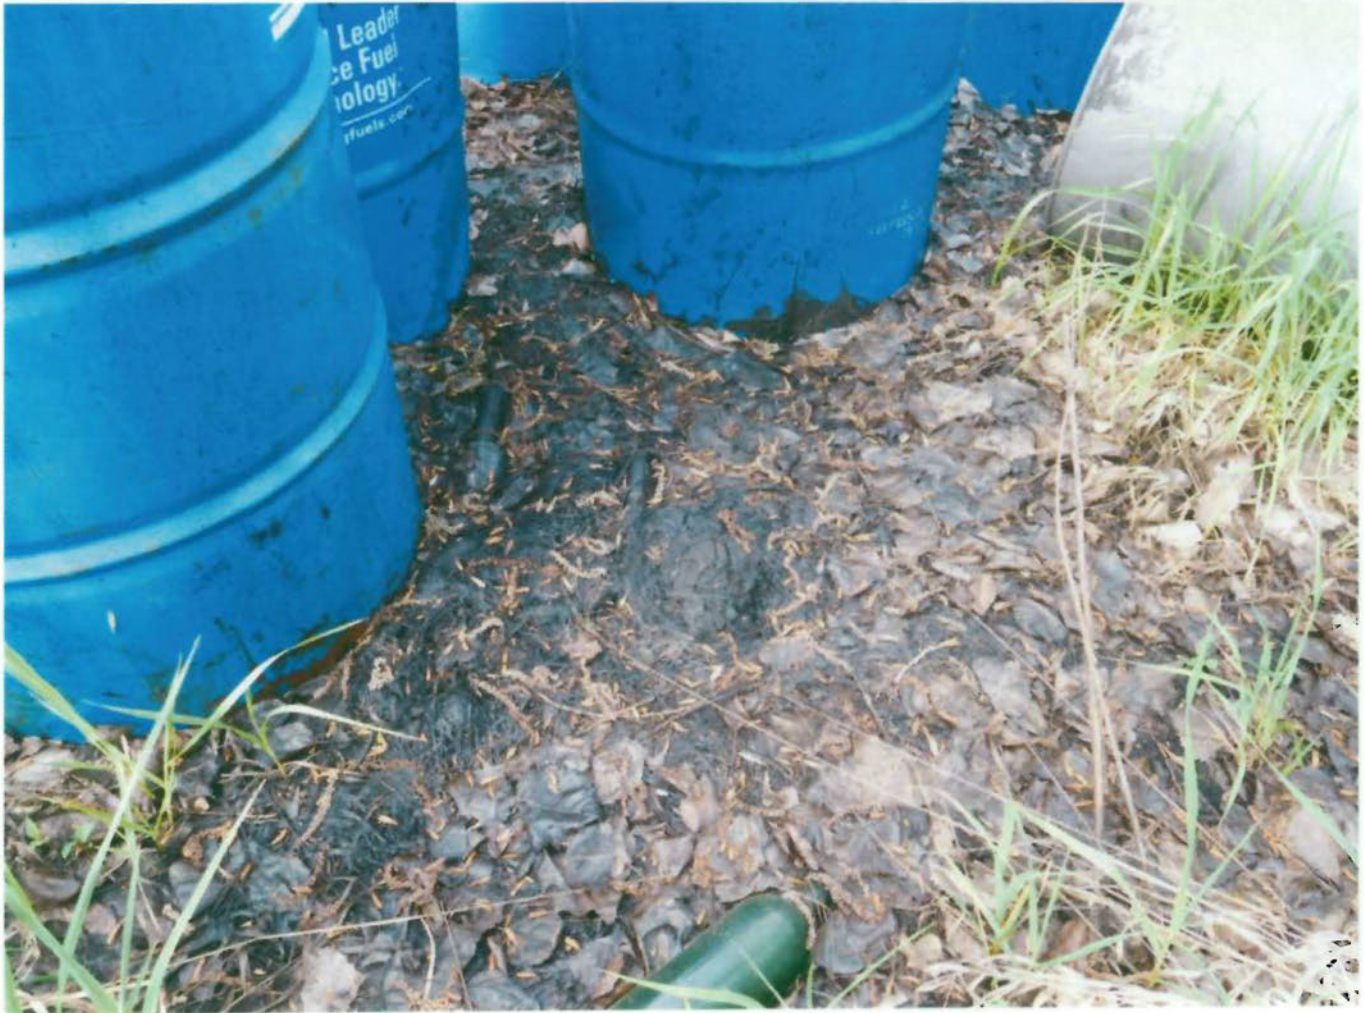
Photo 1173, DSCN1173.jpg, 5/15/2019 9:42 am, photo of spilled or leaked oily-looking waste on ground on north side of drum area

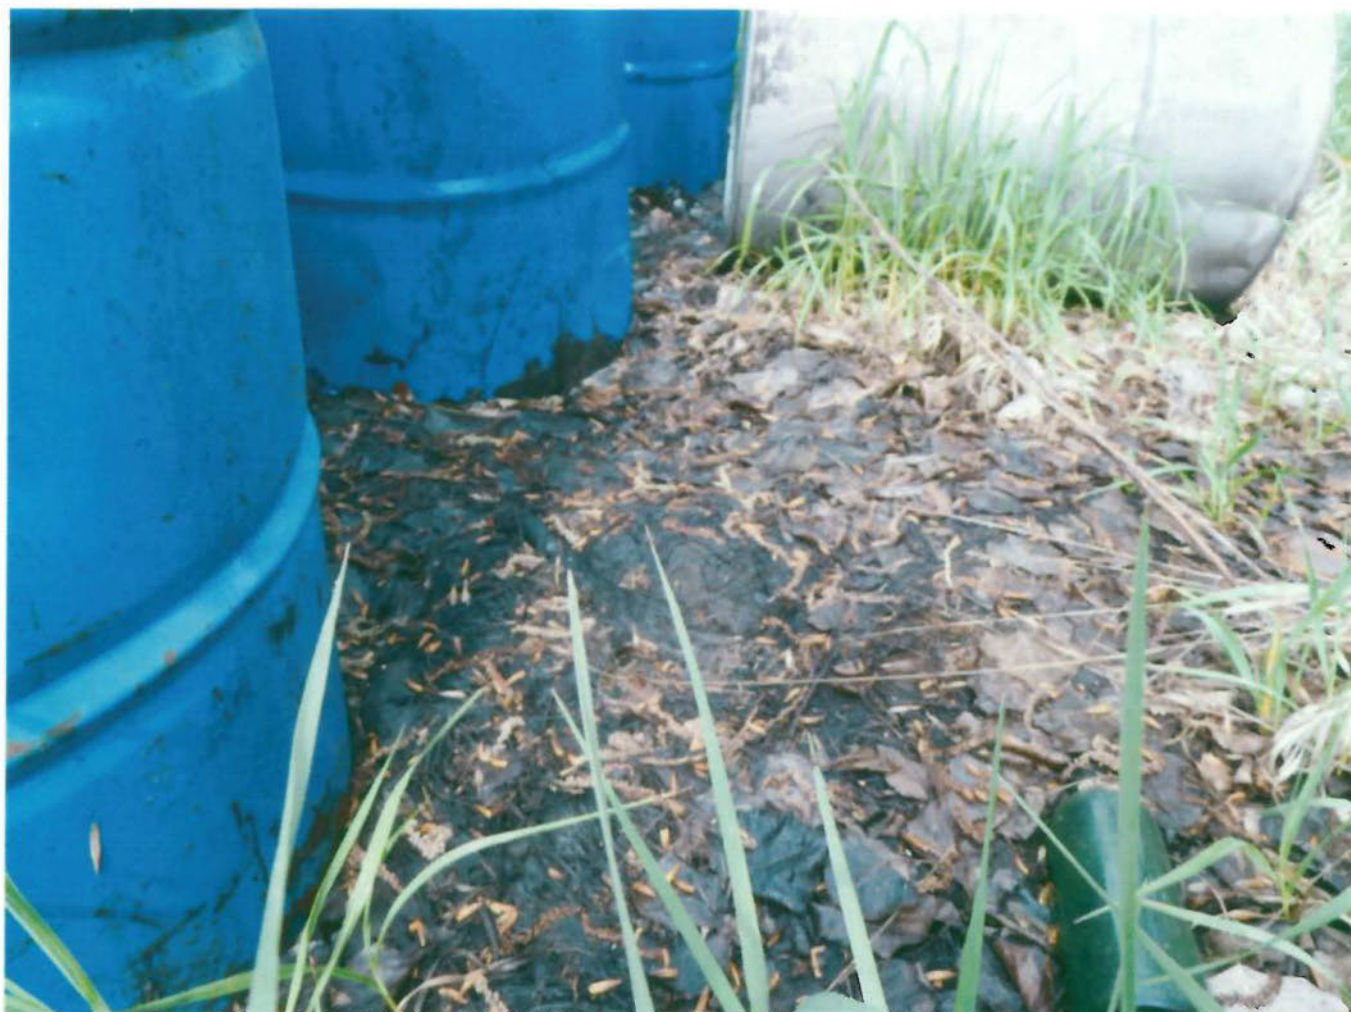
Photo 1174, DSCN1174.jpg, 5/15/2019 9:46 am, photo of spilled or leaked oily-looking waste on ground on north side of drum area.
