**UNITED STATES ENVIRONMENTAL PROTECTION AGENCY
REGION 8
RESOURCE CONSERVATION AND RECOVERY ACT**

Facility Name: Lodge Grass Drum Site
RCRA ID: MTR000211649

Date of Inspection: May 15, 2019

Type and Purpose of Inspection: Compliance Evaluation Inspection
RCRA Section 7003 Inspection

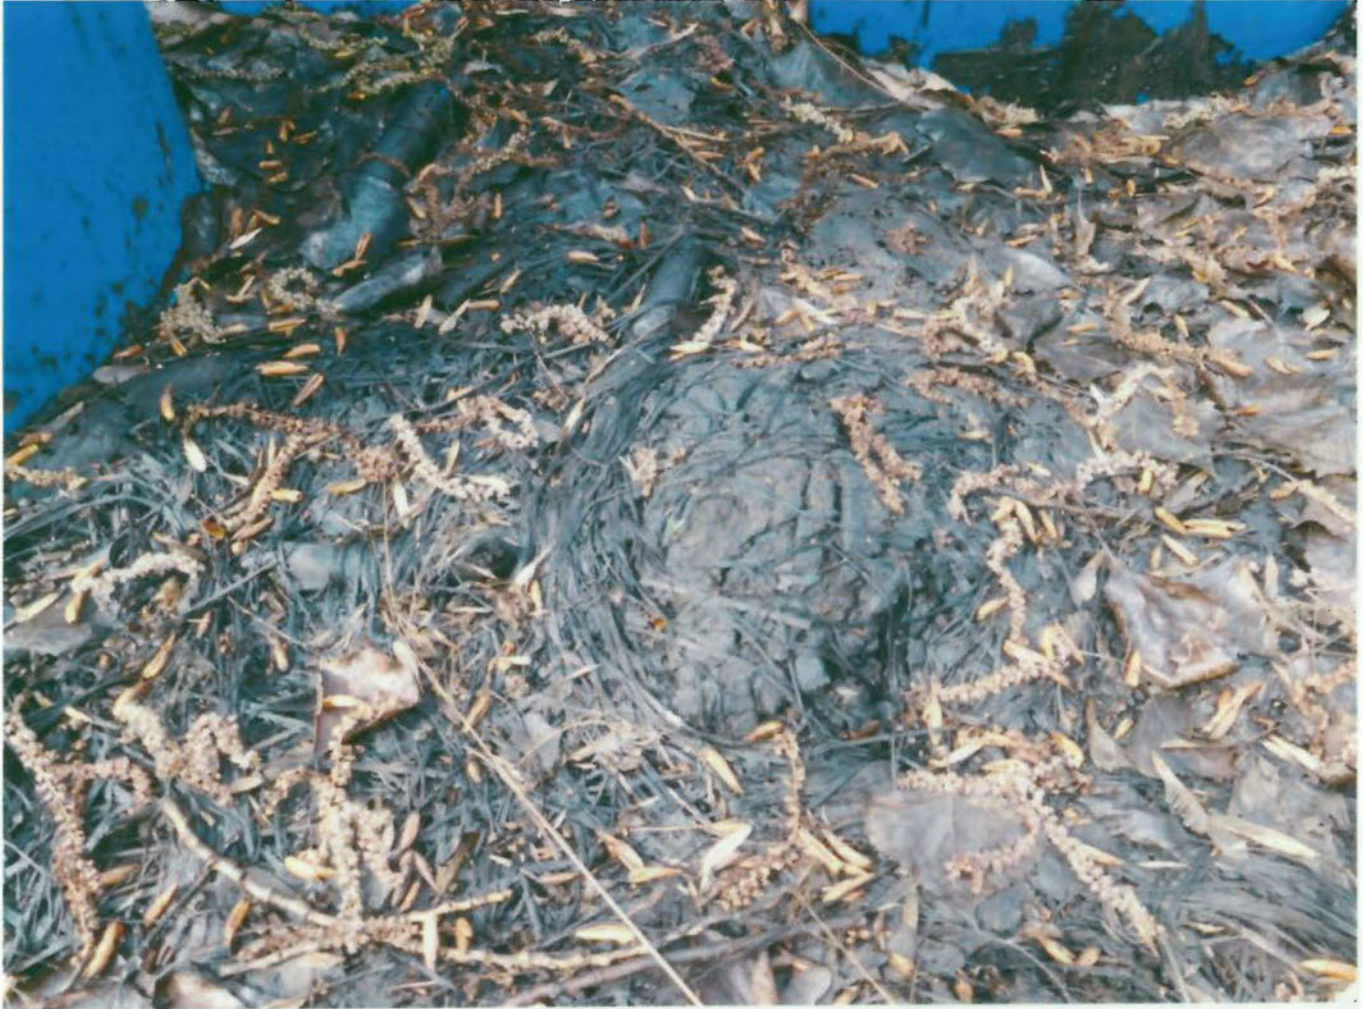
Photo 1175, DSCN1175.jpg, 5/15/2019 9:46 am, photo of spilled or leaked oily-looking waste on ground on north side of drum area.

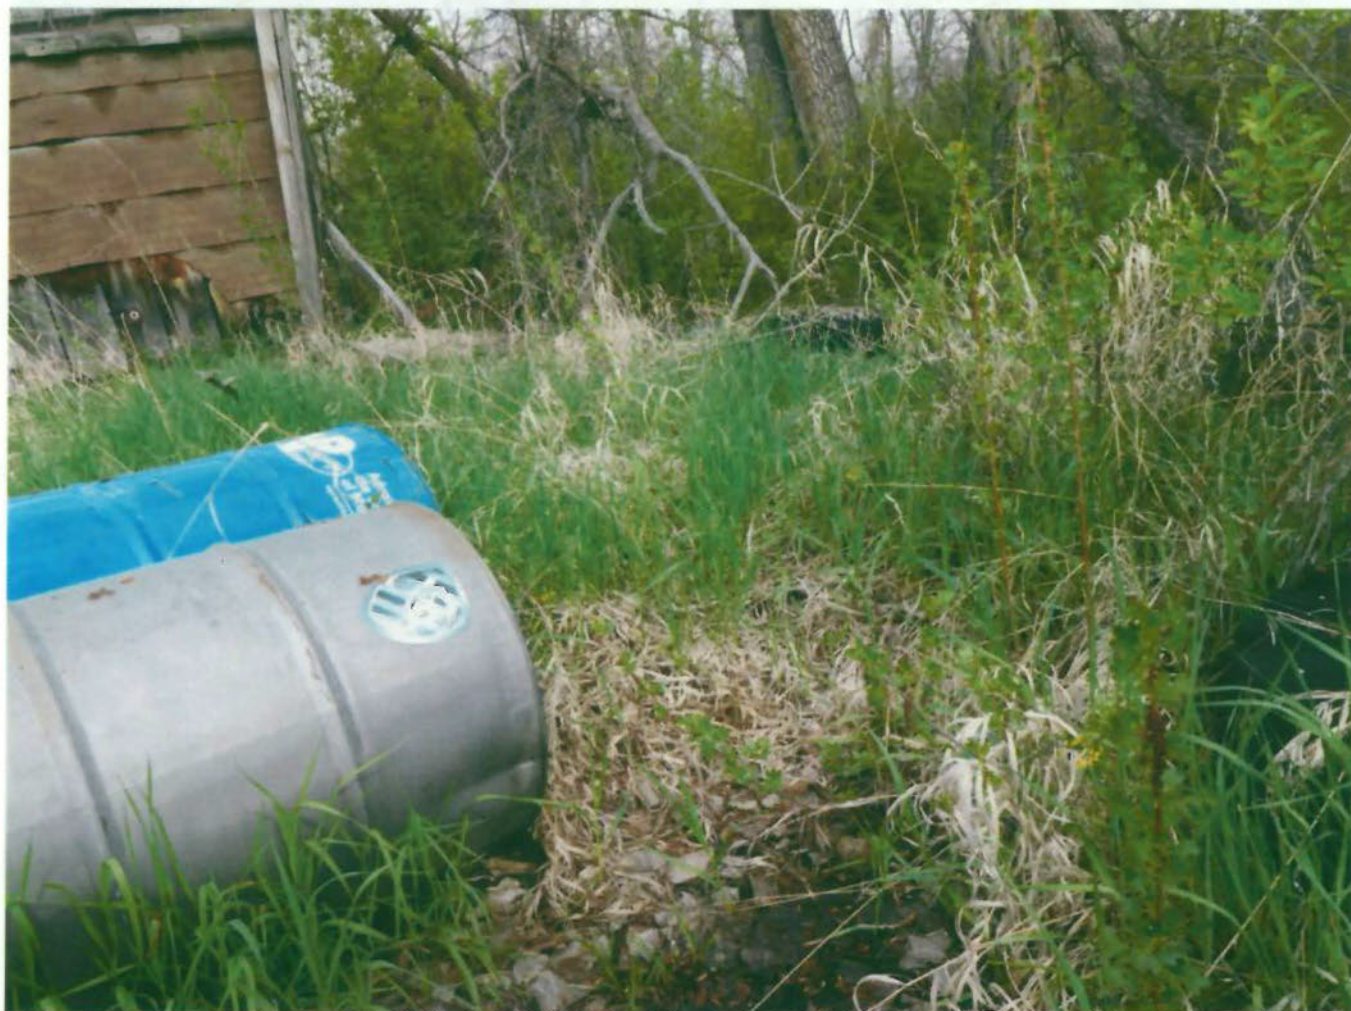
Photo 1176, DSCN1176.jpg, 5/15/2019 9:46 am, photo of spilled or leaked oily-looking waste on ground on north side of drum area, facing toward lower-elevation area located approximately 15 feet to the north of the drums.

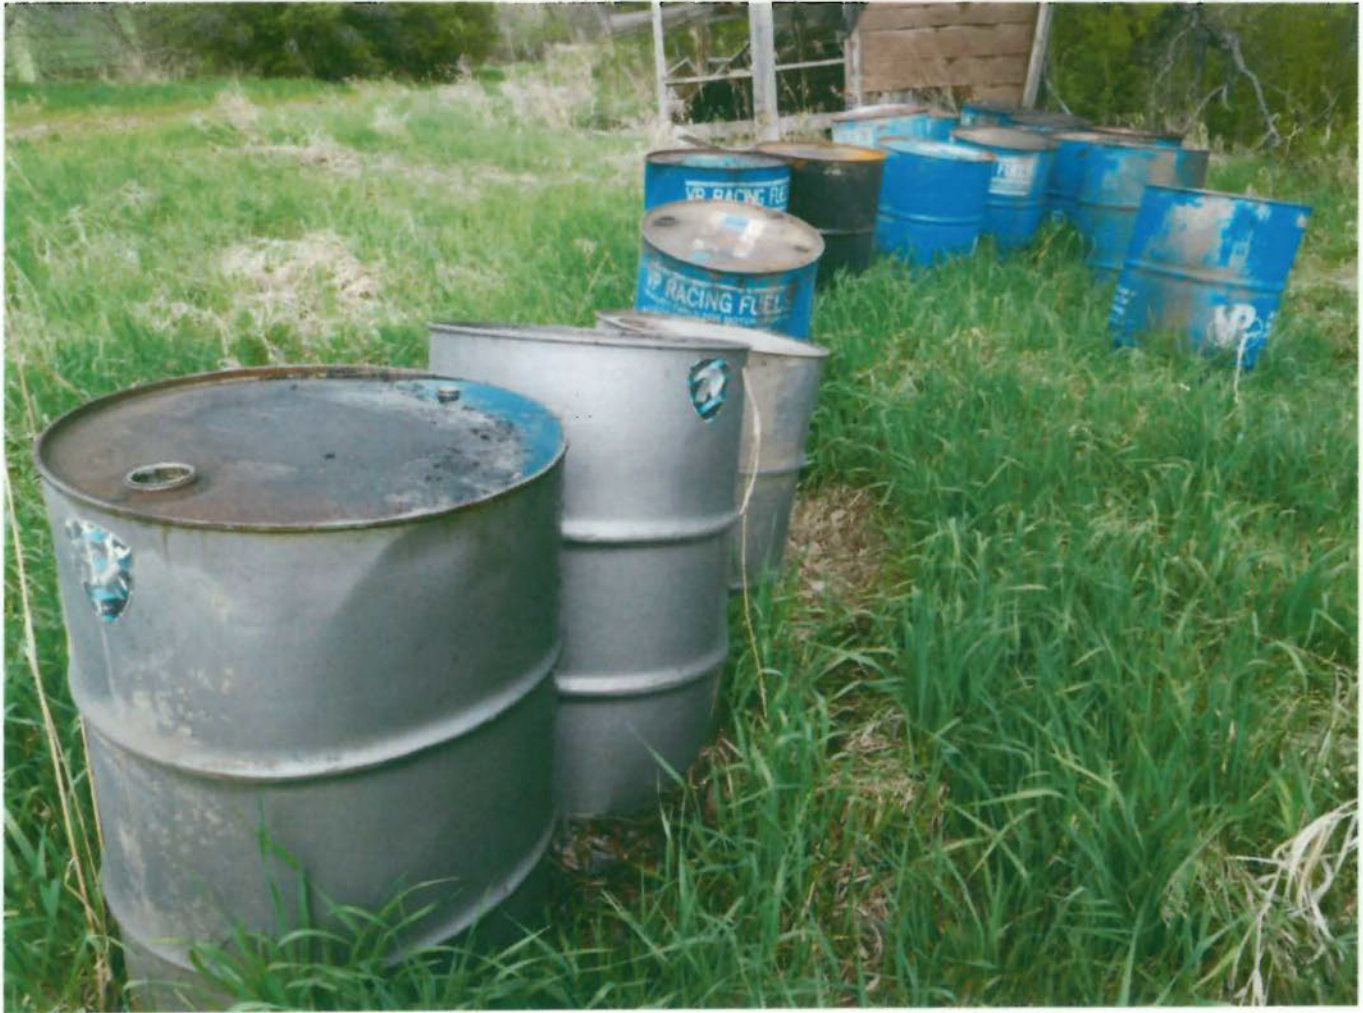
Photo 1177, DSCN1177.jpg, 5/15/2019 9:50 am, photo of all 20 drums, taken facing west.

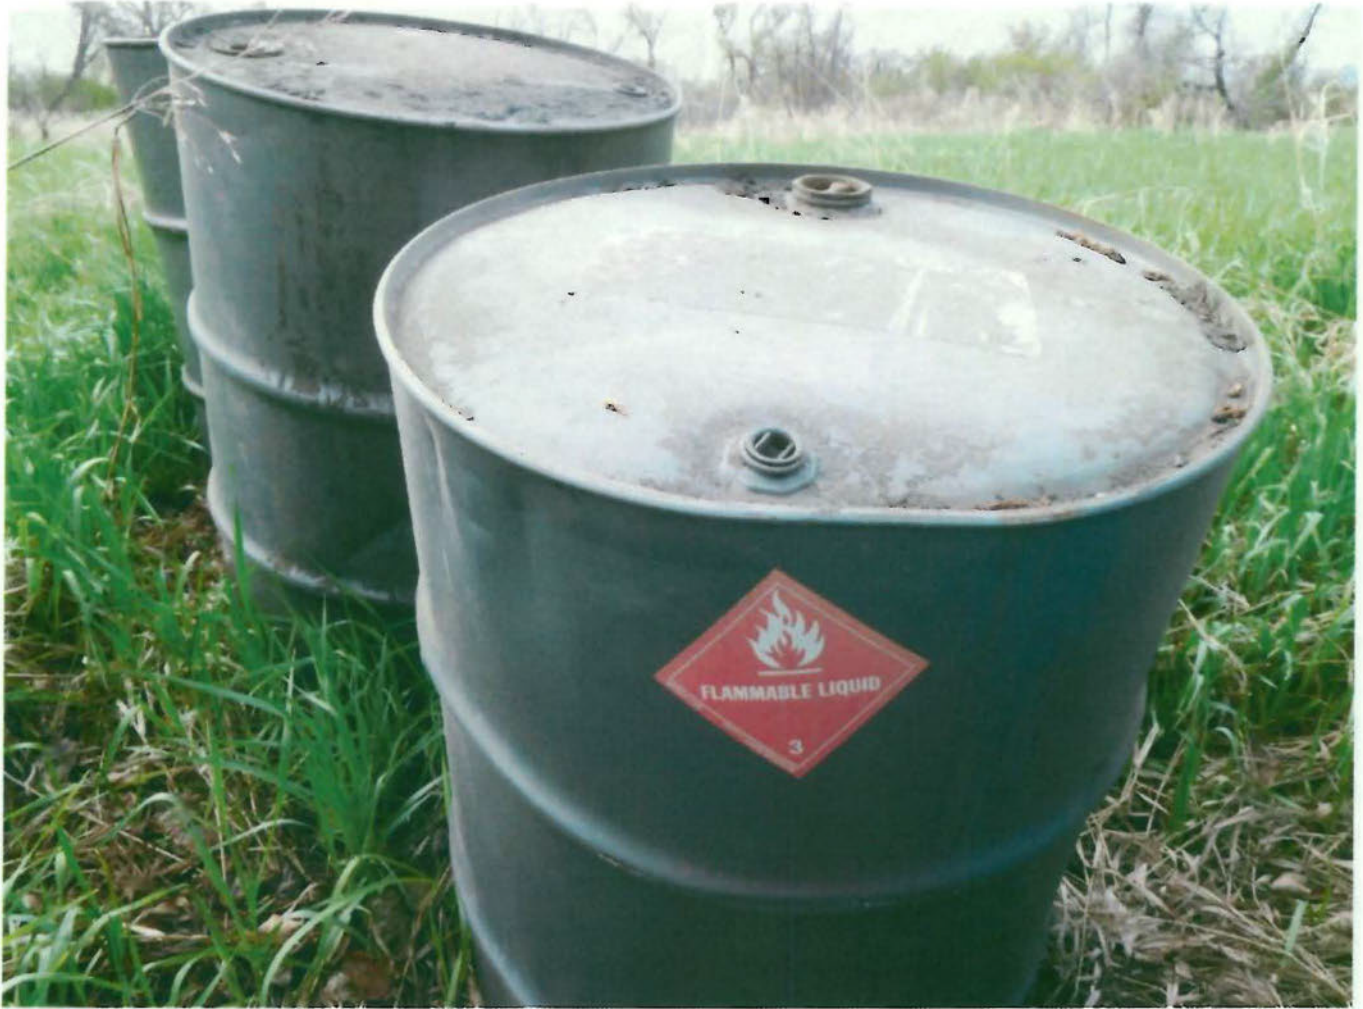
Photo 1178, DSCN1178.jpg, 5/15/2019 9:51 am, photo of drum label.

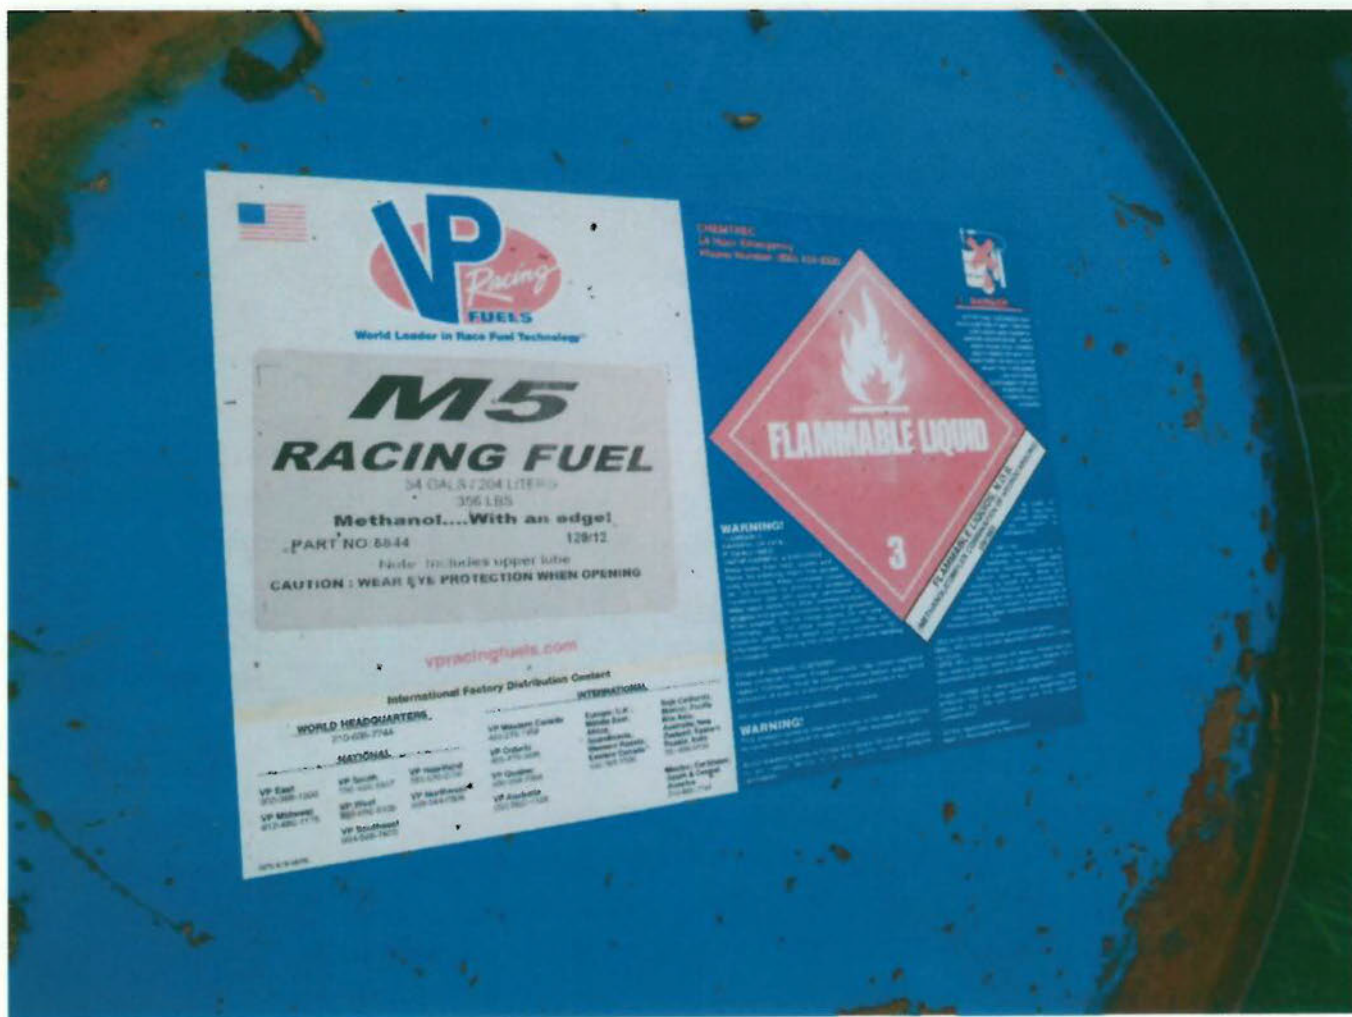
Photo 1179, DSCN1179.jpg, 5/15/2019 9:51 am, photo of drum label.

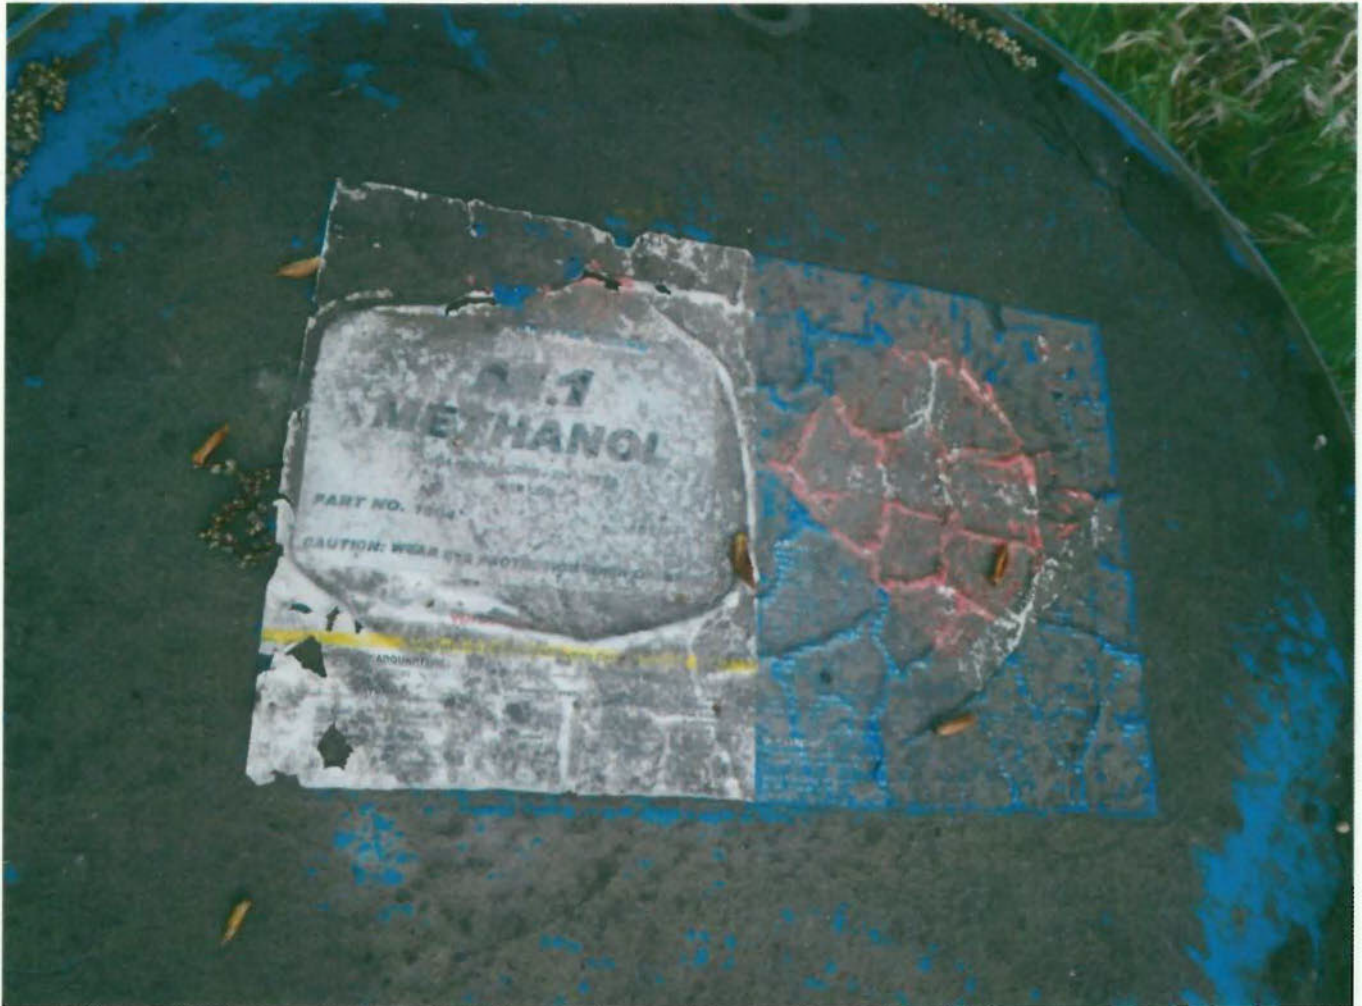
Photo 1180, DSCN1180.jpg, 5/15/2019 9:51 am, photo of drum label.

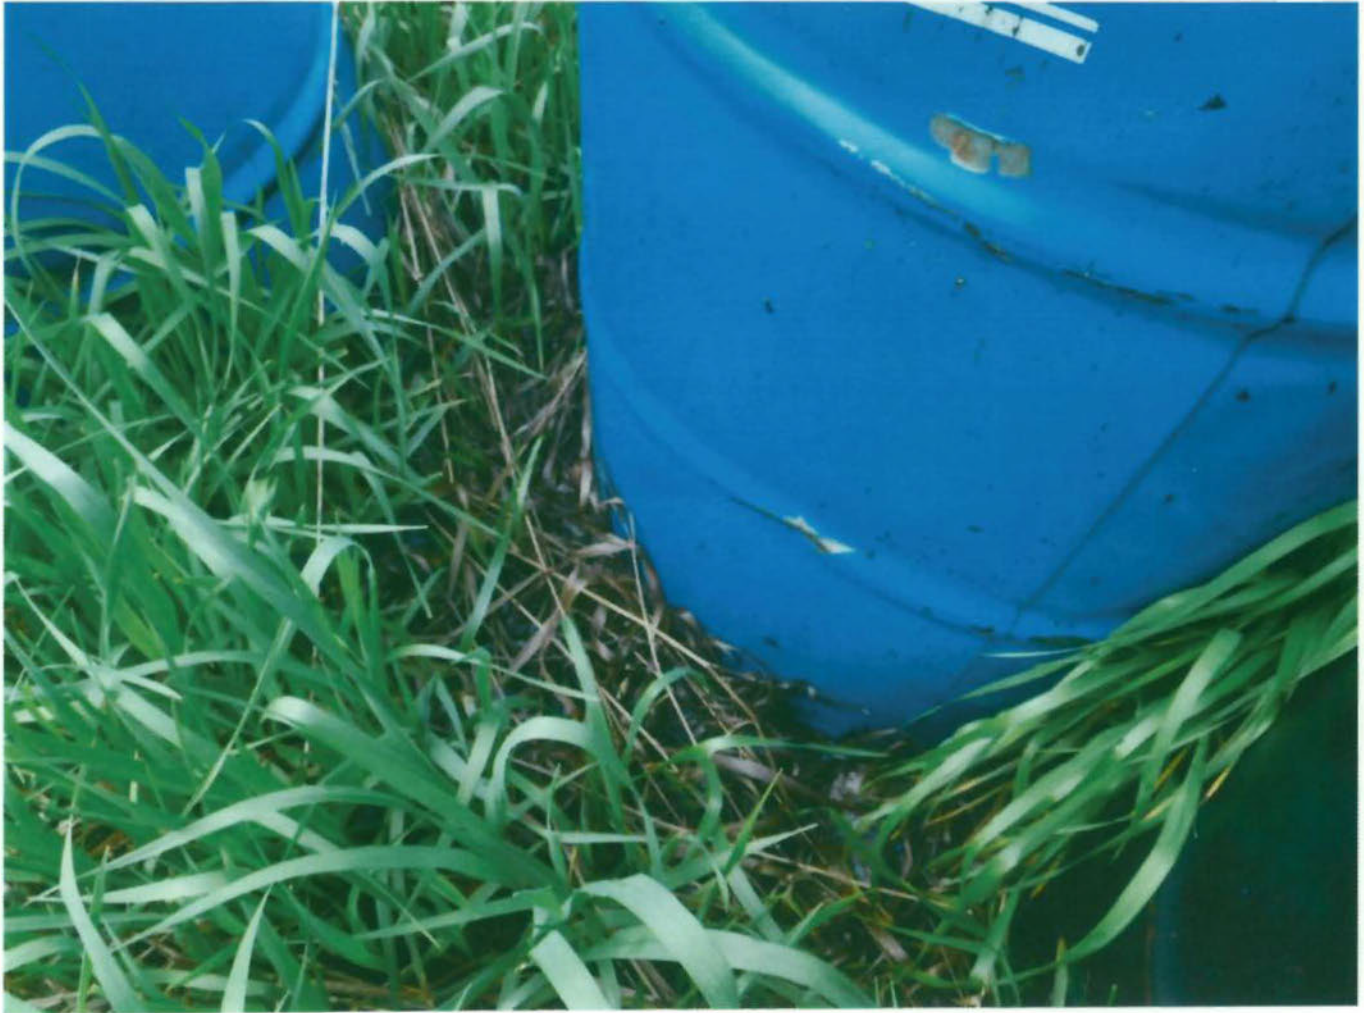
Photo 1181, DSCN1181.jpg, 5/15/2019 9:51 am, photo of stressed vegetation.

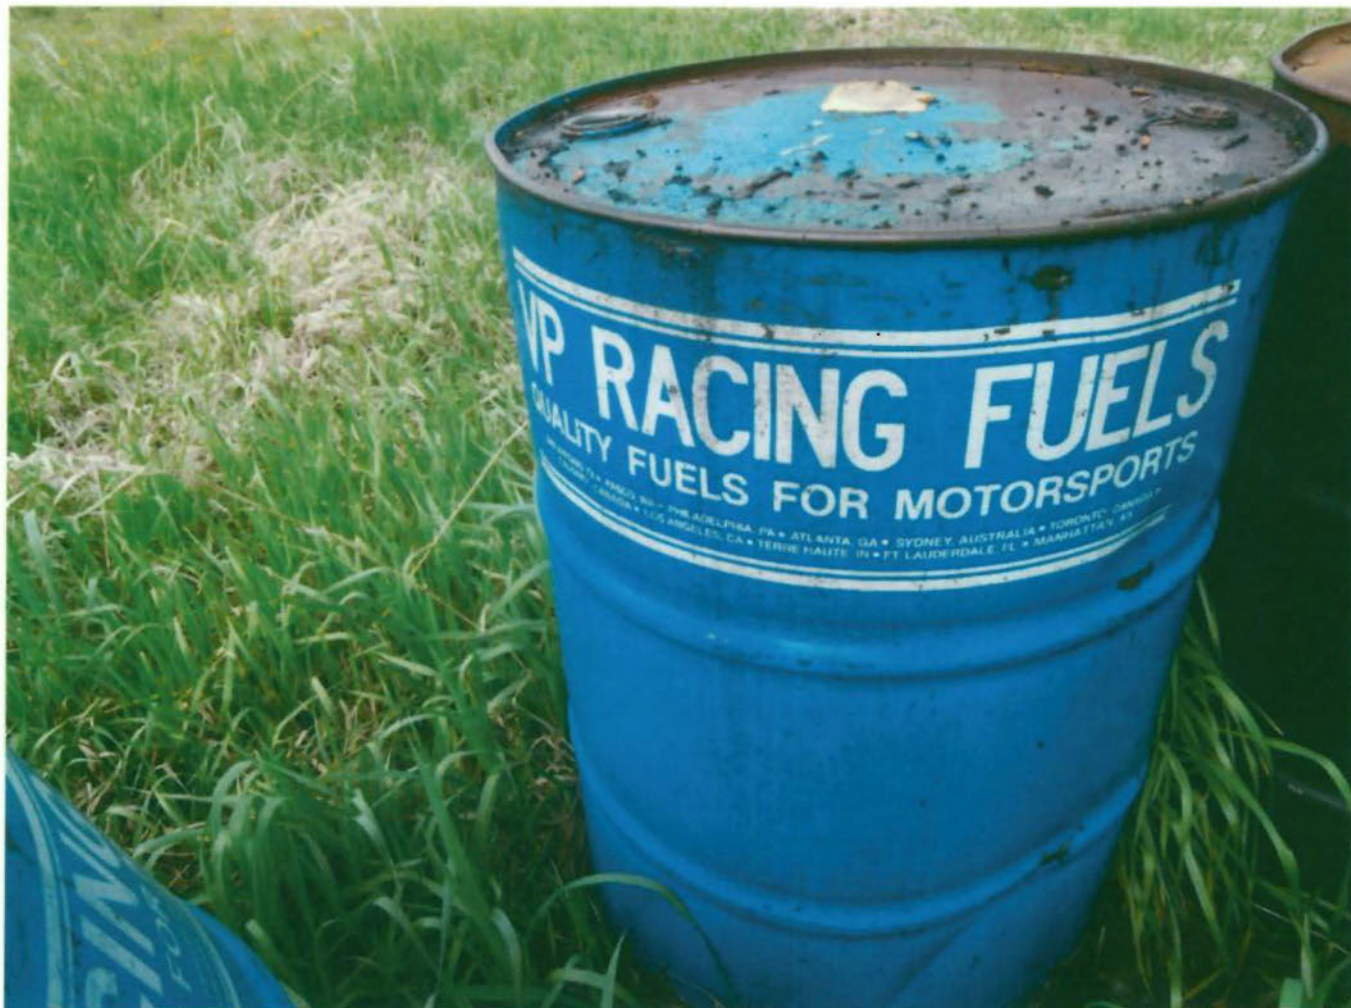
Photo 1182, DSCN1182.jpg, 5/15/2019 9:52 am, photo of drum label.

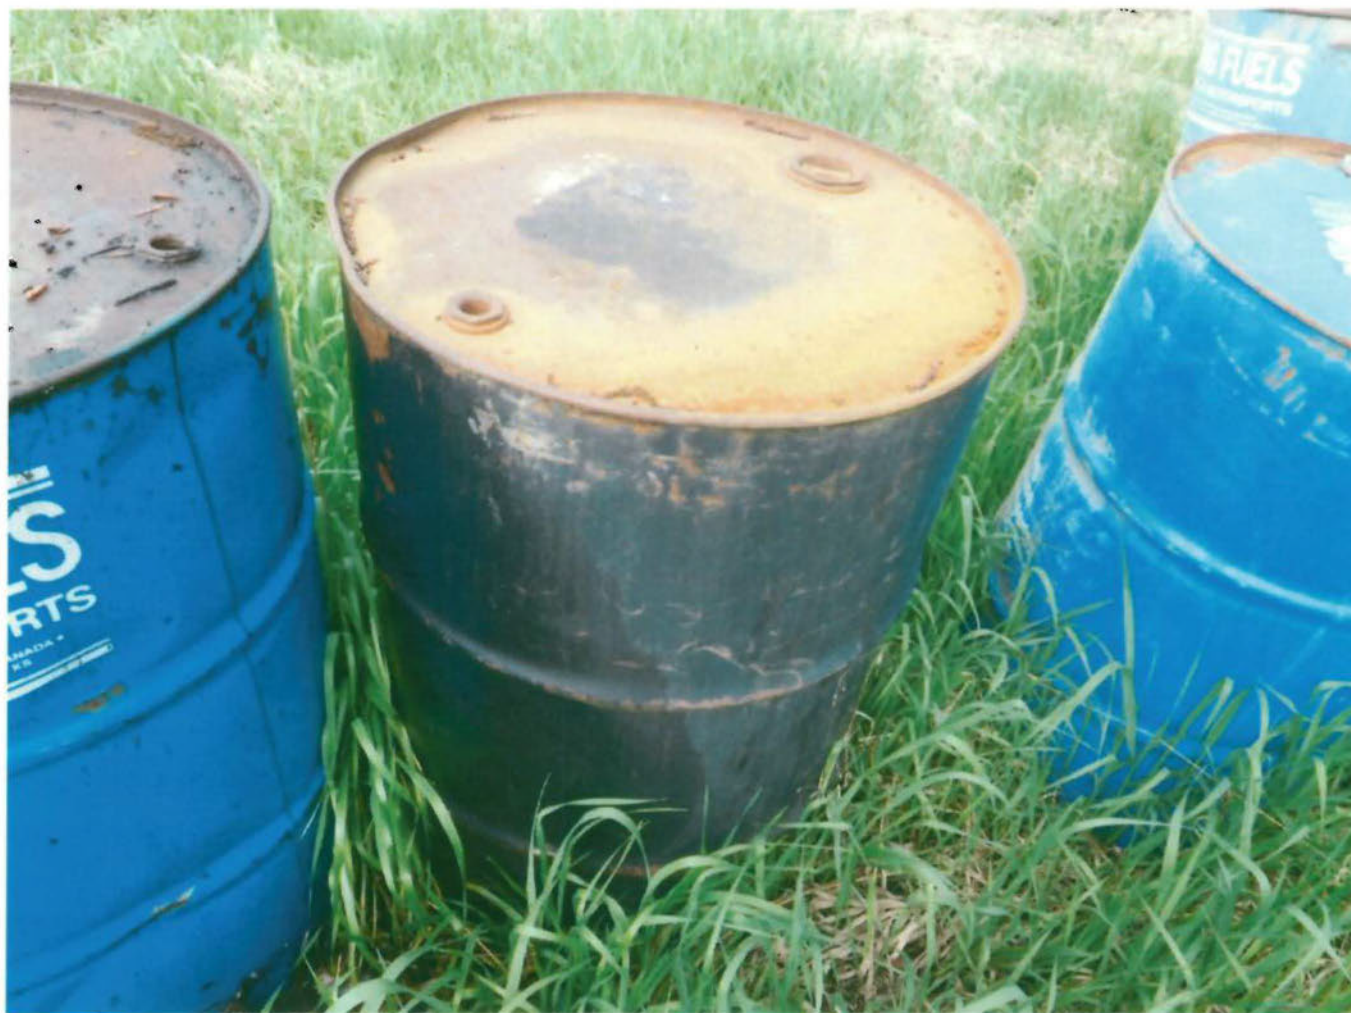
Photo 1183, DSCN1183.jpg, 5/15/2019 9:52 am, photo of drum with no labels.
