UNITED STATES ENVIRONMENTAL PROTECTION AGENCY
REGION 8

Re: Resource Conservation and Recovery Act (RCRA) Inspection
U.S. EPA ID # MTR000211649

**UNITED STATES ENVIRONMENTAL PROTECTION AGENCY
REGION 8
RESOURCE CONSERVATION AND RECOVERY ACT**

Facility Name: Lodge Grass Drum Site
RCRA ID: MTR000211649

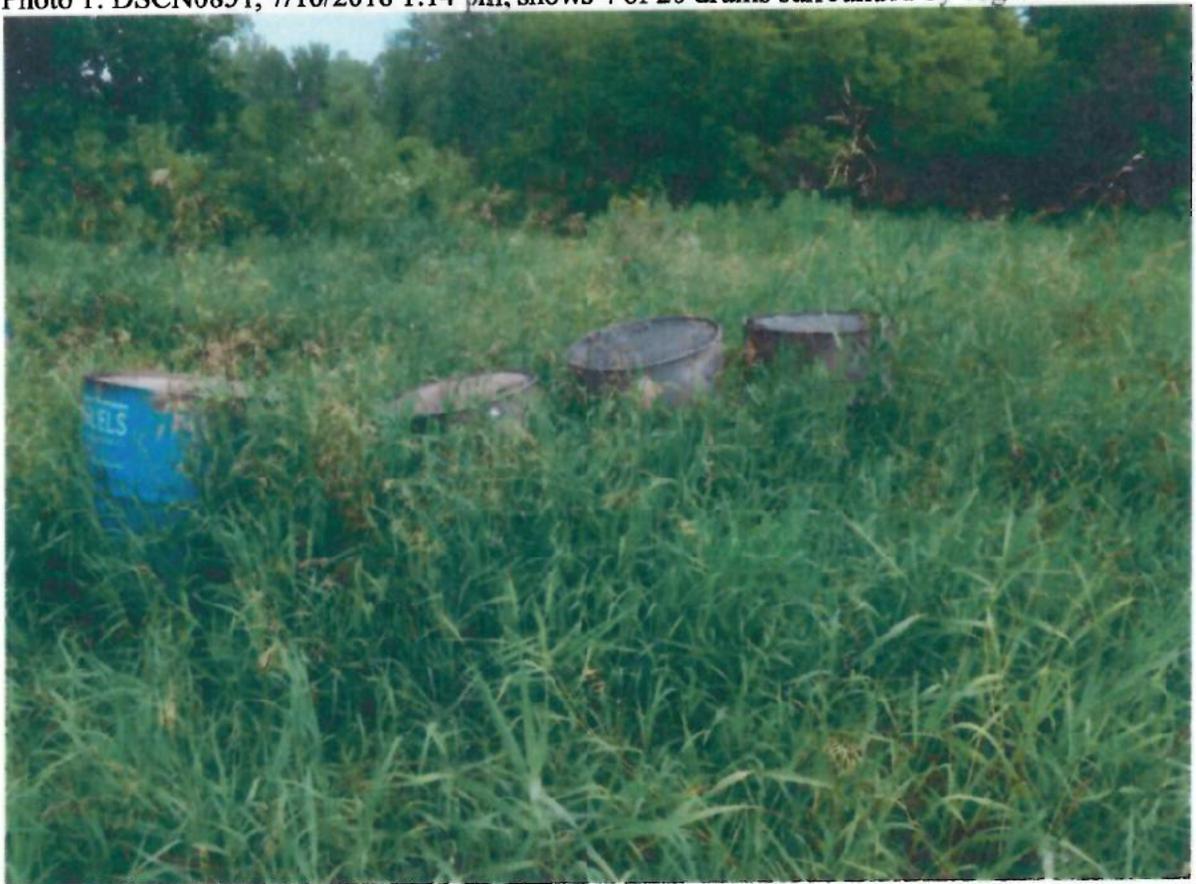
that all appeared to contain liquids. Based on the appearance of the ground including distressed vegetation and the appearance of an oily film in the area around the drums, it appeared that some level of leaking was occurring. The drums appeared in a somewhat deteriorated state, with signs of rust forming. See Appendix B: Photo Log, photos: 0851 – 0857.

Photo 1: DSCN0851, 7/10/2018 1:14 pm, shows 4 of 20 drums surrounded by vegetation

Ms. Bends is requested to ensure and document that the 20 drums observed during the inspection are properly transported for proper reuse, reclamation/recycling, or disposal at a facility authorized to perform that activity. Ms. Bends is requested to submit copies of receipts, manifests, bills of lading, and/or other documentation demonstrating where and how the waste was transported and reused, reclaimed/recycled, or disposed. The documentation must account for all the waste observed during the inspection (20 drums). If oil or other leaked substances are present, Ms. Bends is requested to collect and properly dispose of contaminated soil. Photograph documentation of the area is requested to be provided showing that the drums have been removed from the site.

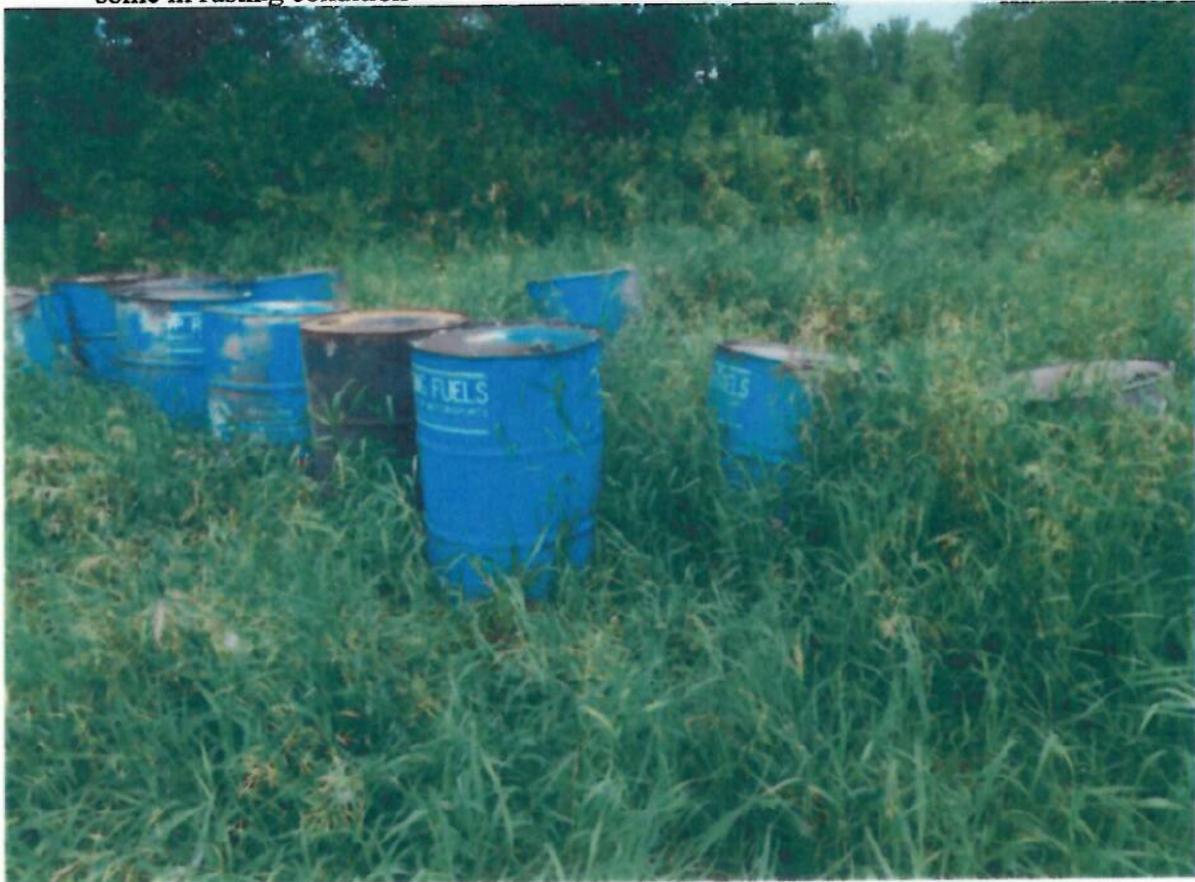
Photo 2: DSCN0852, 7/10/2018 1:14 pm, shows 12 of 20 drums surrounded by vegetation and some in rusting condition

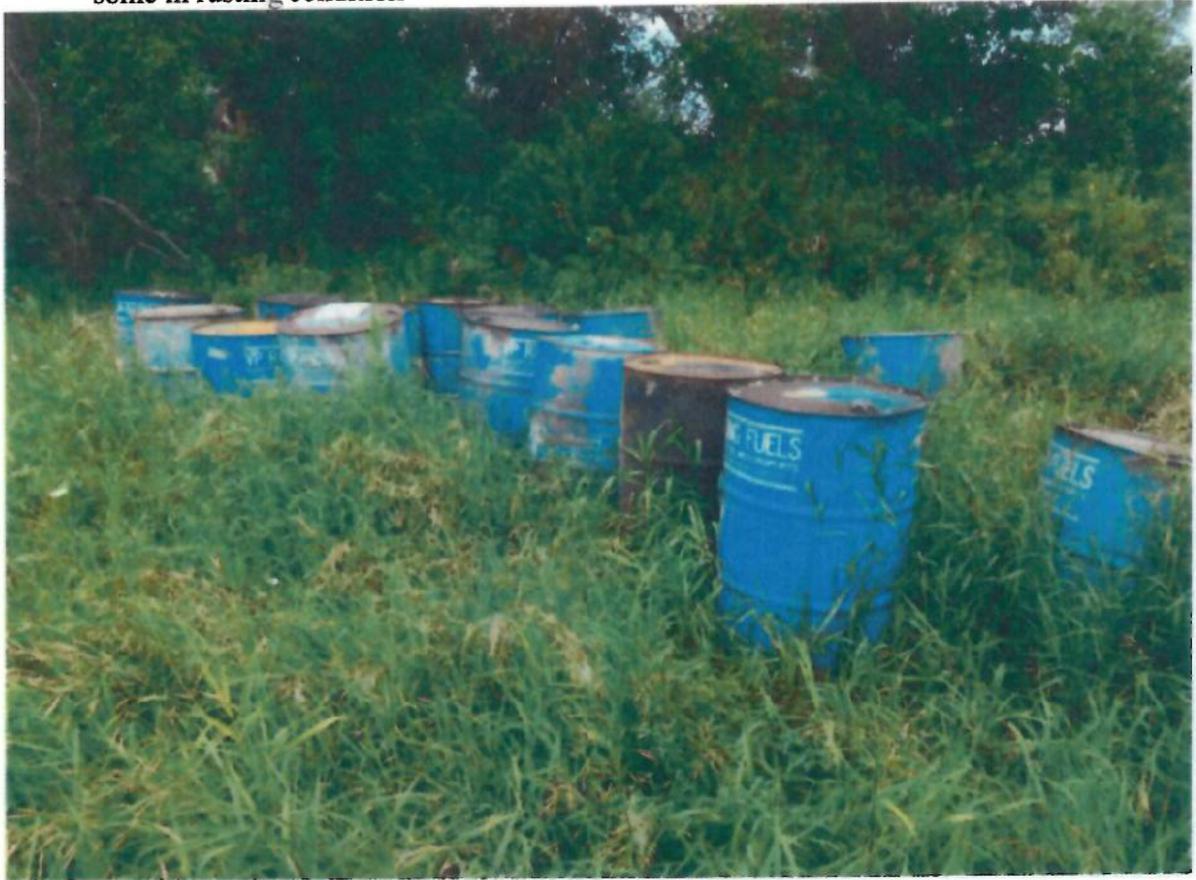
Photo 3: DSCN0853, 7/10/2018 1:14 pm, shows 15 of 20 drums surrounded by vegetation and some in rusting condition

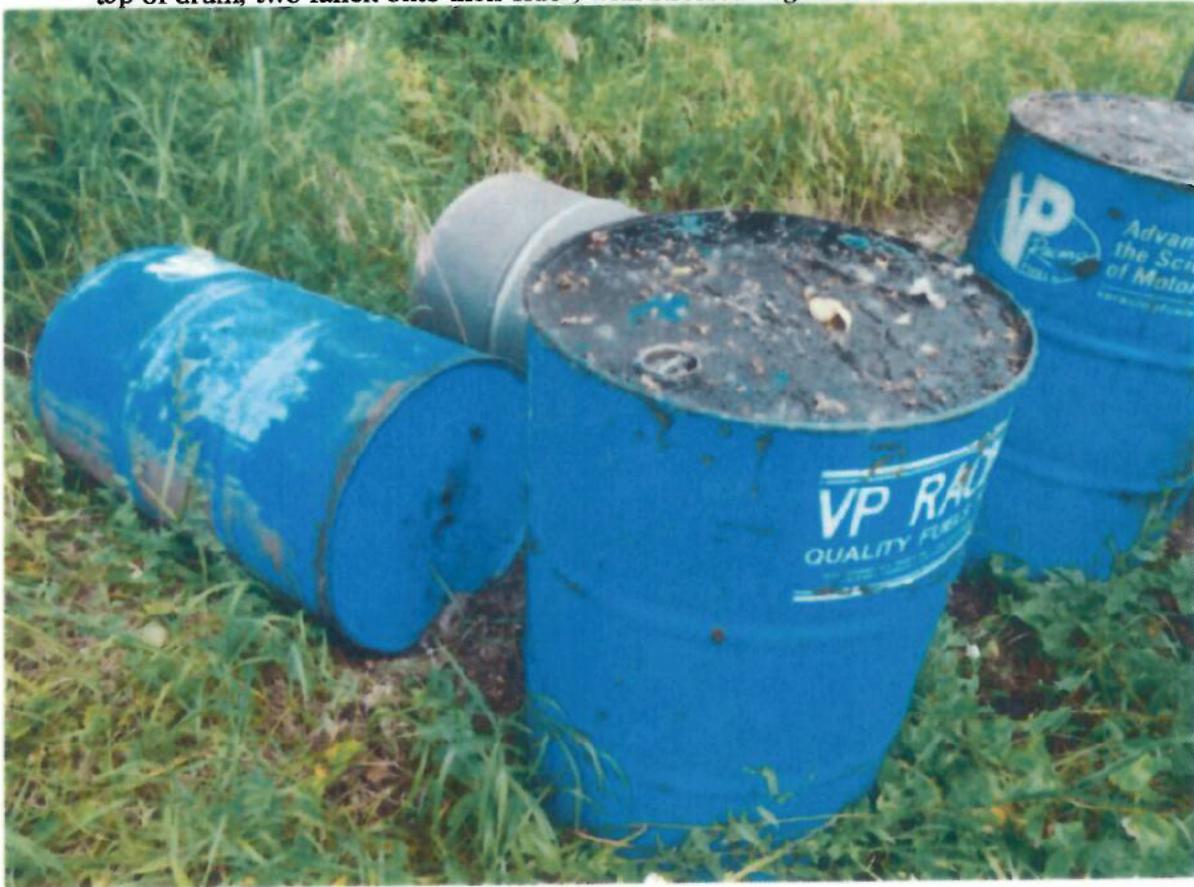
Photo 4: DSCN0854, 7/10/2018 1:16 pm, shows 4 of 20 drums, one with waste liquid (oil) on top of drum, two fallen onto their sides, with stressed vegetation

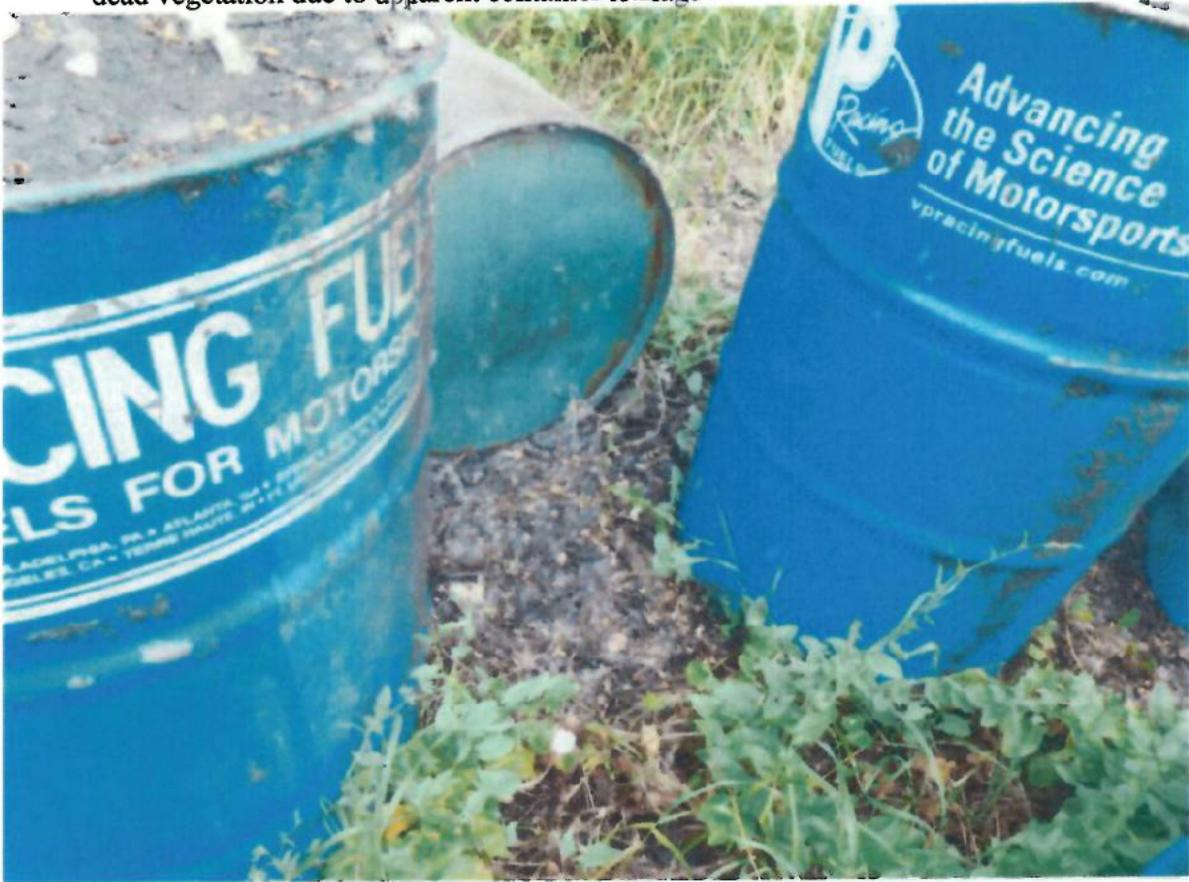
Photo 5: DSCN0855, 7/10/2018 1:16 pm, shows 3 of 20 drums, one fallen onto its side, with dead vegetation due to apparent container leakage

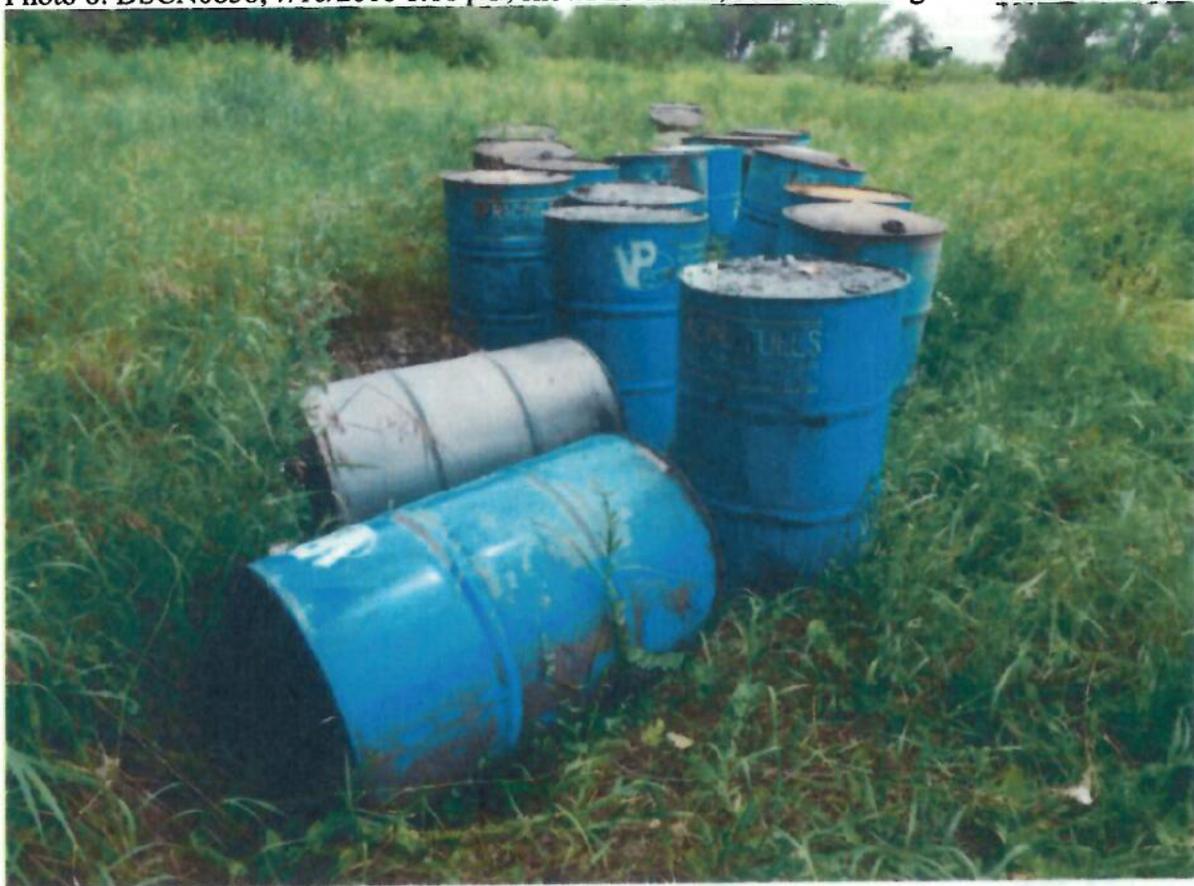
Photo 6: DSCN0856, 7/10/2018 1:16 pm, shows 20 drums, some in rusting condition

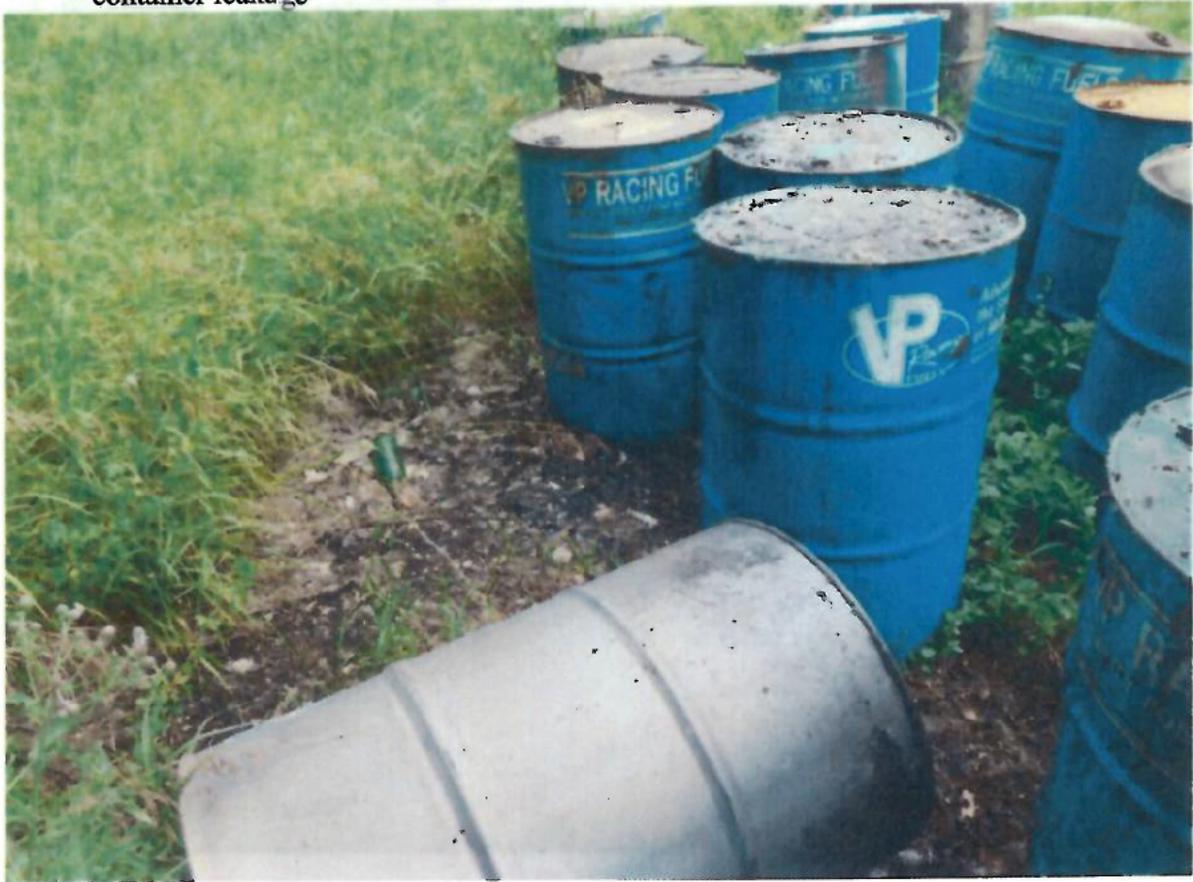
Photo 7: DSCN0857, 7/10/2018 1:16 pm, shows stressed and dead vegetation due to apparent container leakage
