UNITED STATES ENVIRONMENTAL PROTECTION AGENCY
REGION 8

Re: Resource Conservation and Recovery Act (RCRA) Inspection
Lodge Grass Drum Site, U.S. EPA ID No. MTR000211649

**UNITED STATES ENVIRONMENTAL PROTECTION AGENCY
REGION 8
RESOURCE CONSERVATION AND RECOVERY ACT**

Facility Name: Lodge Grass Drum Site
RCRA ID: MTR000211649

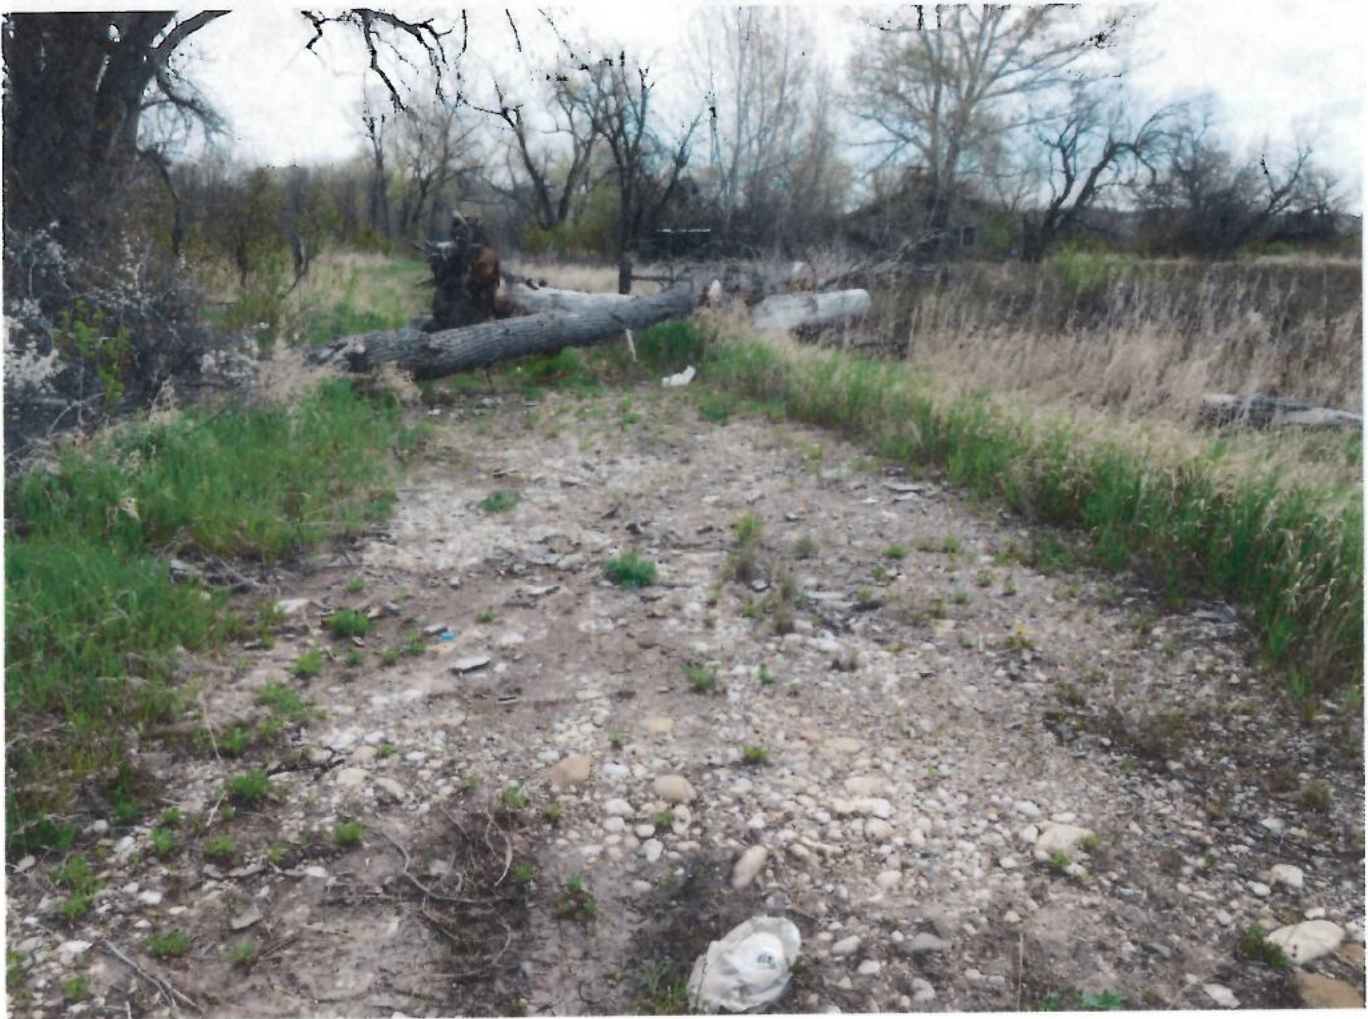
Photo 1159, DSCN1159.jpg, 5/15/2019 9:37 am, photo of driveway leading to area where drums are located. A fallen tree blocks vehicle access to the site. Photo taken facing east.

3. Move the fallen tree from the driveway, or provide instructions to go around the tree, to allow

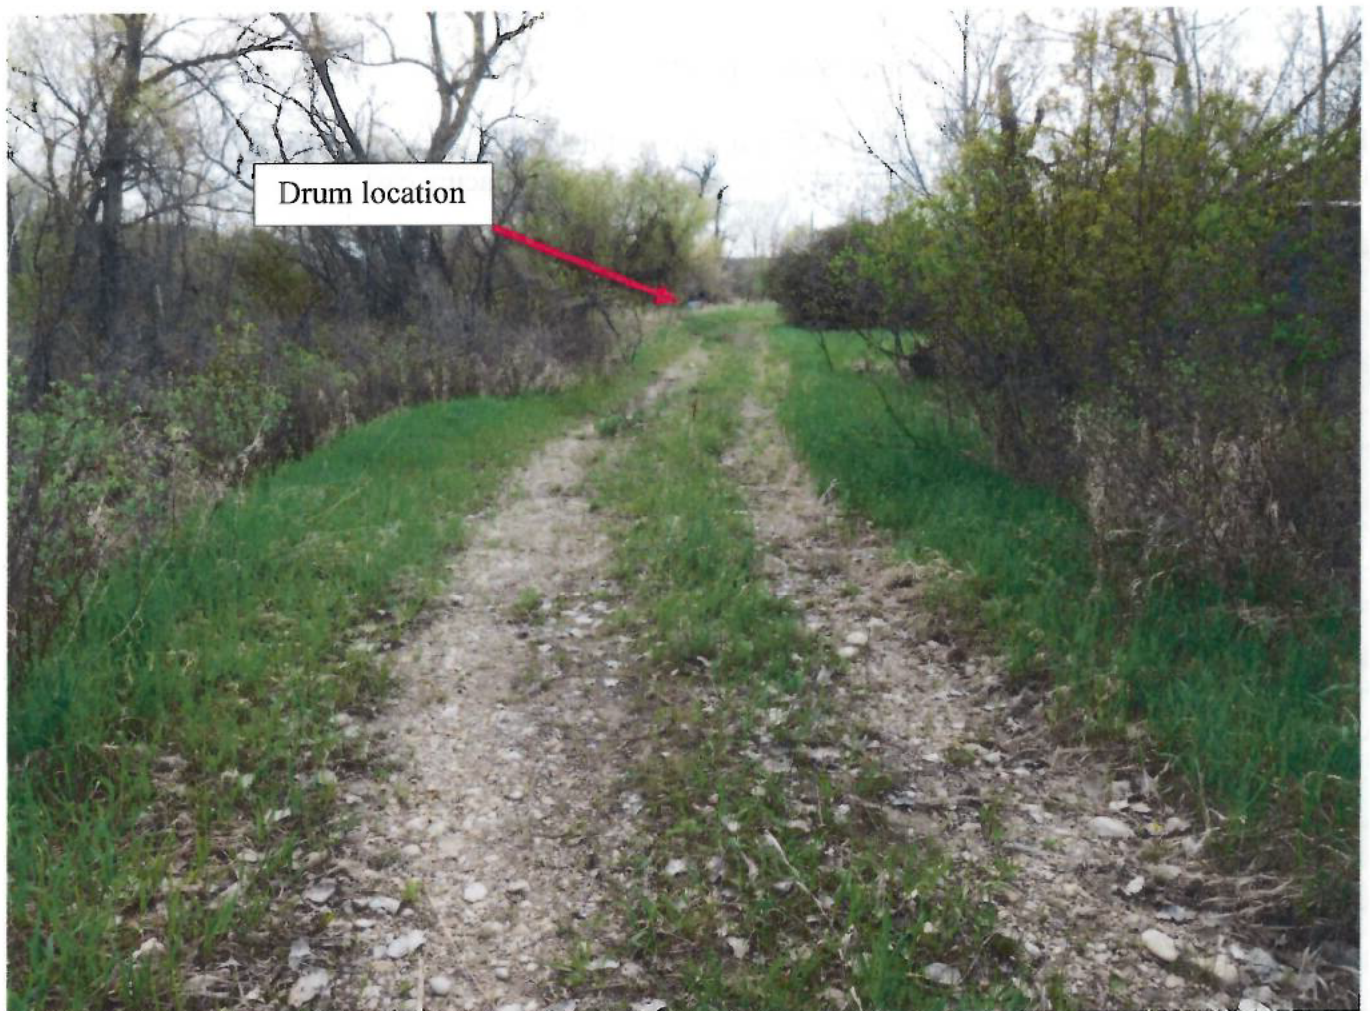
Photo 1160, DSCN1160.jpg, 5/15/2019 9:38 am, photo of driveway beyond (east of) the fallen tree with drums visible in background.

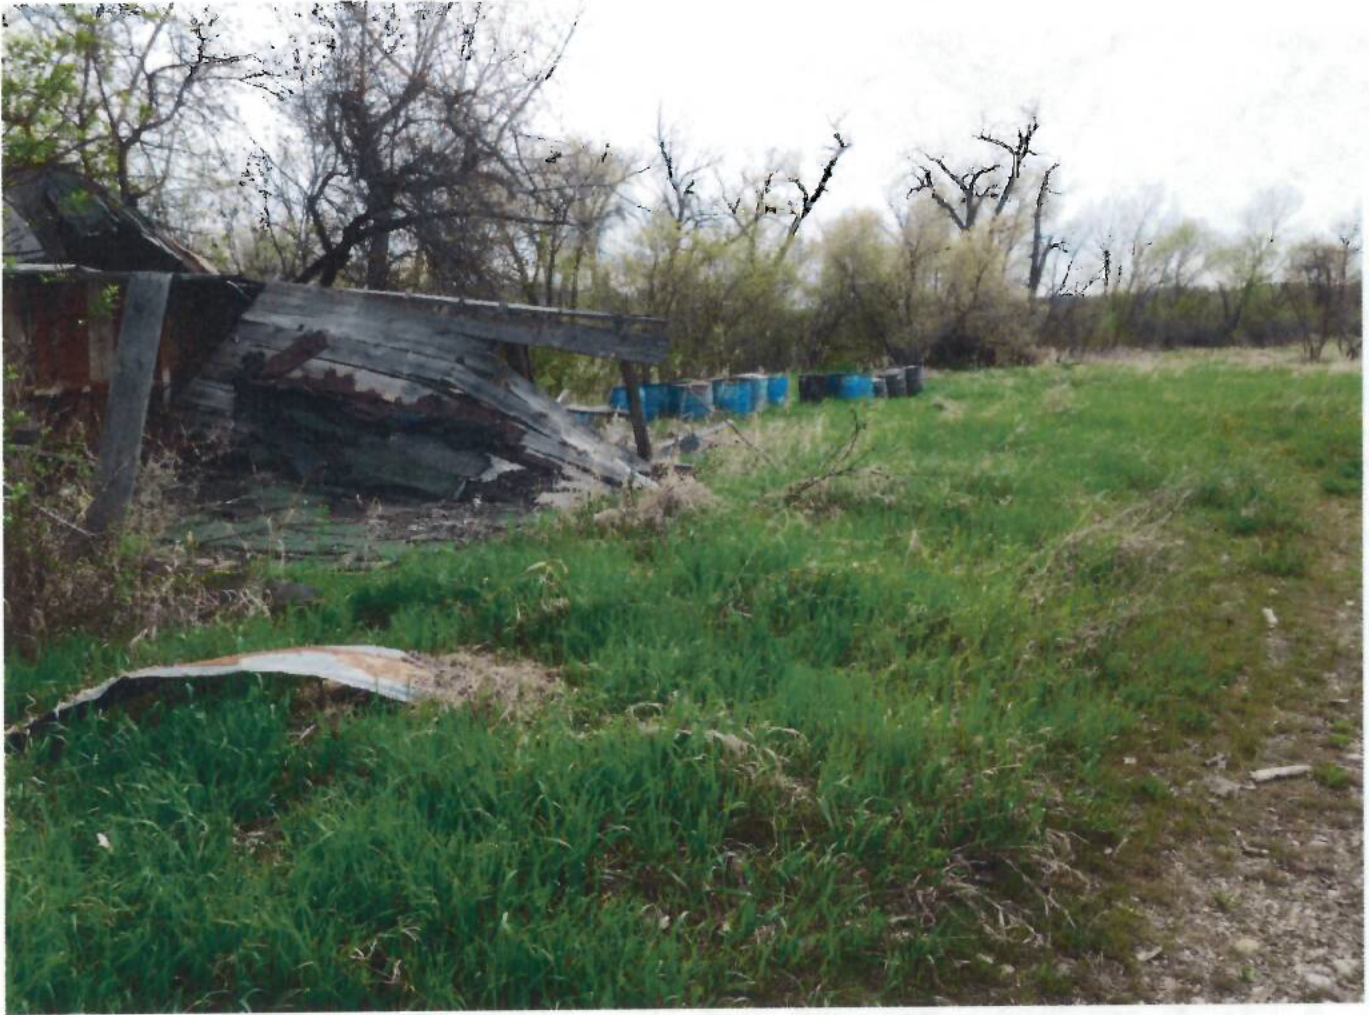
Photo 1161, DSCN1161.jpg, 5/15/2019 9:39 am, photo of drums near eastern end of driveway.

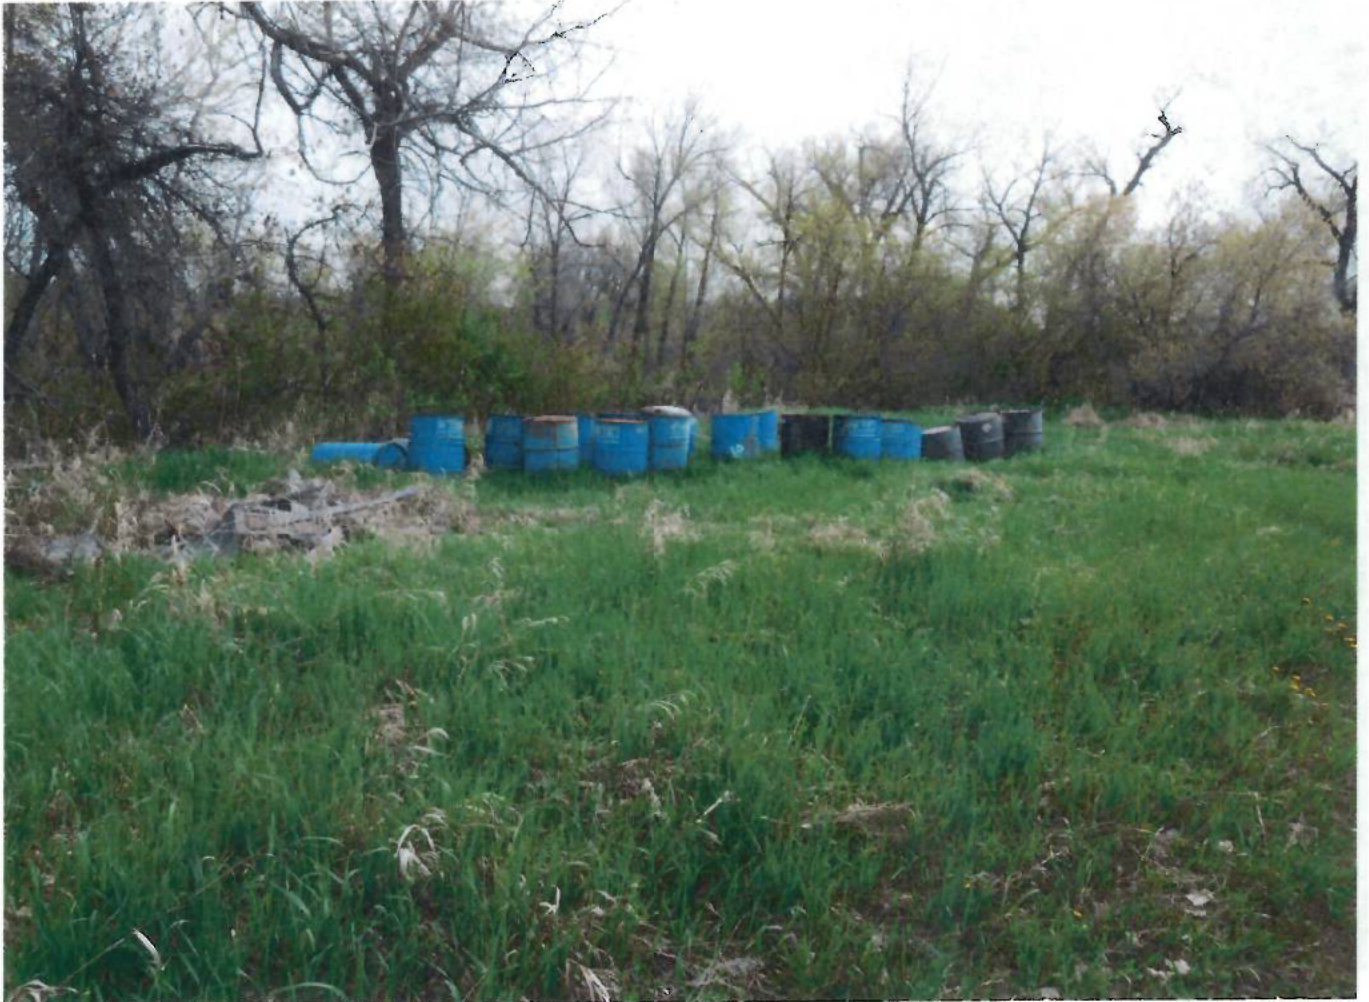
Photo 1162, DSCN1162.jpg, 5/15/2019 9:39 am, photo of drums, showing all 20 drums. Photo taken facing north/northeast.

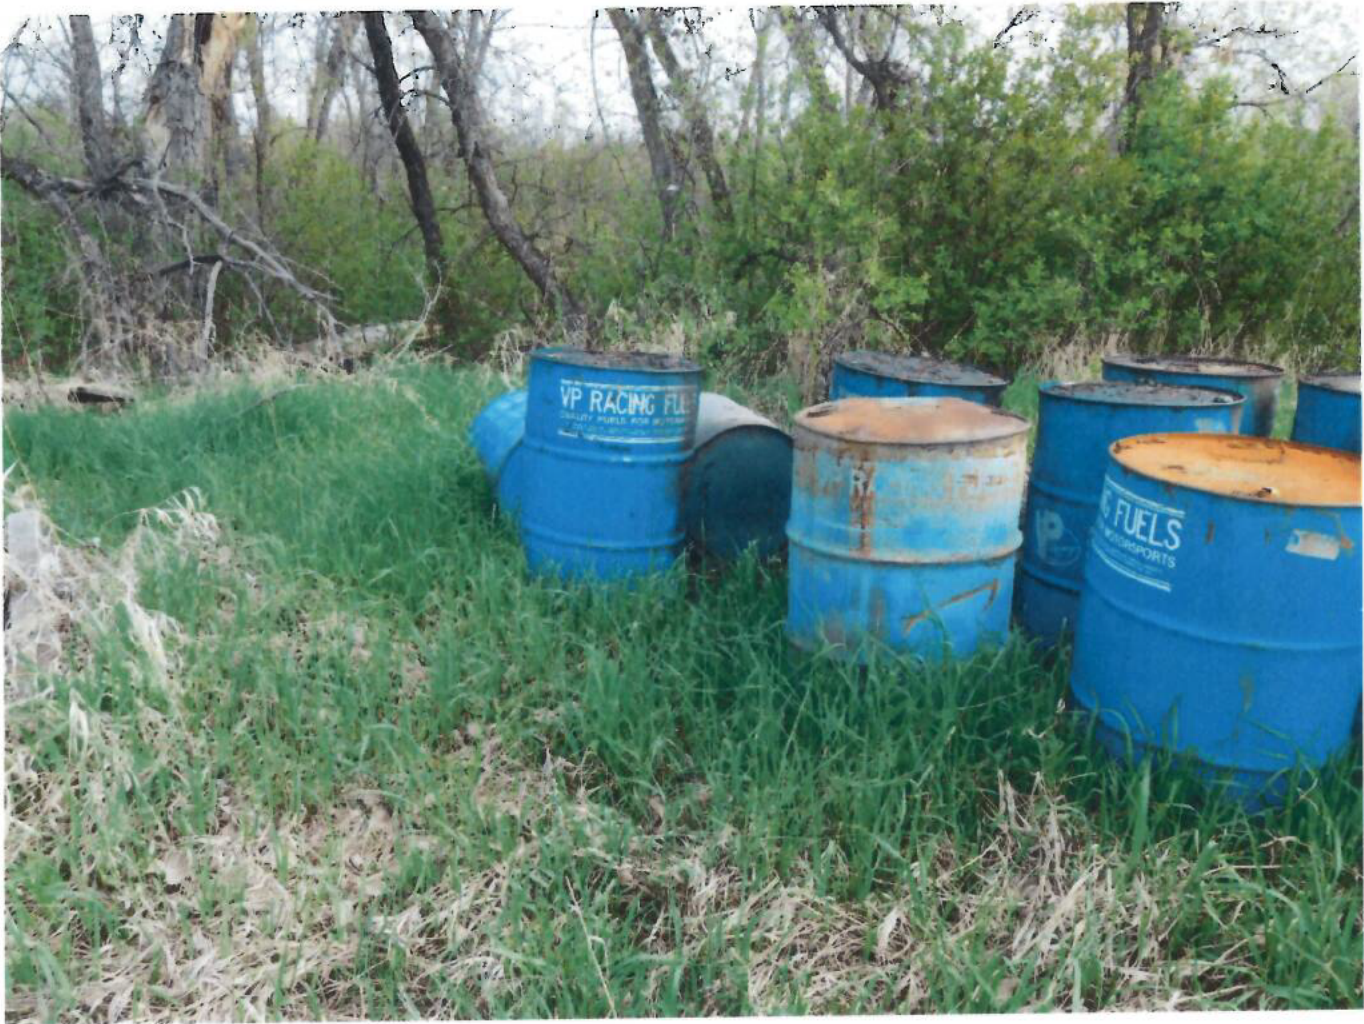
Photo 1163, DSCN1163.jpg, 5/15/2019 9:40 am, photo of westernmost section of drums. Photo includes two drums on their sides and one drum with a bulging top.

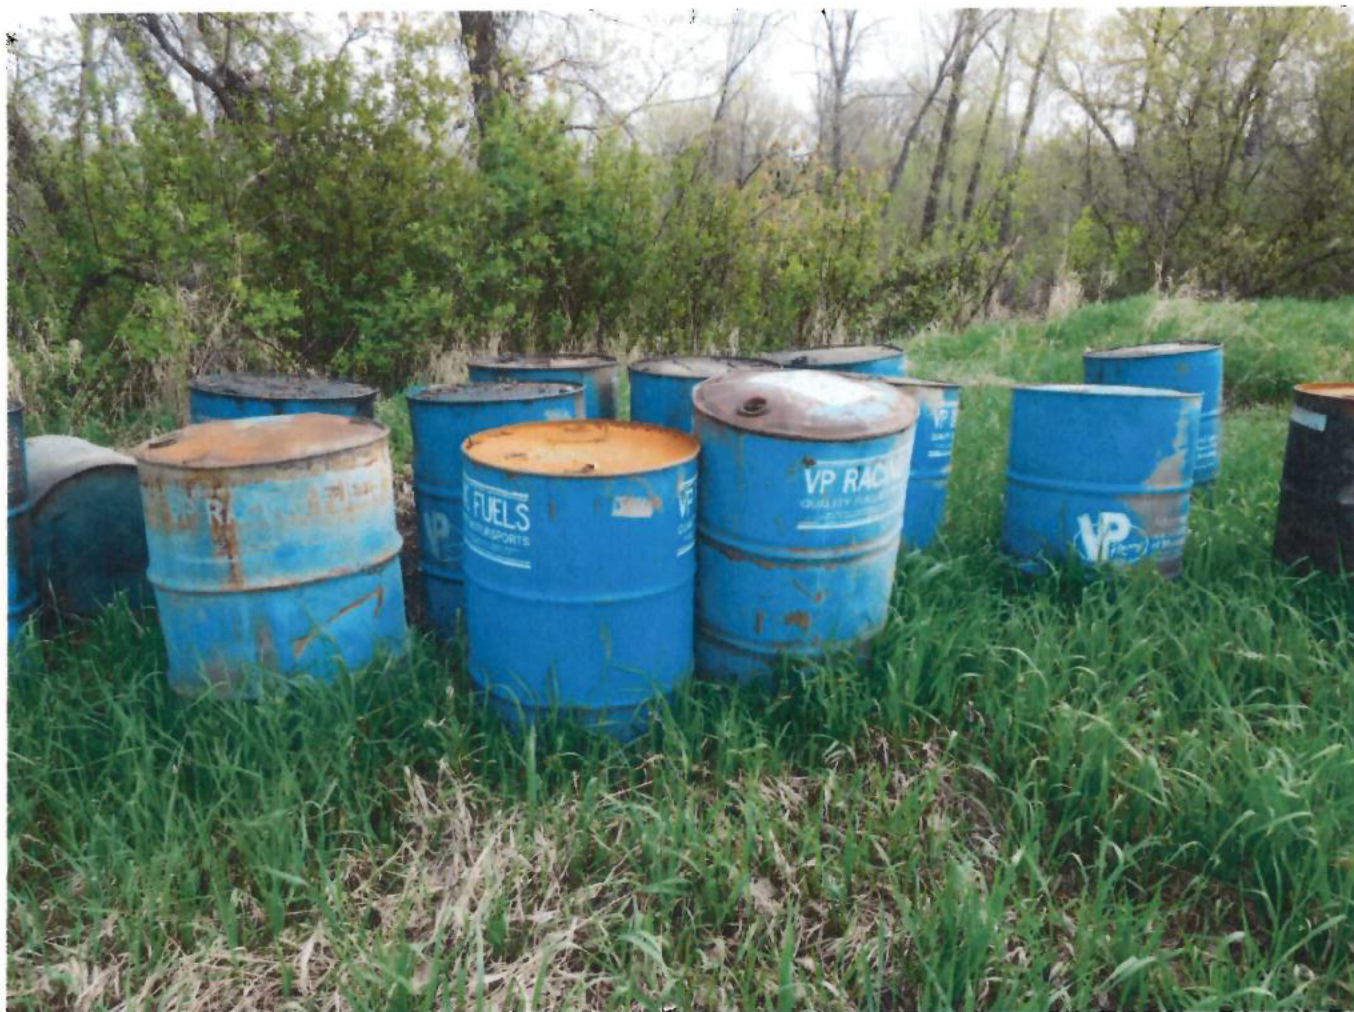
Photo 1164, DSCN1164.jpg, 5/15/2019 9:40 am, photo central section of drums, including two drums with bulging tops (one of which was also shown in photo 1163).

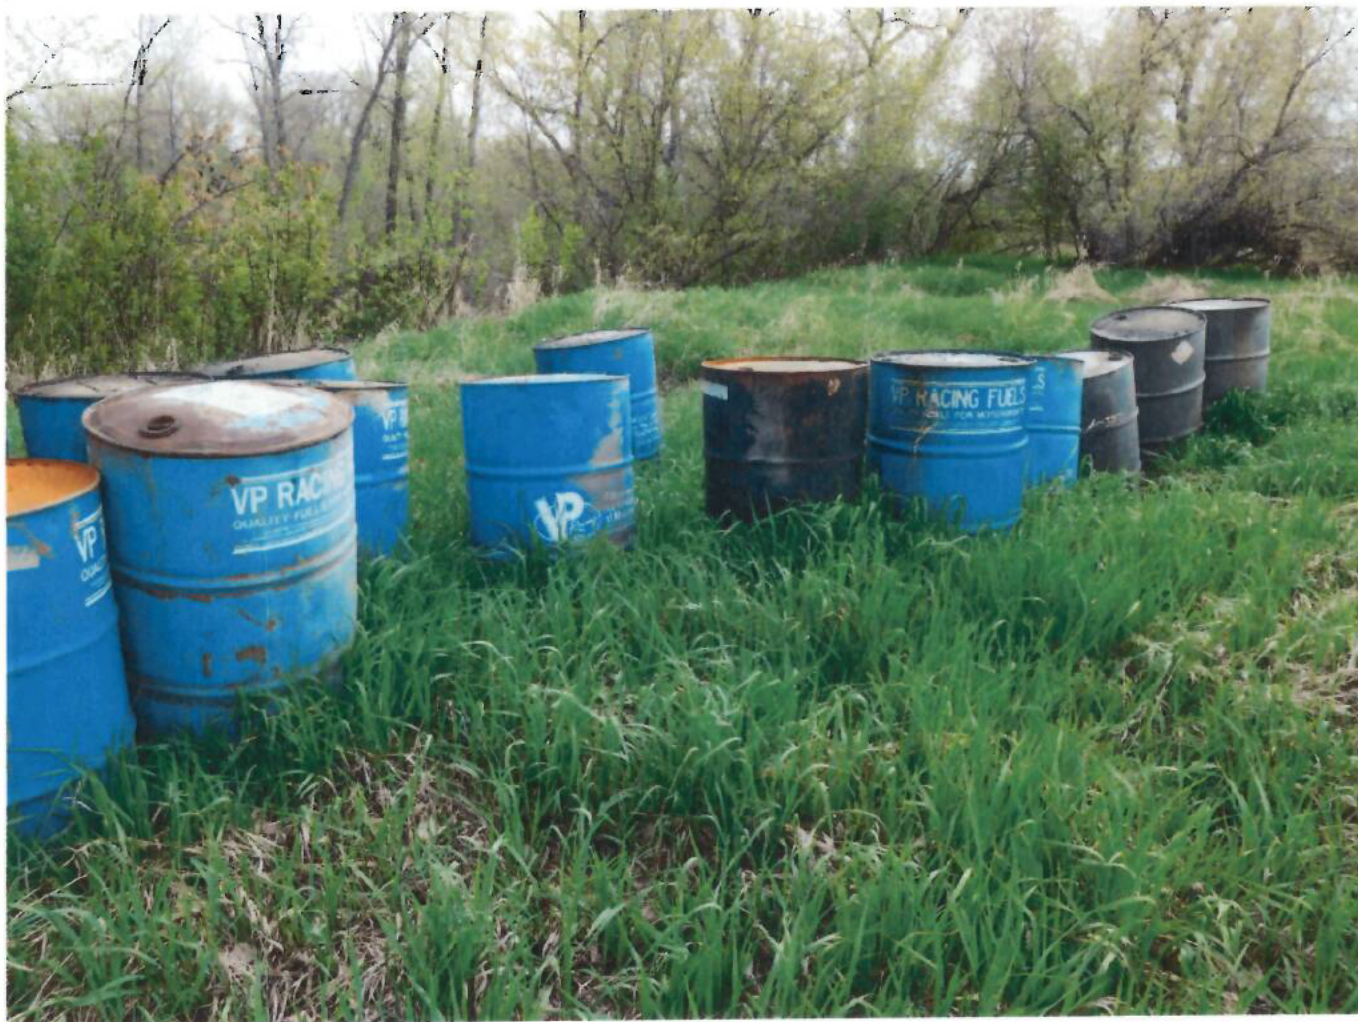
Photo 1165, DSCN1165.jpg, 5/15/2019 9:40 am, photo of easternmost section of drums.

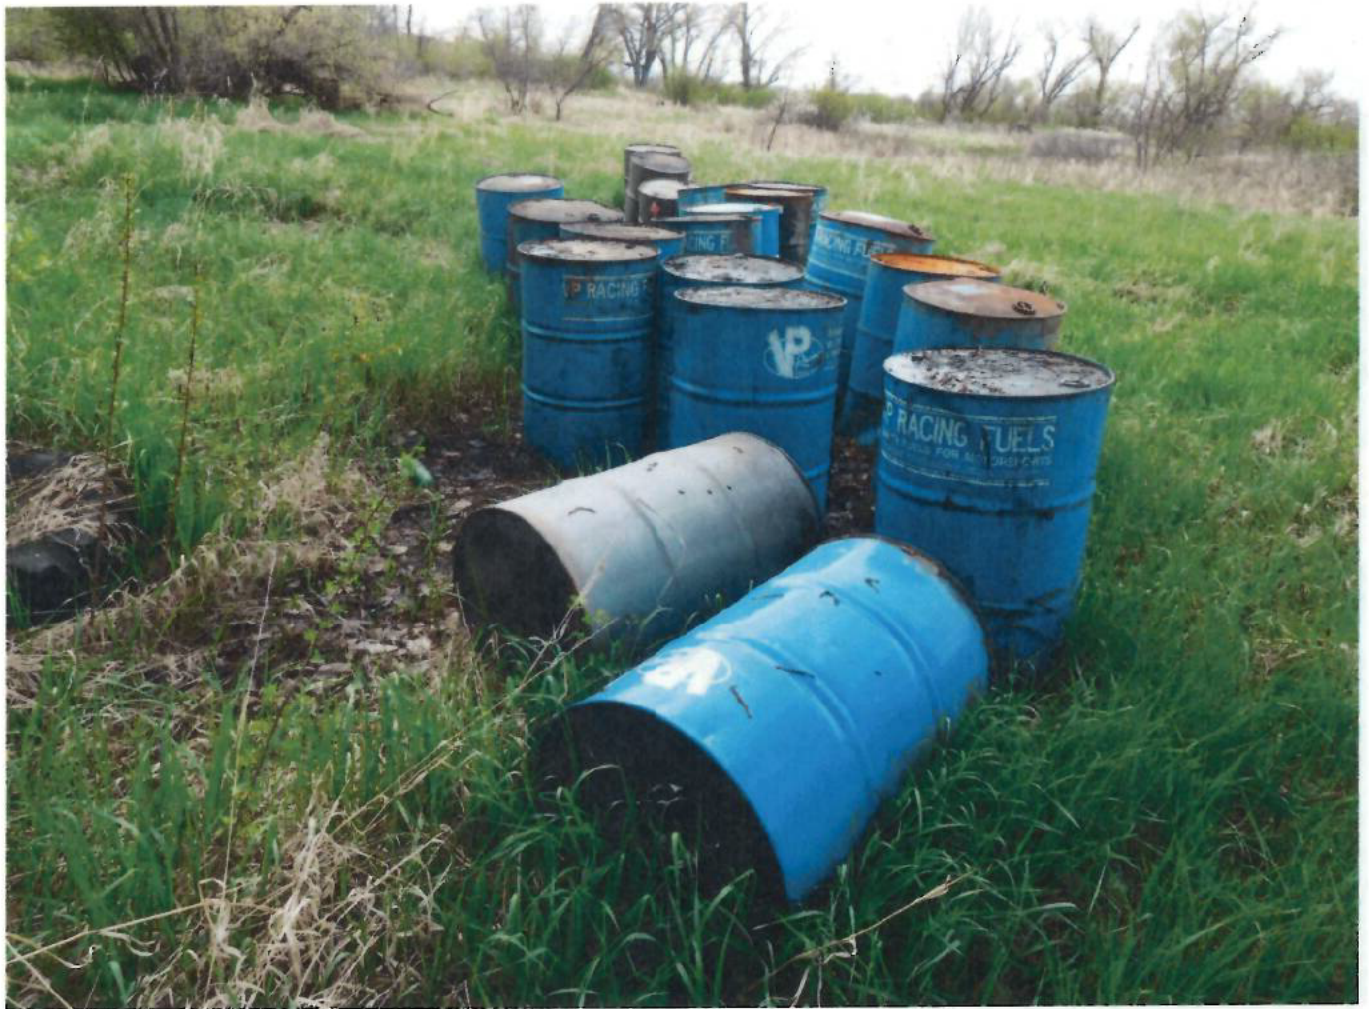
Photo 1166, DSCN1166.jpg, 5/15/2019 9:40 am, photo of all 20 drums, taken facing south.

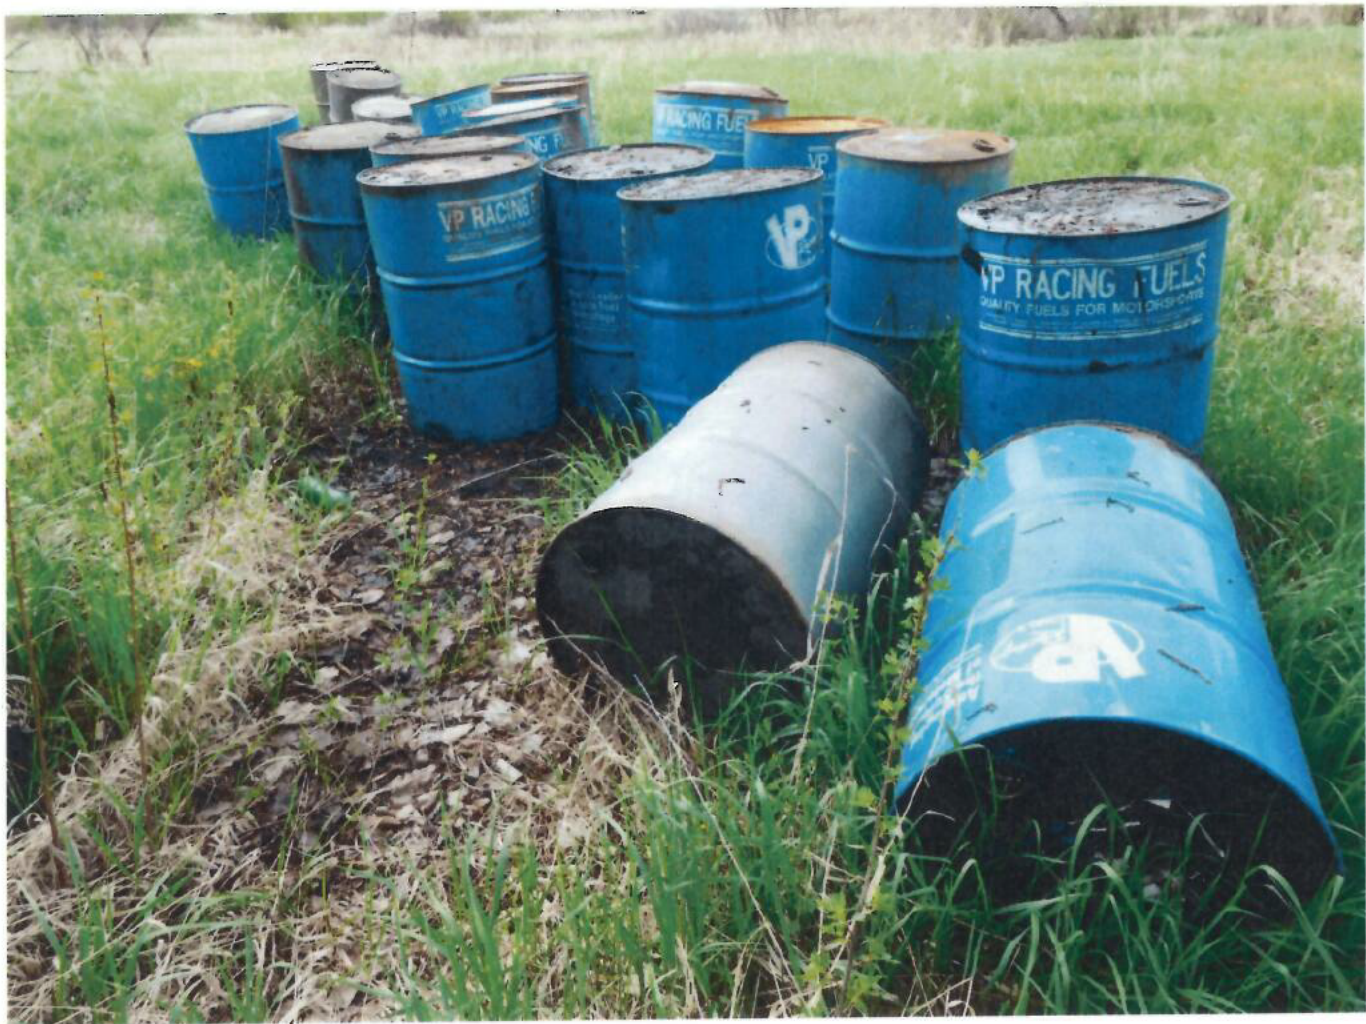
Photo 1167, DSCN1167.jpg, 5/15/2019 9:41 am, photo of all 20 drums, taken facing southeast.

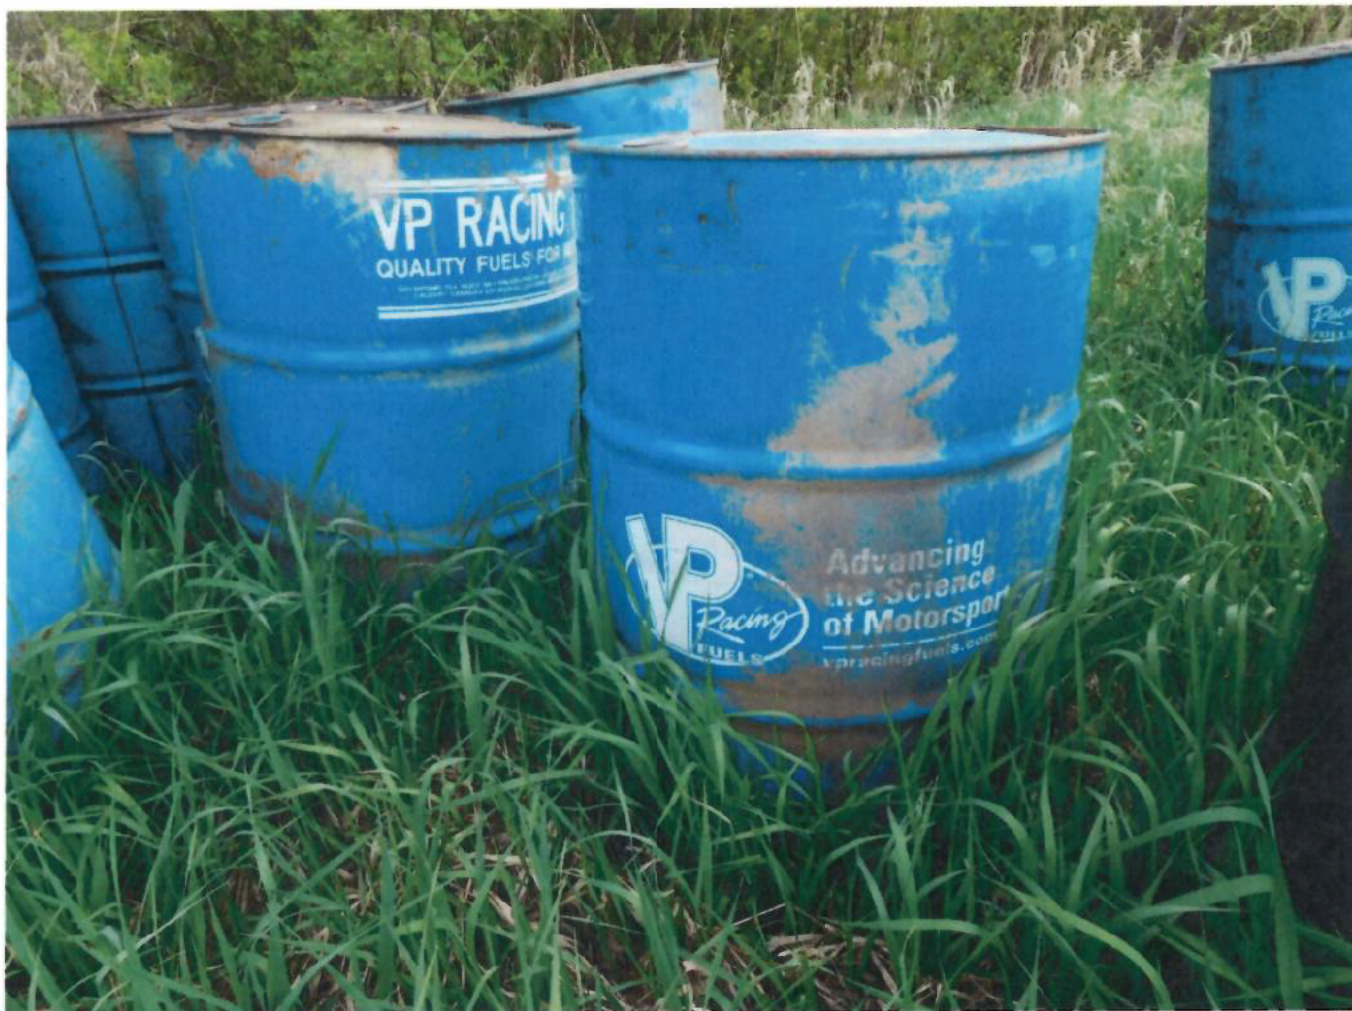
Photo 1168, DSCN1168.jpg, 5/15/2019 9:41 am, photo of drum labeling.

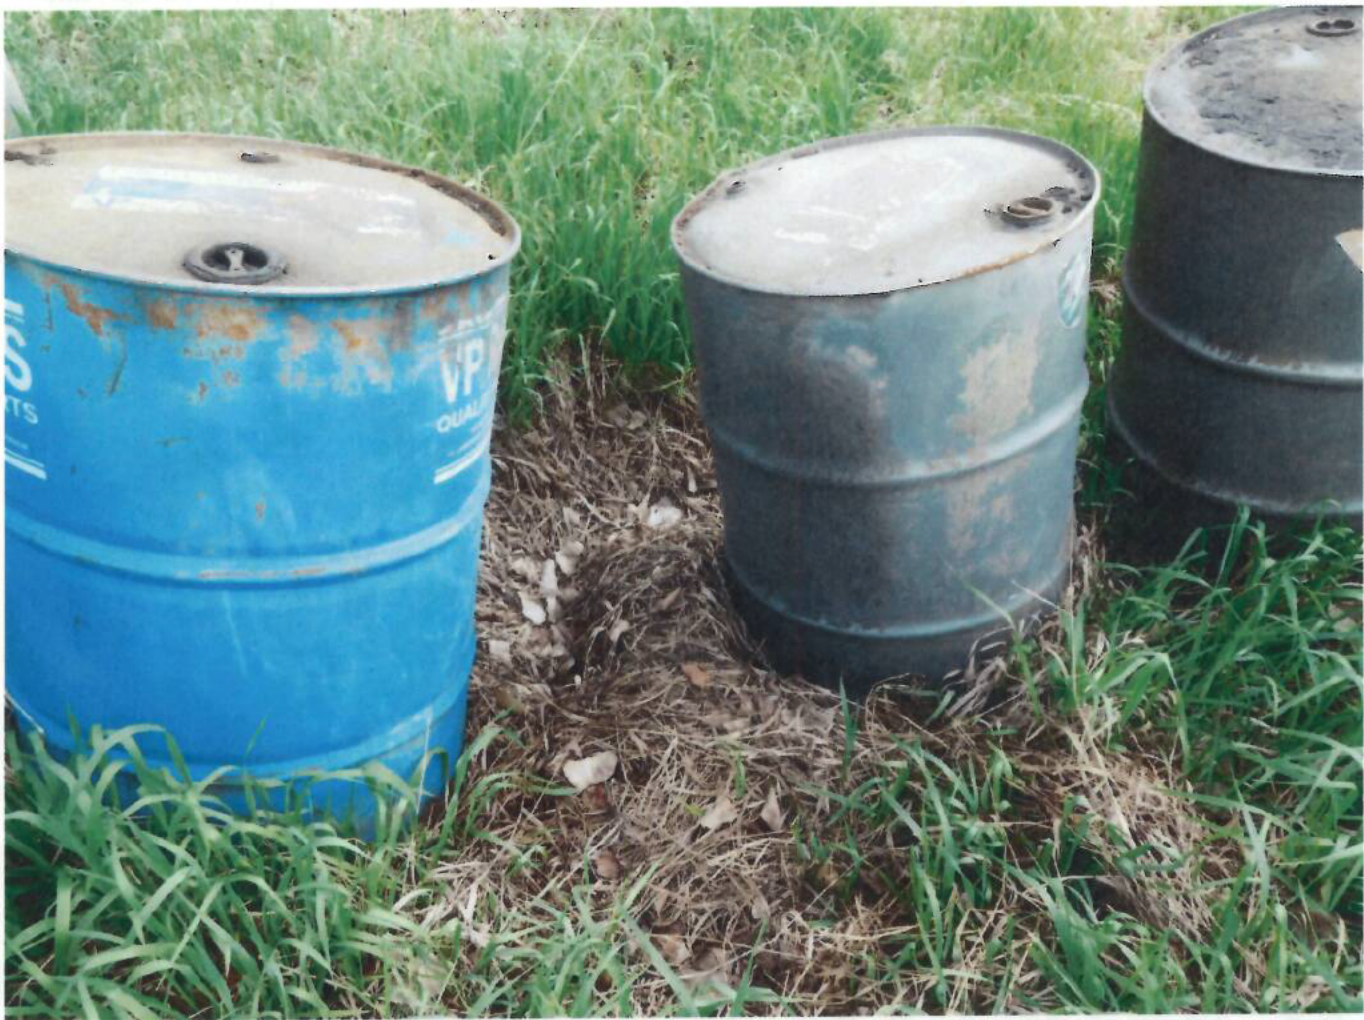
Photo 1169, DSCN1169.jpg, 5/15/2019 9:41 am, photo of stressed vegetation in between drums.

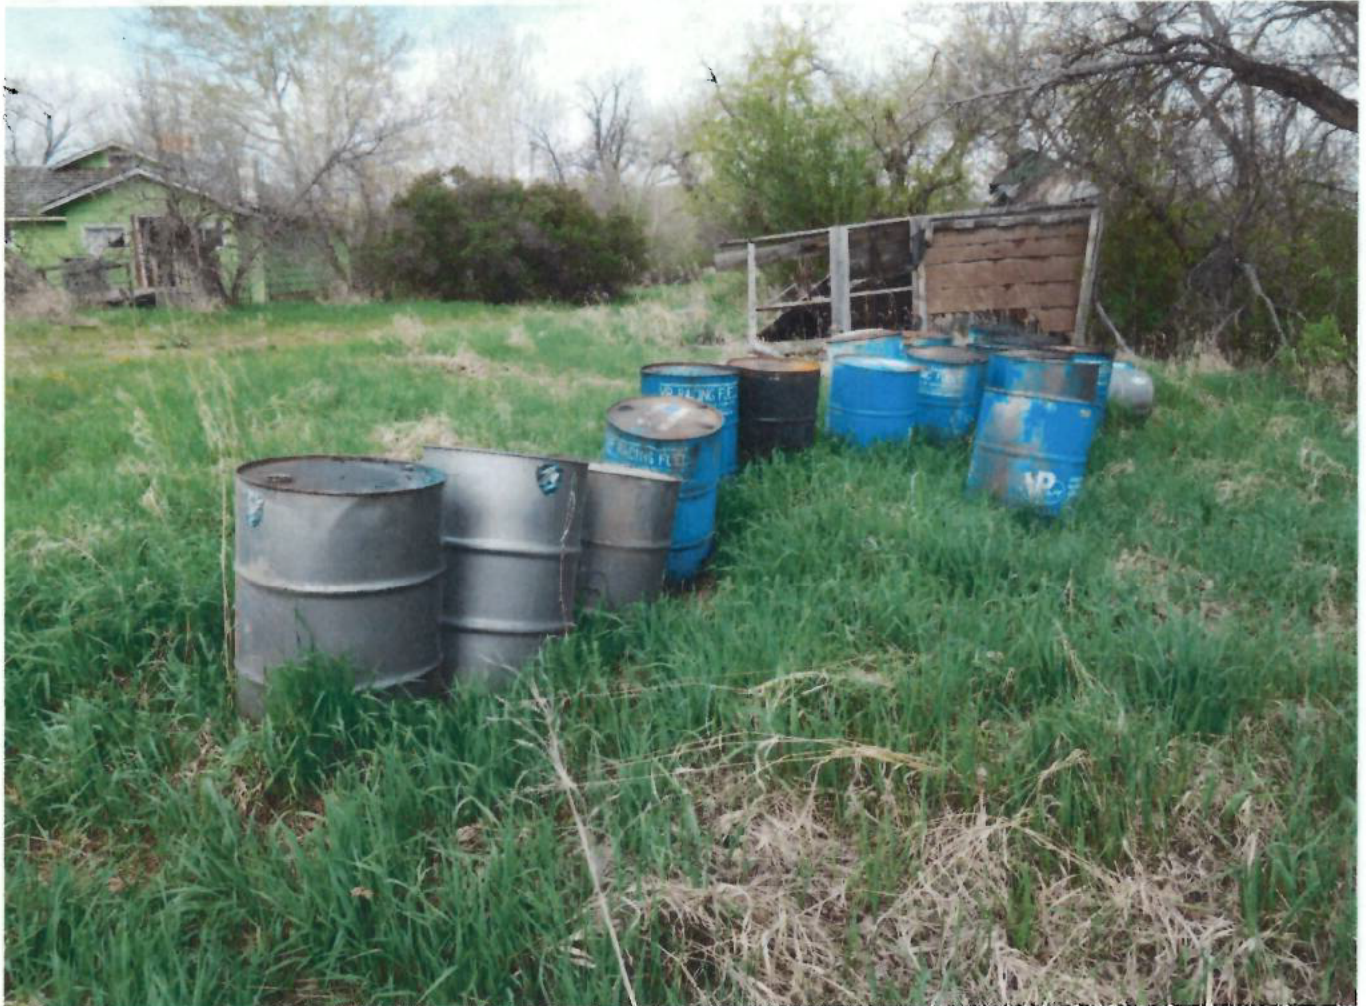
Photo 1170, DSCN1170.jpg, 5/15/2019 9:42 am, photo of all 20 drums, taken facing west. Uninhabited green residential structure and partially fallen-down additional structure included in photo background.

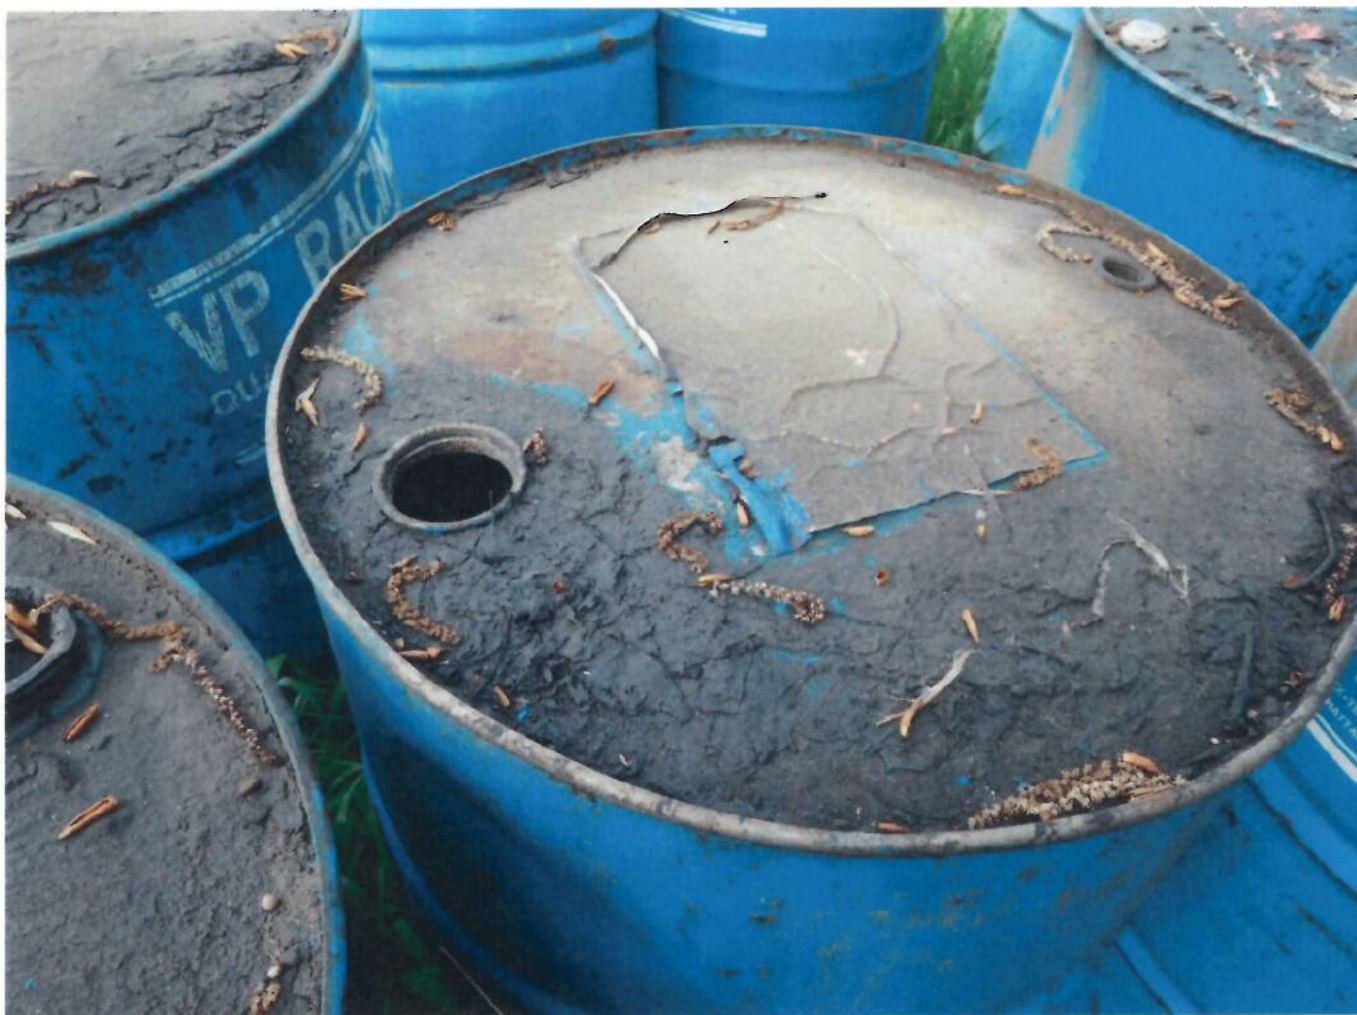
Photo 1171, DSCN1171.jpg, 5/15/2019 9:42 am, photo of an open drum.

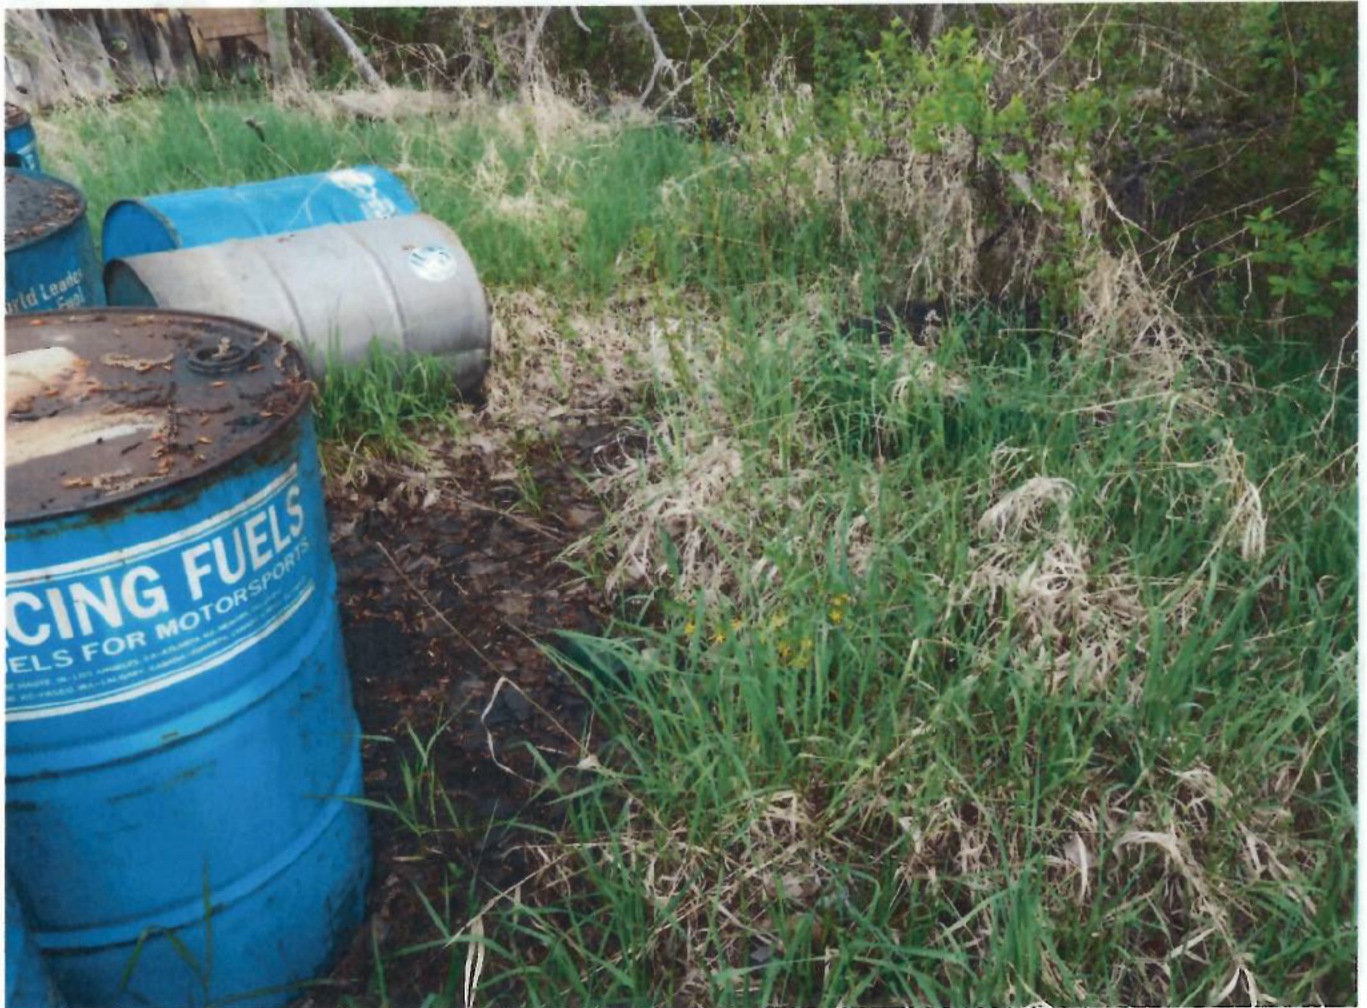
Photo 1172, DSCN1172.jpg, 5/15/2019 9:42 am, photo of spilled or leaked oily-looking waste on ground on north side of drum area.

2. When arranging pickup of the drums, ask if the transporter can also remove the contaminated soil. If not, make separate arrangements to dig up the visible extent of spilled oil, place the contaminated soil in a container that can be closed, and transport it to a disposal facility such as a municipal transfer station or landfill. Please note that waste transported to a solid waste transfer station or landfill may require prior approval from the operator in order to ensure that the facility can accept the waste.

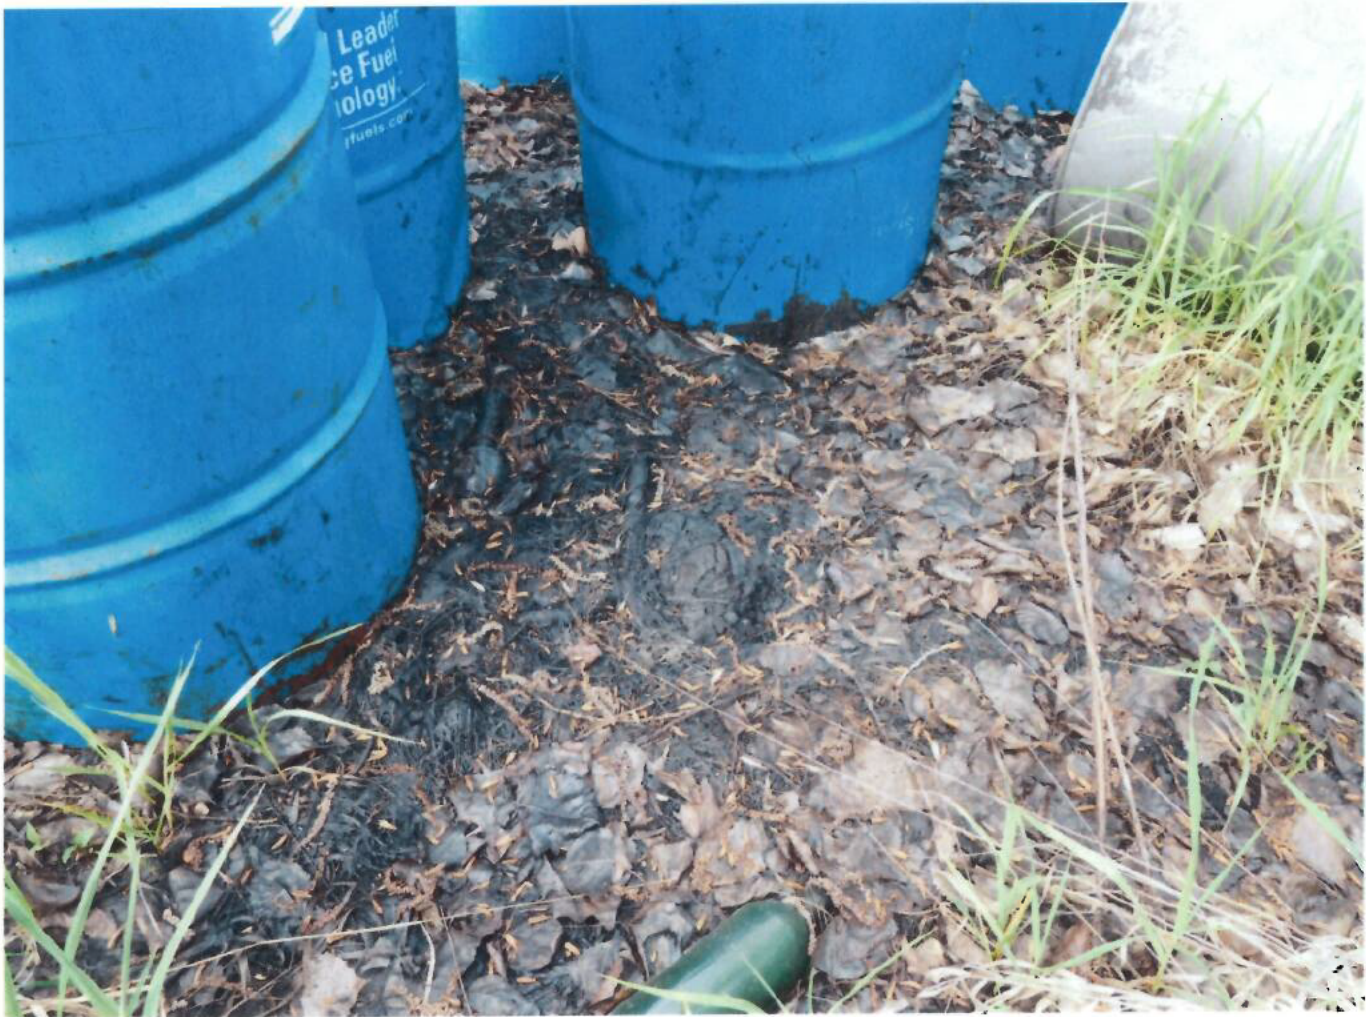
Photo 1173, DSCN1173.jpg, 5/15/2019 9:42 am, photo of spilled or leaked oily-looking waste on ground on north side of drum area

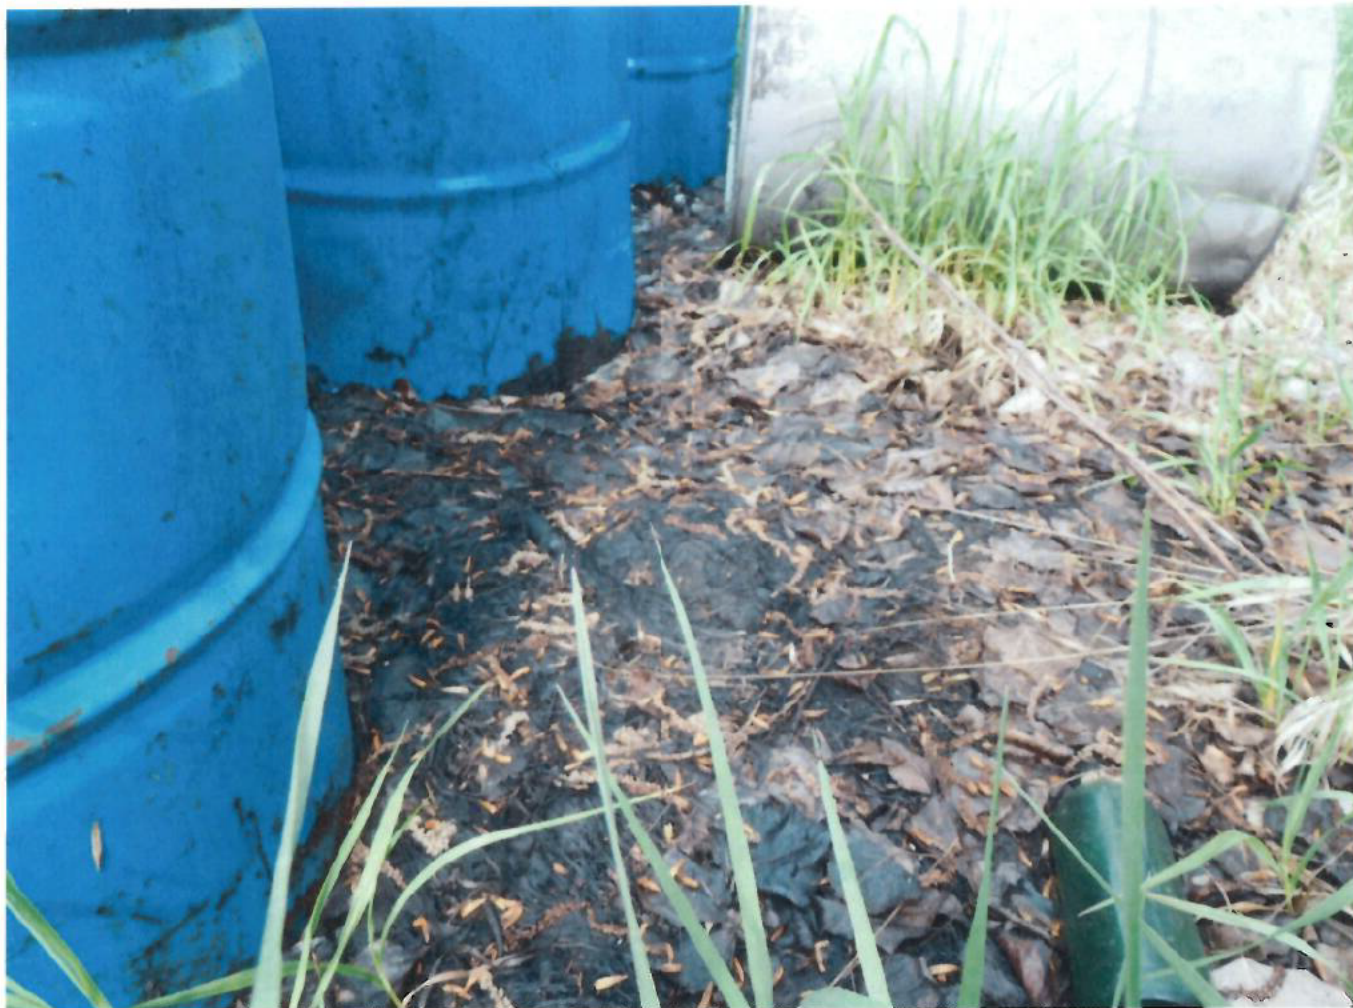
Photo 1174, DSCN1174.jpg, 5/15/2019 9:46 am, photo of spilled or leaked oily-looking waste on ground on north side of drum area.
