UNITED STATES ENVIRONMENTAL PROTECTION AGENCY
REGION 8

Re: Resource Conservation and Recovery Act (RCRA) Inspection
Lodge Grass Drum Site, U.S. EPA ID No. MTR000211649

**UNITED STATES ENVIRONMENTAL PROTECTION AGENCY
REGION 8
RESOURCE CONSERVATION AND RECOVERY ACT**

Facility Name: Lodge Grass Drum Site
RCRA ID: MTR000211649

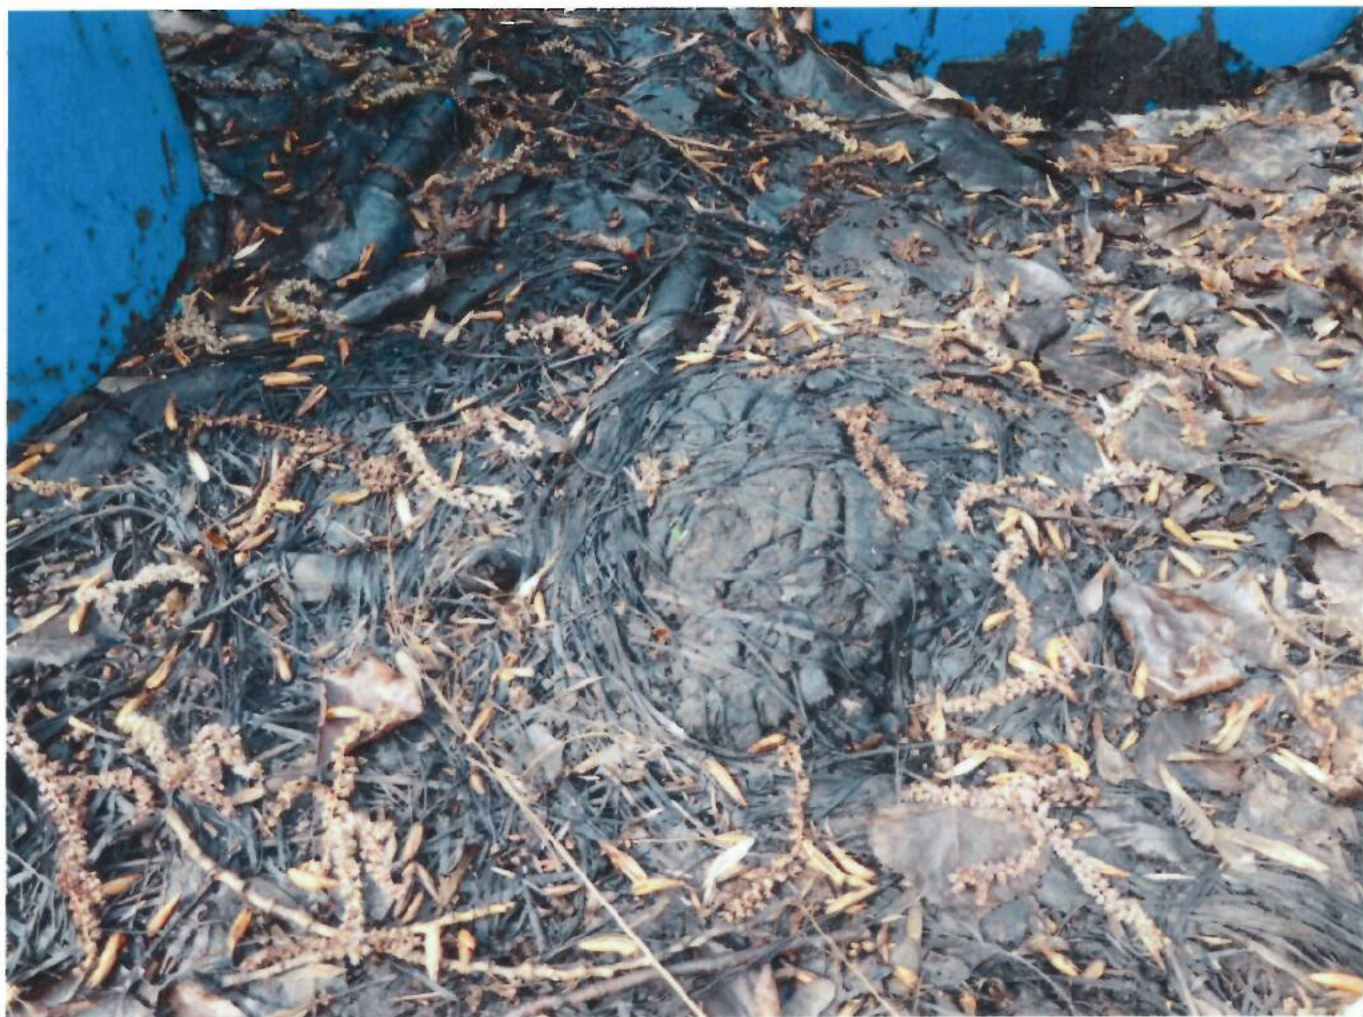
Photo 1175, DSCN1175.jpg, 5/15/2019 9:46 am, photo of spilled or leaked oily-looking waste on ground on north side of drum area.

2. When arranging pickup of the drums, ask if the transporter can also remove the contaminated soil. If not, make separate arrangements to dig up the visible extent of spilled oil, place the contaminated soil in a container that can be closed, and transport it to a disposal facility such as a municipal transfer station or landfill. Please note that waste transported to a solid waste transfer station or landfill may require prior approval from the operator in order to ensure that the facility can accept the waste.

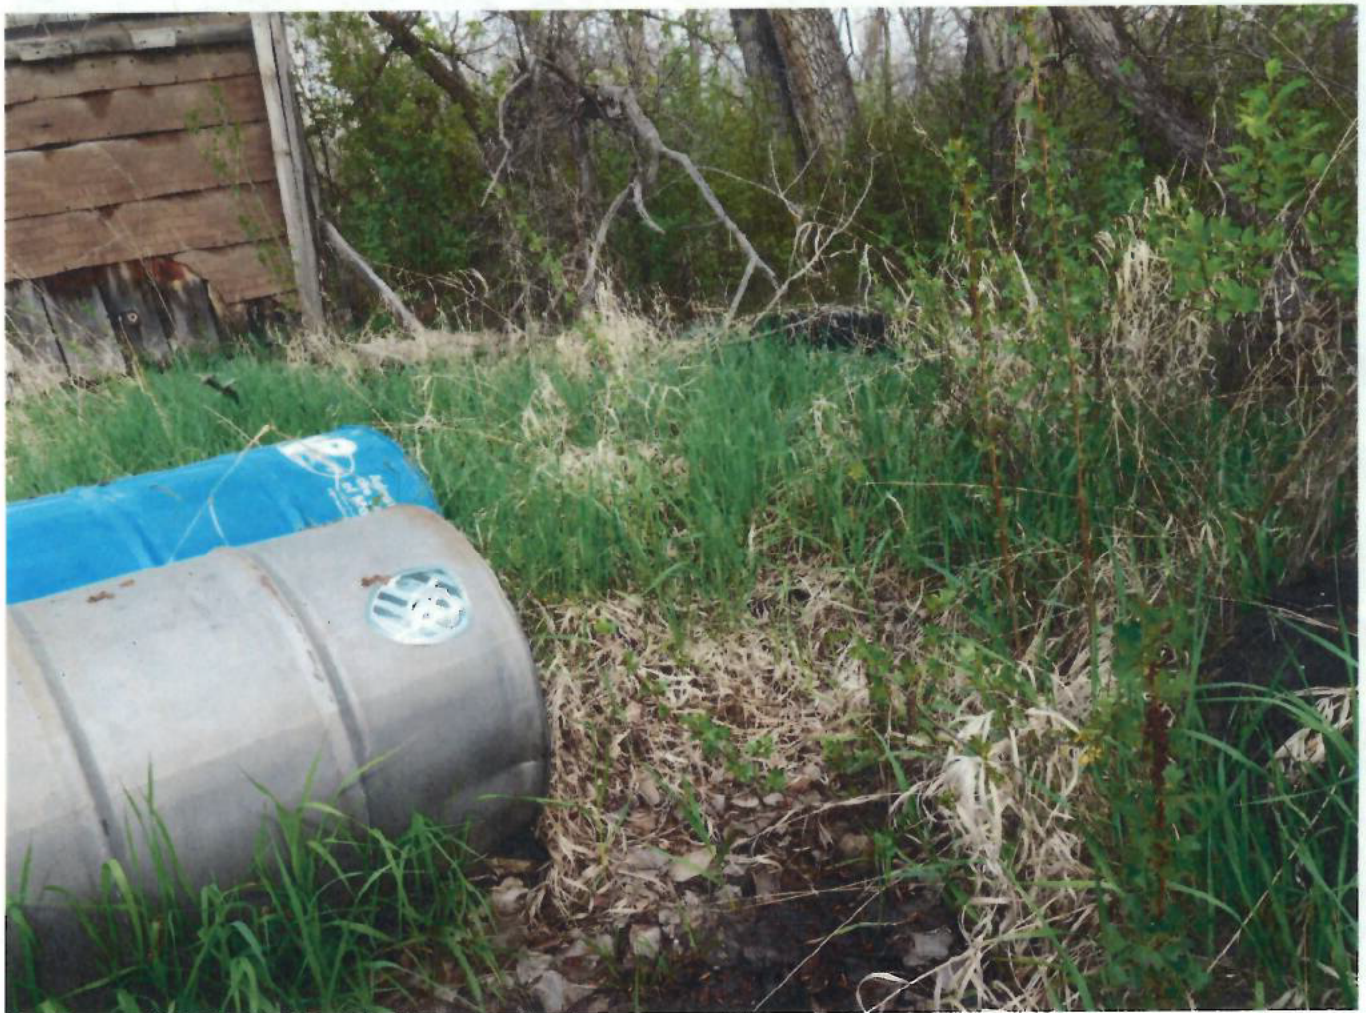
Photo 1176, DSCN1176.jpg, 5/15/2019 9:46 am, photo of spilled or leaked oily-looking waste on ground on north side of drum area, facing toward lower-elevation area located approximately 15 feet to the north of the drums.

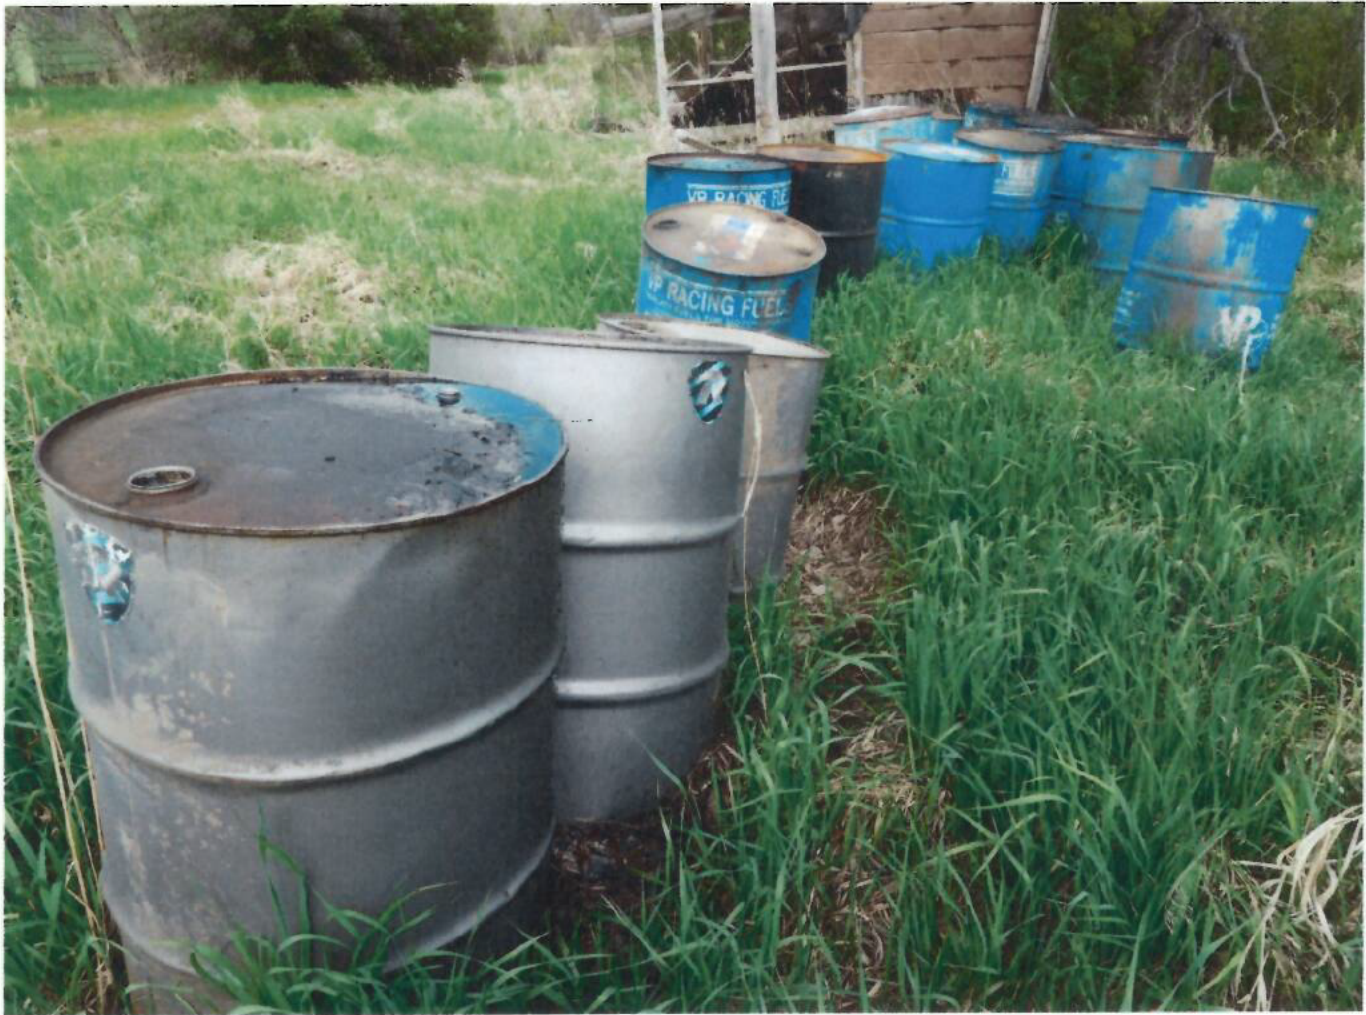
Photo 1177, DSCN1177.jpg, 5/15/2019 9:50 am, photo of all 20 drums, taken facing west.

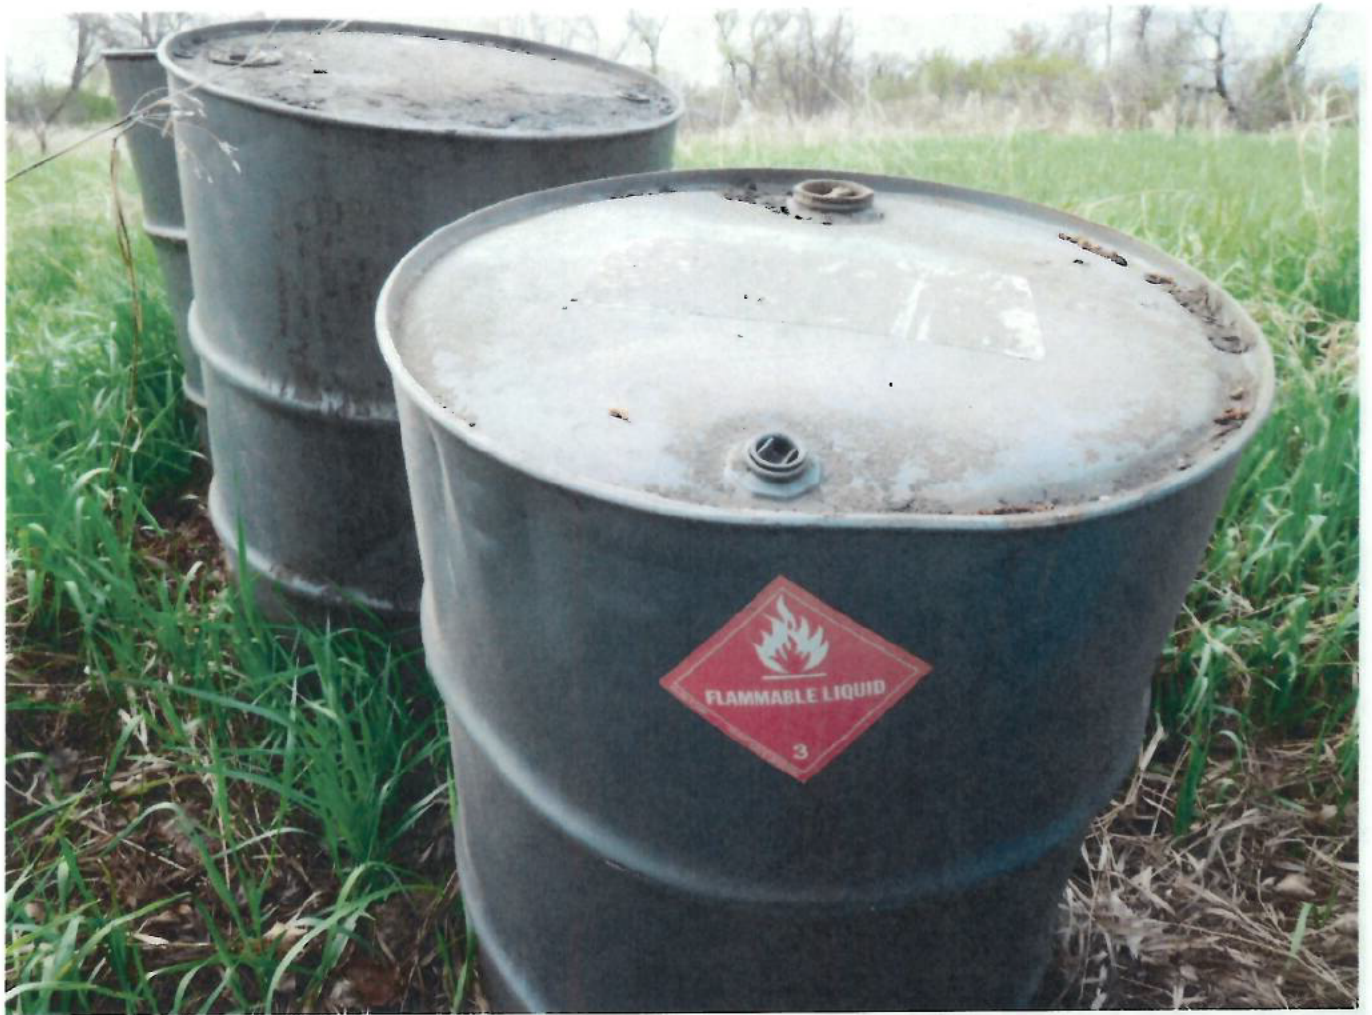
Photo 1178, DSCN1178.jpg, 5/15/2019 9:51 am, photo of drum label.

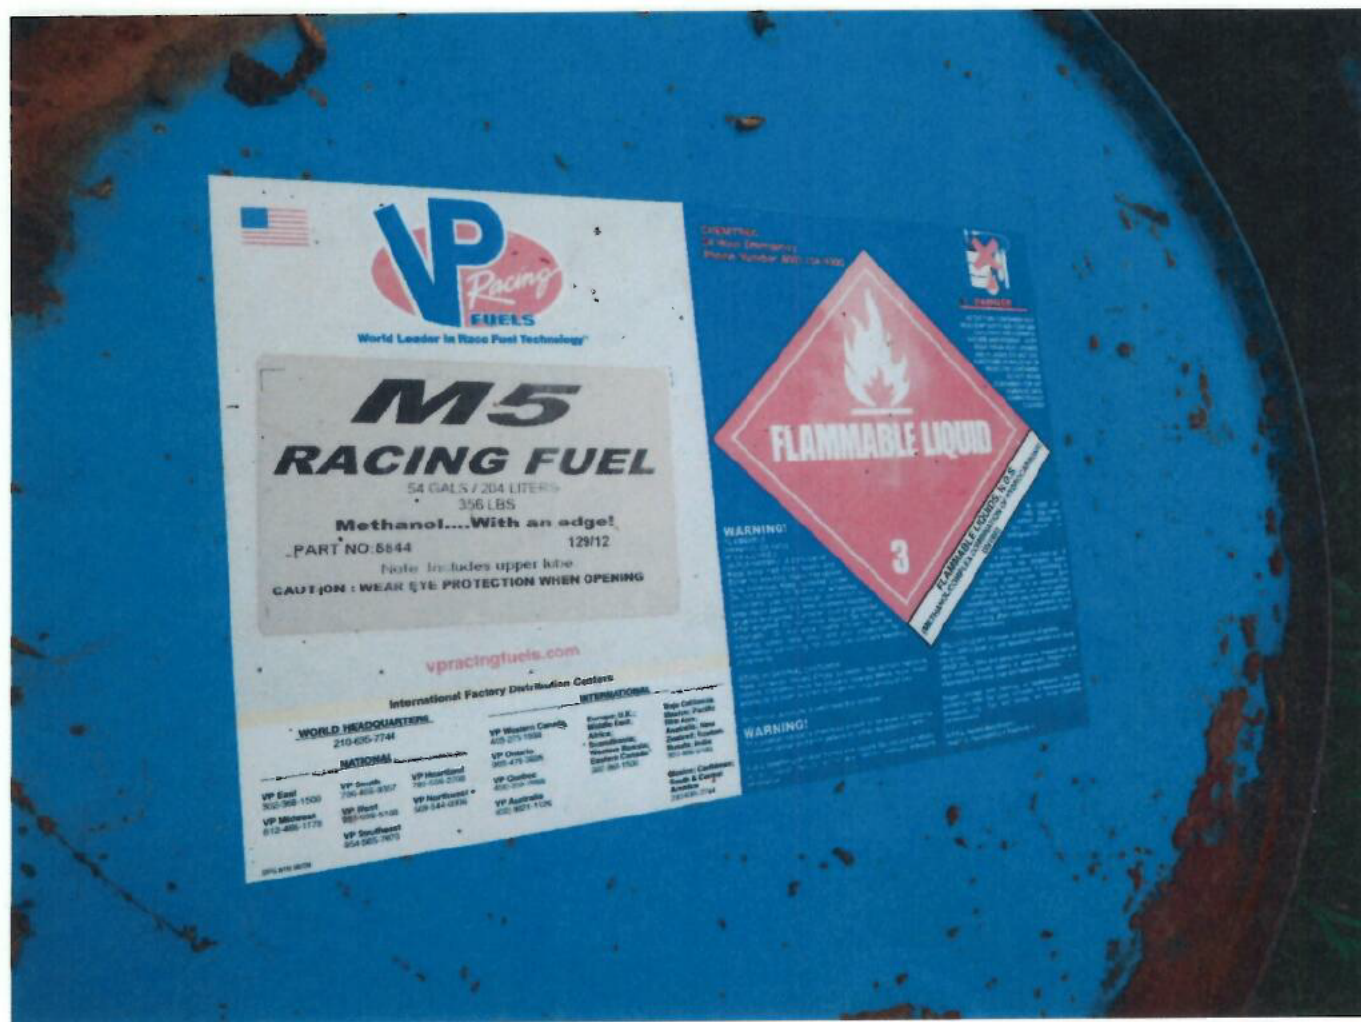
Photo 1179, DSCN1179.jpg, 5/15/2019 9:51 am, photo of drum label.

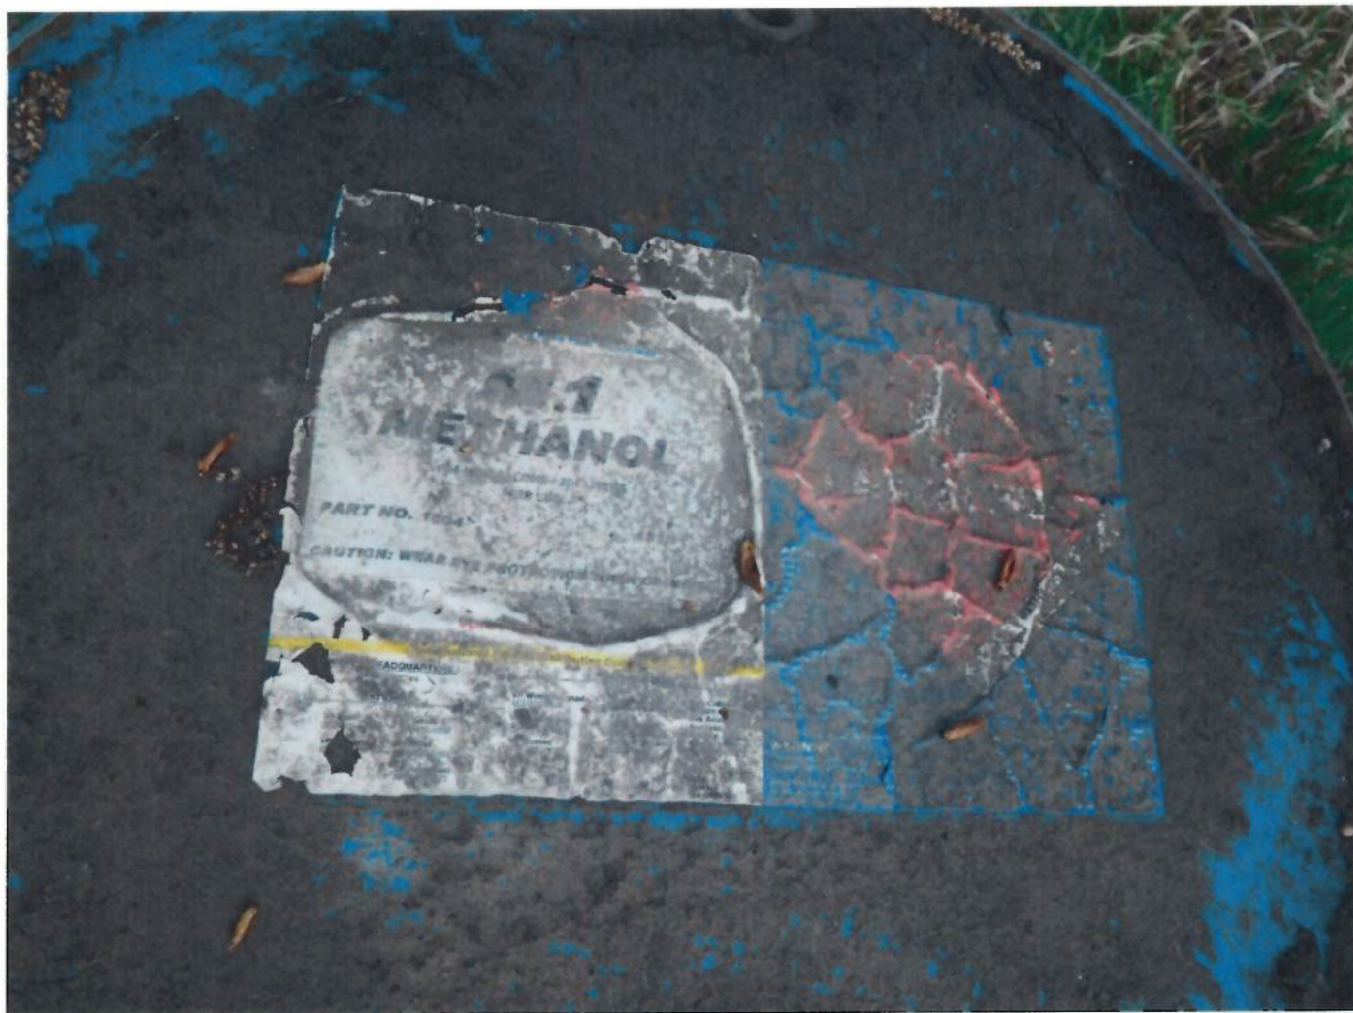
Photo 1180, DSCN1180.jpg, 5/15/2019 9:51 am, photo of drum label.

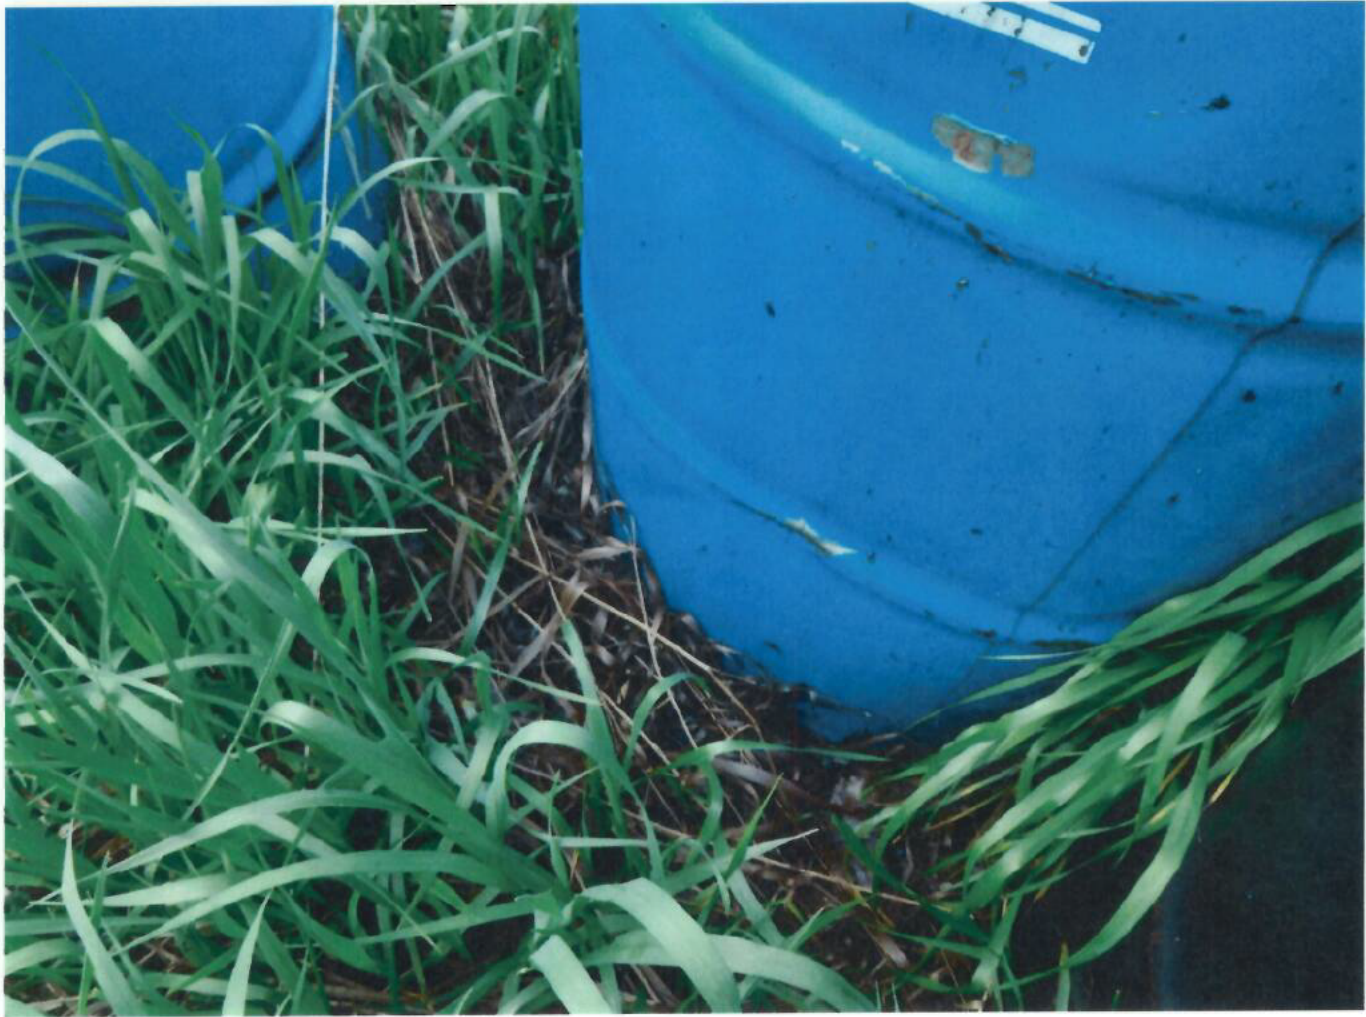
Photo 1181, DSCN1181.jpg, 5/15/2019 9:51 am, photo of stressed vegetation.

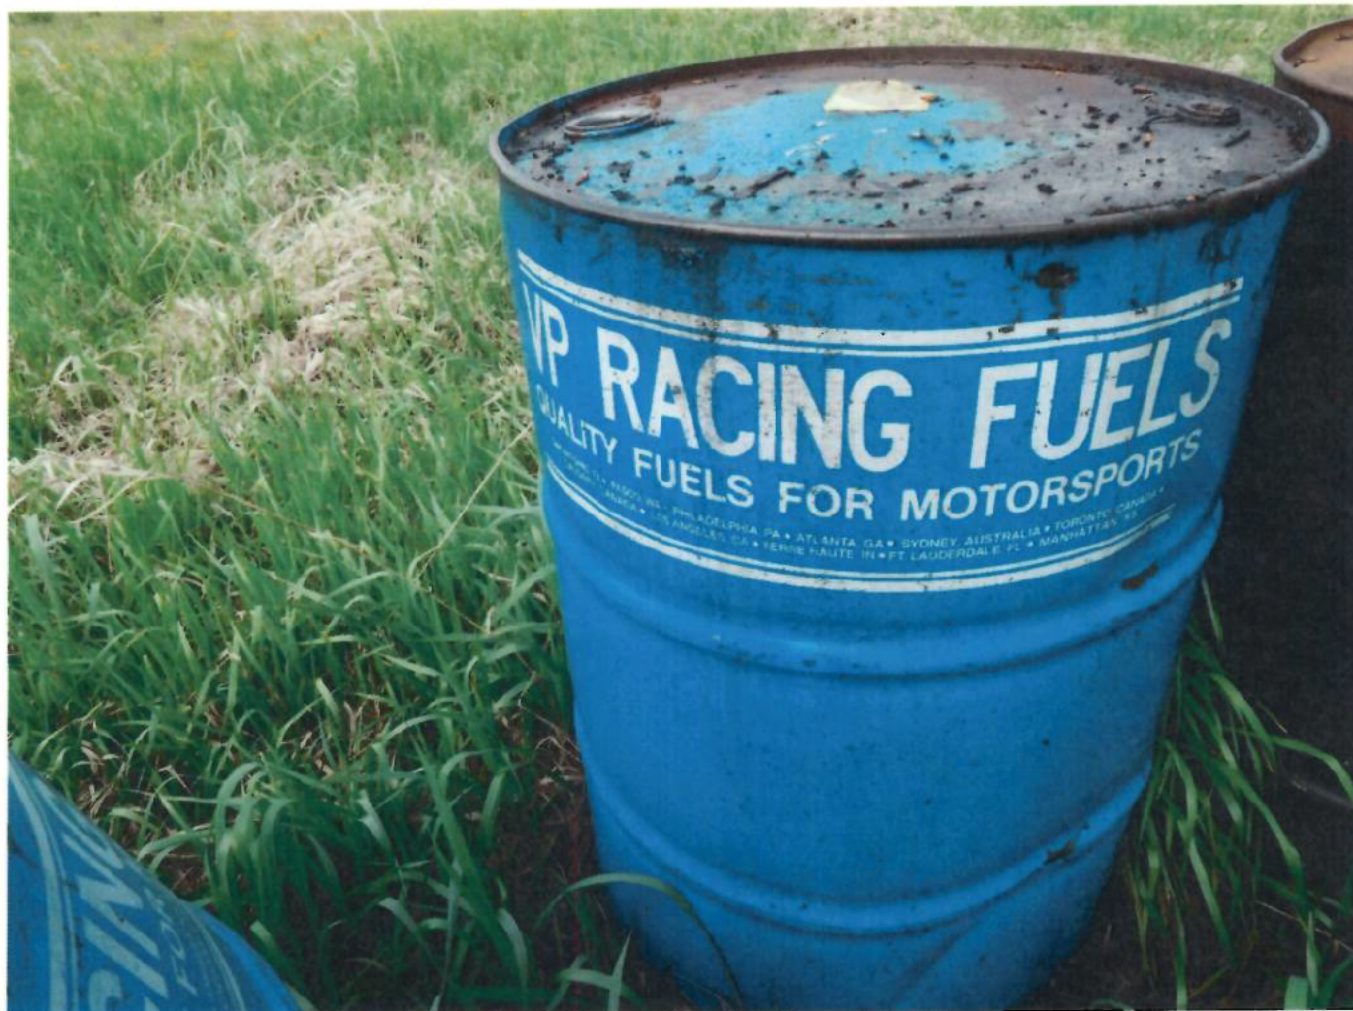
Photo 1182, DSCN1182.jpg, 5/15/2019 9:52 am, photo of drum label.

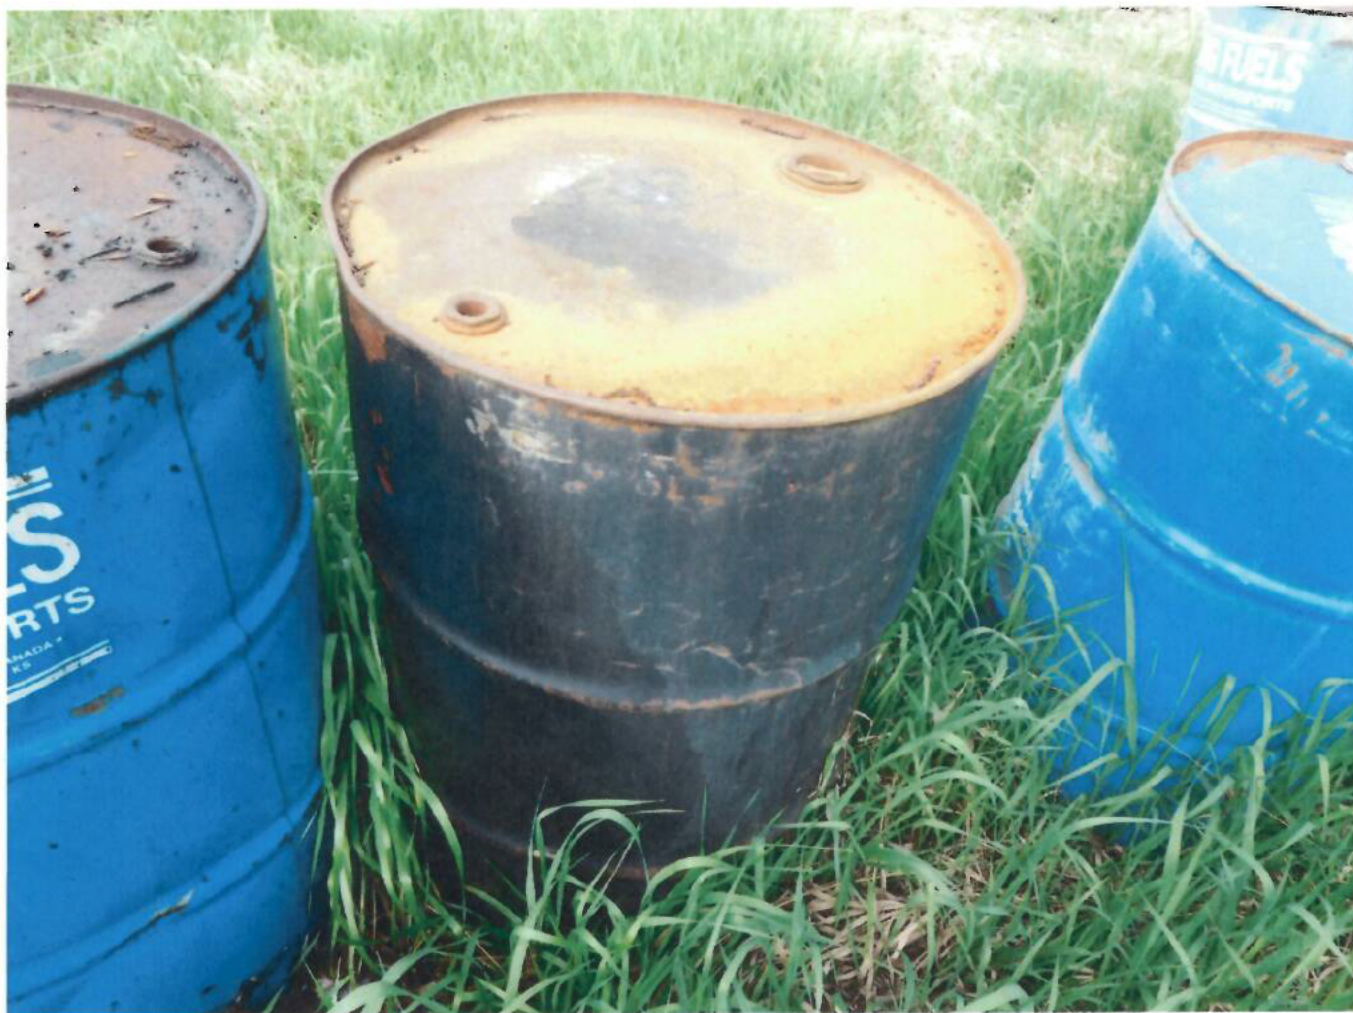
Photo 1183, DSCN1183.jpg, 5/15/2019 9:52 am, photo of drum with no labels.
