ACTION MEMORANDUM

SUBJECT: Approval and Funding for a Removal Action at the Lodge Grass Drums Site in Big Horn County, Montana, pursuant to the On-Scene Coordinator's delegated authority under CERCLA Section 104

UNITED STATES ENVIRONMENTAL PROTECTION AGENCY
REGION 8
RESOURCE CONSERVATION AND RECOVERY ACT

Type and Purpose of Inspection: Compliance Evaluation Inspection
RCRA Section 7003 Inspection

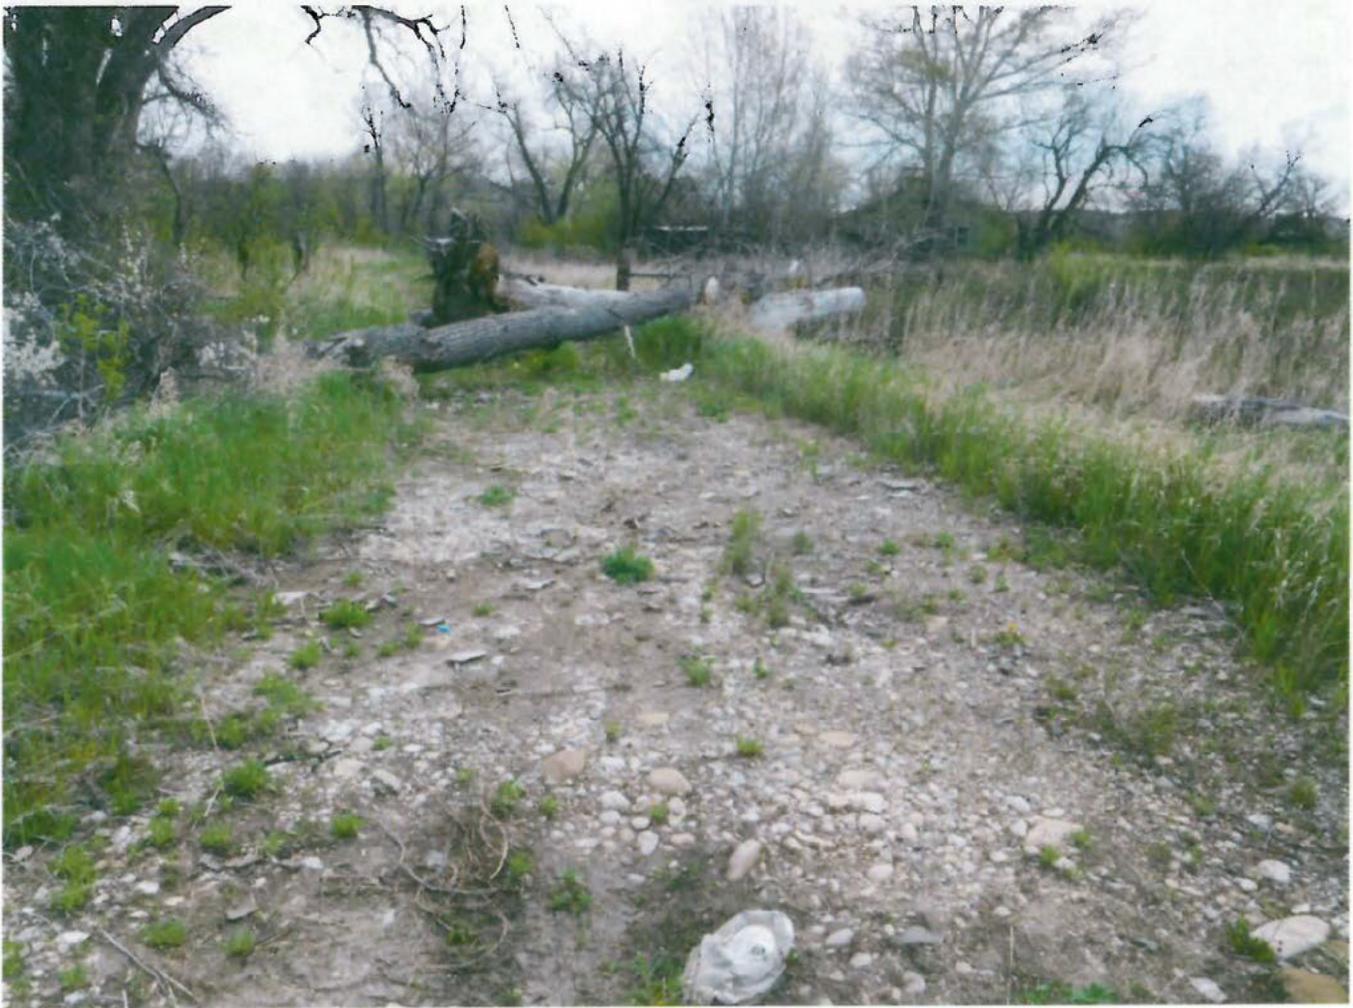
Photo 1159, DSCN1159.jpg, 5/15/2019 9:37 am, photo of driveway leading to area where drums are located. A fallen tree blocks vehicle access to the site. Photo taken facing east.

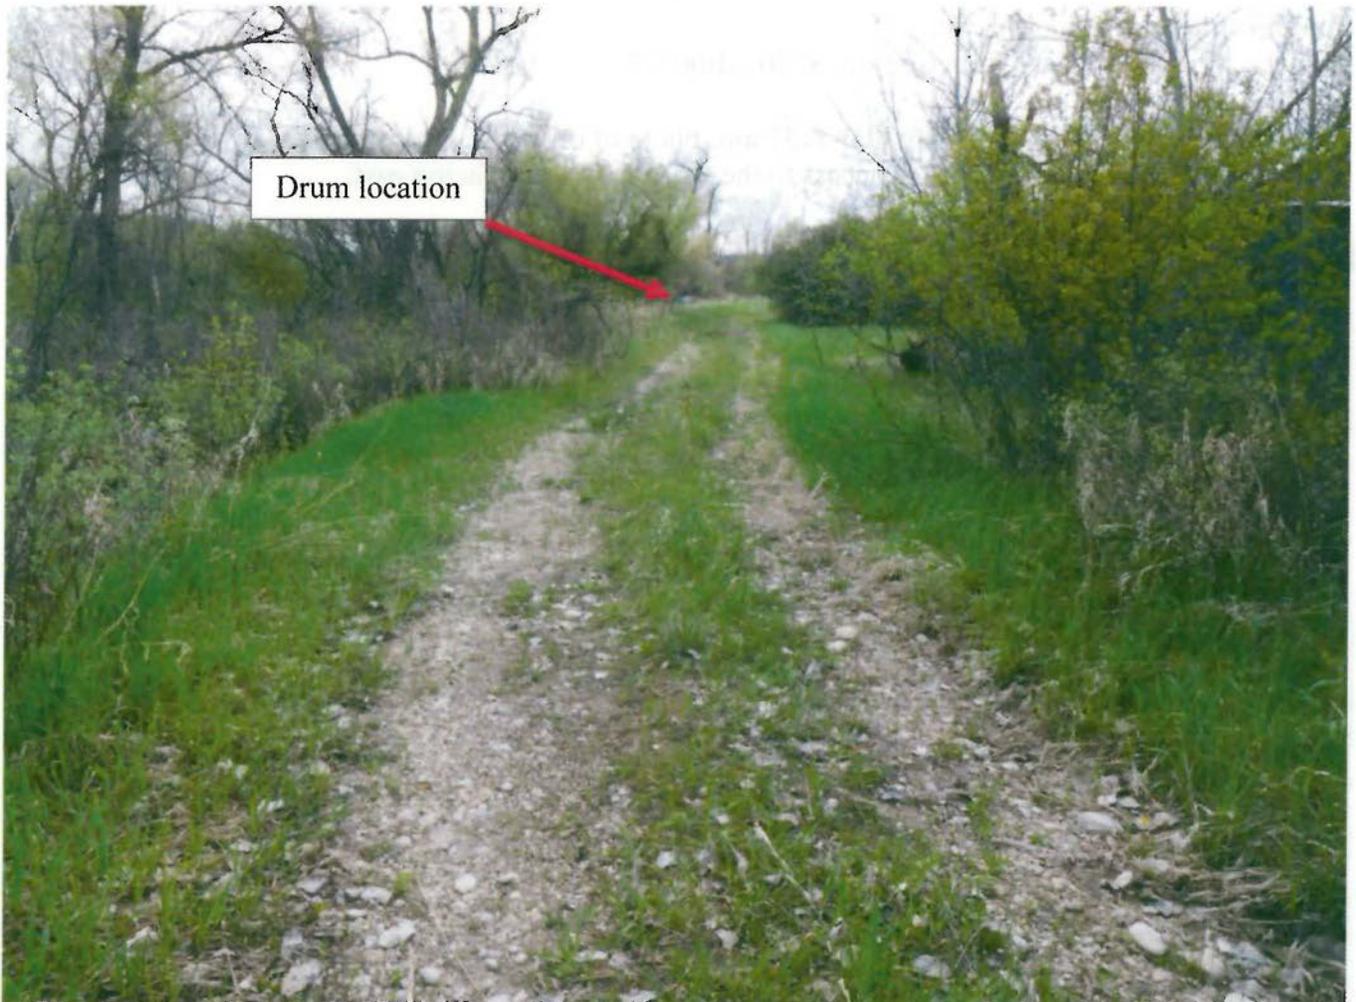
Photo 1160, DSCN1160.jpg, 5/15/2019 9:38 am, photo of driveway beyond (east of) the fallen tree with drums visible in background.

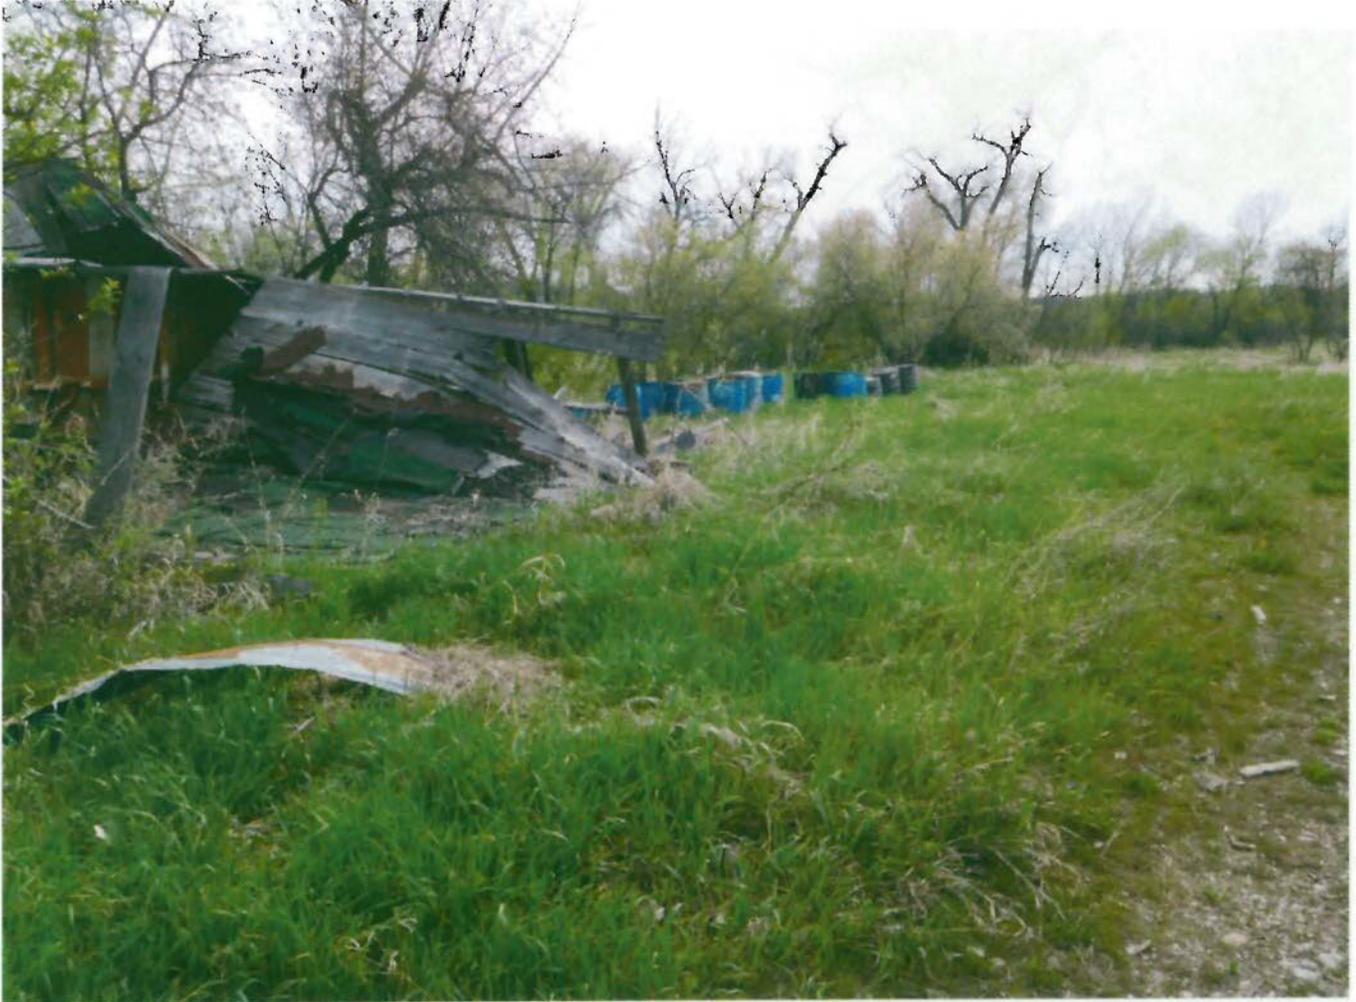
Photo 1161, DSCN1161.jpg, 5/15/2019 9:39 am, photo of drums near eastern end of driveway.

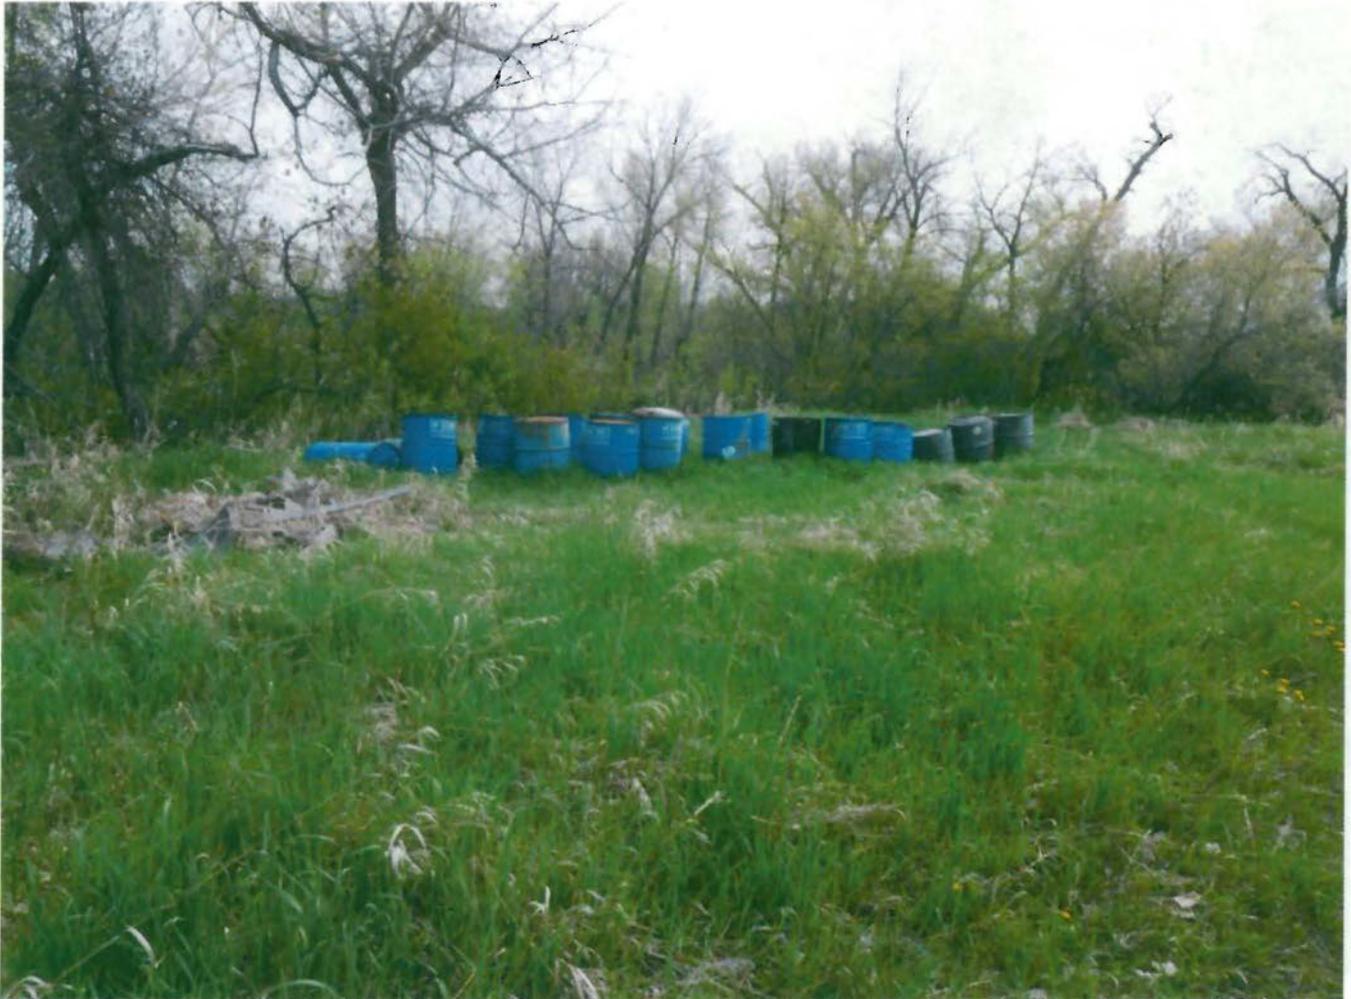
Photo 1162, DSCN1162.jpg, 5/15/2019 9:39 am, photo of drums, showing all 20 drums. Photo taken facing north/northeast.

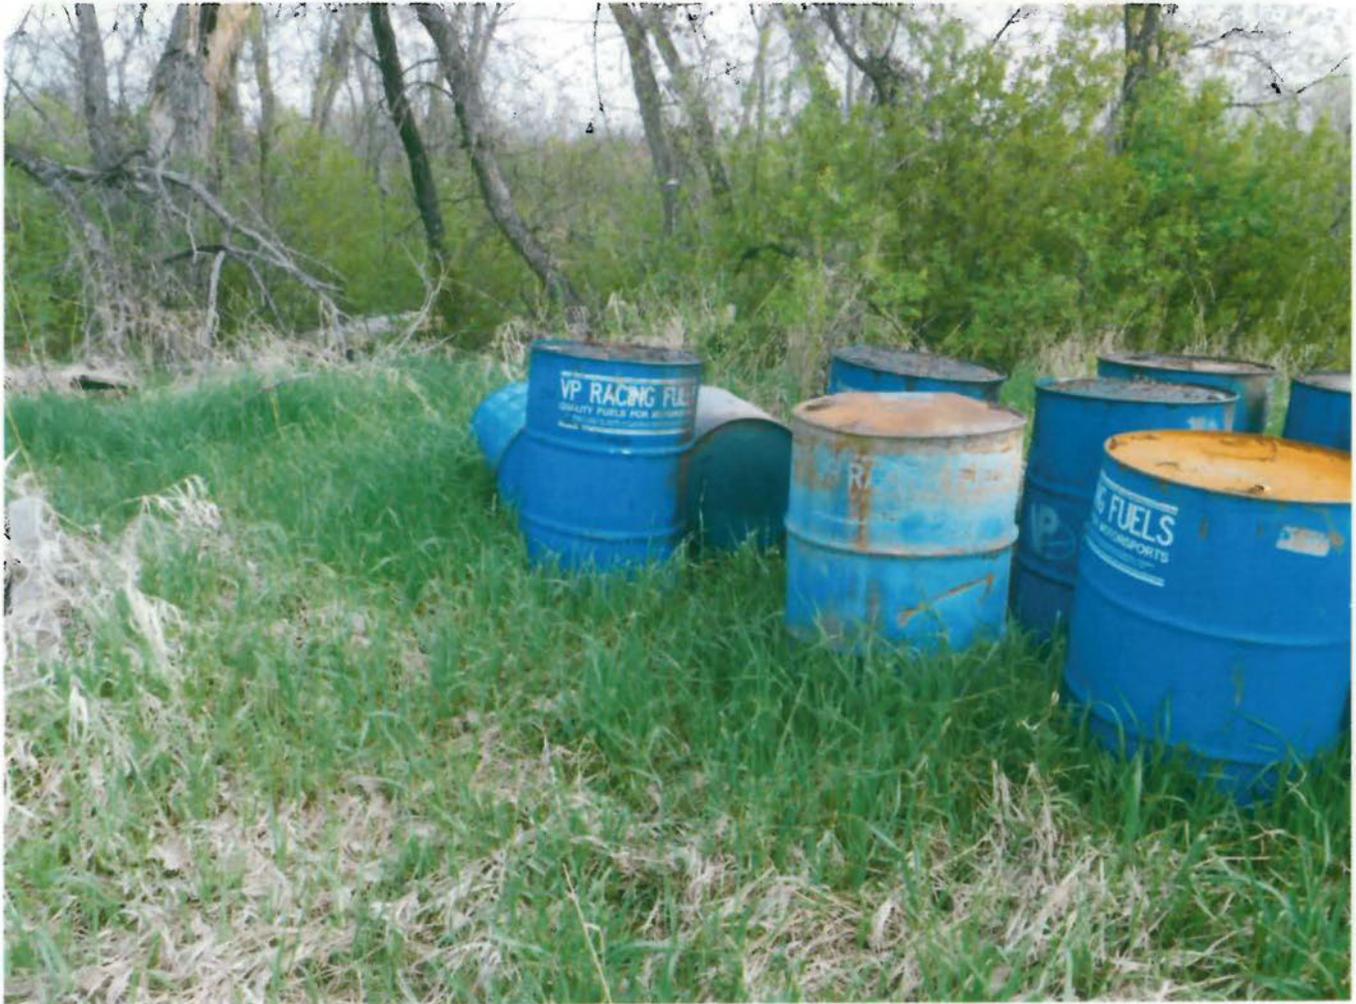
As discussed elsewhere in this document, the drums are reported to contain waste oil, which is a regulated waste under RCRA due to assumed presence of various CERCLA hazardous substances. In addition, some of the drums are bulging, indicating an over-pressure condition either exists or has existed in the past, indicating the potential for additional volatile solvents. Many of these solvents are hazardous substances. Lastly, the actual release of the drums’ contents has also been documented – see Attachment 1.

Photo 1163, DSCN1163.jpg, 5/15/2019 9:40 am, photo of westernmost section of drums. Photo includes two drums on their sides and one drum with a bulging top.

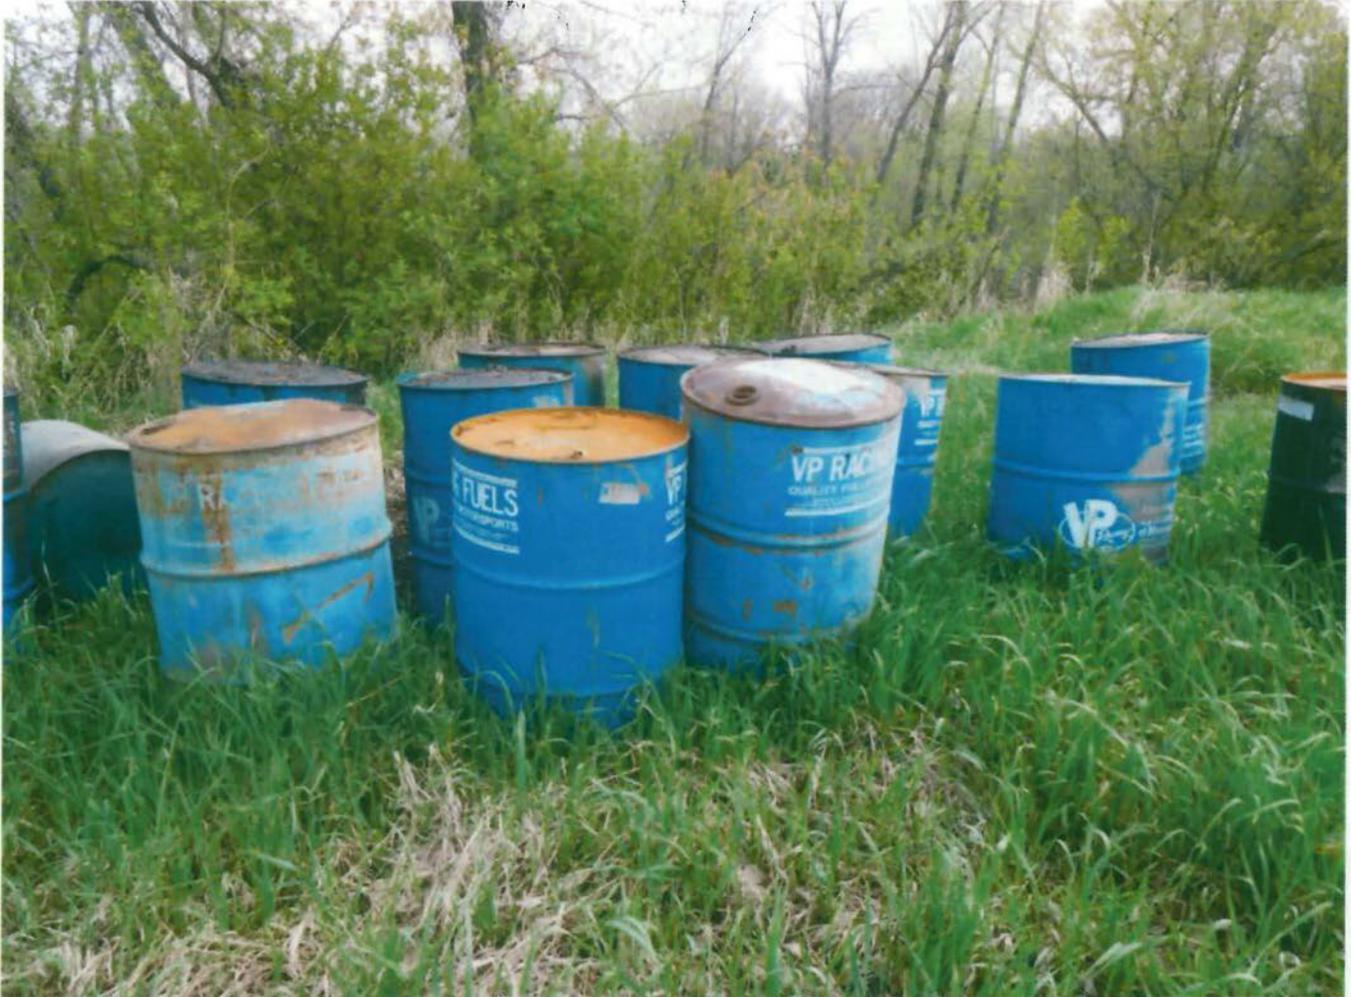
Photo 1164, DSCN1164.jpg, 5/15/2019 9:40 am, photo central section of drums, including two drums with bulging tops (one of which was also shown in photo 1163).

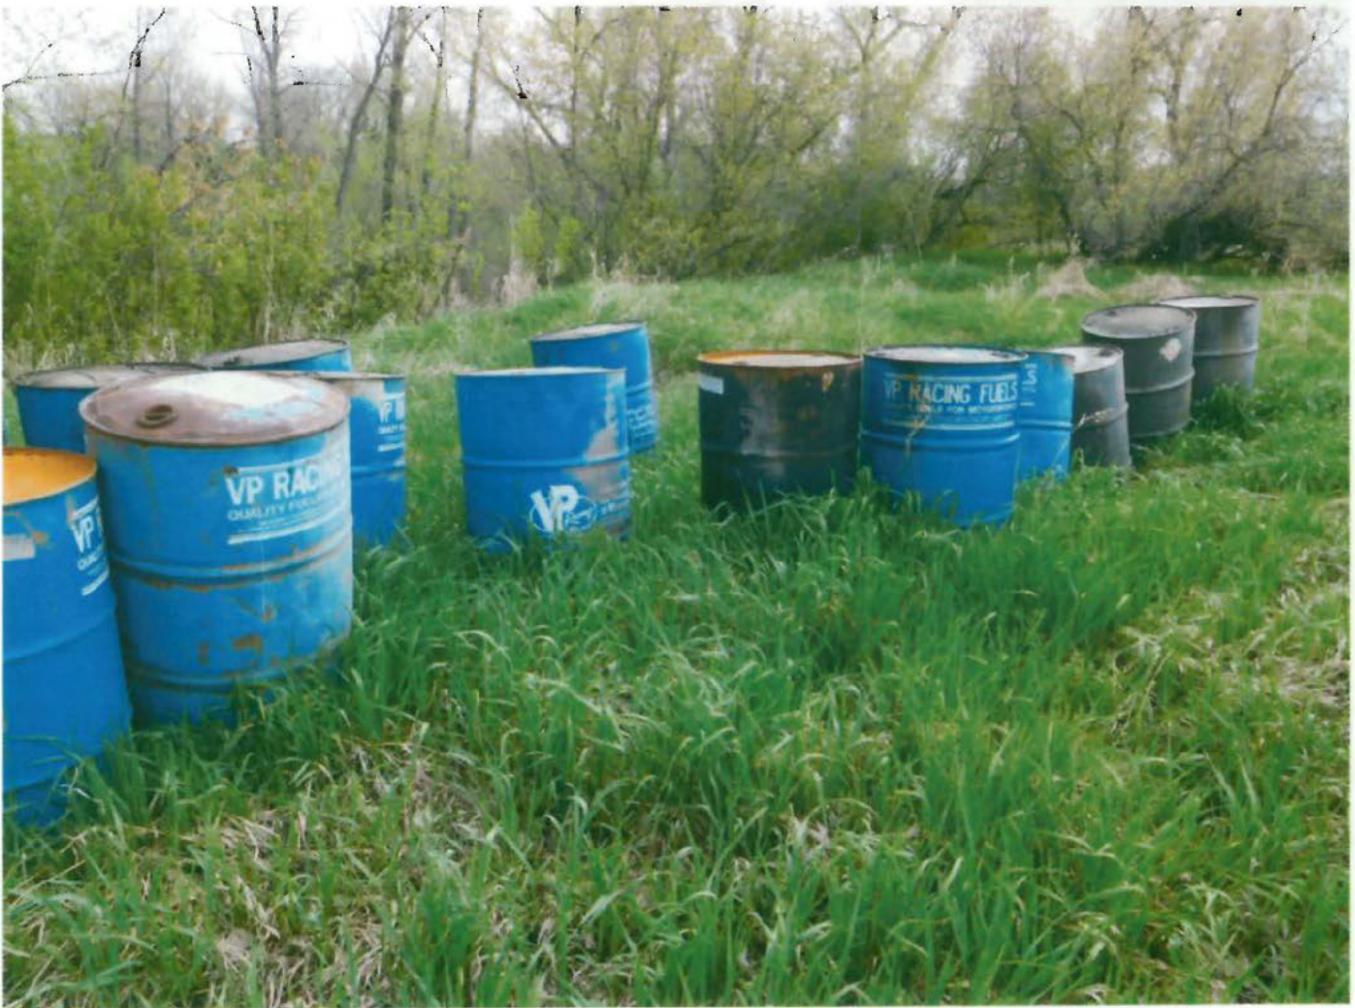
Photo 1165, DSCN1165.jpg, 5/15/2019 9:40 am, photo of easternmost section of drums.

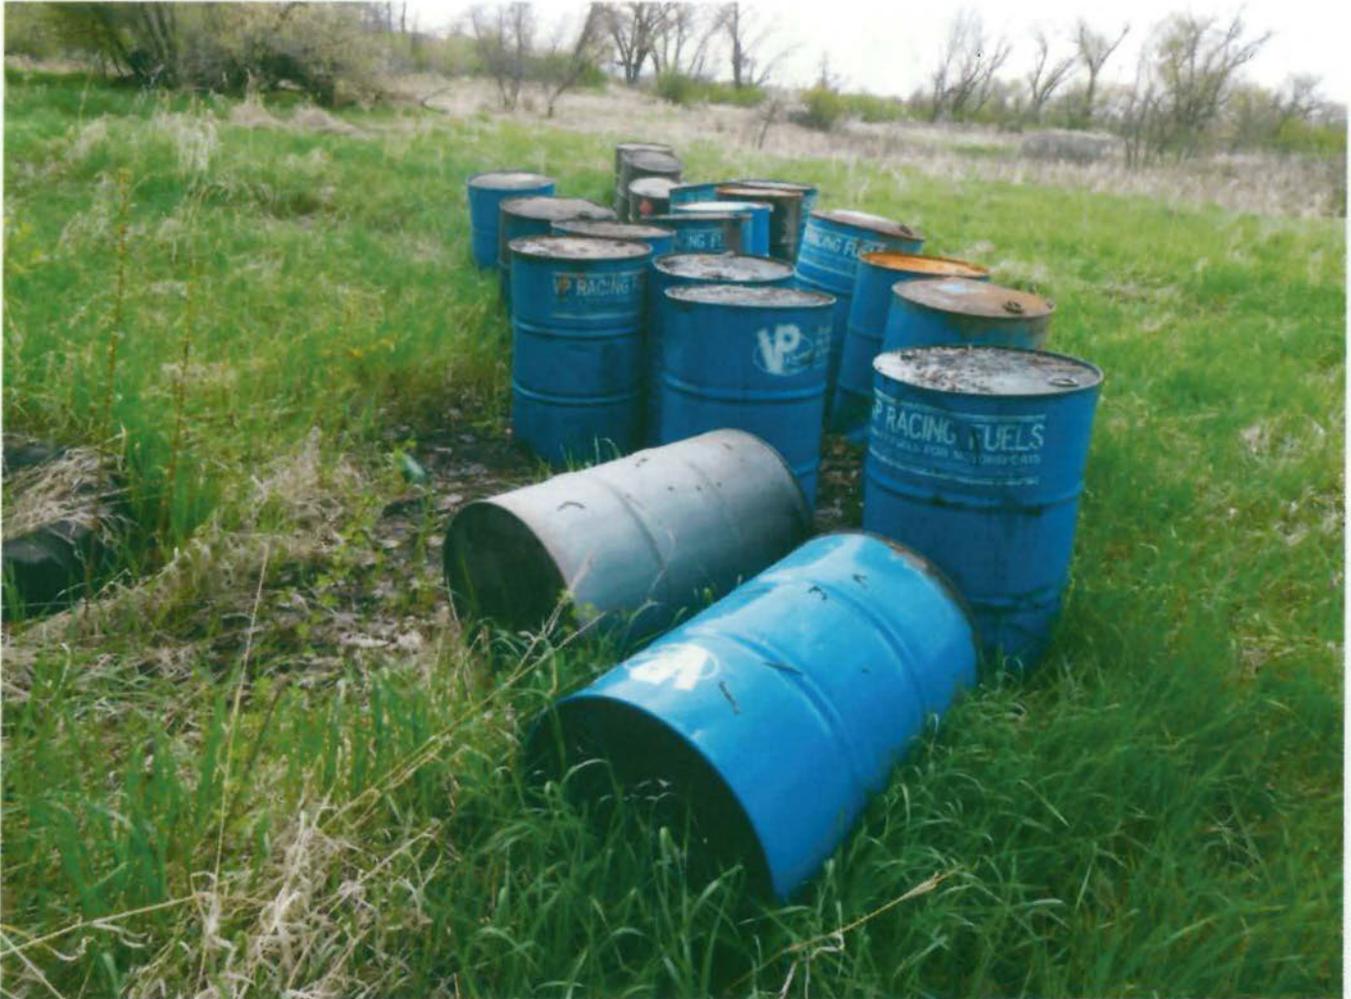
Photo 1166, DSCN1166.jpg, 5/15/2019 9:40 am, photo of all 20 drums, taken facing south.

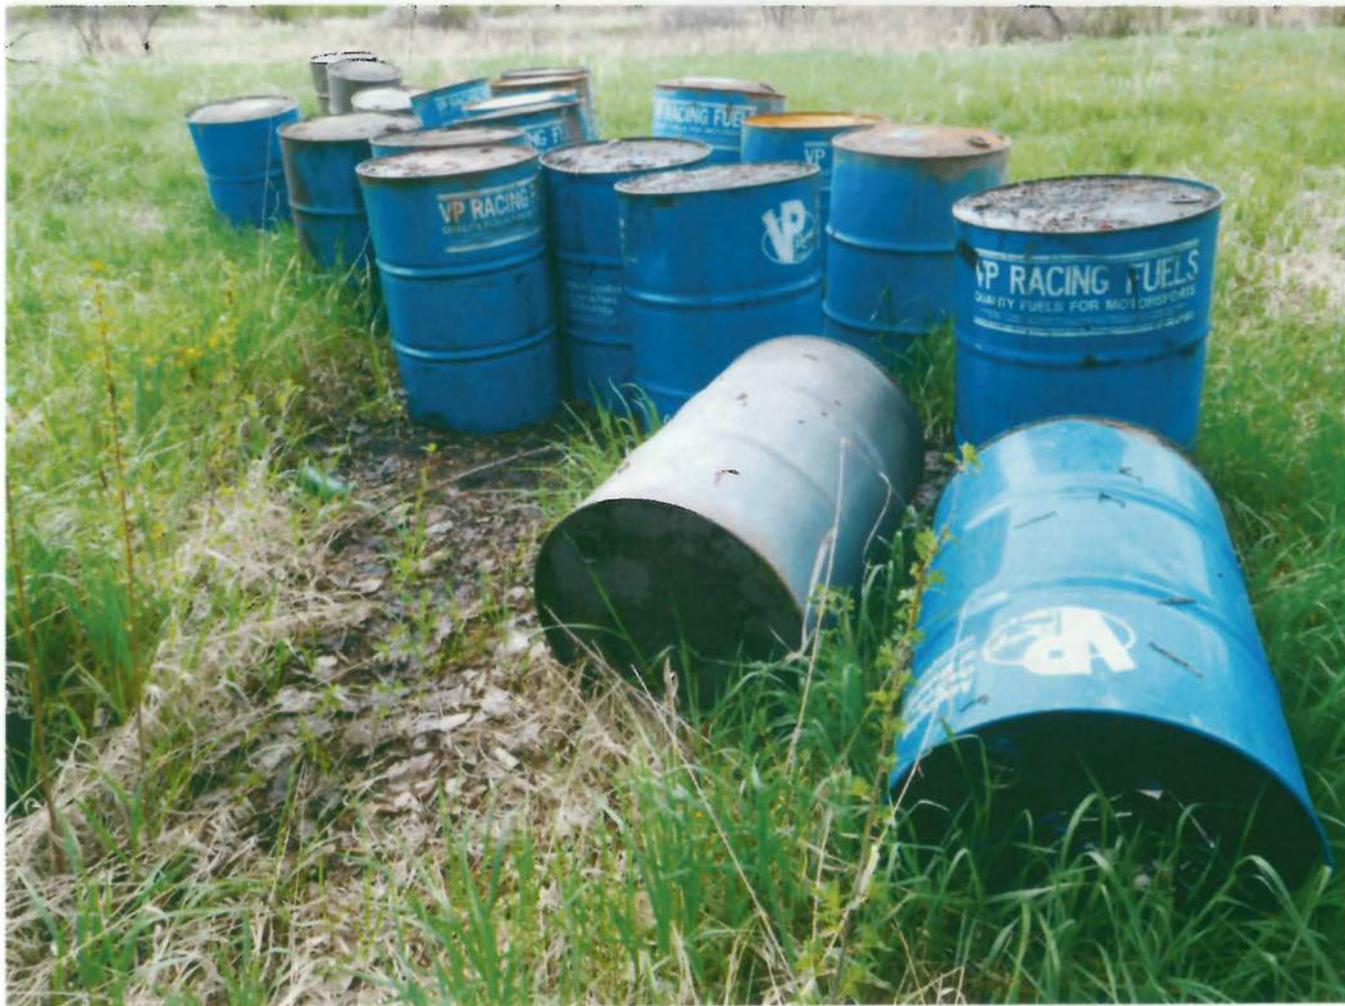
Photo 1167, DSCN1167.jpg, 5/15/2019 9:41 am, photo of all 20 drums, taken facing southeast.

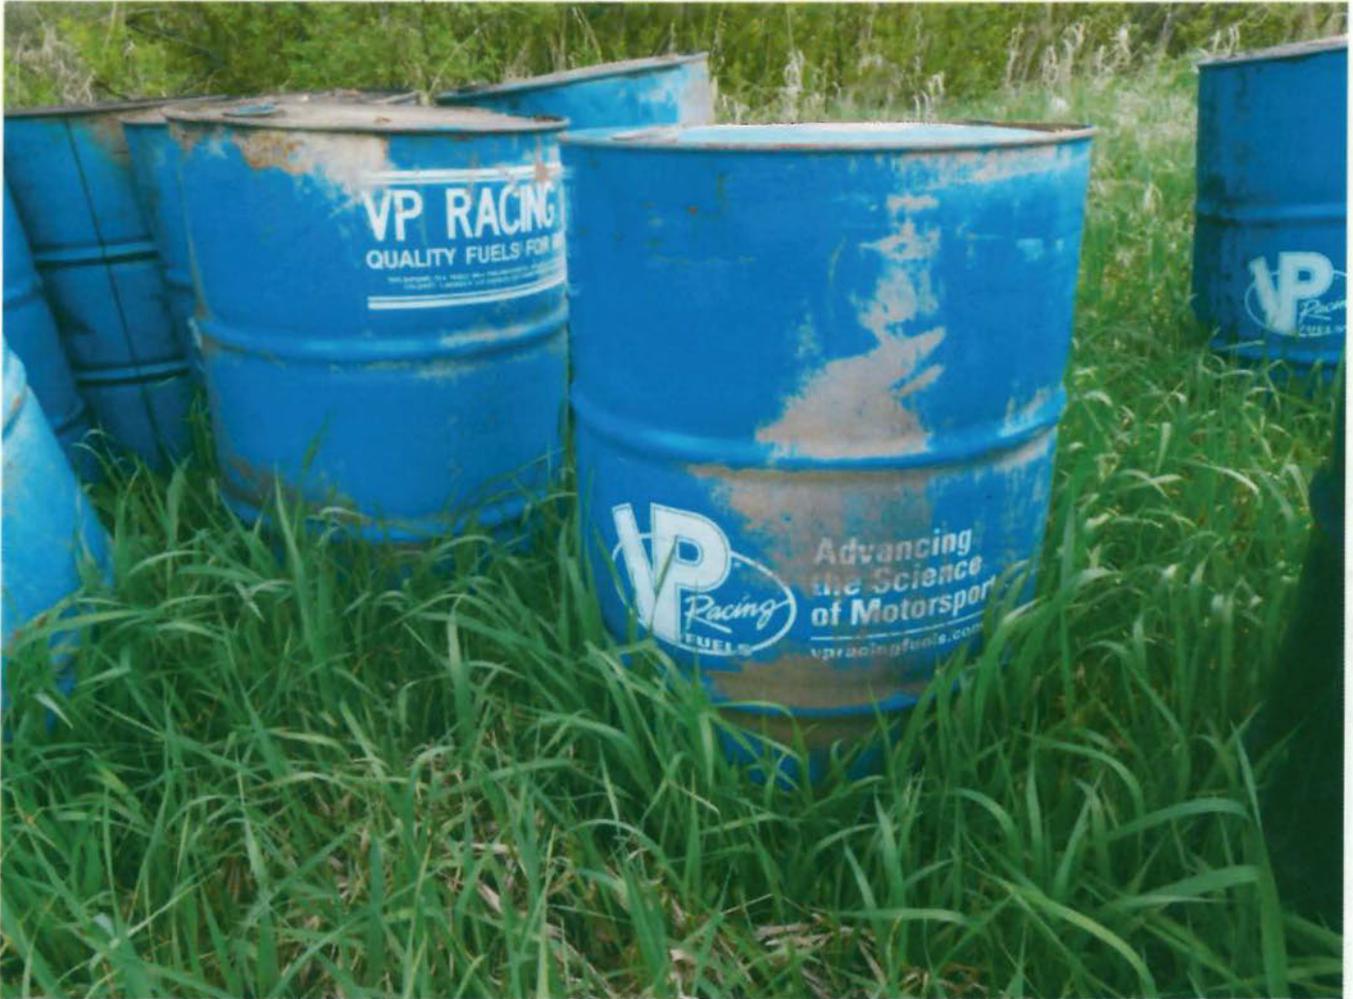
Photo 1168, DSCN1168.jpg, 5/15/2019 9:41 am, photo of drum labeling.

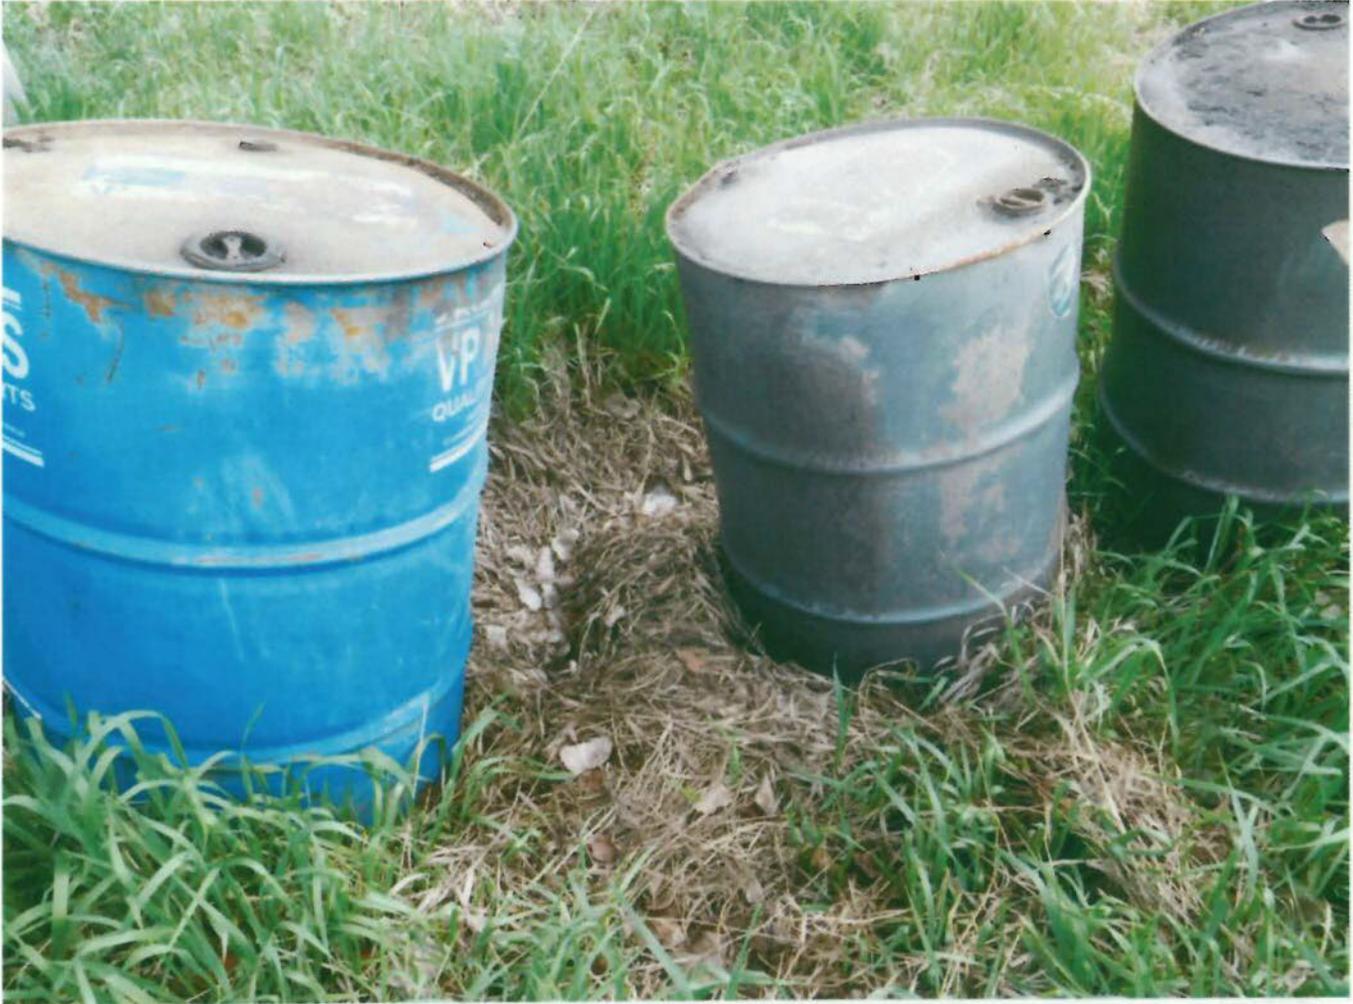
Photo 1169, DSCN1169.jpg, 5/15/2019 9:41 am, photo of stressed vegetation in between drums.

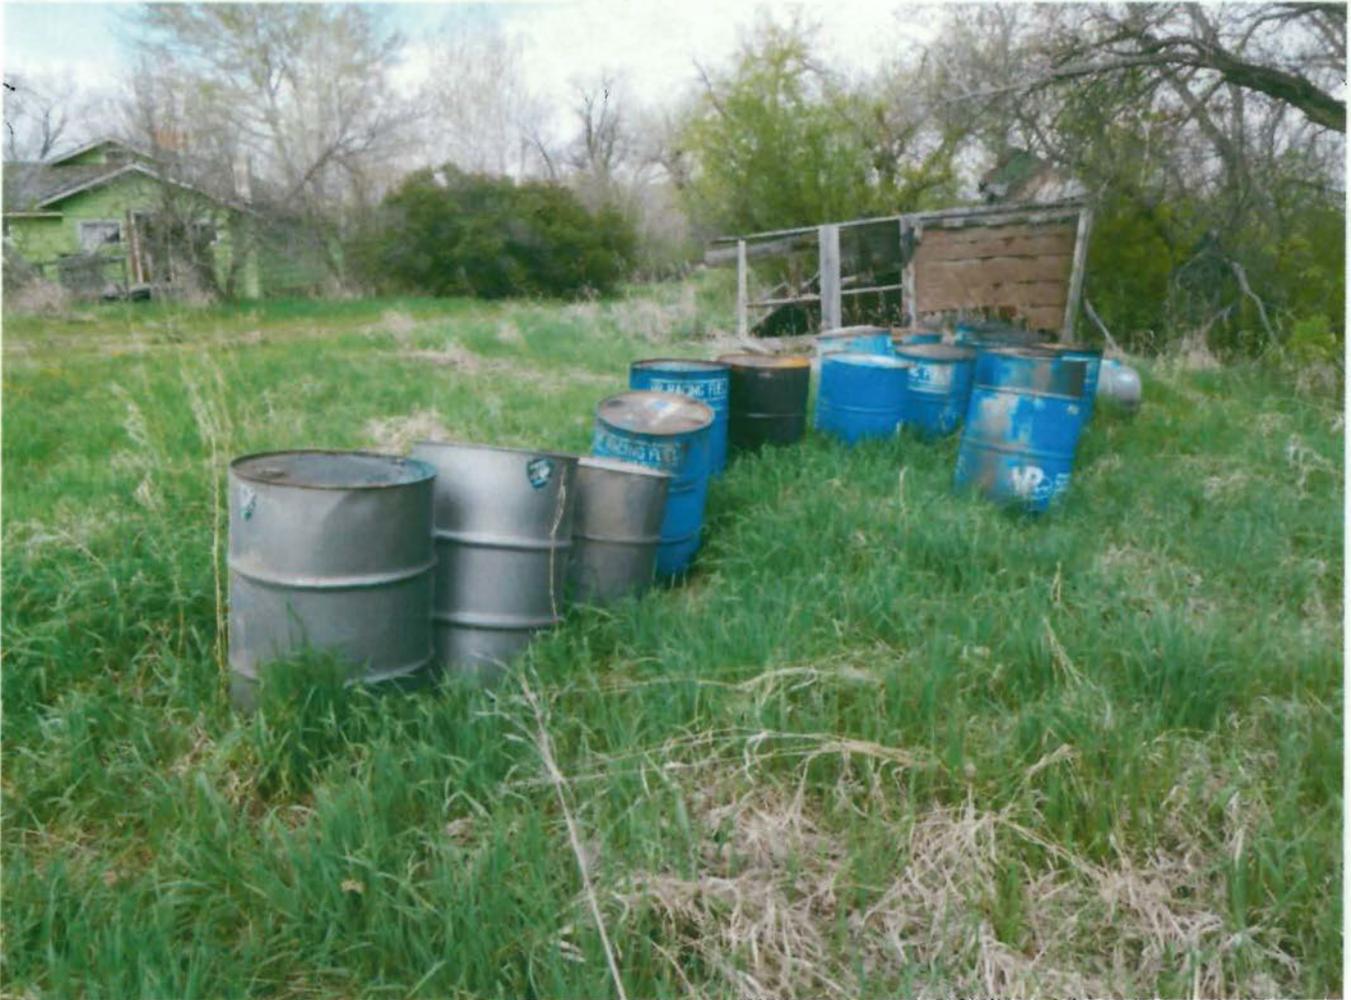
Photo 1170, DSCN1170.jpg, 5/15/2019 9:42 am, photo of all 20 drums, taken facing west. Uninhabited green residential structure and partially fallen-down additional structure included in photo background.

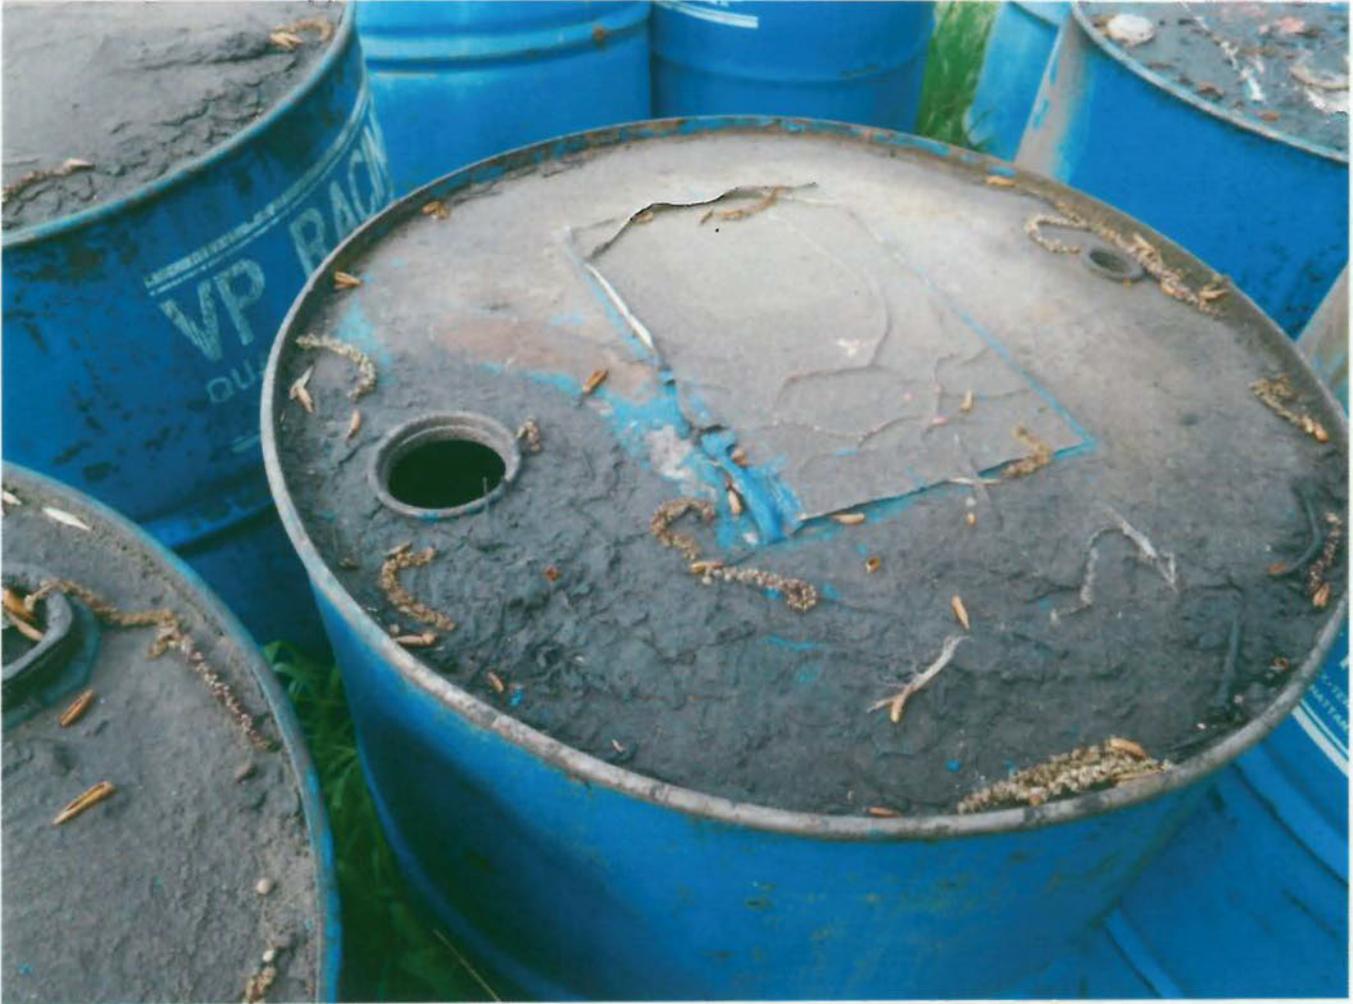
Photo 1171, DSCN1171.jpg, 5/15/2019 9:42 am, photo of an open drum.

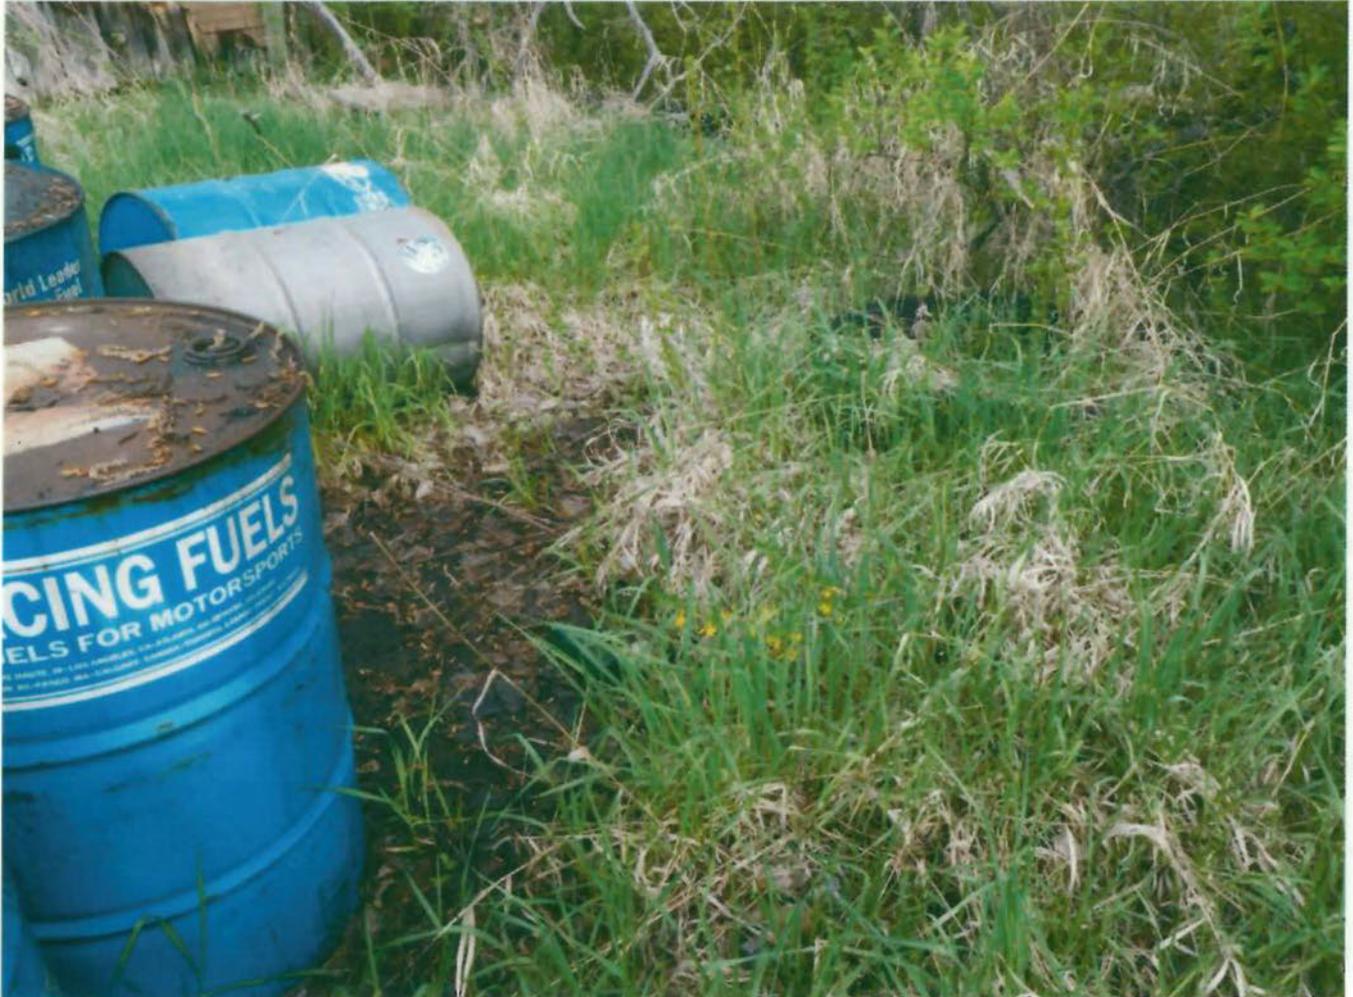
program (Attachment 1) show stained soil indicating an ongoing release that will migrate further with every rain event if left unchecked.

Photo 1172, DSCN1172.jpg, 5/15/2019 9:42 am, photo of spilled or leaked oily-looking waste on ground on north side of drum area.

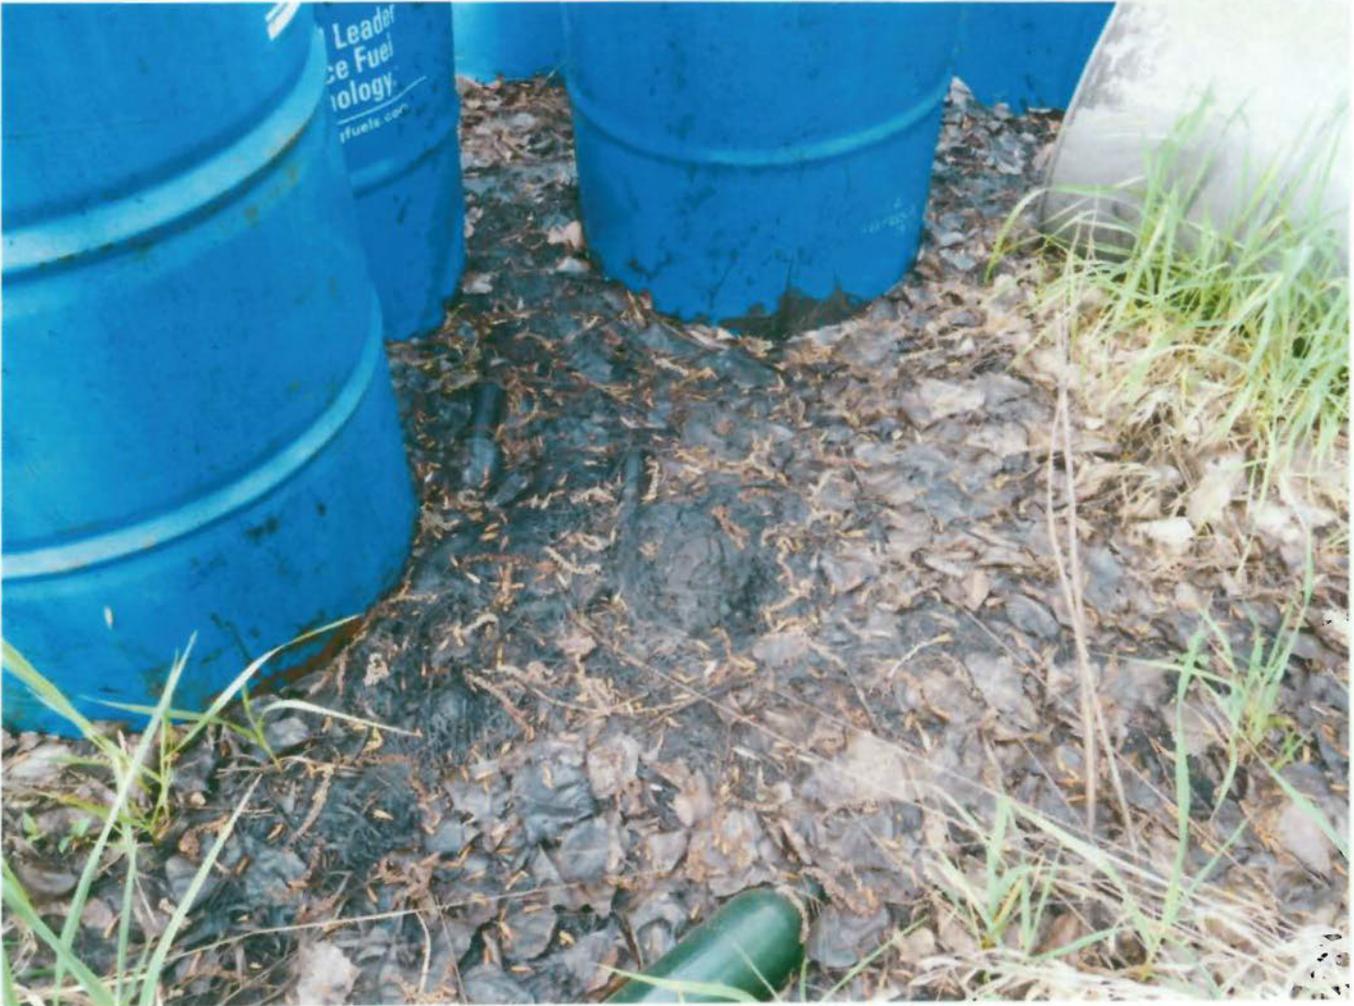
Photo 1173, DSCN1173.jpg, 5/15/2019 9:42 am, photo of spilled or leaked oily-looking waste on ground on north side of drum area

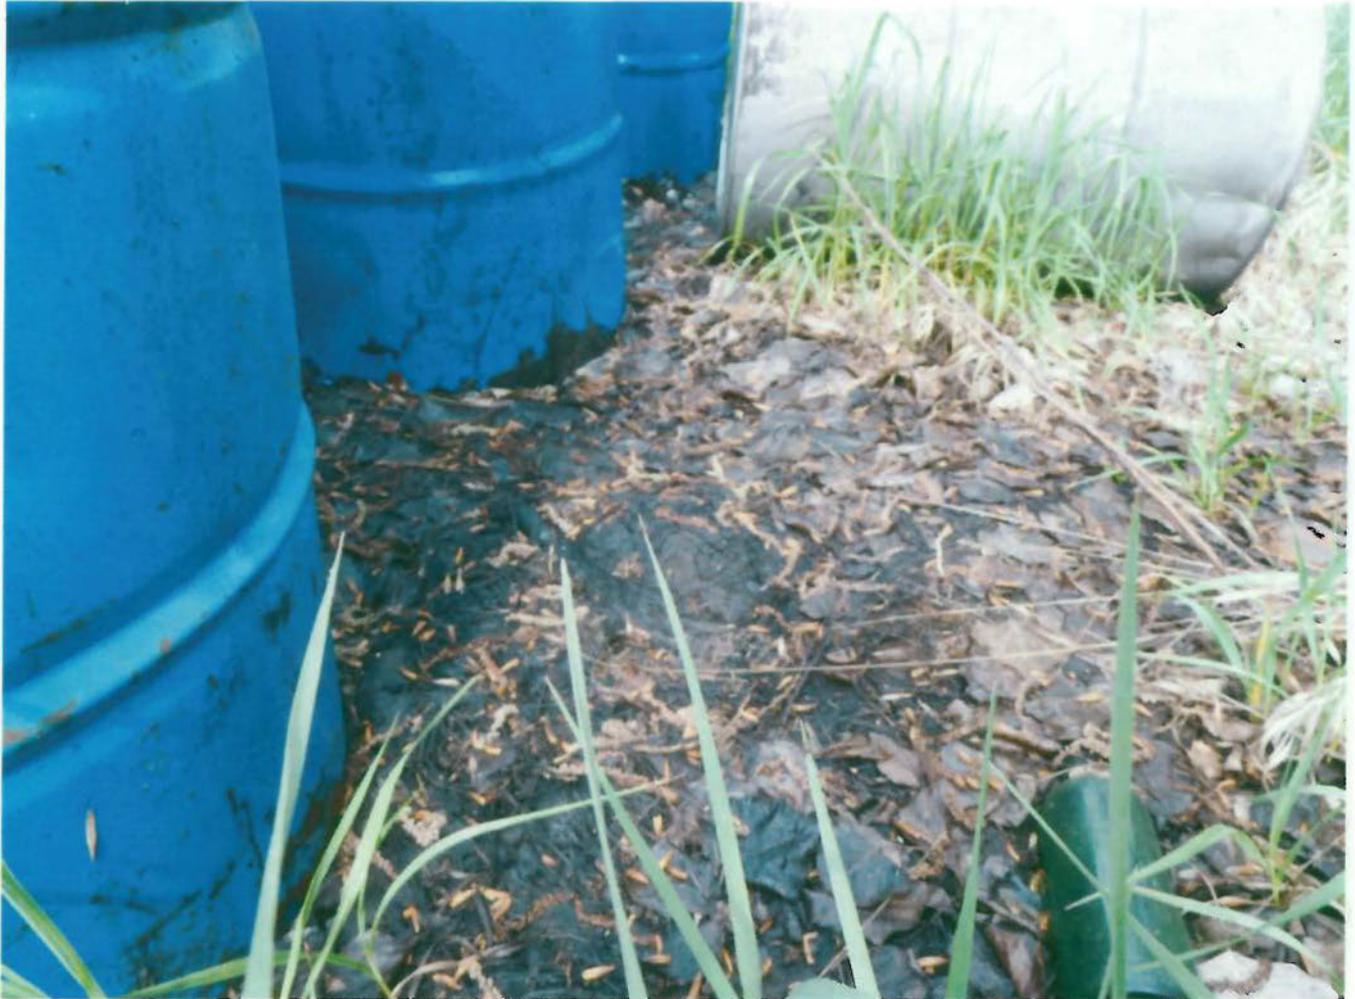
Photo 1174, DSCN1174.jpg, 5/15/2019 9:46 am, photo of spilled or leaked oily-looking waste on ground on north side of drum area.
