ACTION MEMORANDUM

SUBJECT: Approval and Funding for a Removal Action at the Lodge Grass Drums Site in Big Horn County, Montana, pursuant to the On-Scene Coordinator's delegated authority under CERCLA Section 104

UNITED STATES ENVIRONMENTAL PROTECTION AGENCY
REGION 8
RESOURCE CONSERVATION AND RECOVERY ACT

Type and Purpose of Inspection: Compliance Evaluation Inspection
RCRA Section 7003 Inspection

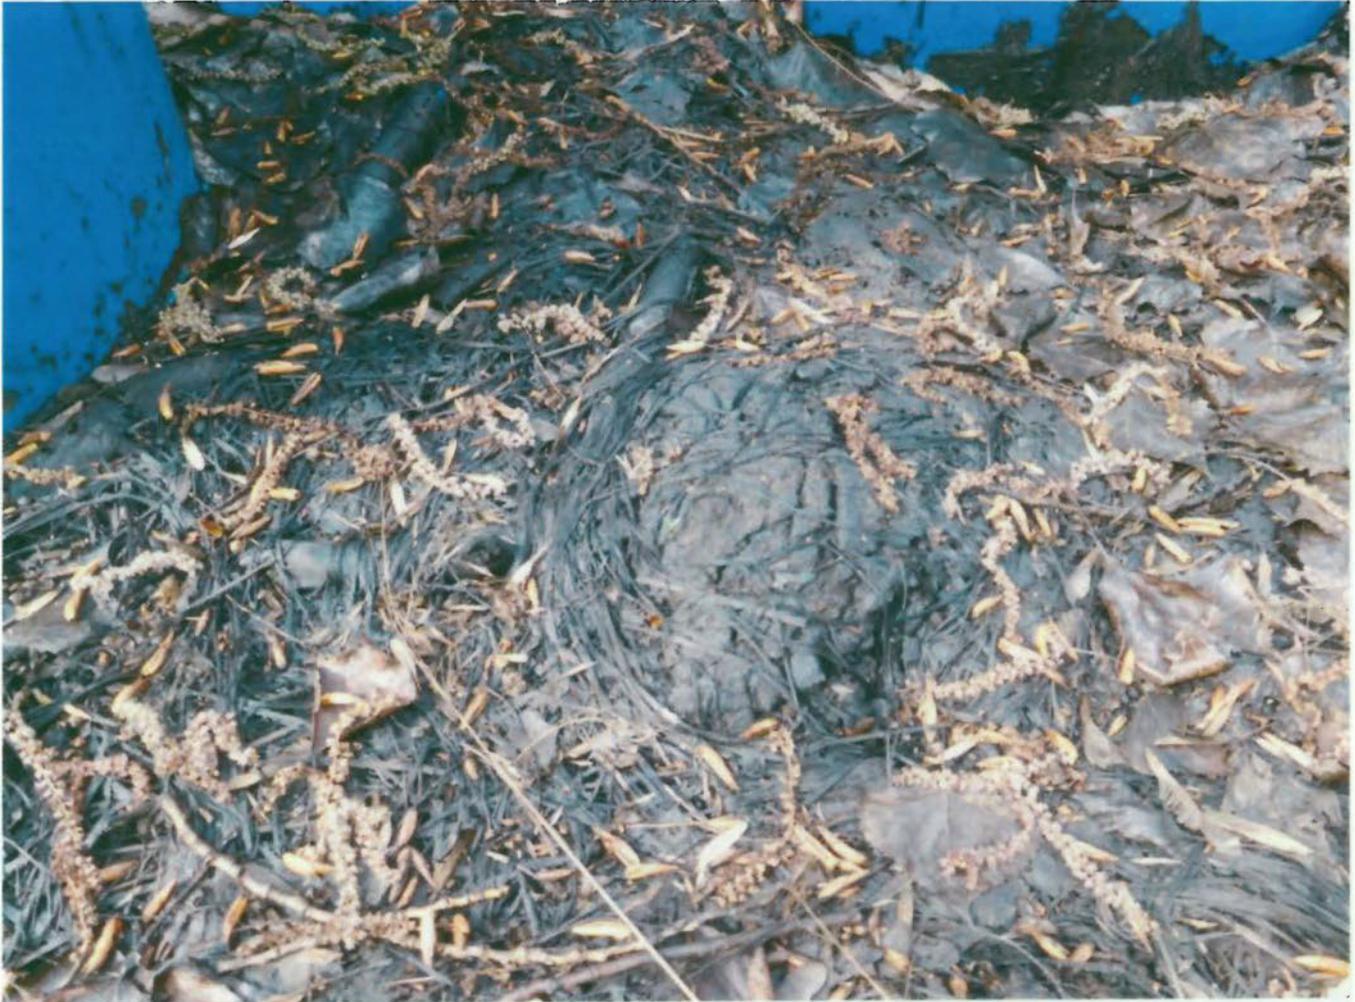
Photo 1175, DSCN1175.jpg, 5/15/2019 9:46 am, photo of spilled or leaked oily-looking waste on ground on north side of drum area.

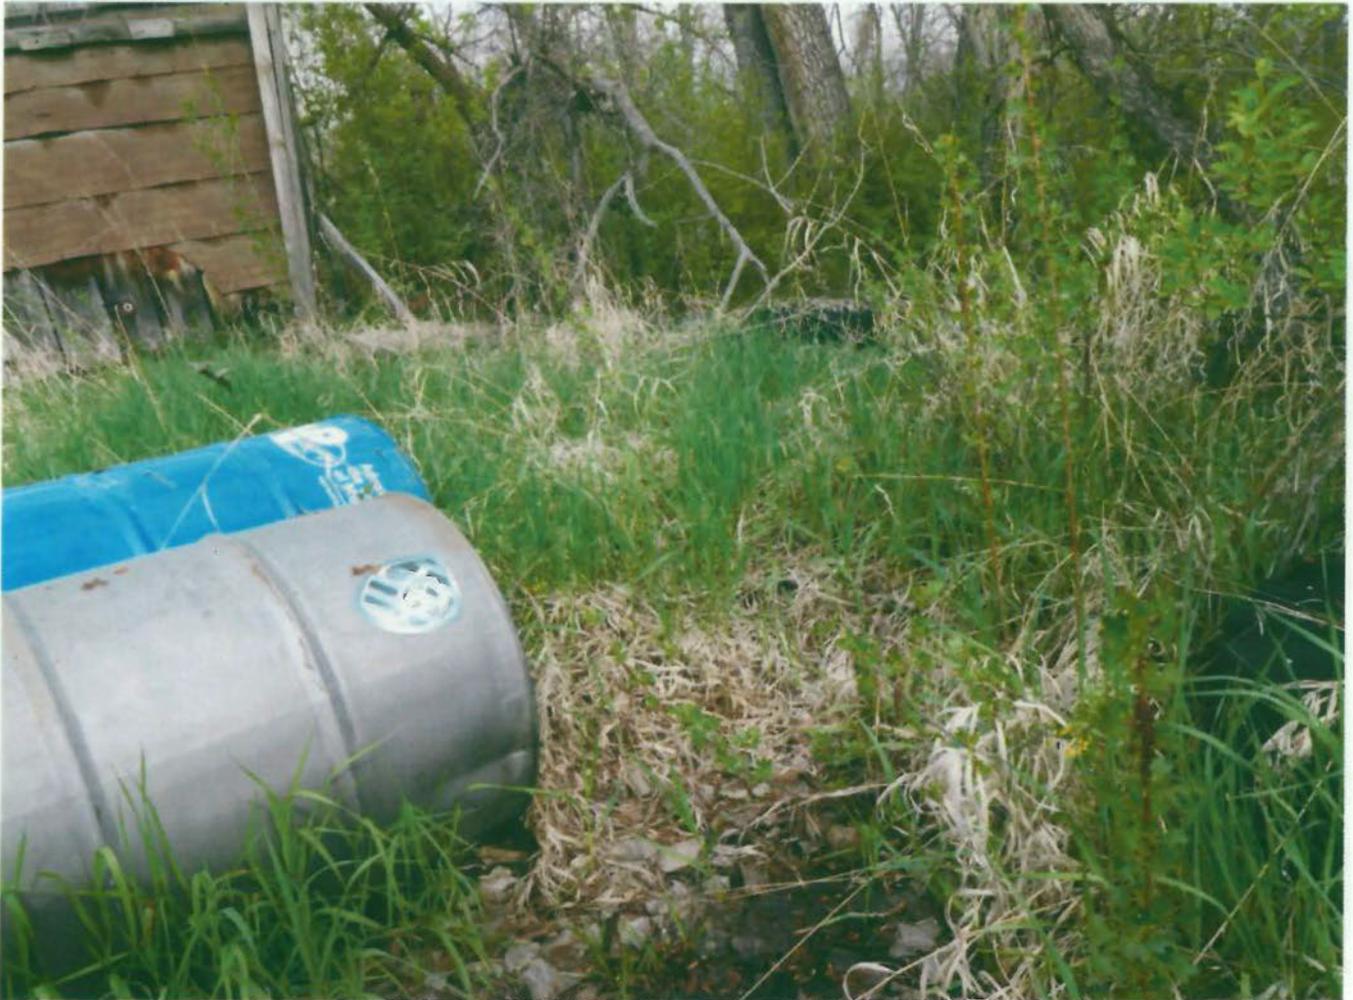
Photo 1176, DSCN1176.jpg, 5/15/2019 9:46 am, photo of spilled or leaked oily-looking waste on ground on north side of drum area, facing toward lower-elevation area located approximately 15 feet to the north of the drums.

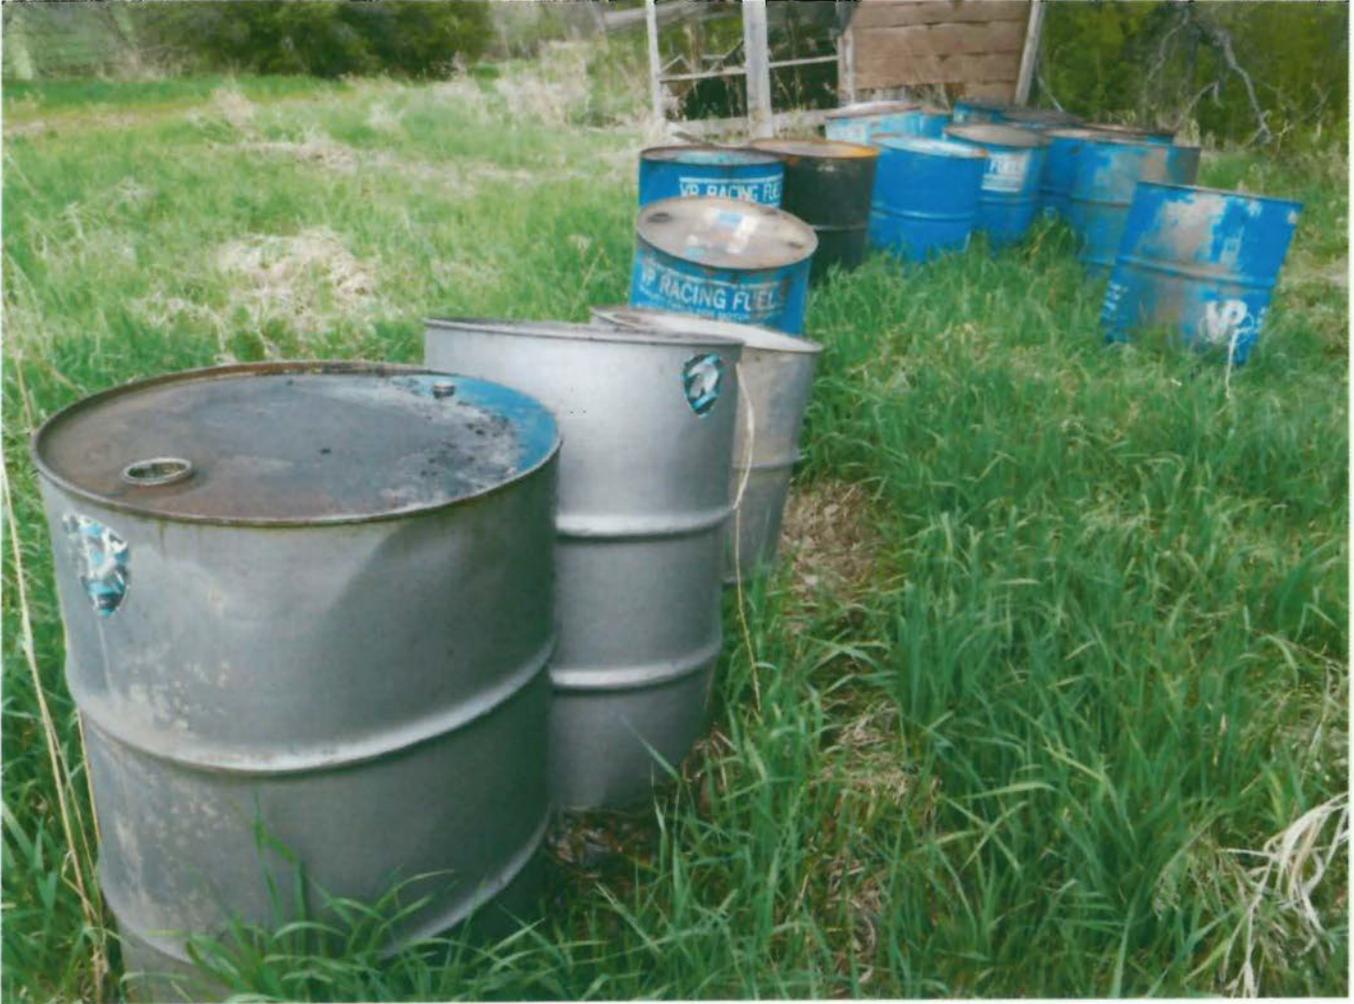
Photo 1177, DSCN1177.jpg, 5/15/2019 9:50 am, photo of all 20 drums, taken facing west.

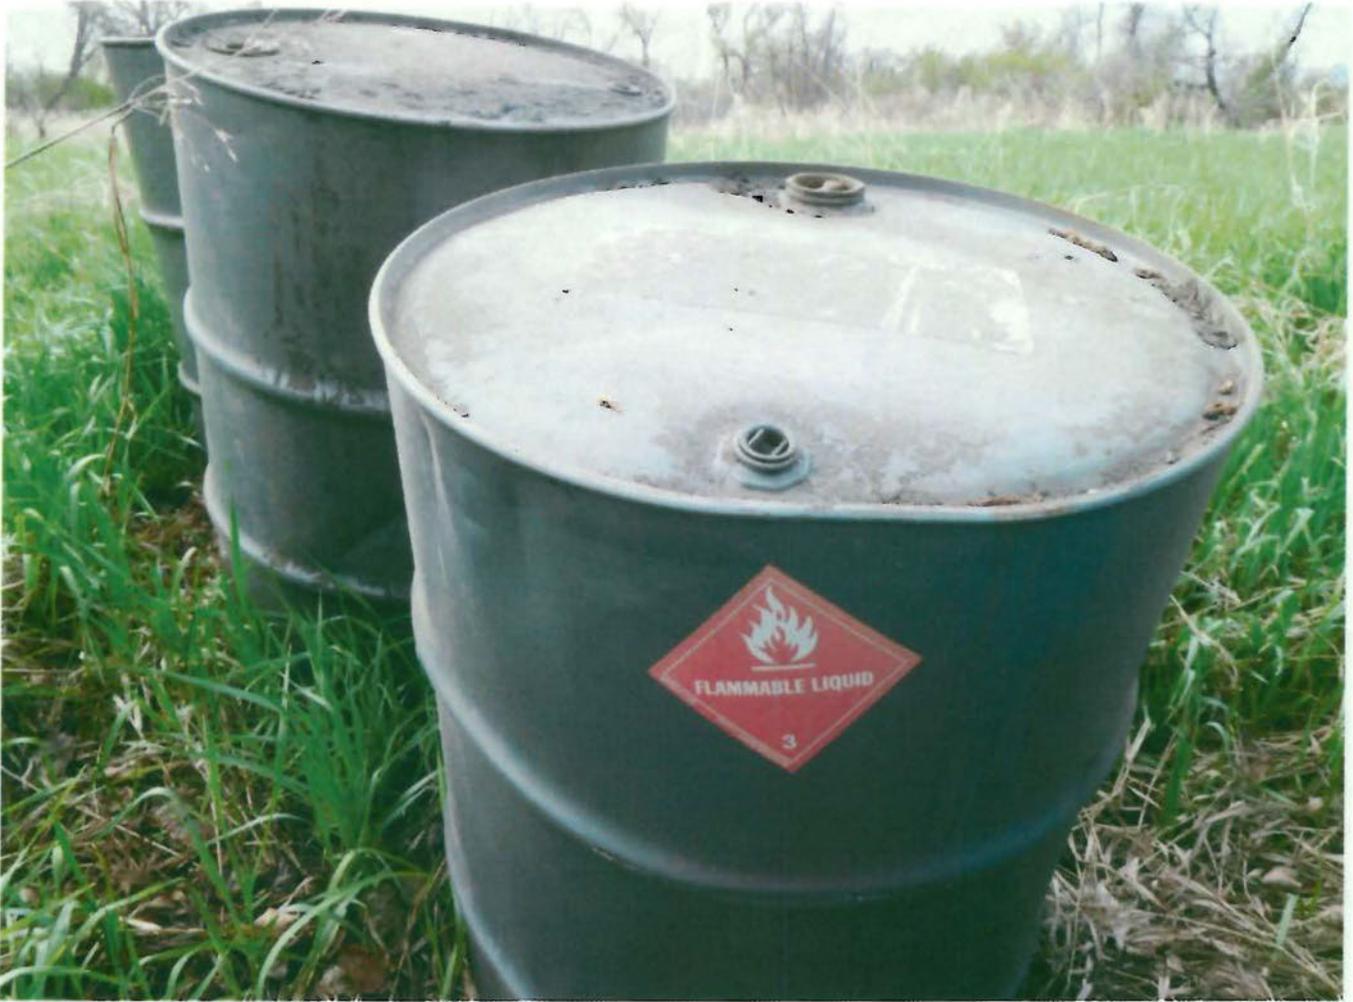
Photo 1178, DSCN1178.jpg, 5/15/2019 9:51 am, photo of drum label.

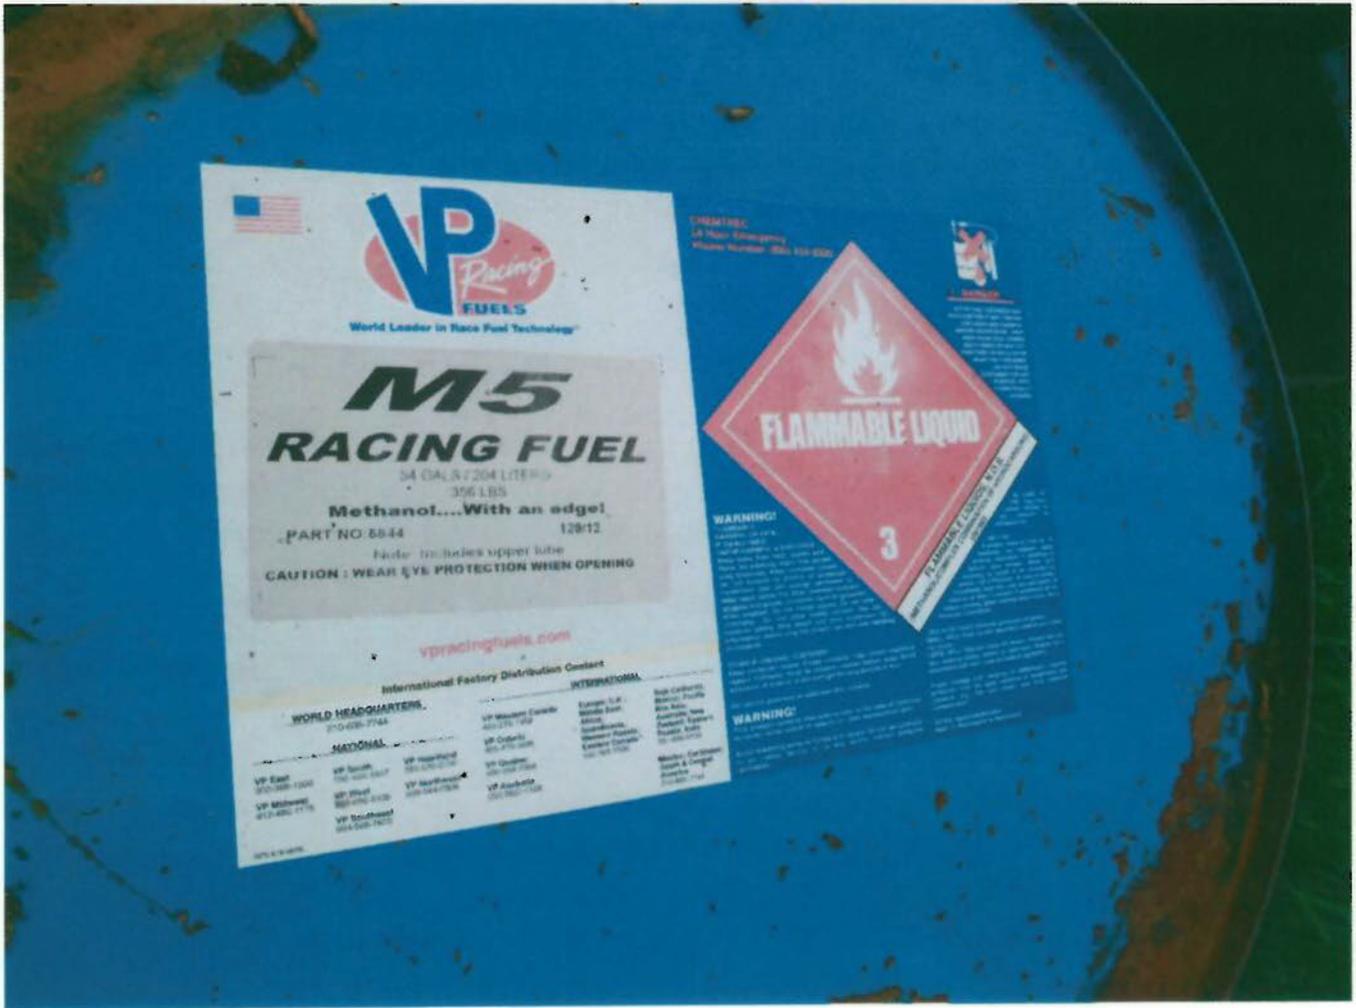
Photo 1179, DSCN1179.jpg, 5/15/2019 9:51 am, photo of drum label.

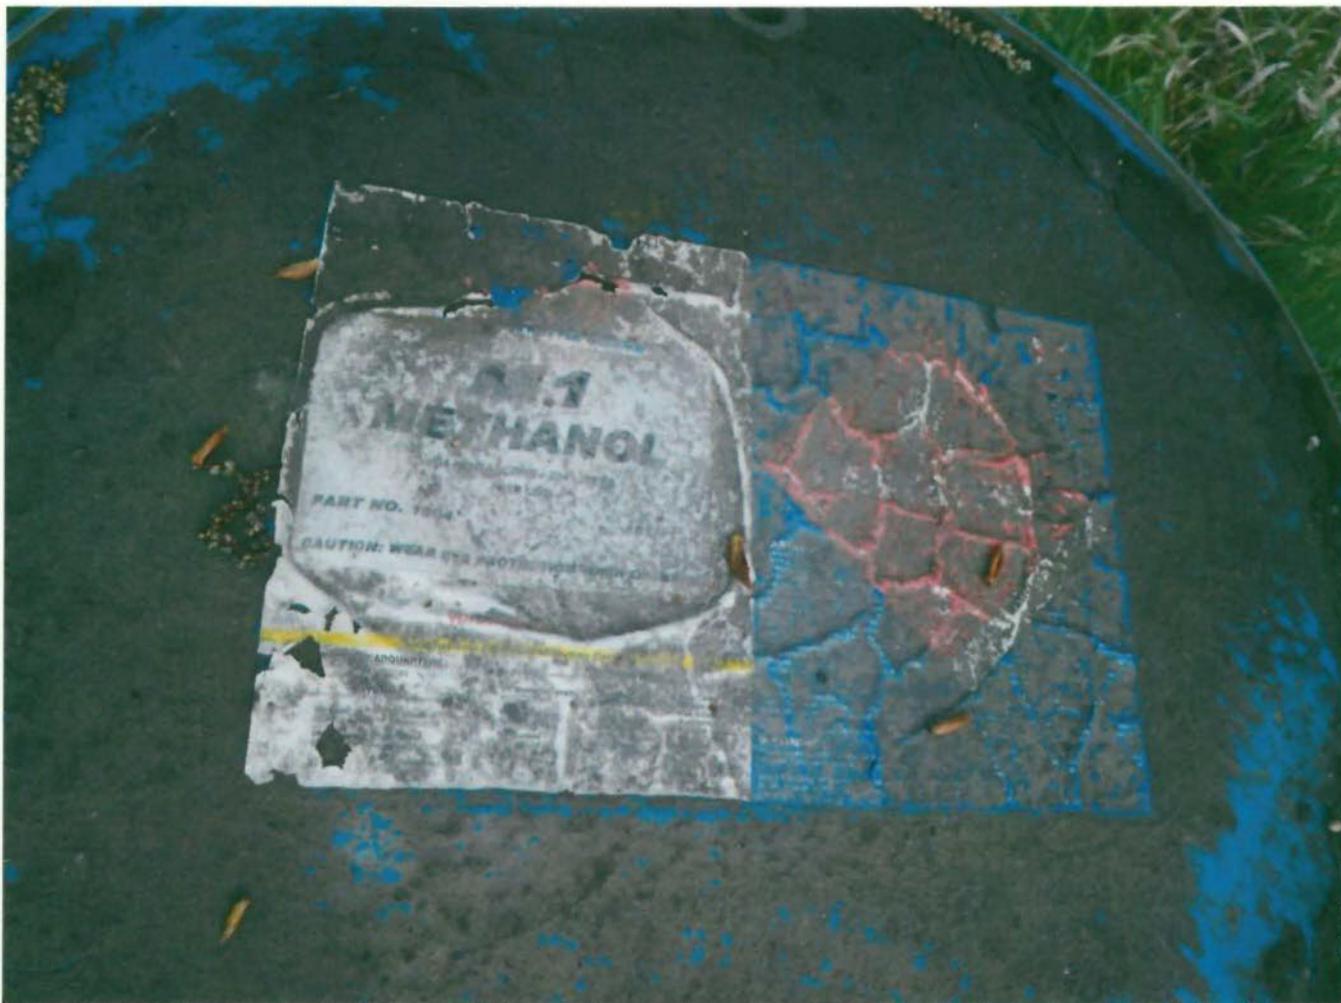
Photo 1180, DSCN1180.jpg, 5/15/2019 9:51 am, photo of drum label.

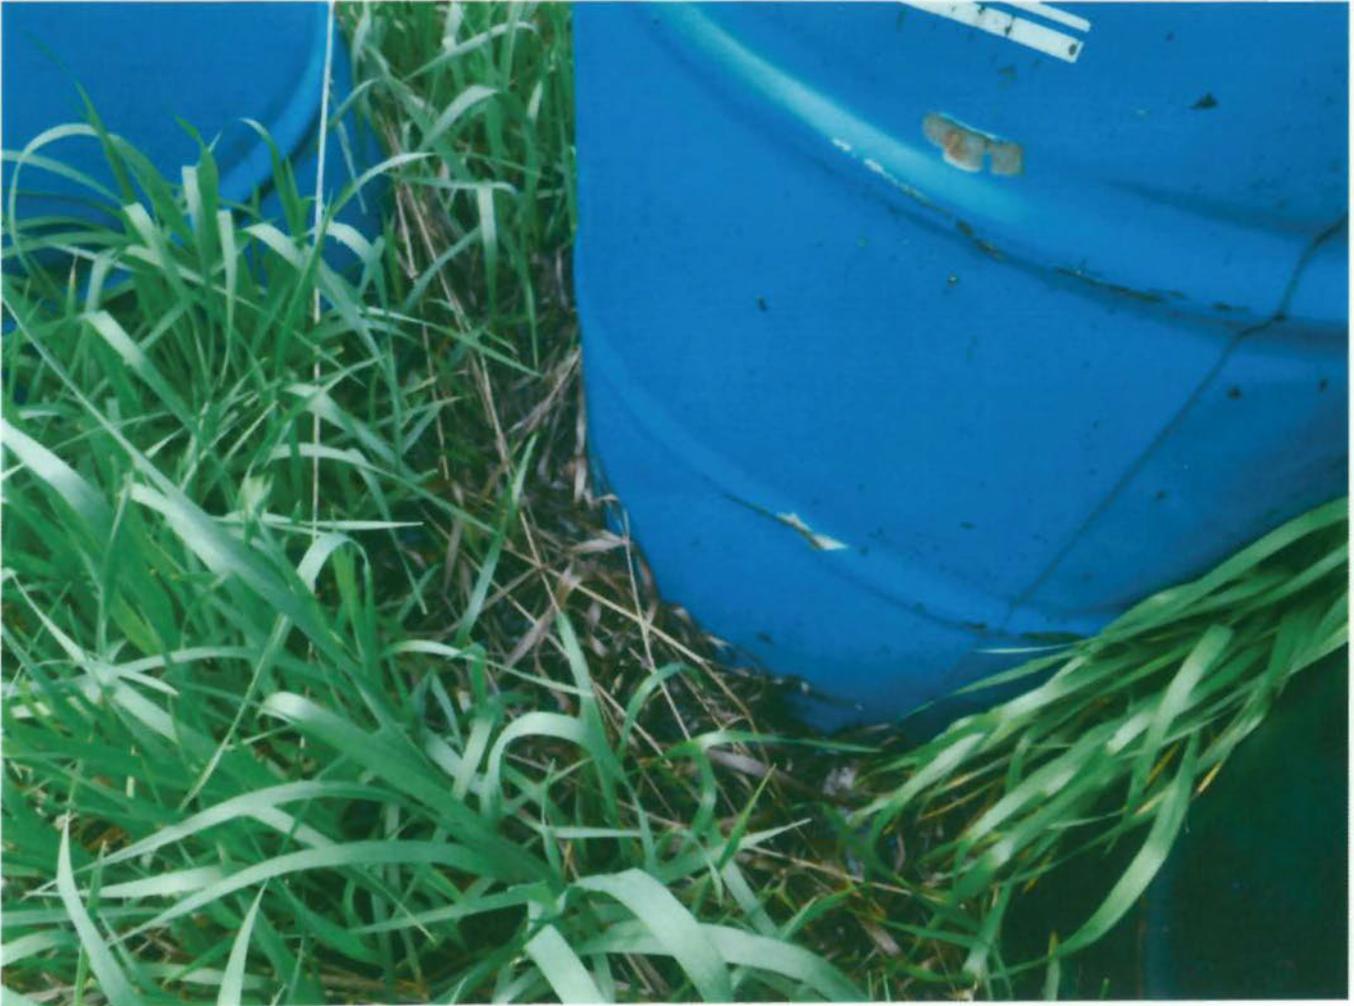
Photo 1181, DSCN1181.jpg, 5/15/2019 9:51 am, photo of stressed vegetation.

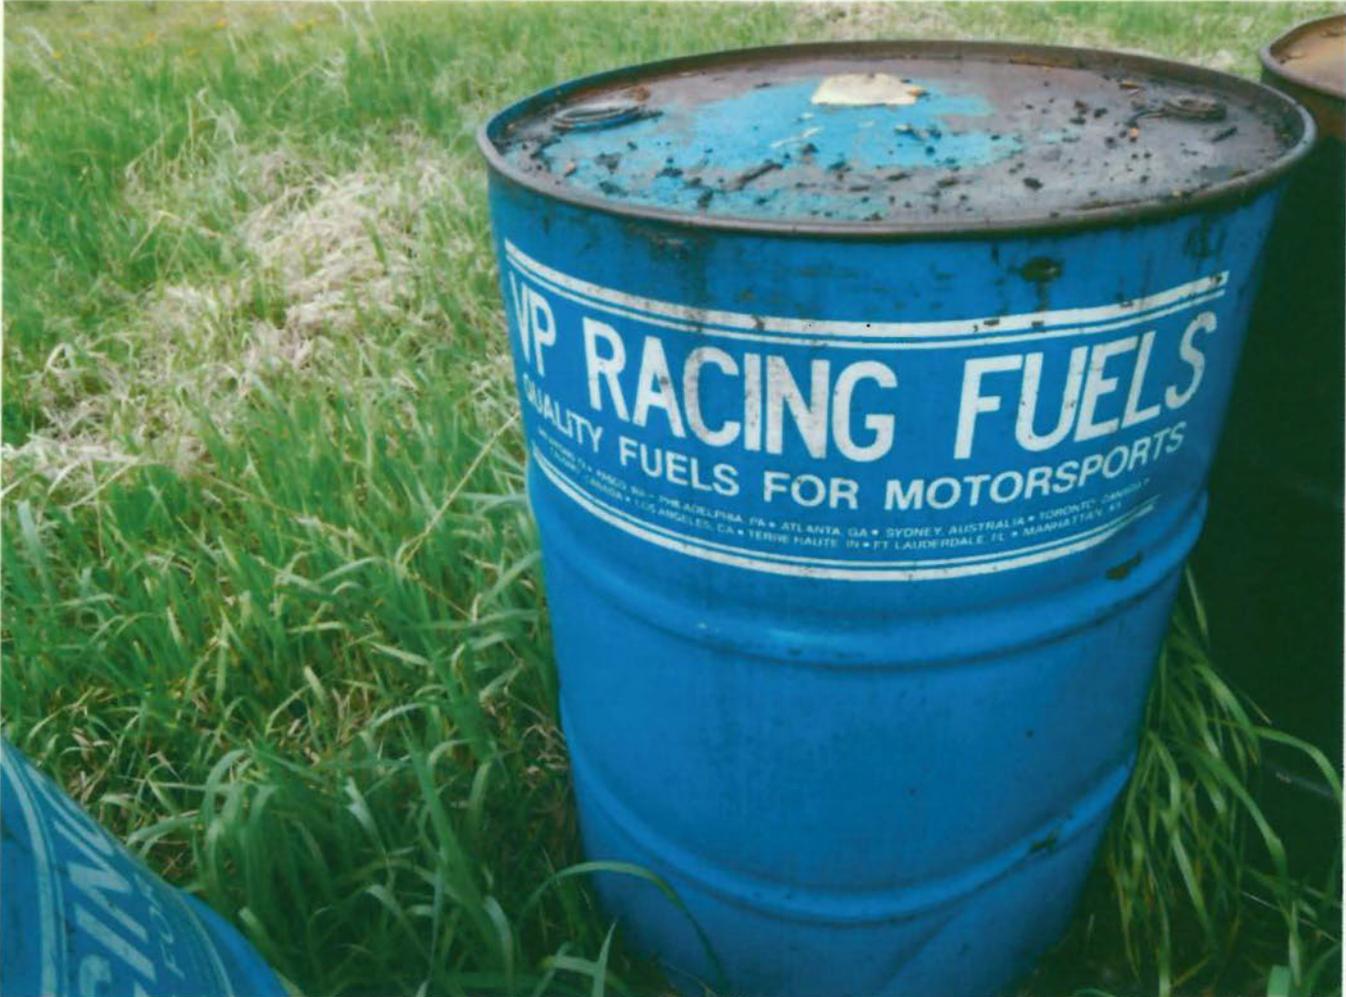
Photo 1182, DSCN1182.jpg, 5/15/2019 9:52 am, photo of drum label.

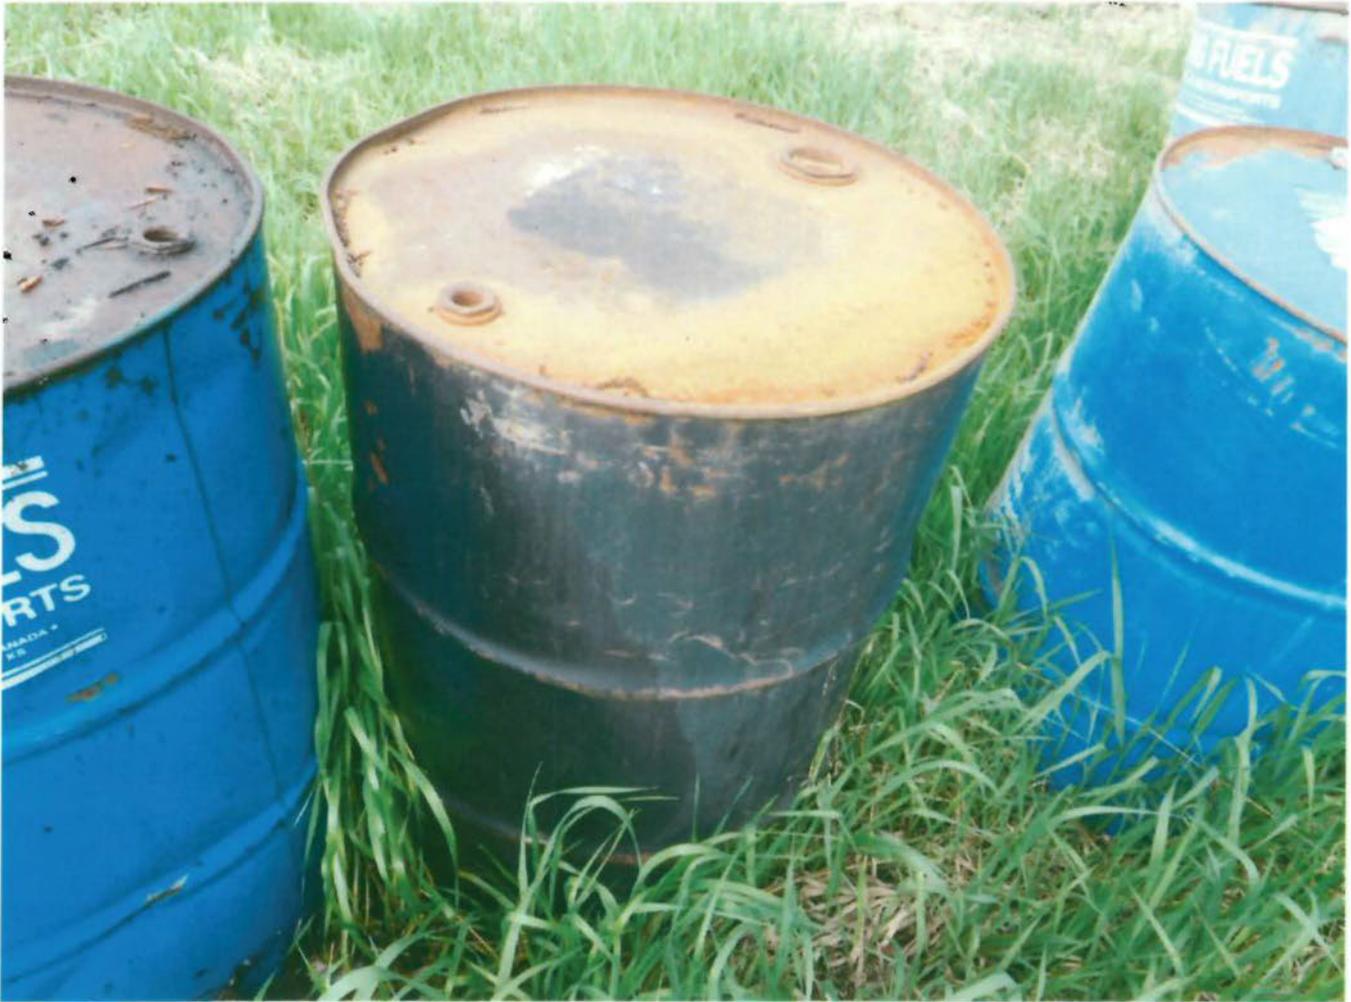
Photo 1183, DSCN1183.jpg, 5/15/2019 9:52 am, photo of drum with no labels.
