**PHASE II ENVIRONMENTAL SITE ASSESSMENT
FOR
CROW TRIBAL BUILDING
#1 BAATCHEEITCHE AVENUE
CROW AGENCY, BIG HORN COUNTY, MONTANA**

Date Prepared	April 2020
TDD No.	0003/2001-02
Document Control No.	W0764.1A.02235
Contract No.	EP-S8-13-01
U.S. EPA Work Assignment Manager	Greg Davis

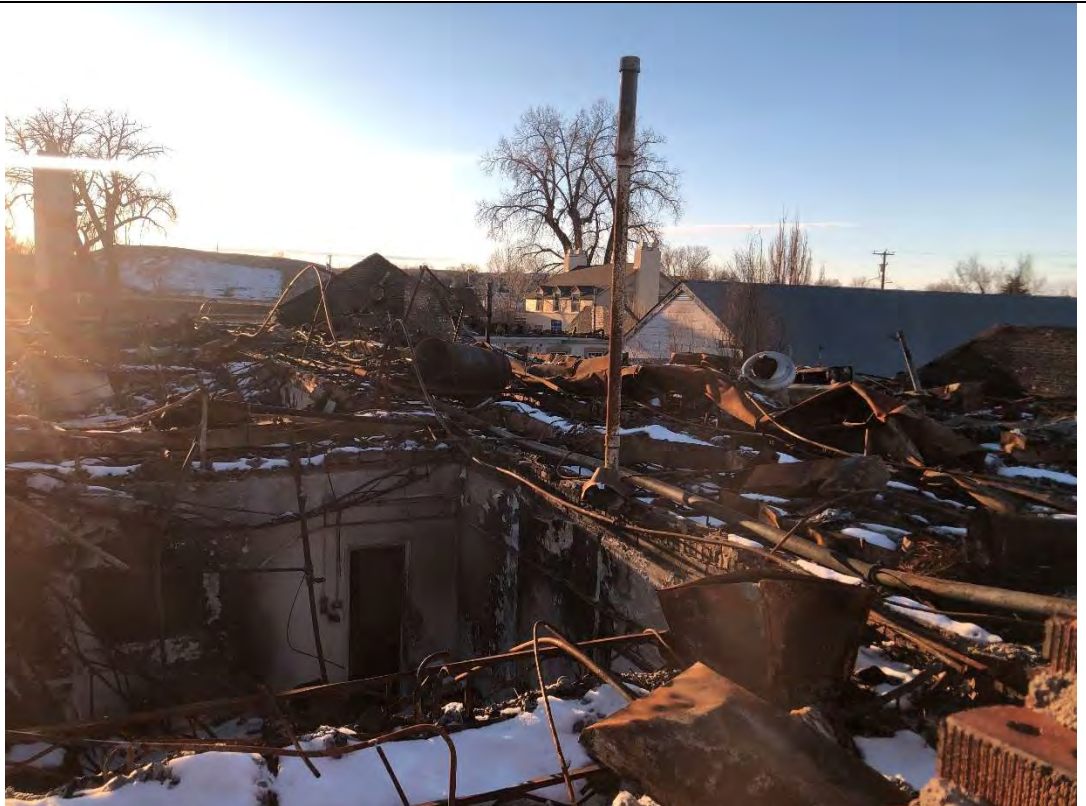
Photo No. 11	Date: 02/14/2020
Photo Coordinates	
Lat	45.6037
Long	-107.460481
Direction Photo Taken: 267.894409179688	
Description: Former roof of the Original Construction. Asbestos roofing felt has collapsed into the building.

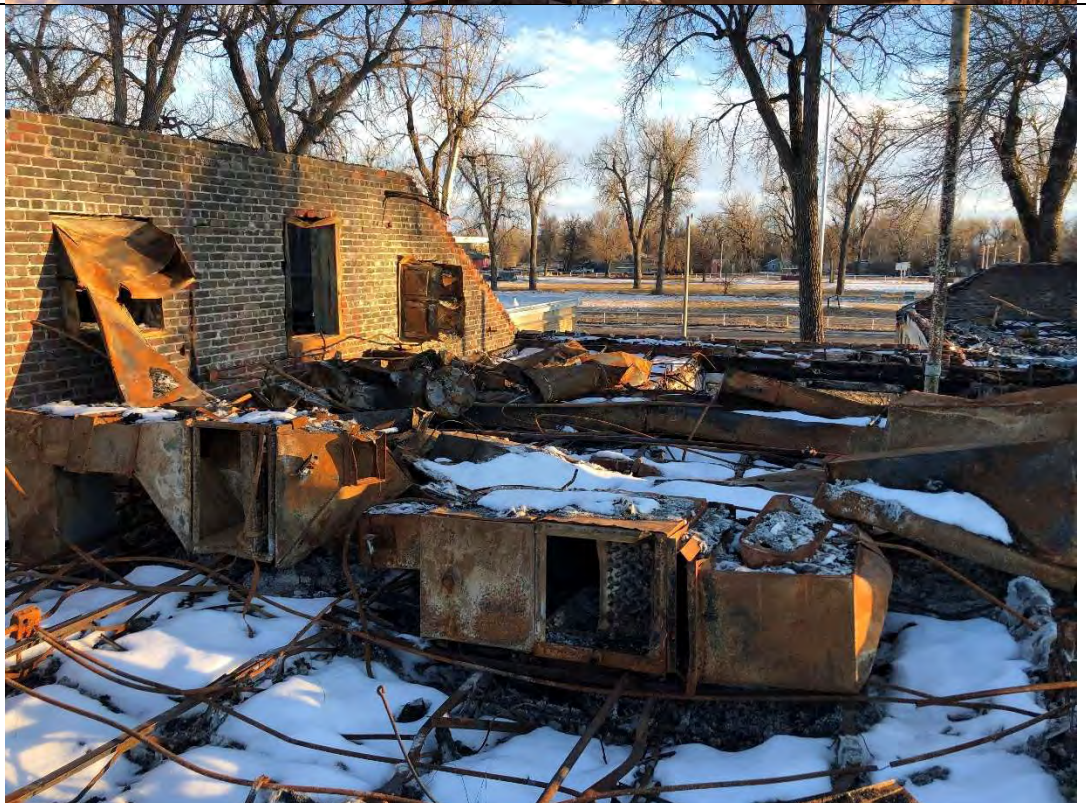
Photo No. 12	Date: 02/14/2020
Photo Coordinates	
Lat	45.603744
Long	-107.460586
Direction Photo Taken: 133.0822906641	
Description: Former roof of the Original Construction. Asbestos roofing felt has collapsed into the building.

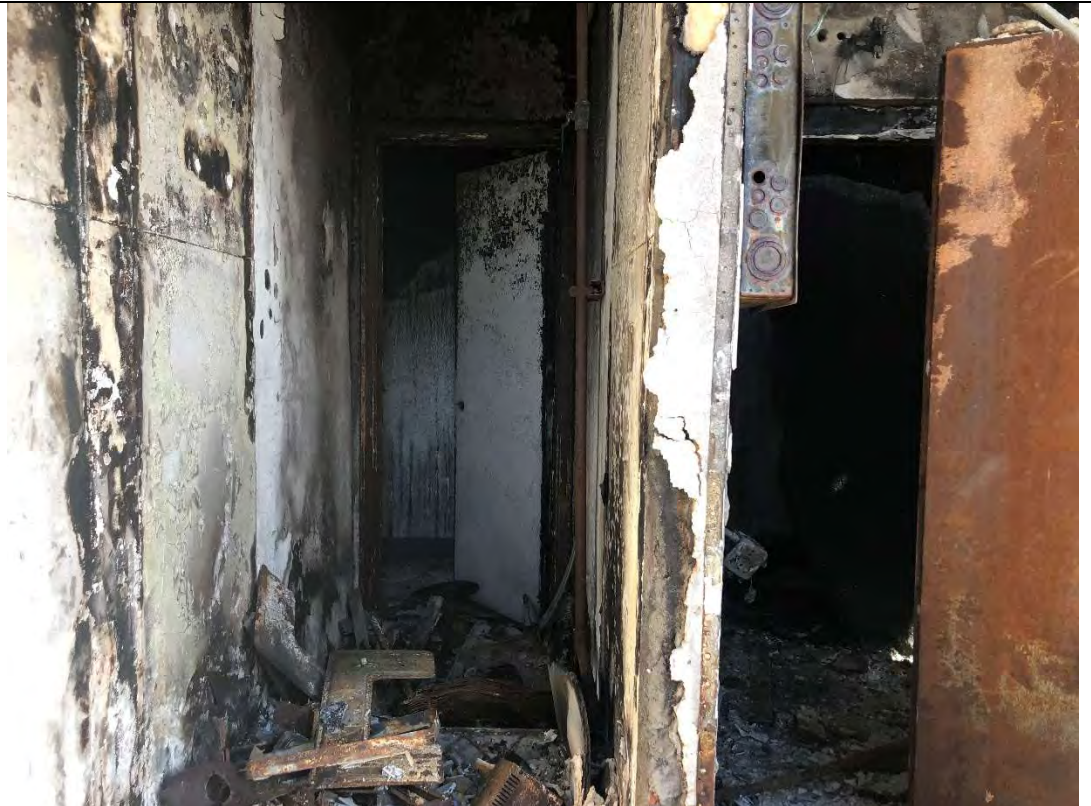
Photo No. 13	Date: 02/16/2020
Photo Coordinates	
Lat	45.603661
Long	-107.461167
Direction Photo Taken: 78.160400390625	
Description: Asbestos fire door present in the Original Construction.

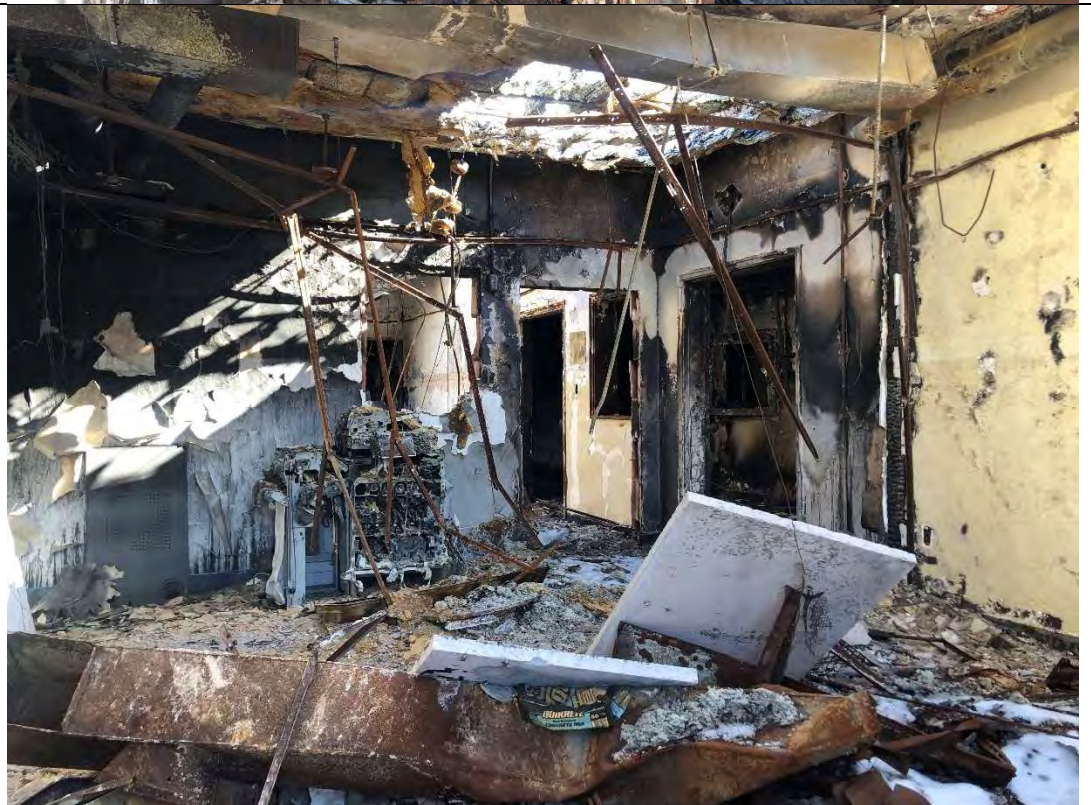
Photo No. 14	Date: 02/16/2020
Photo Coordinates	
Lat	45.603589
Long	-107.461167
Direction Photo Taken: 102.570436507937	
Description: Asbestos fire door present in the Original Construction.

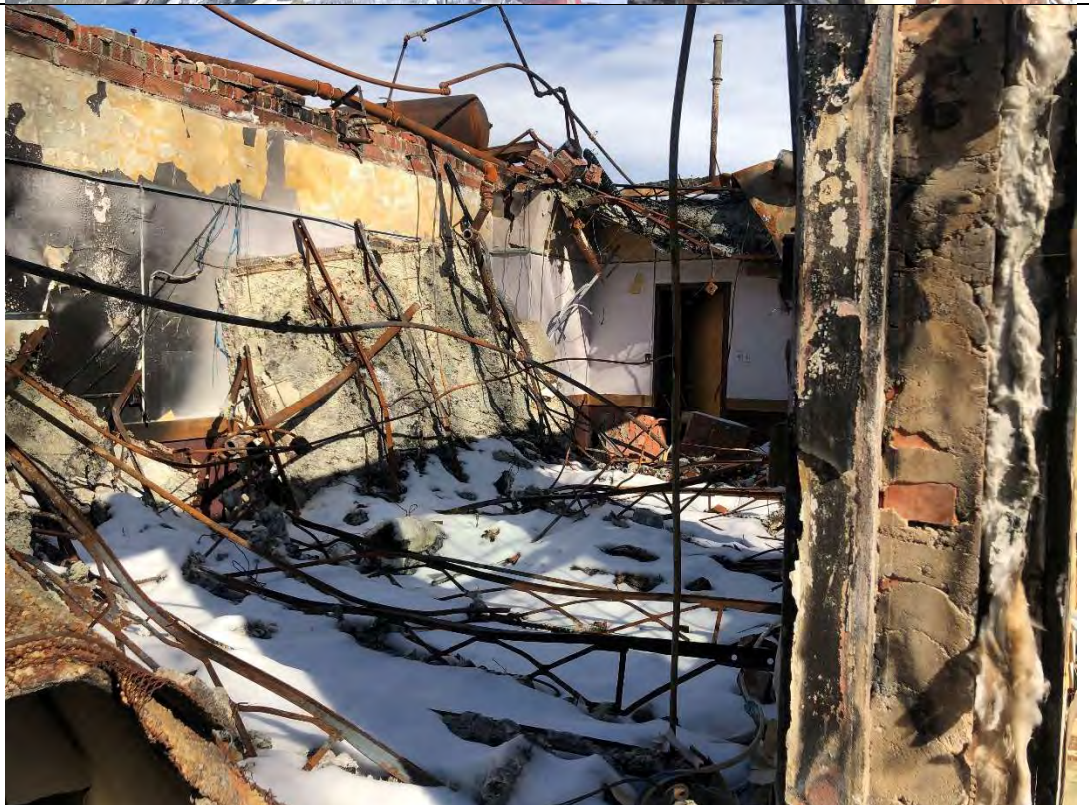
Photo No. 16	Date: 02/16/2020
Photo Coordinates	
Lat	45.603583
Long	-107.460747
Direction Photo Taken: 45.6862487692813	
Description: Original Construction section with collapsed roof.

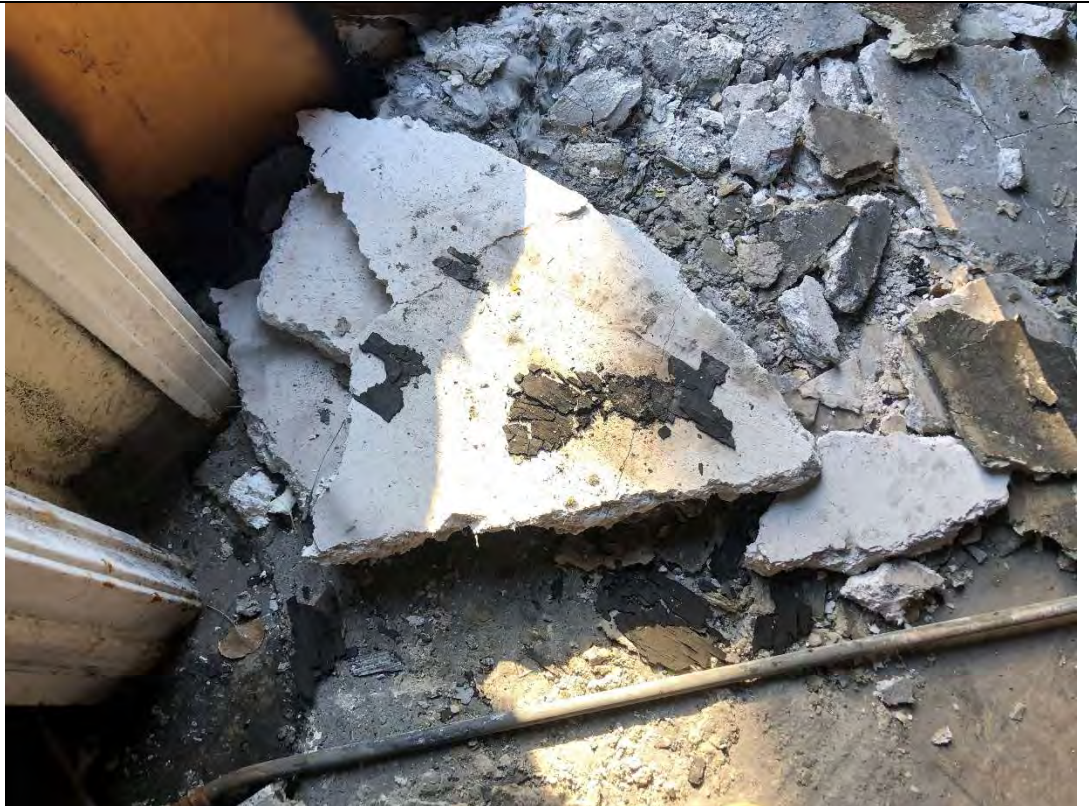
Photo No. 17	Date: 02/16/2020
Photo Coordinates	
Lat	45.603683
Long	-107.460625
Direction Photo Taken: 238.599883855981	
Description: Asbestos fire door debris present in the Original Construction.

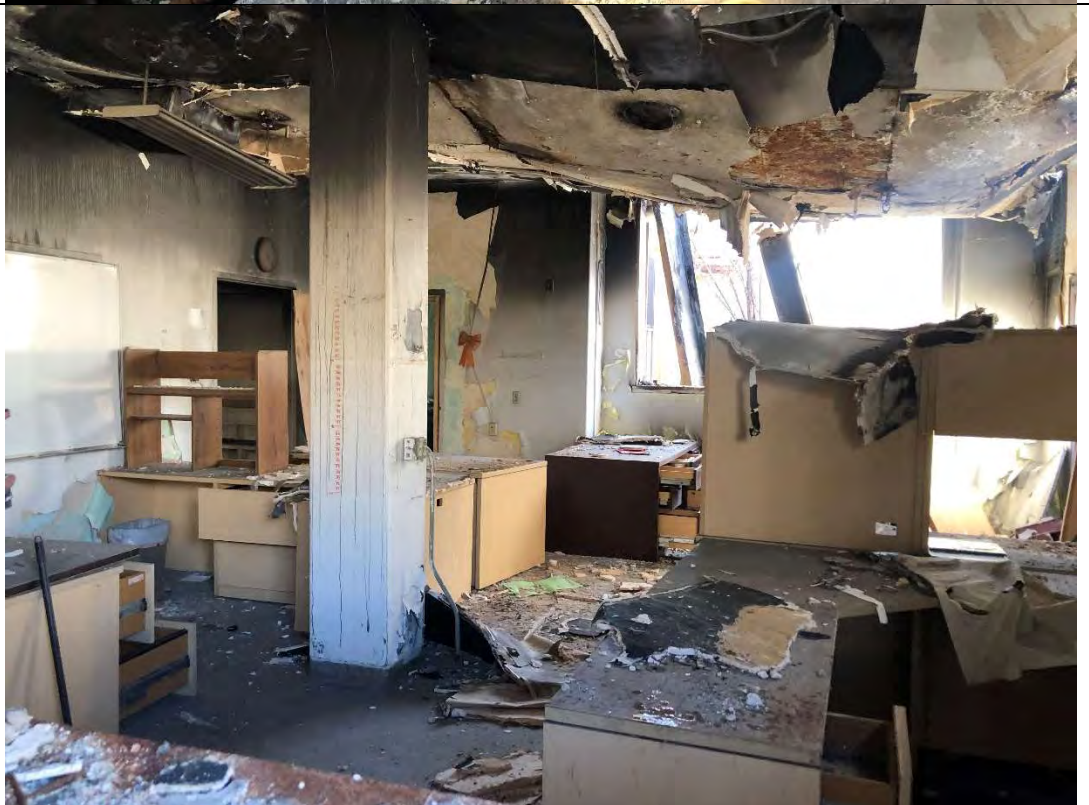
Photo No. 18	Date: 02/16/2020
Photo Coordinates	
Lat	45.603978
Long	-107.460633
Direction Photo Taken: 223.843673668784	
Description: Original Construction section with partially collapsed roof.

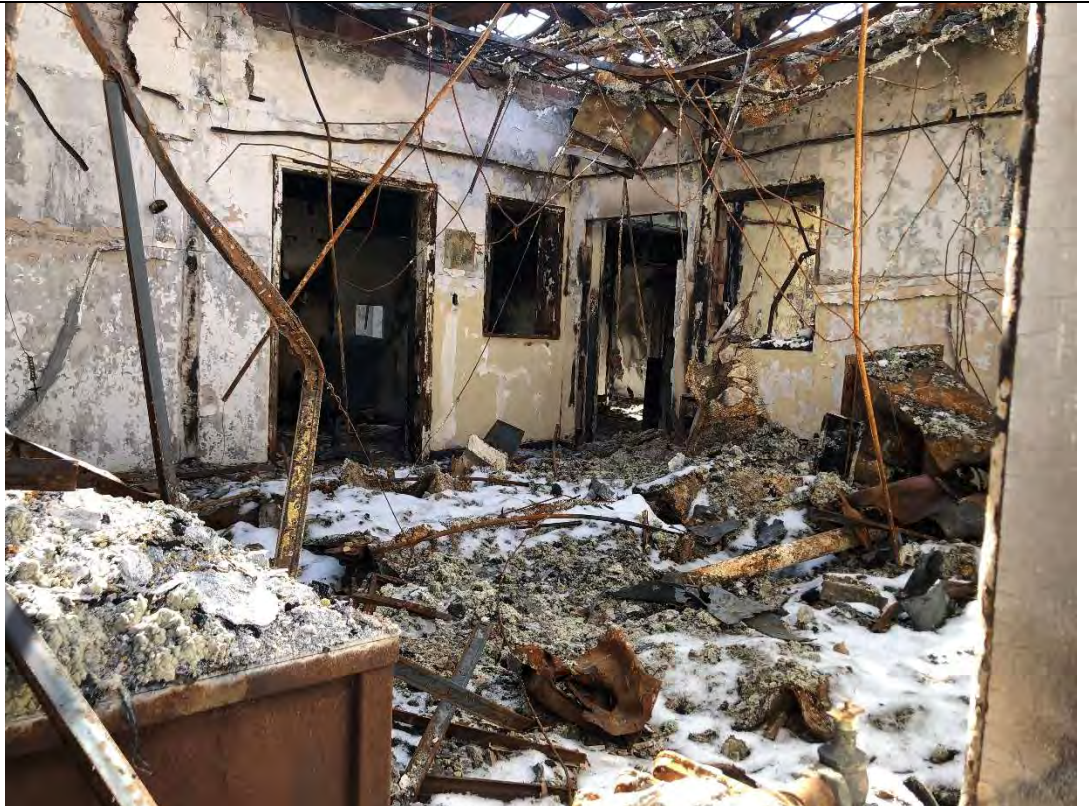
Photo No. 19	Date: 02/16/2020
Photo Coordinates	
Lat	45.6037
Long	-107.460975
Direction Photo Taken: 203.517746066593	
Description: Original Construction section with collapsed roof.

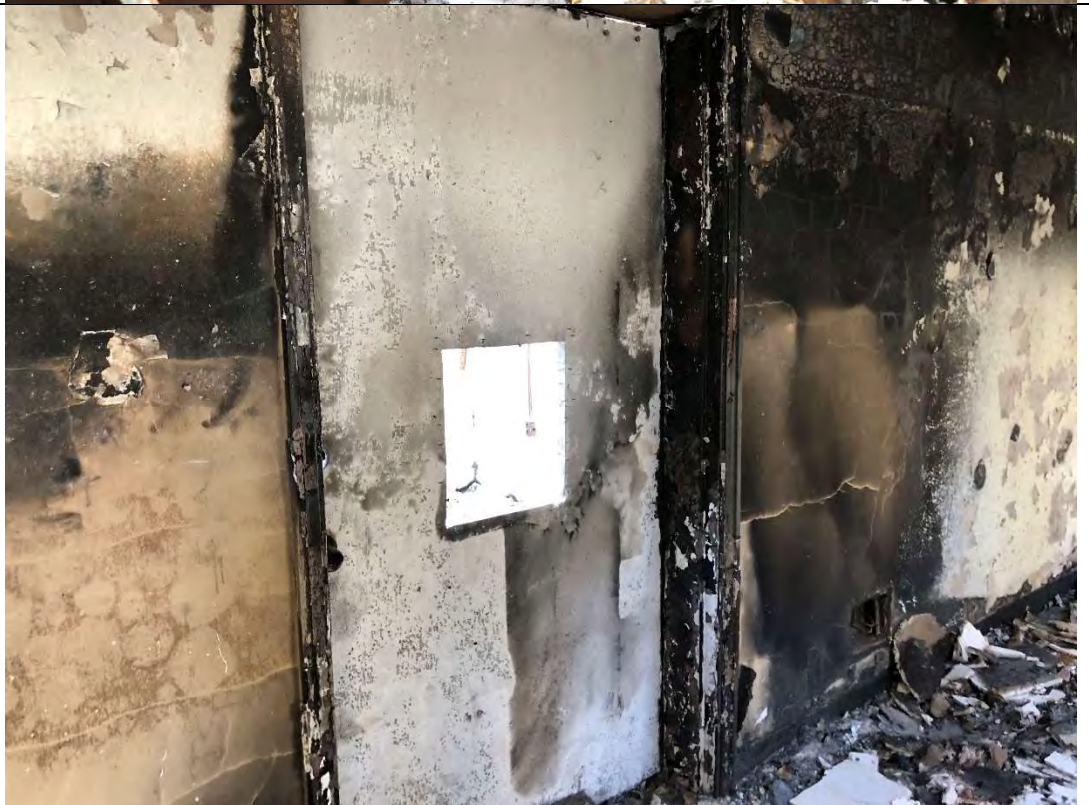
Photo No. 20	Date: 02/16/2020
Photo Coordinates	
Lat	45.603711
Long	-107.461097
Direction Photo Taken: 198.906112469438	
Description: Asbestos fire door present in the Original Construction.

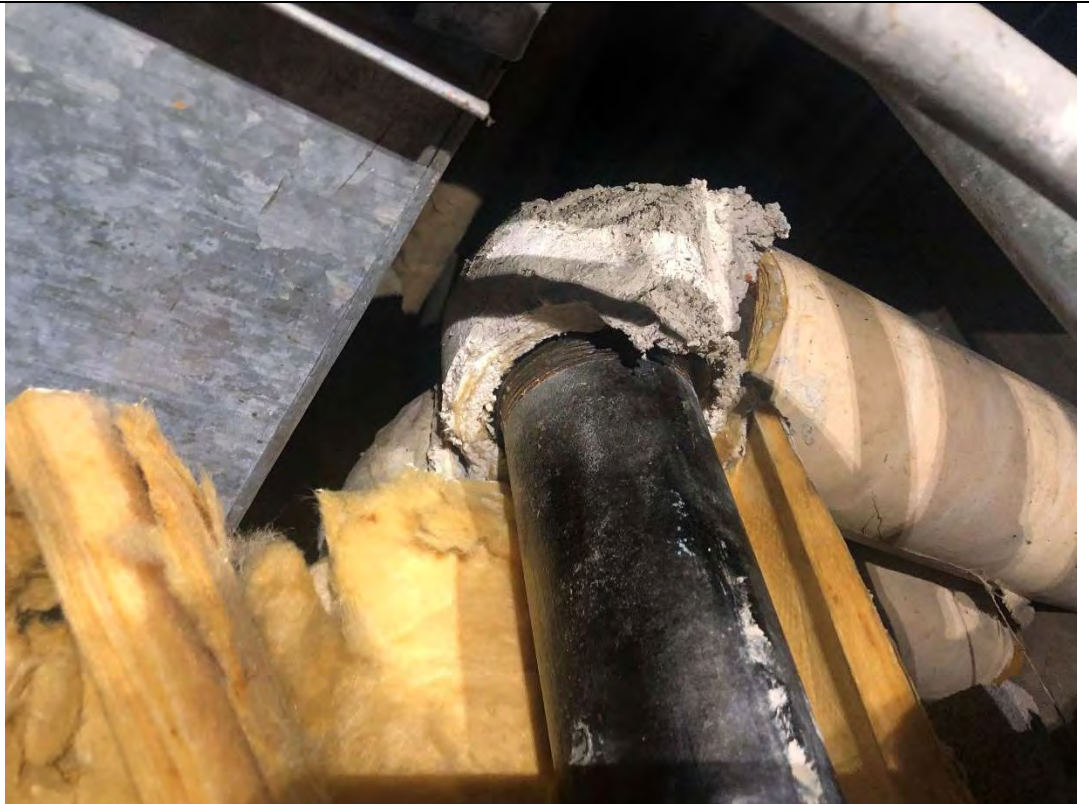
Photo No. 23	Date: 02/16/2020
Photo Coordinates	
Lat	45.566872
Long	-107.456108
Direction Photo Taken: 313.762725779967	
Description: Asbestos in a mudded fitting present in the basement.

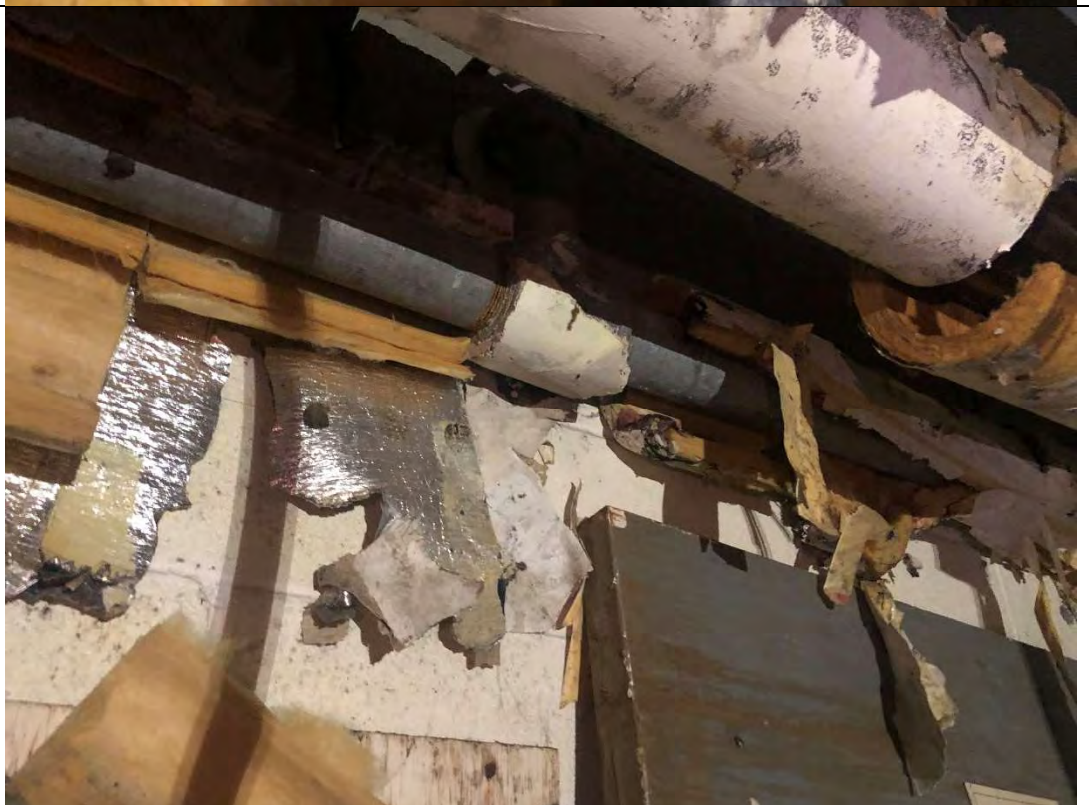
Photo No. 24	Date: 02/16/2020
Photo Coordinates	
Lat	45.564603
Long	-107.455872
Direction Photo Taken: 211.53091447612	
Description: Asbestos in a mudded fitting present in the basement.

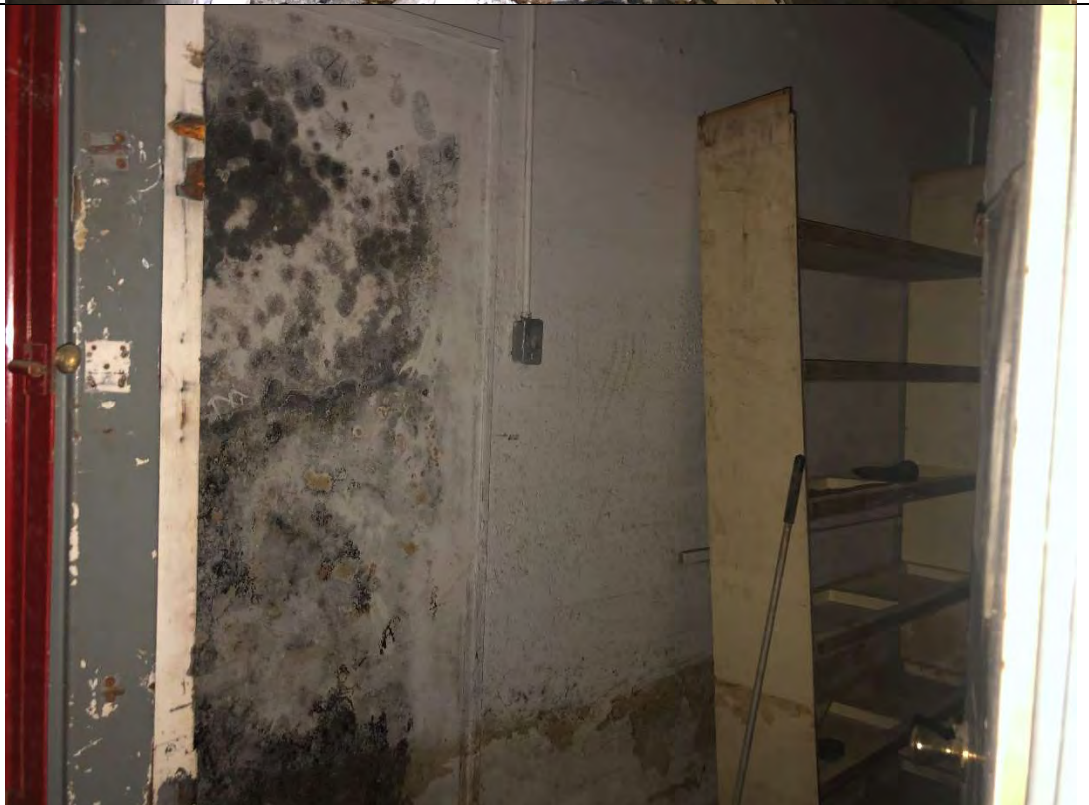
Photo No. 28	Date: 02/16/2020
Photo Coordinates	
Lat	45.603797
Long	-107.460639
Direction Photo Taken: 191.388511749347	
Description: Mold present in the basement.

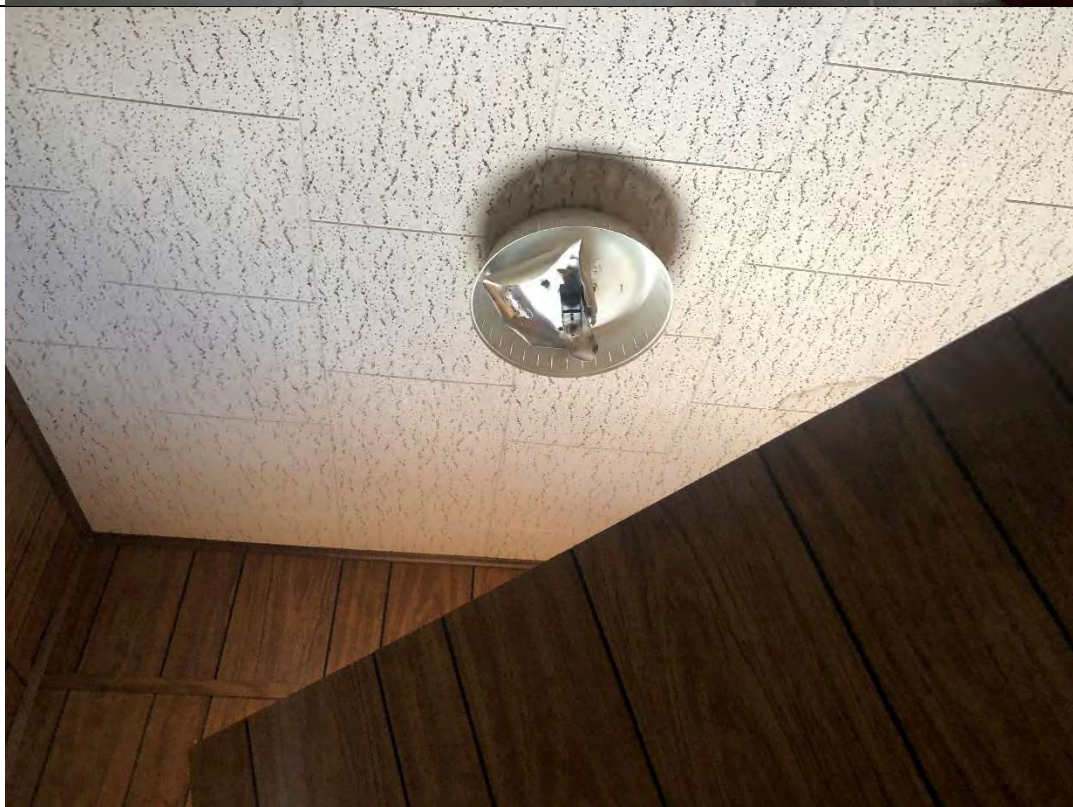
Photo No. 30	Date: 02/13/2020
Photo Coordinates	
Lat	45.603725
Long	-107.461403
Direction Photo Taken: 342.73854099419	
Description: Asbestos in light insulation present in the bathrooms of the Trailer Annex.

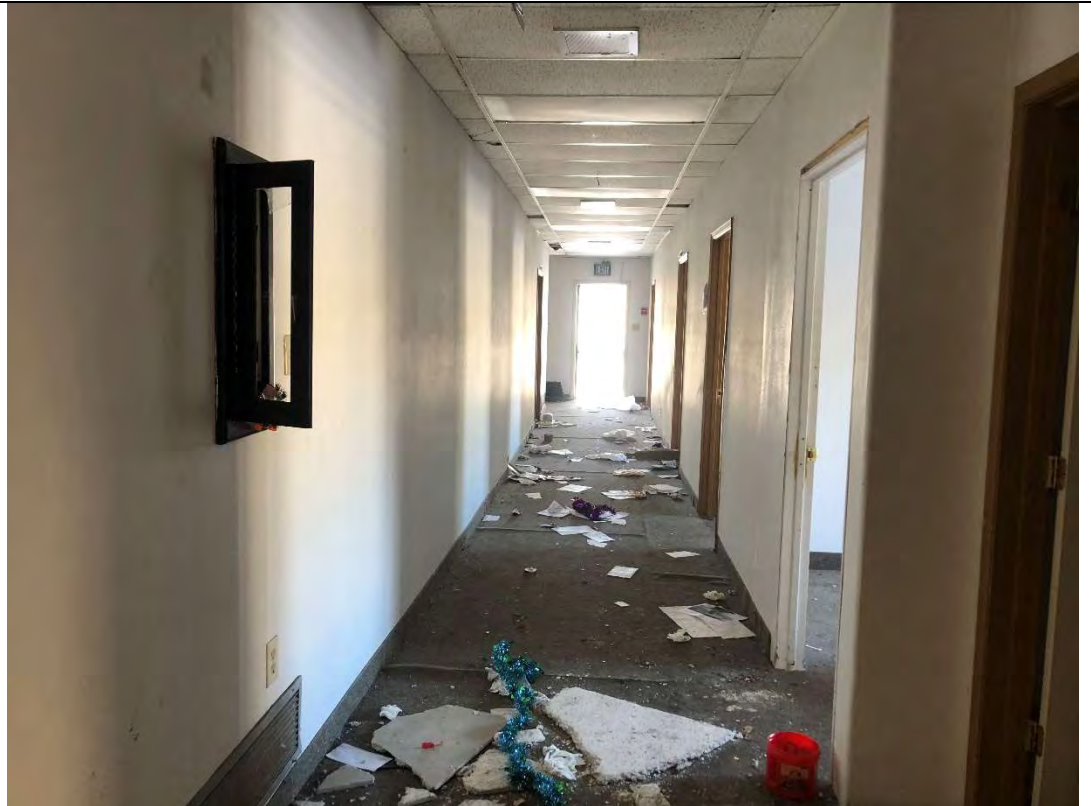
Photo No. 33	Date: 02/13/2020
Photo Coordinates	
Lat	45.603561
Long	-107.460786
Direction Photo Taken: 8.97137451171875	
Description: Dental Wing with asbestos in ceiling tiles.

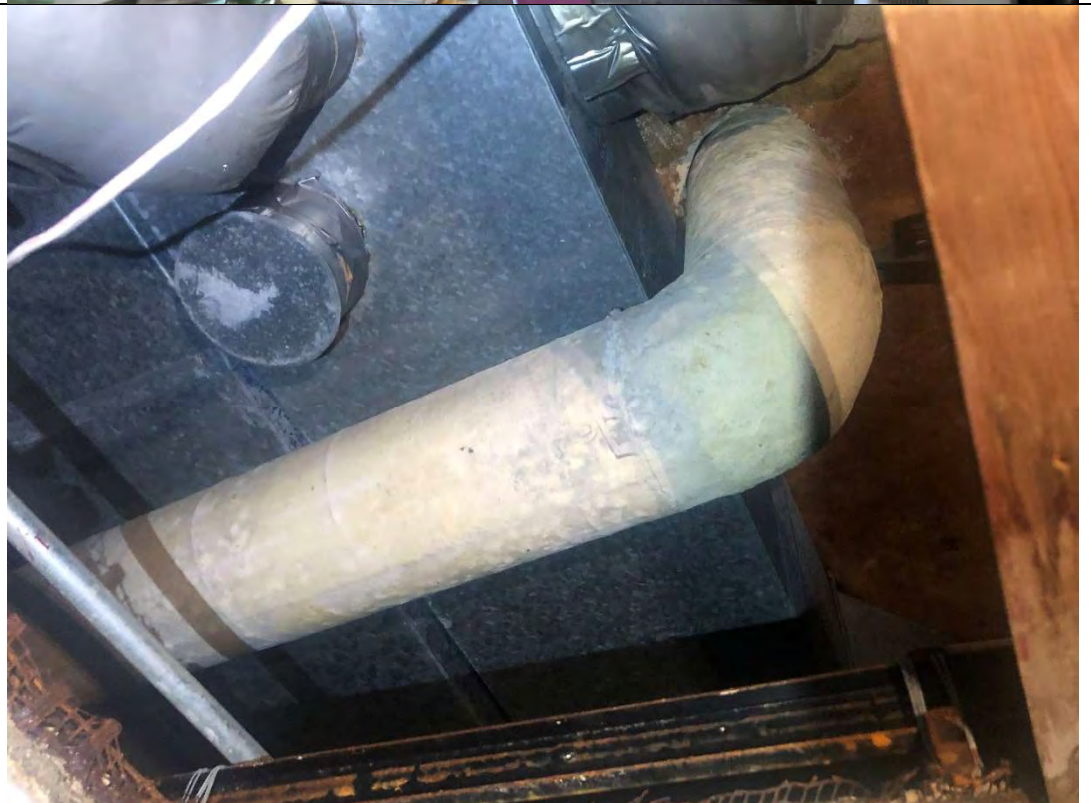
Photo No. 38	Date: 02/14/2020
Photo Coordinates	
Lat	45.602561
Long	-107.458642
Direction Photo Taken: 46.042266824085	
Description: Johns Manville Air Cell pipe insulation and mudded fittings observed in room 102 of the East Addition.

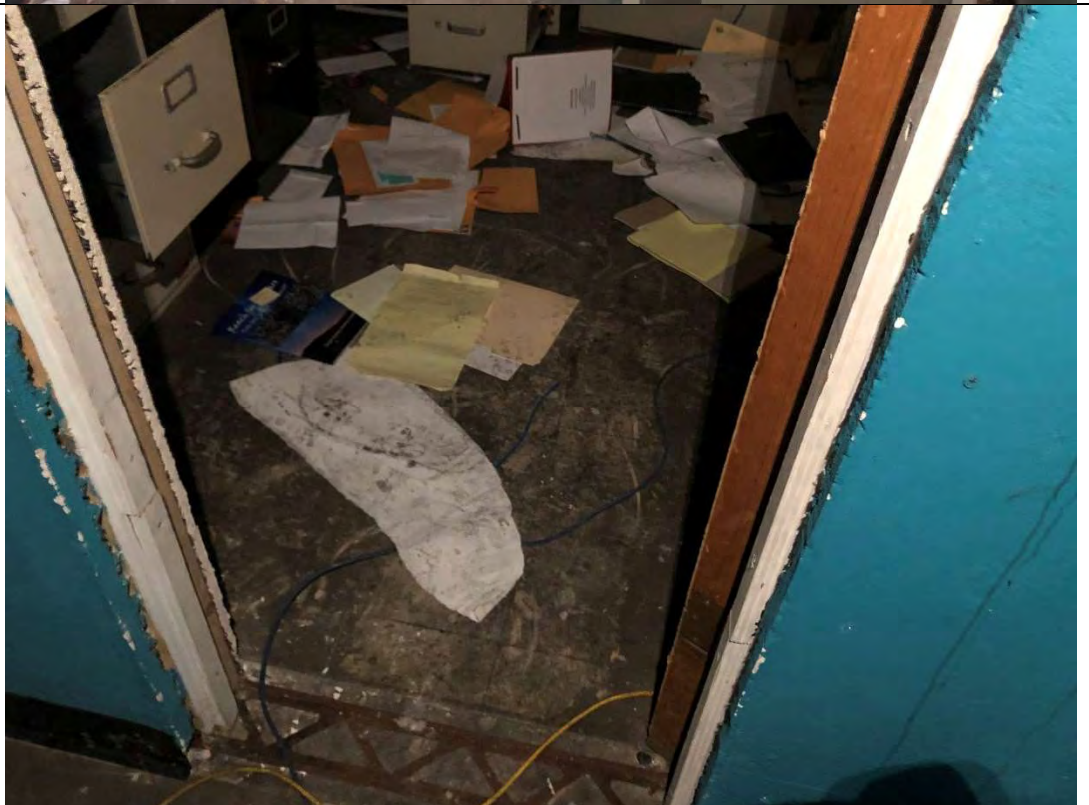
Photo No. 40	Date: 02/14/2020
Photo Coordinates	
Lat	45.601678
Long	-107.461167
Direction Photo Taken: 60.35302734375	
Description: Asbestos in residual 9"x9" floor tiles and black mastic previously not abated in a closet inside the East Addition.

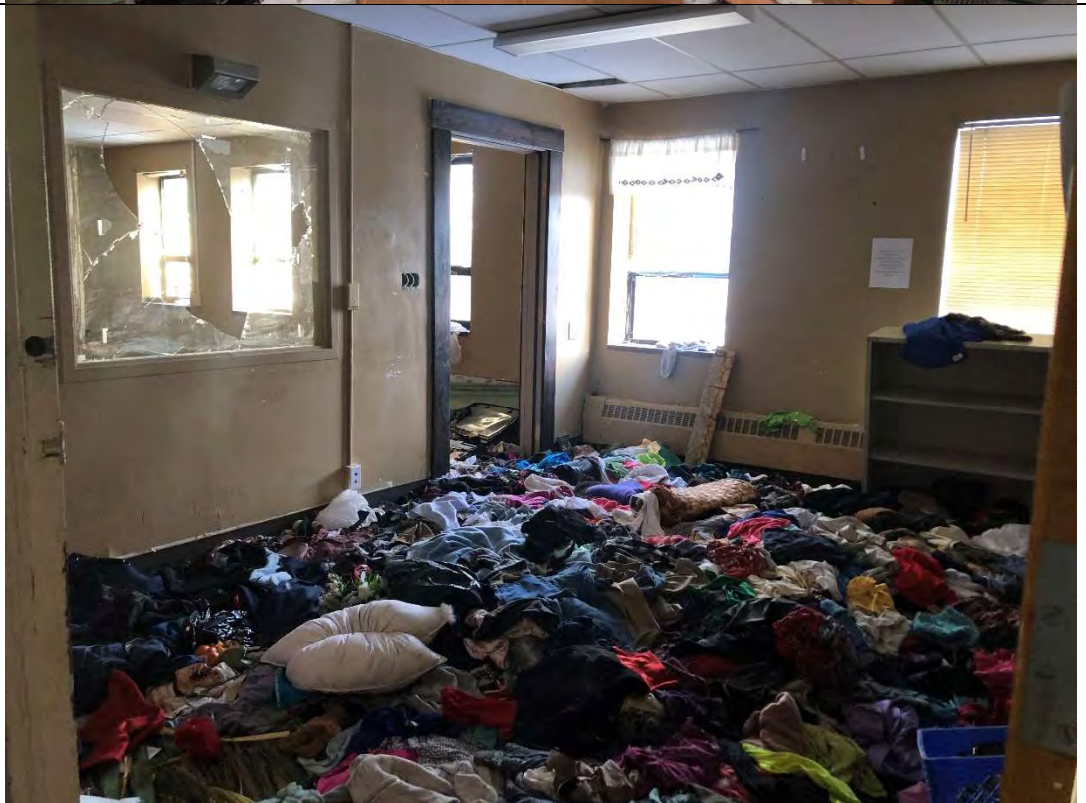
Photo No. 42	Date: 02/14/2020
Photo Coordinates	
Lat	45.603797
Long	-107.460389
Direction Photo Taken: 117.591465001301	
Description: Debris present in a room inside the East Addition.
