Memorandum

Date: April 7, 2016

Subject: Susie Mine Portal Update

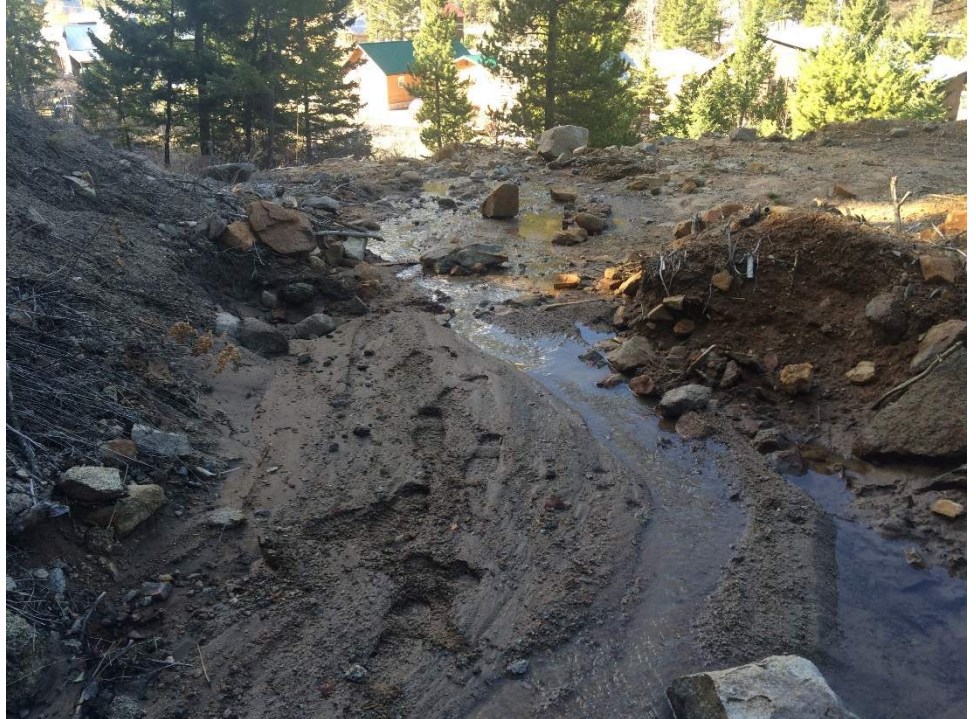
Photo Description:
008 - Looking out from mine portal door

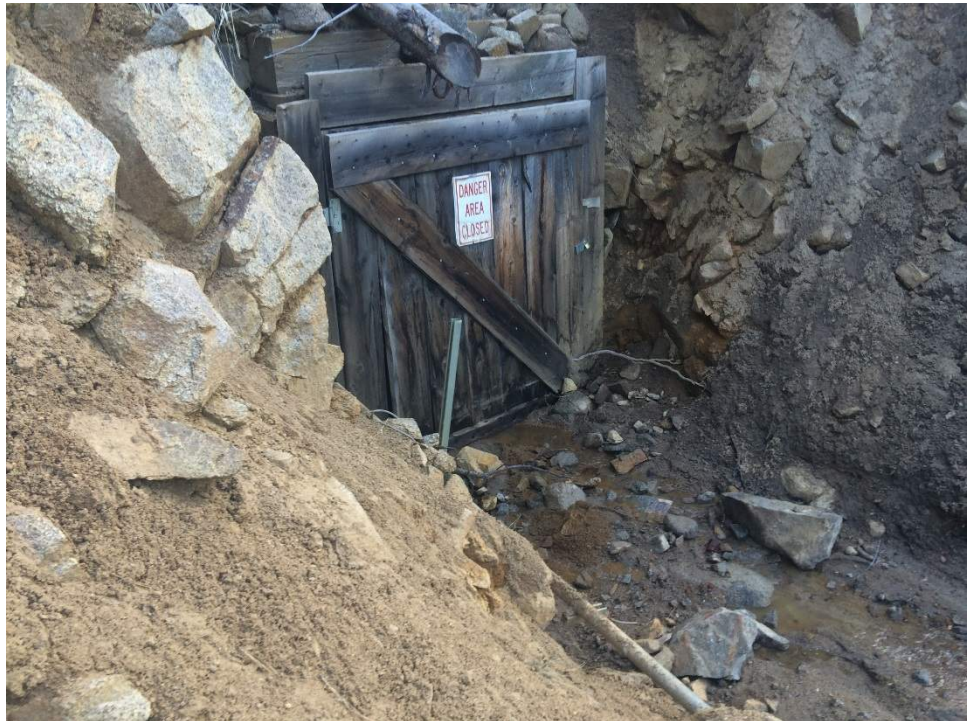
Photo Description:
010 - Mine portal door

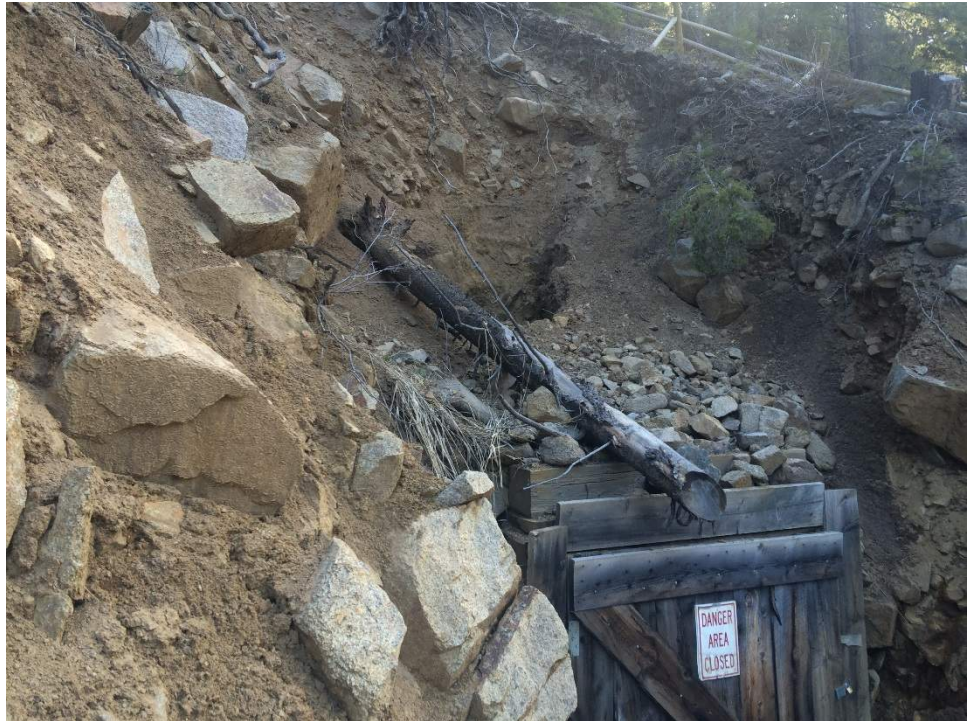
Photo Description:
011 - Collapse hole above portal door

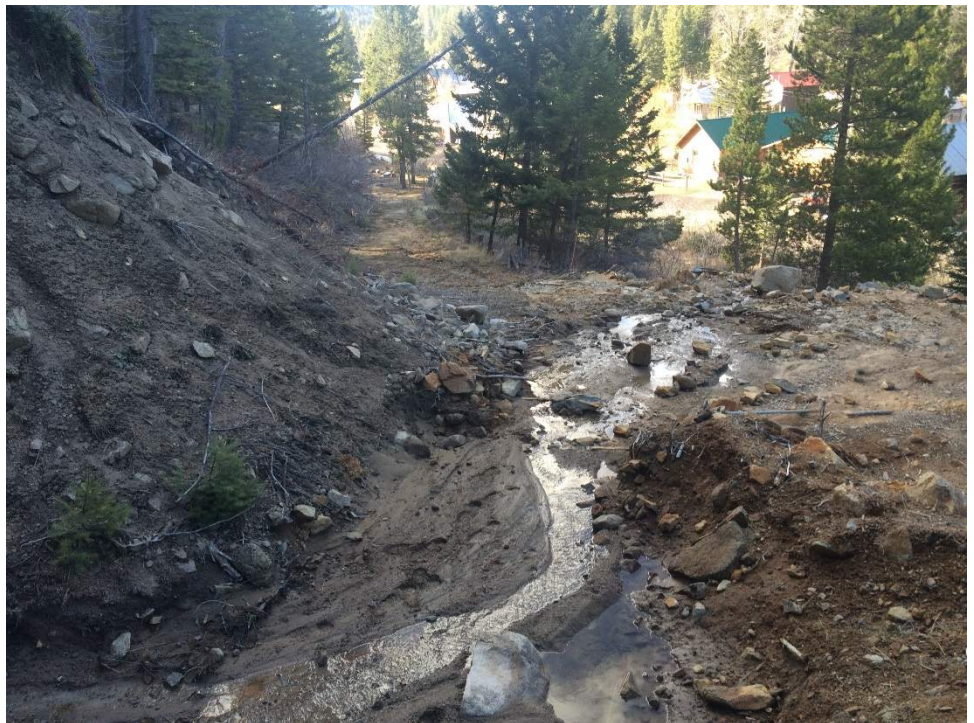
Photo Description:
012 - Discharge running from portal

- Mobilize an excavator to the site, locate the existing drainage pipe outside the portal, expose and clean out the pipe for continued use. Reestablish adit drainage to this pipe to route flow to back to the settling pond on Rimini Road. Rebury the drainage pipe and reestablish the mine access road. **(within 30 days after EPA HQ approval)**

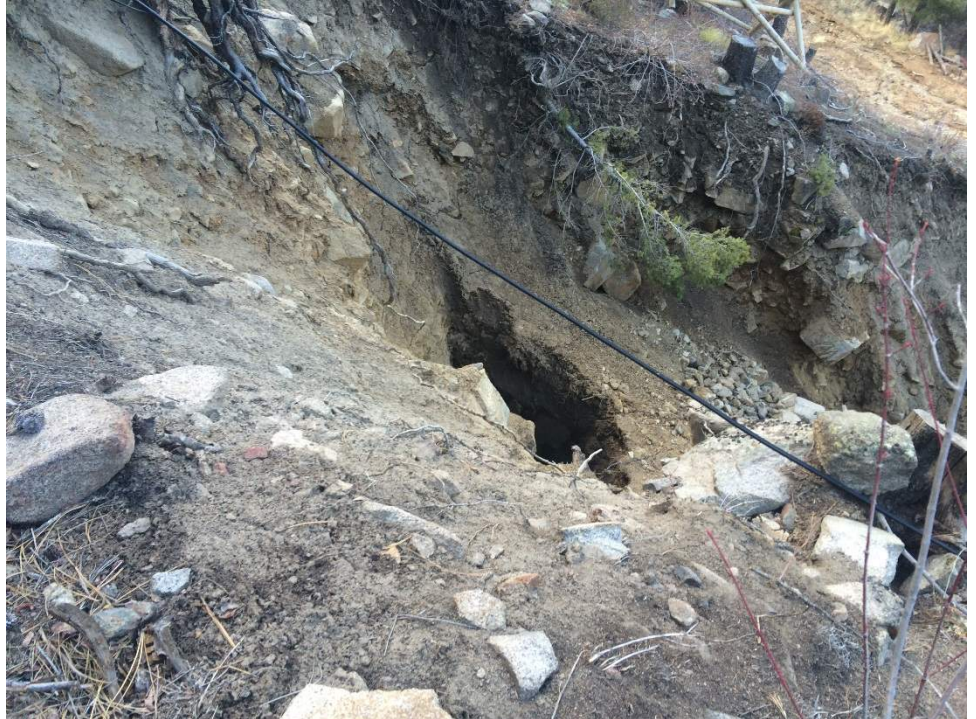
Photo Description:
013 - Collapse hole above portal door

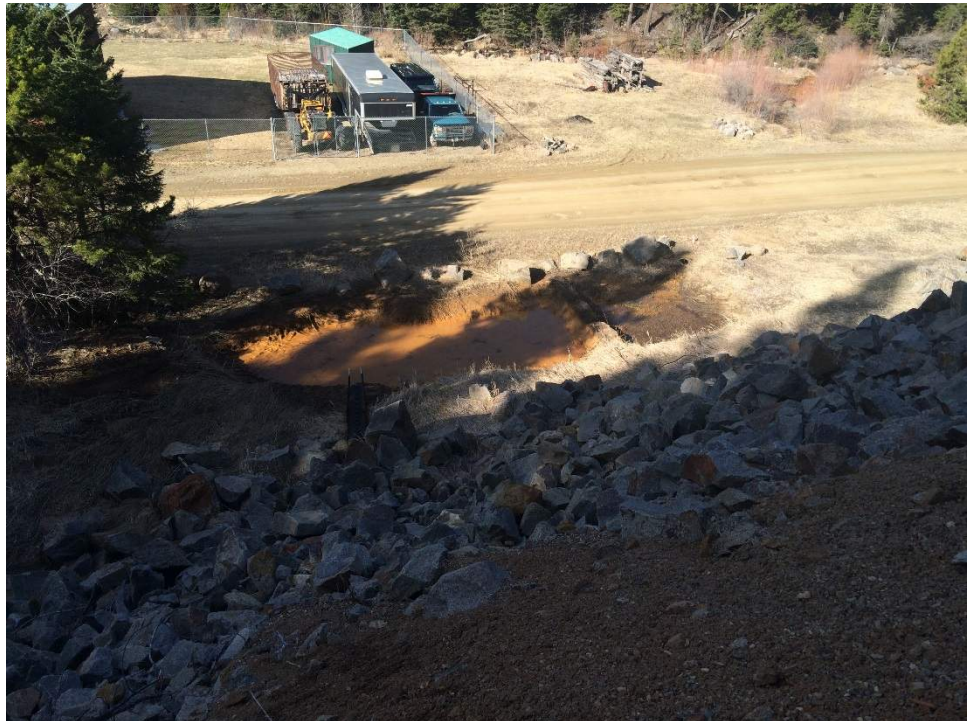
Photo Description:
015 - Existing settling/sludge ponds next to Rimini Road

- Expand the footprint of the existing settling pond at street level to accommodate more sludge volume. Clean out the existing culvert under Rimini road. Clean the sludge build-up out the existing step pools and settling basins on the west side of Rimini down to Tenmile creek. Haul contaminated soils from these excavations to a suitable area for staging until

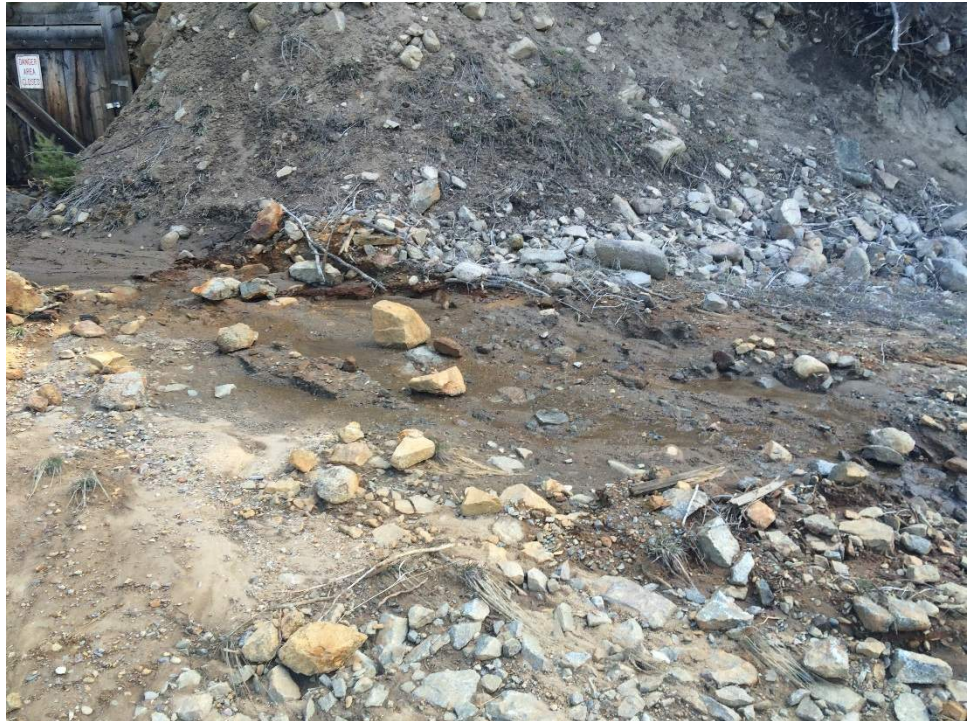
Photo Description:
016 - Evidence of erosion due to release from mine portal

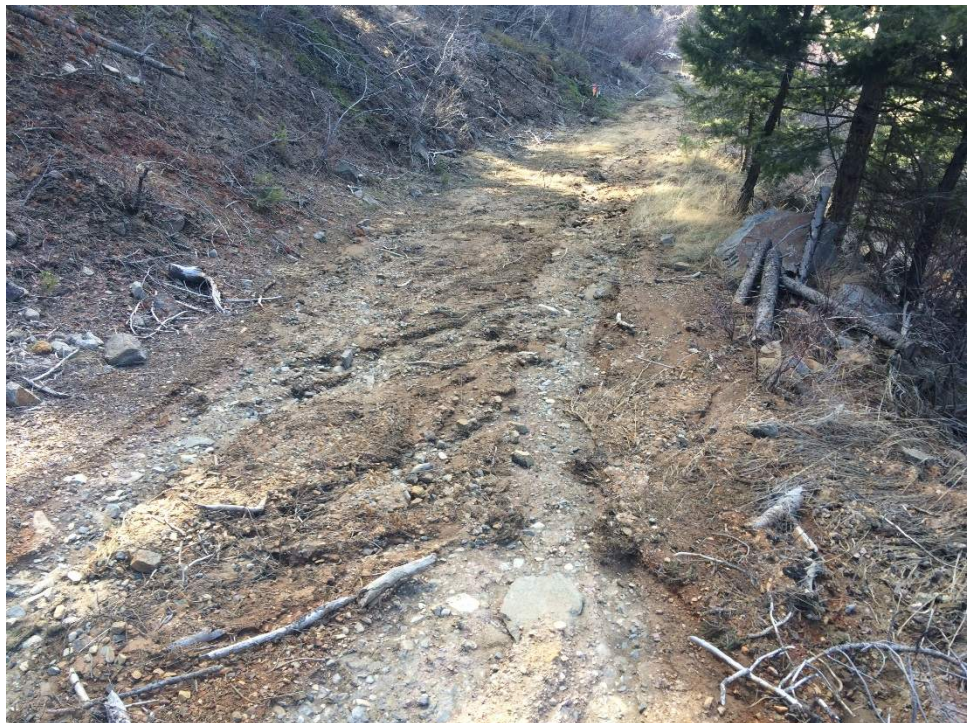
Photo Description:
018 - Evidence of erosion down access road

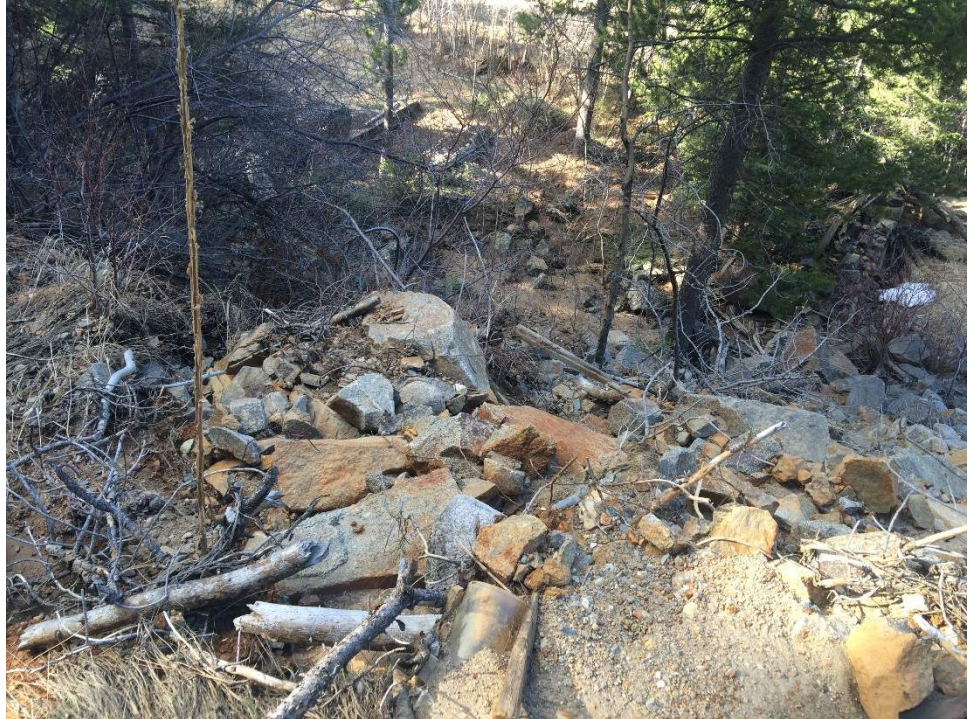
019 - Evidence of erosion down embankment on access road

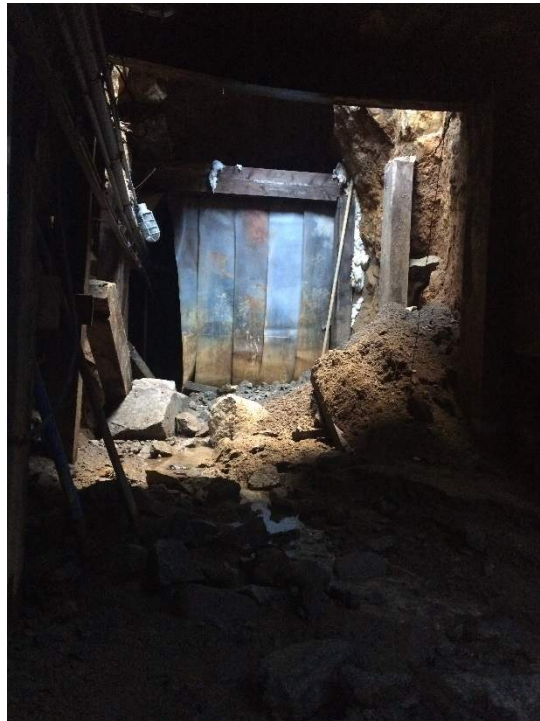
Sunday, April 3, 2016, 9:30 am: I drove to Rimini, met with Mark Poore for a few minutes, we walked up to the site and I was showing him what had happened. I used a sawzall to cut a small hole in the portal door, enough to get a camera in and take a couple photos (see photo 020 in the photolog, which shows sagging ceiling beam at second timber set in the photo as well as material from the collapse). It appeared that one or more of the timber sets installed in 2005 (see

photo 005 in the photolog – historic photo) that has been taking weight from the soils above and showing signs of stress over the last few years had finally collapsed, causing approximately 2-3 cy of soils directly above it to enter the mine tunnel. It appears the soil may have blocked the drainage flow temporarily and water was dammed up behind the collapse. Though it is unclear how long the water may have built up before discharging, it appears that when the water in the tunnel reached a certain point it breached through the soil dam on the tunnel floor and flowed out all at once. Mark asked what we, CDM Smith and U.S. Environmental Protection Agency (EPA), were going to do about this. I told Mark that we would inform EPA of this situation and that we would be putting a plan together to remedy the problem before it got any worse. He asked that we keep him in the loop as to what we were going to do and when. He also asked that we get the mine access road back to a usable condition as soon as possible, as he has plans, this spring, for hazard tree mitigation in the area around and upgradient of the portal. Before leaving, I took a few more photos of the area, and walked above the portal to check for subsidence further back from the portal but there was none. David Shanight called to check status, I told him all was ok, no change since yesterday and we should get together to look at the site Monday, he agreed and said he would set it up.

020 - Interior of Susie portal just inside door showing evidence of collapse.

- Size, procure, and deliver suitable culvert materials to the site for insertion into the portal. Cut a hole in the portal door and push the culvert sections in past the point of the existing collapse. Place a grate on the outlet of the new culvert to prevent anything from getting into the mine tunnel via the culvert. These steps should provide some level of comfort in the short term, such that if the portal continues to collapse, there is something in place to prevent the build-up of water inside the tunnel. **(within 30 days after EPA HQ approval)**

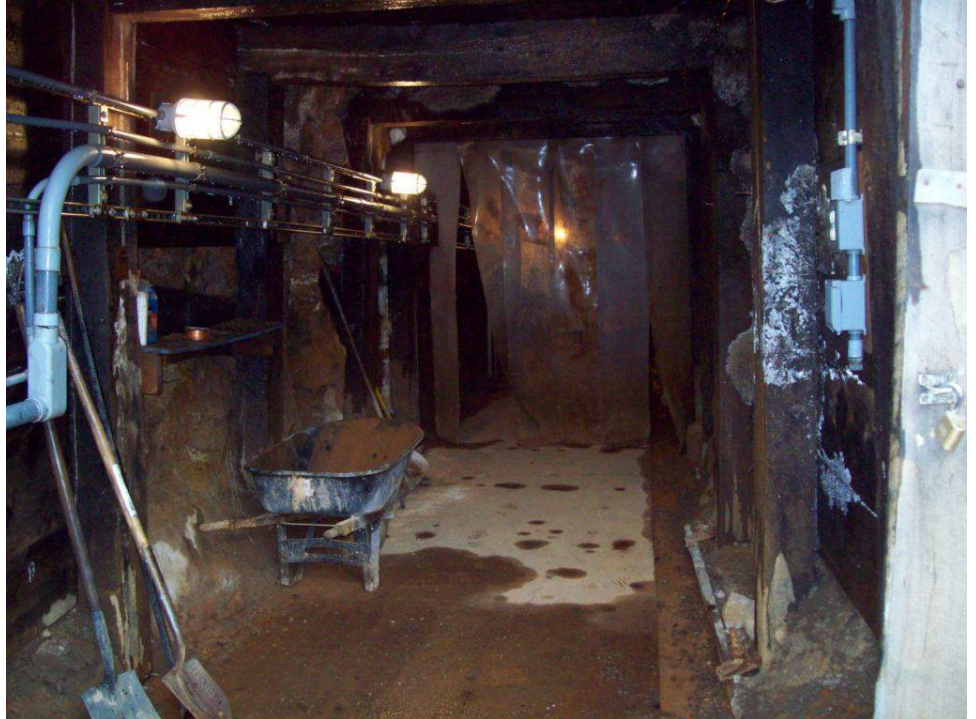
Photo Description:
005 - Interior of Susie portal from just inside door from 2008.
