Telluride Valley Floor
San Miguel County, Colorado

Site Vicinity

Site Vicinity Photographs

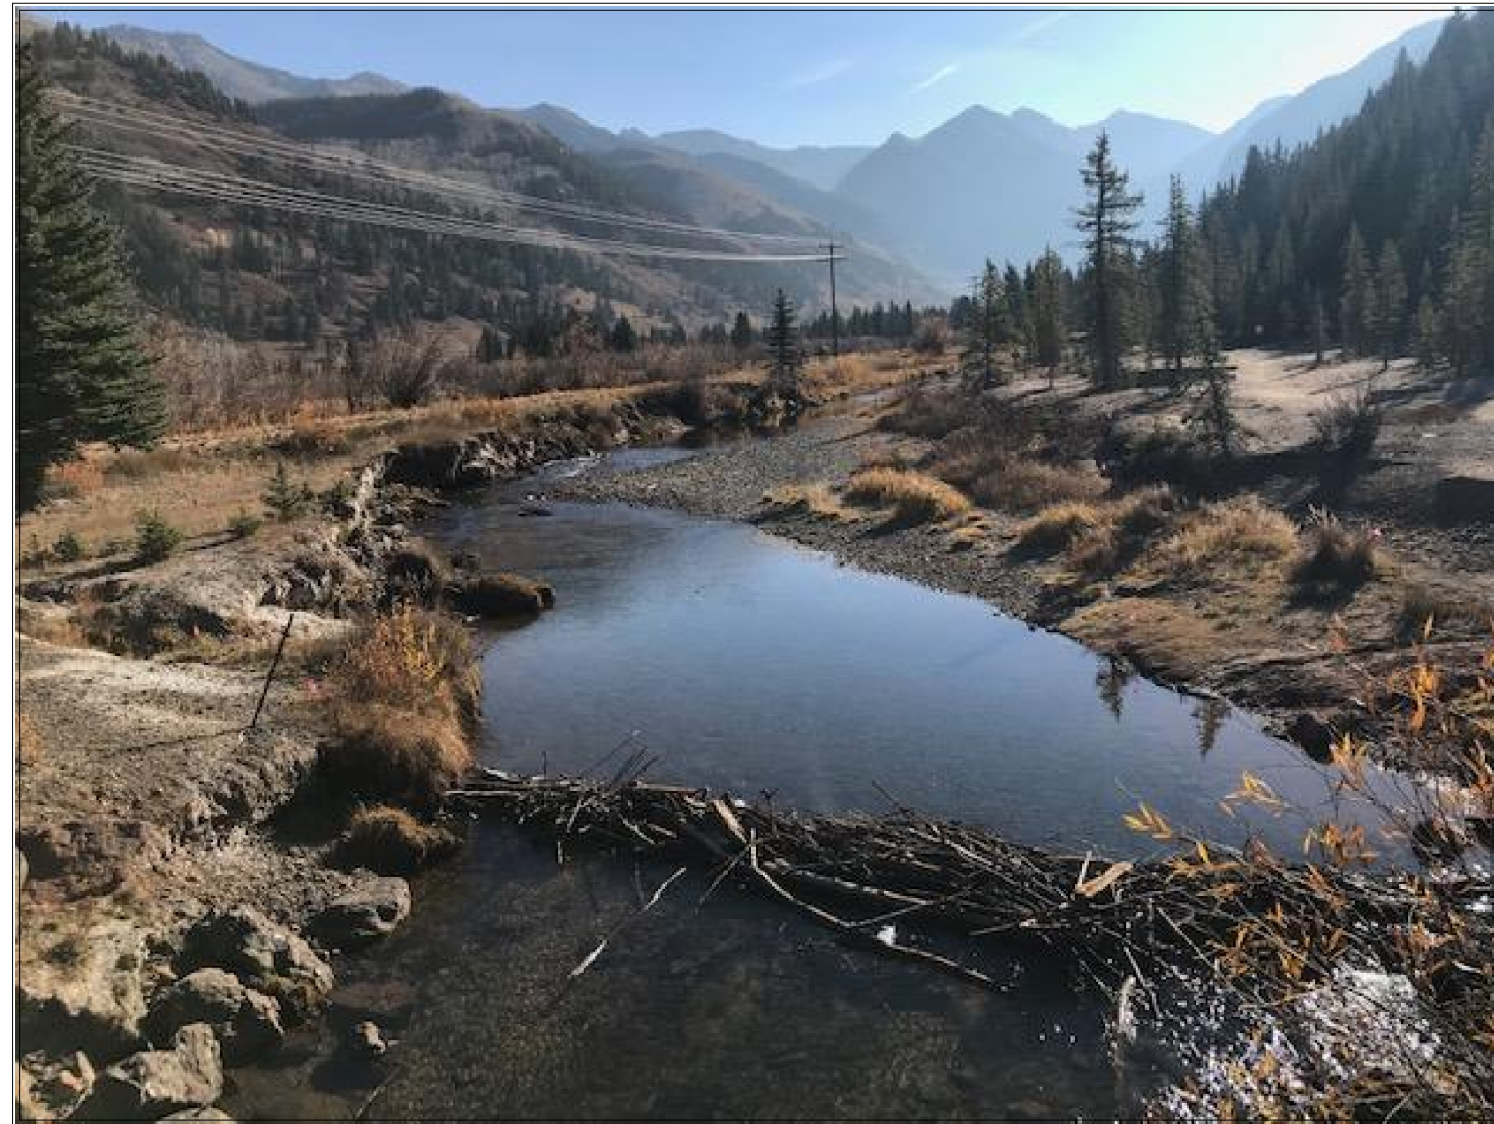
Picture taken on Boomerang Bridge looking east. Shows eroding tailings on both sides of the San Miguel River and open space on the south side of the river bank where trespassing frequently occurs.

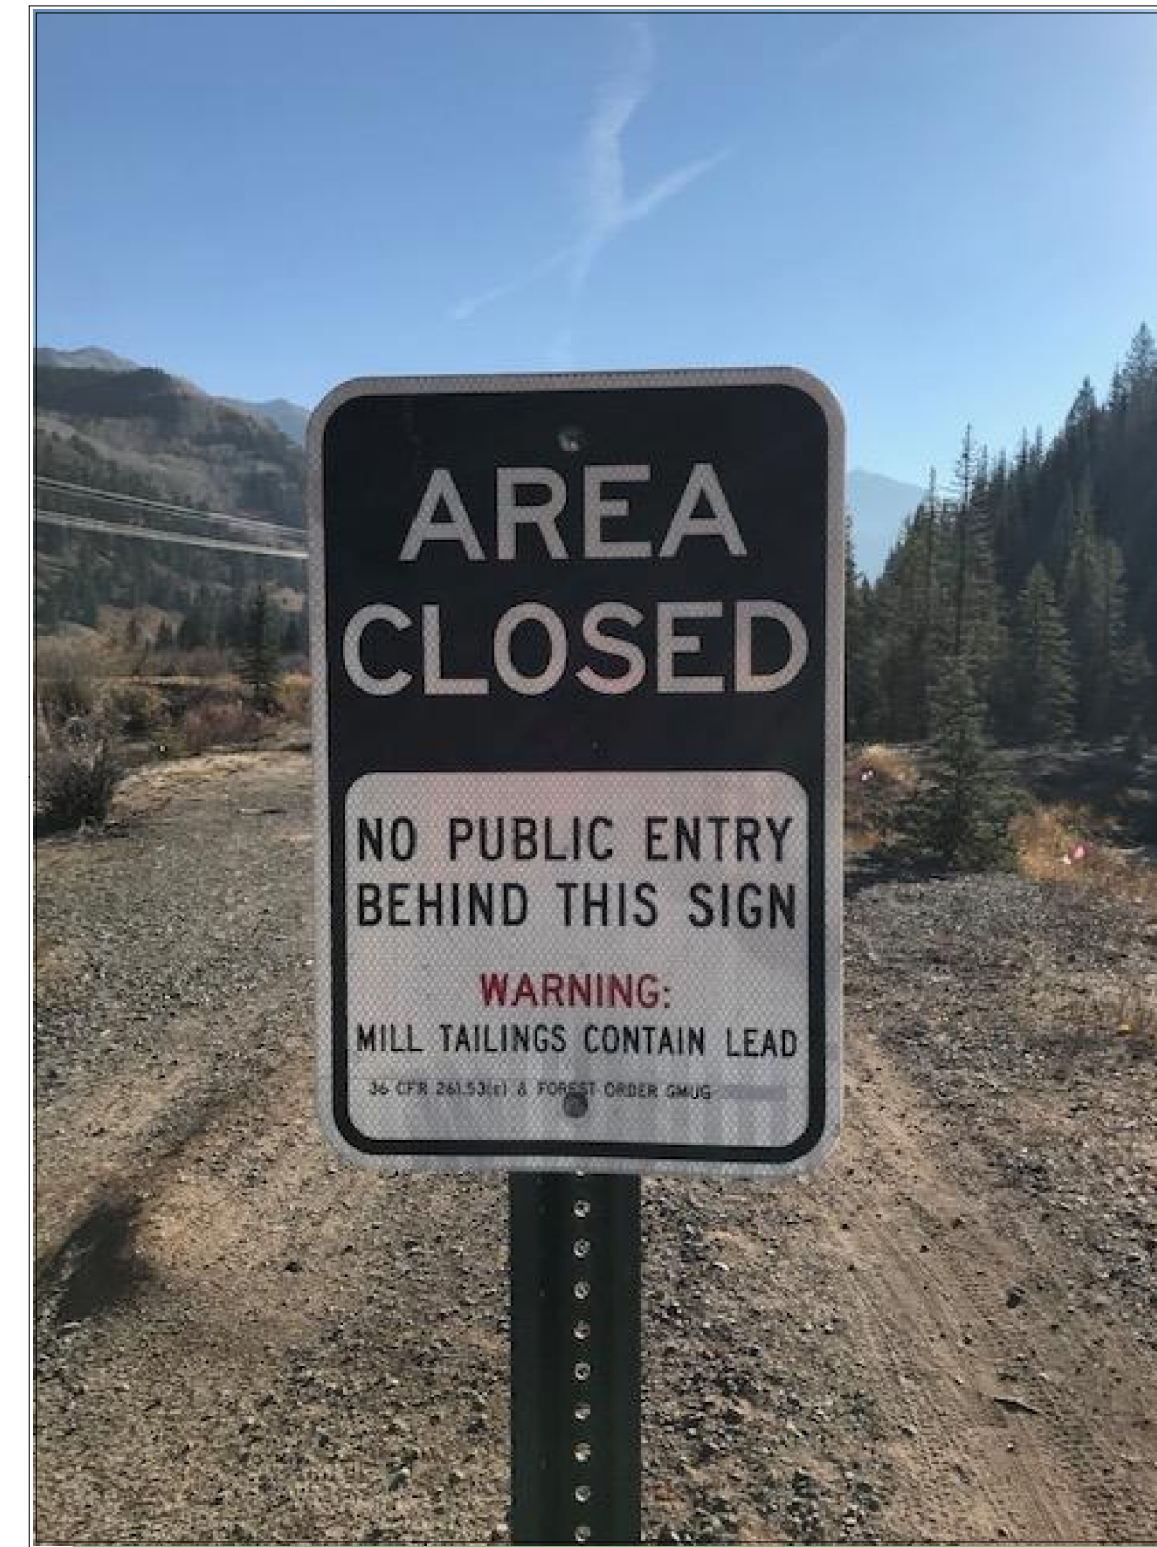
Photo of area closed sign.

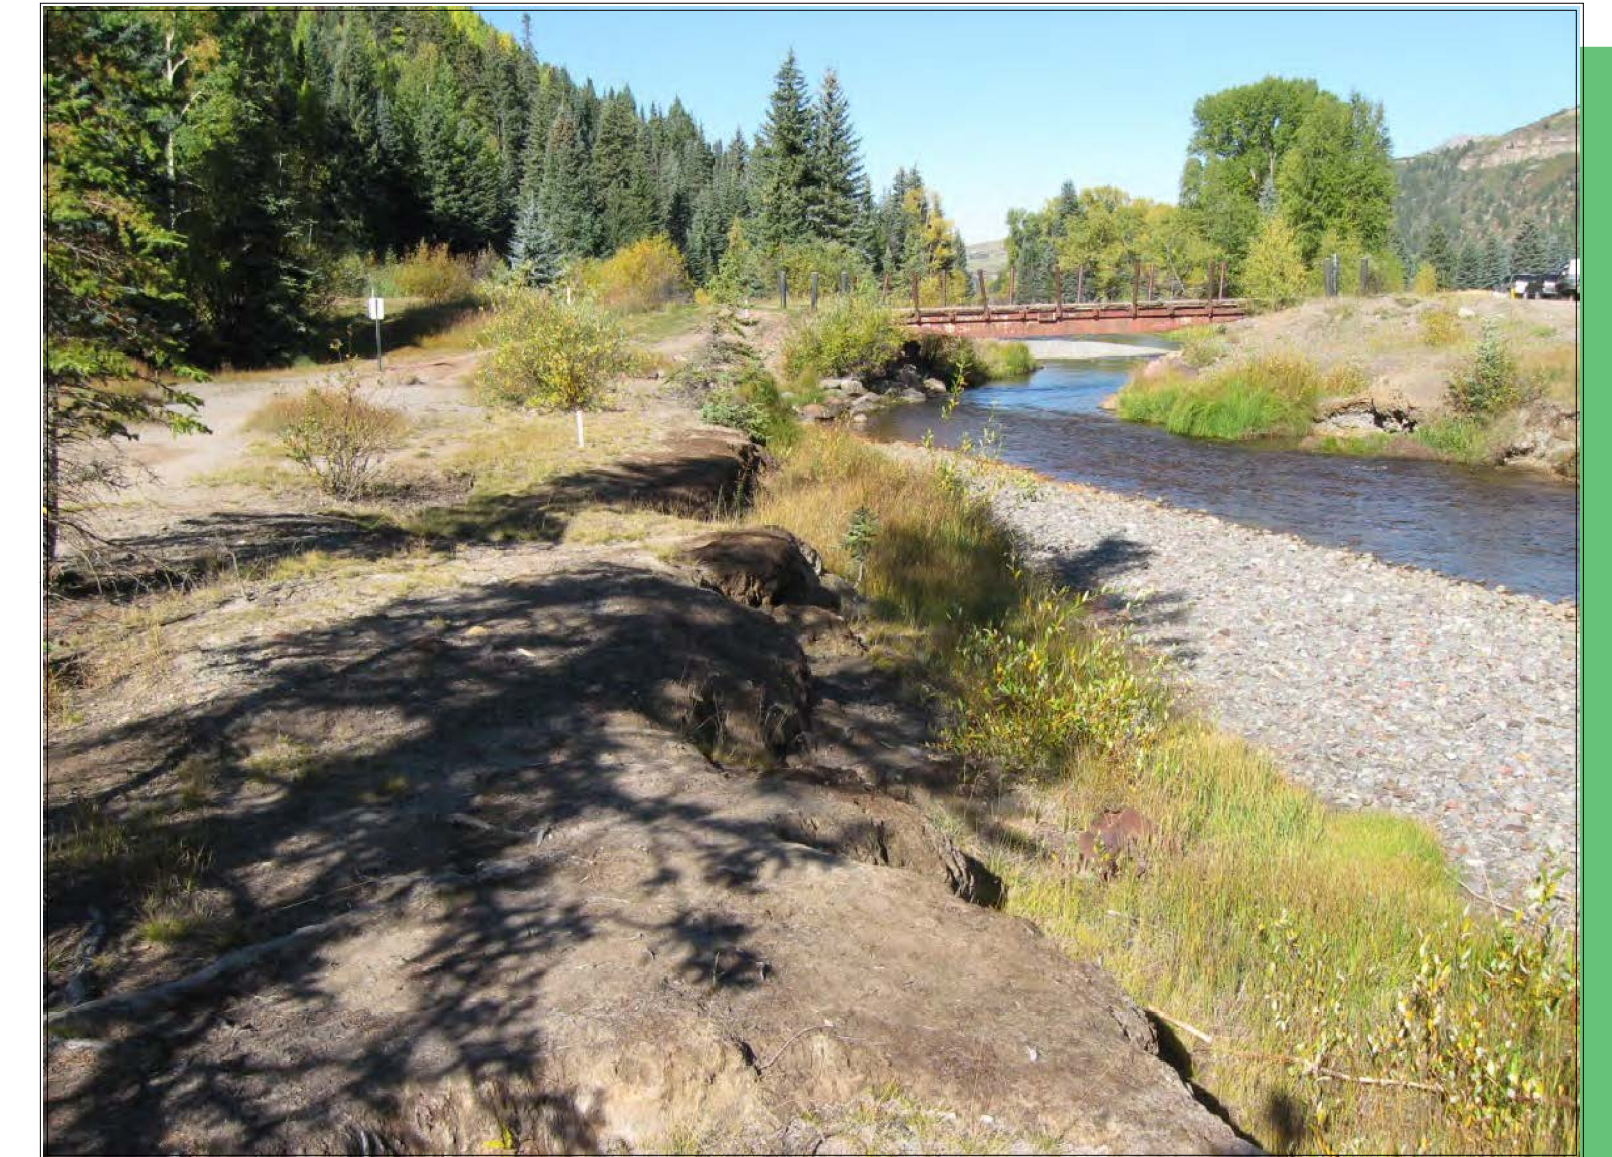
Looking west along San Miguel River.

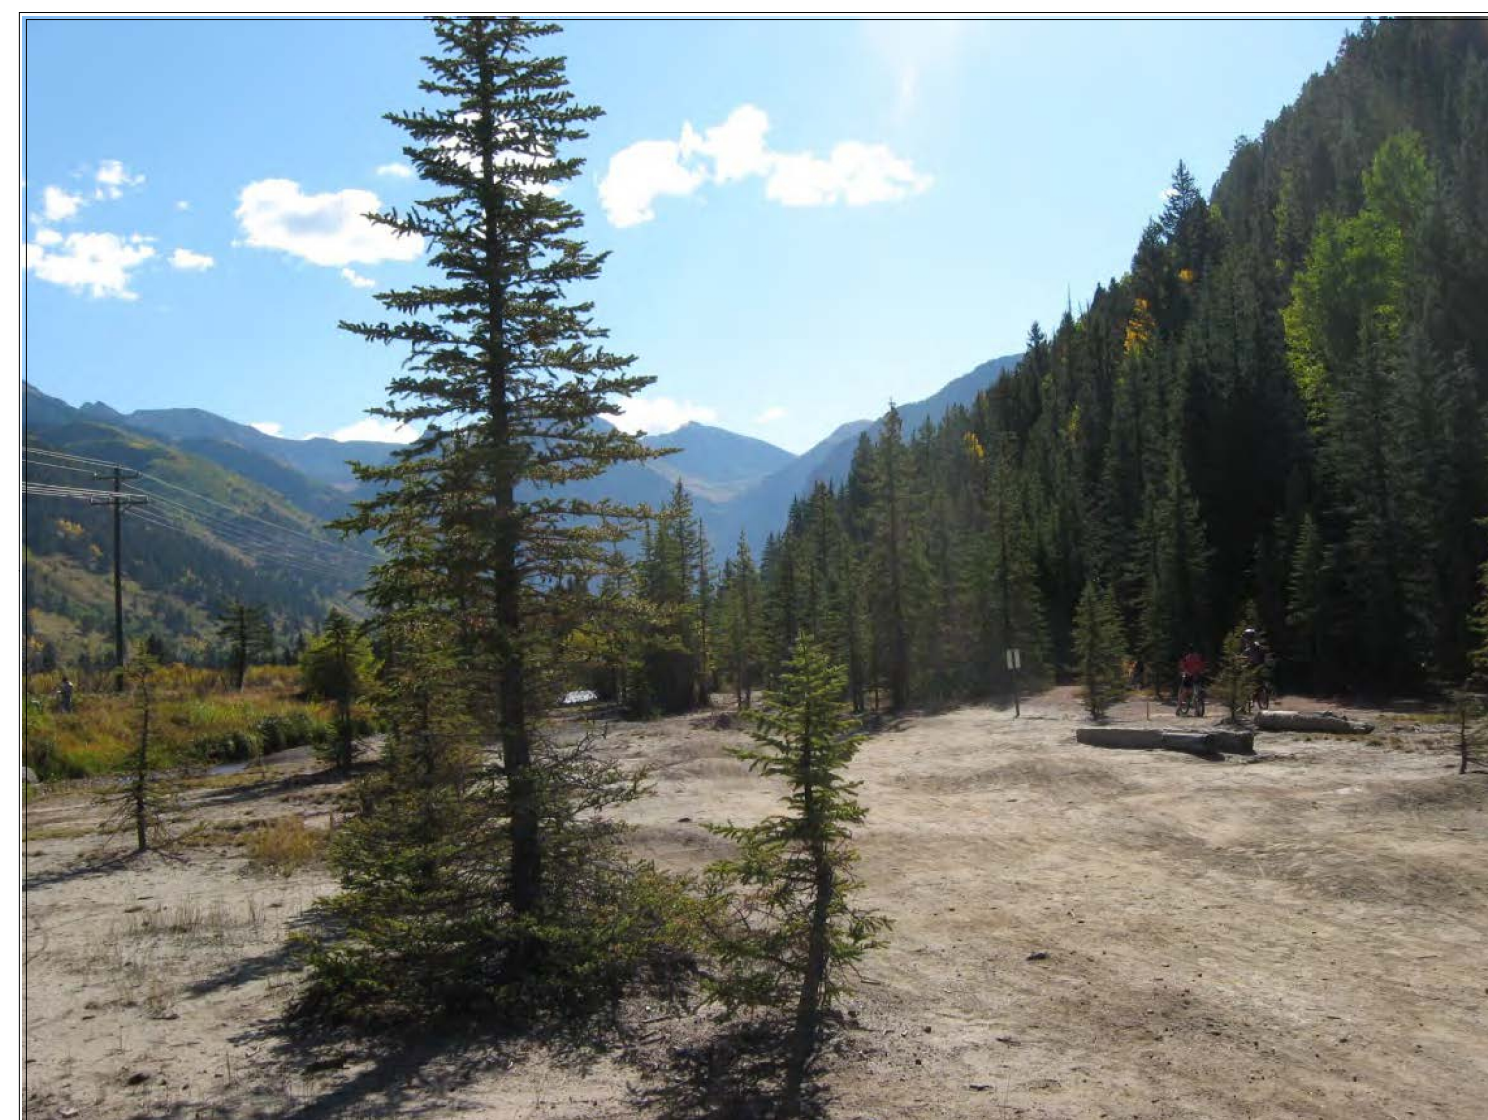
Looking east at user-created trails and jumps within small bicycle park (BMX Area).

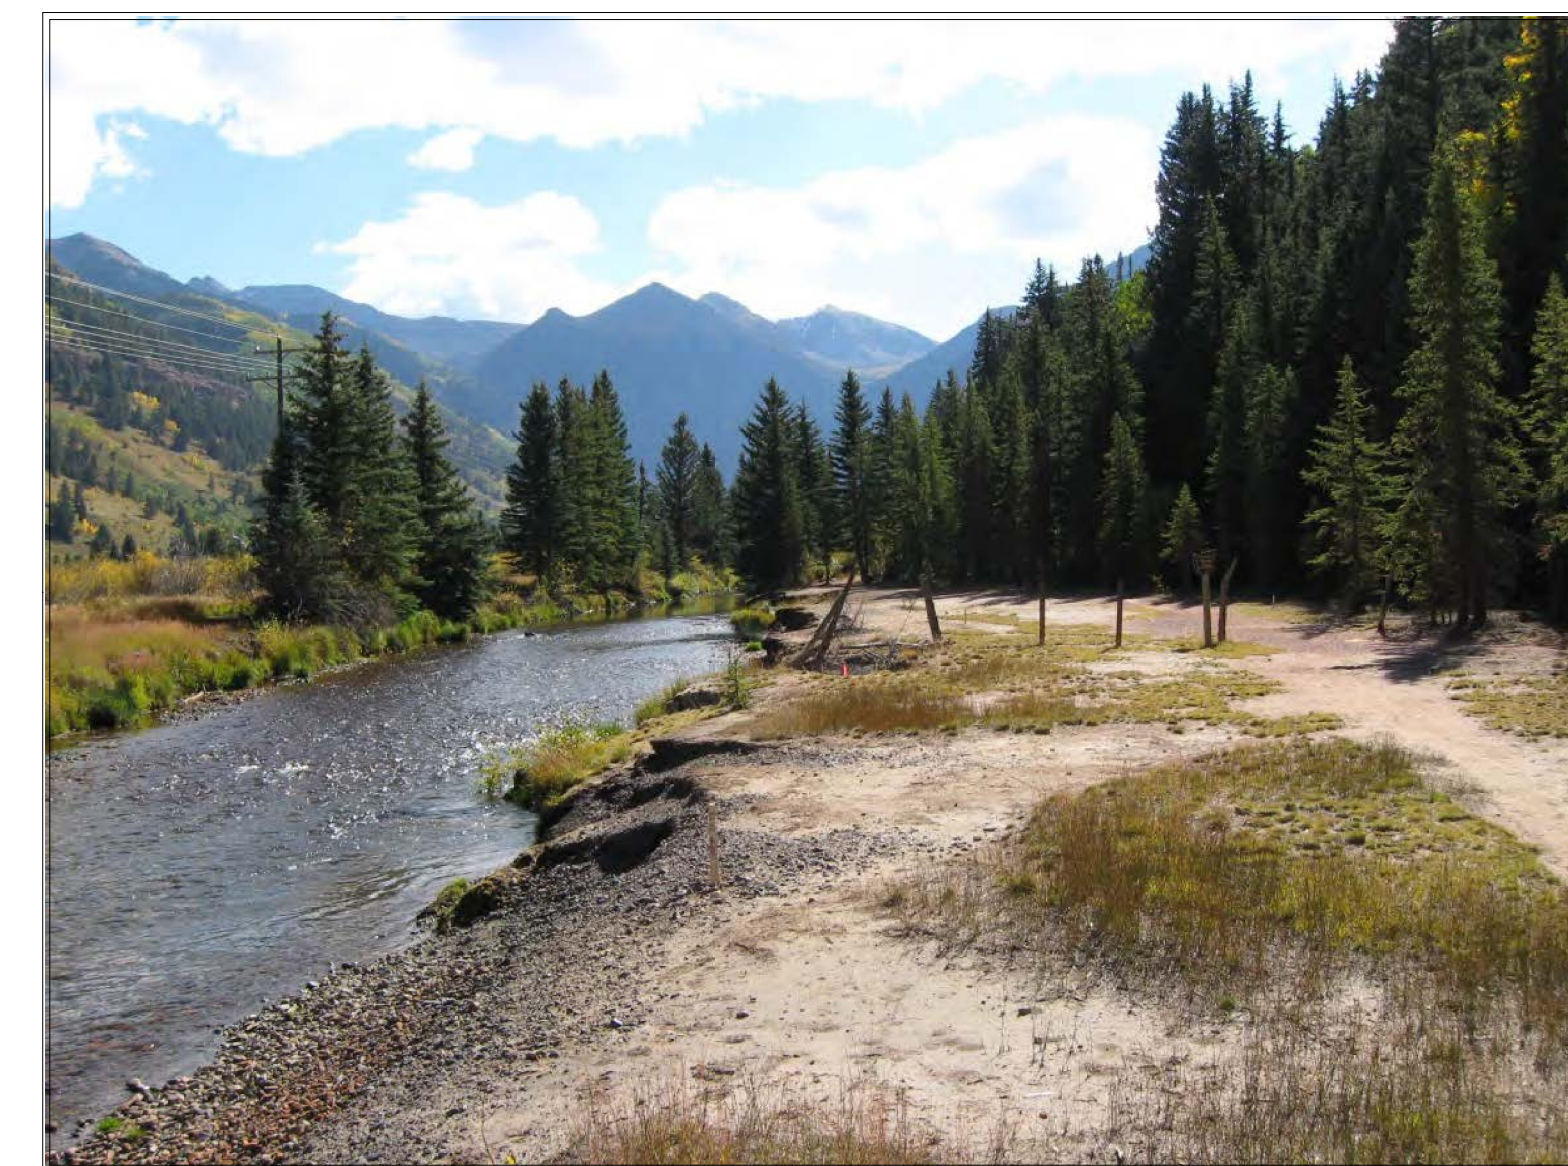
Looking east San Miguel River and Valley Floor Trail at eastern boundary.
