Penstock Break and Repair Daily Logs

June 25—August 20, 2001

Prepared By:
D.G. Jones/Associates
P.O. Box 2186
Sitka, Alaska 99835
(907) 747-7998
Fax: 747-7997

**Sheldon Jackson College
Sage Hydro Penstock Repair
Saint Paul Insurance Claim CK08403010 09T003**

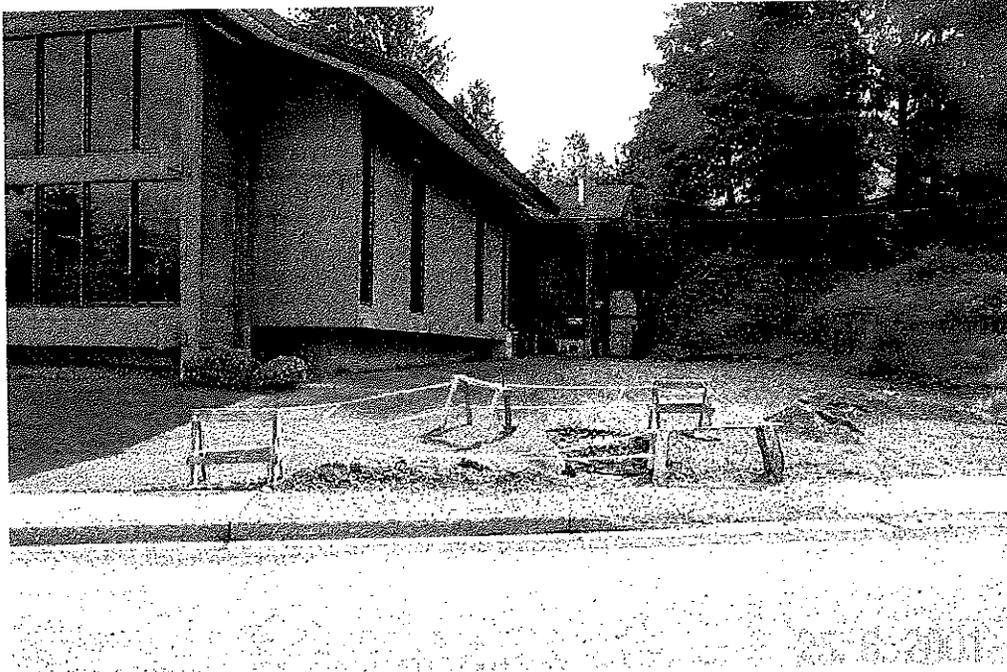
Location
photo from
Lincoln
Street
looking

approximately East

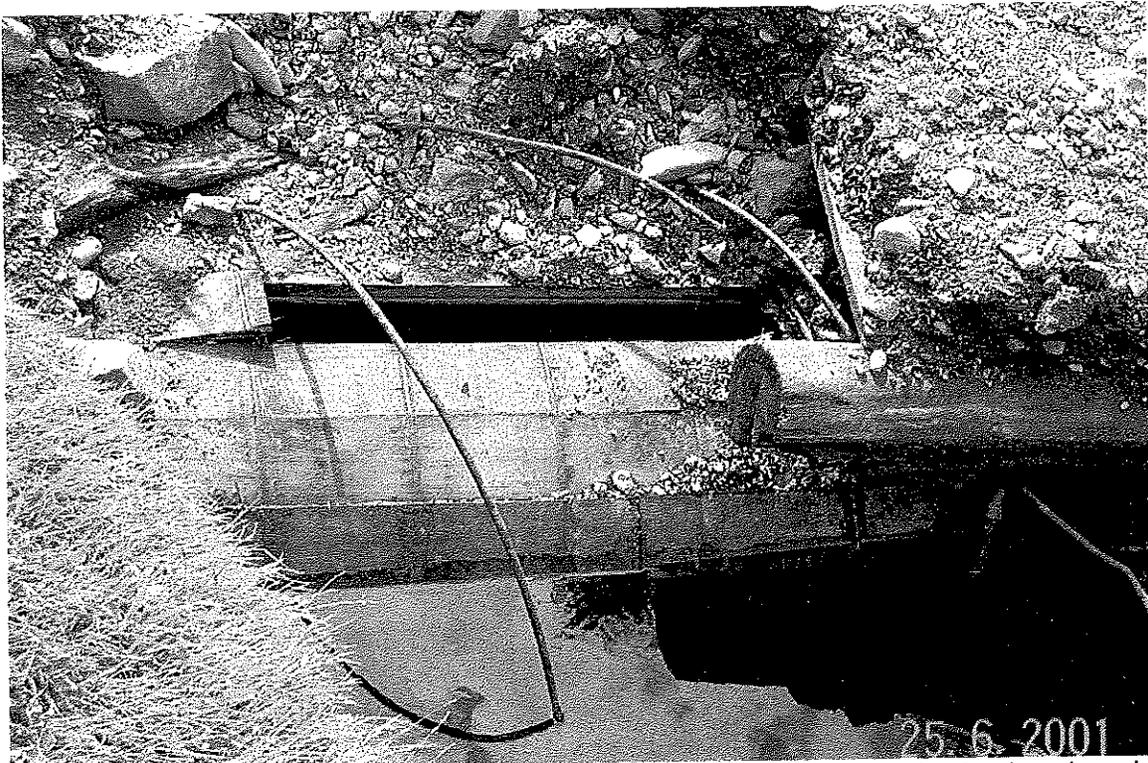
Top of penstock showing one of the broken staves, and one of the broken bands

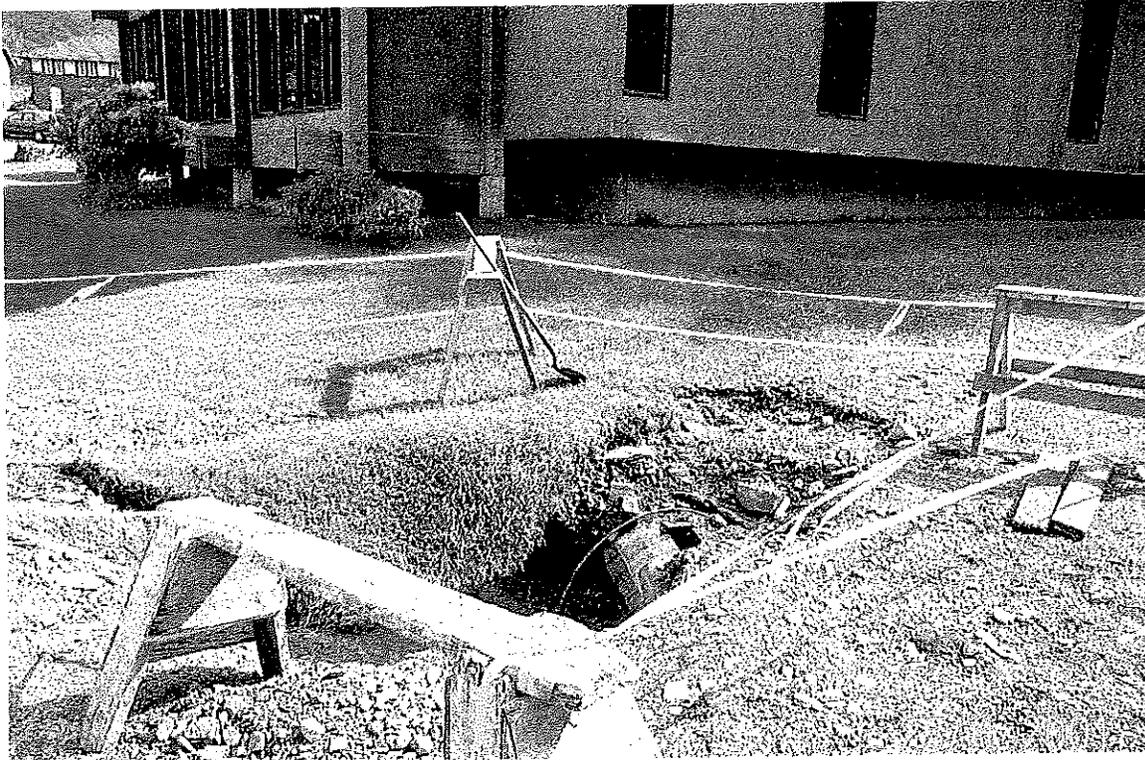
Closeup of penstock, additional broken staves below water level.

Prepared a memo to Stuart Denslow regarding possible cause(s) of the break and indicating that, in addition to repairing the break, the runner in the Sage hydro turbine should be removed to reduce backpressure in the penstock.

In addition to repairing the penstock itself, we recommend that the flow probe ordered some years ago be installed, and that the Sage hydro turbine runner (internals) be removed from the casing.

The flow probe should be installed now because of the convenience of making the installation while the penstock is empty, but the removal of the hydro turbine runner should be considered an integral part of the scope of repair and prevention of another penstock break. It appears that the debris that collects on the turbine runner while it is locked creates a significant backpressure on the penstock that would not exist if the turbine were operating.

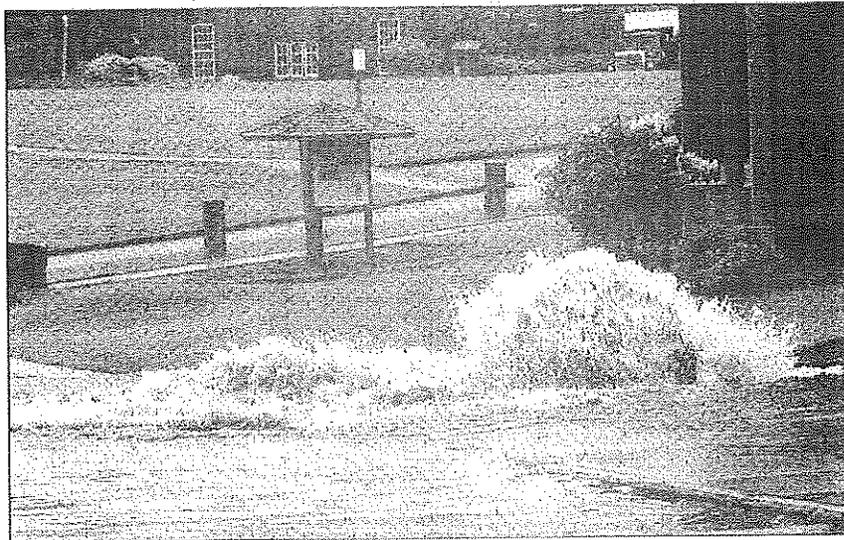
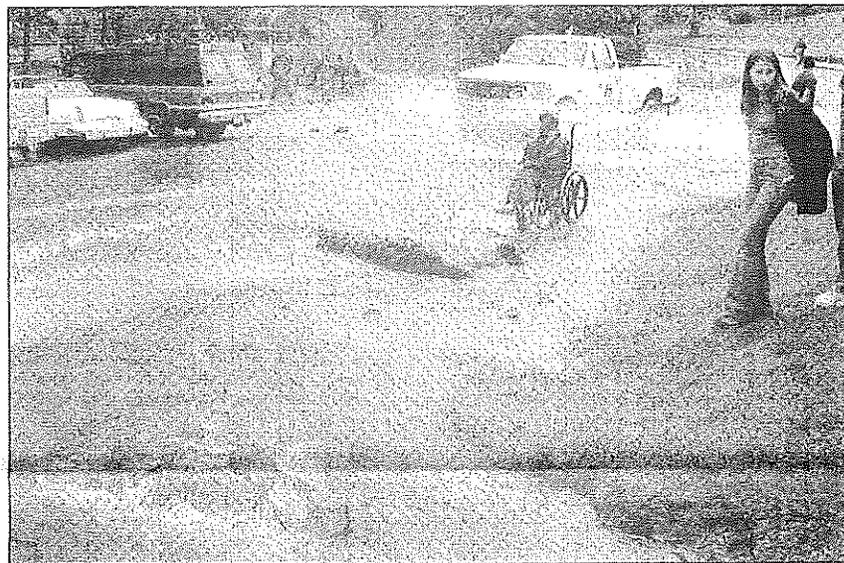
Sheldon Jackson College volunteer Glen Robinson had his camera handy when the SJC hatchery water line burst Friday afternoon. In the below

photo, bystanders gather as city crews and SJC maintenance workers arrive to assess the damage. (Photos by Glen Robinson and James Poulson)

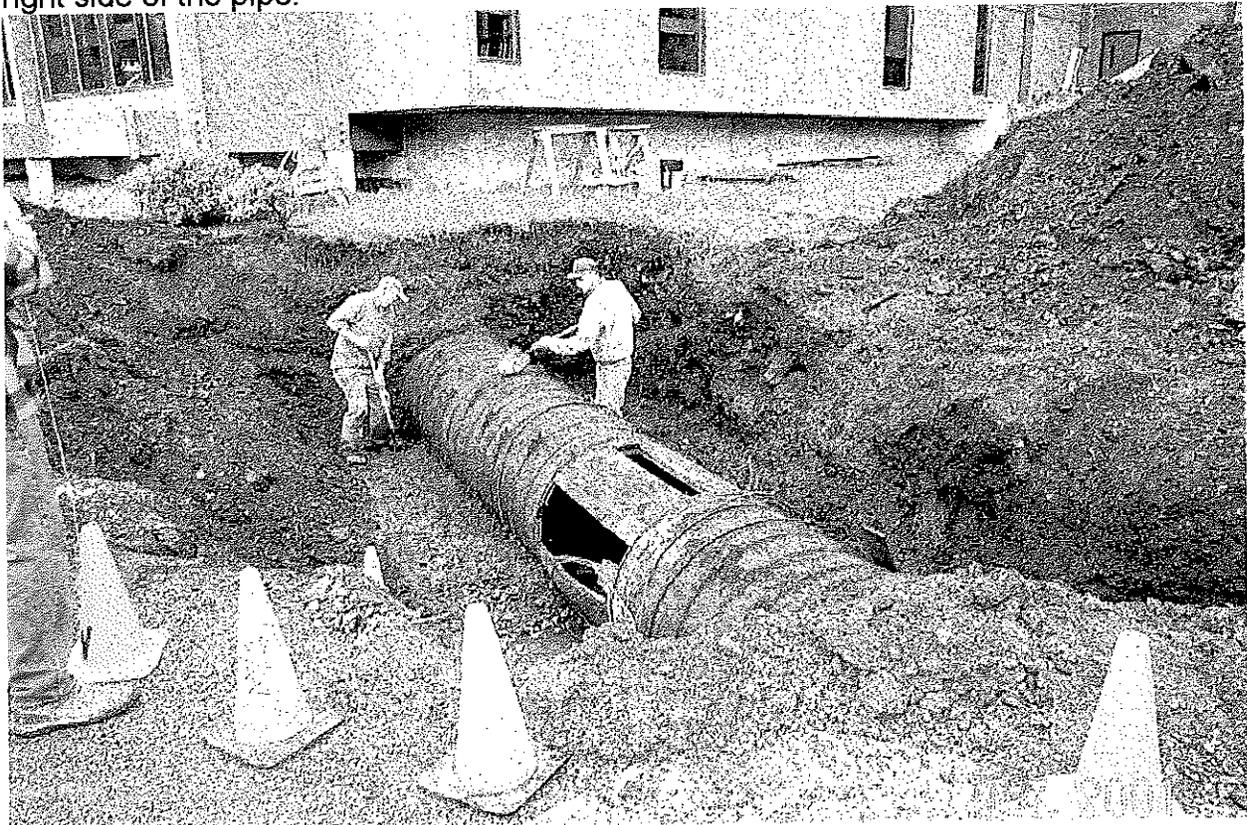
Pictures: 42" wood staved water line exposed with contaminated soil in the ditch on the right side of the pipe.

Contaminated soil was found on the east side of the wood stave pipe and was stockpiled beside the ditch.

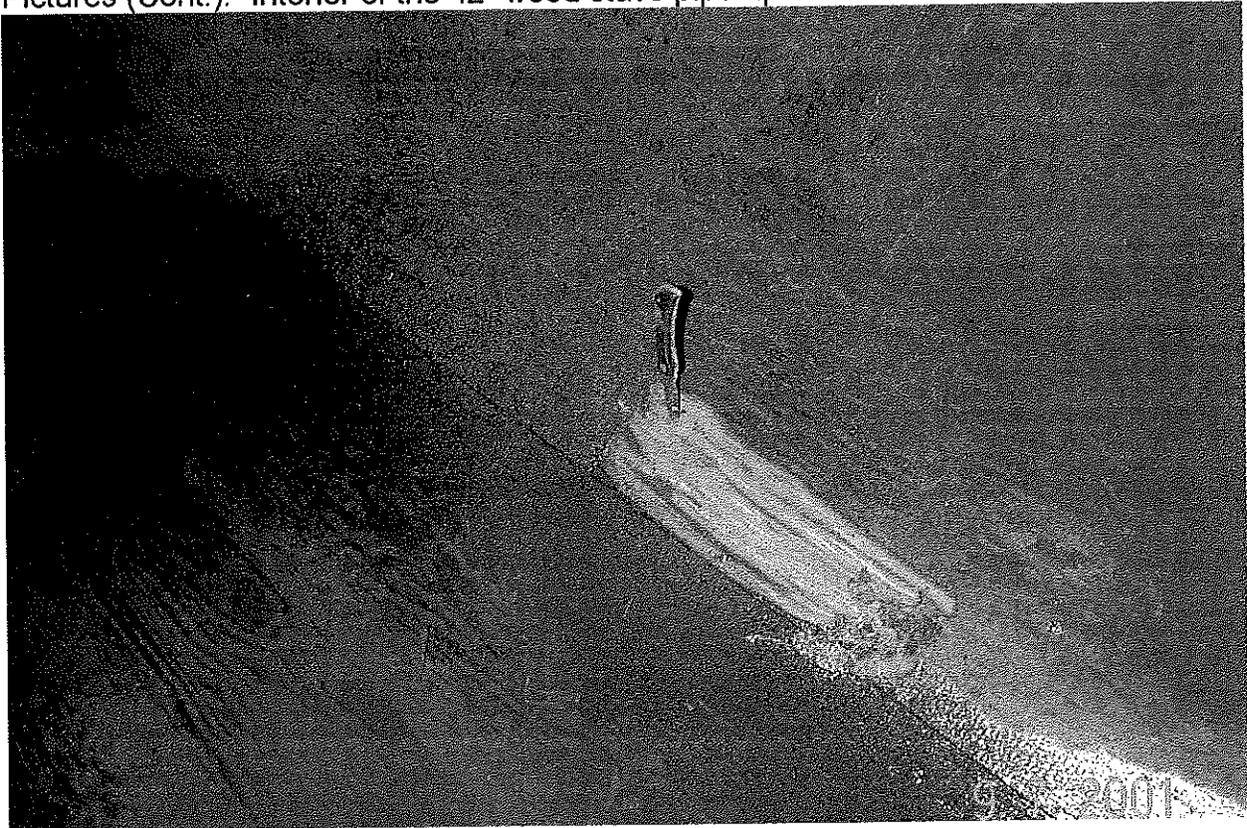
Pictures (Cont.): Interior of the 42" wood stave pipe upstream from the break.

Dan Jones duck-walked the inside of the pipe upstream to the inlet and downstream to under the pavement (where the water was getting to deep). There was a significant accumulation of gravel and other debris downstream of the break. Otherwise, the interior of the wood pipe looked good the entire way, with just some light slim build-up and the grain of the wood raised by contact with the running water. The accumulation of gravel and debris in the lower end of the pipe is likely due to the backpressure in the pipe caused by flow having to travel through the locked rotor of the hydro turbine.

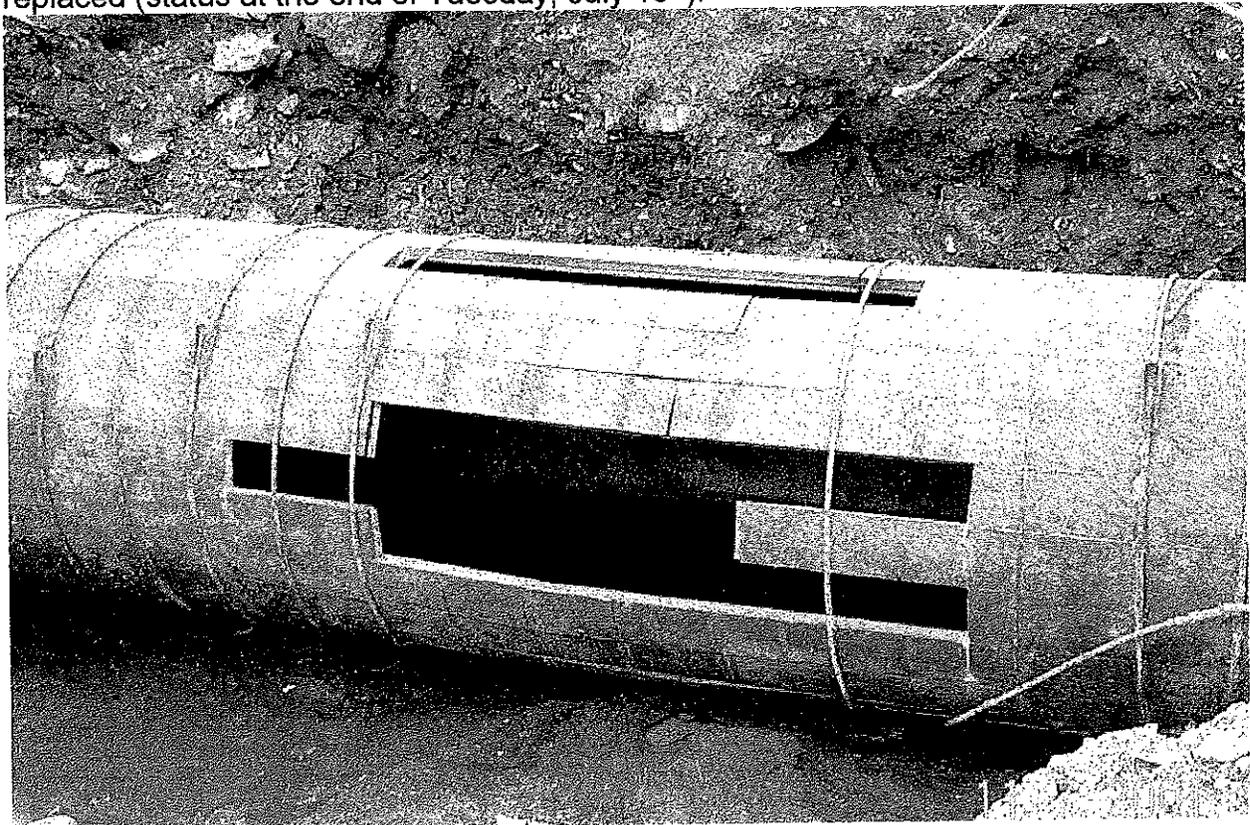
Pictures: The 42" wood stave pipe with the broken staves cut out and ready to be replaced (status at the end of Tuesday, July 10th).

The cleaned out the cracks in the wood staves and made clean cuts in the broken staves to facilitate repairs.

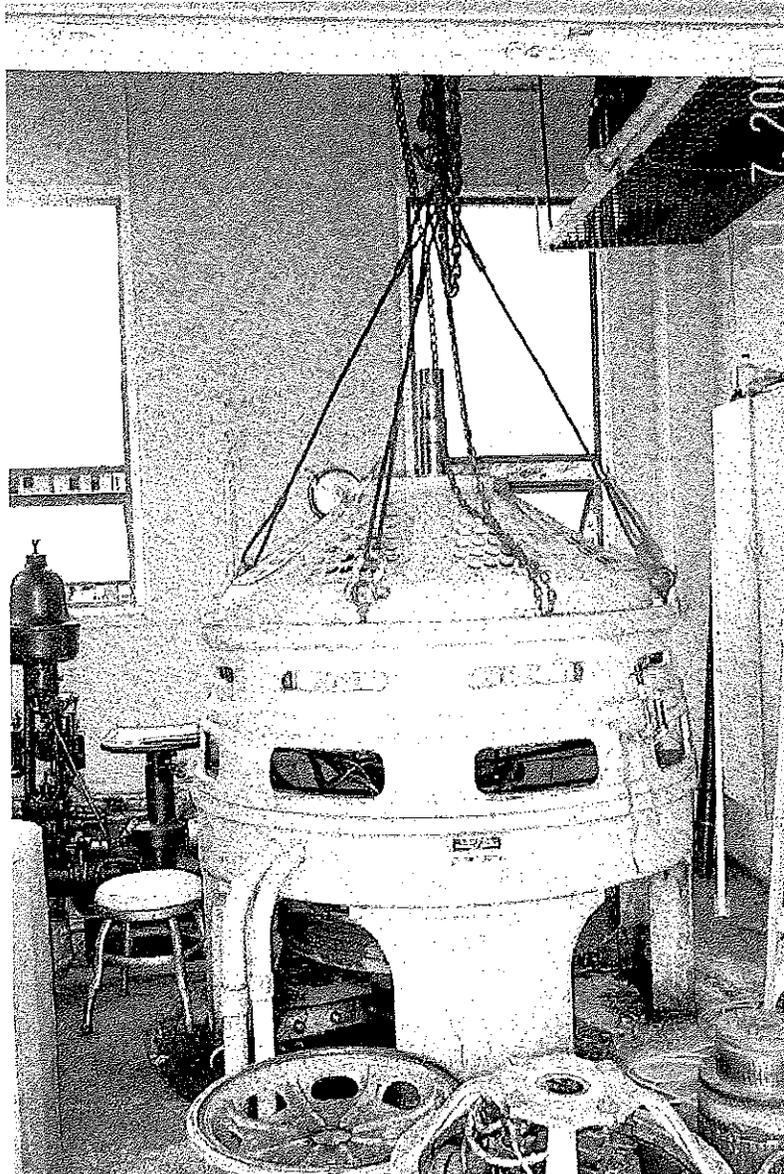
The generator rigged for removal with the exciter already on the floor (status at the end of Tuesday, July 10th).

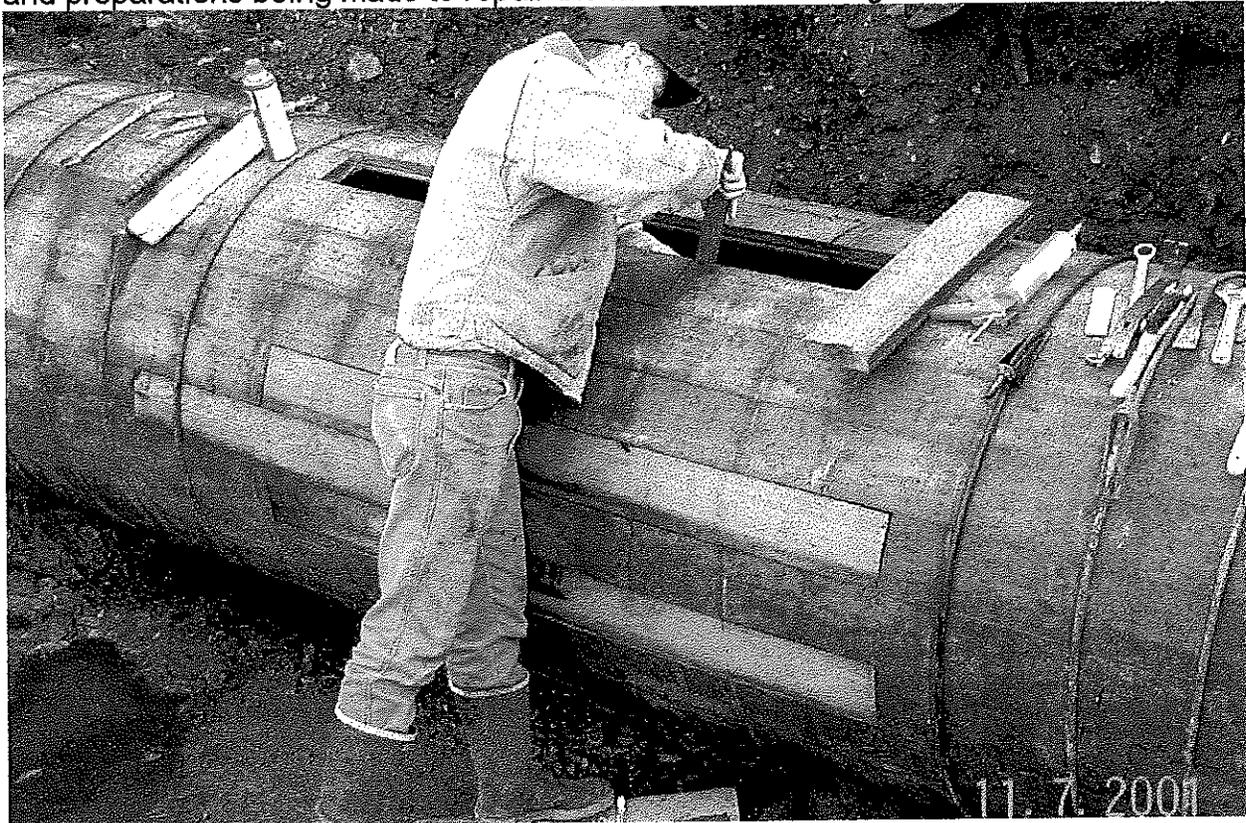
Pictures: The 42" wood stave pipe with the repairs made to the lower broken staves and preparations being made to repair the last broken/missing stave.

Del Company repaired the broken staves in the 42" line.

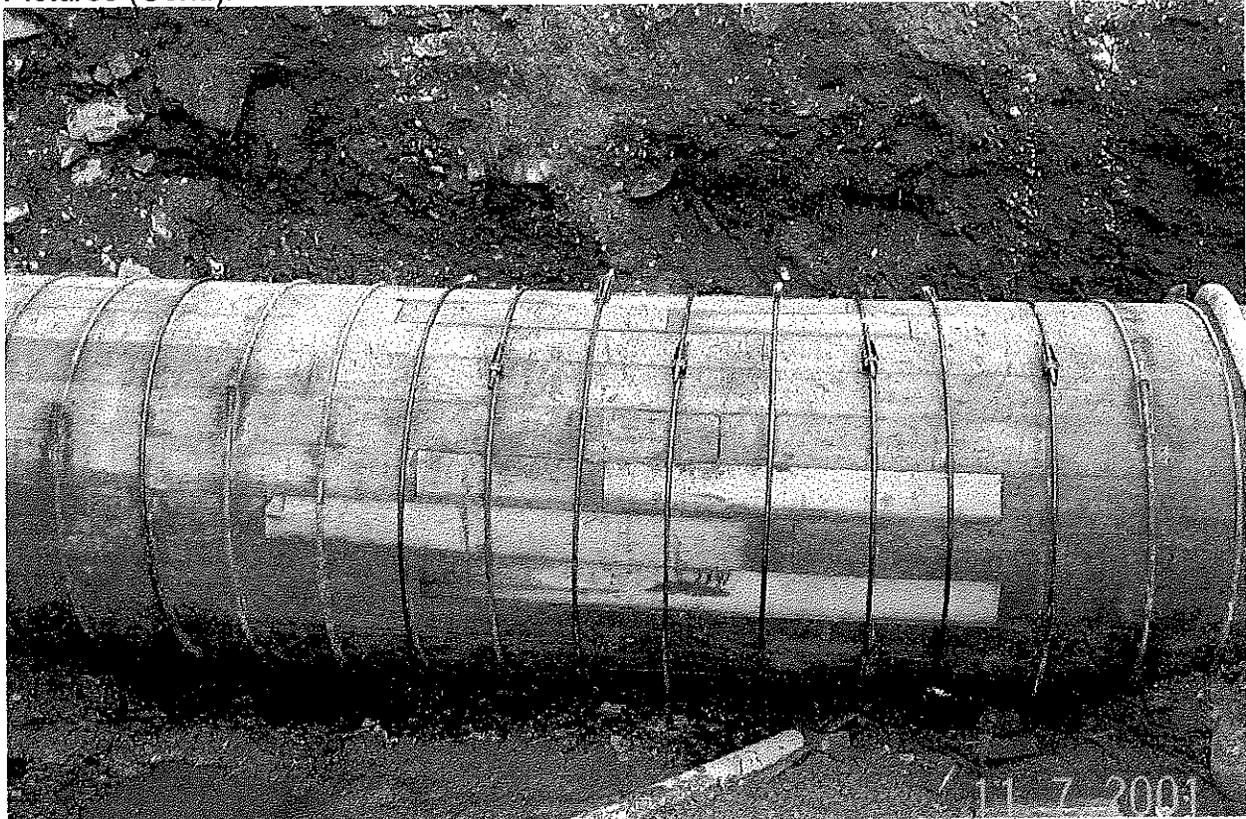
The repaired 42" wood stave pipe. Note the new (black) bands and clean wood staves and black caulk in the repaired areas of the pipe.

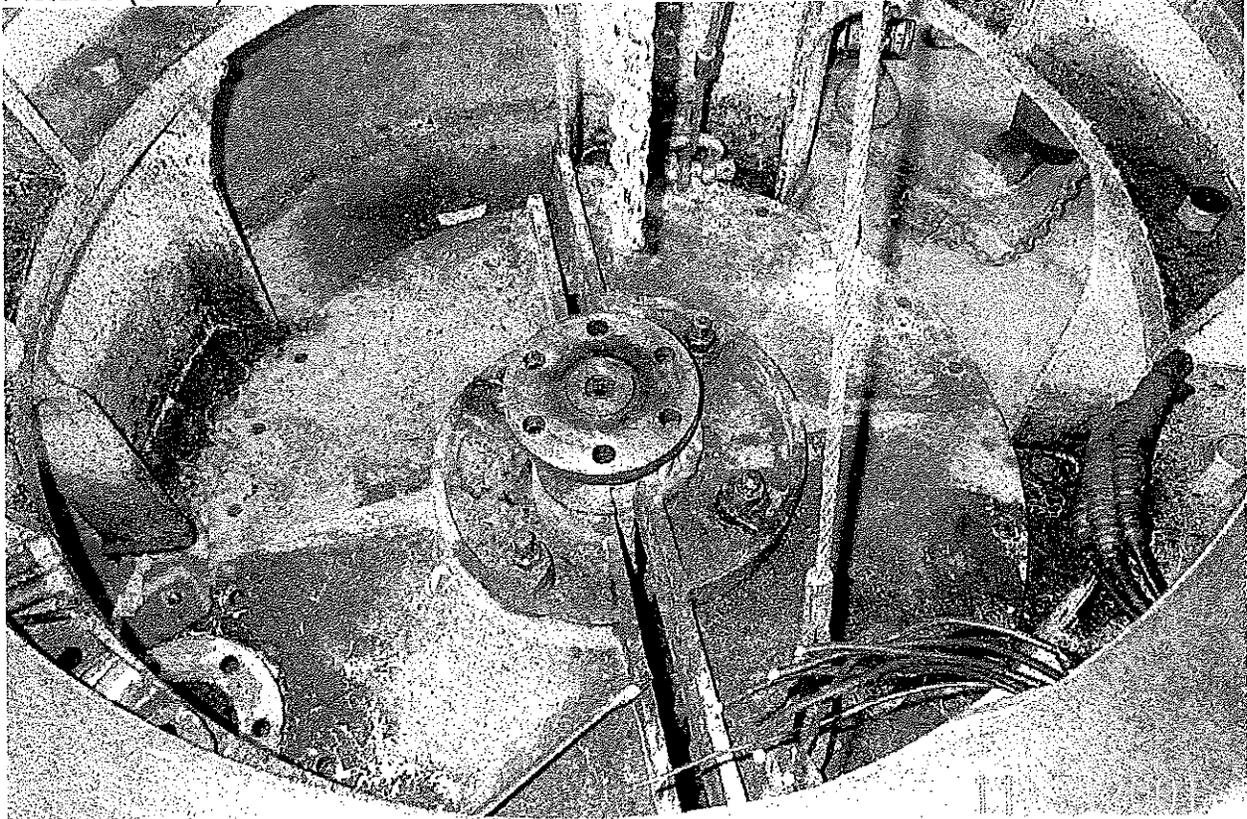
Preparing to remove the cap and the turbine with the drive shaft in the center of the picture.

S&S removed the generator and the turbine and then replaced the cap over the vault/turbine housing.

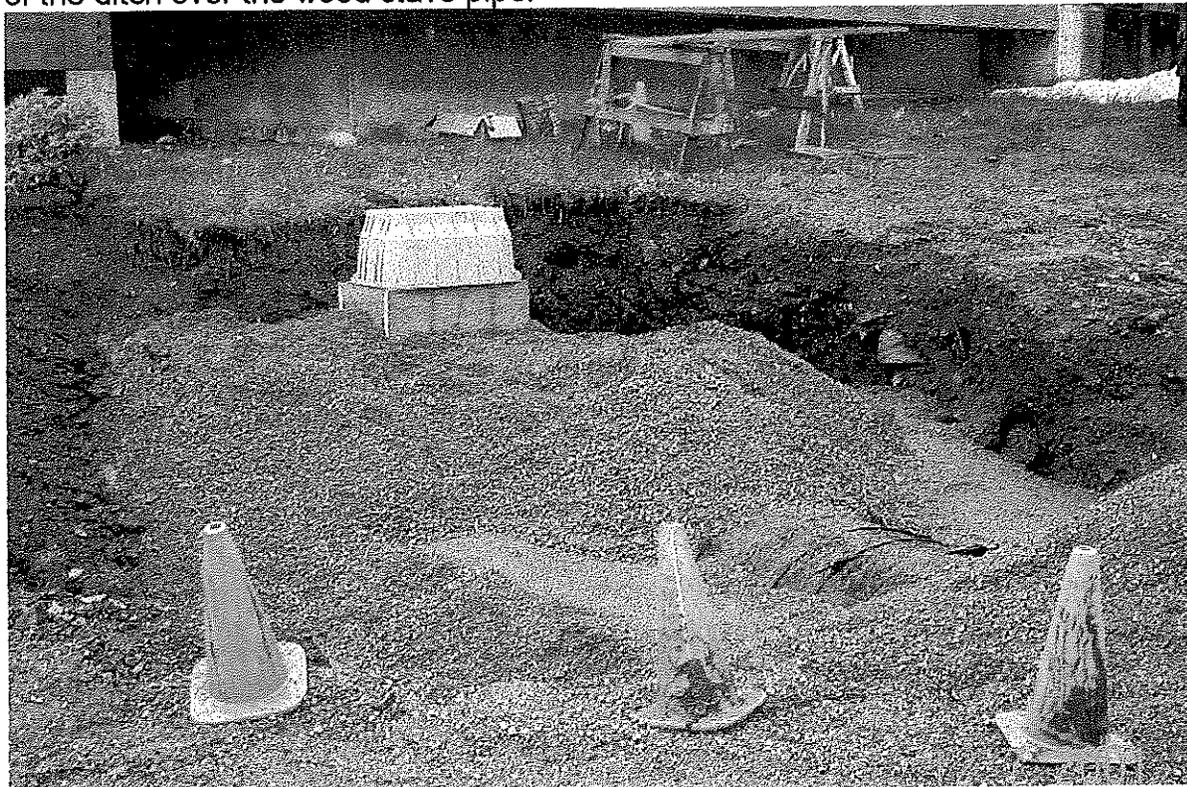
Pictures: The 42" wood stave pipe covered with D1 and the flow meter box in the back of the ditch over the wood stave pipe.

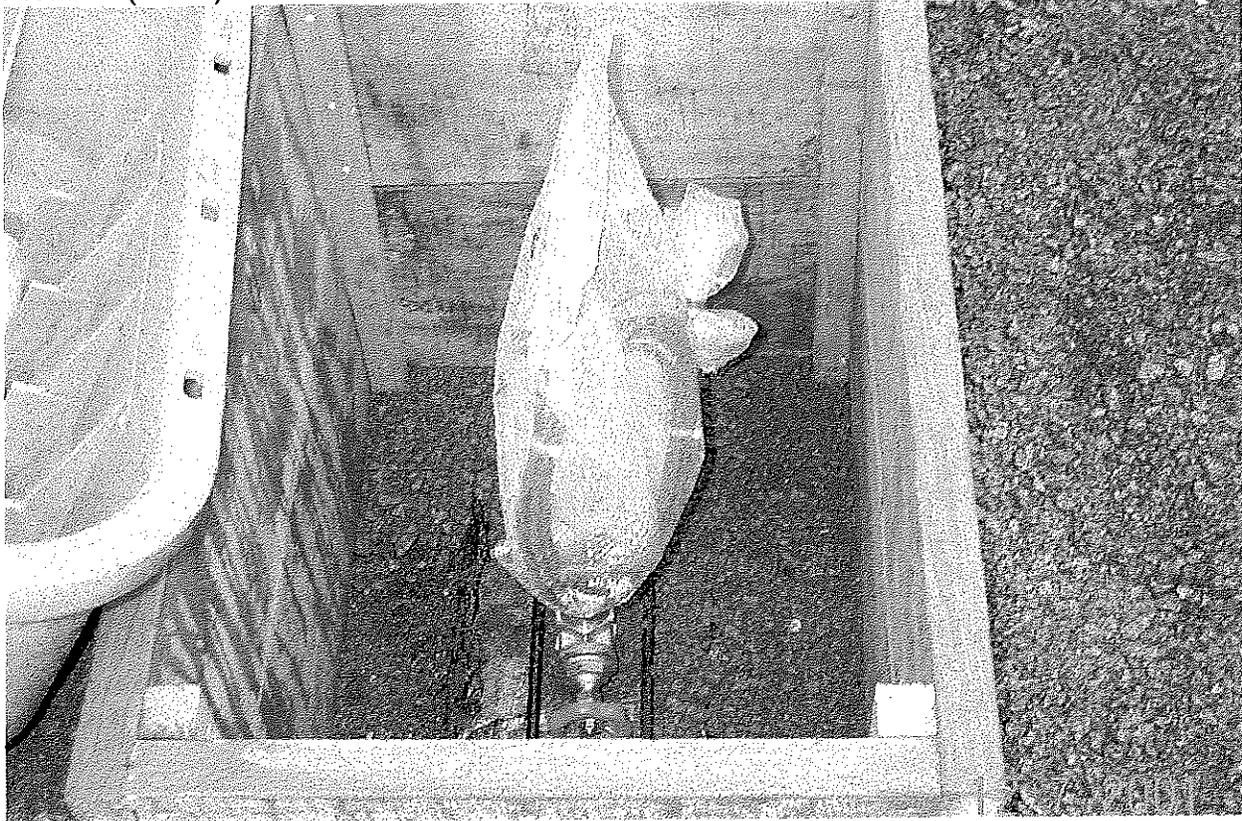
Flow Meter and saddle installed over the 42" wood stave pipe.

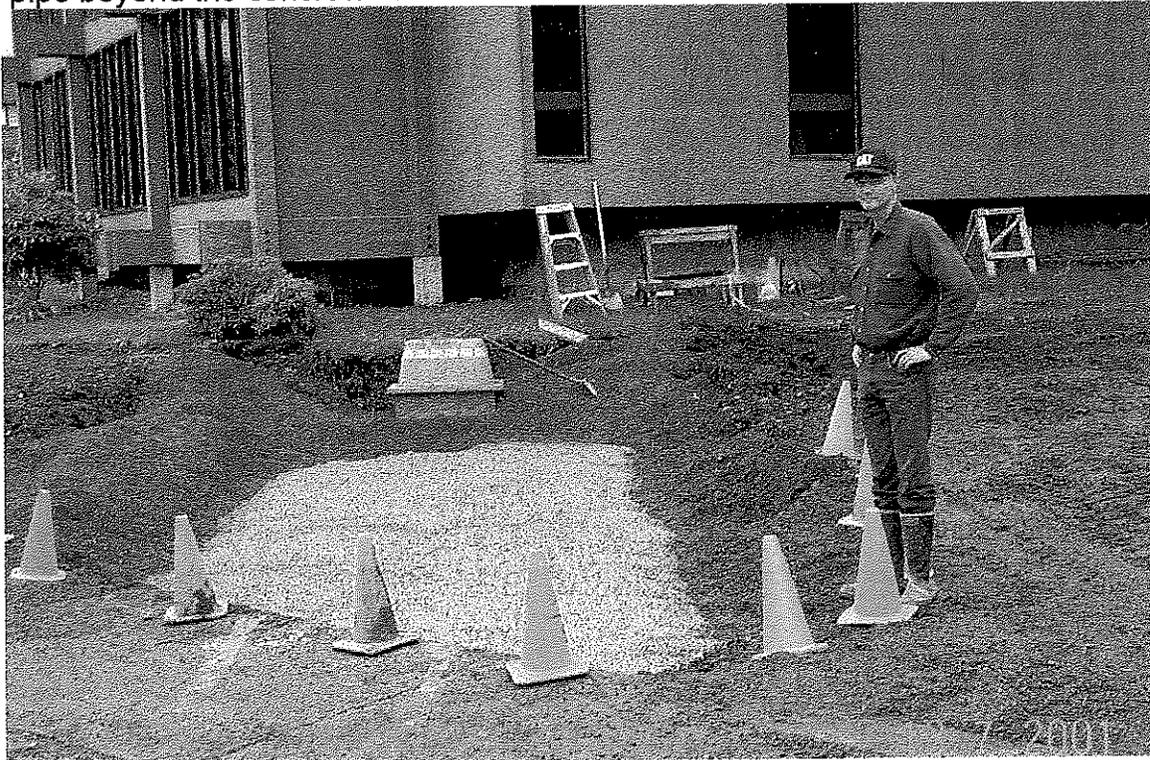
Pictures: The concrete is installed over the 42" wood stave pipe, with 6" of D1 over the top of the pipe before the 6" concrete slab was installed. Note the flow meter box for the pipe beyond the concrete slab.

Del Company finished burying the 42" wood stave pipe, put a 6" lift of D1 over it, and then installed a 6" concrete slab over the D1 to protect the wood stave pipe. They also excavated some contaminated soil from the east side of the area excavated to repair the wood stave pipe so Dan Jones could collect some samples to send off to the lab for testing.

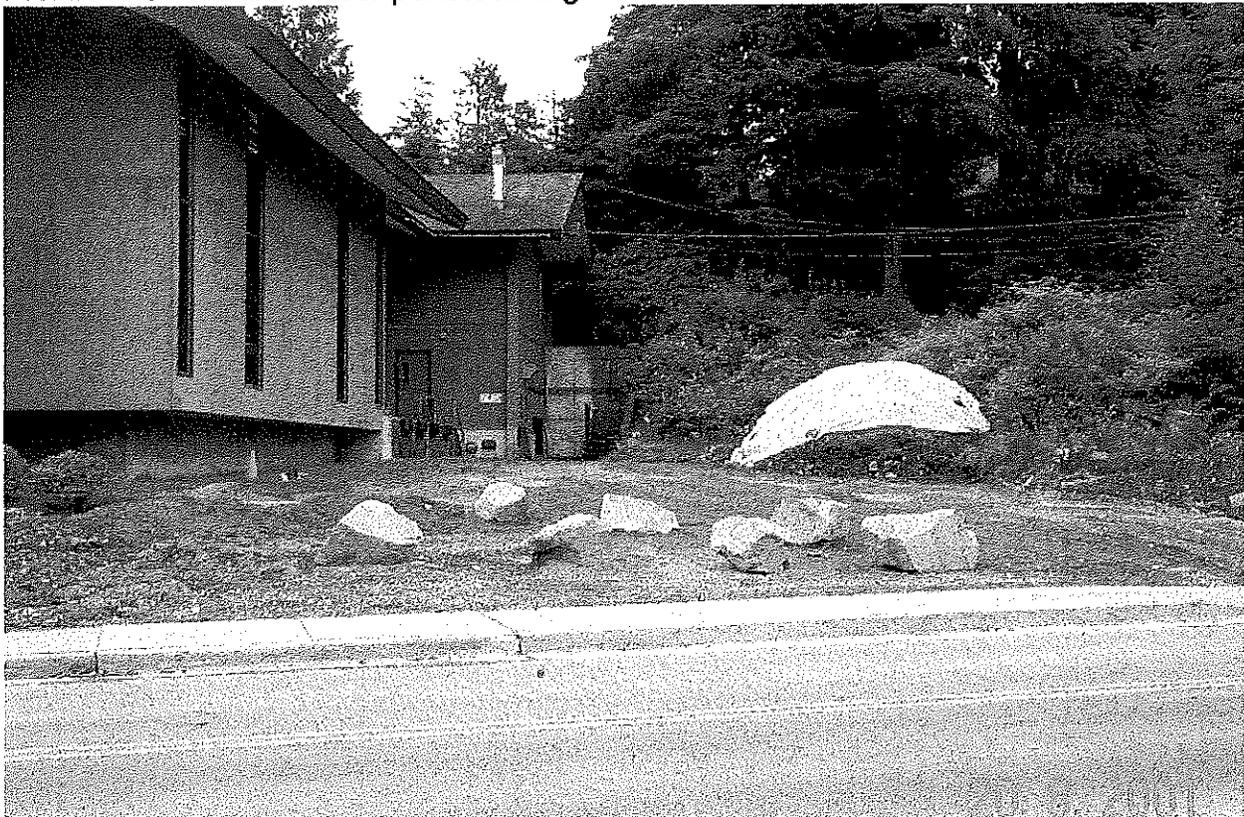
Pictures: Guard rocks over penstock alignment.

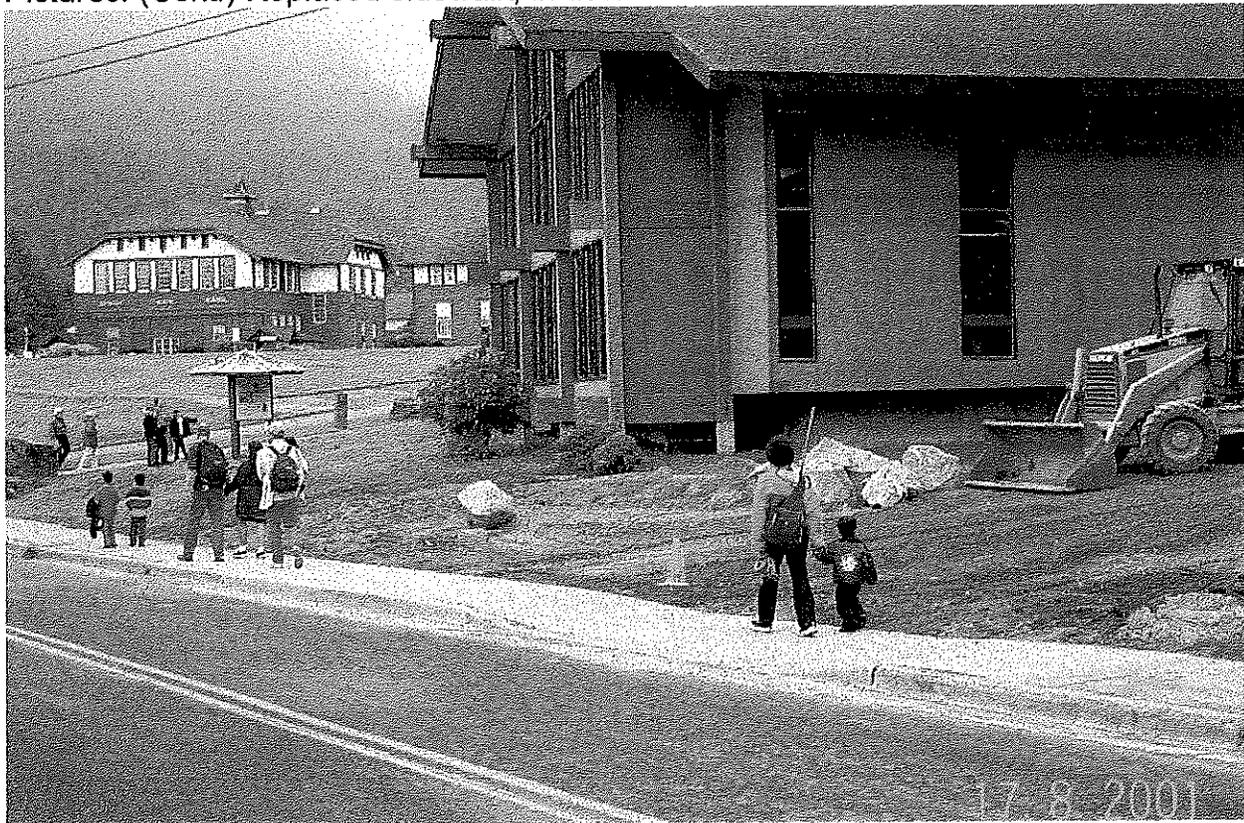
Pictures: (Cont.) Replaced sidewalk, in use.

Rennie's Concrete formed and placed new sidewalk where the original was undermined by the running water. Formwork was done late the week of 23 July, and the concrete was placed on Tuesday 31 July. The driveway for access to the rear of Stratton Library was moved slightly south from its previous location and made more narrow, in order to keep delivery vehicle off of the penstock.

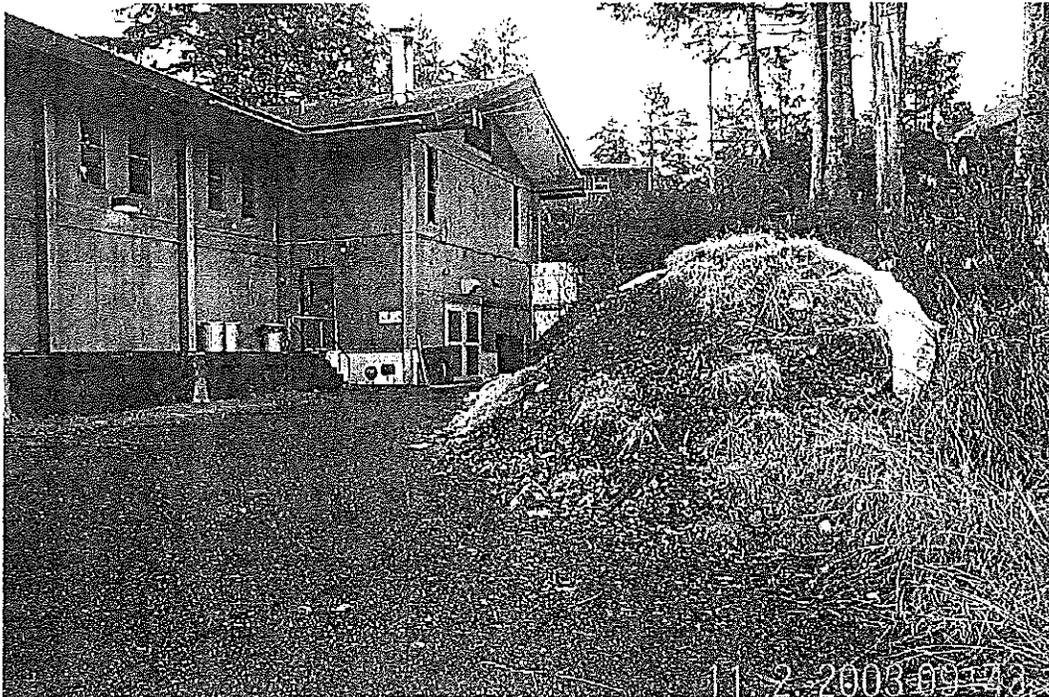
Where is the contaminated soil now located?- The soil is stockpiled just west of the penstock alignment where it was found, and south of the Stratton Library. It was not placed on a membrane, but was covered with reinforced plastic. An inspection today found that the plastic cover is currently displaced and there are weeds growing out of portions of the pile, but found no signs of leaching of contamination onto the adjacent ground. See the photo below.

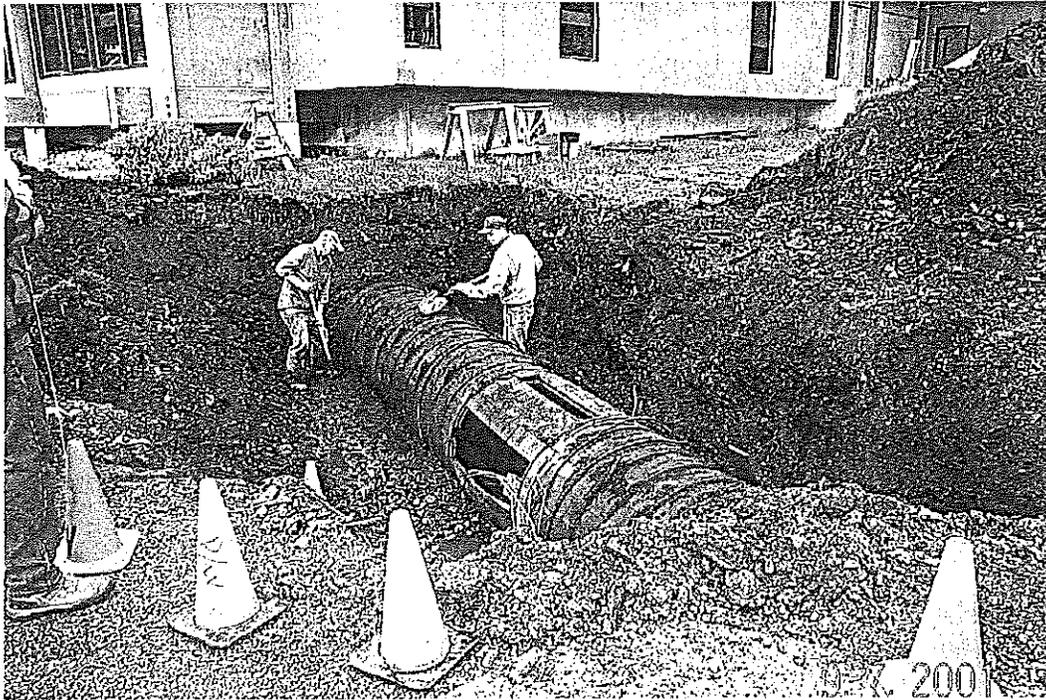
Amount of soil removed- Approximately 30 CY. This amount was removed in order to complete the work under which the discovery was made, and represents only a fraction of the material that is presumed to remain in place.

A photo of the penstock excavation indicating the extent of excavation done at that time follows on the next page.
