MEMORANDUM

RE: RESULTS OF CULTURAL RESOURCES MONITORING

PROJECT: SITKA OIL SPILL-ODCS

PROJECT SITE: SITKA, AK

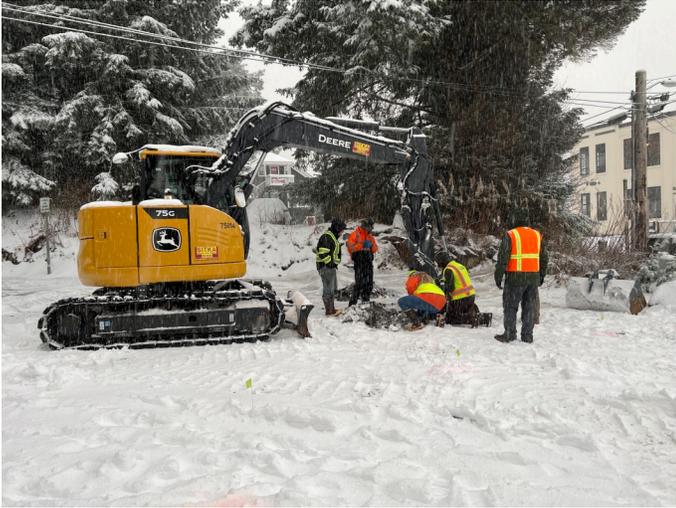
S 179°. Commencing excavation of units in the Statton Library Parking Lot.

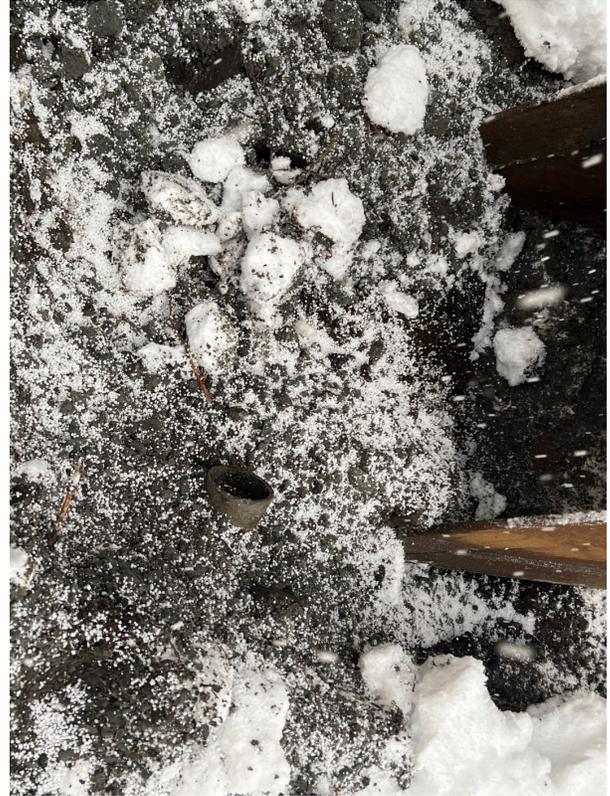
Overview of exposed utility pipe just below the surface.

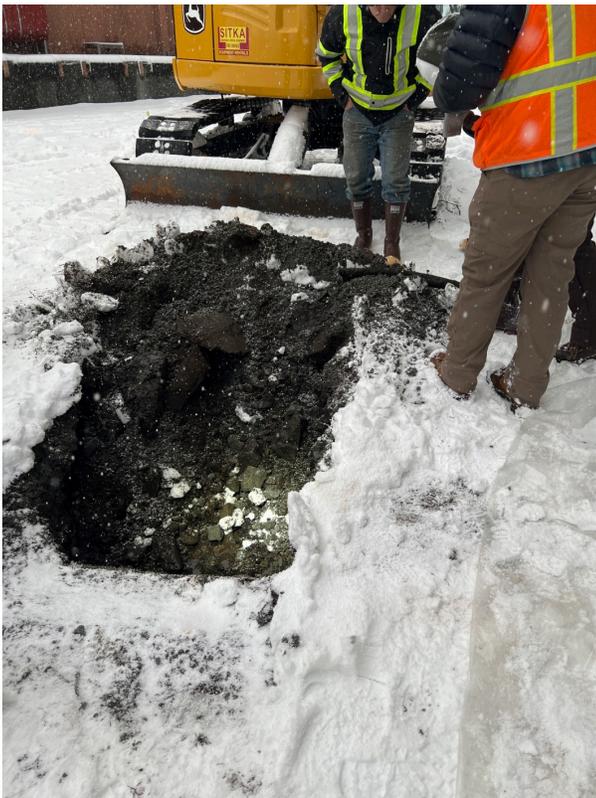
SE 57°. Removal of small likely abandoned utility pipe.

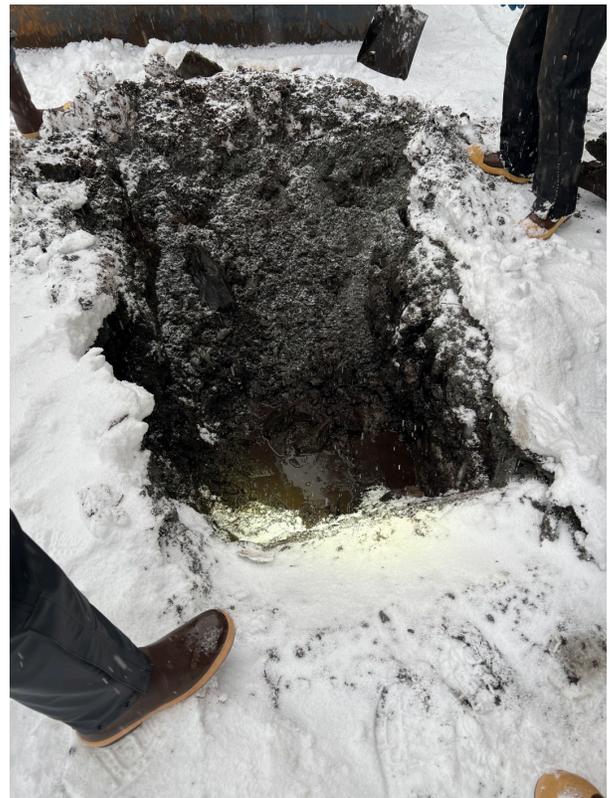
Overview of ground water at 15" below the surface.

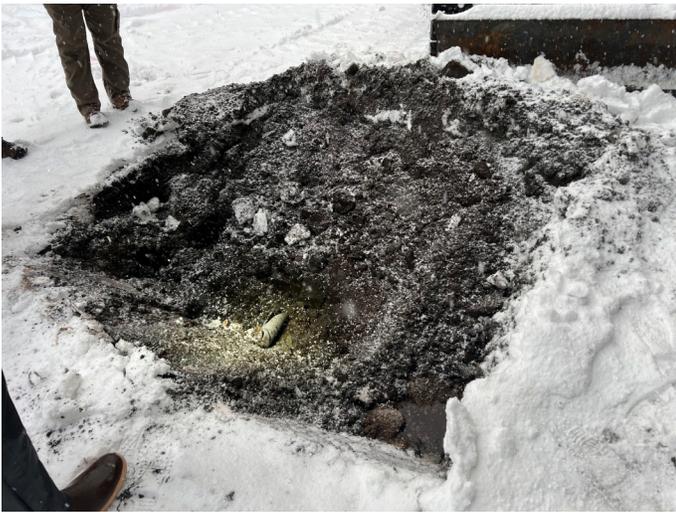
Overview of more exposed abandoned utility conduit.

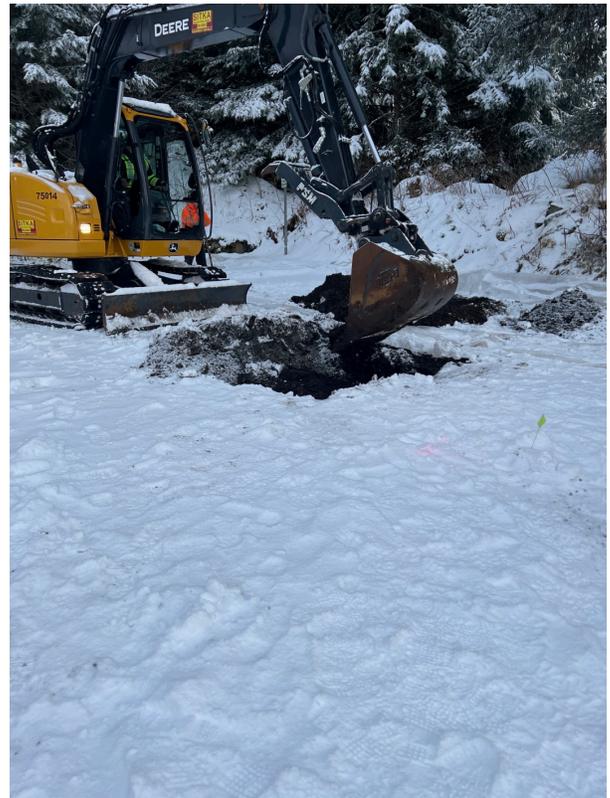
E 103°. Refilling excavated area

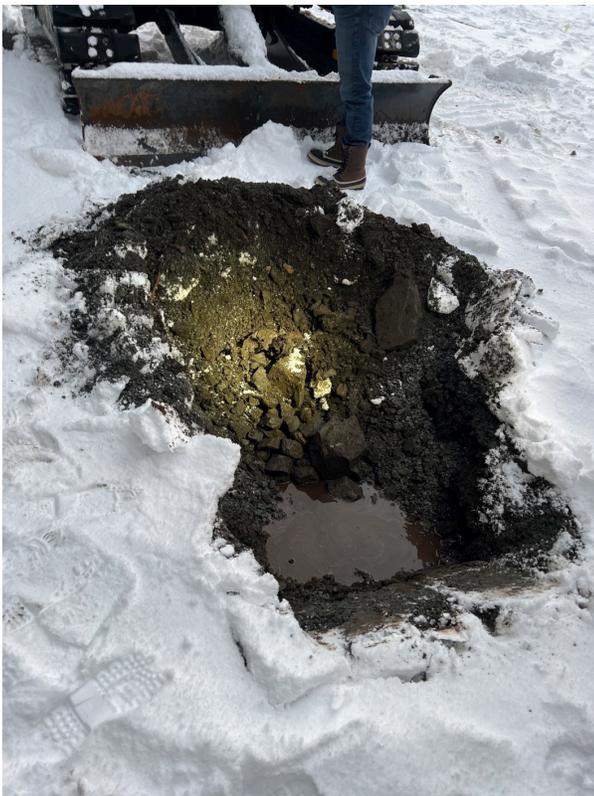
Overview of second location and ground water at 15" below the surface.

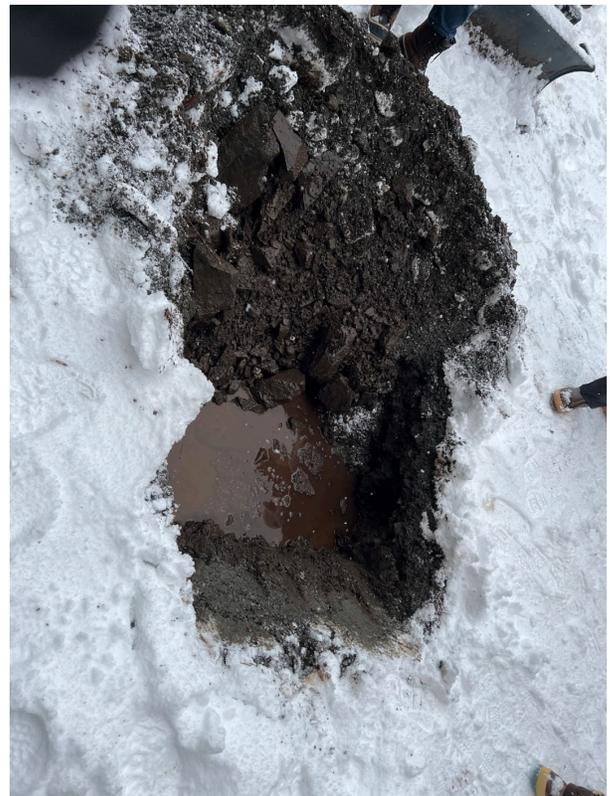
Overview of completed excavation to 2'.

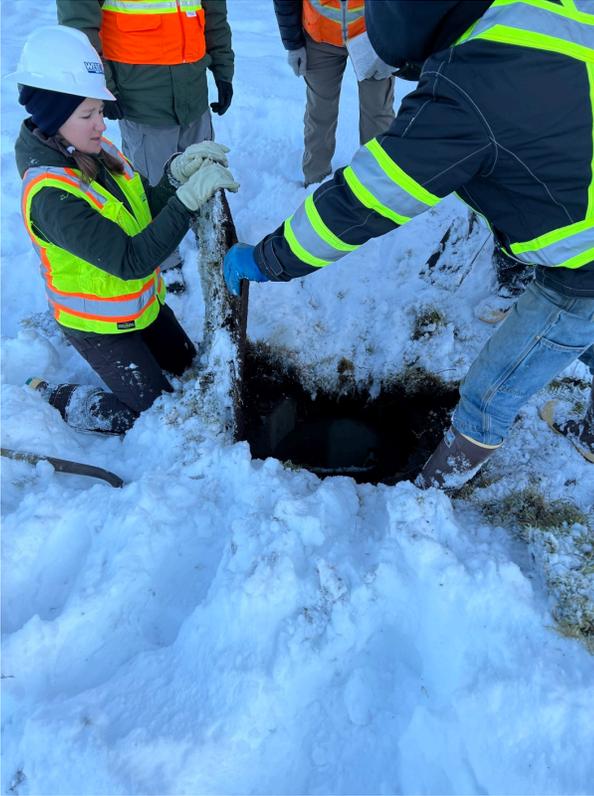
NE 38. Removal of storm drain cover.

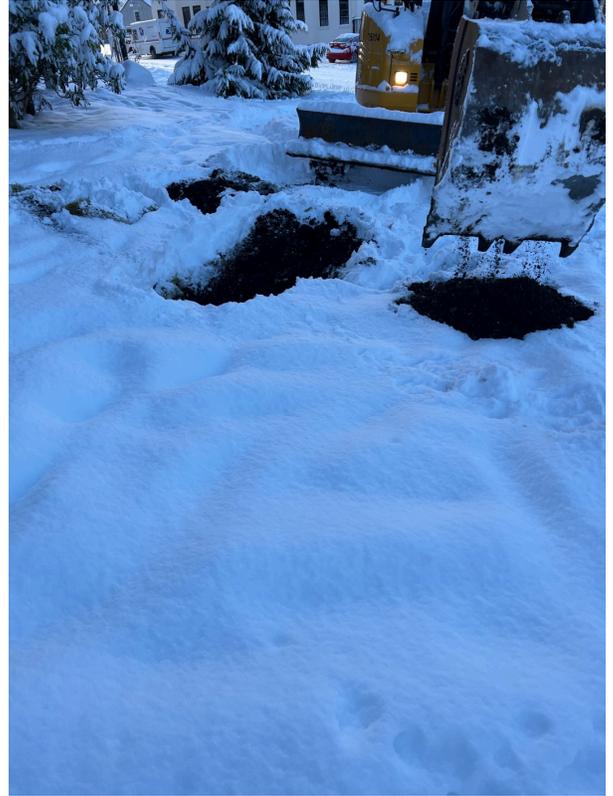
SW 210°. Overview of excavation.

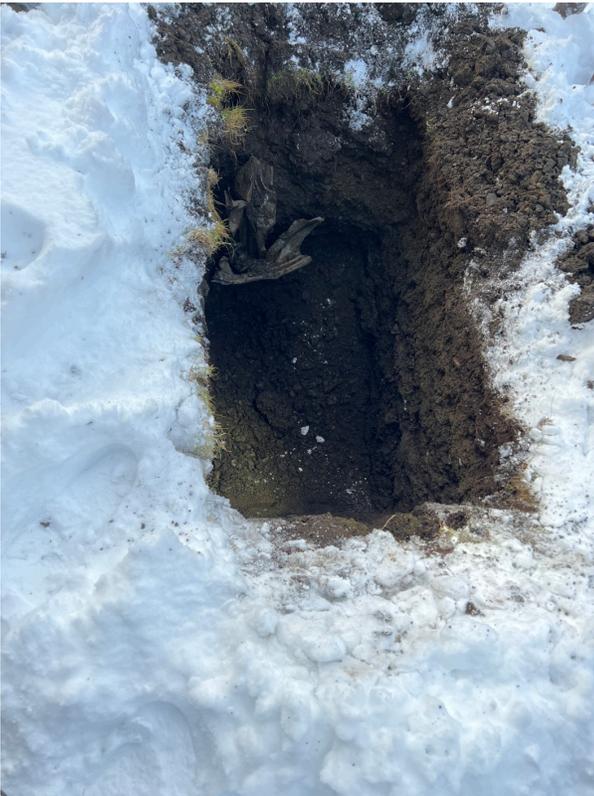
Overview of unit to 6 feet b.s.

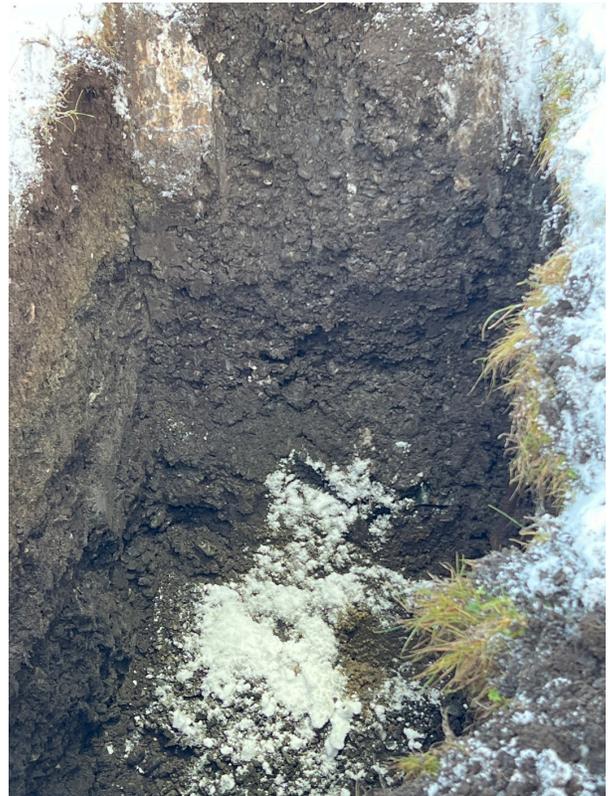
Close up of unit excavation. Snow was placed where the iron/
concrete pipe was removed.

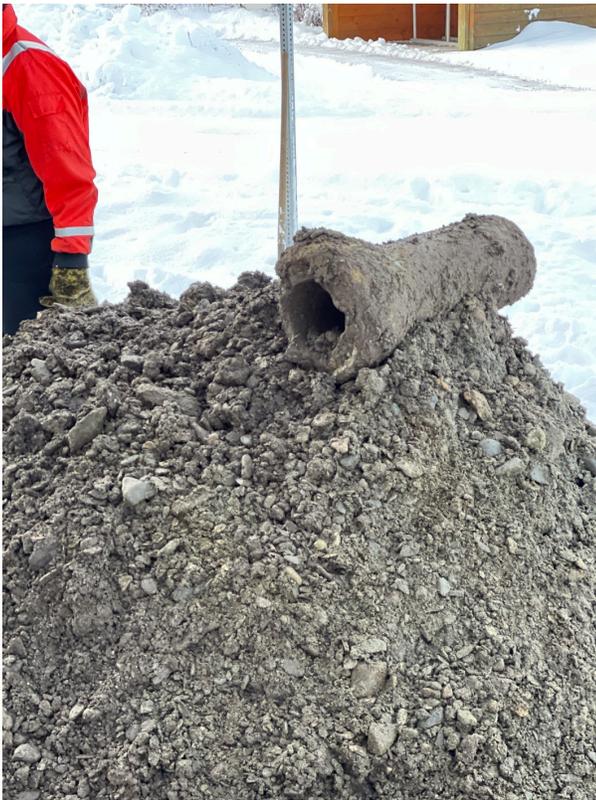
Pipe removed from the unit. Operator noted the pipe to be ductal iron, but also looks to be concrete.

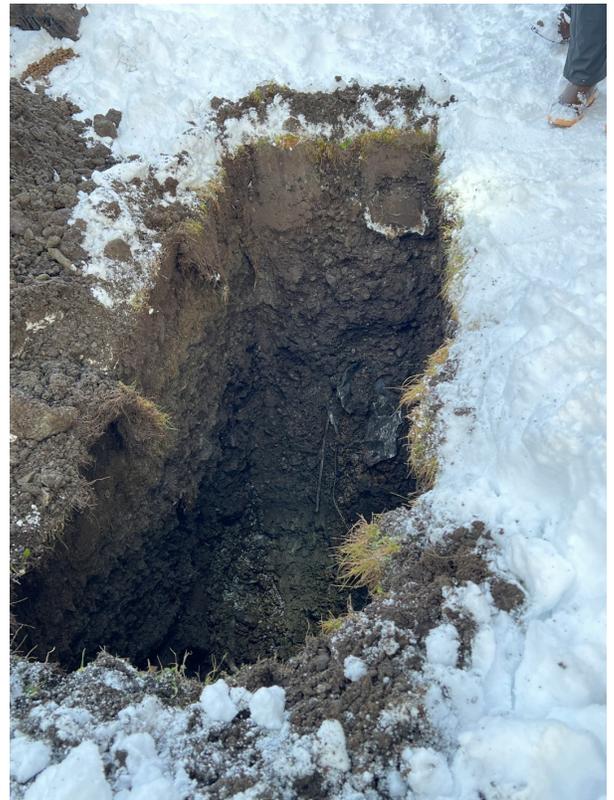
Overview of unit at 7 feet below the surface.

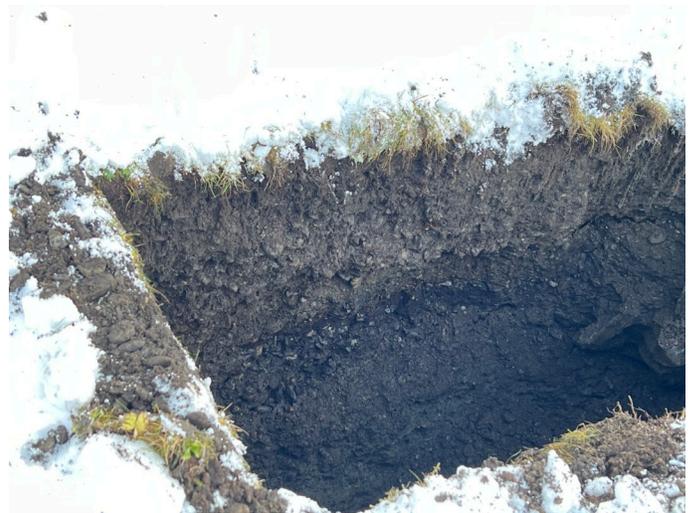
S 168°. Soil profile.

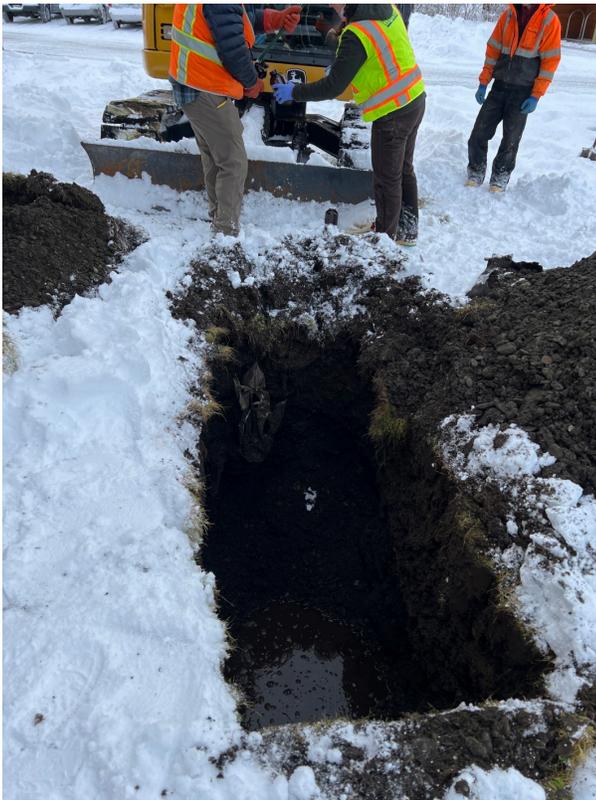
Crew sampling ground water.

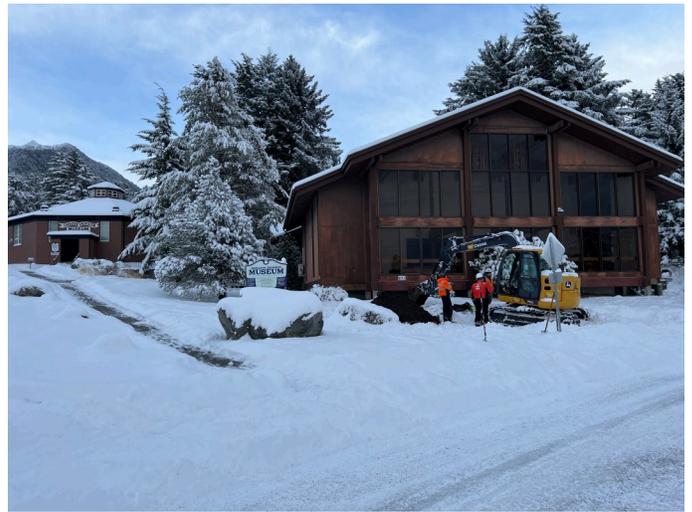
E 92°. Overview of unit location in front of the Stratton Library.
