FEDERAL ON-SCENE COORDINATOR'S AFTER ACTION REPORT FOR THE HAMBURG KAERCHER CREEK SITE HAMBURG, BERKS COUNTY, PENNSYLVANIA

Assessment Dates: April through August 2018
Removal Dates: April 16, 2019 through October 22, 2021

Tetra Tech, Inc.
240 Continental Drive
Newark, DE 19713

February 2022

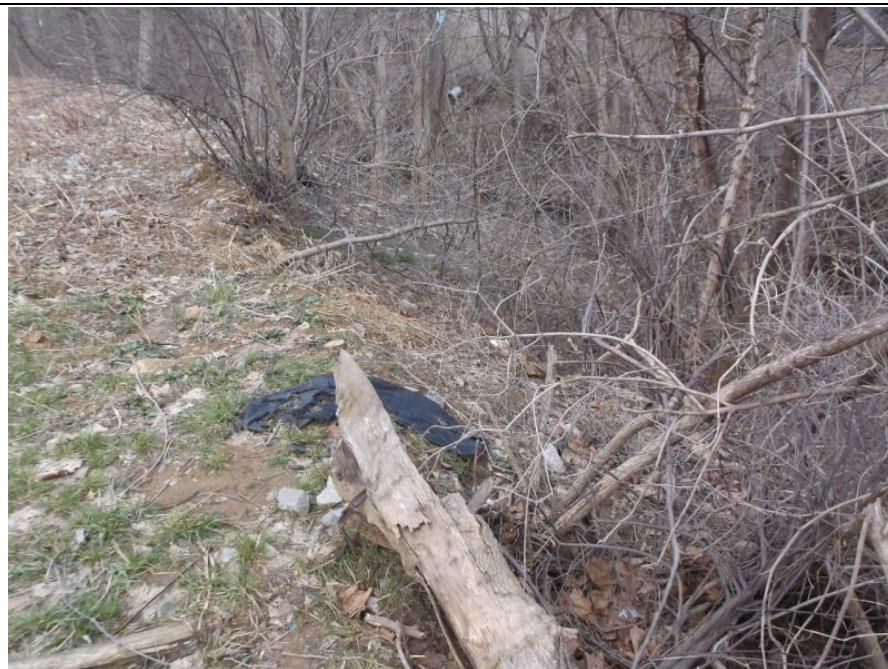
Photograph No. 2

View of exposed geotextile fabric and general erosion damage along Kaercher Creek bank.

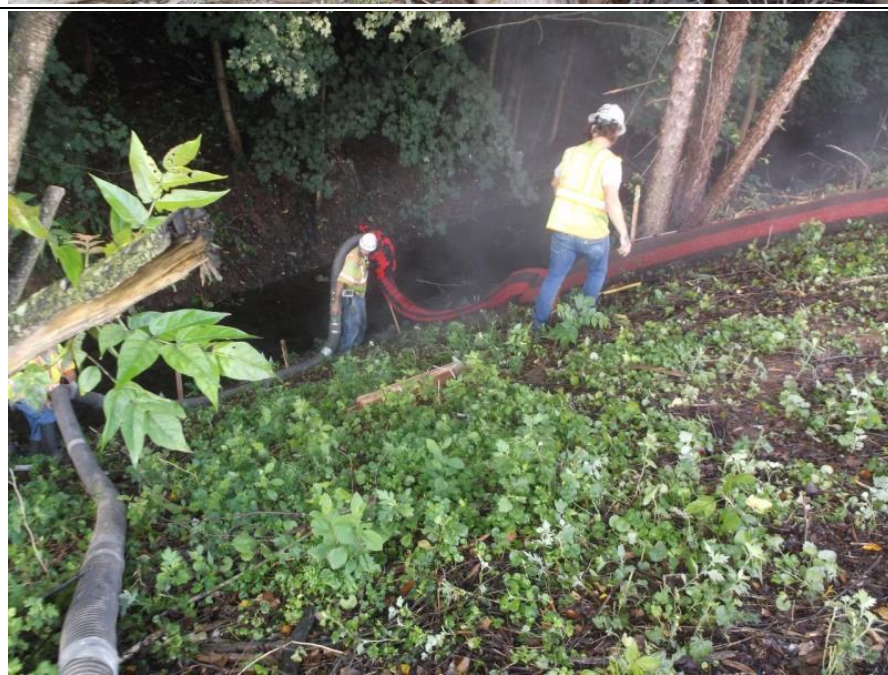
Installing 18-inch filter sock along creek bank.

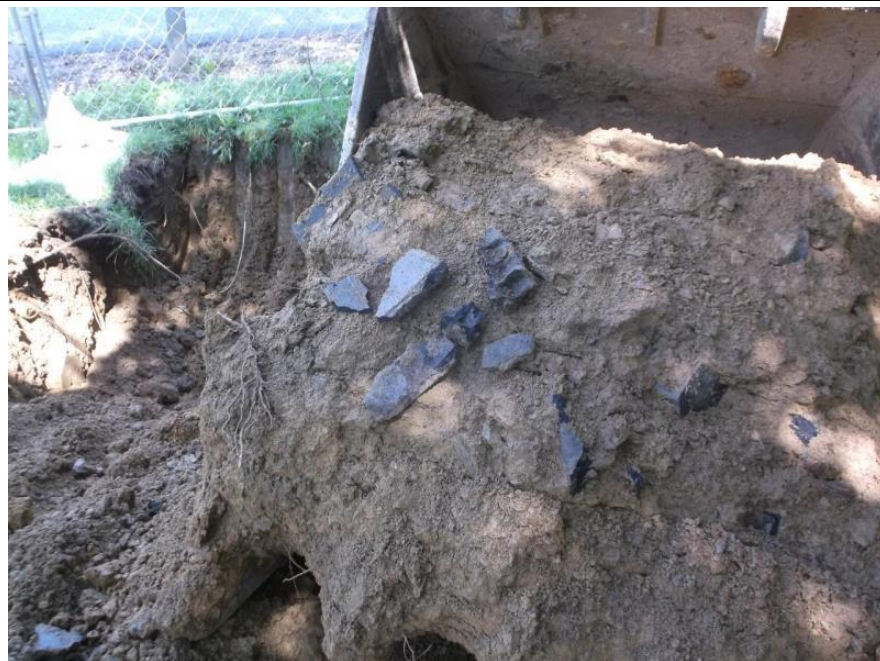
Description:
Battery fragments in excavator bucket at east end.

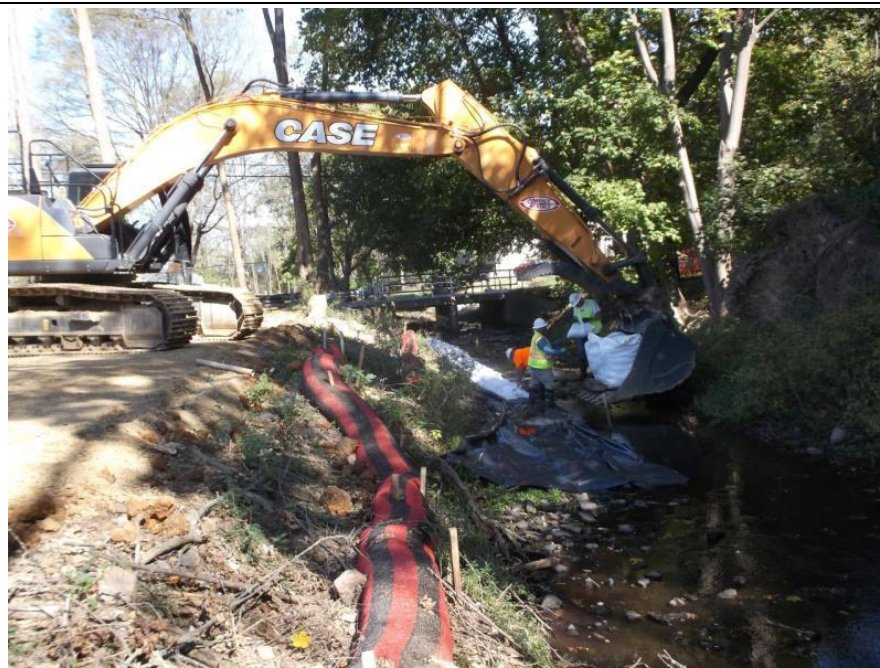
Photograph No. 4

Description:
Installing coffer dam in Kaercher Creek prior to excavation.

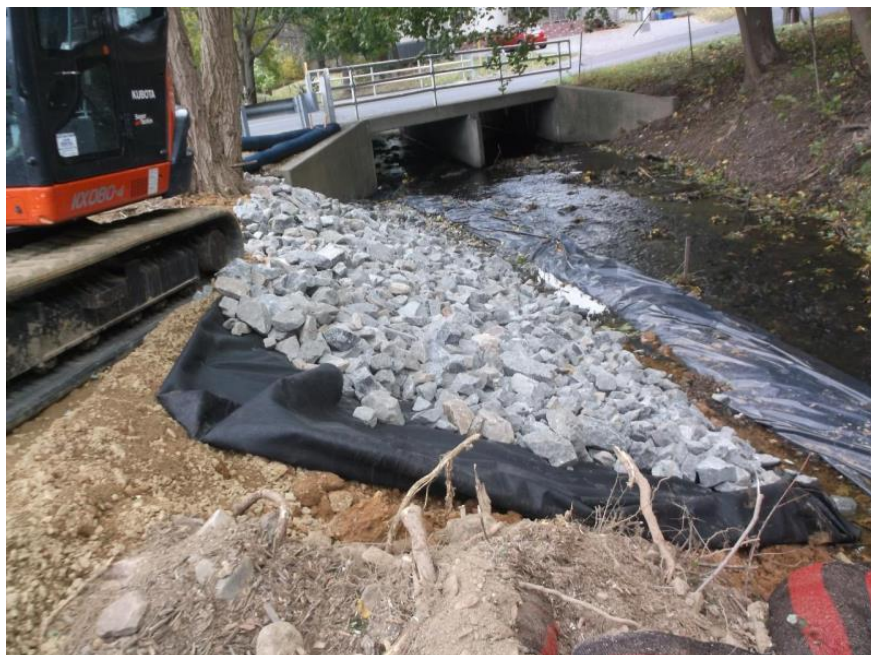
Description:
First section of completed creek bank showing the Pine Street Bridge.

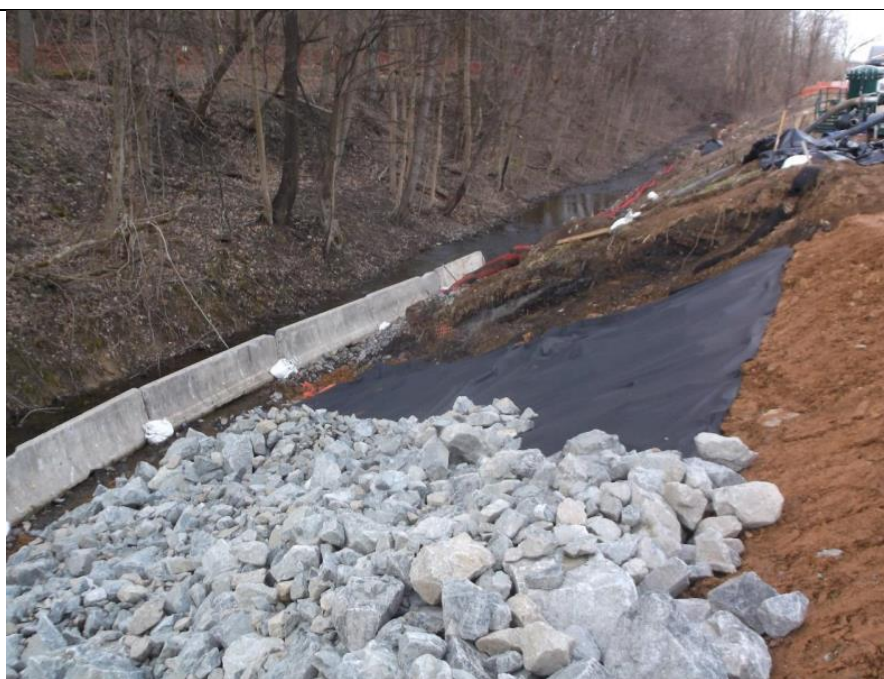
Photograph No. 6

Description:
View looking west showing coffer dam, leading edge of excavation, clay backfill, geotextile fabric, and revetment stone.

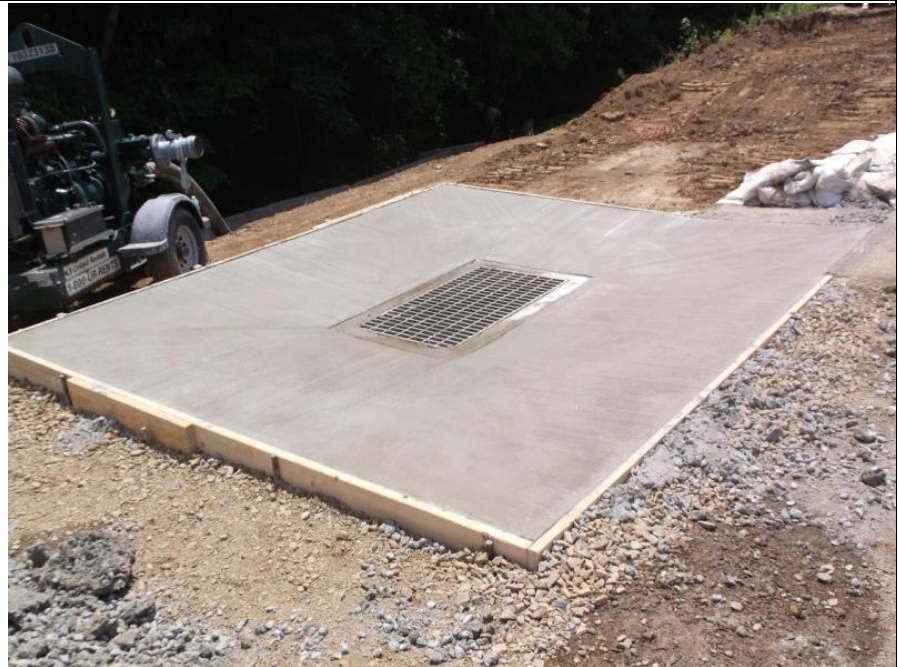
Newly installed concrete apron around storm drain inlet.

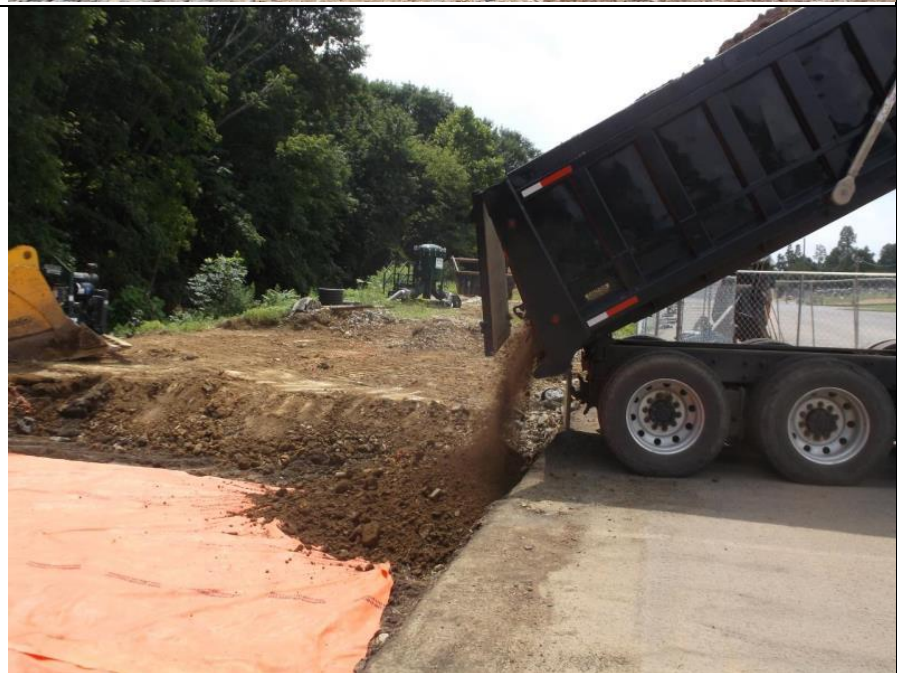
Photograph No. 10

Backfill clay being placed onto orange barrier fabric.

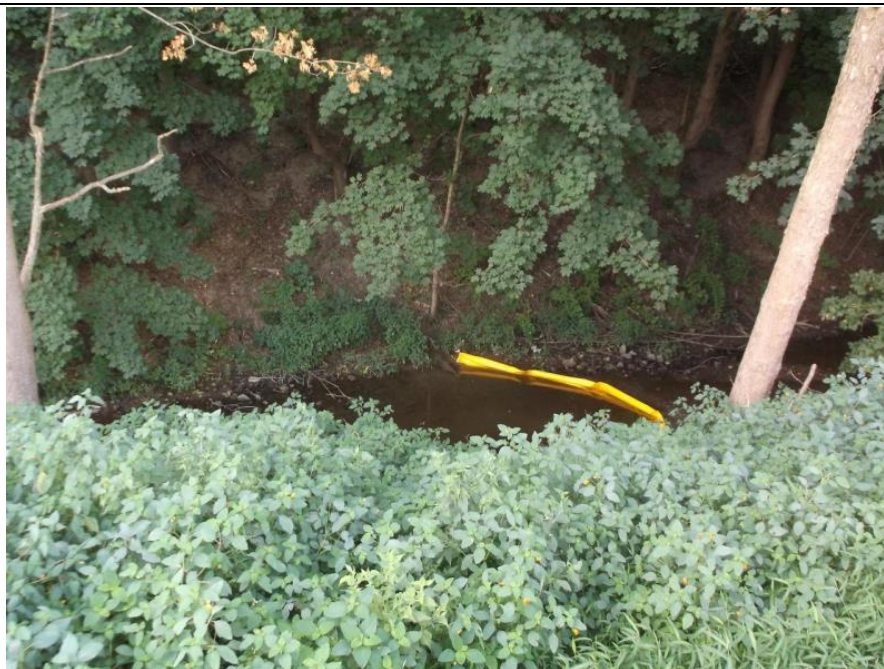
Description:
View of turbidity curtain
installed downstream (west)
of the rock check dam.

In preparation for predicted rain events and tropical storms, added erosion and sediment control measures were installed in 2020. Two turbidity curtains were installed downstream from the rock check dam to enhance stream protection from any fugitive contaminated sediment released due to the heavy precipitation events. On August 2, 2020, approximately 6 inches of rain fell in the area after a series of thunderstorms. On August 4, 2020, a tropical storm hit the area and caused a washout of the edge of the excavation. Some sediment got past the cofferdam and into the creek.

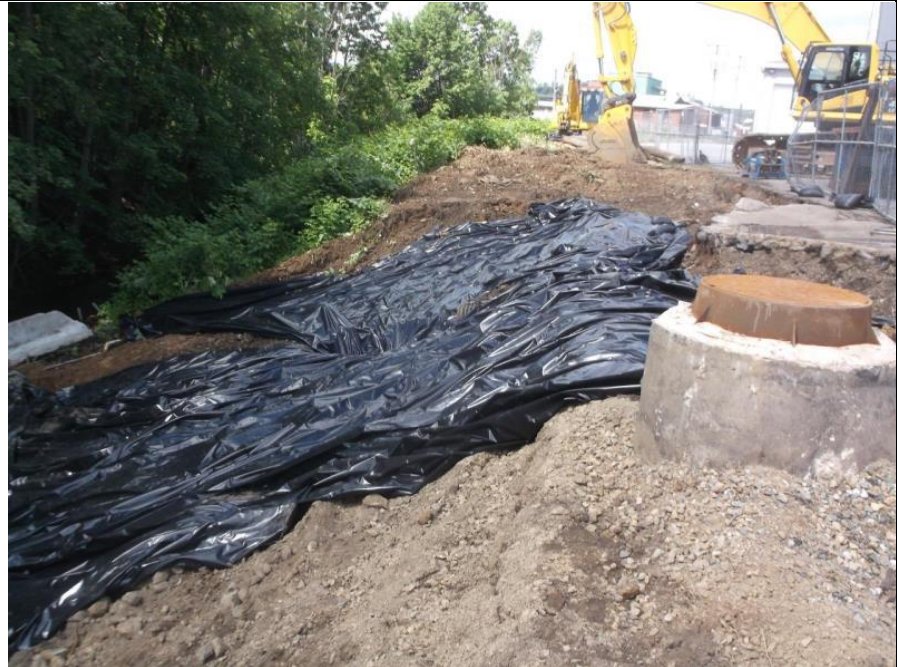
Description:
View of raised manhole and temporary poly sheeting on bank.

The Hamburg Municipal Utilities Authority needed to install extensions on two manholes in the contaminated area. ERRS assisted with the excavation of contaminated soil from around the manholes and hauled the excavated soil to the hazardous soil stockpile.

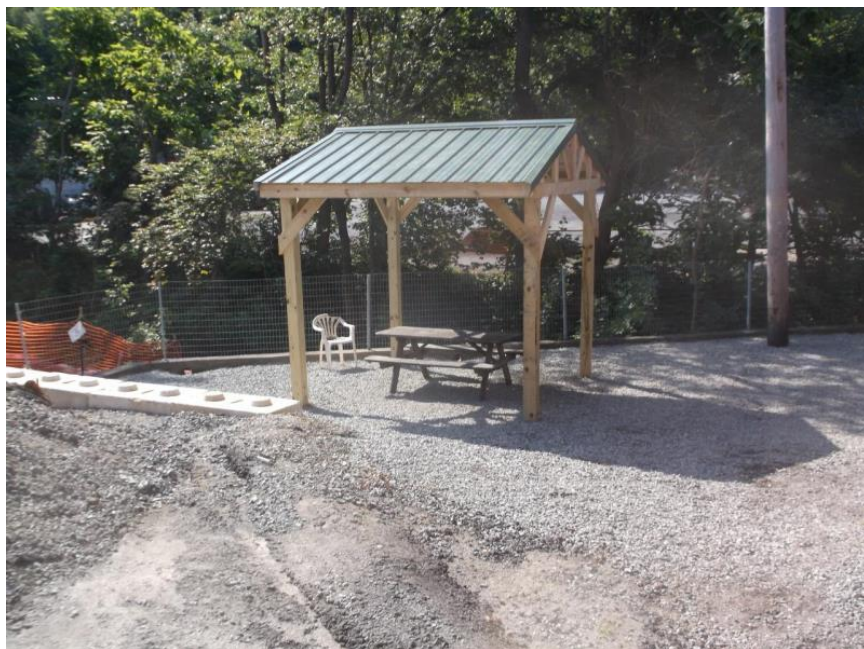
The shade structure completed. Concrete block retaining wall shown.

The area adjacent to the rear of the foundry was excavated and restored with crushed stone. A 10-foot by 10-foot shade structure was constructed in this area after restoration activities were complete. This shade structure provides foundry employees with a break area with shade since all trees previously providing shade were removed to remediate the area.

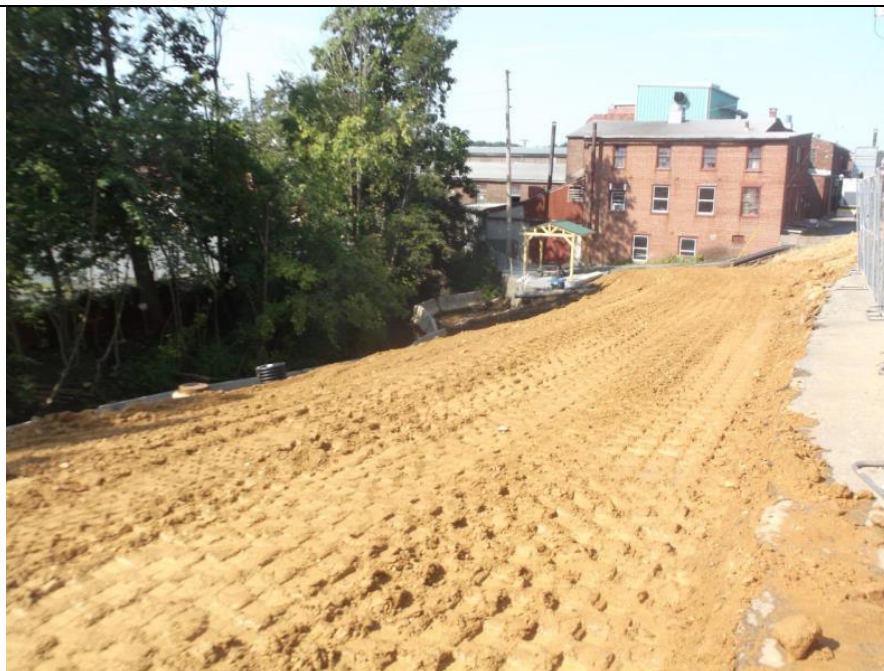
Description:
View of backfill clay after being compacted with a sheep's foot roller. Foundry seen in background.
