Prepared for:
U.S. EPA Region 8

Prepared By:
Weston Solutions, Inc.
START IV

FIGURE 1
SITE LOCATION MAP
FORMER GUEST HOUSE
YANKTON SIOUX
TRIBE PROPERTIES
MARTY, SOUTH DAKOTA

St. Katherine's, Marty Indian School (Floor Plan) and Sample Locations
 1989 Asbestos Inspection and 2013 TBA Phase II Inspection

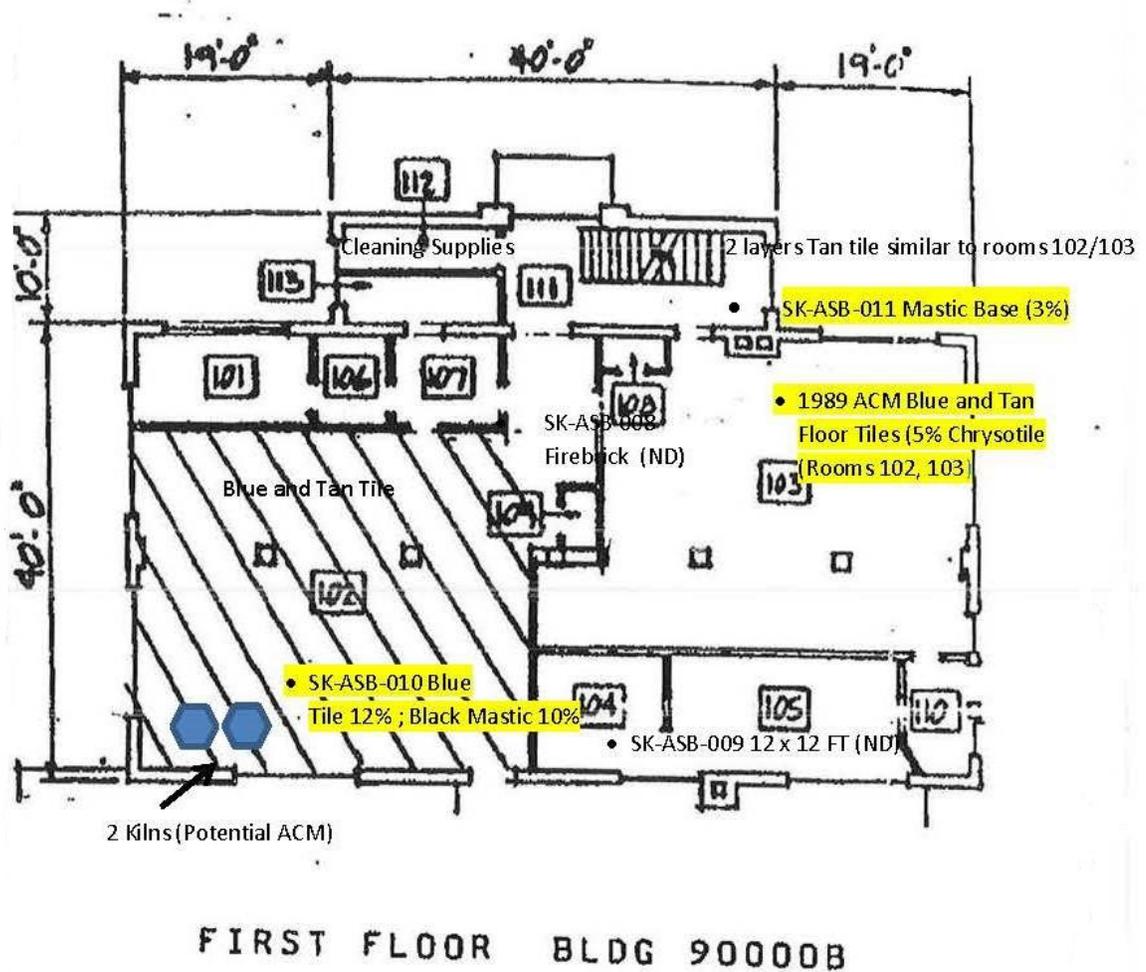
Figure 3. Floor Plan and Sampling Locations (1st Floor)

Components with ACM > 1% highlighted in yellow (2013 and 1989 sampling)

Emergency Lights and Exit Signs (lithium batteries)

Light Fixtures (fluorescent light bulbs)

No Soil samples – surrounded by concrete sidewalks

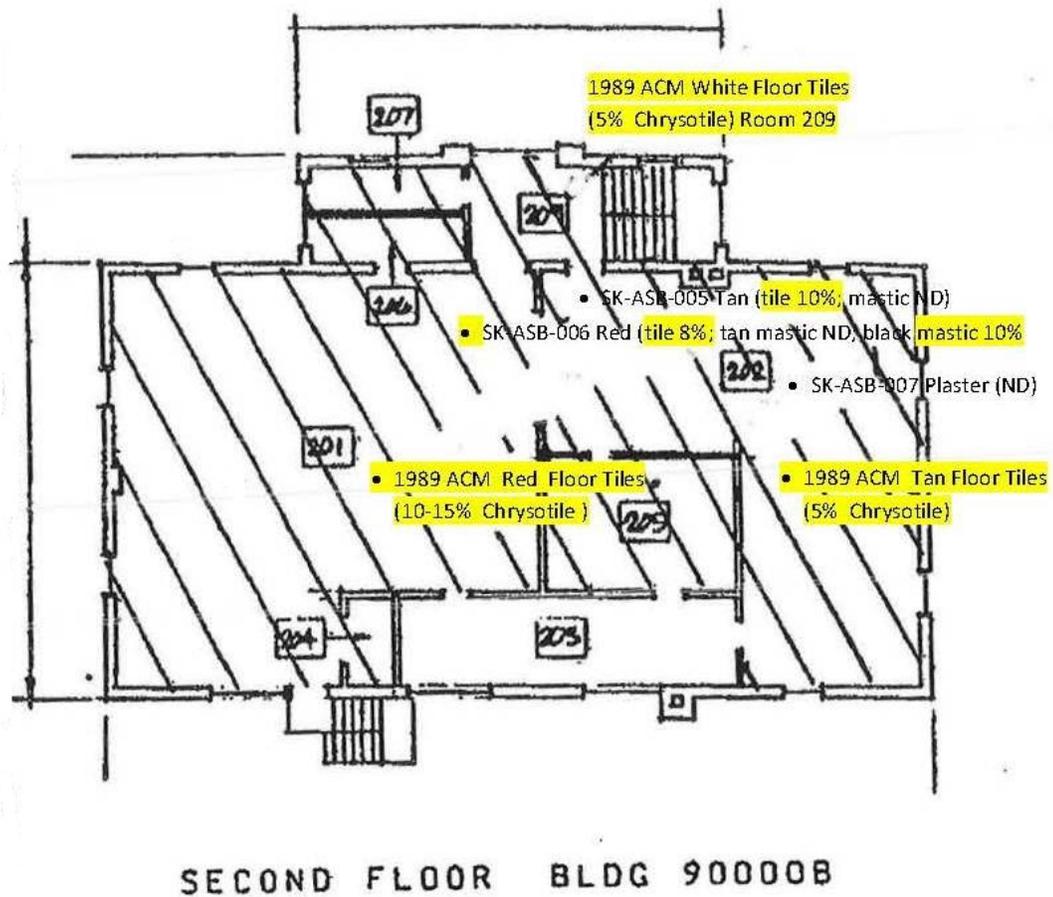
Figure 4. Floor Plan and Sampling Locations (2nd Floor)

Components containing >1% ACM highlighted in yellow (2013 and 1989 samples)
Emergency Lights and Exit Signs (lithium batteries)
Light Fixtures (ballasts/fluorescent bulbs)

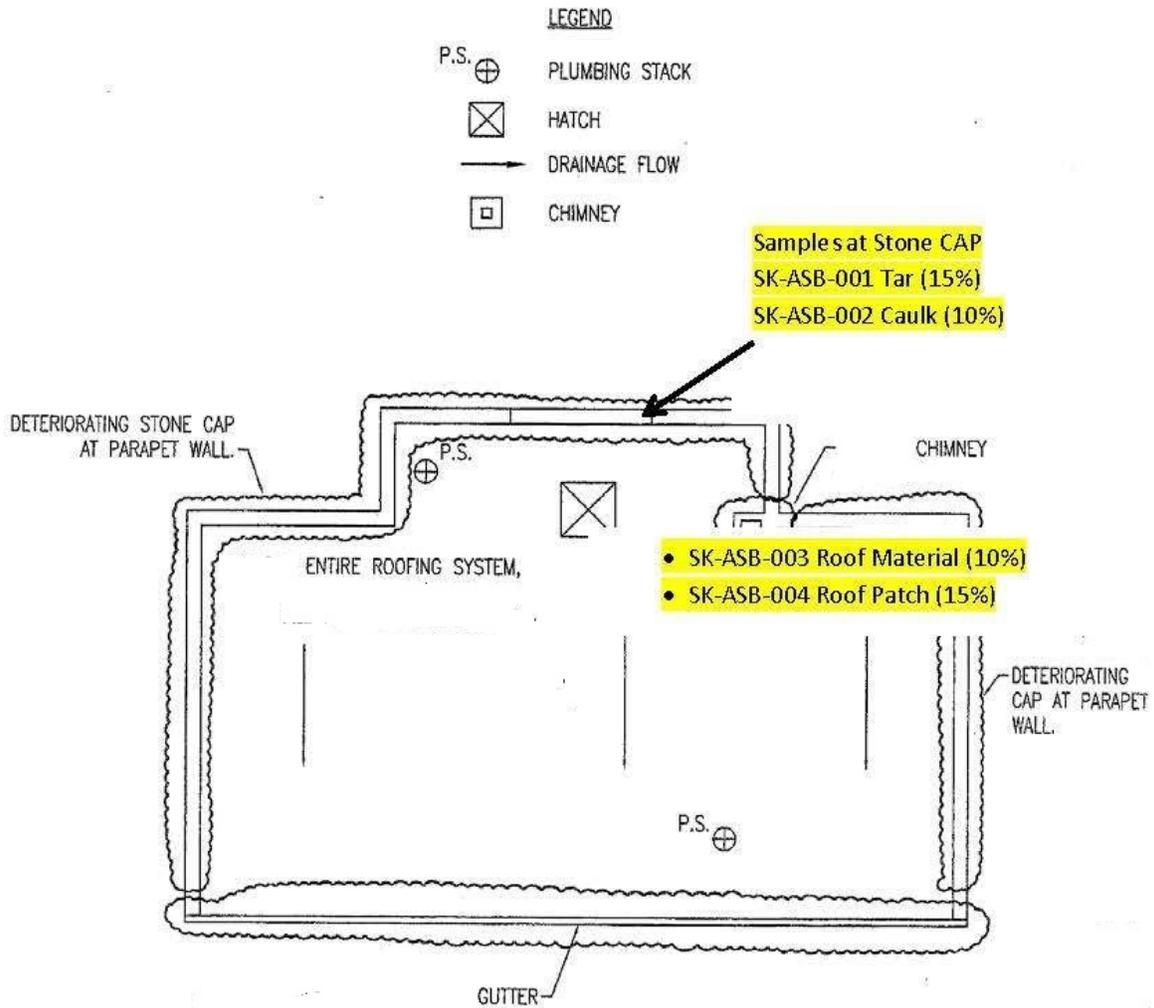
Figure 6. Floor Plan and Sampling Locations (Roof)

Components containing >1% ACM highlighted in yellow
