Prepared for:
U.S. EPA Region 8

Prepared By:
Weston Solutions, Inc.
START IV

FIGURE 1
SITE LOCATION MAP
FORMER GUEST HOUSE
YANKTON SIOUX
TRIBE PROPERTIES
MARTY, SOUTH DAKOTA

St. Joseph's, Marty Indian School Floor Plans and Sampling Locations
1989 Asbestos Inspection and 2013 TBA Phase II Inspection

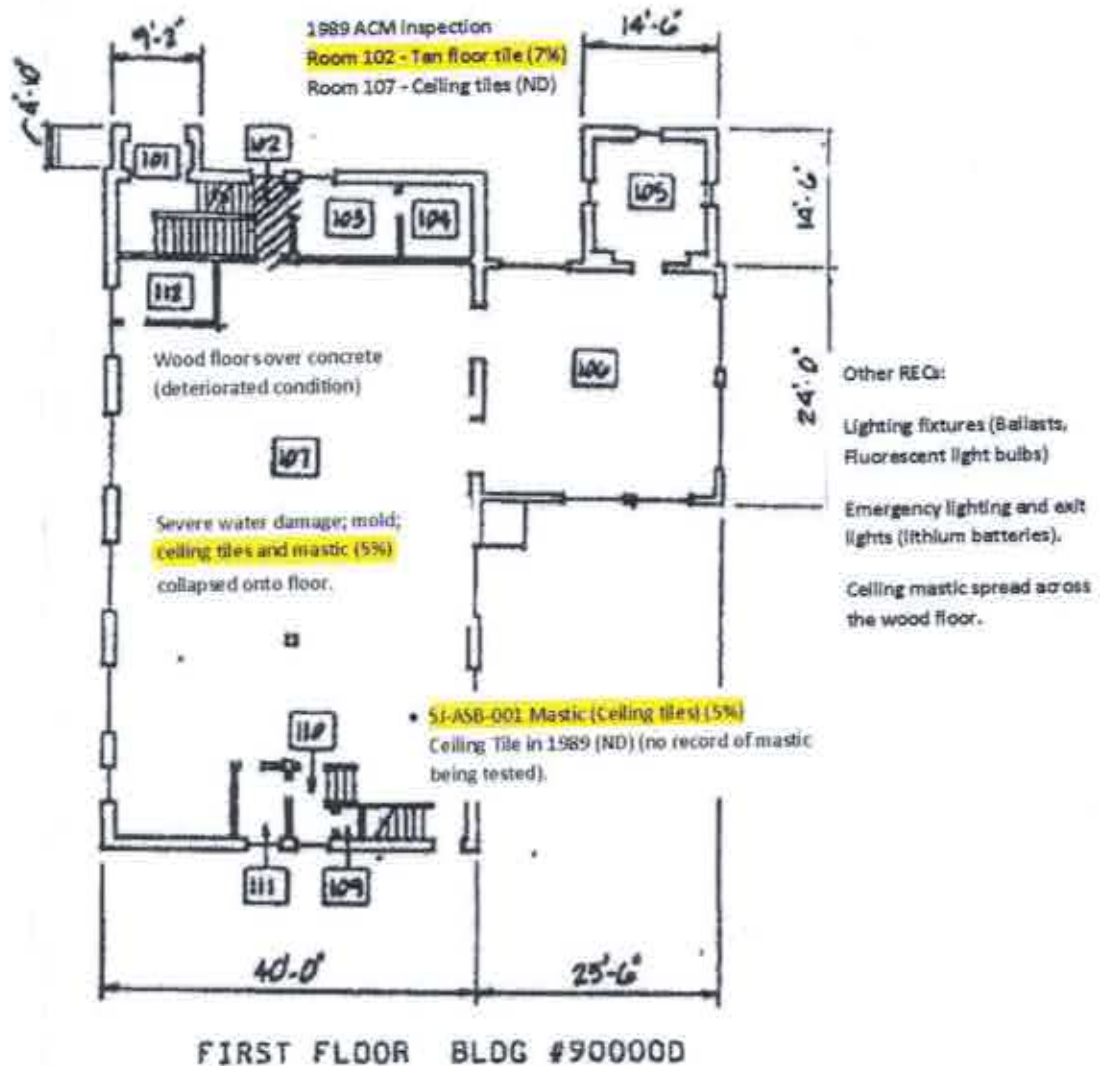
Figure 3. Floor Plan and Sampling Locations (1st Floor)

Only one interior sample (ceiling tile mastic) was taken (at entrance) due to health and safety issues: live pigeons roosting; pigeon feces, extreme mold, odor, deteriorating floor and ceiling conditions. EPA WAM Stephanie Metz was notified of condition. Photographs were taken and included in Appendix. One XRF reading was taken at exterior window. Based on results, composite soil samples were collected at each external wall.

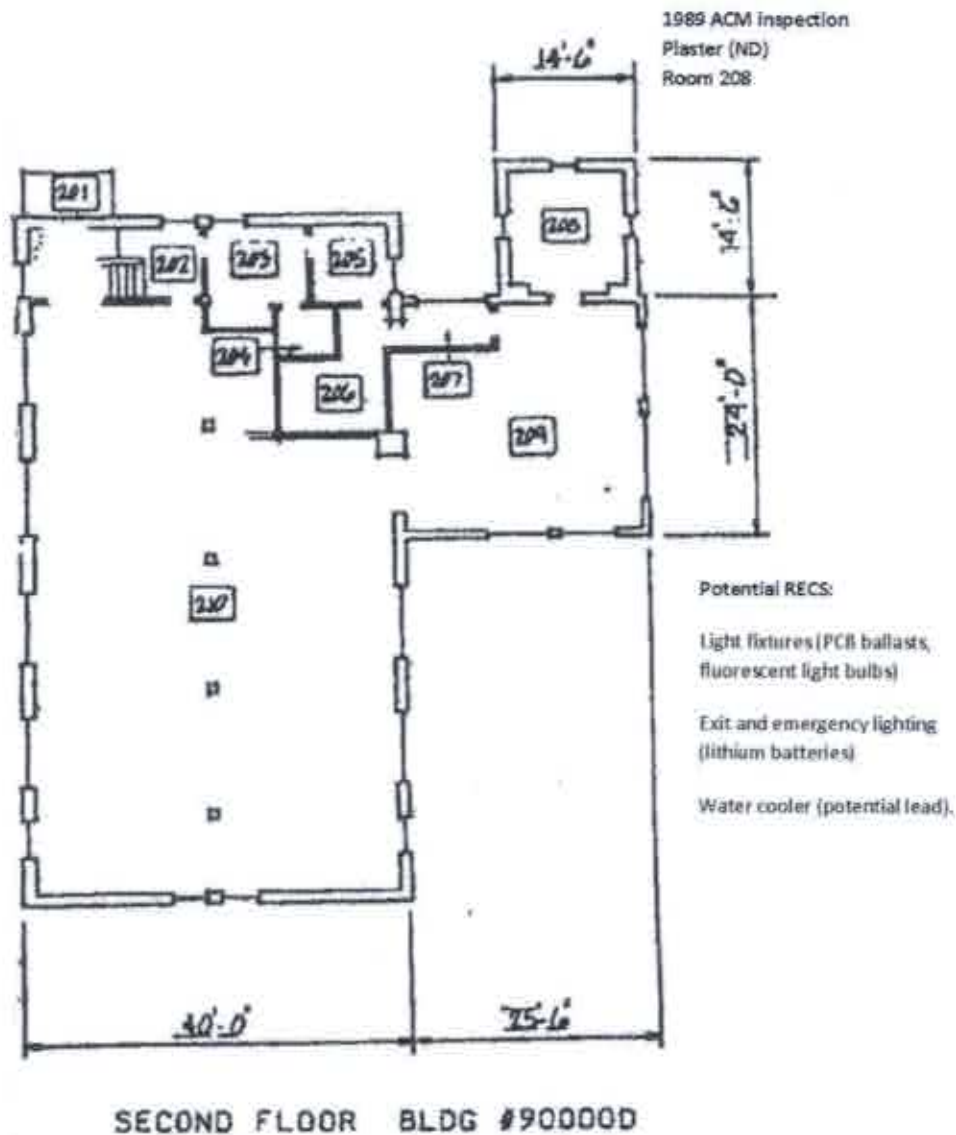
Figure 4. Floor Plan and Sampling Locations (2nd Floor)

Did not sample in the 2nd floor due to pigeon feces, deteriorating floor and ceiling conditions, and presence of mold. Photographs were taken and included in Appendix.

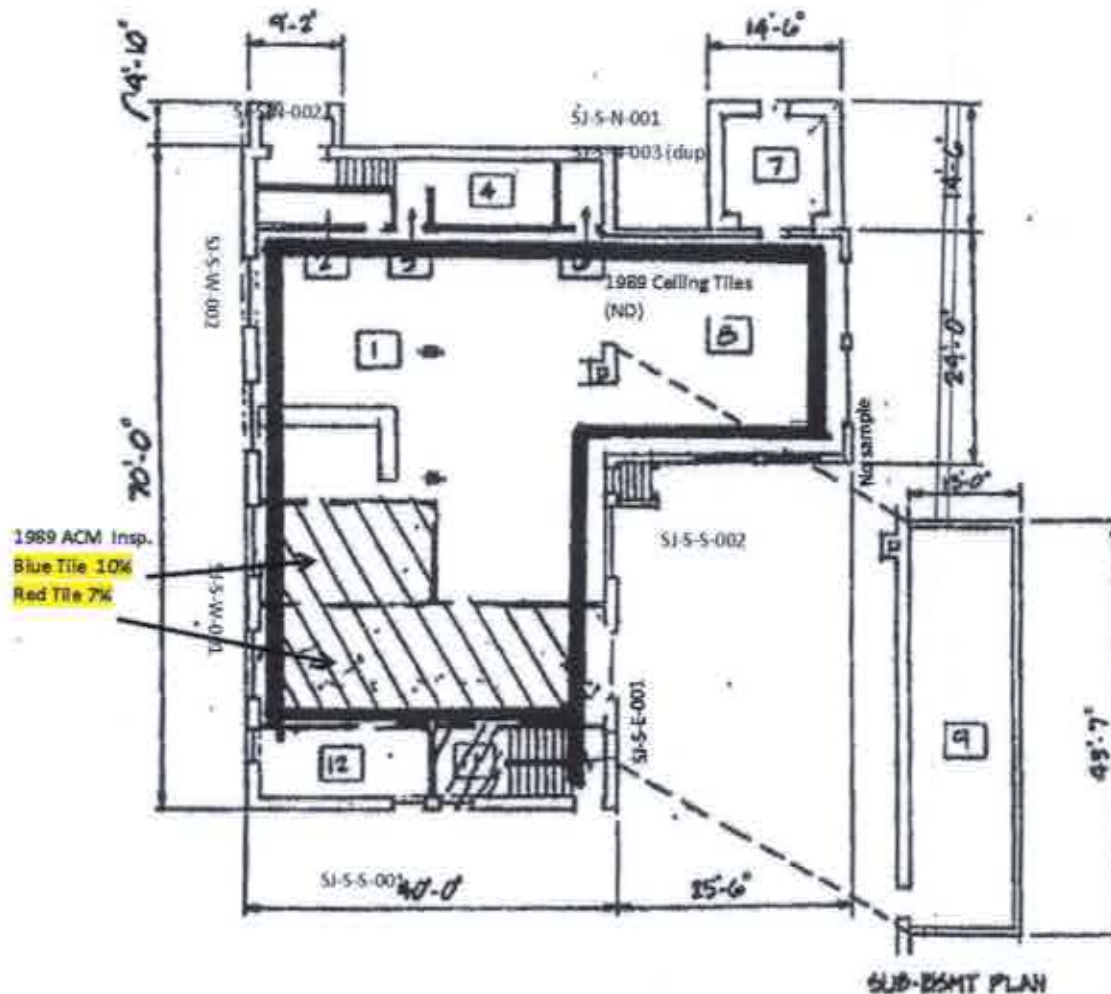
Figure 5. St. Joseph's Floor Plan and Sampling Locations (Basement)

Did not sample in the basement due to 20+ live pigeons roosting; pigeon feces, extreme mold. Photographs were taken and included in Appendix. Building has health and safety issues. EPA WAM was notified on 9/25 of intention not to sample. Cleaning supplies and paint were stored in basement. Photographs provided in Appendix. Sub-basement was not accessed.
