Phase II Environmental Site Assessment (ESA) Building Materials

**GLACIER HOTEL
15 1ST AVENUE SW
CUT BANK, MONTANA**

SWEETGRASS DEVELOPMENT

AUGUST 2016

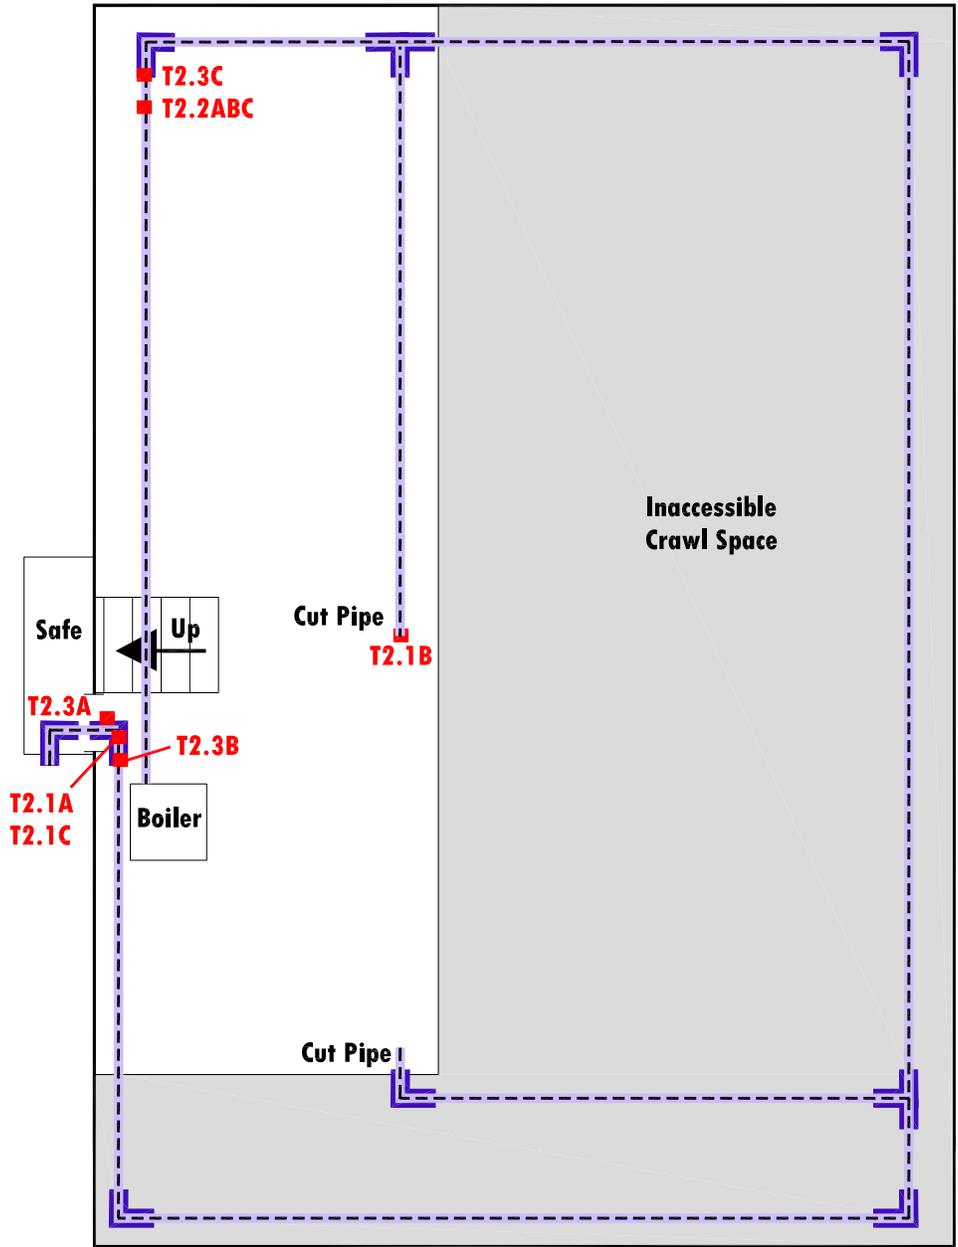
Original Hotel (Building A) - Basement
Asbestos Sample Locations
Glacier Hotel
Cut Bank, Montana
Figure 3a

- Tan Pipe Insulation – Regulated Asbestos-Containing Material (RACM) – Hotel Unfinished Basement
- Gold Pipe Insulation (RACM) – Hotel Unfinished Basement

- Off-White Pipe Insulation (RACM) – Hotel Unfinished Basement
- Window Glazing (Category II non-friable ACBM) – Hotel Exterior
- Yellow Mastic (Category I non-friable ACBM) – Hotel Kitchen Storage Area

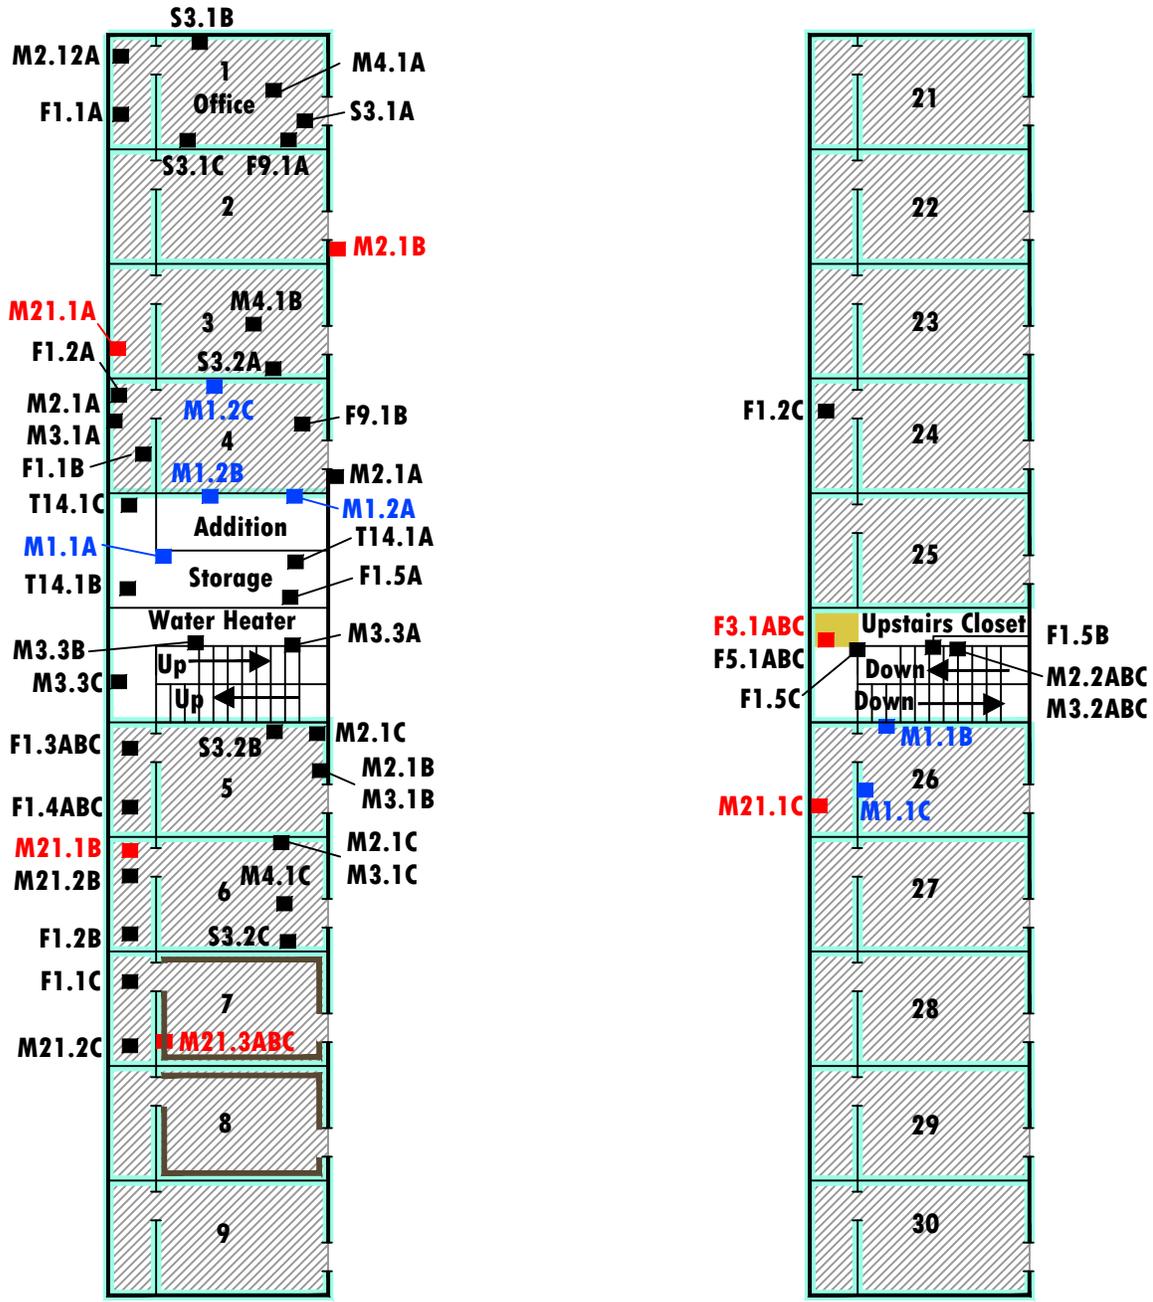
Motel (Building D)
 Asbestos Sample Locations
 Glacier Hotel
 Cut Bank, Montana
 Figure 7

Note: Entire Roof of Office Building Will Need Abatement

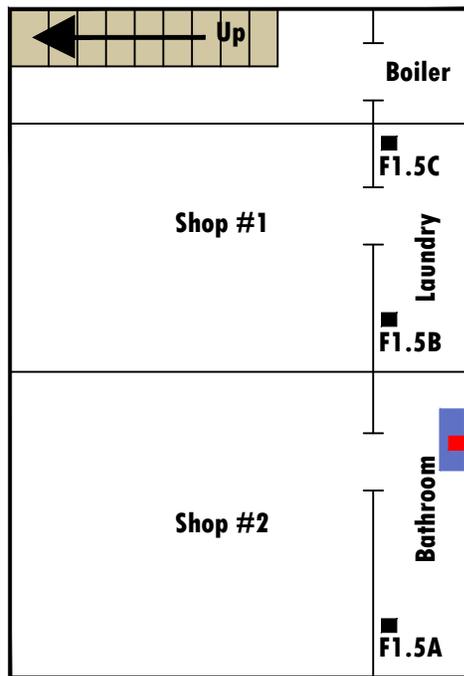
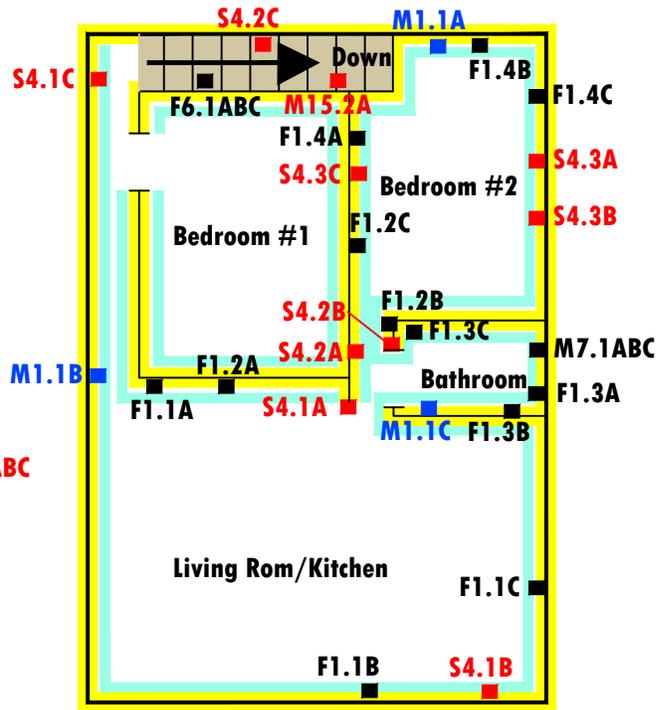
Motel Office (Building E)
Asbestos Sample Locations
Glacier Hotel
Cut Bank, Montana
Figure 8

Note: Entire Roof of Office Building Will Need Abatement

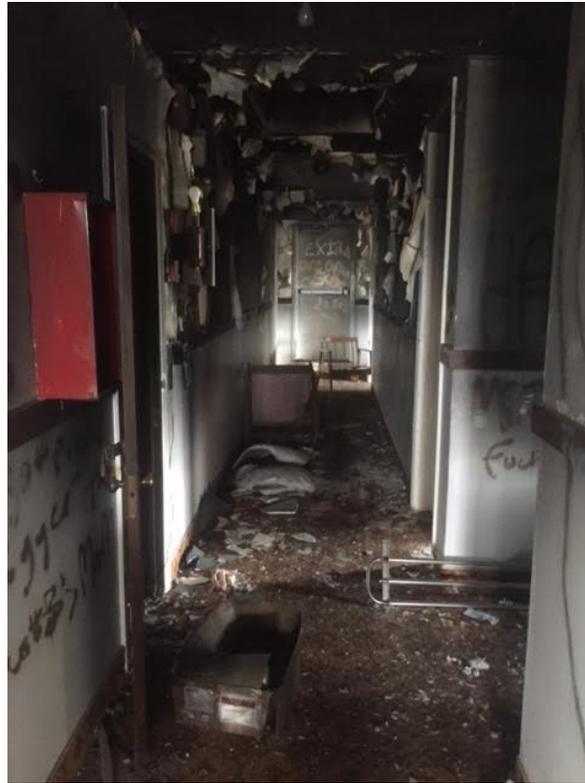
- Fire damage is present in three areas of the hotel. One fire occurred in the hotel laundry room, and another on the third floor. Severe fire damage is present in both of these areas. Fire damage also appears to be present in the unfinished basement, though the fire's occurrence could not be confirmed by the Cut Bank municipal fire department. Fire damage has raised concerns regarding the structural integrity of the building in affected areas.

Photo 1. Fire damage on the third floor hall of the hotel/lounge, facing east.

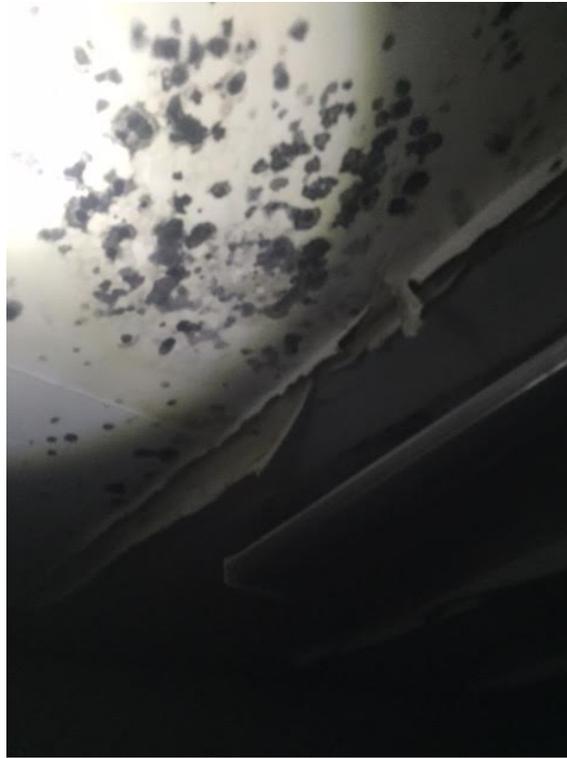
- Water damage present throughout the hotel appears to be the result of the operation of fire suppression systems and a leaking roof.
- Severe mold growth observed throughout the hotel is likely related to the observed water damage.

Photo 3. Black mold on the ground floor ceiling of the hotel/lounge building.

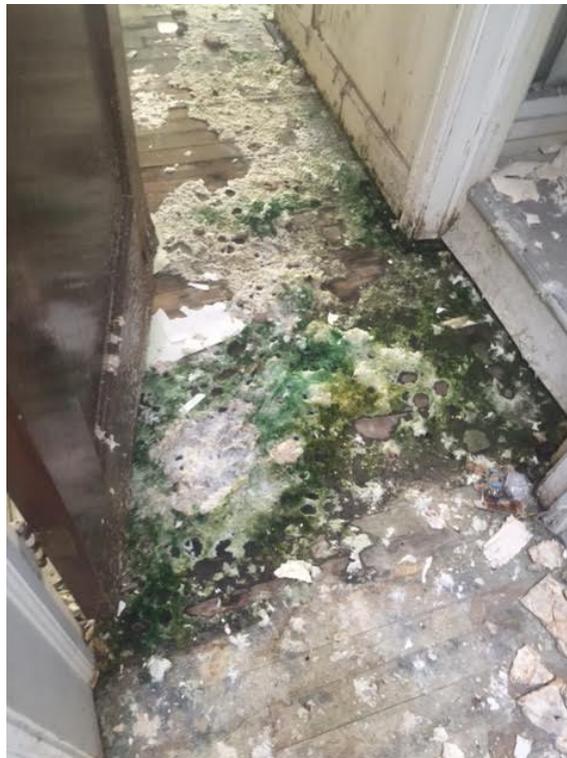
Photo 4. Mold on the second floor of the hotel/lounge building.

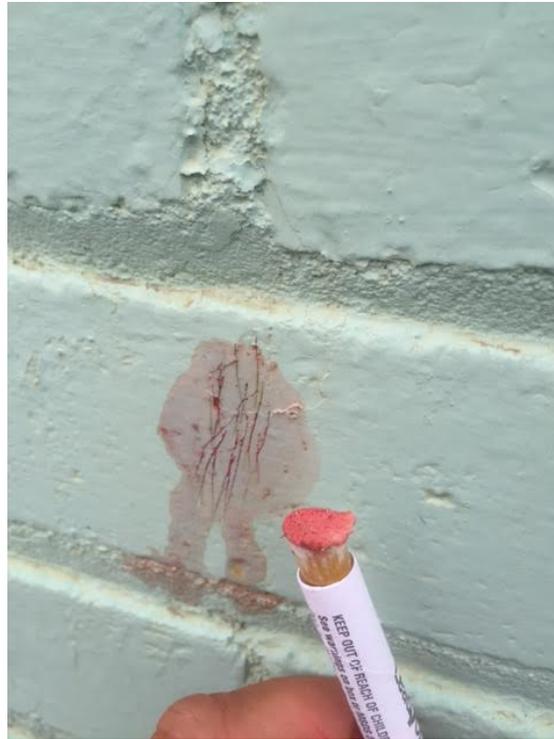
Photo 5. Positive lead check on the green paint on the north wall of the hotel/lounge building.

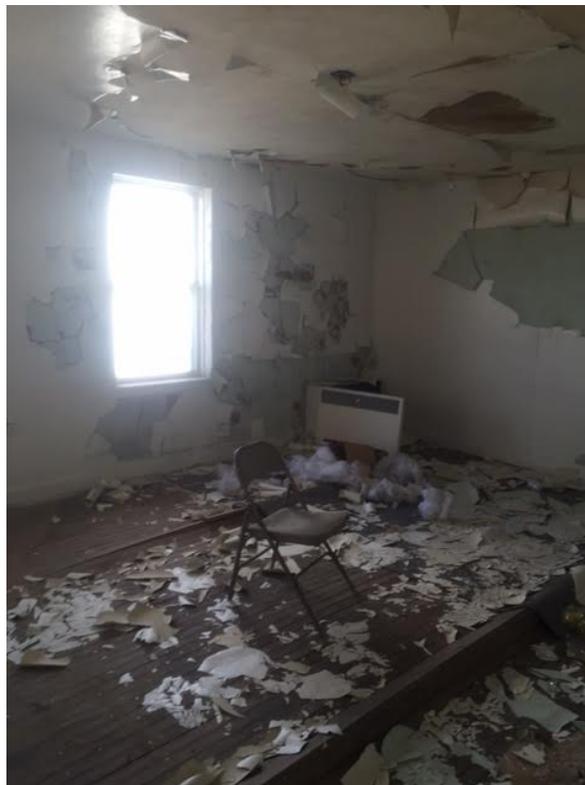
Photo 6. Water damage in a second floor hotel room in the hotel/lounge building.

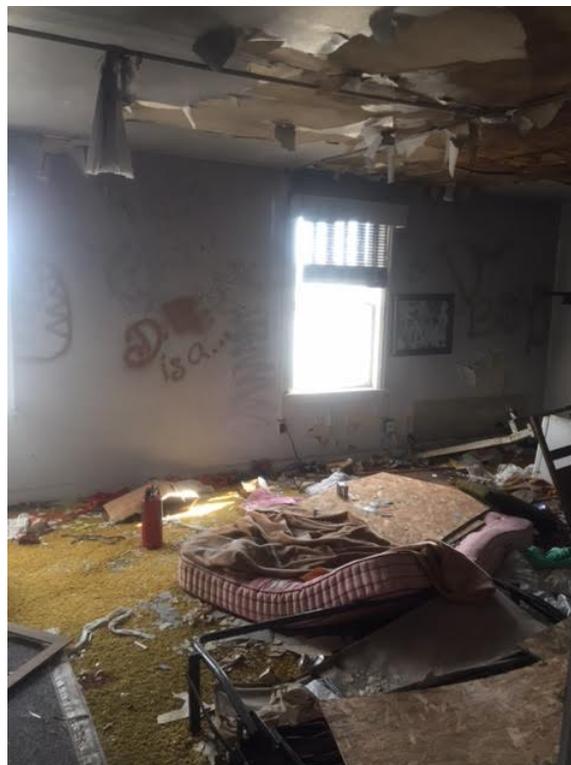
- Vandalism from trespassers/squatters is present throughout the hotel. The police department reported conducting regular walkthroughs of the building and cites the property as a common location for trespassing, alcohol consumption, and illegal drug use. It is possible that trespassers/squatters were the source of one or more of the fires. During the site walkthrough in June 2016, NewFields personnel observed conditions that suggest the presence of methamphetamine in many of the hotel rooms.

Photo 8. Trespasser/squatter impacts in a second floor hotel room, in the hotel/lounge building.

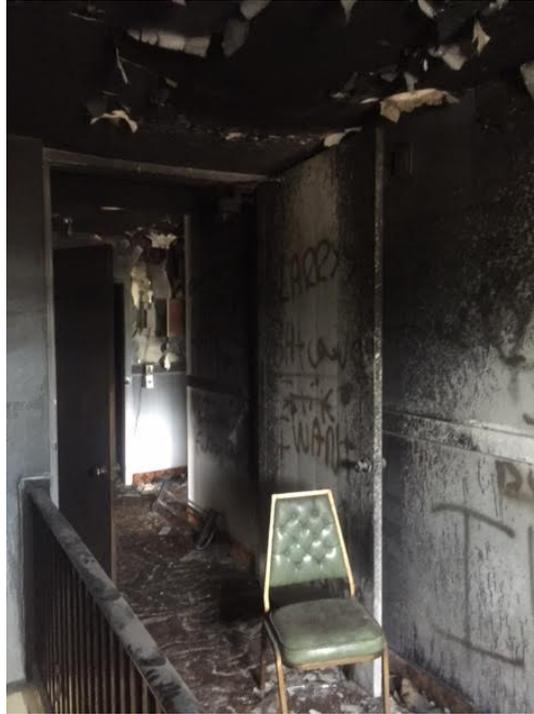
Photo 9. Third floor fire damage and squatter impacts in the hotel/lounge.

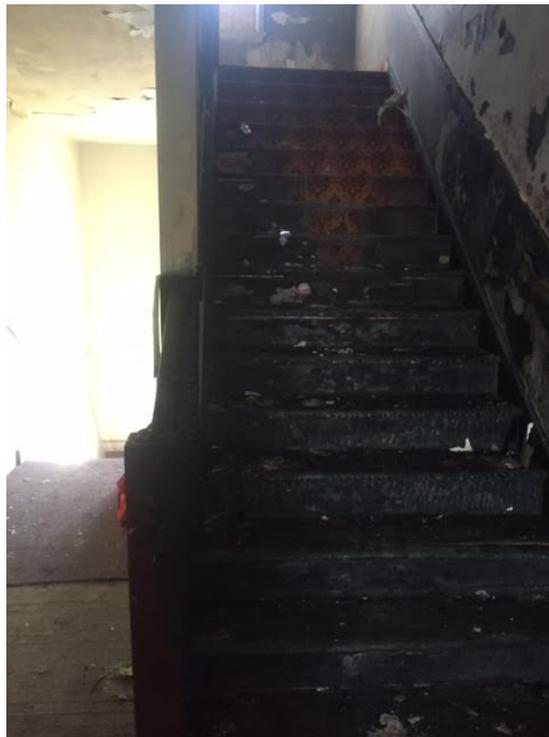
Photo 10. Fire damage on the second floor stair well, in the hotel/lounge building.

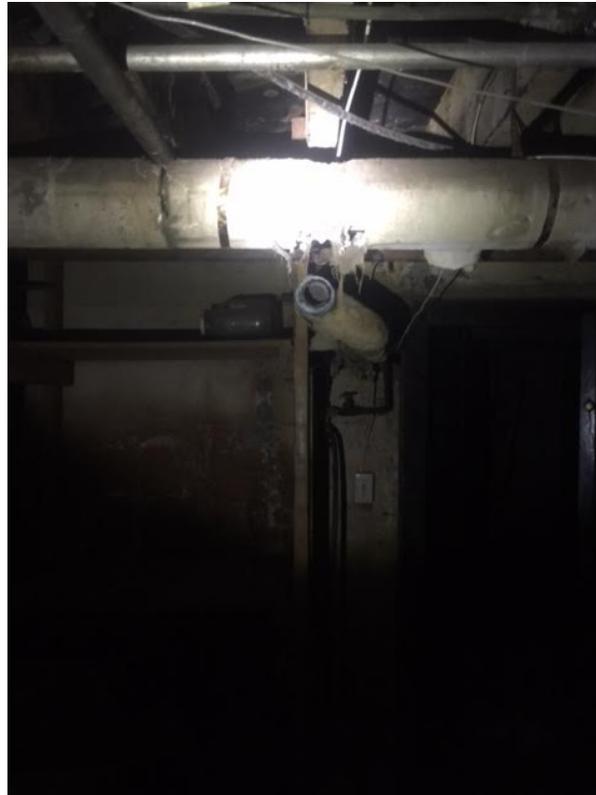
Photo 11: Asbestos positive thermal systems insulation in the basement of the hotel/lounge building.
