**Subject: Contract No. 68HERH19D0018; Task Order (TO) No. 68E0719F0190
Former Rath Buildings, 1442, 1508, 1620, and 1656 Sycamore Street,
Waterloo, Black Hawk County, Iowa
Targeted Brownfields Assessment, Hazardous Materials Survey**

**TARGETED BROWNFIELDS ASSESSMENT
HAZARDOUS MATERIALS SURVEY**

**FORMER RATH BUILDINGS
1442, 1508, 1620, AND 1656 SYCAMORE STREET
WATERLOO, BLACK HAWK COUNTY, IOWA**

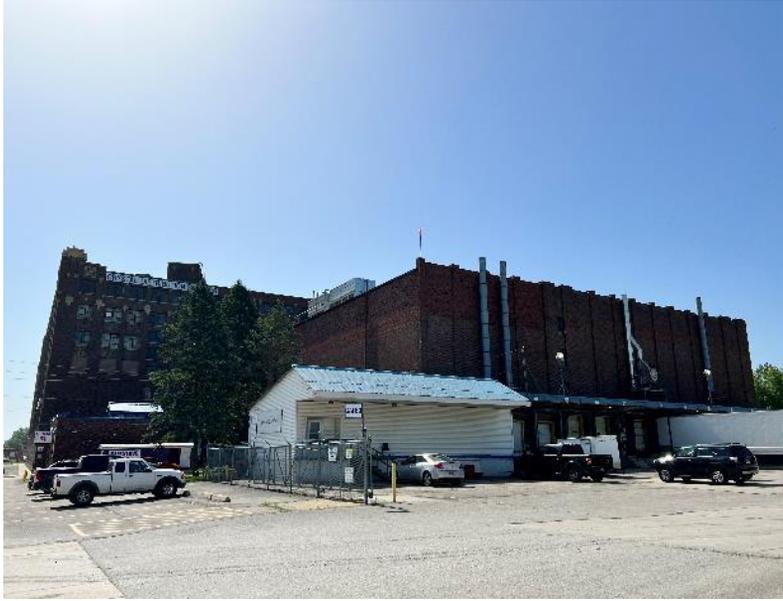
SUBTASK NO. 010.05 Direction: Southwest	DESCRIPTION	This photograph shows the subject property building.	1
	CLIENT	U.S. Environmental Protection Agency (EPA)	Date
	PHOTOGRAPHER	Zach Usher	6/16/2022

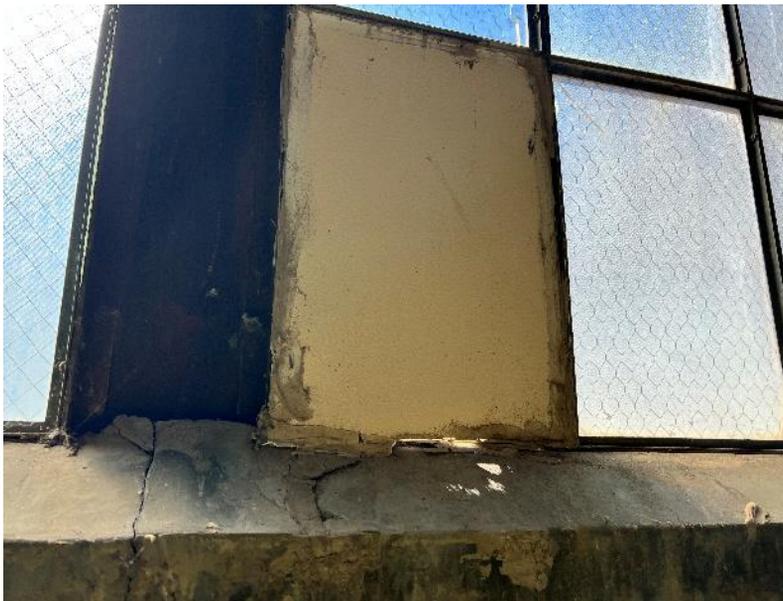
SUBTASK NO. 010.05 Direction: NA	DESCRIPTION	This photograph shows white window caulk and window glazing on interior square-paned windows.	2
	CLIENT	EPA	Date
	PHOTOGRAPHER	Zach Usher	6/16/2022

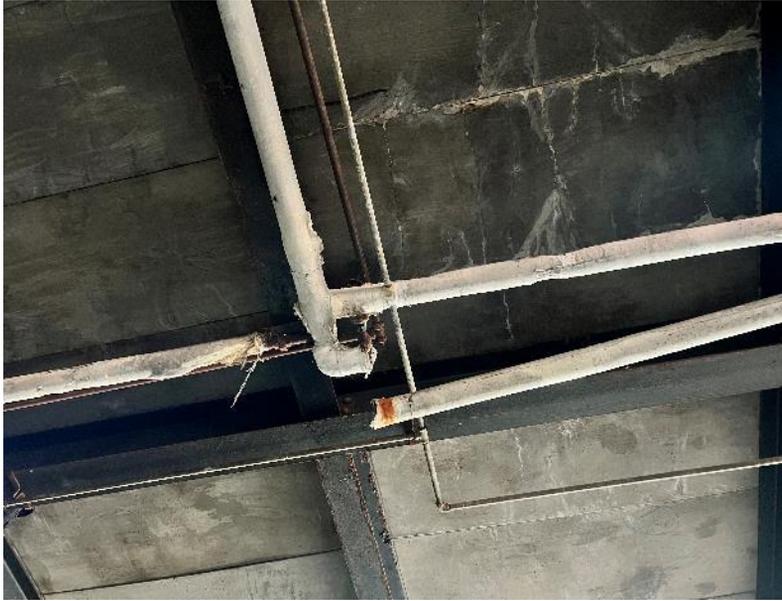
SUBTASK NO. 010.05 Direction: NA	DESCRIPTION	This photograph shows asbestos-containing white pipe insulation throughout the building.	3
	CLIENT	EPA	Date
	PHOTOGRAPHER	Zach Usher	6/16/2022

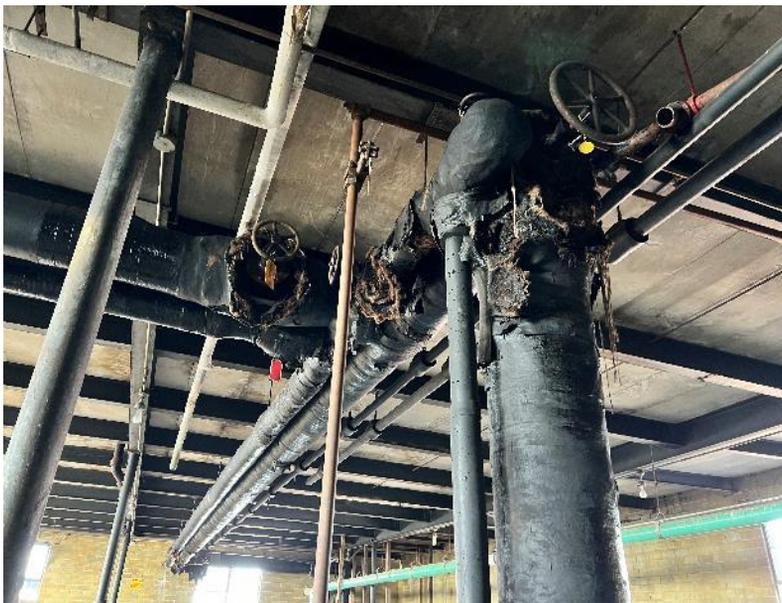
SUBTASK NO. 010.05 Direction: NA	DESCRIPTION	This photograph shows black 8"-24" pipe insulation throughout the building.	4
	CLIENT	EPA	Date
	PHOTOGRAPHER	Zach Usher	6/16/2022

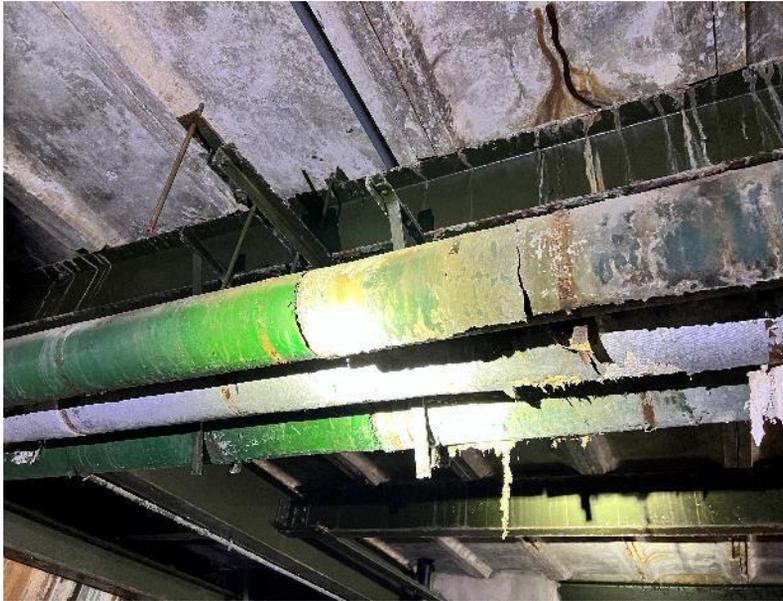
SUBTASK NO. 010.05 Direction: NA	DESCRIPTION	This photograph shows asbestos-containing green pipe insulation on the 7 th floor – C71 and C72.	5
	CLIENT	EPA	Date
	PHOTOGRAPHER	Zach Usher	6/16/2022

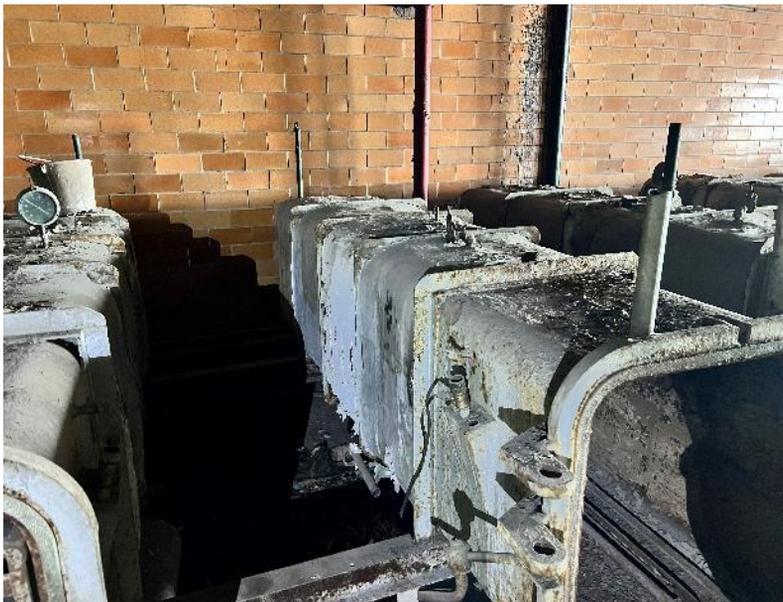
SUBTASK NO. 010.05 Direction: NA	DESCRIPTION	This photograph shows asbestos-containing heater insulation on the 5 th floor heaters.	6
	CLIENT	EPA	Date
	PHOTOGRAPHER	Zach Usher	6/16/2022

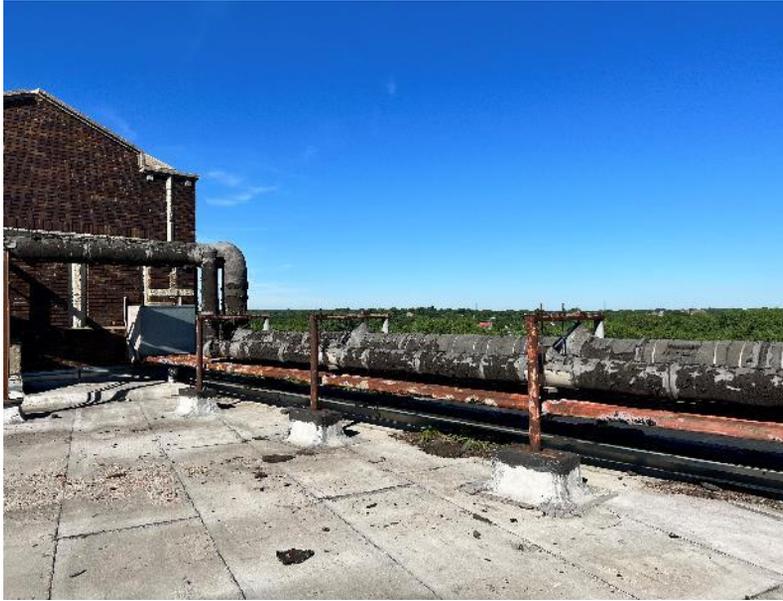
SUBTASK NO. 010.05 Direction: NA	DESCRIPTION	This photograph shows black, asbestos-containing, felt-wrapped pipe insulation on the roofs.	7
	CLIENT	EPA	Date
	PHOTOGRAPHER	Zach Usher	6/16/2022

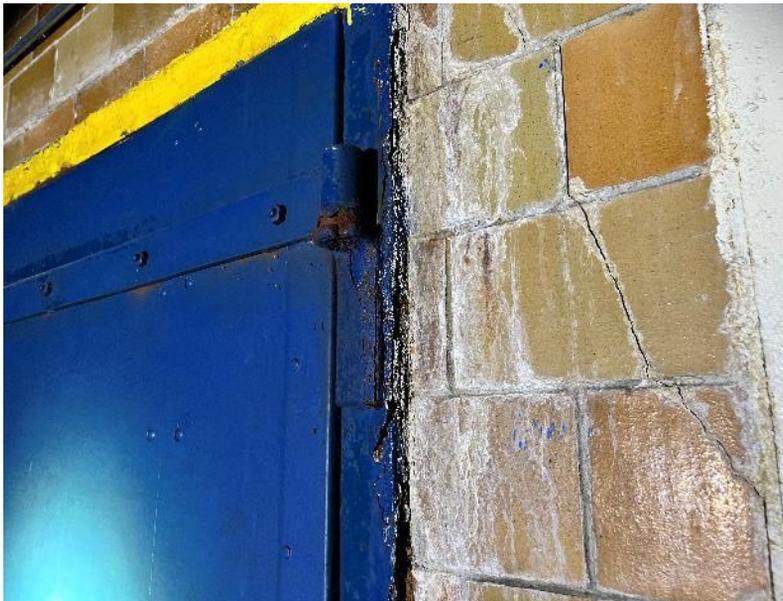
SUBTASK NO. 010.05 Direction: NA	DESCRIPTION	This photograph shows black asbestos-containing door caulk on elevator doors.	8
	CLIENT	EPA	Date
	PHOTOGRAPHER	Zach Usher	6/16/2022

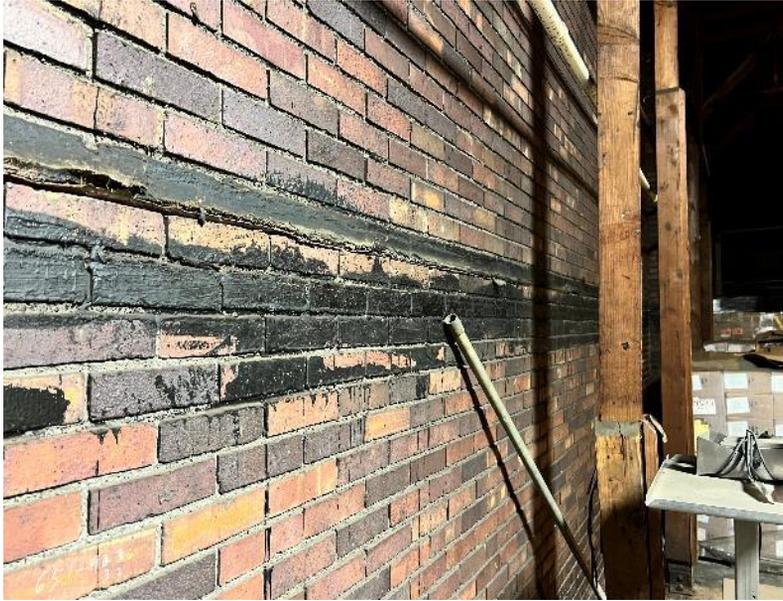
SUBTASK NO. 010.05 Direction: NA	DESCRIPTION	This photograph shows tar typical of that observed on walls and ceilings throughout the building.	9
	CLIENT	EPA	Date
	PHOTOGRAPHER	Zach Usher	6/16/2022

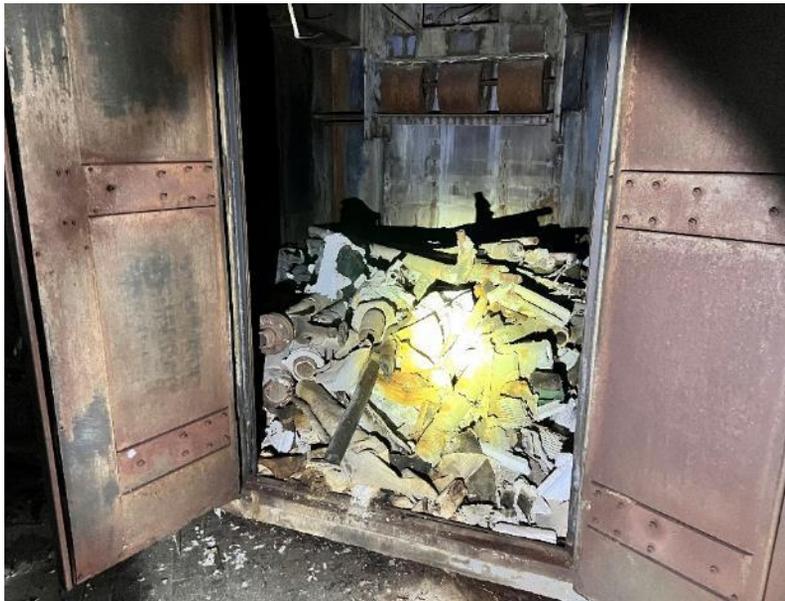
SUBTASK NO. 010.05 Direction: NA	DESCRIPTION	This photograph shows asbestos-containing boiler insulation (scattered pipe insulation debris) in C64, C71, C72, B56, C51, and G51.	10
	CLIENT	EPA	Date
	PHOTOGRAPHER	Zach Usher	6/16/2022

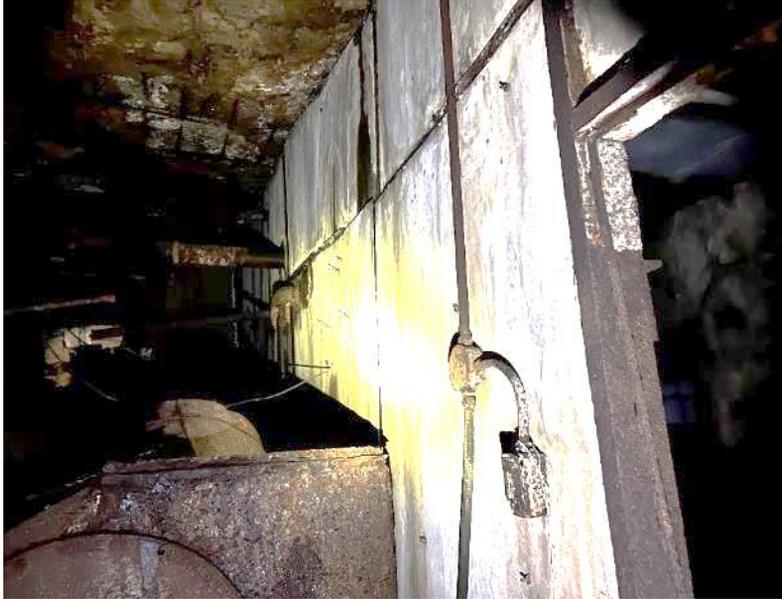
SUBTASK NO. 010.05 Direction: NA	DESCRIPTION	This photograph shows asbestos-containing transite wall panels on the 6 th floor – H area and E61.	11
	CLIENT	EPA	Date
	PHOTOGRAPHER	Zach Usher	6/16/2022

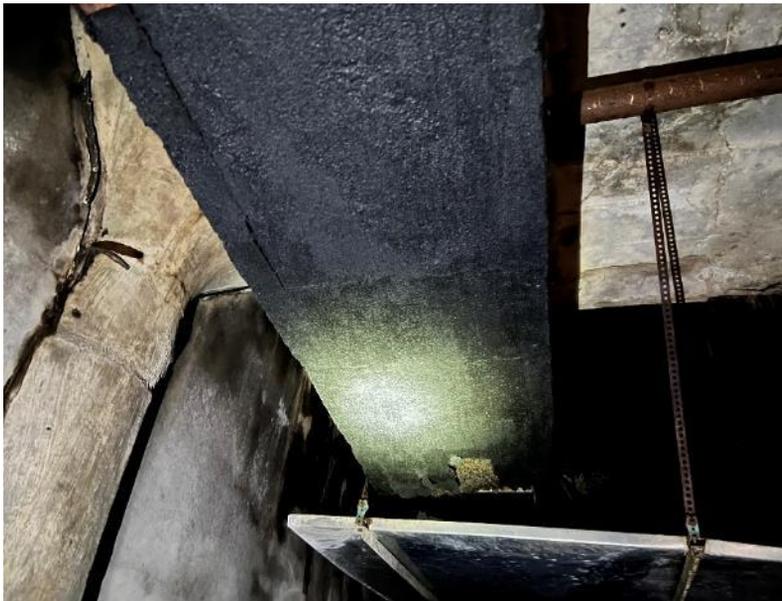
SUBTASK NO. 010.05 Direction: NA	DESCRIPTION	This photograph shows asbestos-containing black duct sealant on the 6 th floor – G area, A3, and C64.	12
	CLIENT	EPA	Date
	PHOTOGRAPHER	Zach Usher	6/16/2022

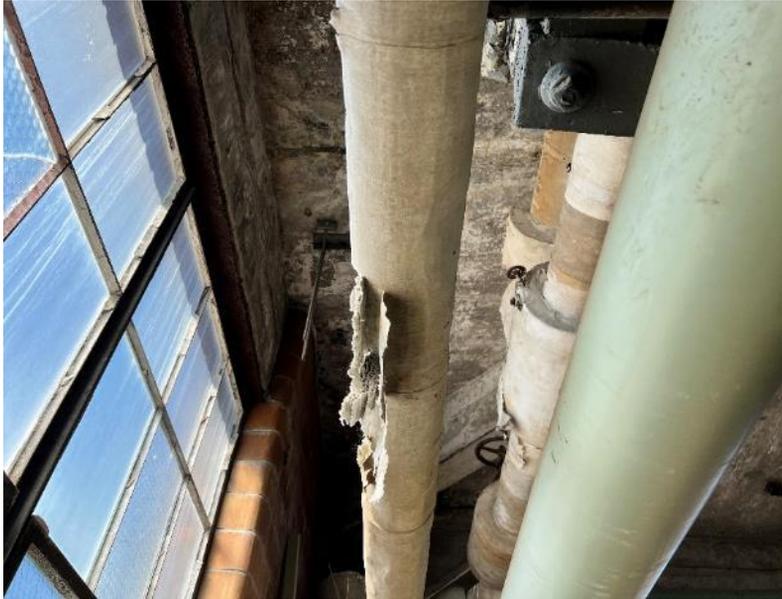
SUBTASK NO. 010.05 Direction: NA	DESCRIPTION	This photograph shows asbestos-containing aircell pipe insulation in C51, E51, G22, basement boiler room, and east abandoned bathroom.	13
	CLIENT	EPA	Date
	PHOTOGRAPHER	Zach Usher	6/16/2022

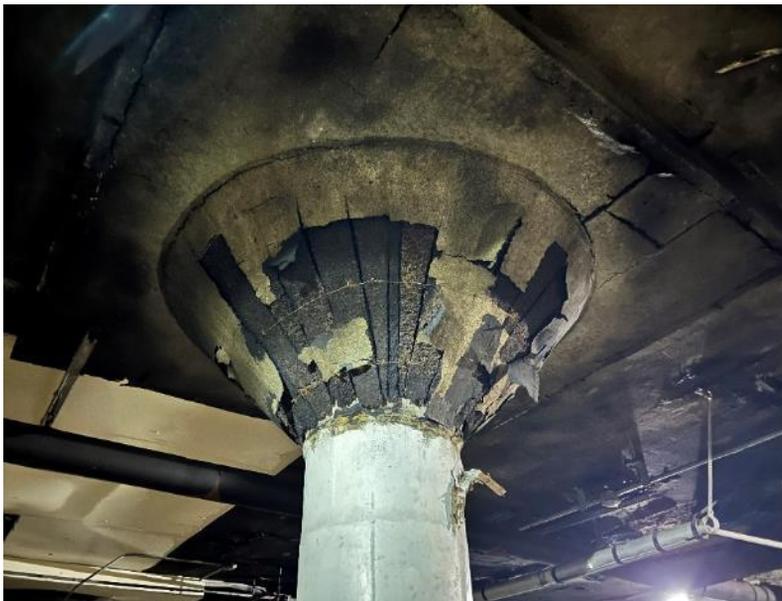
SUBTASK NO. 010.05 Direction: NA	DESCRIPTION	This photograph shows asbestos-containing asphalt shingles over cork insulation on the upper columns and ceiling of B55.	14
	CLIENT	EPA	Date
	PHOTOGRAPHER	Zach Usher	6/16/2022

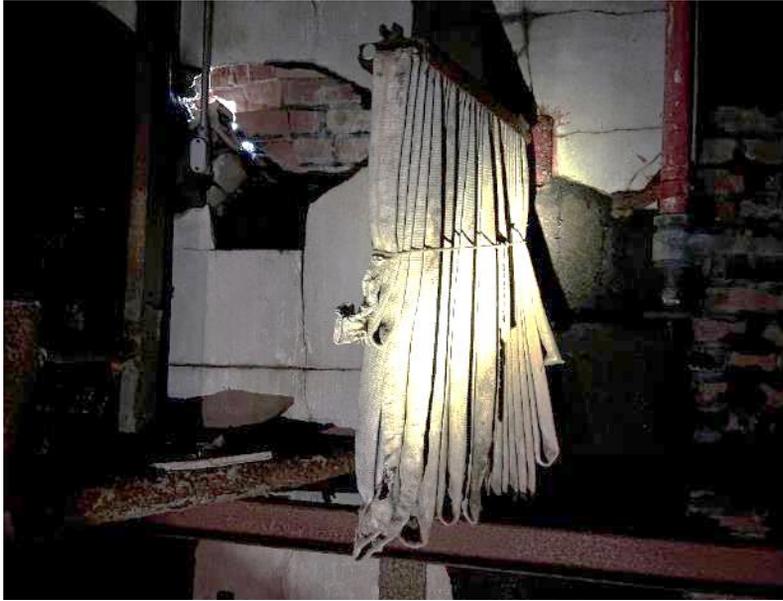
SUBTASK NO. 010.05 Direction: NA	DESCRIPTION	This photograph shows a fire hose in E61.	15
	CLIENT	EPA	Date
	PHOTOGRAPHER	Zach Usher	6/16/2022

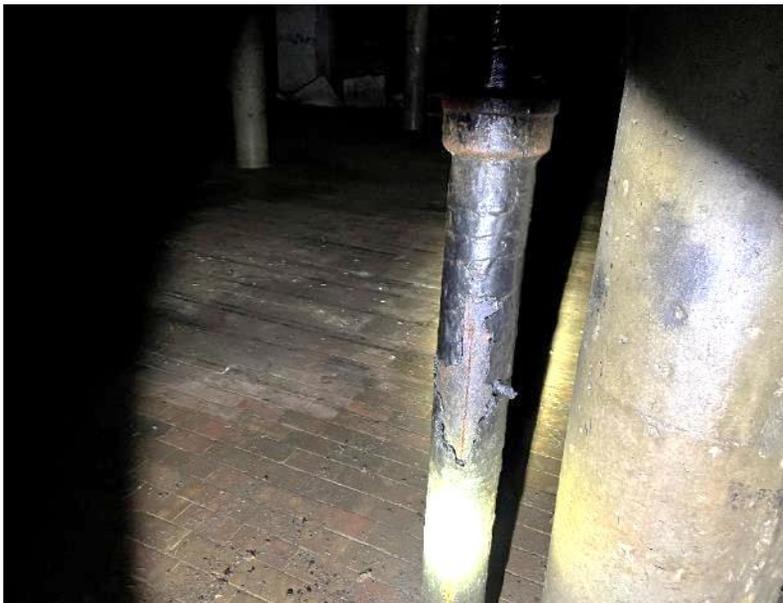
SUBTASK NO. 010.05 Direction: NA	DESCRIPTION	This photograph shows black pipe wrap in F51.	16
	CLIENT	EPA	Date
	PHOTOGRAPHER	Zach Usher	6/16/2022

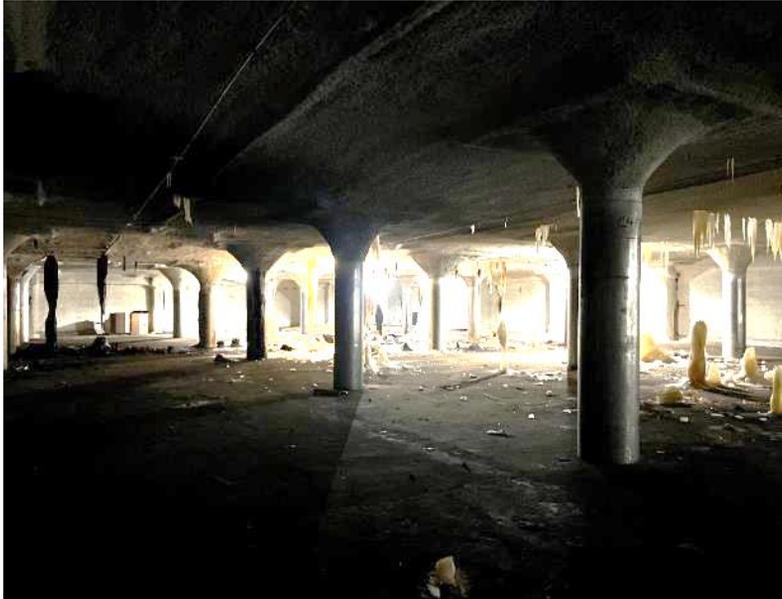
SUBTASK NO. 010.05 Direction: NA	DESCRIPTION	This photograph shows freezer wall coating typical of that on the walls and ceilings of freezers throughout the building.	17
	CLIENT	EPA	Date
	PHOTOGRAPHER	Zach Usher	6/16/2022

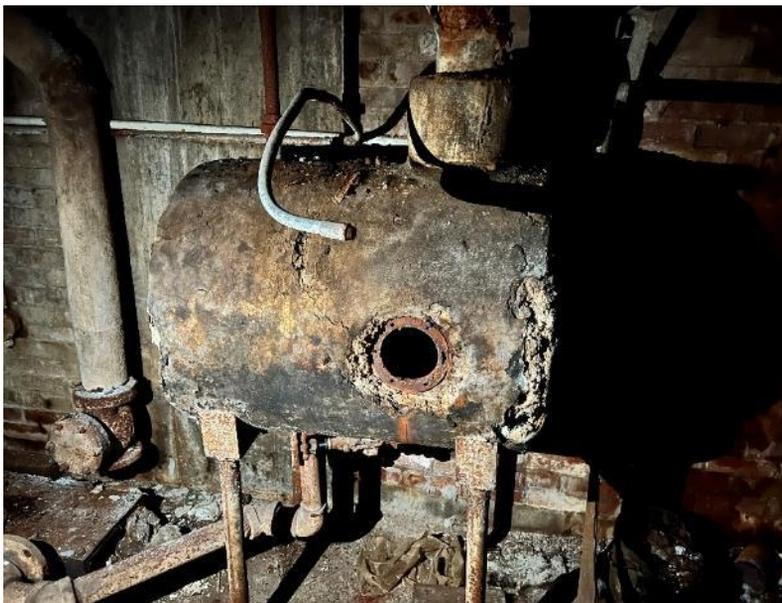
SUBTASK NO. 010.05 Direction: NA	DESCRIPTION	This photograph shows asbestos-containing white tank insulation on tanks in G22 and CB1.	18
	CLIENT	EPA	Date
	PHOTOGRAPHER	Zach Usher	6/16/2022

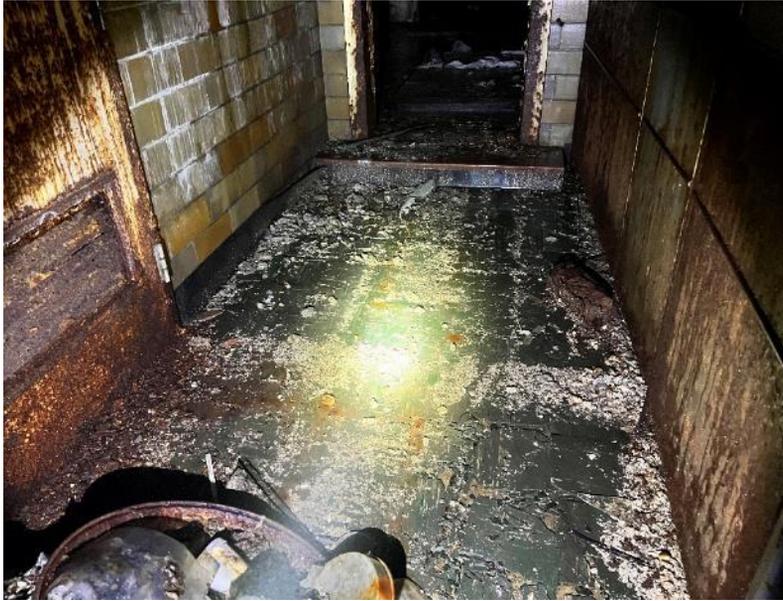
SUBTASK NO. 010.05 Direction: NA	DESCRIPTION	This photograph shows asbestos-containing green 9" x 9" vinyl floor tile in the C22 – lab area.	19
	CLIENT	EPA	Date
	PHOTOGRAPHER	Zach Usher	6/16/2022

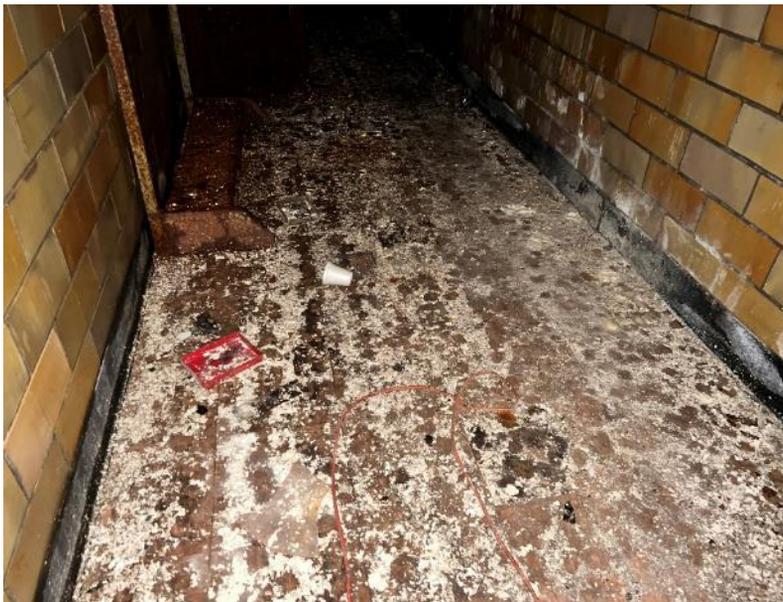
SUBTASK NO. 010.05 Direction: NA	DESCRIPTION	This photograph shows asbestos-containing brown 12" x 12" vinyl floor tile in the C22 – lab hallway.	20
	CLIENT	EPA	Date
	PHOTOGRAPHER	Zach Usher	6/16/2022

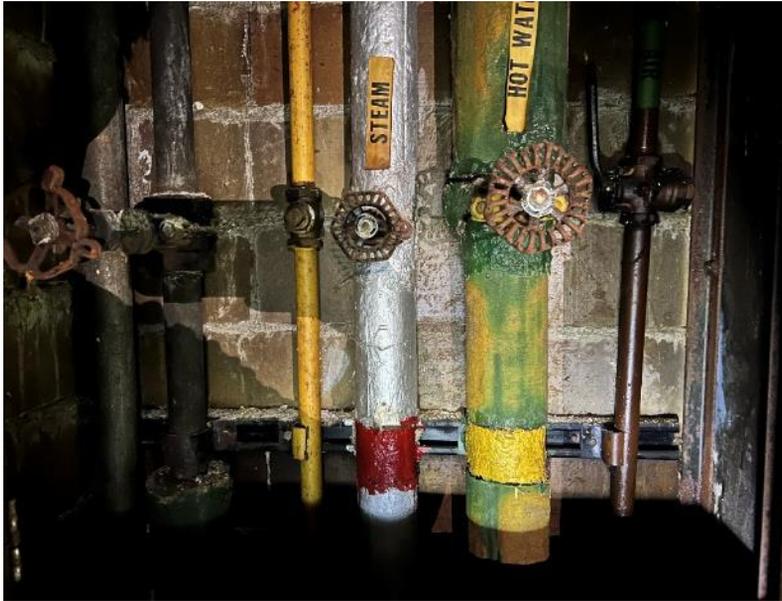
SUBTASK NO. 010.05 Direction: NA	DESCRIPTION	This photograph shows silver-painted asbestos-containing insulation in the C22 – lab area.	21
	CLIENT	EPA	Date
	PHOTOGRAPHER	Zach Usher	6/16/2022

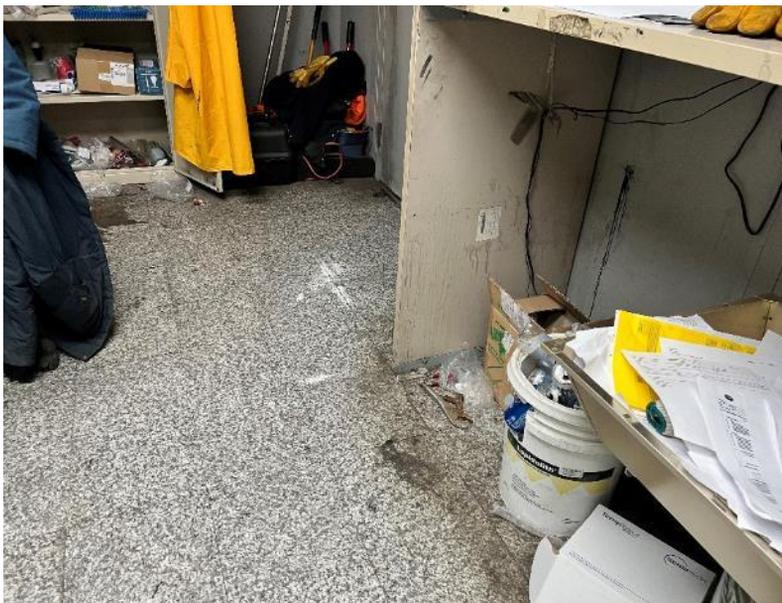
SUBTASK NO. 010.05 Direction: NA	DESCRIPTION	This photograph shows grey 12" x 12" vinyl floor tile in the loading dock office.	22
	CLIENT	EPA	Date
	PHOTOGRAPHER	Zach Usher	6/16/2022

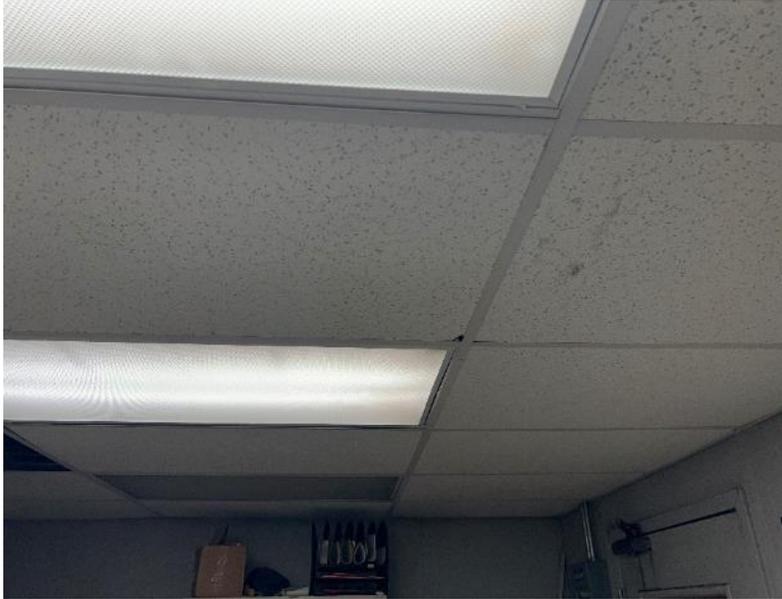
SUBTASK NO. 010.05 Direction: NA	DESCRIPTION	This photograph shows white fissure 2' x 4' ceiling tile in the loading dock office.	23
	CLIENT	EPA	Date
	PHOTOGRAPHER	Zach Usher	6/16/2022

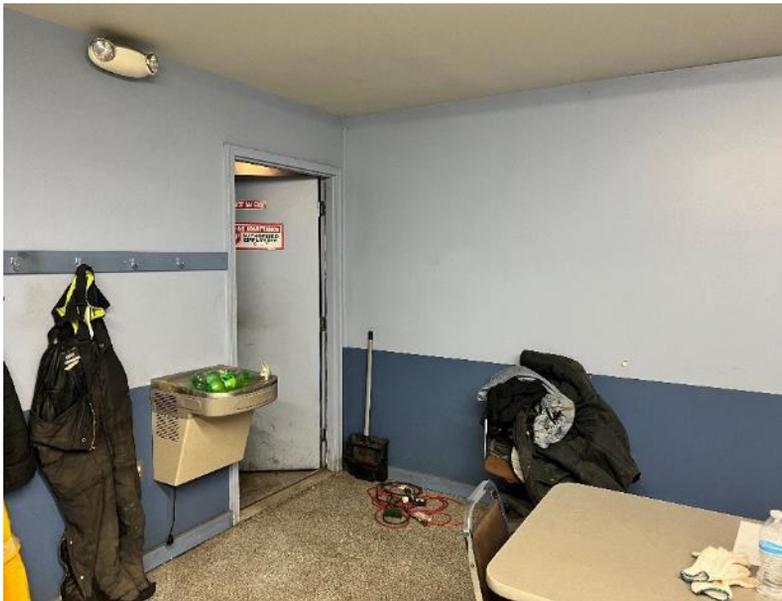
SUBTASK NO. 010.05 Direction: NA	DESCRIPTION	This photograph shows drywall joint compound in the breakroom.	24
	CLIENT	EPA	Date
	PHOTOGRAPHER	Zach Usher	6/16/2022

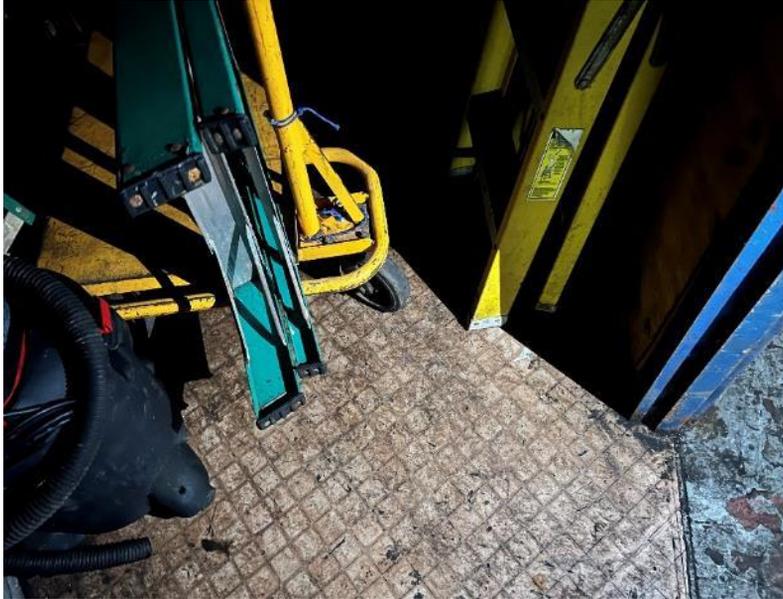
SUBTASK NO. 010.05 Direction: NA	DESCRIPTION	This photograph shows brown sheet flooring in the 1 st floor closet.	25
	CLIENT	EPA	Date
	PHOTOGRAPHER	Zach Usher	6/16/2022

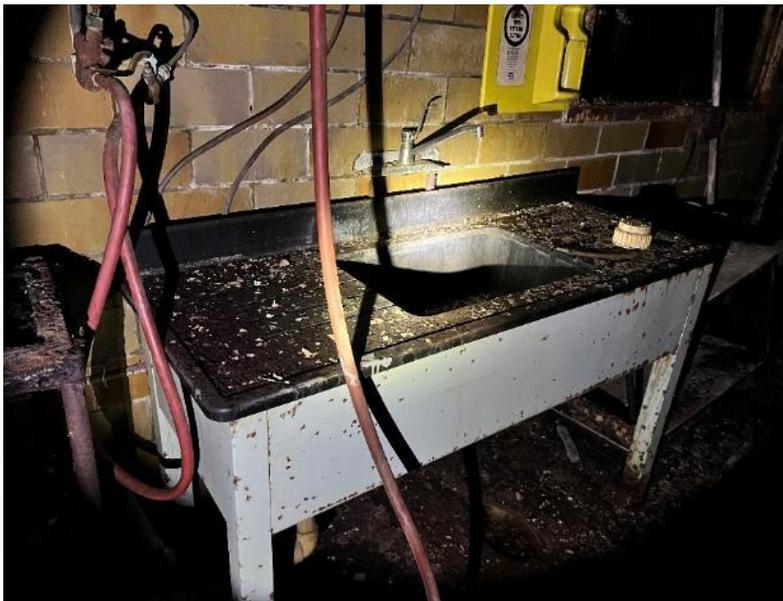
SUBTASK NO. 010.05 Direction: NA	DESCRIPTION	This photograph shows black countertop in the C22 – lab area.	26
	CLIENT	EPA	Date
	PHOTOGRAPHER	Zach Usher	6/16/2022

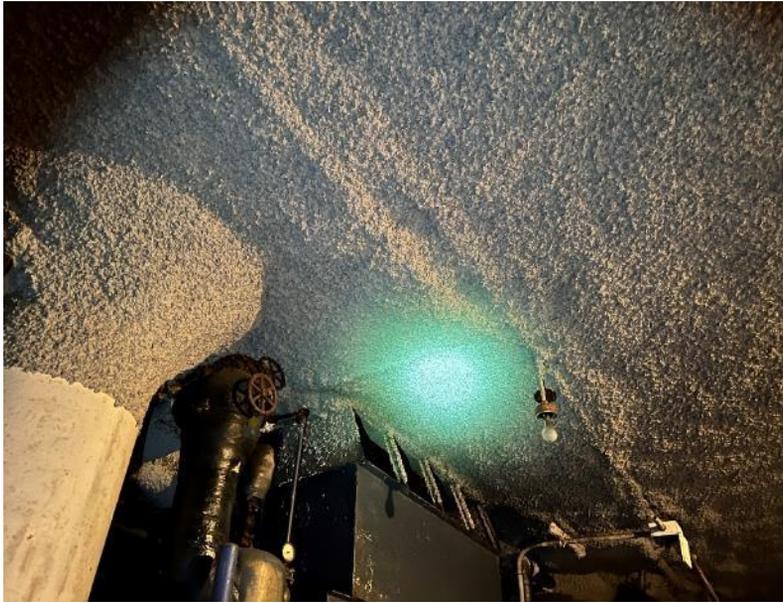
SUBTASK NO. 010.05 Direction: NA	DESCRIPTION	This photograph shows spray-on fireproofing in AB2.	27
	CLIENT	EPA	Date
	PHOTOGRAPHER	Zach Usher	6/16/2022

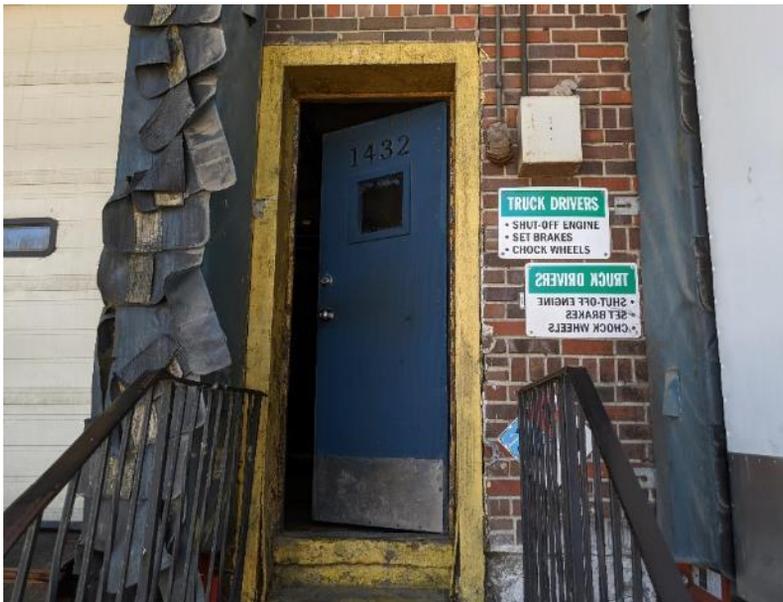
SUBTASK NO. 010.05 Direction: North	DESCRIPTION	This photograph shows asbestos-containing door caulk on the west exterior loading dock door.	28
	CLIENT	EPA	Date
	PHOTOGRAPHER	Zach Usher	6/16/2022

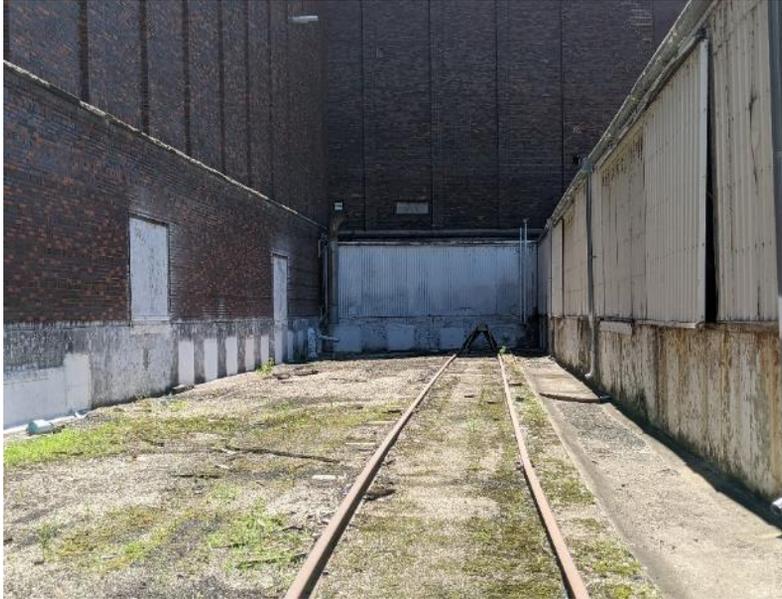
SUBTASK NO. 010.05 Direction: NA	DESCRIPTION	This photograph shows asbestos-containing corrugated transite panels on the southwest rail dock wall.	29
	CLIENT	EPA	Date
	PHOTOGRAPHER	Zach Usher	6/16/2022

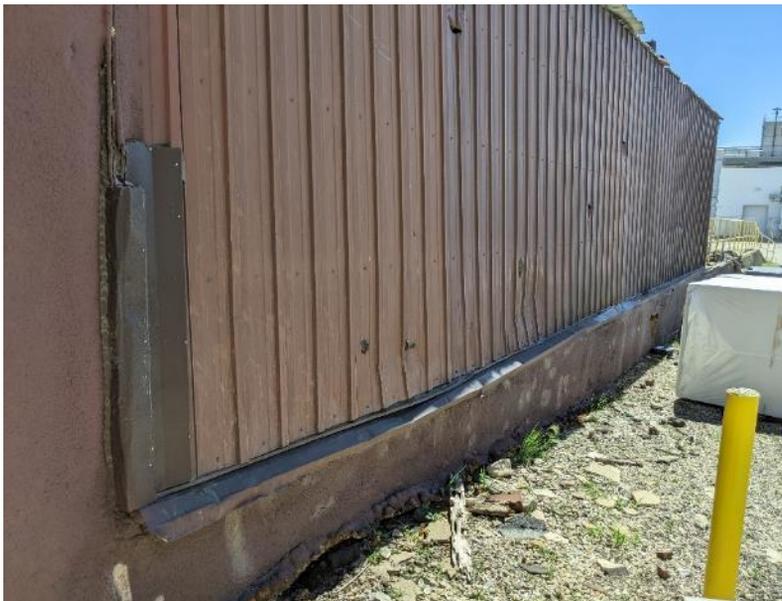
SUBTASK NO. 010.05 Direction: NA	DESCRIPTION	This photograph shows grey expansion caulk on the exterior of C13 southeast corner.	30
	CLIENT	EPA	Date
	PHOTOGRAPHER	Zach Usher	6/16/2022

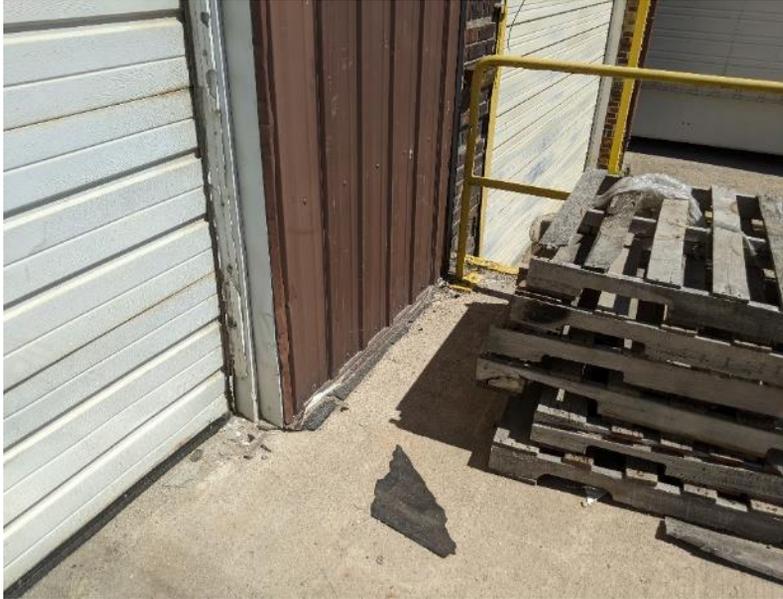
SUBTASK NO. 010.05 Direction: NA	DESCRIPTION	This photograph shows asphaltic floor seam on the exterior of the C13 ramp.	31
	CLIENT	EPA	Date
	PHOTOGRAPHER	Zach Usher	6/16/2022

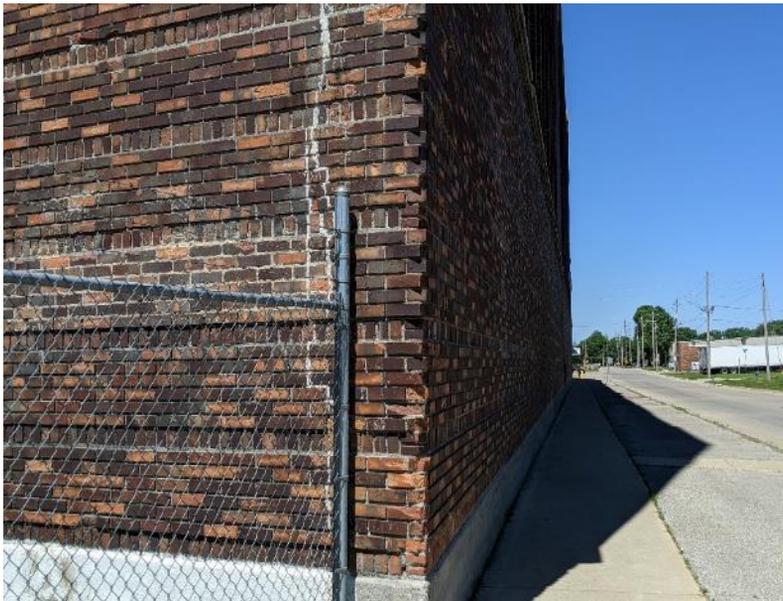
SUBTASK NO. 010.05 Direction: NA	DESCRIPTION	This photograph shows white expansion joint (soft) on the northeast and north center of C12.	32
	CLIENT	EPA	Date
	PHOTOGRAPHER	Zach Usher	6/16/2022

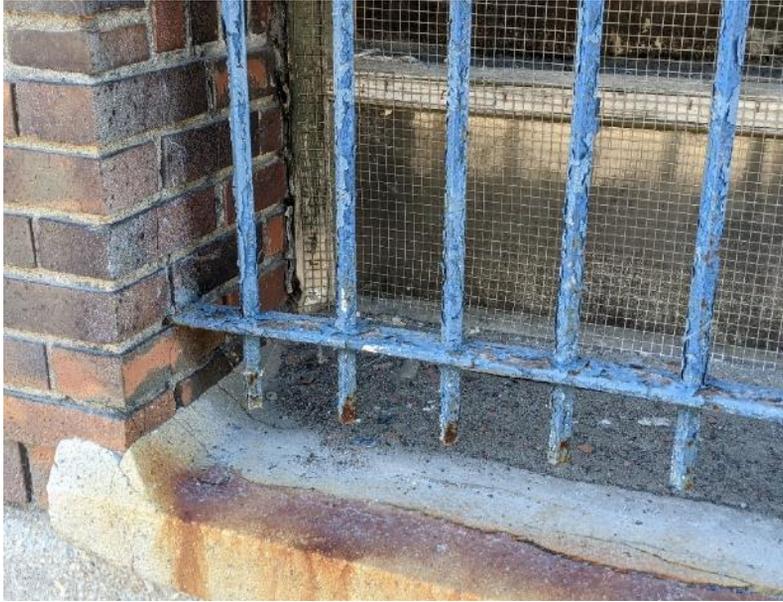
SUBTASK NO. 010.05 Direction: NA	DESCRIPTION	This photograph shows grey asbestos-containing caulk on the north exterior street level windows.	33
	CLIENT	EPA	Date
	PHOTOGRAPHER	Zach Usher	6/16/2022

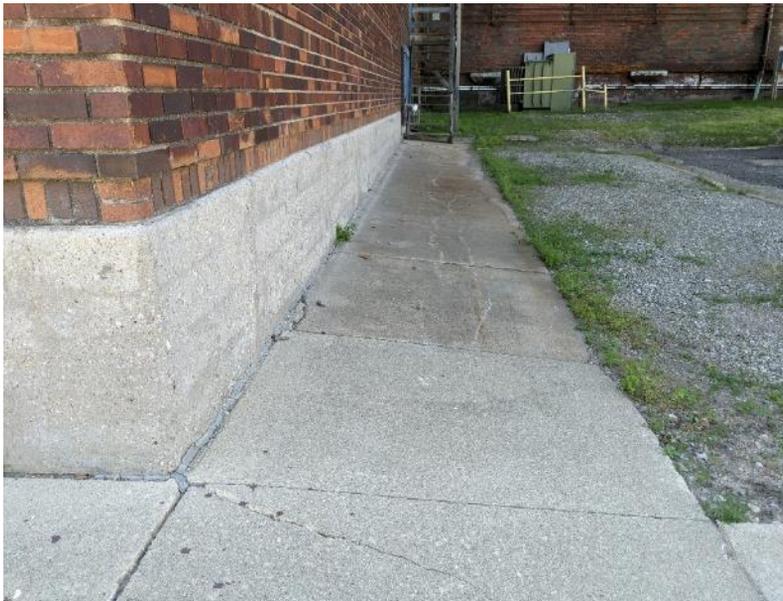
SUBTASK NO. 010.05 Direction: West	DESCRIPTION	This photograph shows grey expansion joint on the northwest ground perimeter.	34
	CLIENT	EPA	Date
	PHOTOGRAPHER	Zach Usher	6/16/2022

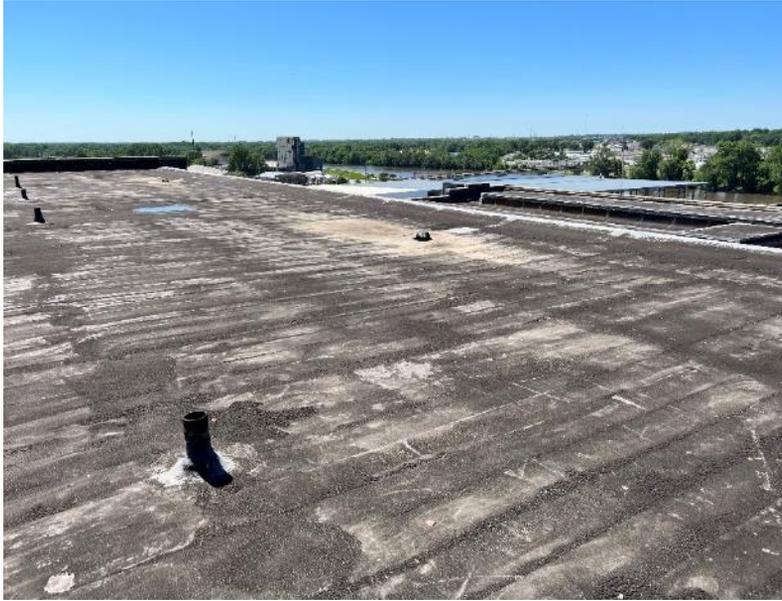
SUBTASK NO. 010.05 Direction: NA	DESCRIPTION	This photograph shows roofing material on roofs B and C.	35
	CLIENT	EPA	Date
	PHOTOGRAPHER	Zach Usher	6/16/2022

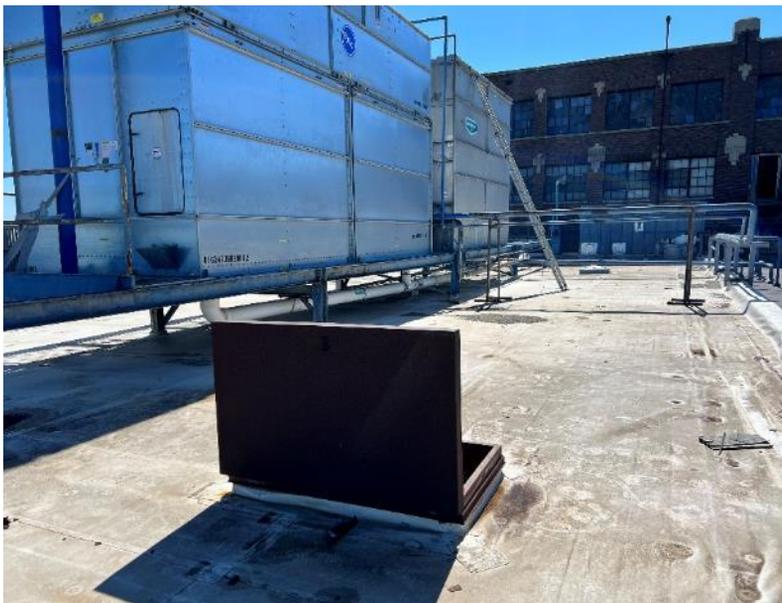
SUBTASK NO. 010.05 Direction: NA	DESCRIPTION	This photograph shows roofing material on roof A.	36
	CLIENT	EPA	Date
	PHOTOGRAPHER	Zach Usher	6/16/2022

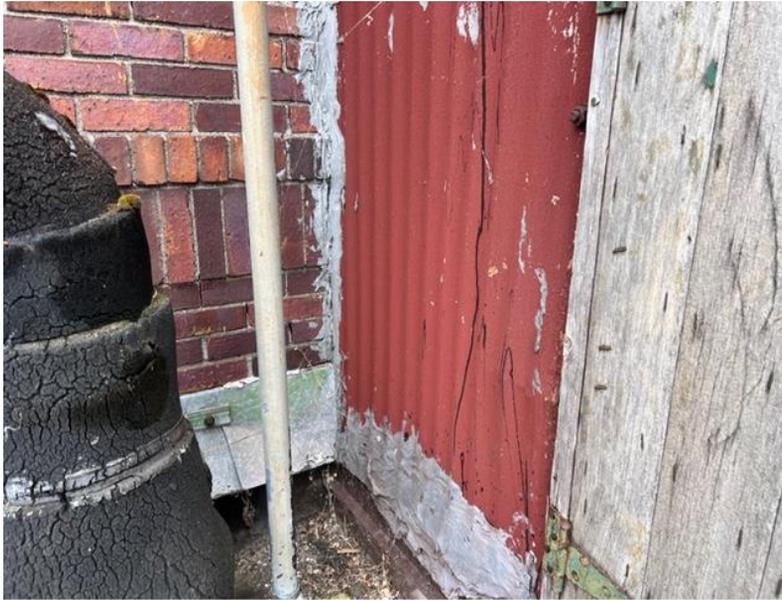
SUBTASK NO. 010.05 Direction: NA	DESCRIPTION	This photograph shows grey asbestos-containing roofing tar on all roofs.	37
	CLIENT	EPA	Date
	PHOTOGRAPHER	Zach Usher	6/16/2022

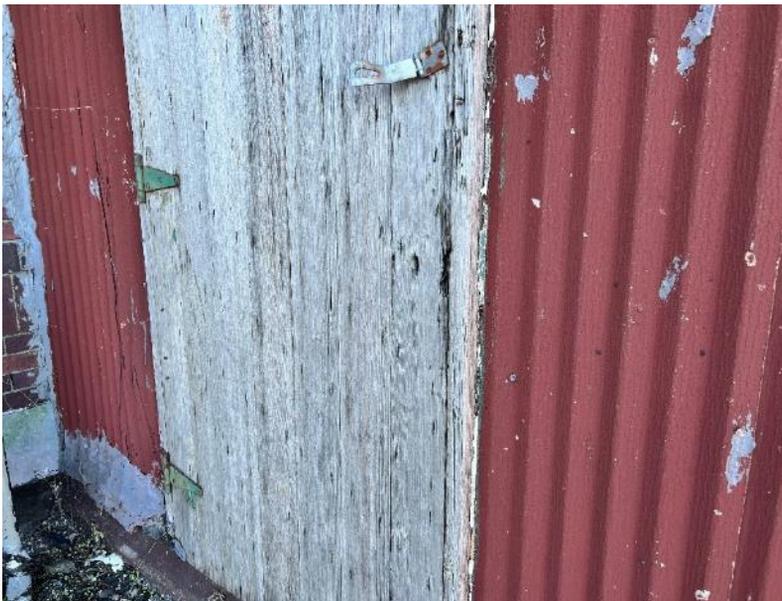
SUBTASK NO. 010.05 Direction: NA	DESCRIPTION	This photograph shows white roofing caulk on roof A.	38
	CLIENT	EPA	Date
	PHOTOGRAPHER	Zach Usher	6/16/2022

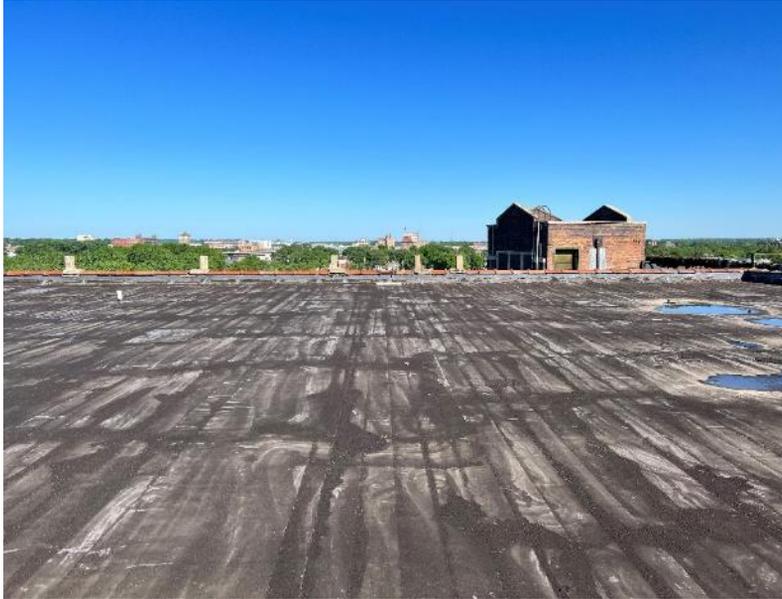
SUBTASK NO. 010.05 Direction: NA	DESCRIPTION	This photograph shows roofing material on roofs F and G.	39
	CLIENT	EPA	Date
	PHOTOGRAPHER	Zach Usher	6/16/2022

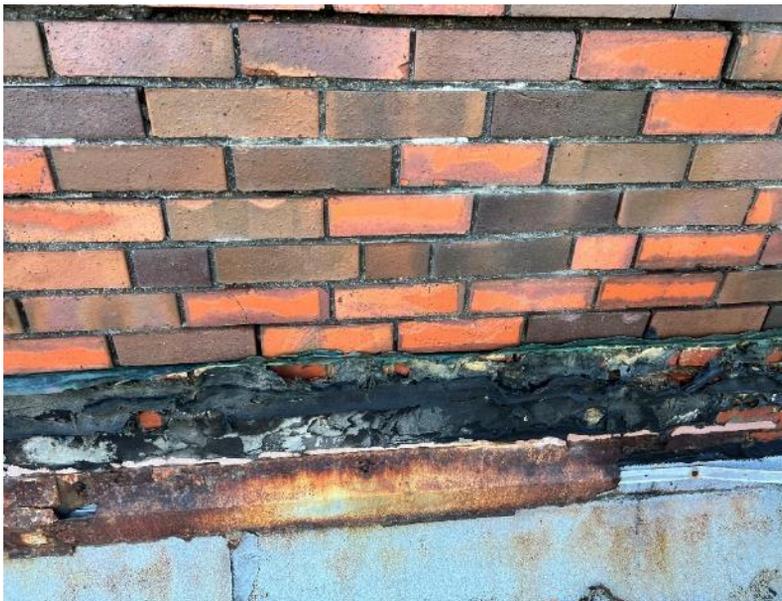
SUBTASK NO. 010.05 Direction: NA	DESCRIPTION	This photograph shows black roofing tar typical of that observed on all roofs.	40
	CLIENT	EPA	Date
	PHOTOGRAPHER	Zach Usher	6/16/2022

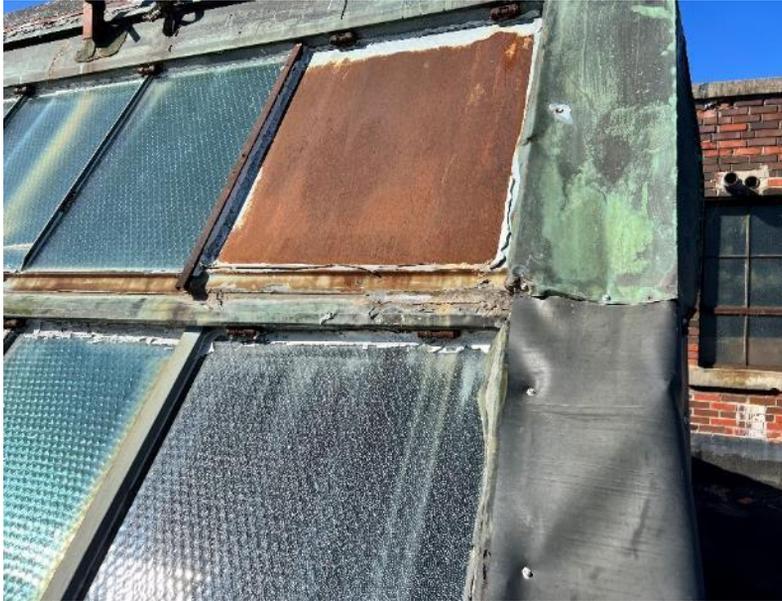
SUBTASK NO. 010.05 Direction: NA	DESCRIPTION	This photograph shows white window caulk on roof B skylight windows.	41
	CLIENT	EPA	Date
	PHOTOGRAPHER	Zach Usher	6/16/2022

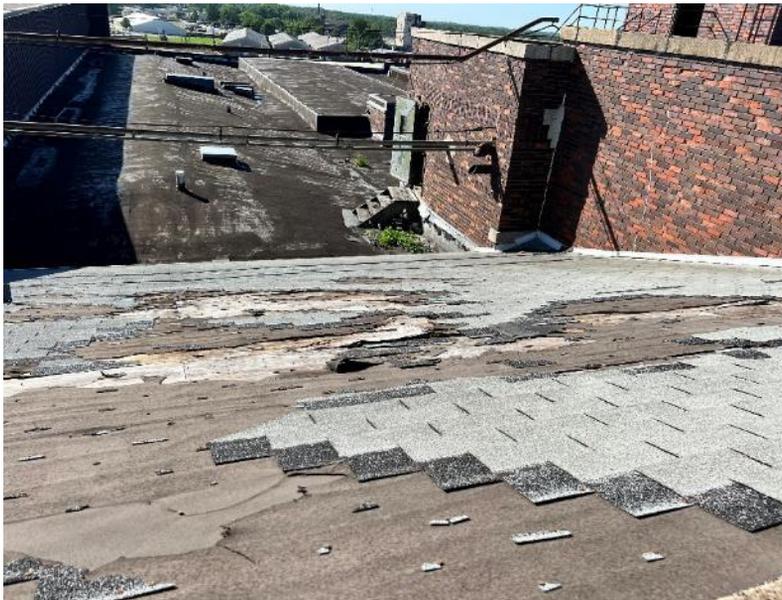
SUBTASK NO. 010.05 Direction: NA	DESCRIPTION	This photograph shows asphalt shingles on roof B/C transition.	42
	CLIENT	EPA	Date
	PHOTOGRAPHER	Zach Usher	6/16/2022

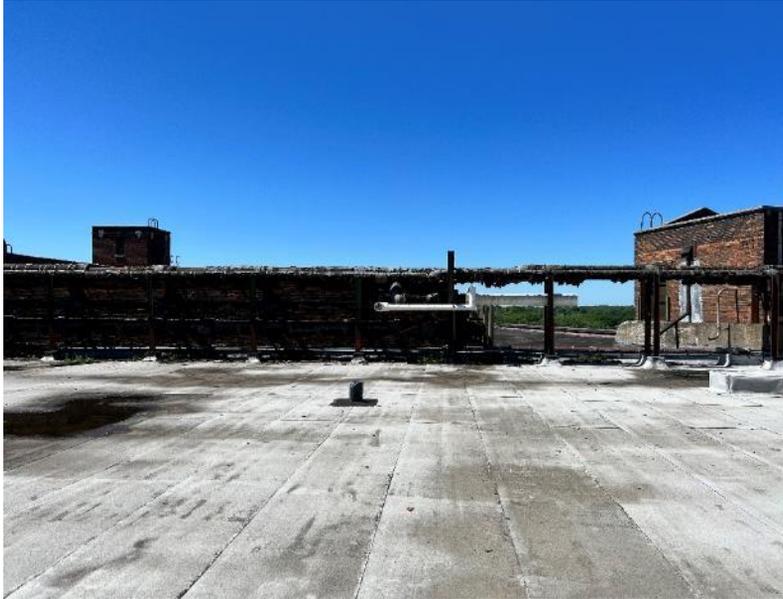
SUBTASK NO. 010.05 Direction: NA	DESCRIPTION	This photograph shows roofing material on roofs D and H.	43
	CLIENT	EPA	Date
	PHOTOGRAPHER	Zach Usher	6/16/2022

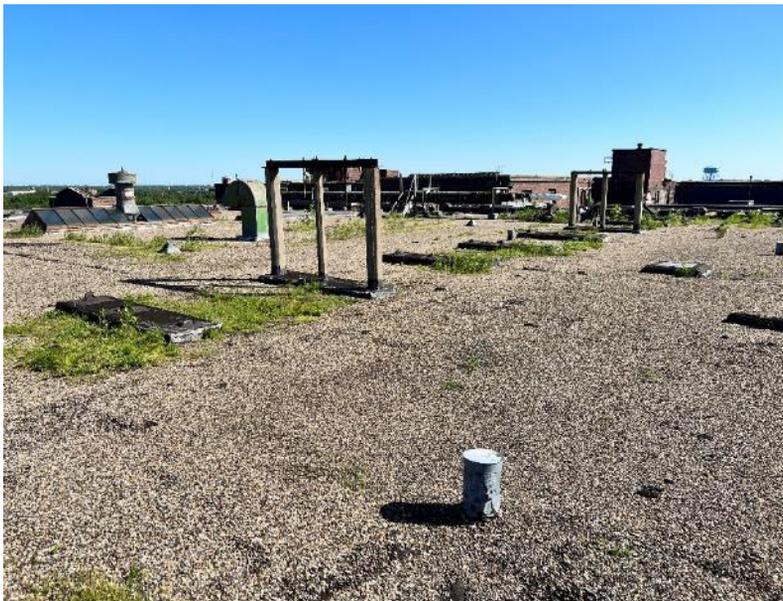
SUBTASK NO. 010.05 Direction: NA	DESCRIPTION	This photograph shows asbestos-containing roofing material on roof E.	44
	CLIENT	EPA	Date
	PHOTOGRAPHER	Zach Usher	6/16/2022
