**Subject: Contract No. 68HERH19D0018; Task Order (TO) No. 68E0719F0190
Former Rath Buildings, 1442, 1508, 1620, and 1656 Sycamore Street,
Waterloo, Black Hawk County, Iowa
Targeted Brownfields Assessment, Hazardous Materials Survey**

**TARGETED BROWNFIELDS ASSESSMENT
HAZARDOUS MATERIALS SURVEY**

**FORMER RATH BUILDINGS
1442, 1508, 1620, AND 1656 SYCAMORE STREET
WATERLOO, BLACK HAWK COUNTY, IOWA**

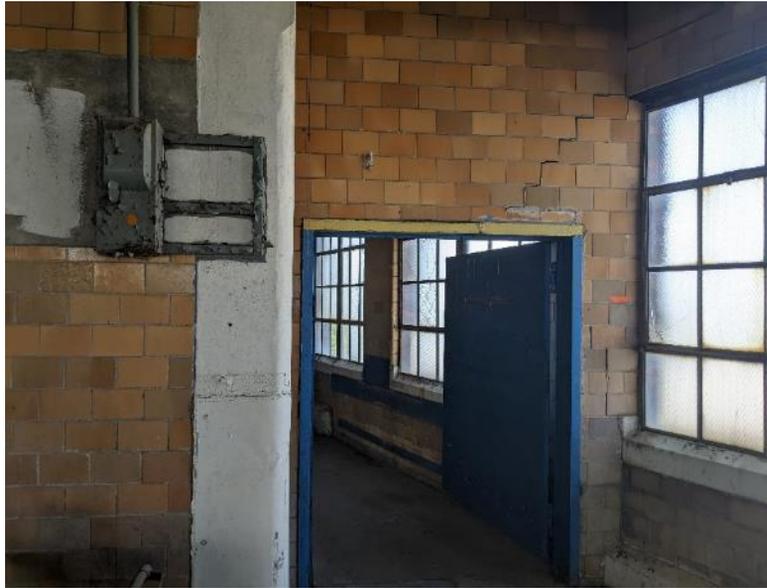
SUBTASK NO. 010.05 Direction: NA	DESCRIPTION	This photograph shows a representative view of blue and yellow lead-based paint (LBP) on door frames throughout the facility.	45
	CLIENT	EPA	Date
	PHOTOGRAPHER	Cory Nichols	6/16/2022

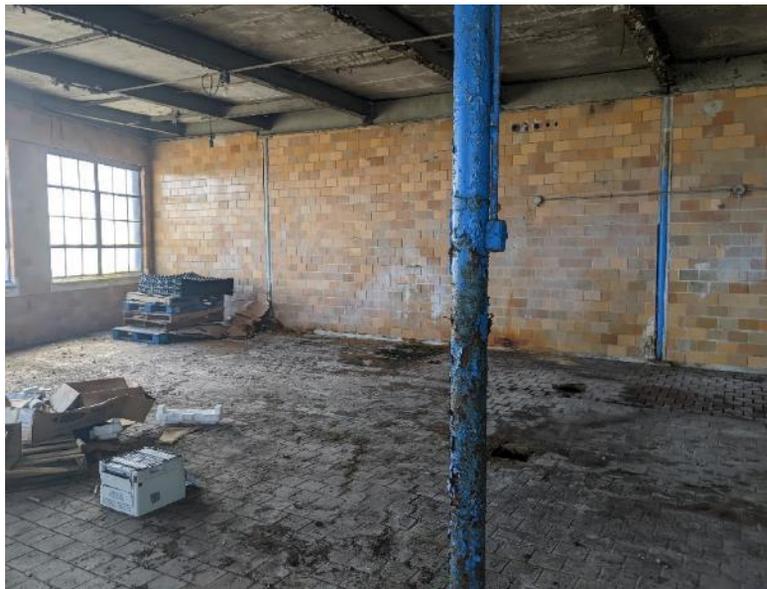
SUBTASK NO. 010.05 Direction: NA	DESCRIPTION	This photograph shows a representative view of blue LBP on metal posts in room B71.	46
	CLIENT	EPA	Date
	PHOTOGRAPHER	Cory Nichols	6/16/2022

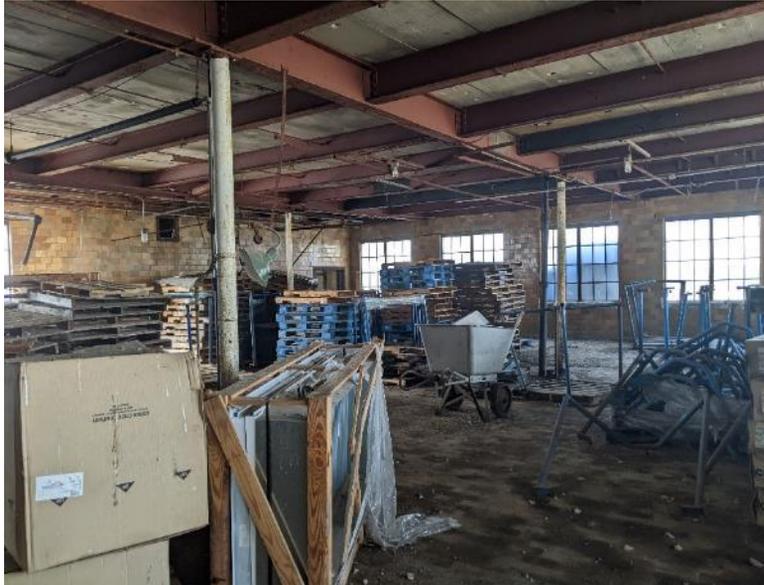
SUBTASK NO. 010.05 Direction: NA	DESCRIPTION	This photograph shows a representative view of white LBP on metal posts in room B73.	47
	CLIENT	EPA	Date
	PHOTOGRAPHER	Cory Nichols	6/16/2022

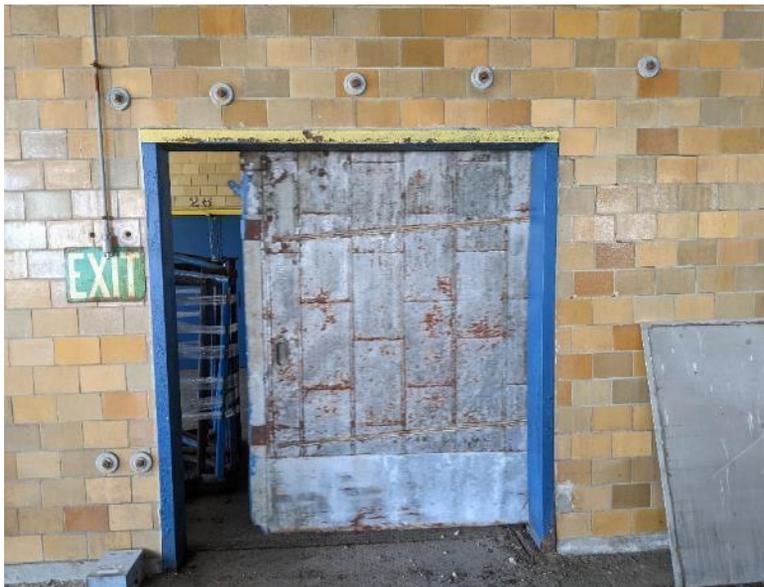
SUBTASK NO. 010.05 Direction: NA	DESCRIPTION	This photograph shows grey LBP on a metal door in room B72.	48
	CLIENT	EPA	Date
	PHOTOGRAPHER	Cory Nichols	6/16/2022

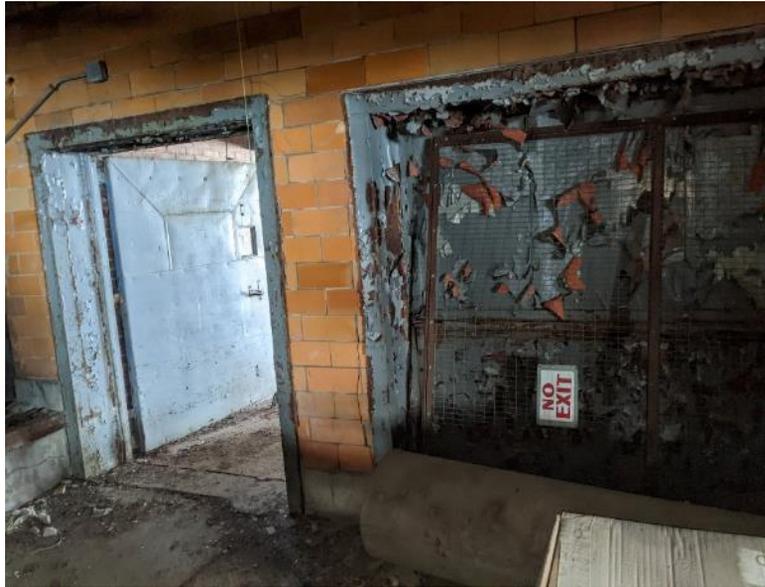
SUBTASK NO. 010.05 Direction: NA	DESCRIPTION	This photograph shows grey LBP on the metal door frames and elevator door in room C71.	49
	CLIENT	EPA	Date
	PHOTOGRAPHER	Cory Nichols	6/16/2022

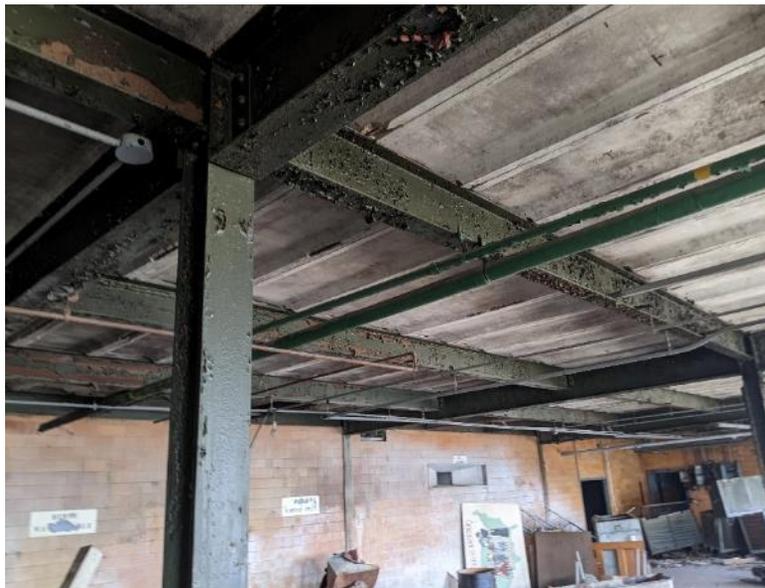
SUBTASK NO. 010.05 Direction: NA	DESCRIPTION	This photograph shows a representative view of green LBP on structural steel in rooms C72 and C71.	50
	CLIENT	EPA	Date
	PHOTOGRAPHER	Cory Nichols	6/16/2022

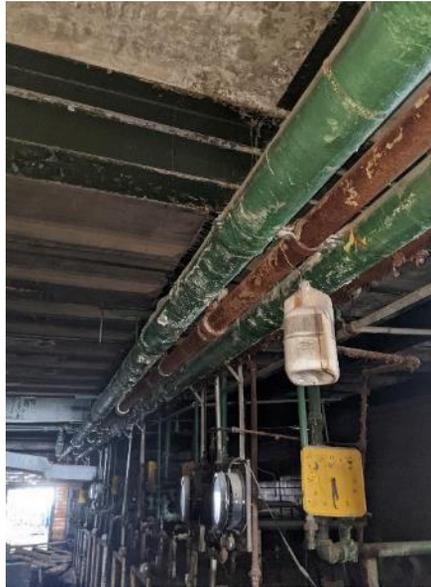
SUBTASK NO. 010.05 Direction: NA	DESCRIPTION	This photograph shows green LBP on pipe wrap in room C71.	51
	CLIENT	EPA	Date
	PHOTOGRAPHER	Cory Nichols	6/16/2022

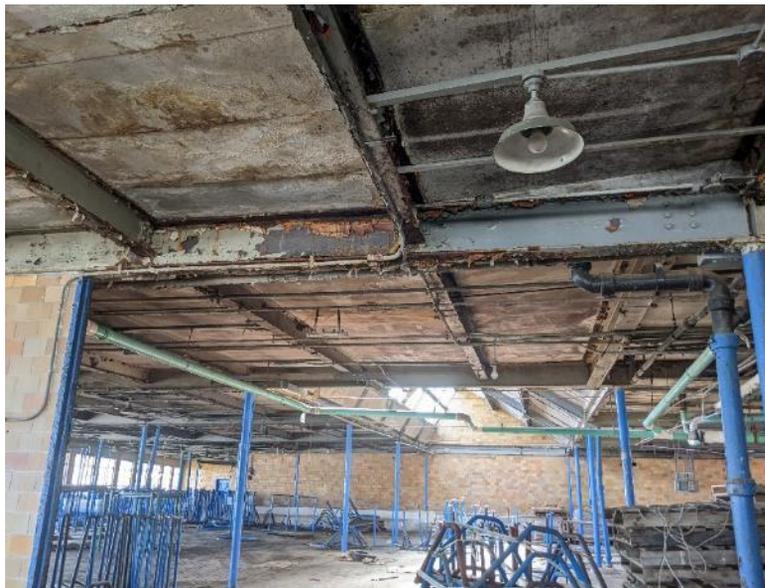
SUBTASK NO. 010.05 Direction: NA	DESCRIPTION	This photograph shows a representative view of grey LBP on structural steel in rooms B71 and B73.	52
	CLIENT	EPA	Date
	PHOTOGRAPHER	Cory Nichols	6/16/2022

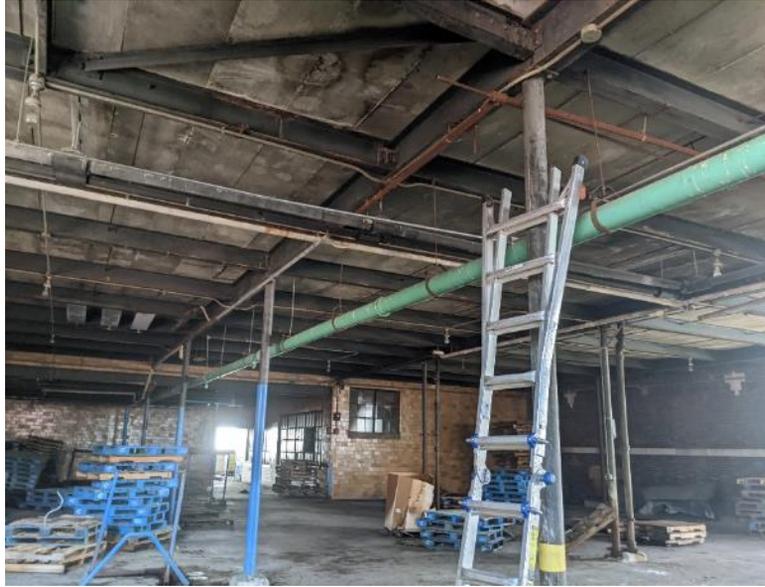
SUBTASK NO. 010.05 Direction: NA	DESCRIPTION	This photograph shows a representative view of black LBP on structural steel and posts in room B74.	53
	CLIENT	EPA	Date
	PHOTOGRAPHER	Cory Nichols	6/16/2022

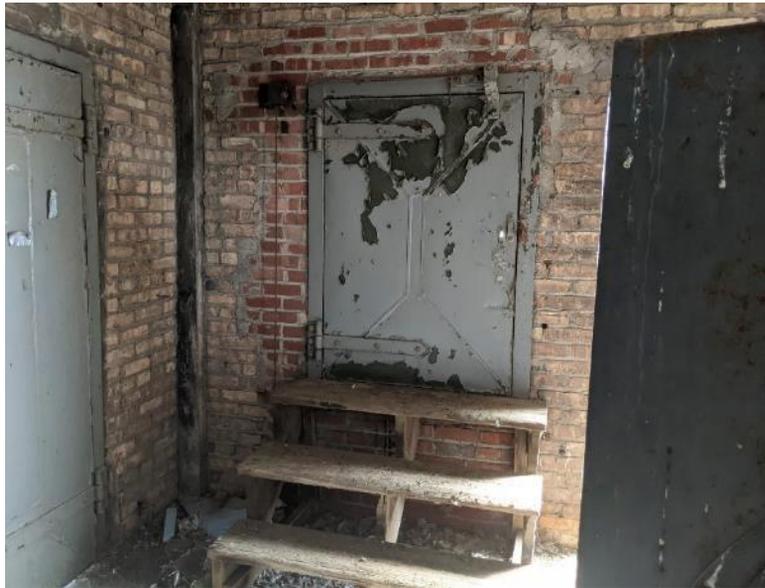
SUBTASK NO. 010.05 Direction: NA	DESCRIPTION	This photograph shows a representative view of grey LBP on metal door frames in room H71.	54
	CLIENT	EPA	Date
	PHOTOGRAPHER	Cory Nichols	6/16/2022

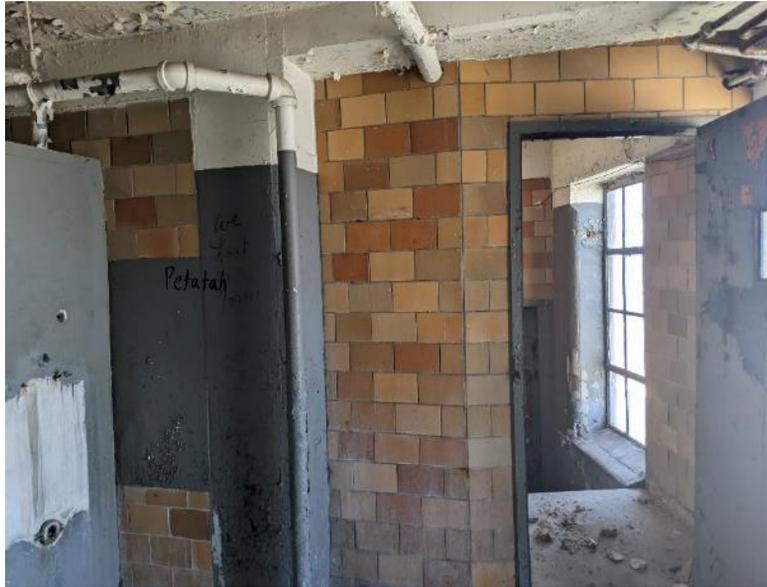
SUBTASK NO. 010.05 Direction: NA	DESCRIPTION	This photograph shows grey LBP on the metal door frames and wall dividers in room B72.	55
	CLIENT	EPA	Date
	PHOTOGRAPHER	Cory Nichols	6/16/2022

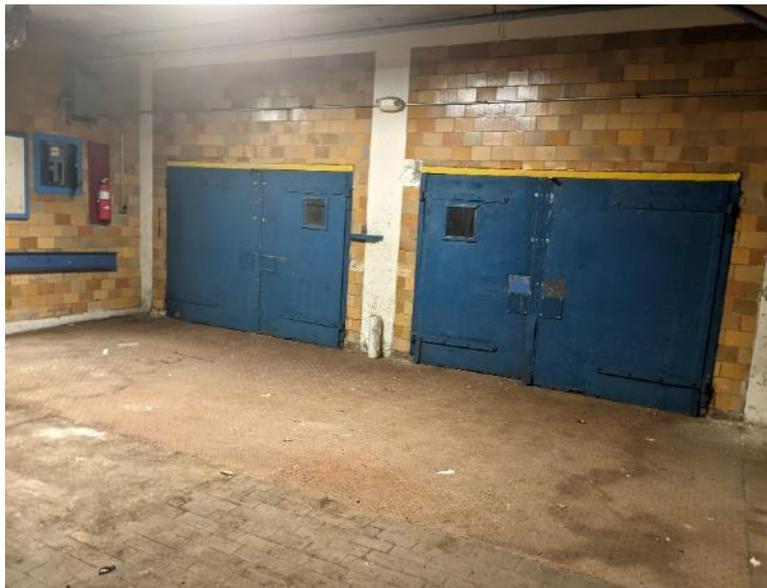
SUBTASK NO. 010.05 Direction: NA	DESCRIPTION	This photograph shows a representative view of blue and yellow LBP on metal door frames on the elevator doors.	56
	CLIENT	EPA	Date
	PHOTOGRAPHER	Cory Nichols	6/16/2022

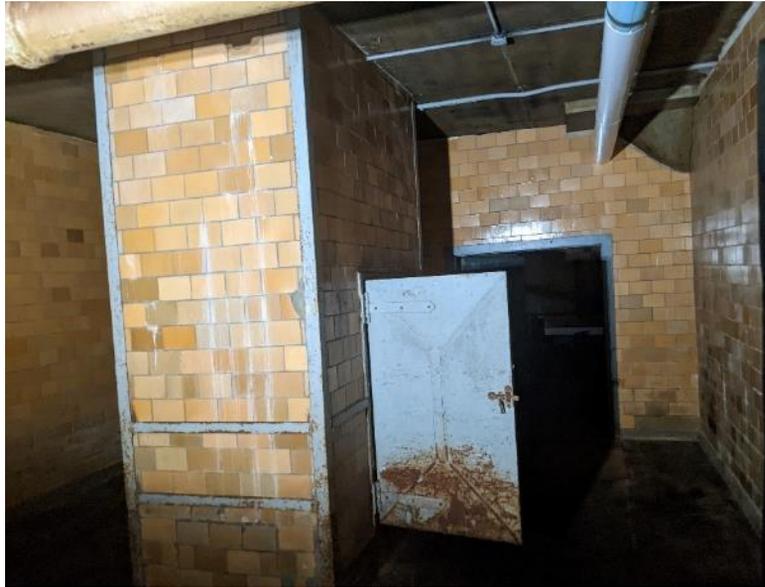
SUBTASK NO. 010.05 Direction: NA	DESCRIPTION	This photograph shows a representative view of grey LBP on metal trim in rooms C63 and C64.	57
	CLIENT	EPA	Date
	PHOTOGRAPHER	Cory Nichols	6/16/2022
