Subject: Trip Report
Dempster Industries Site – Beatrice, Nebraska
EPA ID No. NED007282486
U.S. EPA Region 7 START 5, Contract No. 68HE0719D0001
Task Order No. 21F0136
Task Monitor: Michael Davis, On-Scene Coordinator

TRIP REPORT

**REMOVAL ACTION SUPPORT
DEMPSTER INDUSTRIES SITE – BEATRICE, NEBRASKA
EPA ID No. NED007282486**

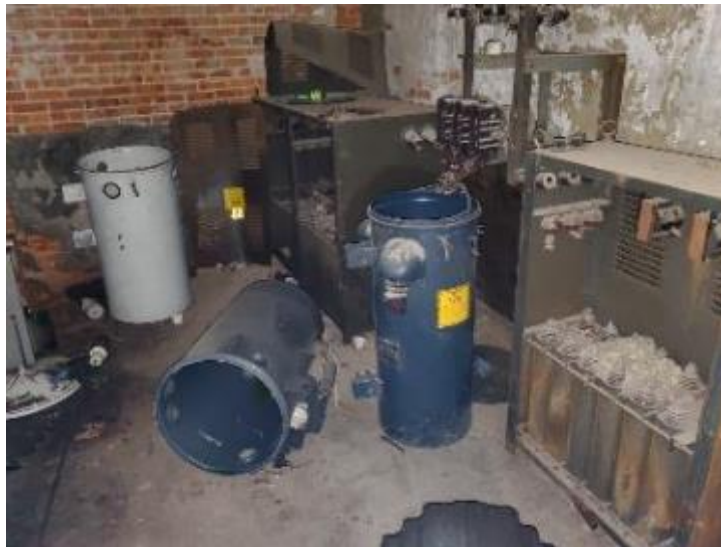
TETRA TECH PROJECT NO. X903021F0136.000 Direction: Southwest	PHOTO DESCRIPTION	This photograph shows the contents of Removal Area 1 including two cabinets housing polychlorinated biphenyls (PCB)-containing capacitors, one small transformer one-third full of PCB oil, and two small transformers with residual PCB oil.	2
	CLIENT	EPA Region 7	Date
	PHOTOGRAPHER	B. Martin (START)	9/30/21

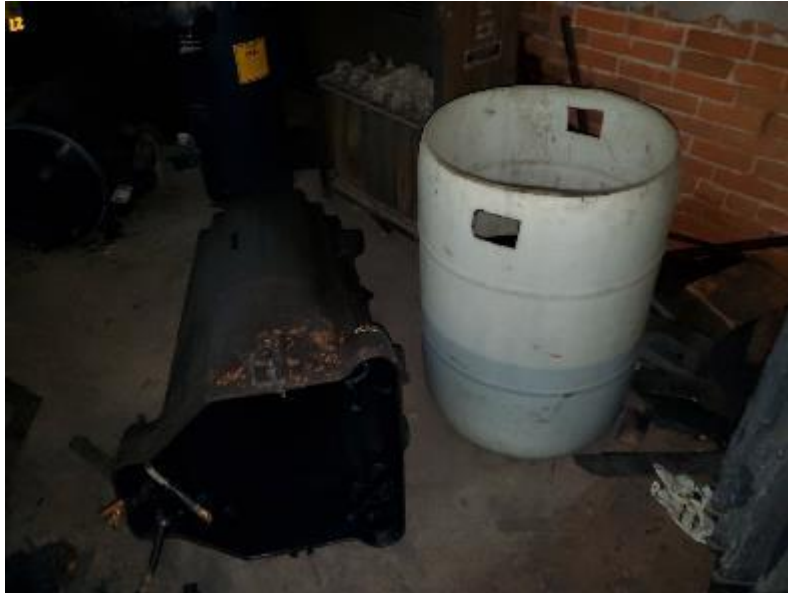
TETRA TECH PROJECT NO. X903021F0136.000 Direction: Southwest	PHOTO DESCRIPTION	This photograph shows the contents of Removal Area 1 including one small transformer with residual PCB oil, and one poly drum one-third full of suspected PCB oil.	3
	CLIENT	U.S. Environmental Protection Agency (EPA) Region 7	Date
	PHOTOGRAPHER	B. Martin (START)	9/30/21

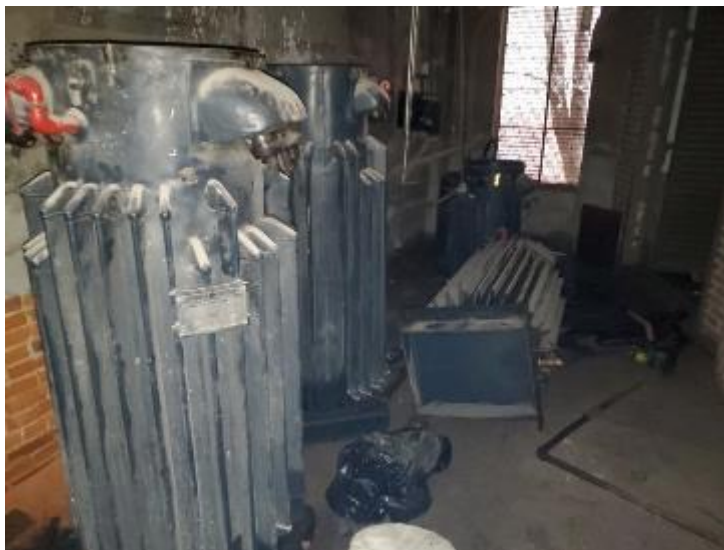
TETRA TECH PROJECT NO. X903021F0136.000 Direction: North	PHOTO DESCRIPTION	This photograph shows the contents of Removal Area 1 including two medium transformers with residual PCB oil, one medium transformer one-eighth full of PCB oil, one small transformer one-fourth full of PCB oil, and one poly drum one-fourth full of suspected PCB oil.	4
	CLIENT	EPA Region 7	Date
	PHOTOGRAPHER	B. Martin (START)	9/30/21

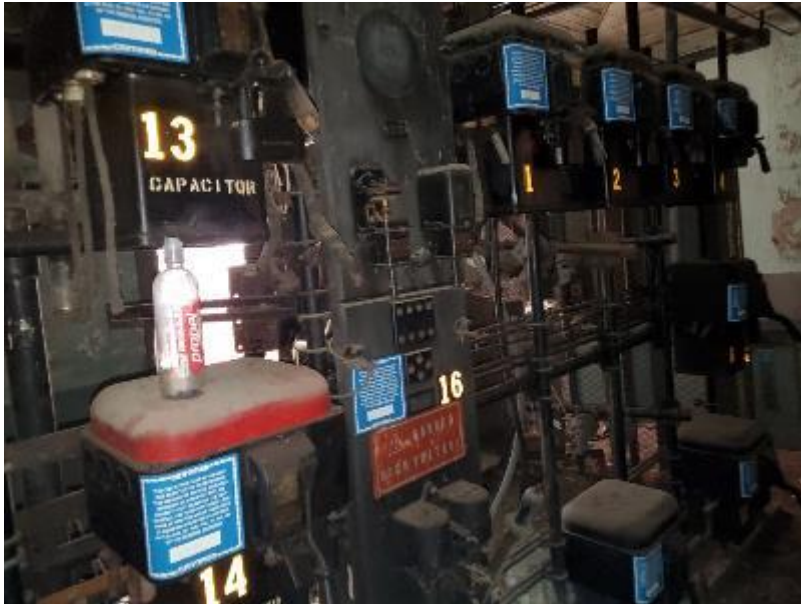
TETRA TECH PROJECT NO. X903021F0136.000 Direction: Northeast	PHOTO DESCRIPTION	This photograph shows the contents of Removal Area 1 including 11 capacitors with PCB oil.	5
	CLIENT	U.S. Environmental Protection Agency (EPA) Region 7	Date
	PHOTOGRAPHER	B. Martin (START)	9/30/21

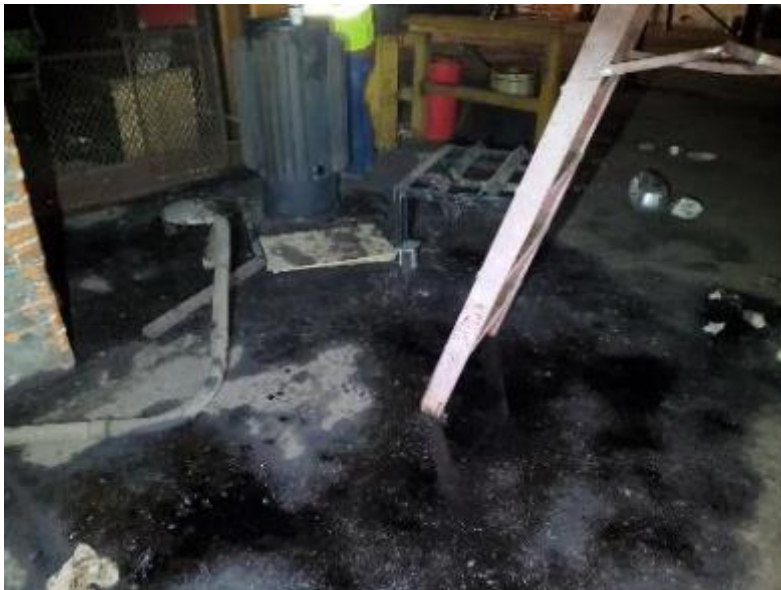
TETRA TECH PROJECT NO. X903021F0136.000 Direction: Southeast	PHOTO DESCRIPTION	This photograph shows the contents of Removal Area 2 including one small transformer with residual PCB oil and suspected PCB oil spill.	6
	CLIENT	EPA Region 7	Date
	PHOTOGRAPHER	B. Martin (START)	9/30/21

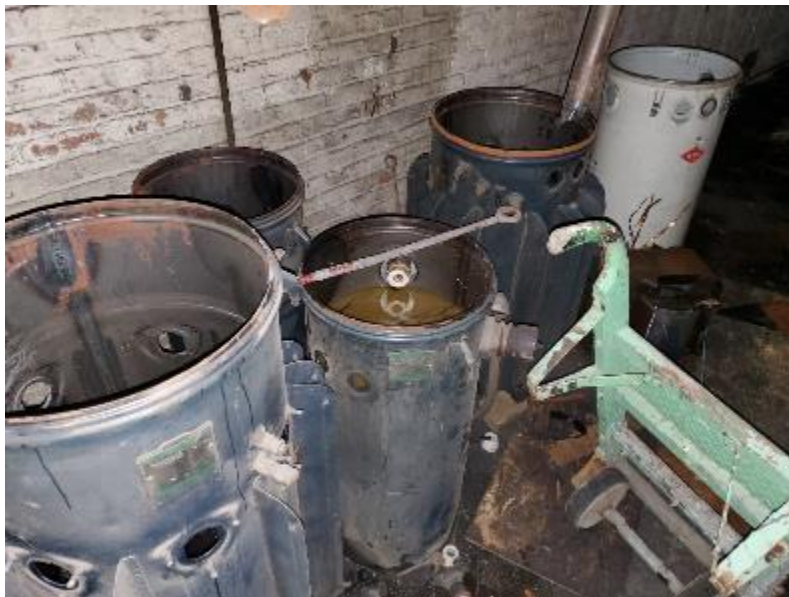
TETRA TECH PROJECT NO. X903021F0136.000 Direction: Northeast	PHOTO DESCRIPTION	This photograph shows the contents of Removal Area 2 including one medium transformer one-fourth full of PCB oil, two small transformers full of PCB oil, and two small transformers one-half and one-quarter full of PCB oil, respectively.	7
	CLIENT	EPA Region 7	Date
	PHOTOGRAPHER	B. Martin (START)	9/30/21

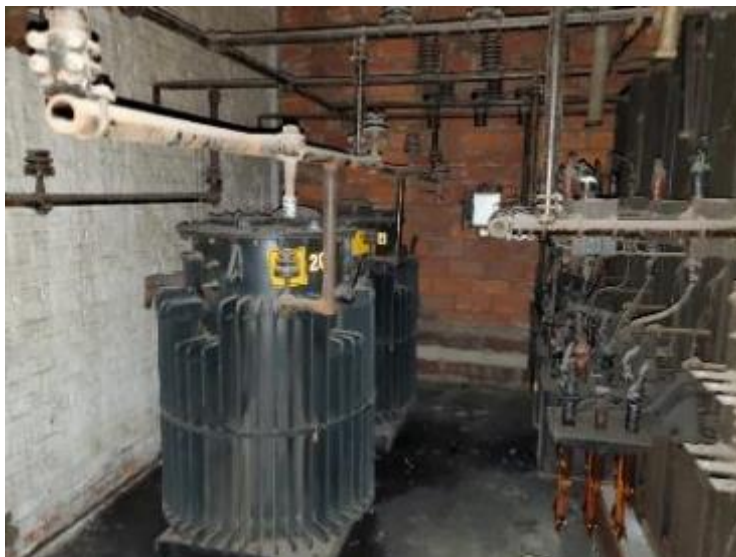
TETRA TECH PROJECT NO. X903021F0136.000 Direction: East	PHOTO DESCRIPTION	This photograph shows the contents of Removal Area 2 including two large transformers full of PCB oil and five PCB-containing capacitors.	8
	CLIENT	EPA Region 7	Date
	PHOTOGRAPHER	B. Martin (START)	9/30/21

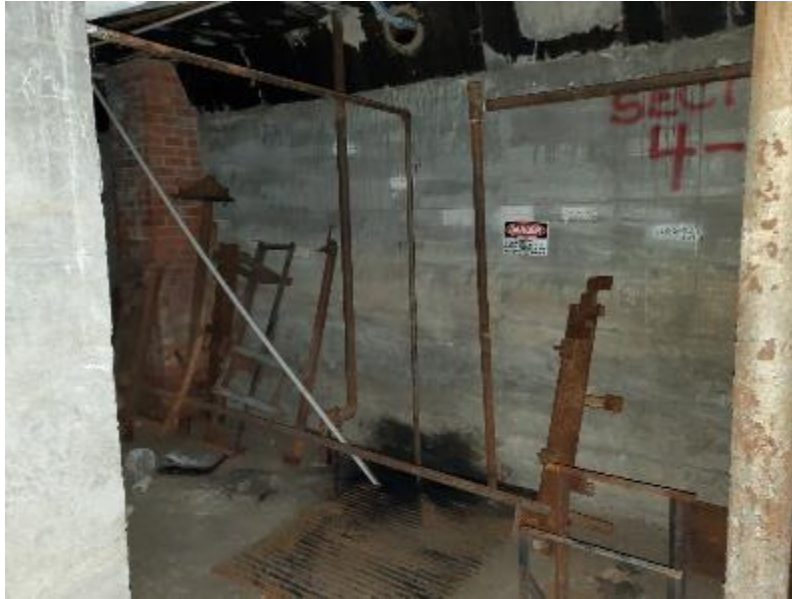
In the basement below Removal Area 2 were two areas of oil staining. Oil had migrated into one area through the ceiling and down the wall; oil had dripped into the second area out of a pipe directly above a floor drain. The floor drain was full of water at the time of the site walk, indicating lack of drainage.

TETRA TECH PROJECT NO. X903021F0136.000 Direction: NA	PHOTO DESCRIPTION	This photograph shows the basement below Removal Area 2 where oil stains indicated entry of oil into the floor drain.	9
	CLIENT	EPA Region 7	Date
	PHOTOGRAPHER	B. Martin (START)	9/30/21

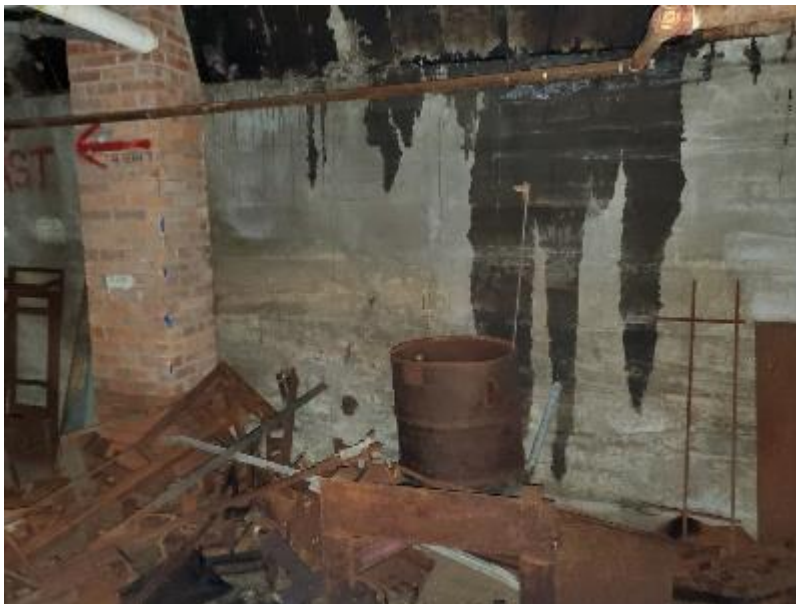
TETRA TECH PROJECT NO. X903021F0136.000 Direction: NA	PHOTO DESCRIPTION	This photograph shows the basement below Removal Area 2 where oil stains indicated migration of oil through the ceiling and onto the walls.	10
	CLIENT	EPA Region 7	Date
	PHOTOGRAPHER	B. Martin (START)	9/30/21

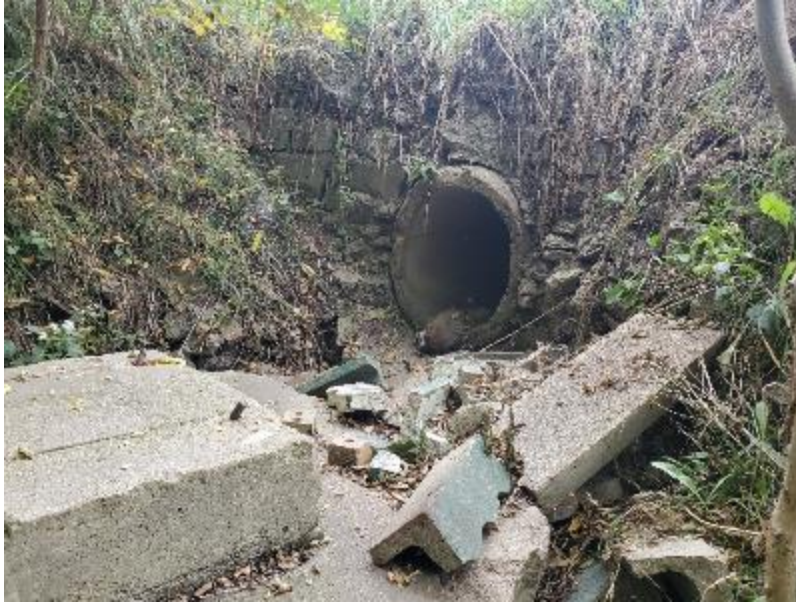
The site walk included inspections of the site outfall and headwaters of the unnamed drainage ditch that flows into the Big Blue River. No indication of a recent oil release was evident at the site outfall or the nearby municipal outfalls. Scrap metal was observed at the right descending bank of the unnamed drainage ditch near the site outfall, and was eroding into the ditch. A dead racoon was observed in the site outfall, and a second dead racoon was observed approximately 100 feet downstream of the municipal outfalls.

TETRA TECH PROJECT NO. X903021F0136.000 Direction: Northwest	PHOTO DESCRIPTION	This photograph shows the site outfall directly south of the site property boundary. A dead racoon was observed in the outfall opening.	11
	CLIENT	EPA Region 7	Date
	PHOTOGRAPHER	B. Martin	9/30/21

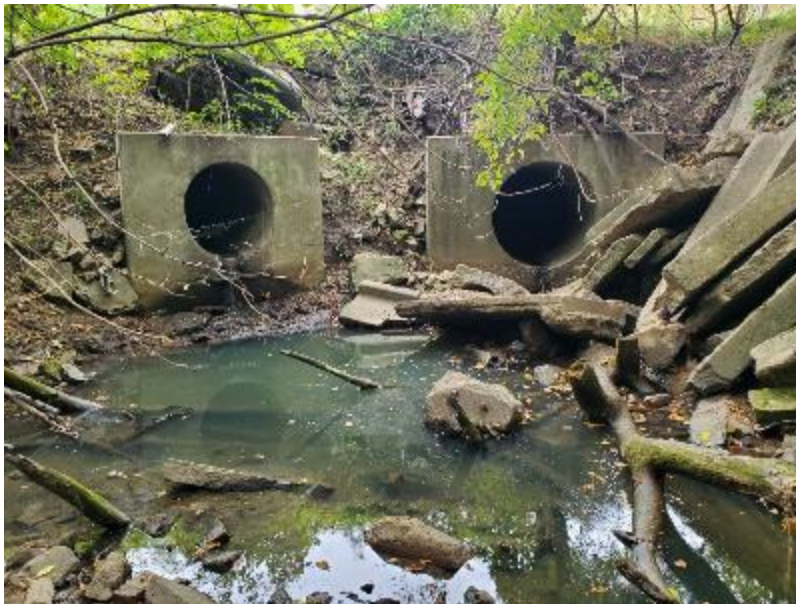
TETRA TECH PROJECT NO. X903021F0136.000 Direction: North	PHOTO DESCRIPTION	This photograph shows two municipal outfalls immediately downgradient of the site outfall.	12
	CLIENT	EPA Region 7	Date
	PHOTOGRAPHER	B. Martin	9/30/21

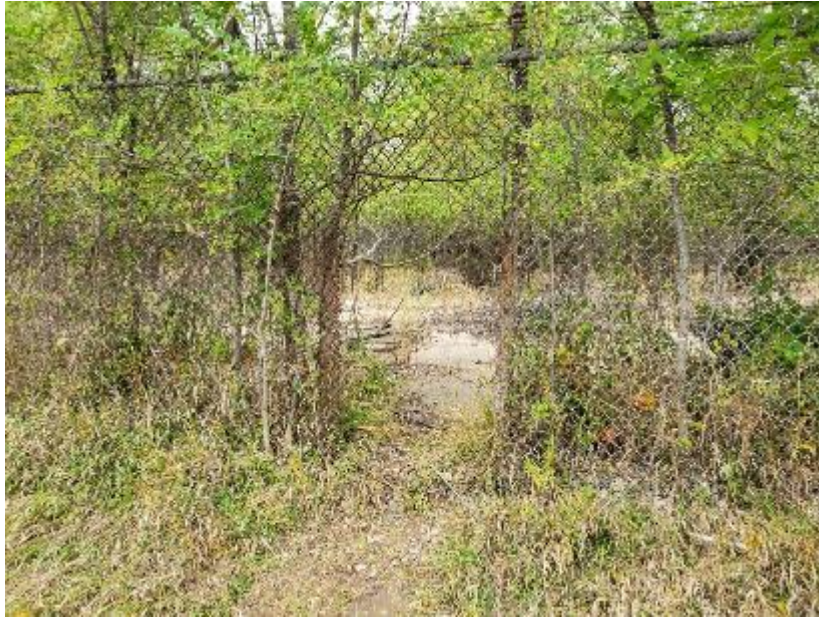
Participants in the site walk observed evidence of previous entry to the site by trespassers—a breach in the fence along the southern property boundary, and broken windows along the northeastern property boundary. These indicated that the site was not secured. Other evidence of trespassers, including spray paint graffiti and indications of salvaging valuable metals, was apparent throughout the site.

TETRA TECH PROJECT NO. X903021F0136.000 Direction: South	PHOTO DESCRIPTION	This photograph shows a breach in the southern site property fence indicating that the site is not secured.	13
	CLIENT	EPA Region 7	Date
	PHOTOGRAPHER	B. Martin (START)	9/30/21

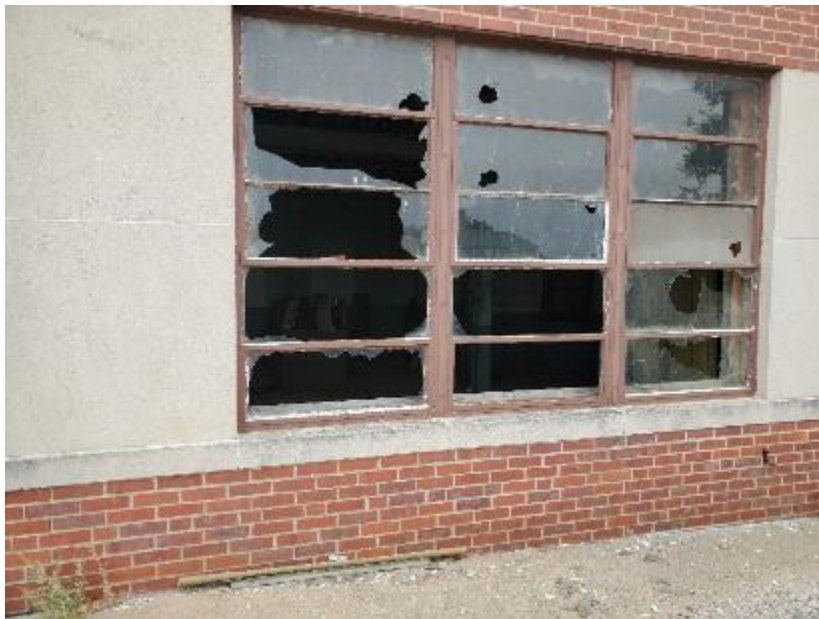
TETRA TECH PROJECT NO. X903021F0136.000 Direction: Southwest	PHOTO DESCRIPTION	This photograph shows broken windows at a northeastern site building indicating that the site is not secured.	14
	CLIENT	EPA Region 7	Date
	PHOTOGRAPHER	B. Martin (START)	9/30/21

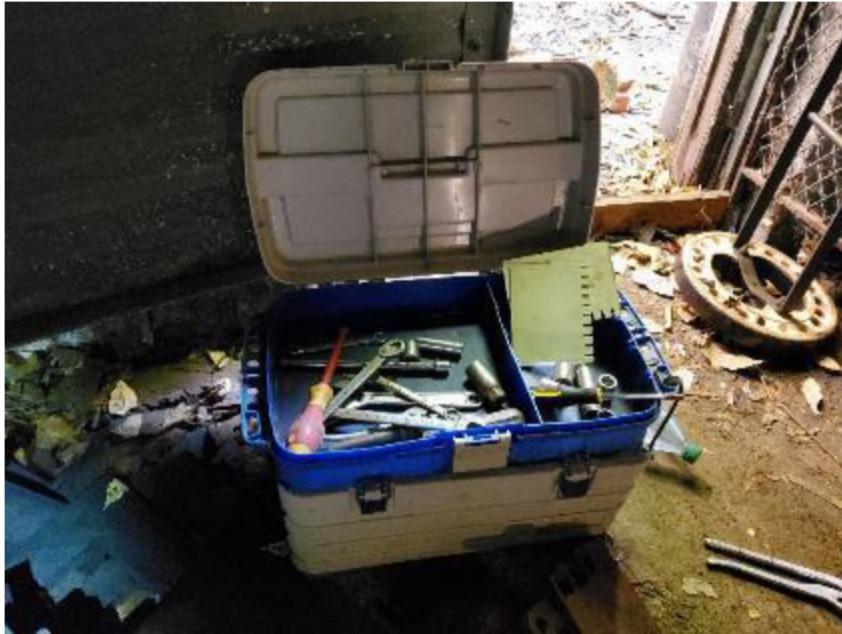
TETRA TECH PROJECT NO. X903021F0136.000 Direction: North	PHOTO DESCRIPTION	This photograph shows a toolbox found in Removal Area 1 following identification of trespassers on site.	15
	CLIENT	EPA Region 7	Date
	PHOTOGRAPHER	B. Martin (START)	10/12/21

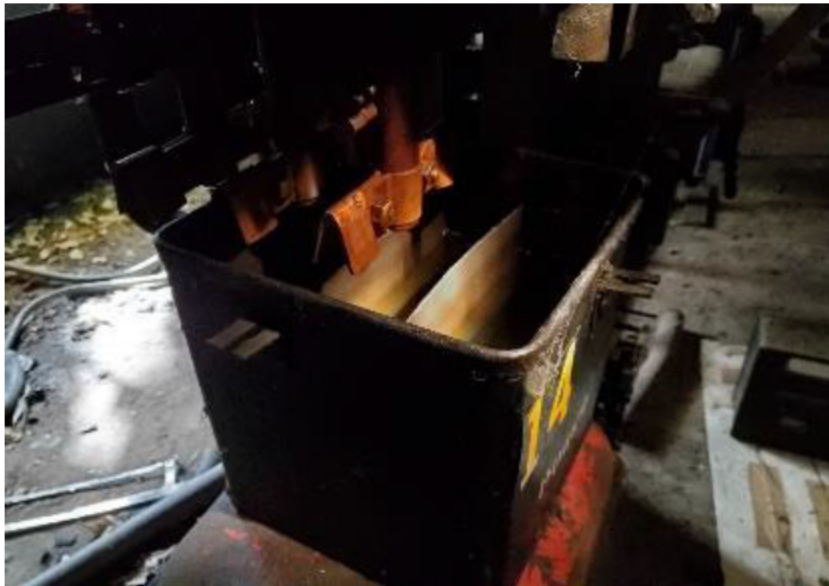
TETRA TECH PROJECT NO. X903021F0136.000 Direction: Northeast	PHOTO DESCRIPTION	This photograph shows an opened PCB-containing capacitor in Removal Area 1 following identification of trespassers on site.	16
	CLIENT	EPA Region 7	Date
	PHOTOGRAPHER	B. Martin	10/12/21

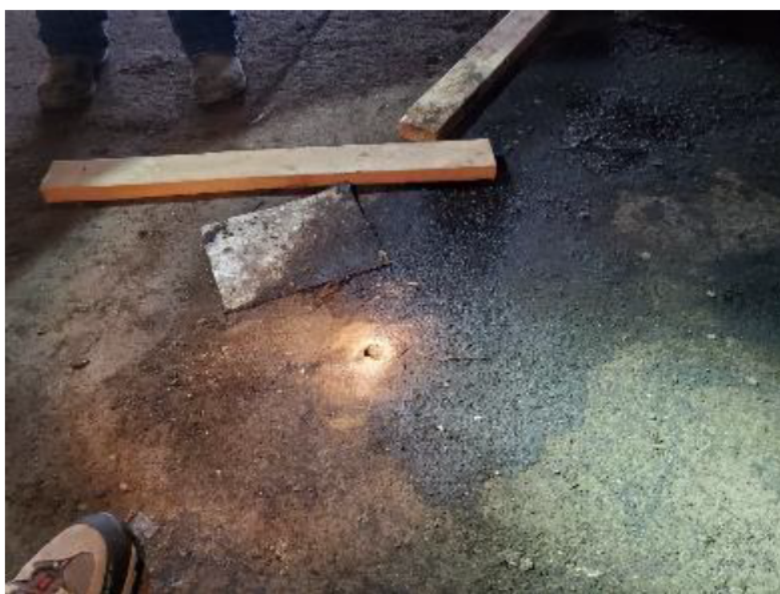
<p>TETRA TECH PROJECT NO. X903021F0136.000</p> <p>Direction: NA</p>	PHOTO DESCRIPTION	This photograph shows a hole in the floor in Removal Area 2 suspected to allow migration of spilled PCB oil to the basement where the floor drain is located.	18
	CLIENT	EPA Region 7	Date
	PHOTOGRAPHER	B. Martin	11/2/21
