Accident analysis of Beijing Jimei Dahongmen 25 MWh DC solar-storage-charging integrated station project

Institute of energy storage and novel electric technology, China Electric Power Technology Co., Ltd.

April 2021

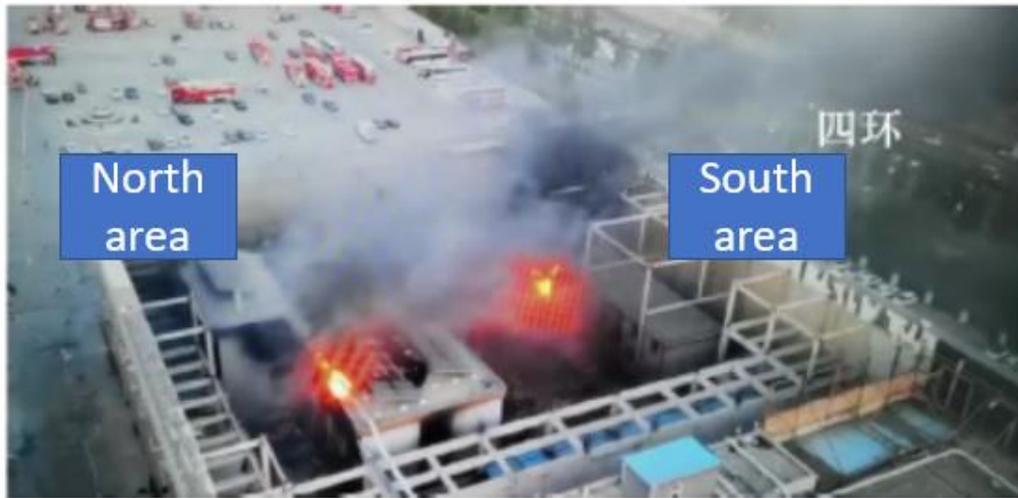
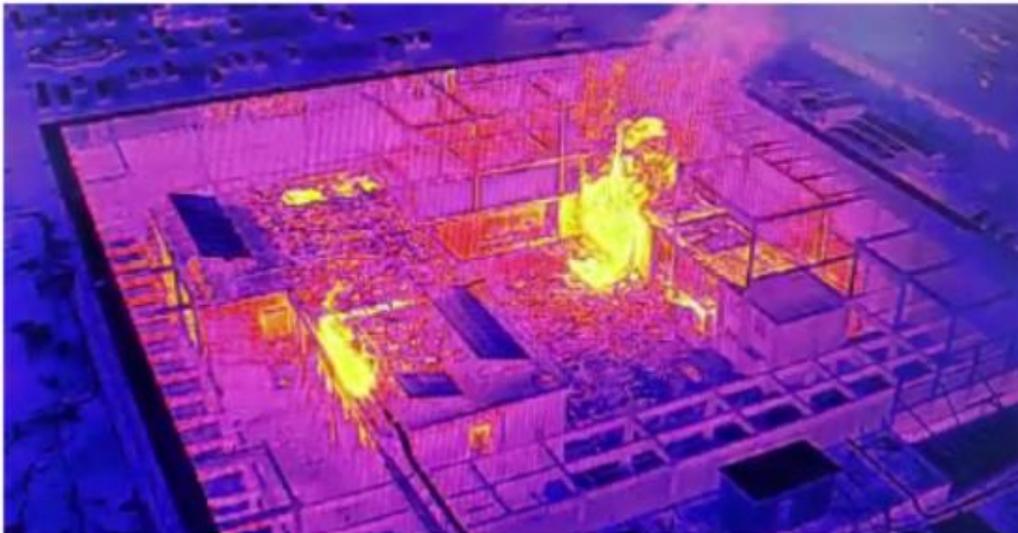
Fig. 8 Aerial photography of the accident scene

It was learnt through preliminary investigation that on-site debugging was undertaken prior to the accident. At 23:40 pm on 16th April 2021, the naked fire was extinguished. However, the cooling-down was still in process. The reasons and property loss were under investigation.

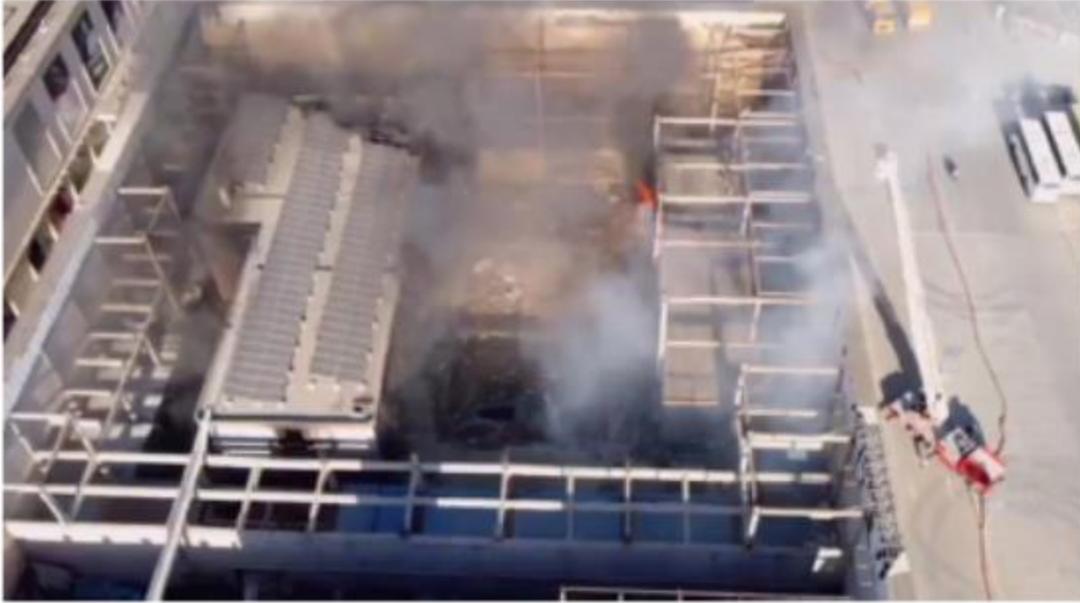
Fig. 9 The power station after fire fighting
