**MERSEYSIDE
FIRE & RESCUE
SERVICE**

SIGNIFICANT INCIDENT REPORT

Incident: 018965 - 15092020

Address: **Orsted BESS, Carnegie Road, Liverpool, L137HY**

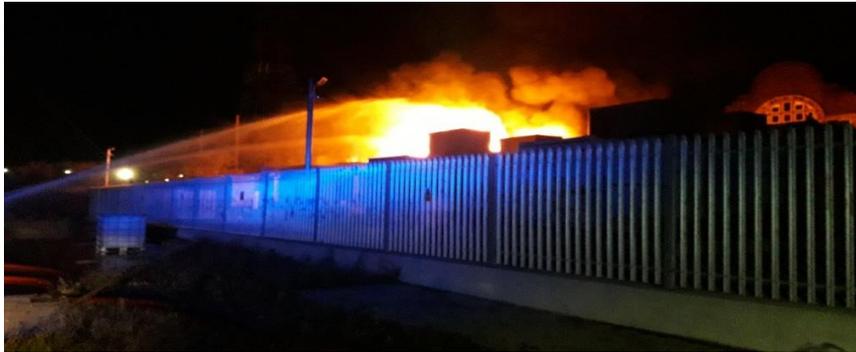
Firefighting action from Sector 1.

2 ground monitors at work.

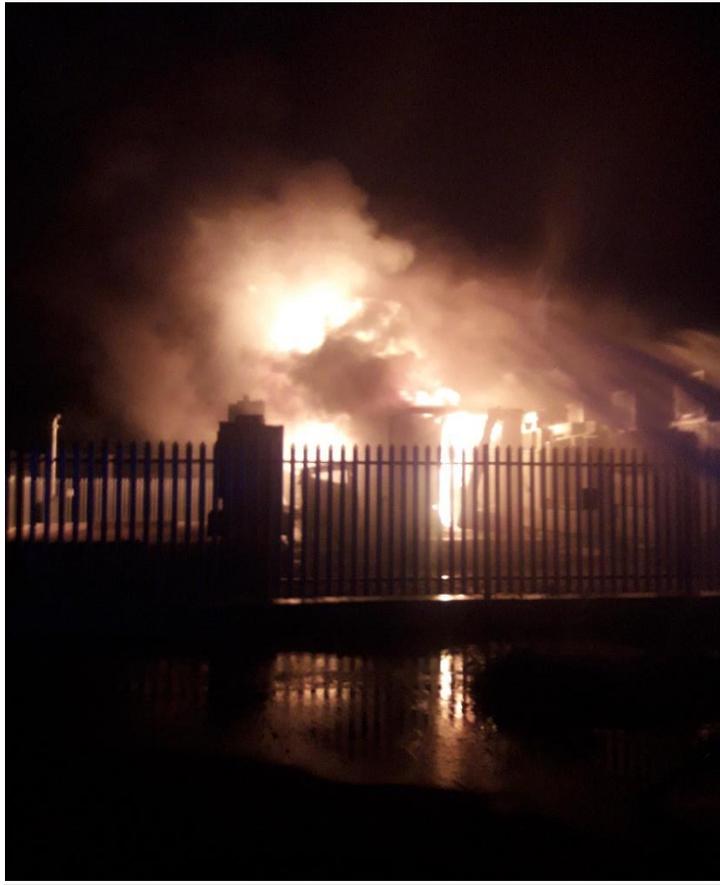
Fire development from the unit at approximately 01:30 hours.

Note the intensity of fire and therefore heat from the centre of the unit and extension of flame into the plume.

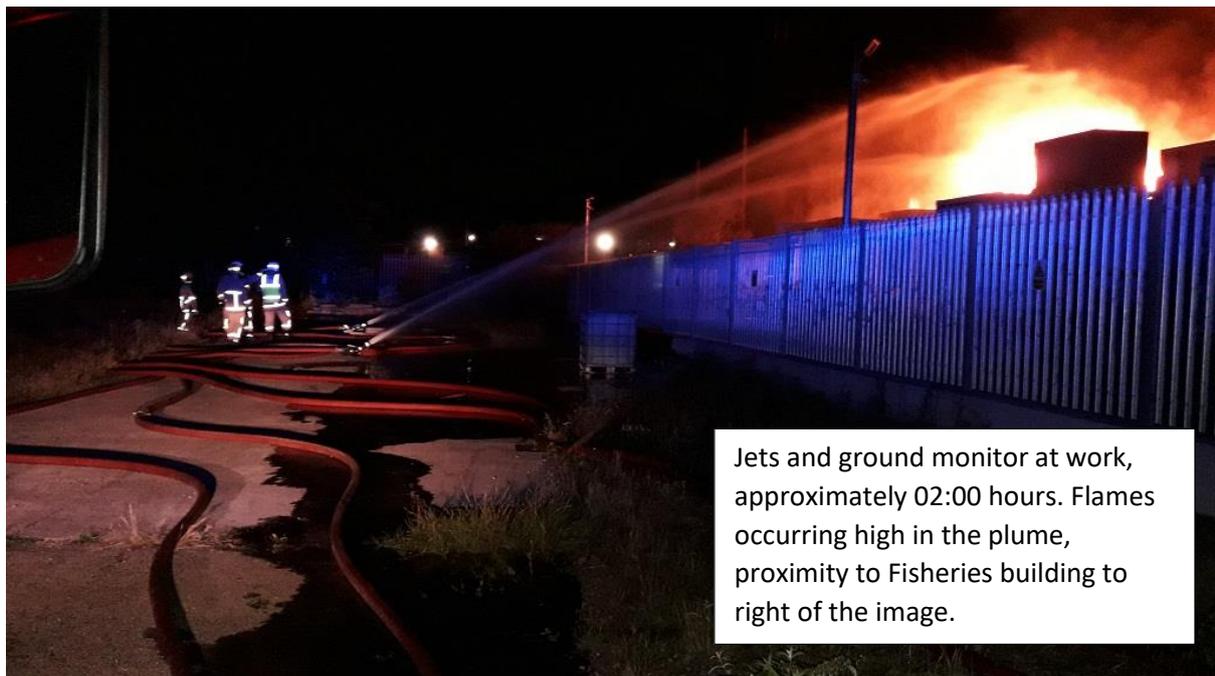
Jets and ground monitor at work, approximately 02:00 hours. Flames occurring high in the plume, proximity to Fisheries building to right of the image.

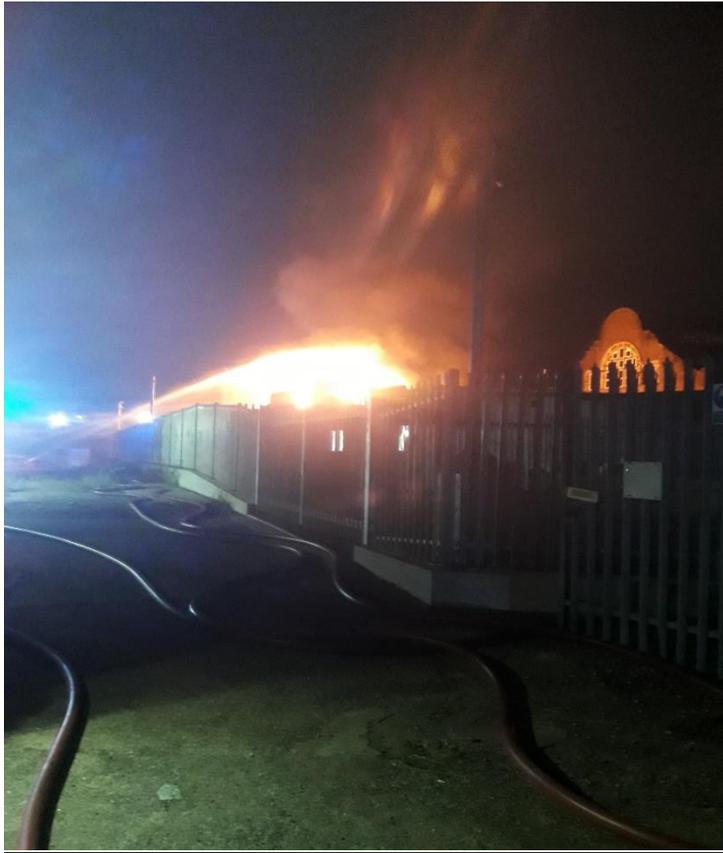
Ground monitors in use and personnel upwind of plume approximately 03:00 hours.
Information on plume toxicity gained at this point.

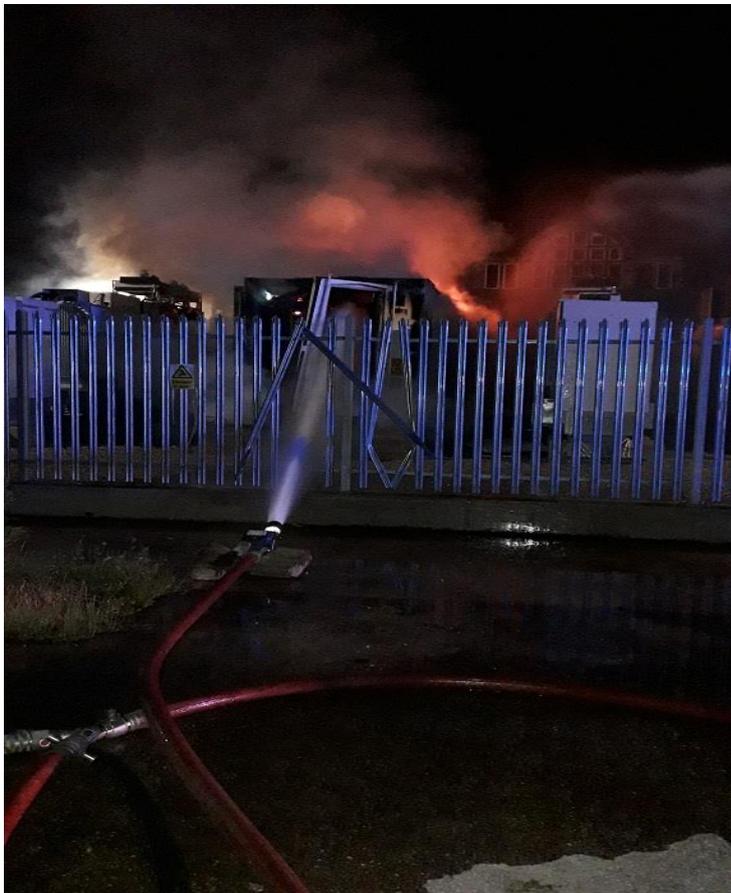
Ground monitor in use at approximately 05:15hrs.
Note sections of railings opened by MFRS to allow straight play of monitor jet.

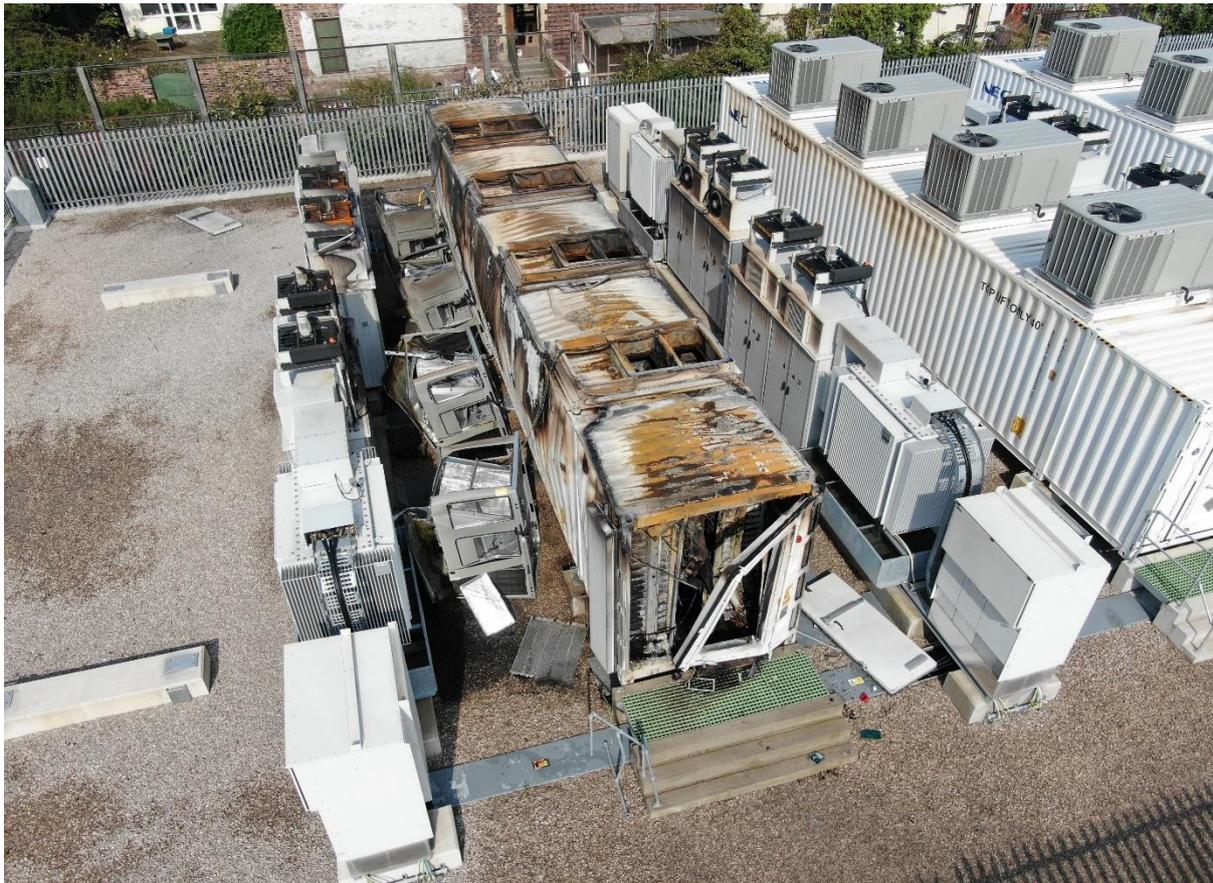
Image above: Taken from GMFRS AIR Unit. Full extent of damage visible. Roof mounted cooling units ejected to side of unit. Pressure damage visible along length of unit. Note scorching of top edge of second unit to mid-right of image. Firefighting tactics mitigated further spread and damaged beyond original unit and blast.

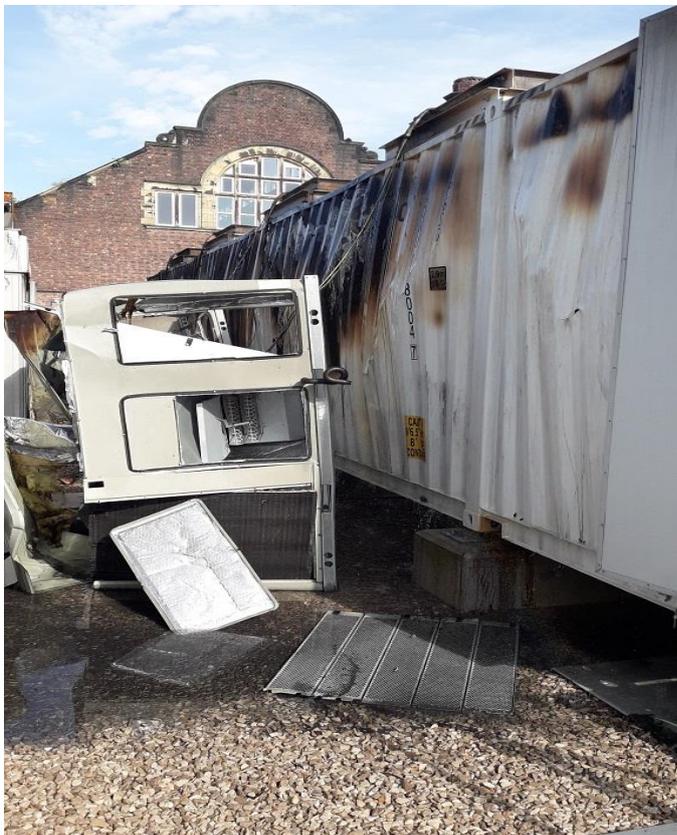
Image left: FI Photography, note pressure damage and expansion of unit above burn line pattern. Remains of cooling unit pictured to left hand side.

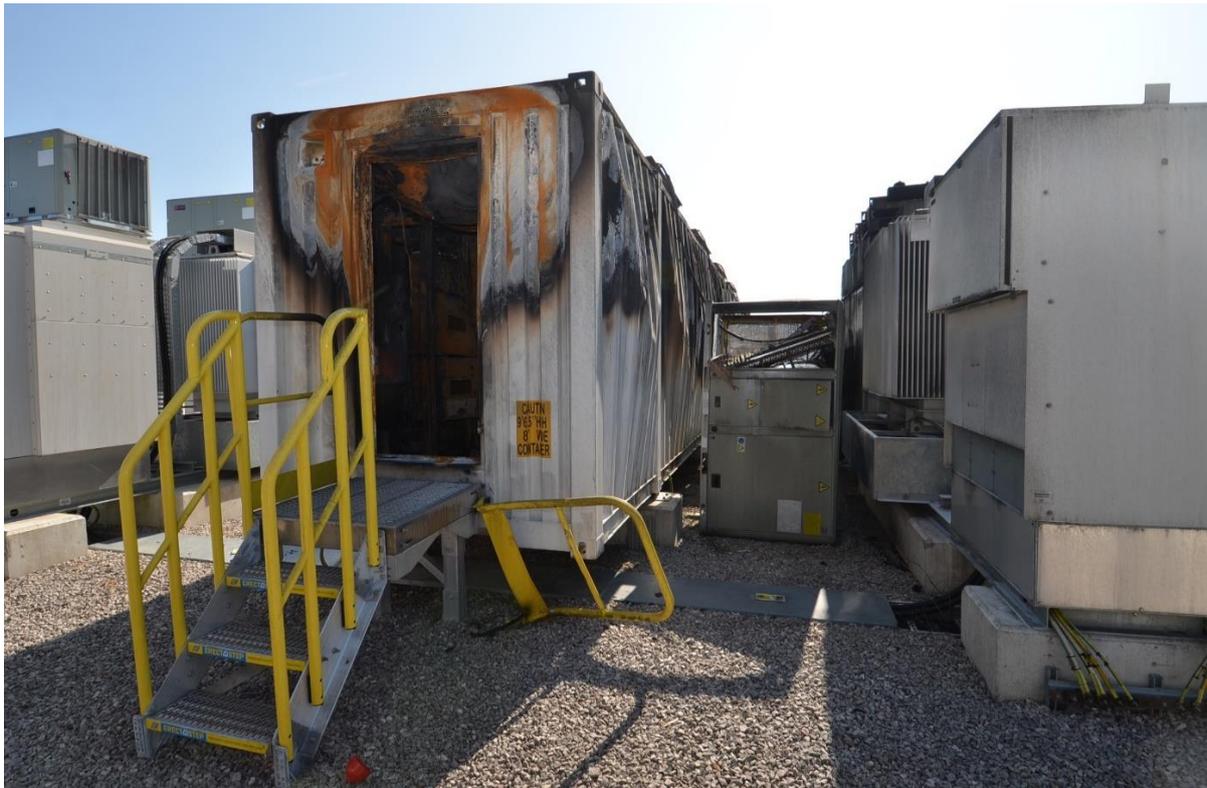
Image above: Exterior of unit with pressure damage to side.

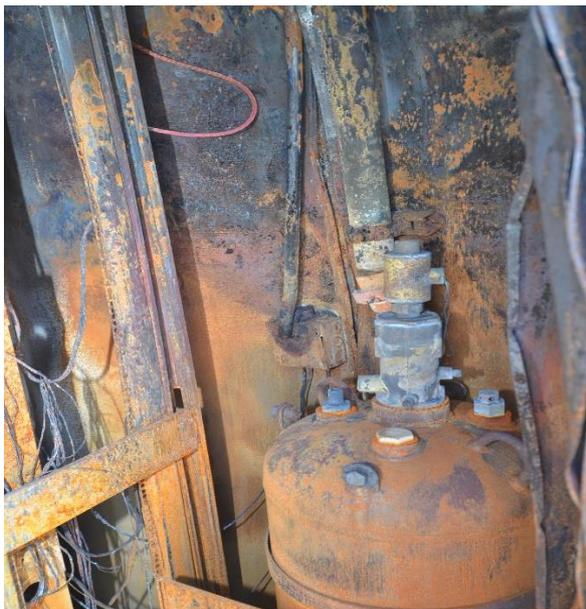
- The NOVEC 1230 system did not actuate, confirmed by internal CCTV.
- A white gas was liberated prior to ignition, indicative of a lithium ion cell failure and liberation of toxic gases detailed above.
- The potential ignition cause is allocated to the failure of a single lithium cell, one of several due for replacement as near end of service life.
- A major blast event was captured by CCTV externally.
- A pressure relief valve may have delayed or prevented a blast event.
- Several elements were ejected from the unit, a component of one of the air cooling units found at 74ft (22.5m) from the unit.

Image below left: Fire damaged NOVEC 1230 unit.

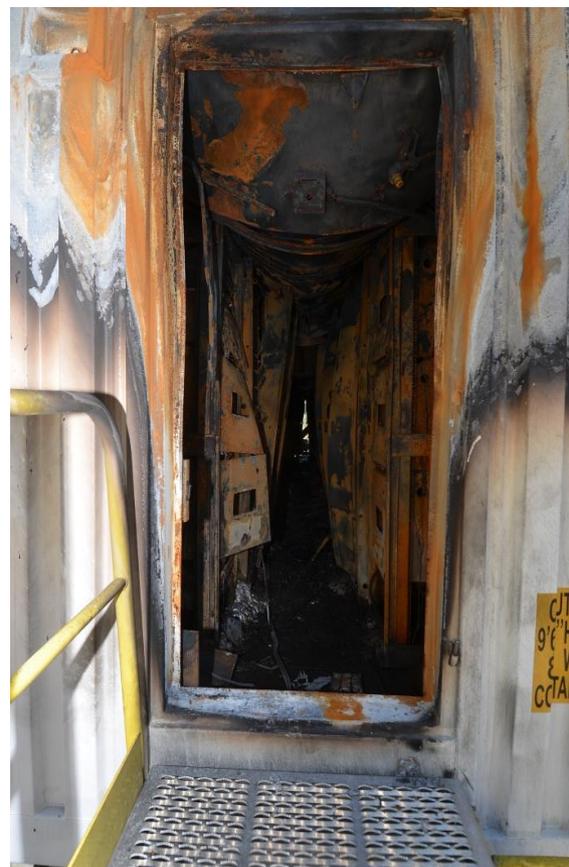
Image below right: Internal view of modules.
