January 25, 2022

Victorian Big Battery Fire: July 30, 2021

REPORT OF TECHNICAL FINDINGS

Fisher Engineering, Inc.

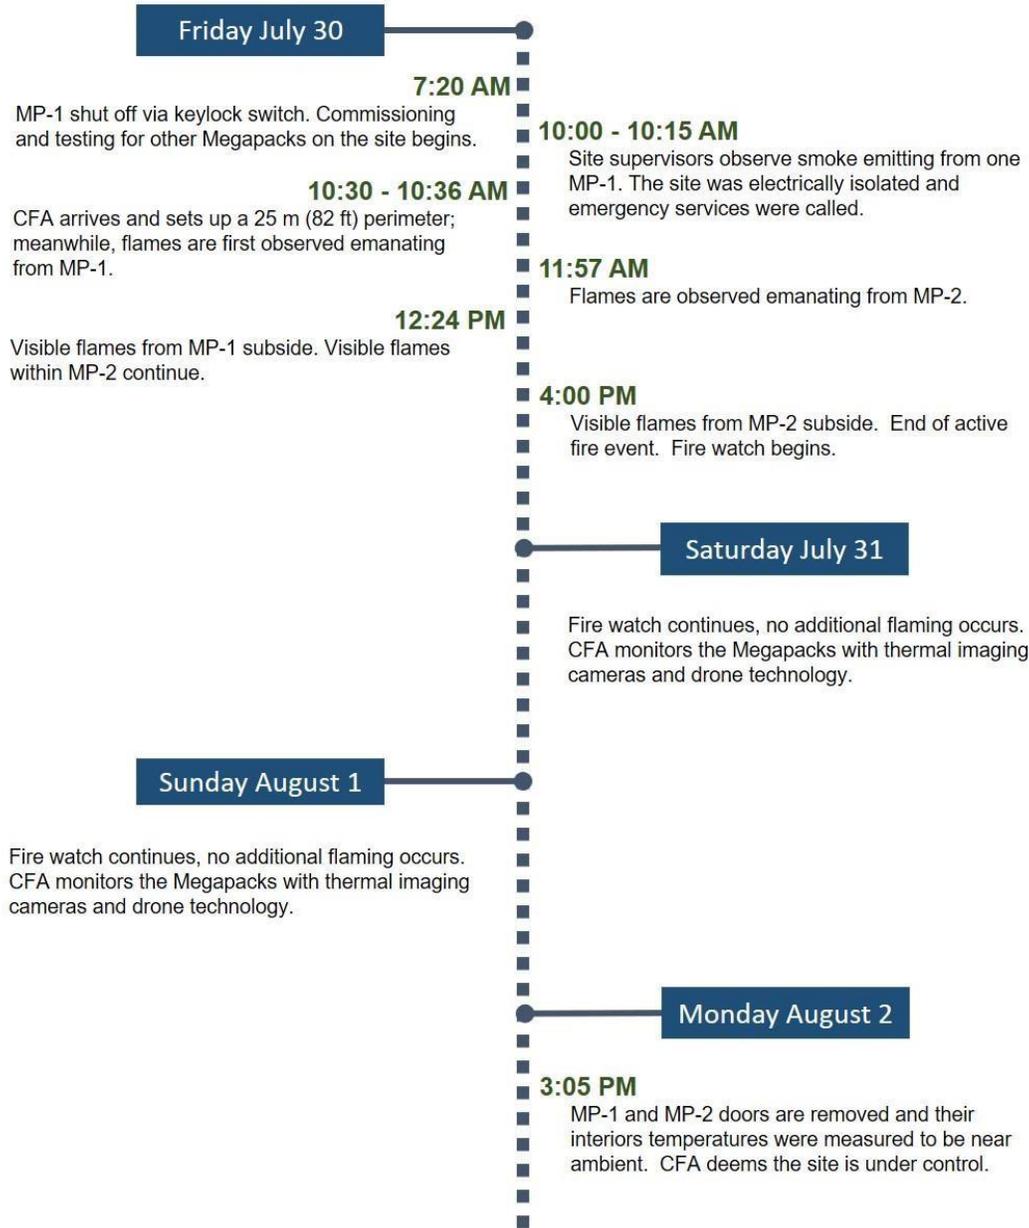
Incident Timeline

At the time of the fire, the VBB was fitted with approximately one-half of the 212 total Megapacks intended for the site. The Megapacks that were installed at VBB were undergoing routine testing and commissioning on the day of the fire. At 7:20 AM Australian Eastern Standard Time (AEST) on the morning of July 30, 2021, commissioning and testing of a number of Megapacks commenced. One such Megapack (denoted herein as MP-1), was not going to be tested that day and was therefore shut off manually by means of the keylock

switch.³ At the time MP-1 was shut down via the keylock switch, the unit displayed no abnormal conditions to site personnel. Around 10:00 AM, smoke was observed emitting from MP-1 by site personnel. Site personnel

electrically isolated all the Megapacks on-site and called emergency services: Country Fire Authority (CFA). The CFA arrived shortly thereafter and set up a 25 m (82 ft) perimeter around MP-1. They also began applying cooling water to nearby exposures as recommended in Tesla's ERG. The fire eventually spread into a neighbor Megapack (MP-2) installed 15 centimeters (cm), or 6 inches (in), behind MP-1. The CFA permitted MP-1 and MP-2 to burn themselves out and did not directly apply water into or onto either Megapack, as recommended in Tesla's ERG. By 4:00 PM (approximately six hours after the start of the event), visible fire had subdued and a fire watch was instituted. The CFA monitored the site for the next three days before deeming it under control on August 2, 2021, at which time, the CFA handed the site over for the fire investigation to begin.

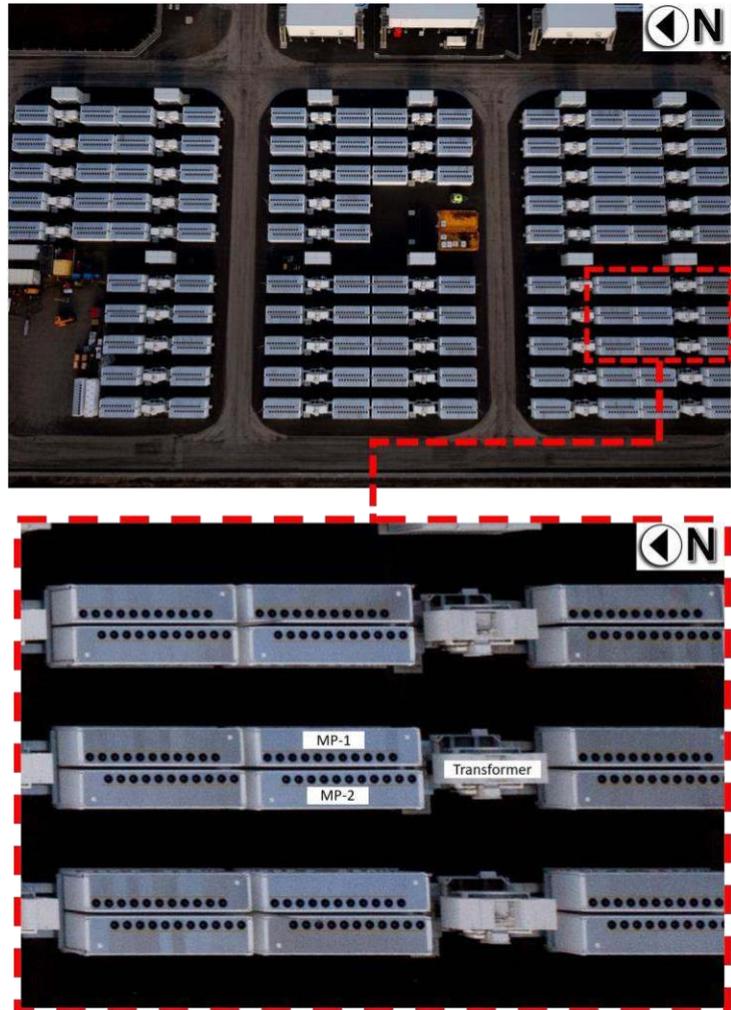
Figure 1 VBB Megapack layout (top) and area of fire origin (bottom)

The VBB fire investigation process involved analyzing not only the root cause of the initial fire in MP-1 but also the root cause of the fire propagation into MP-2. The Megapack has been designed to be installed in close proximity to each other without fire propagating to adjacent units. The design objective of the Megapack in terms of limiting fire propagation was mainly reliant on the thermal insulation of the Megapack's exterior vertical steel panels and the sheer mass of the battery modules acting as a heat sink (i.e., they are difficult to heat up). With this thermal insulation, the Megapack spacing can be as close as 15 cm (6 in) to the sides and back of each unit with 2.4 m (8 ft) aisles in front of each Megapack, as shown in Figure 1. This product spacing has been validated in UL9540A unit level tests.⁸ Similar to the fire origin and cause investigation, the on-site inspections were supported simultaneously with an analysis of telemetry data (such as internal temperatures) from MP-2 and fire testing. The on-site investigation findings, the telemetry data analysis and fire tests, when combined, identified a scenario where Megapack to Megapack fire propagation can occur.

Flames exiting the roof of MP-1 were significantly impacted by the wind conditions at the time of the fire. Wind speeds were recorded between 20-30 knots⁹ which pushed the flames exiting the roof of MP-1 towards the roof of MP-2. This direct flame impingement on the top of the thermal roof of MP-2 ignited the internal

components of MP-2, most notably, the plastic overpressure vents that seal the battery bay¹⁰ from the thermal roof. Once ignited, the overpressure vents provided a direct path for flames and hot gases to enter into the battery bays, thus exposing the battery modules of MP-2 to fire and/or elevated temperatures. Exposed to temperatures above their thermal runaway threshold of 139°C (282°F), the cells within the battery modules eventually failed and became involved in the fire.

The wind was the dominant contributory factor in the propagation of fire from MP-1 to MP-2. At the time of the fire, a 20-30 knot (37-56 km/hr, 23-35 mph) wind was recorded out of the north. The wind conditions at the time of the fire pushed the flames exiting out of the top of MP-1 towards the top of MP-2 leading to direct flame impingement on the thermal roof of MP-2. This type of flame behavior was not observed during previous product testing or regulatory testing per UL9540A. In UL9540A unit level testing, the maximum wind speed permitted¹² during the test is 10.4 knots (19.3 km/hr, 12.0 mph); whereas, wind conditions during the VBB fire were two to three times greater in magnitude. As such, the wind conditions during the VBB fire appear to have identified a weakness in the Megapack's thermal roof design (unprotected, plastic overpressure vents in the ceiling of the battery bays) that allows Megapack-to-Megapack fire propagation. This weakness was not identified previously during product or regulatory testing and does not invalidate the Megapack's UL9540A certification, as the cause of fire propagation was primarily due to an environmental condition (wind) that is not captured in the UL9540A test method.

- Installation of newly designed, thermally insulated steel vent shields within the thermal roof of all Megapacks. These vent shields protect the plastic overpressure vents from direct flame impingement or hot gas intrusion, thus keeping the IP66 battery bay enclosures isolated from a fire above in the thermal roof. Their performance was validated through a series of fire tests, including unit level fire testing of entire Megapack units.¹³ The vent shields are placed over the top of the overpressure vents and will come standard on all new Megapack installations. For existing Megapacks, the vent shields can be installed in the field (retrofit) with minimal effort or disruption to the unit. At the time of this report, the vent shields are nearing production stage and will be retrofitted to applicable Megapack sites shortly.
