**Hudson Falls Former Powerhouse Deconstruction  
Environmental Monitoring and Protective Measures Work Plan  
Work Task Description – East Trench Debris and Related Water Management –  
Addendum No. 2**

**Original WTD – May 11, 2023  
Revised WTD (Addendum No. 1) – June 14, 2023  
WTD Addendum No. 2 – August 31, 2023**

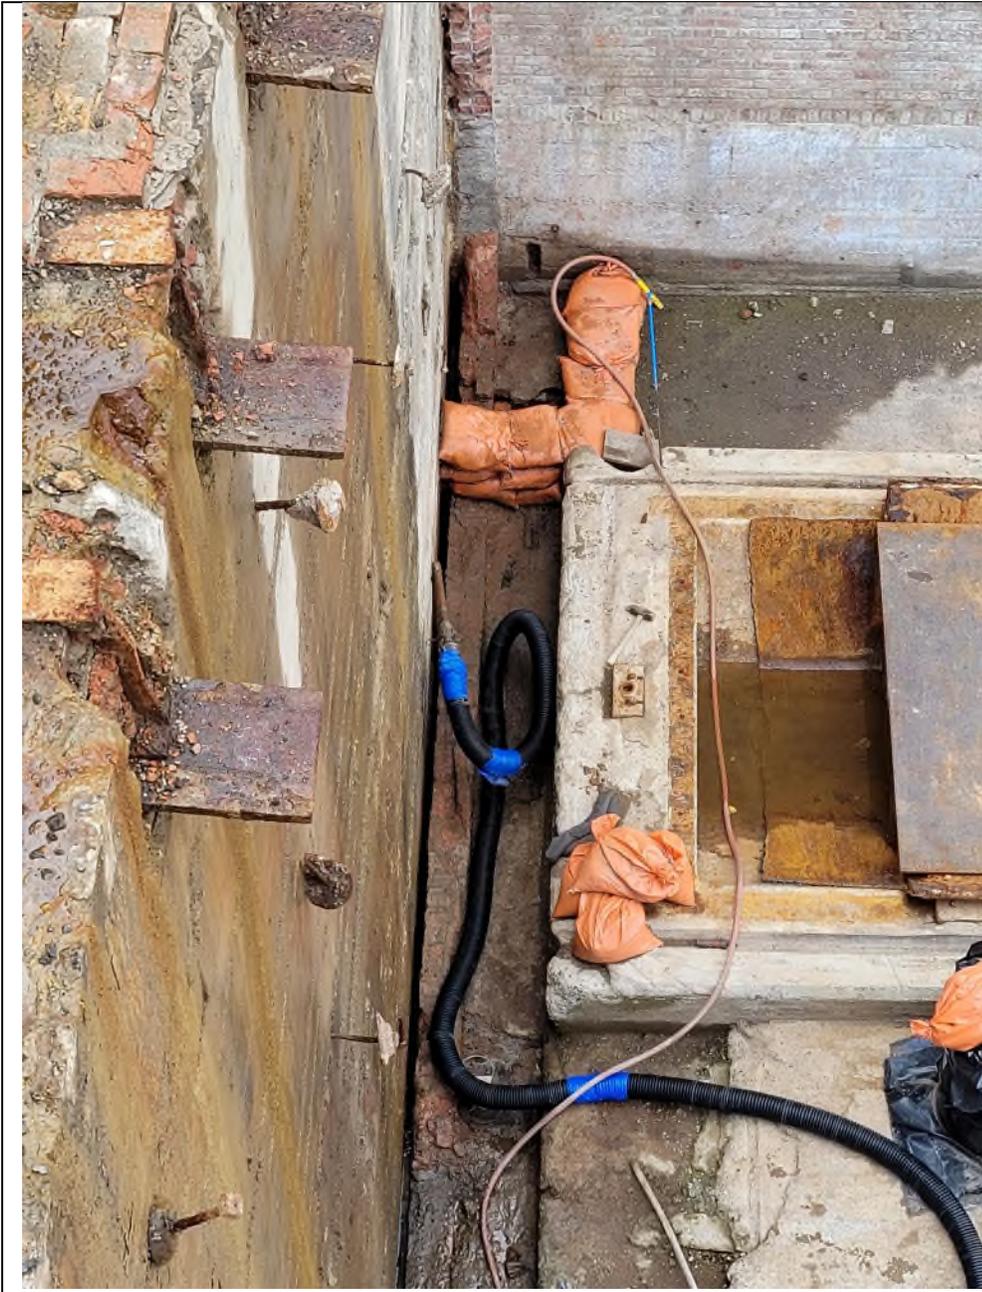
**Photograph: 1**

**Description:**  
Flushing and vacuuming activities occurring at south end of Foundation/Wall Gap.

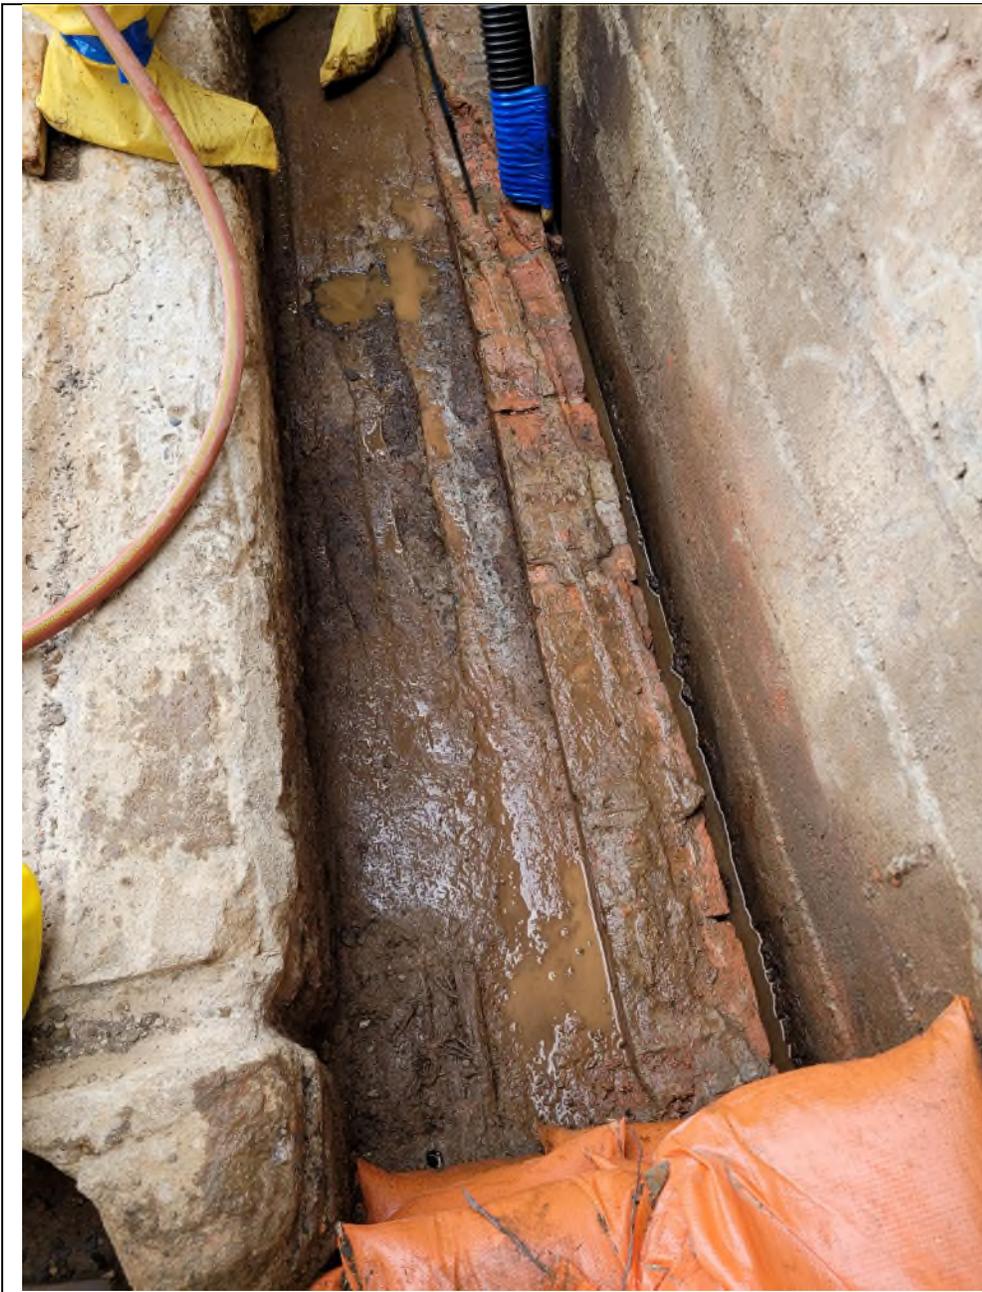
**Photograph: 2**

**Description:**  
Flushed/vacuumed  
area adjacent to south  
turbine foundation.

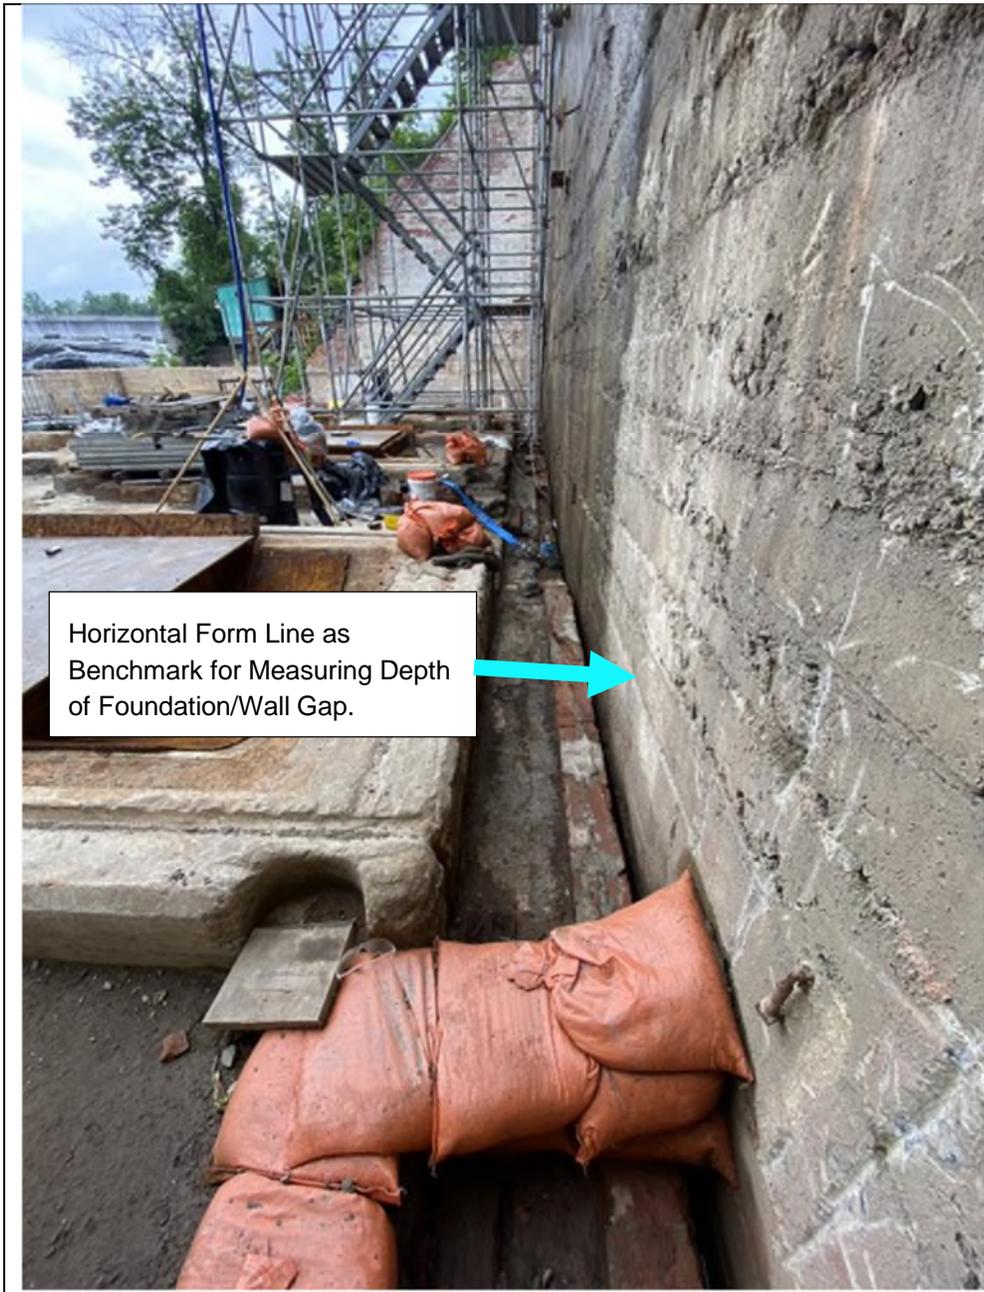
**Photograph: 3**

Horizontal Form Line as Benchmark for Measuring Depth of Foundation/Wall Gap.

**Description:**  
Measure point for depth of Foundation/Wall Gap.

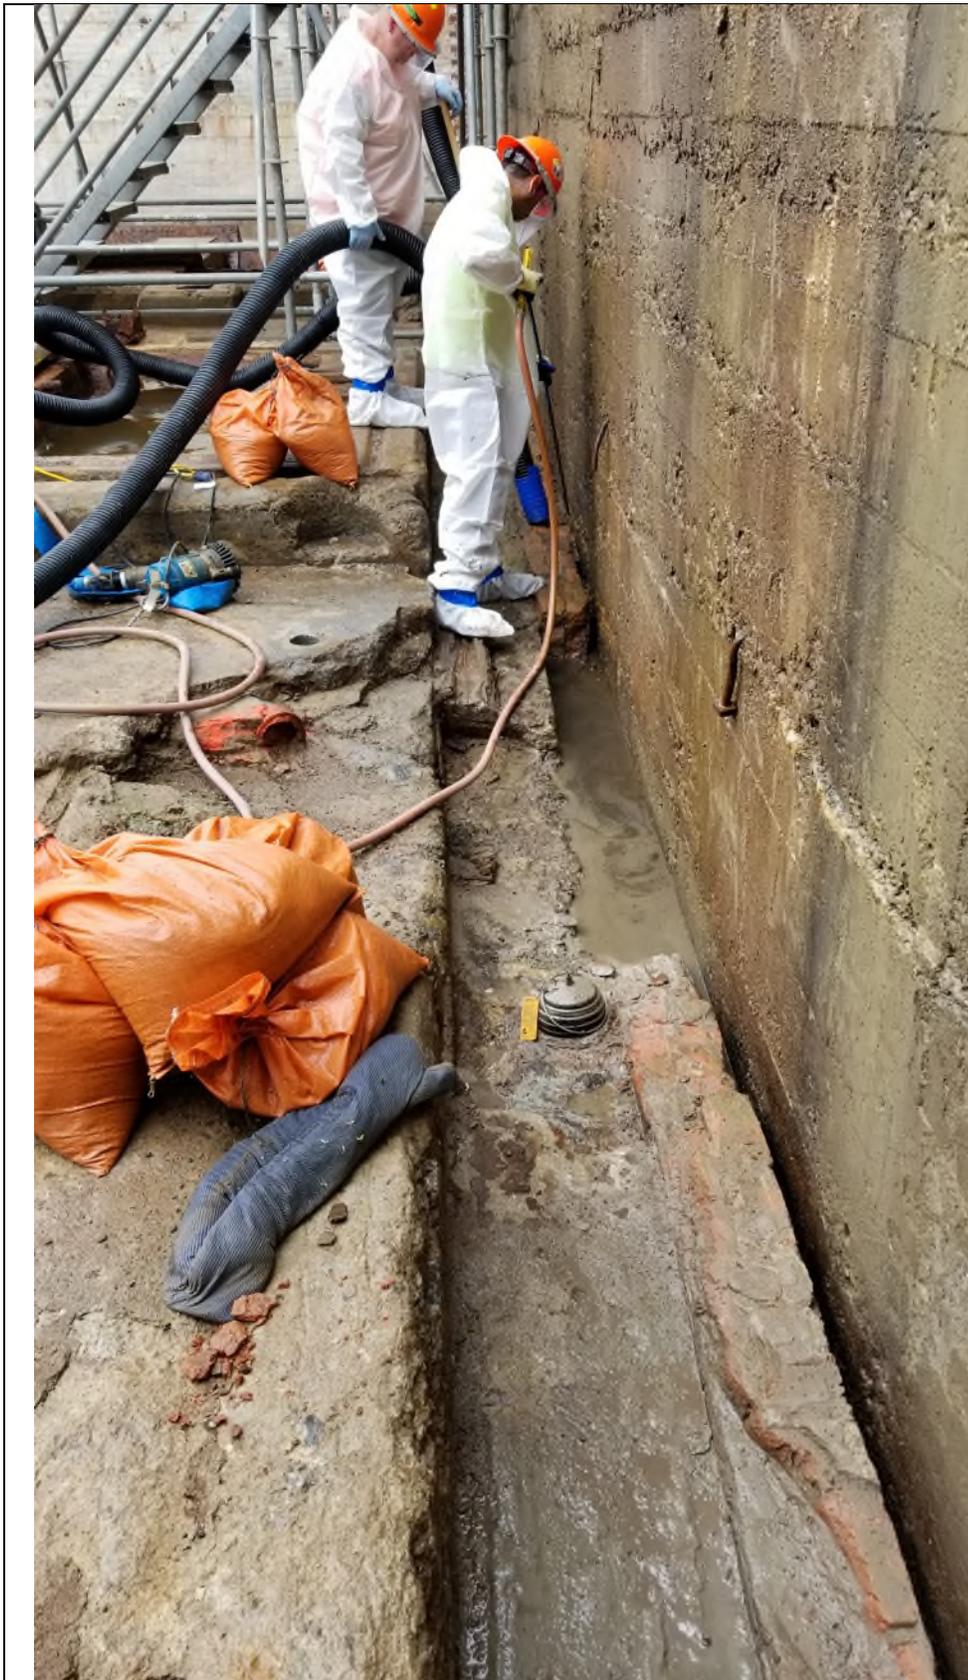
**Photograph: 4**

- At approximately 25 feet from the south wall (Figure 4), a black oily LNAPL was observed floating on the water surface and a petroleum-like odor was noted when flushing the Trench Contents. This location is generally aligned with the south edge of the former central turbine unit foundation/pad. As shown on Photograph 5, oil staining was observed on the East Foundation Wall in this same area.

Area where black oily material observed floating on water surface.

Note the southern drain pipe fitted with inflatable packer in foreground.

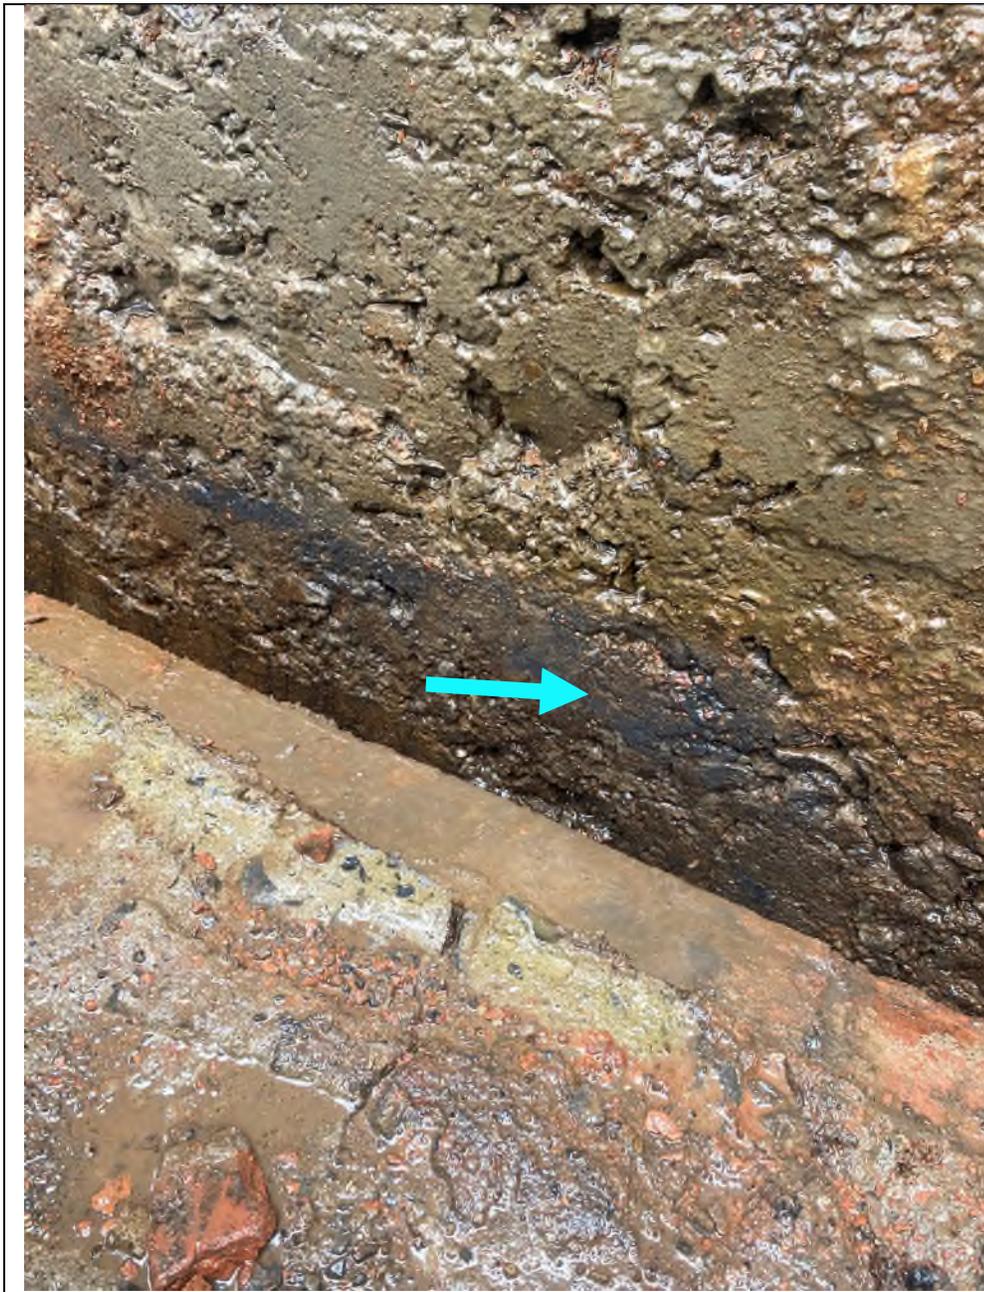
**Photograph: 5**

Black staining observed on East Foundation Wall after removing section of Remaining Brick Wall. Location is aligned with the central turbine foundation/pad.

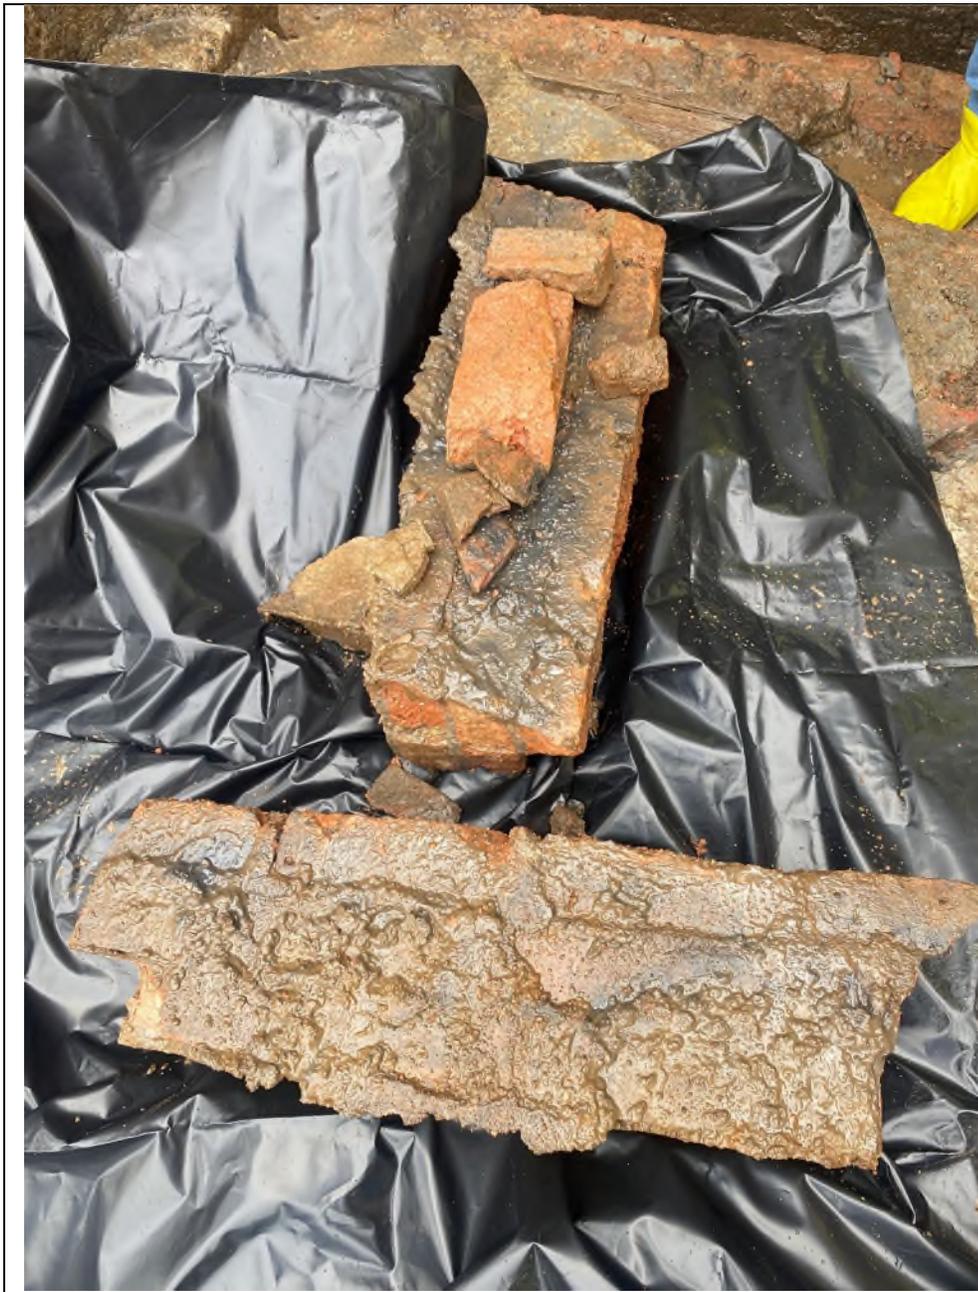
**Photograph: 6**

- A section of Remaining Brick Wall starting at approximately 24 feet to 29 feet from the south wall was manually loosened and dislodged with a pry bar and removed and placed on and covered with polyethylene sheeting. The removed section (approximately 4.25 feet long, 8.5 inches wide and 8.5 inches high) is currently staged on the floor slab pending removal for off-site disposal. Black staining was observed on the east side of the removed brick wall section as well as the corresponding west face of the East Foundation Wall of the former Powerhouse structure. This stained area is generally aligned with and opposite the former central turbine unit/foundation pad. Refer to Photographs 4, 5, and 6 for the cleanout and observed staining on the concrete foundation wall and dislodged brick wall section.

**Description:**  
Section from Remaining Brick Wall with oil staining after removal from the East Trench adjacent to central turbine foundation/pad.

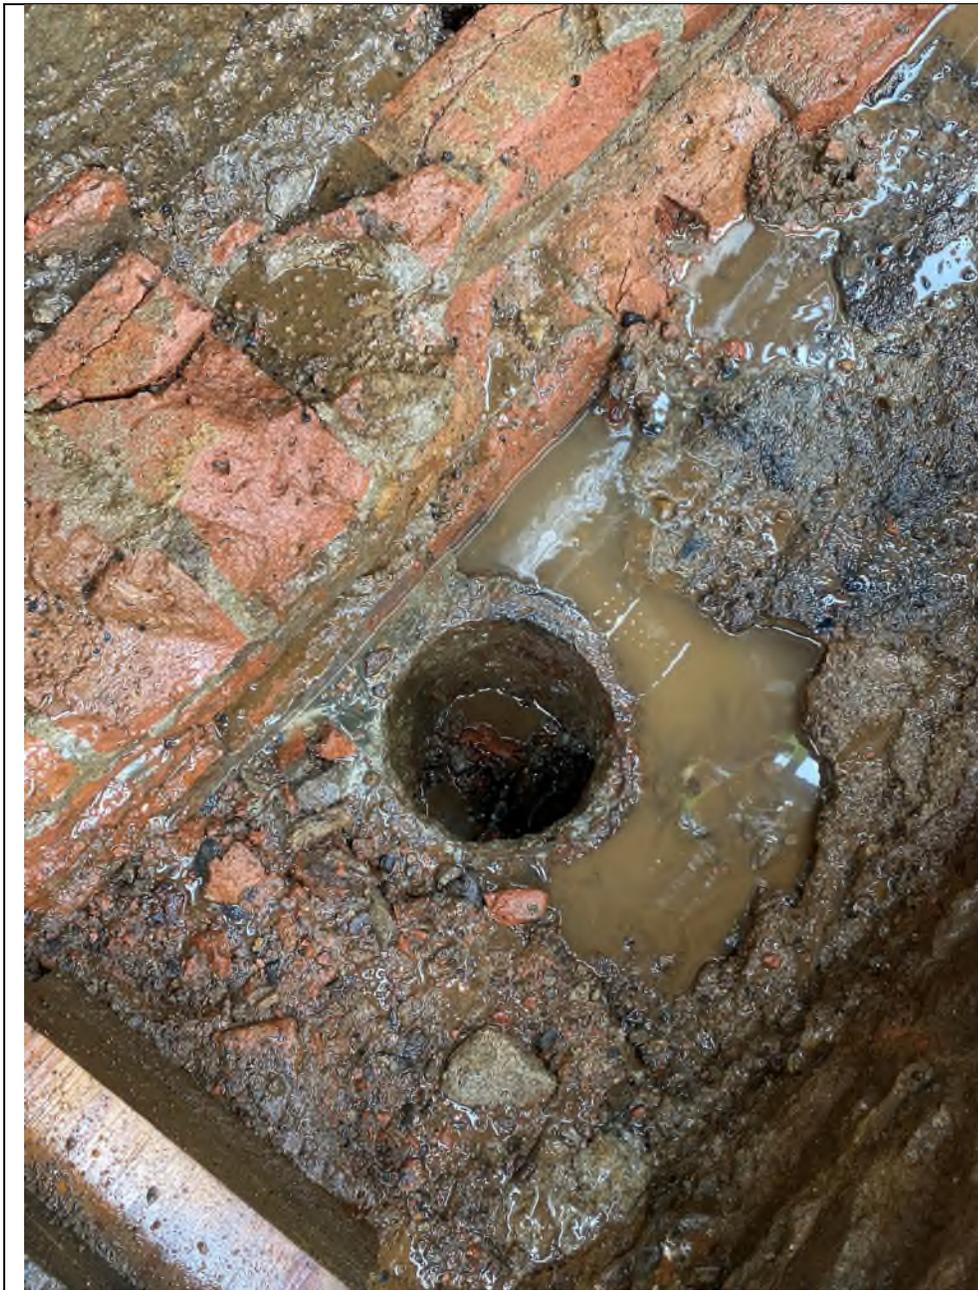
**Photograph: 7**

- During the initial (May 22, 2023) cleaning activities, a pipe penetration and seven-inch diameter cast iron pipe elbow were identified in the East Trench. This pipe drain is located approximately 16 feet north from the south wall of the former Powerhouse. A similar seven-inch diameter cast iron pipe was found during the June 27, 2023, cleanout activities at approximately 42 feet north of the former Powerhouse south wall. The pipe rim was even with the bottom of the East Trench (former

gutter portion). The inside of the pipe appeared to be filled with a cementitious plug approximately four inches below the pipe rim, prohibiting further inspections or observations at that time. This northern pipe was plugged with an inflatable packer to prevent water and conveyance from the trench. Refer to Photographs 7 and 8 and Figure 1.

**Description:**  
Northern 7-inch East  
Trench drain pipe after  
cleaning.

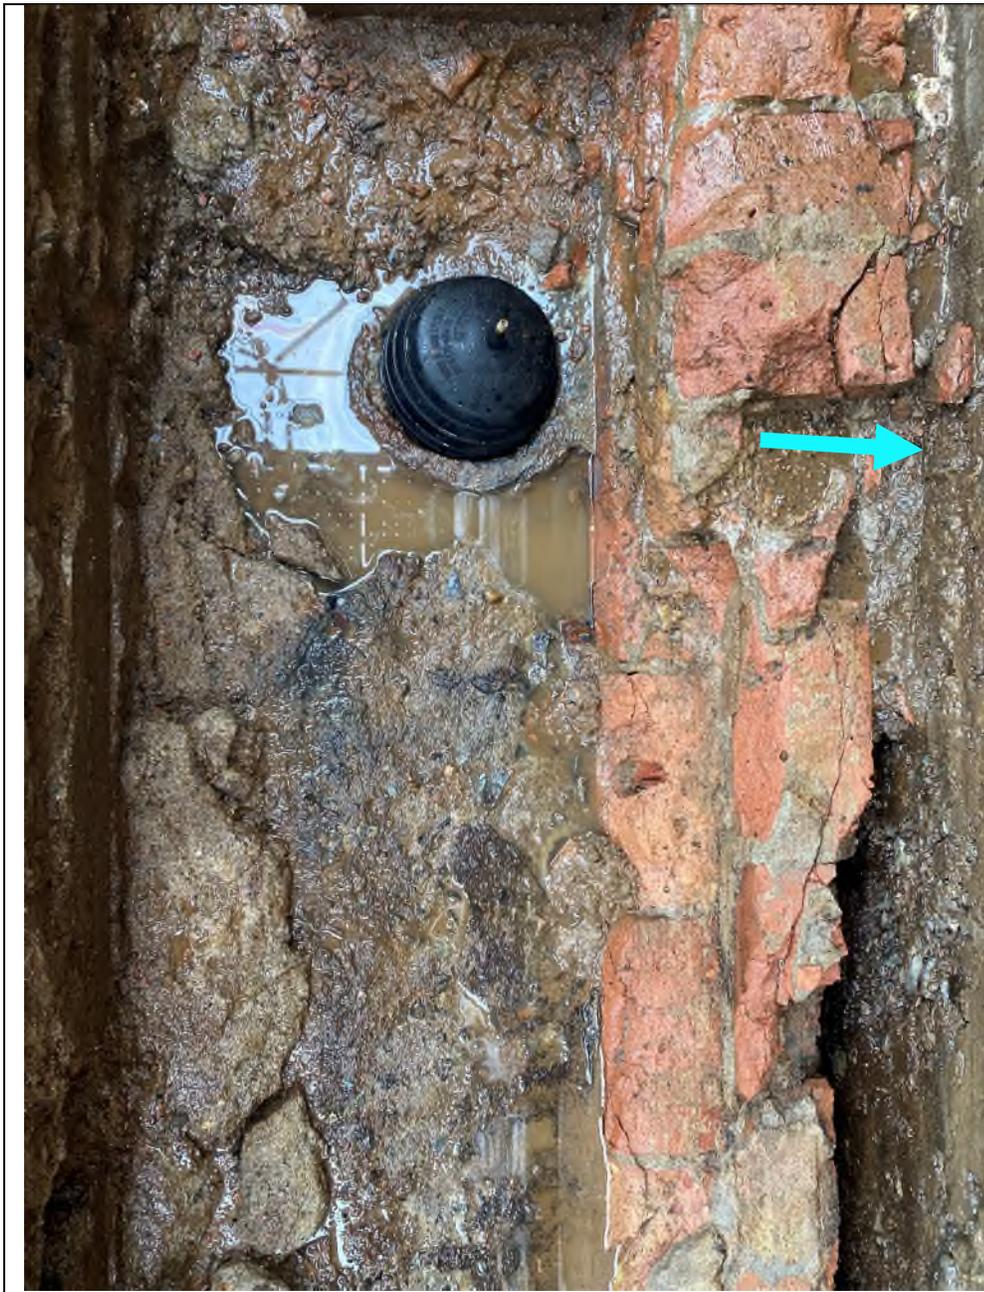
**Photograph: 8**

- From approximately 41 to 48 feet from the south wall, the Foundation/Wall Gap was observed to be filled with concrete. During cleaning activities adjacent to this area, cleaning water introduced into the East Trench was not observed to flow through or under this portion of the gap. Therefore, cleaning water collected and was pumped from lower-elevation portions of the trench on either side this gap (sump pumps are located at approximately 19 feet and 54 feet). Refer to Photographs 8 and 9 that show the area where the gap is filled.

- 1. South end of the filled portion of the Foundation/Wall Gap
- 2. East Trench drain fitted with inflatable packer.

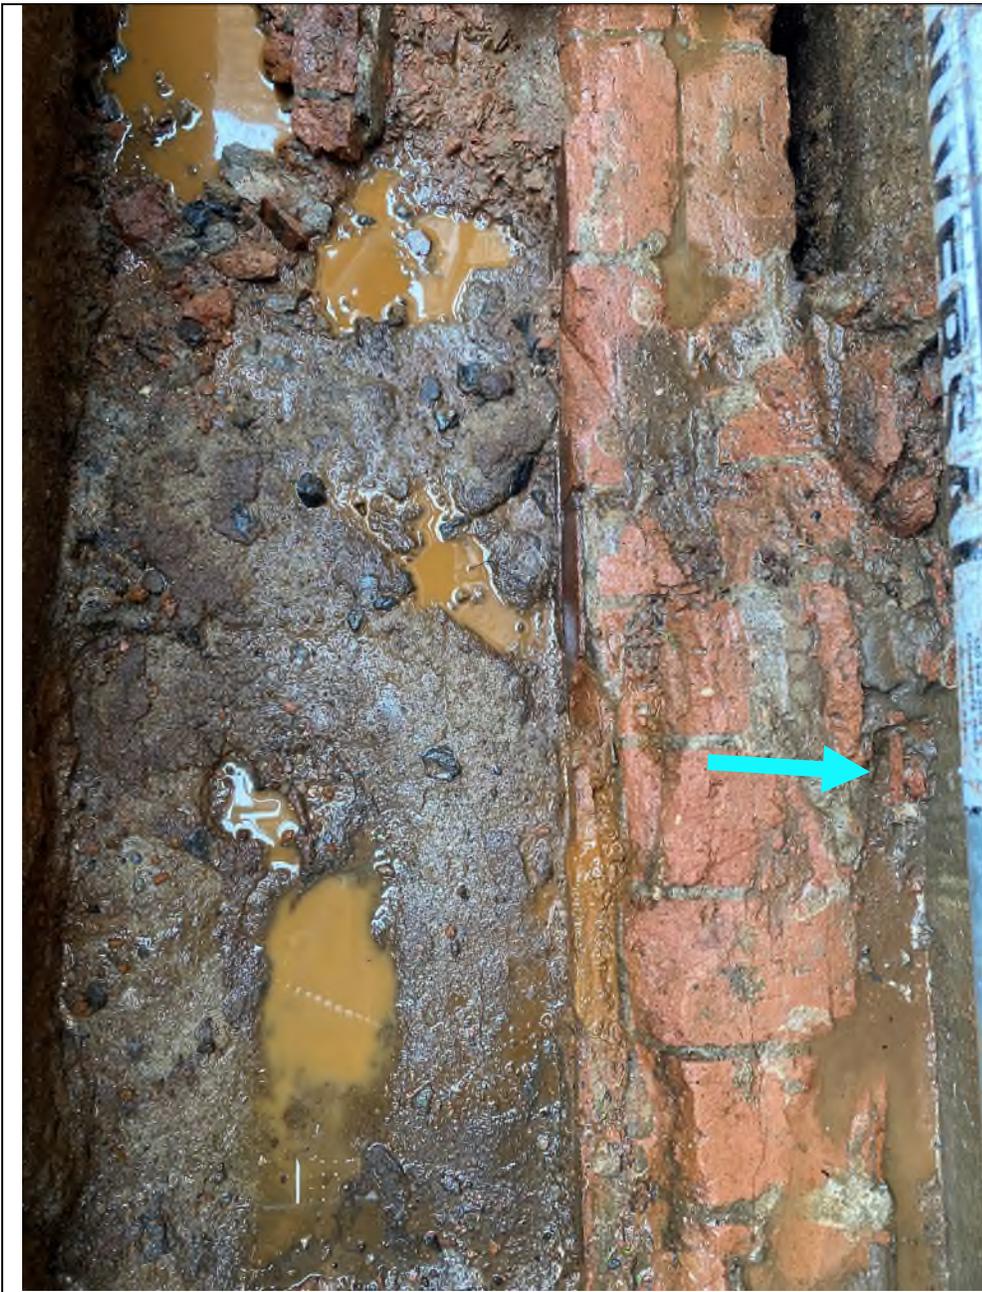
**Photograph: 9**

**Description:**  
North end of the filled  
portion of  
Foundation/Wall Gap.

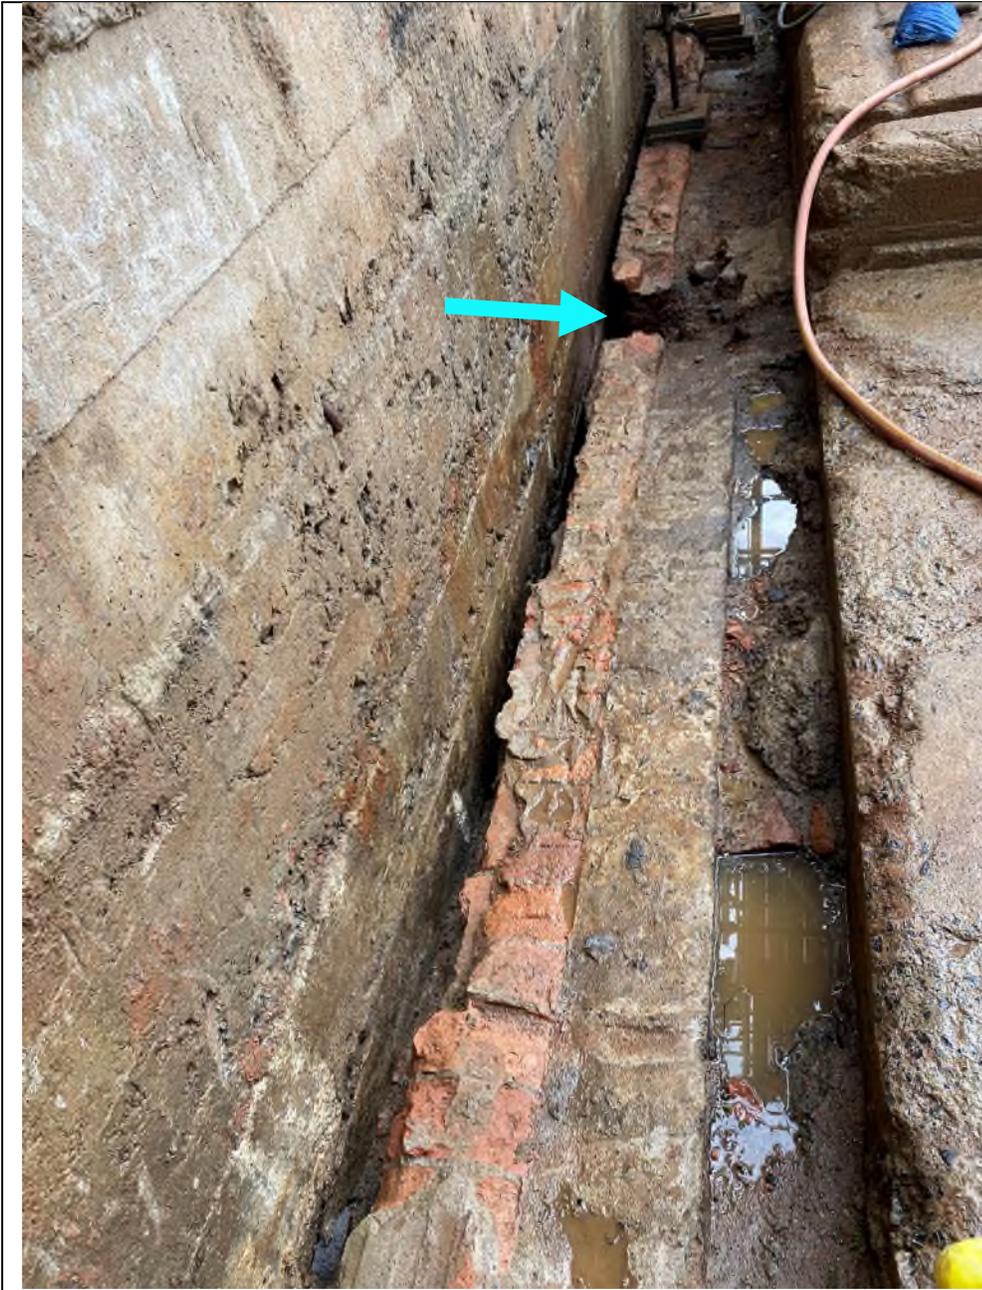
**Photograph: 10**

**Description:**  
Notch in Remaining  
Brick Wall, adjacent to  
north turbine  
foundation/pad.

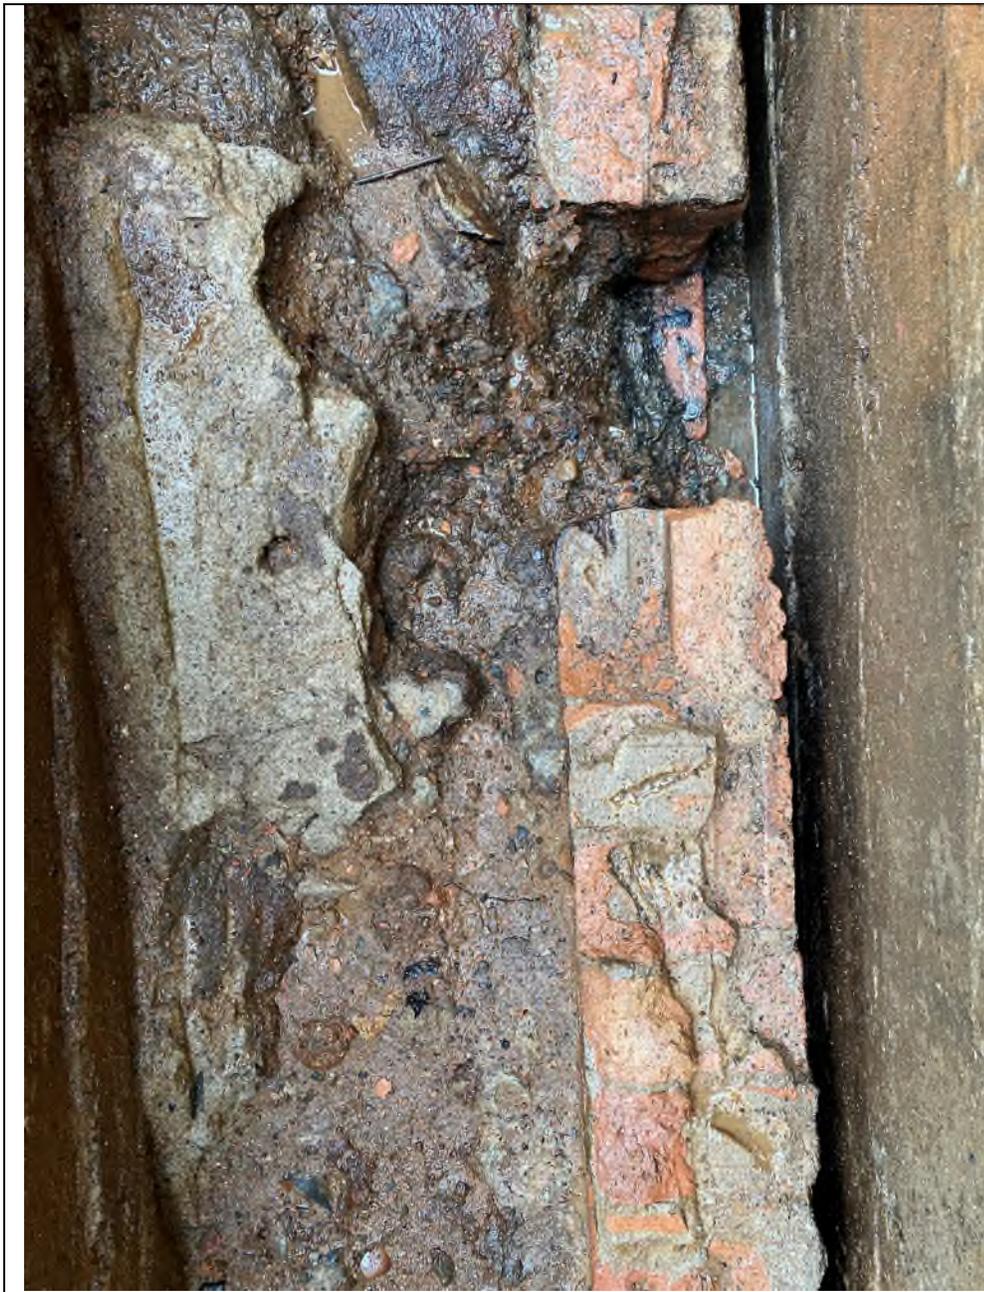
**Photograph: 11**

**Description:**  
View of Notch in the  
Remaining Brick Wall.

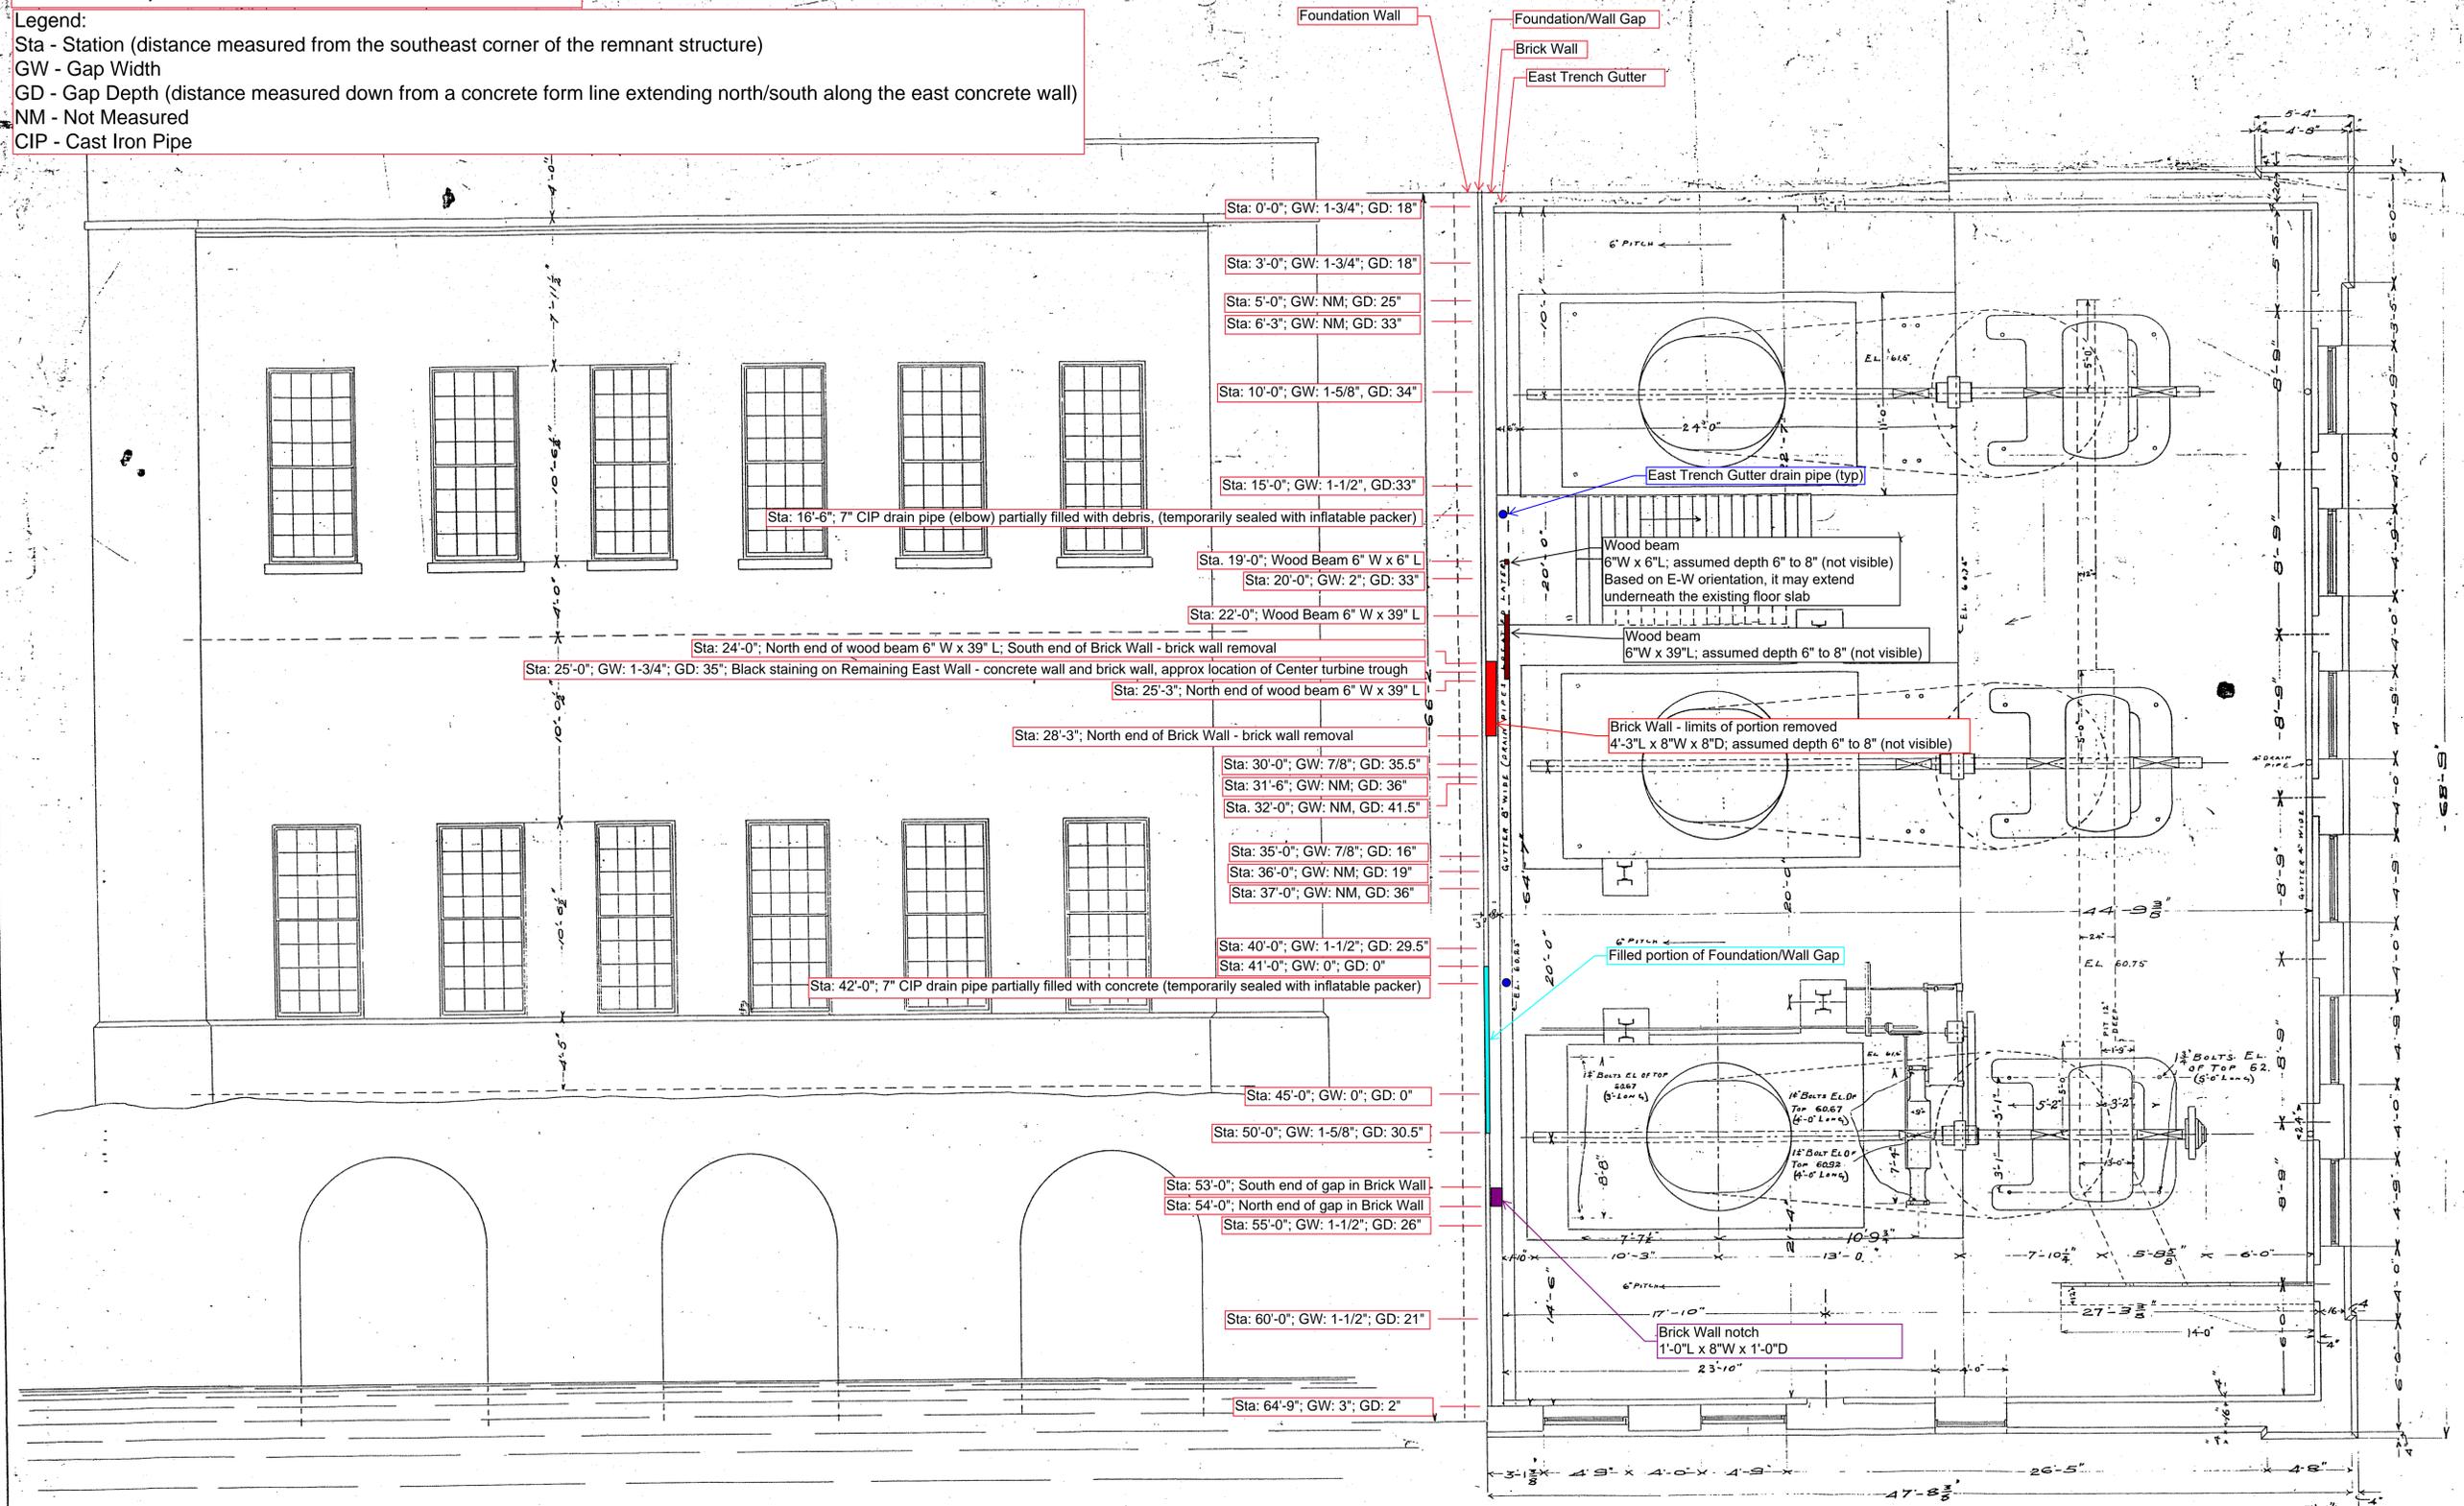
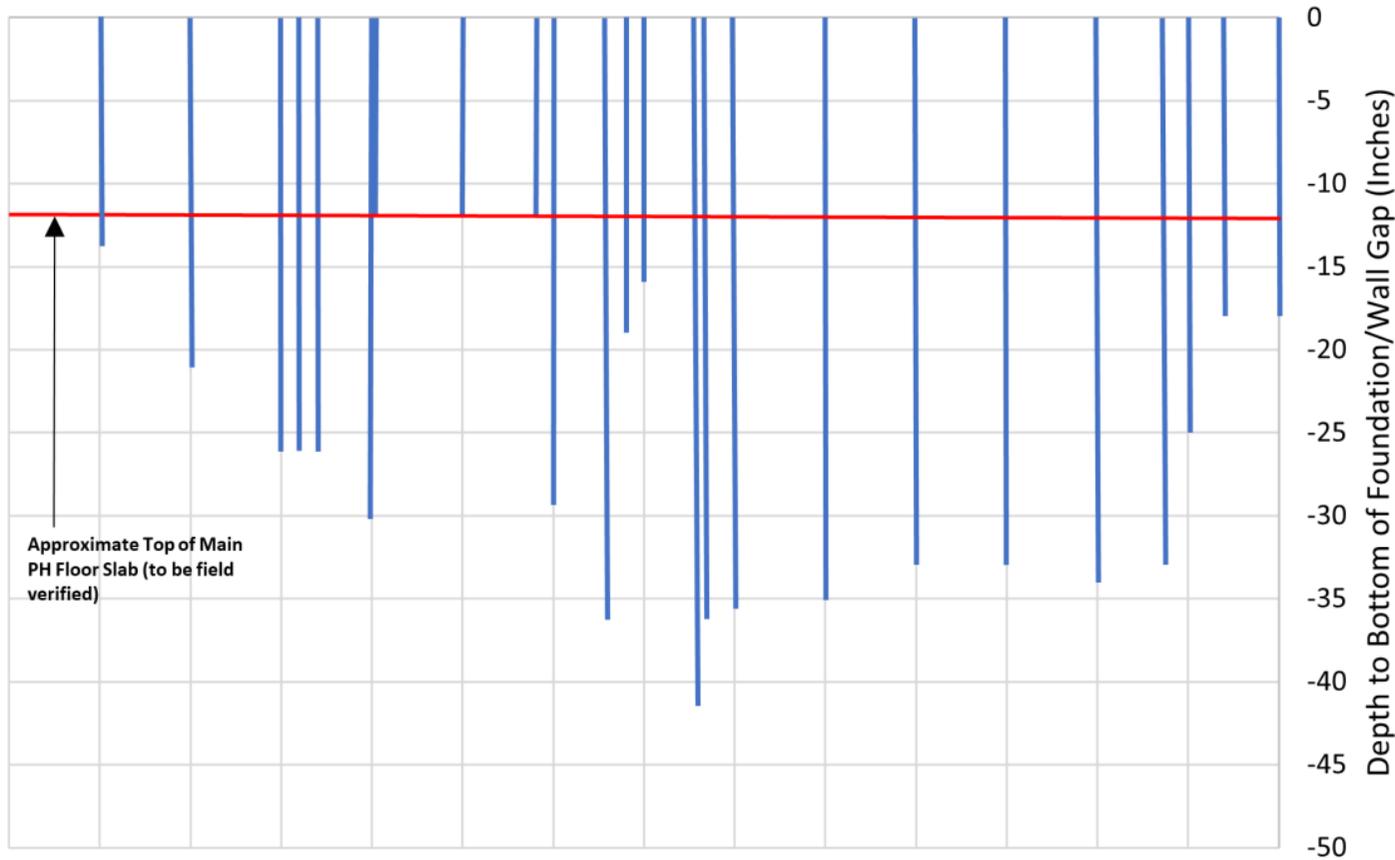
**FIGURE 1**  
**National Grid Powerhouse Deconstruction**  
**(East Trench Clean-Out**  
**June 26-27, 2023**

As part of the East Trench cleanout activities, stationing along the trench was established starting from the south wall of the former Powerhouse (i.e., the south wall is located at Station 0 feet, 0 inches). Refer to Figure 1 for details related to the position of the work along the East Trench. Figure 1 is a markup of the 1902 architectural drawing that presents field measurement approximate widths and depths of the Foundation/Wall Gap. Measurements were recorded at approximate five-foot intervals from south to north along the alignment of the East Trench. Soundings were performed using a pry bar and tape measure. Vertical measurements are in reference to a common measurement line (apparent formwork line) along the east foundation wall (Photograph 3). A graphical depiction of the depth soundings is provided in Figure 2. Though not conclusive at this time, the depth soundings indicate the central section of the trench may be lower than the north and south sections. The actual trench configuration will be field verified once remaining materials within the trench are removed.
