August 11, 2016

RE: Results of Borehole Geophysical Logging: ERT-44-I
Site: Crown Cleaners Superfund Site, Village of Herrings, NY

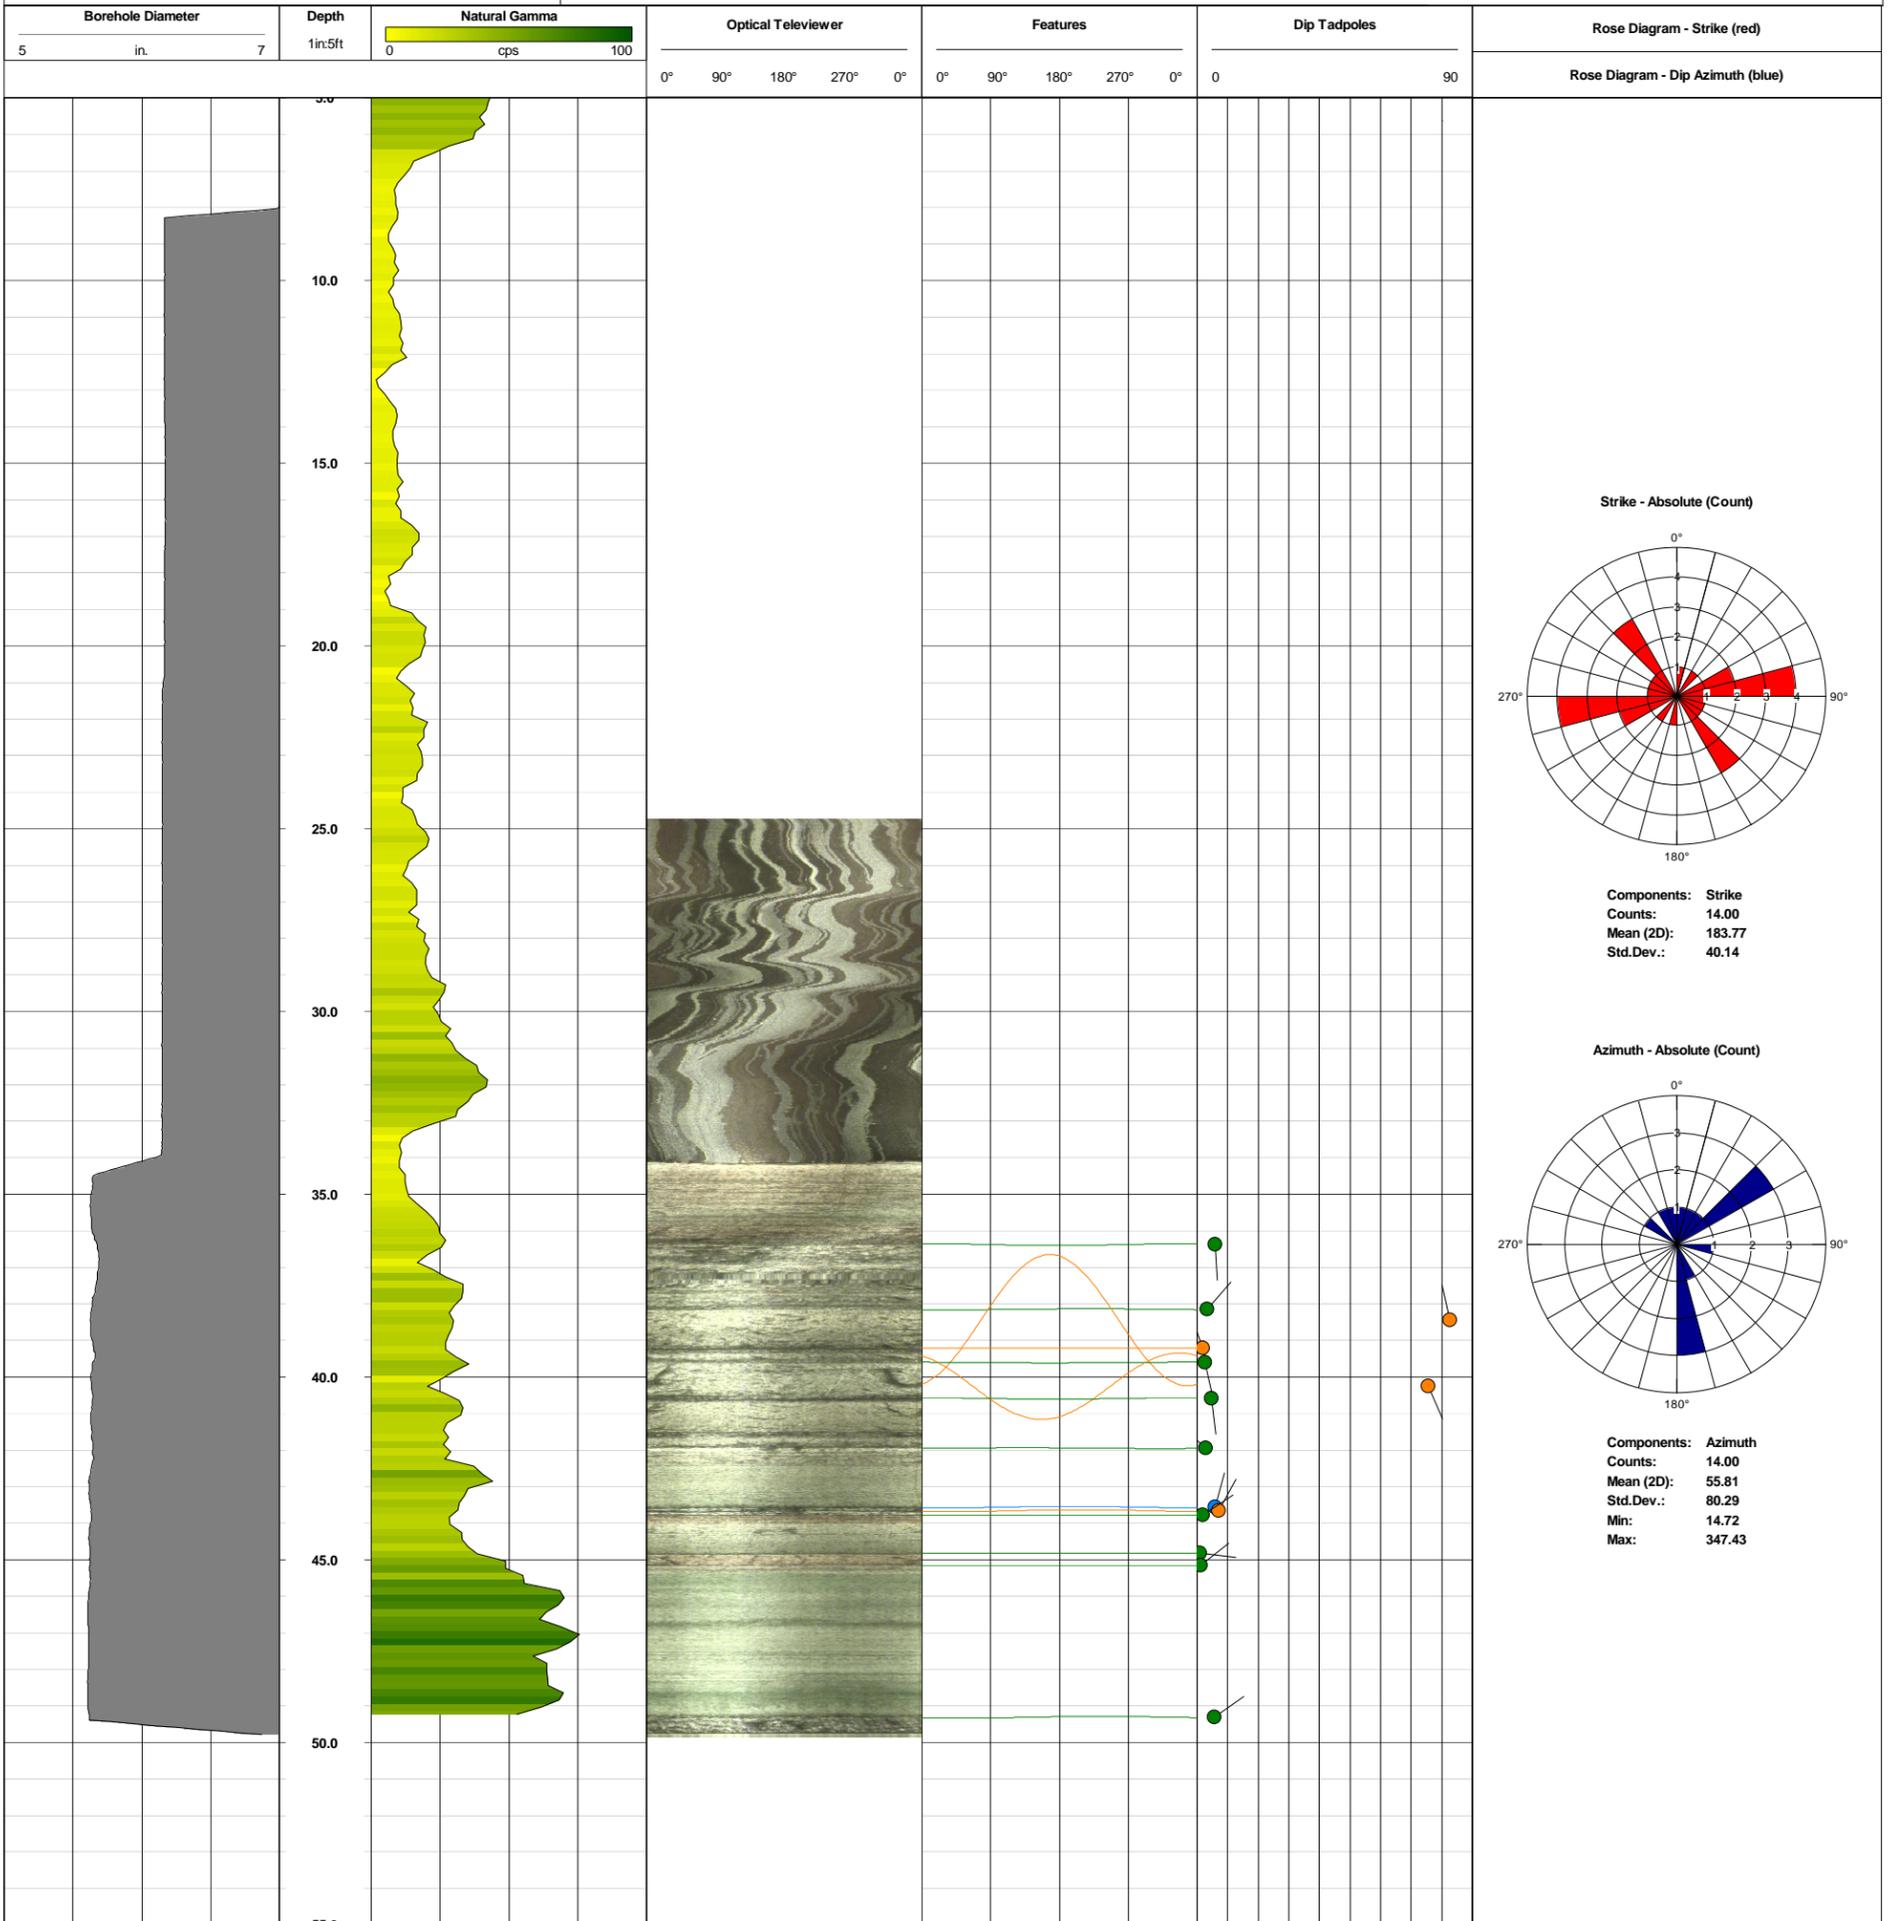
- No major fractures identified
- Relative changes in lithology between 45’-49’ (higher natural gamma)

OTV features: 14 (see attached summary table and graphical presentation)

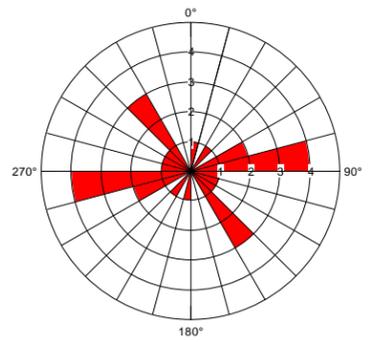
Strike - Absolute (Count)

Apparent strike: East-Northeast – West-Southwest (primary) & Northwest – Southeast (secondary)

Components: **Strike**
 Counts: **14.00**
 Mean (2D): **183.77**
 Std.Dev.: **40.14**

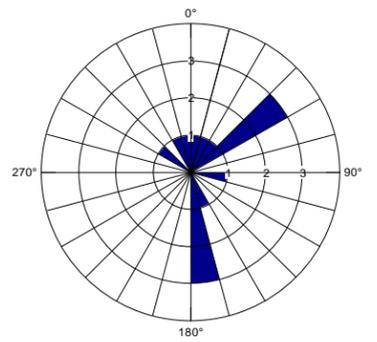
Azimuth - Absolute (Count)

Apparent dip: South-Southeast & Northeast

Components: **Azimuth**
 Counts: **14.00**
 Mean (2D): **55.81**
 Std.Dev.: **80.29**
 Min: **14.72**
 Max: **347.43**
