**REMOVAL PROGRAM  
AFTER ACTION REPORT  
FOR THE  
TEMPLE STUART SITE  
BALDWINVILLE, WORCESTER COUNTY, MASSACHUSETTS  
26 AUGUST 2002 THROUGH 2 AUGUST 2004**

Weston Solutions, Inc.  
Superfund Technical Assessment and Response Team 2000 (START)  
37 Upton Drive  
Wilmington, Massachusetts 01887

April 2005

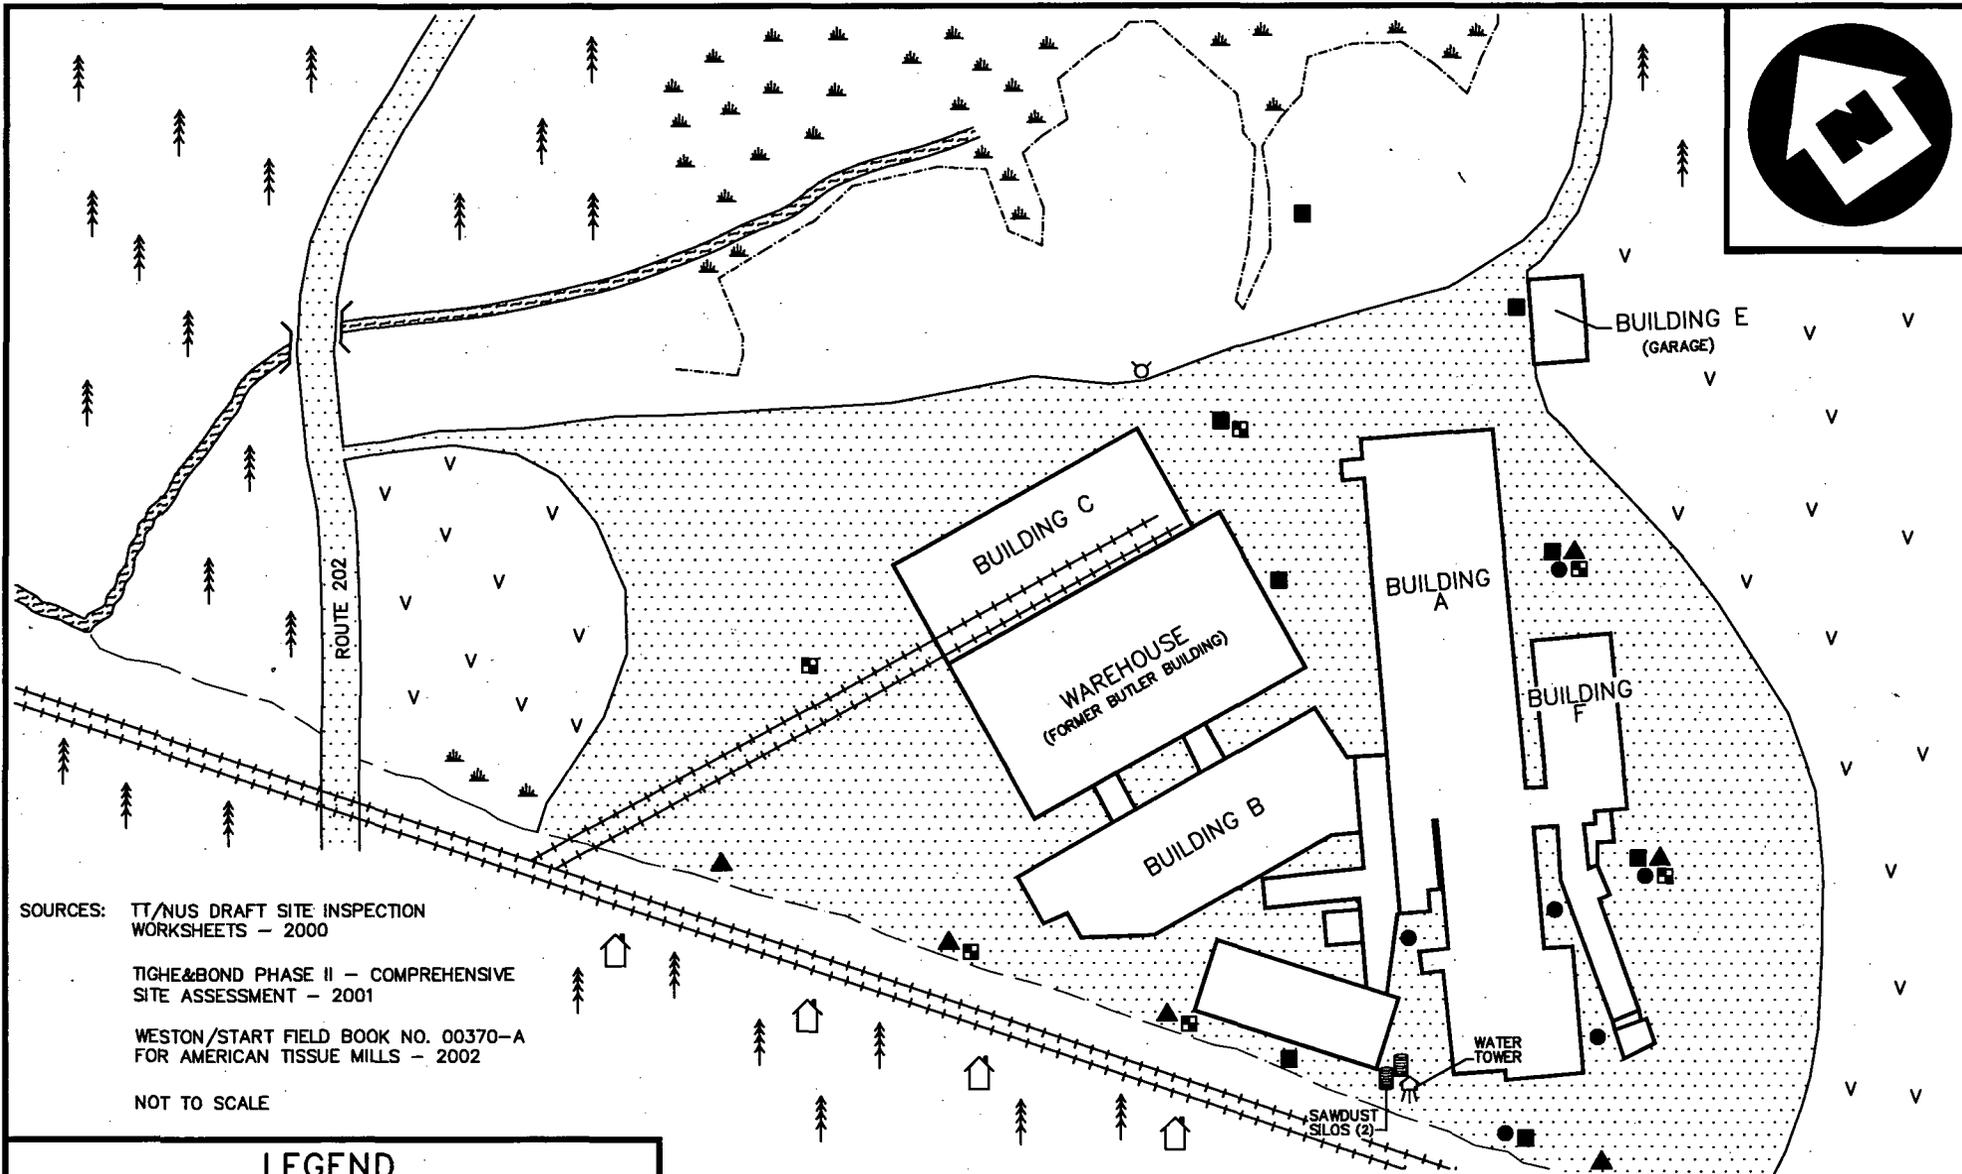
TDD # 04-05-0011	DRAWN BY: K. BRENNAN	DATE 02/17/05
FILE NAME: R:\04050011\FIGURES\8027_ACM AIR.DWG		FIGURE 3

- V GRASS
- WETLANDS
- ACM AIR SAMPLE LOCATION COLLECTED DURING 08/28/02 TO 09/17/02
- ACM AIR SAMPLE LOCATION COLLECTED DURING 09/24/02 TO 09/30/02
- ACM AIR SAMPLE LOCATION COLLECTED DURING 10/24/02 TO 12/10/02
- ACM AIR SAMPLE LOCATION COLLECTED DURING 01/10/03 TO 03/25/03
- LANDFILL BOUNDARY
- RAILROAD TRACKS
- CULVERT
- FIRE HYDRANT
- SURFACE WATER
- PAVED AREA
- RESIDENCE
- WOODED AREA

For the duration of ACM abatement and demolition activities, SL Brennan conducted perimeter ACM air sampling each work day unless weather conditions prevented it [see Appendix C - Perimeter Asbestos-Containing Material (ACM) Air Sampling Log; and for sample locations, see Appendix D - Sampling Diagrams - ACM Air Sample Location Diagram (Figure 3)]. Air monitoring was conducted in accordance with the document, entitled *Air Monitoring Plan For The Temple Stuart Site, Templeton, Worcester County, Massachusetts*.

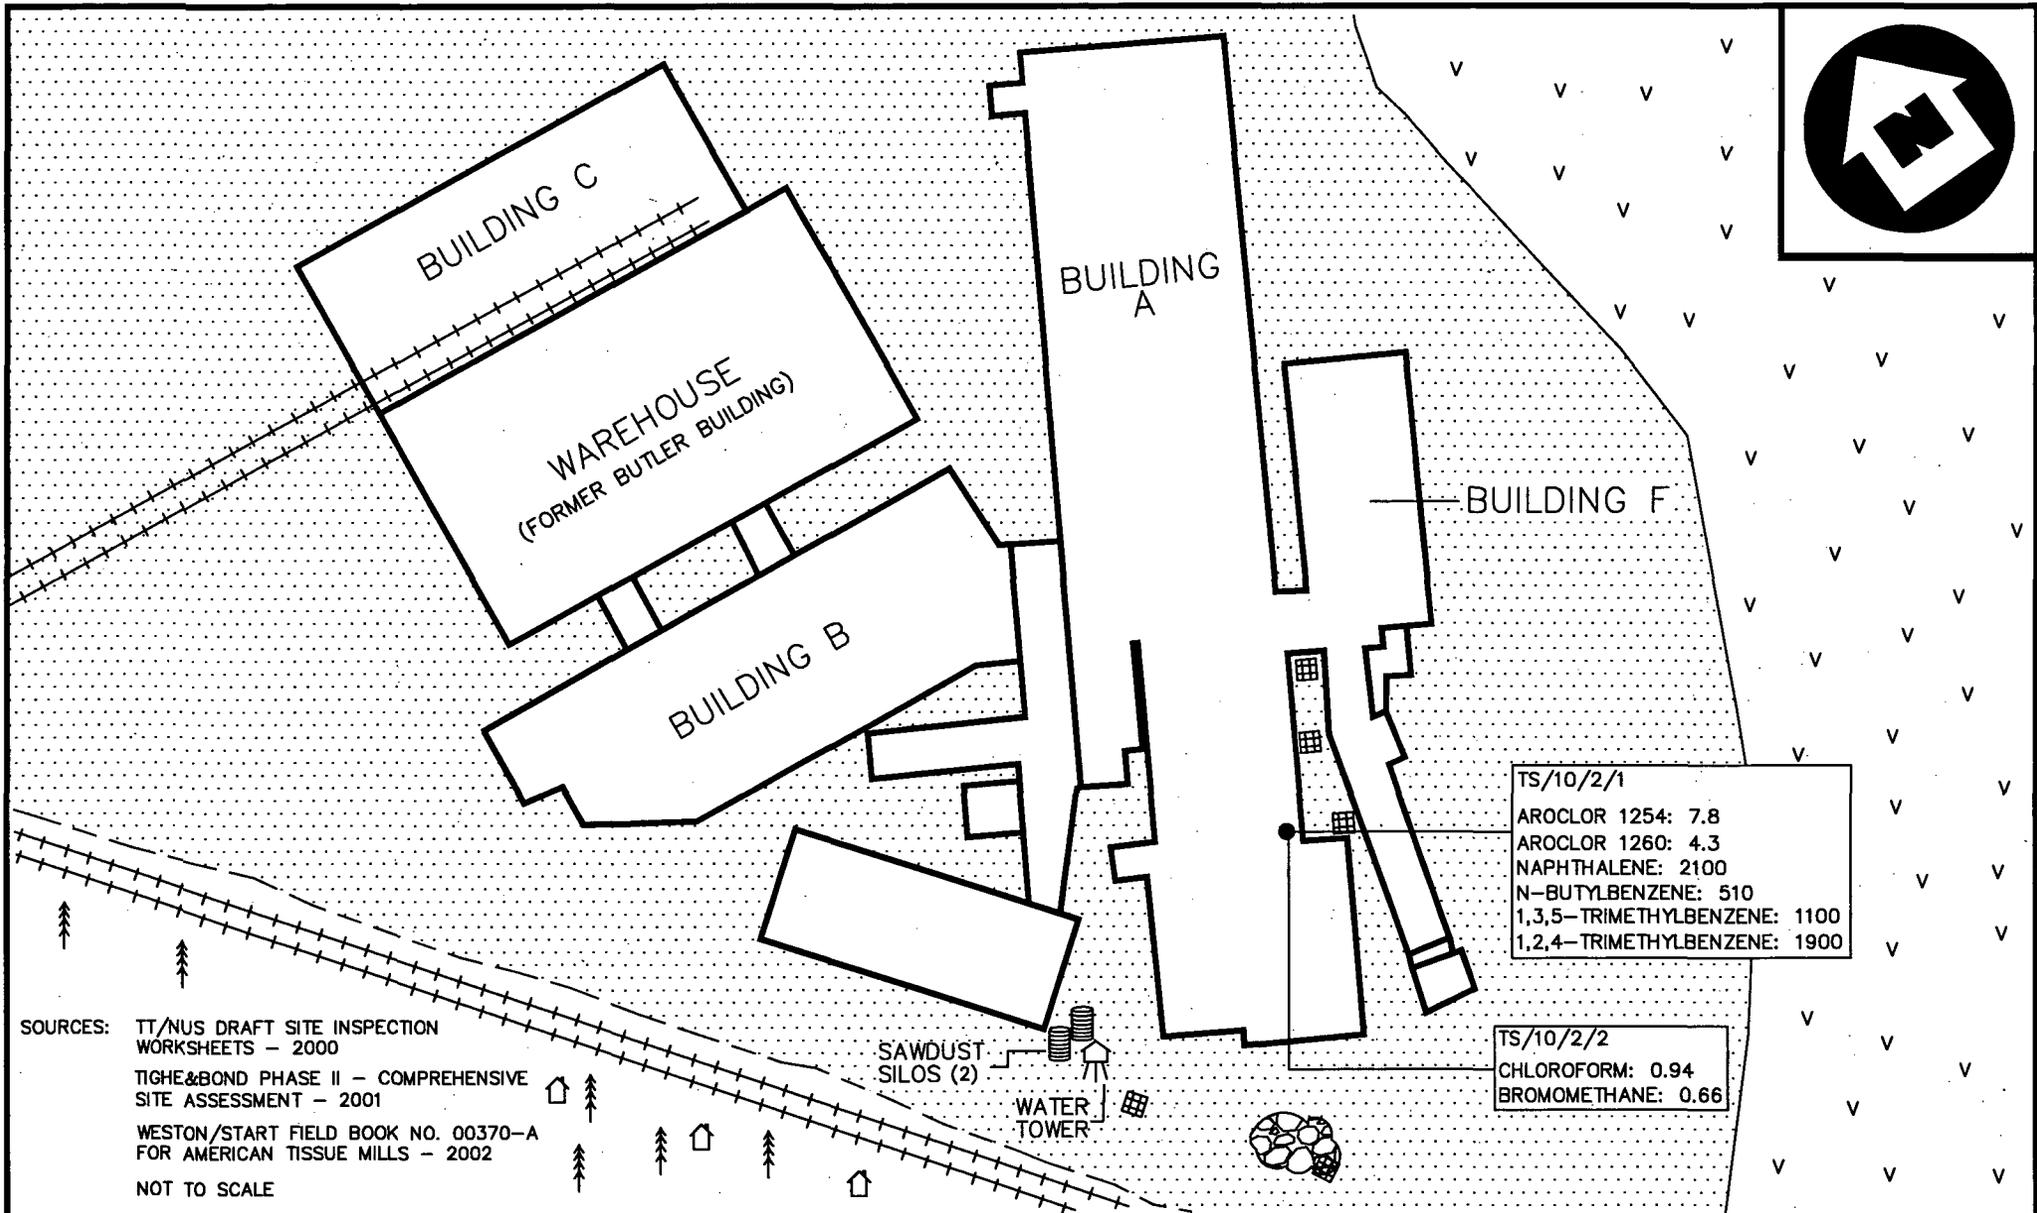
FIGURE 5

- TANK SAMPLE LOCATION
- ☐ WETLANDS
- ☐ DEBRIS PILE
- ☐ CATCHBASIN
- ☐ PAVED AREA
- V GRASS
- ↑ RESIDENCE
- +— RAILROAD TRACKS
- ↑ WOODED AREA

On 2 October 2002, Massachusetts State Representative Anne Gobi was on site to perform a site visit. OSC Stanton and SL Brennan collected tank samples, labeled TS/10/02/01 and TS/10/02/02, from an aboveground storage vault tank located within the southeast corner of the former Building A boiler room [see Appendix D - Sample Diagrams - Tank Sample Location Diagram (Figure 5)]. MARCOR personnel were on site to demobilize remaining equipment from site.

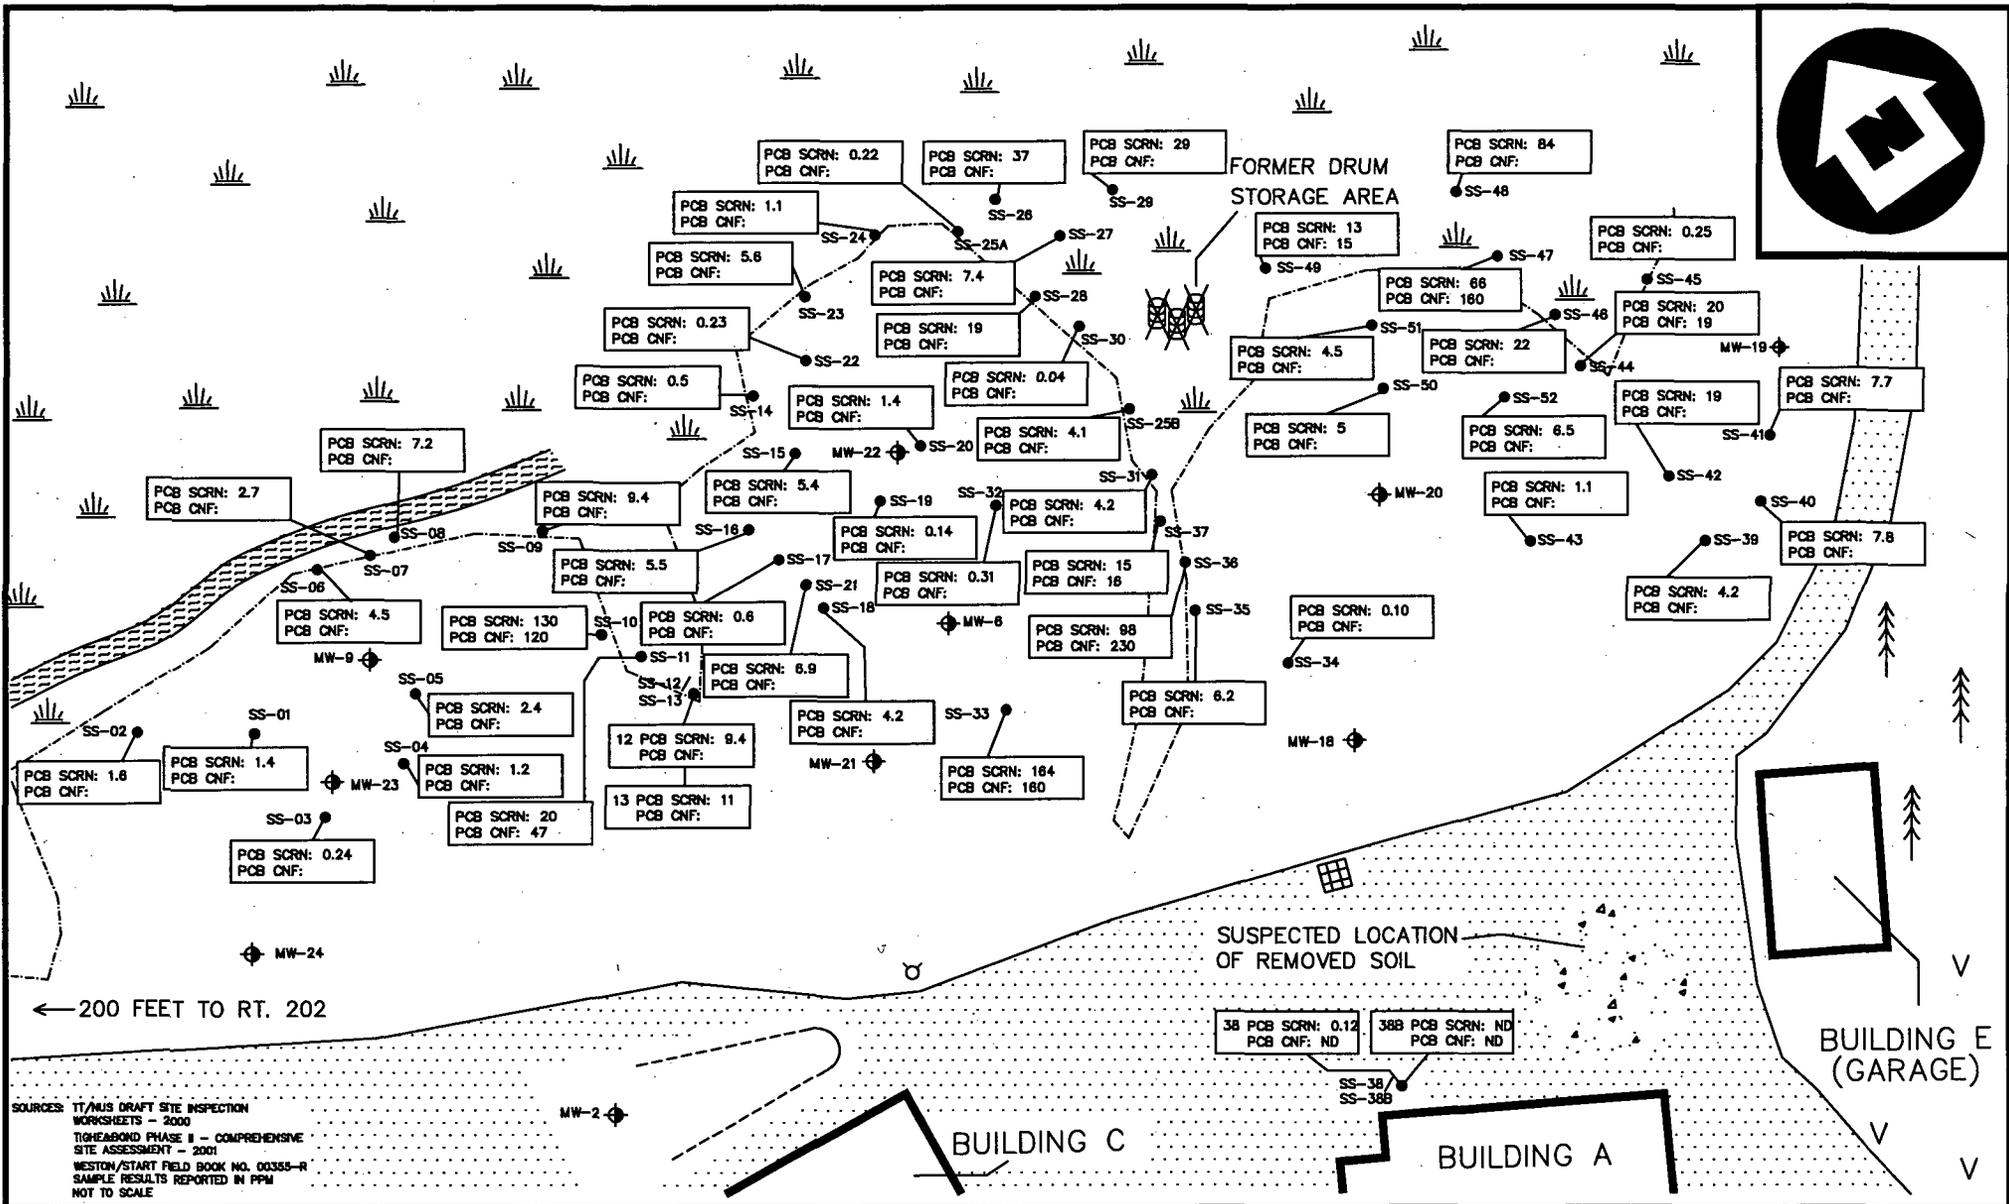
TDD # 04-05-0011	DRAWN BY: K. BRENNAN	DATE 11/11/02
FILE NAME: R:\04050011\FIGURES\8027_SS_PCB_DIAGRAM.dwg		FIGURE 6

- SURFACE WATER
  - PAVED AREA
  - GRASS
  - WETLANDS
  - FIRE HYDRANT
  - LANDFILL BOUNDARY
  - SCRN: SCREENING RESULT
  - CNF: CONFIRMATION RESULT
  - ND: NON DETECT
  - MONITORING WELL (SCREENED INTERVAL UNKNOWN)
  - SOIL SAMPLING LOCATION
  - WOODED AREA
  - CULVERT
  - CATCHBASIN
- SAMPLING DATE: 21 - 22 OCTOBER 2002

On 21 October 2002, CCB personnel were on site to complete the load out of the paper machine for APC. START member Dirk Chin-Leung was on site to aid SL Brennan in the collection of surficial soil samples from the landfill area located in the northeastern portion of the site. EPA Chemist Scott Clifford was on site with the EPA Mobile Laboratory to perform PCB analysis of soil samples collected from the landfill area. Surface soil samples labeled, SS-01 through SS-38, were collected by START personnel and submitted to the EPA Mobile Laboratory for analysis [see Appendix D - Sampling Diagrams - Landfill Surface Soil Sample Location Diagram (Figure 6)].

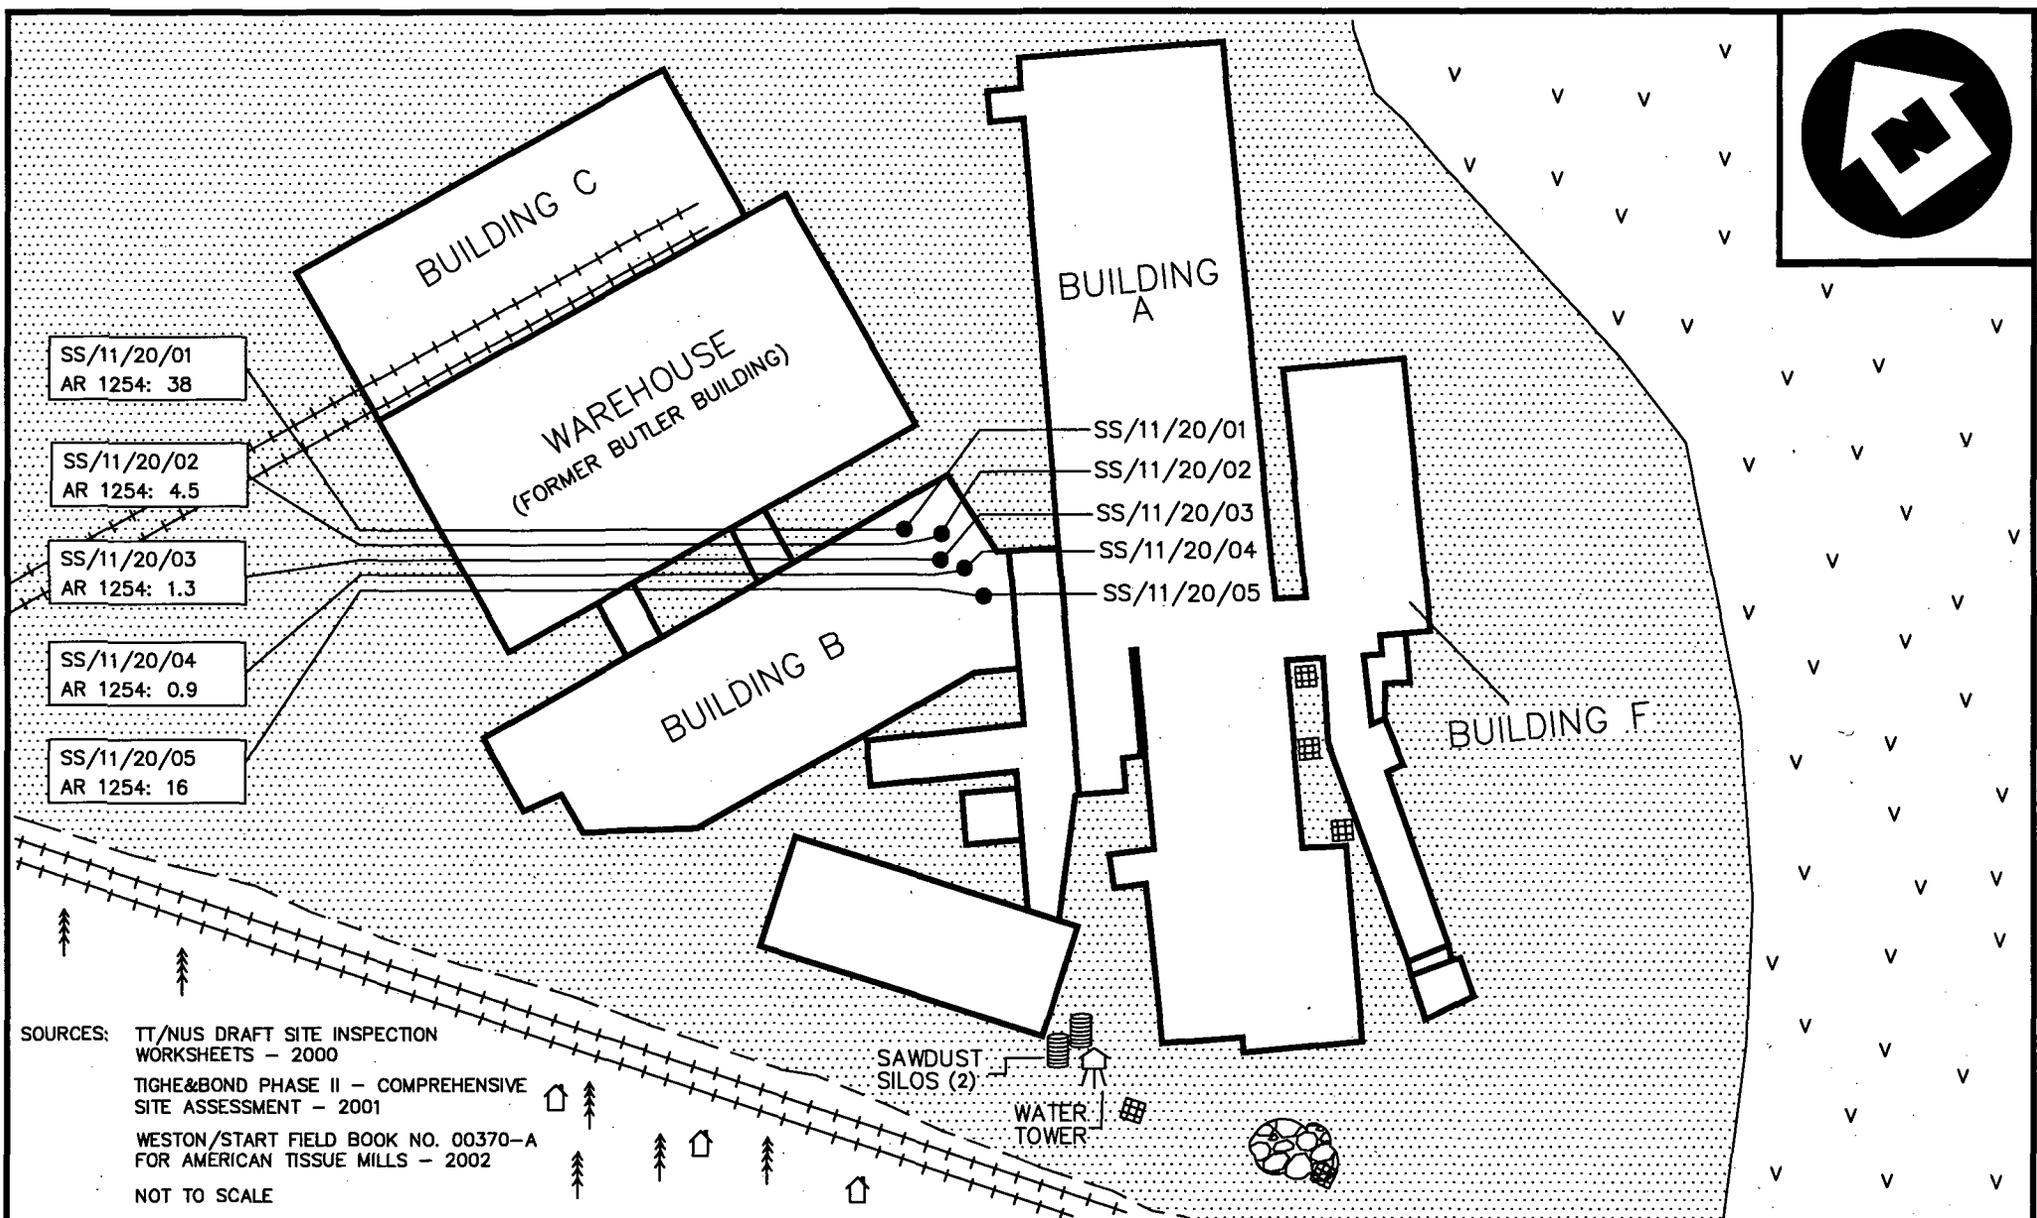
FILE NAME: R:\04050011\FIGURES\8027_BLDG_B_SS.DWG	FIGURE 7
--	----------

- SS/11/20/01  
AR 1254: 38
- SS/11/20/02  
AR 1254: 4.5
- SS/11/20/03  
AR 1254: 1.3
- SS/11/20/04  
AR 1254: 0.9
- SS/11/20/05  
AR 1254: 16

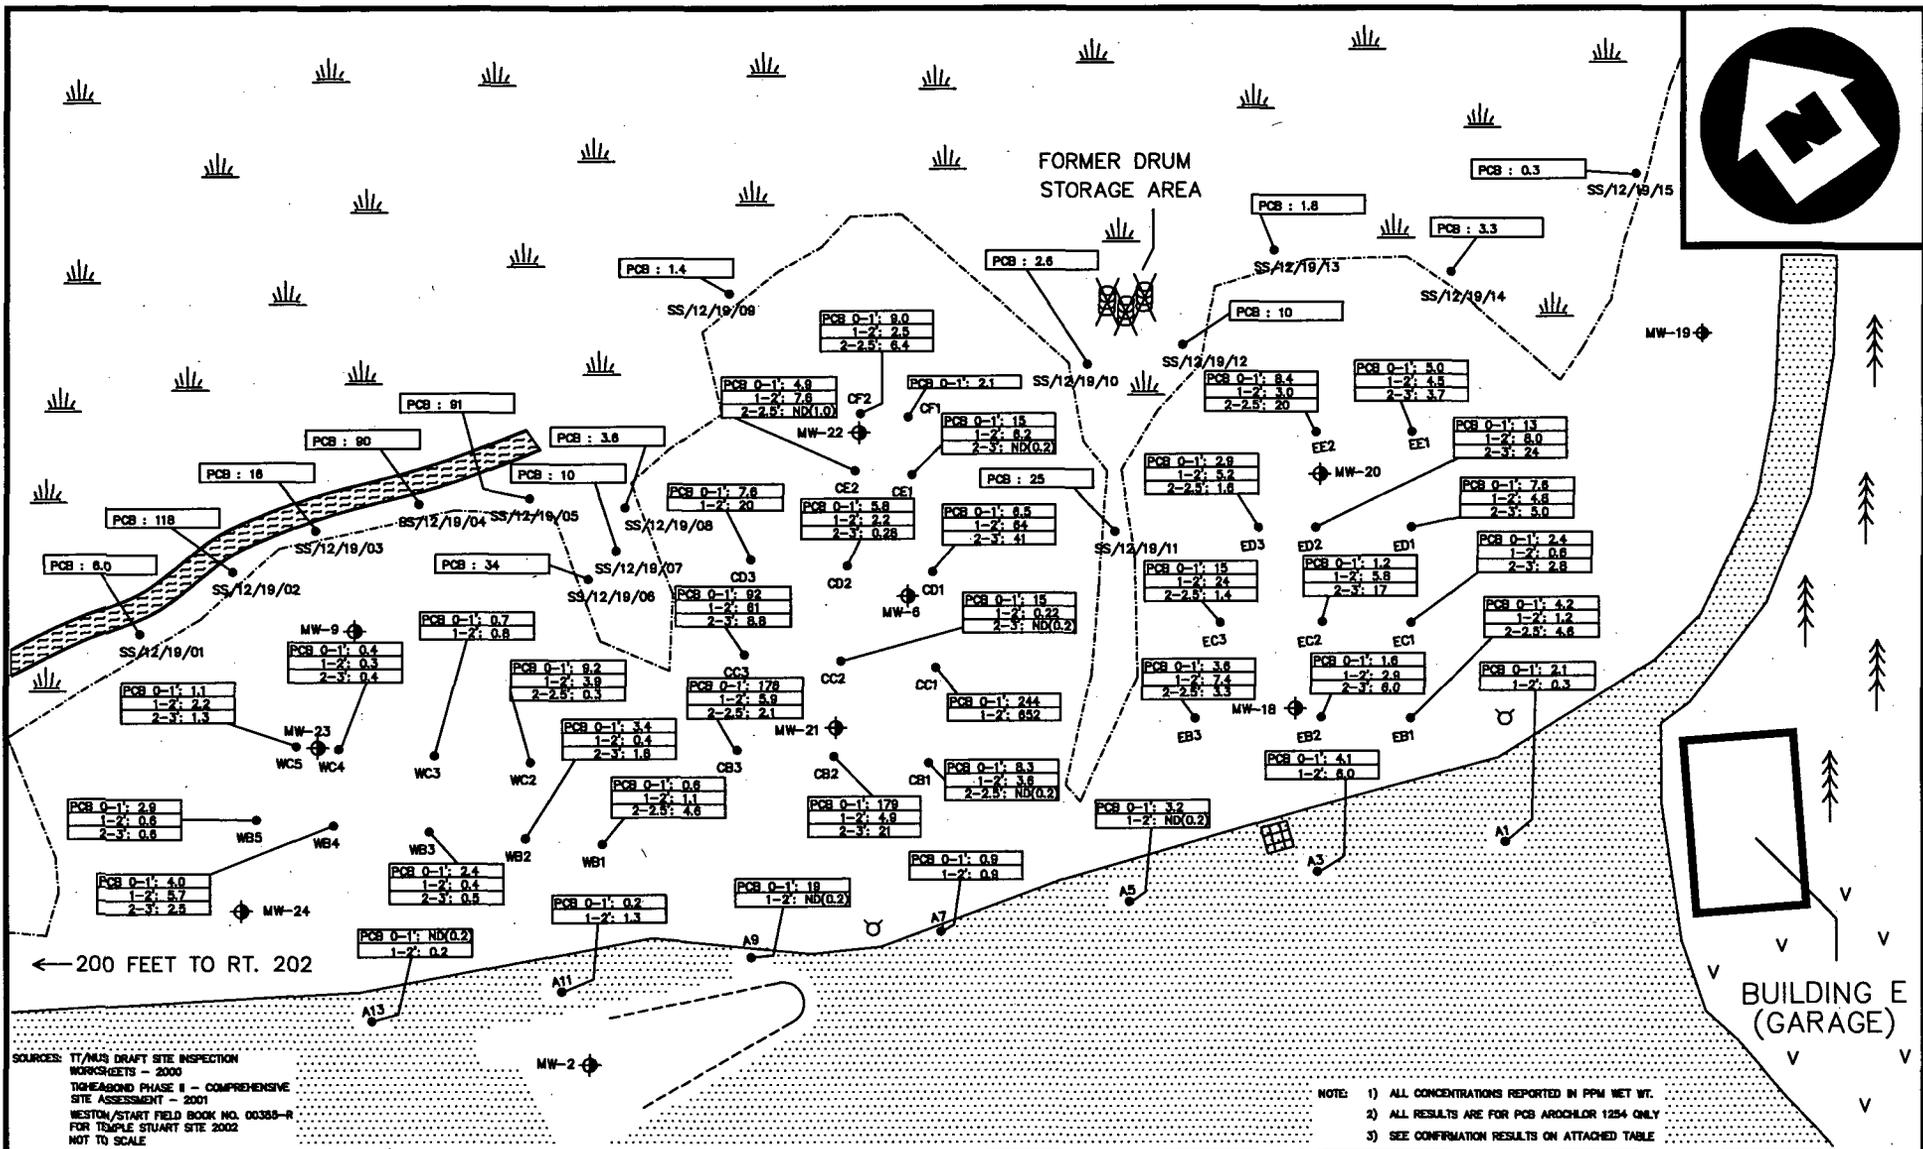
TDD # 04-05-0011	DRAWN BY: D. CHIN-LEUNG	DATE 01/03/03
FILE NAME: R:\04050011\FIGURES\8027_PCB GRID.DWG		FIGURE 9

SURFACE WATER	MONITORING WELL (SCREENED INTERVAL UNKNOWN)
PAVED AREA	PCB SAMPLING LOCATION
GRASS	WOODED AREA
WETLANDS	CULVERT
FIRE HYDRANT	CATCHBASIN
LANDFILL BOUNDARY

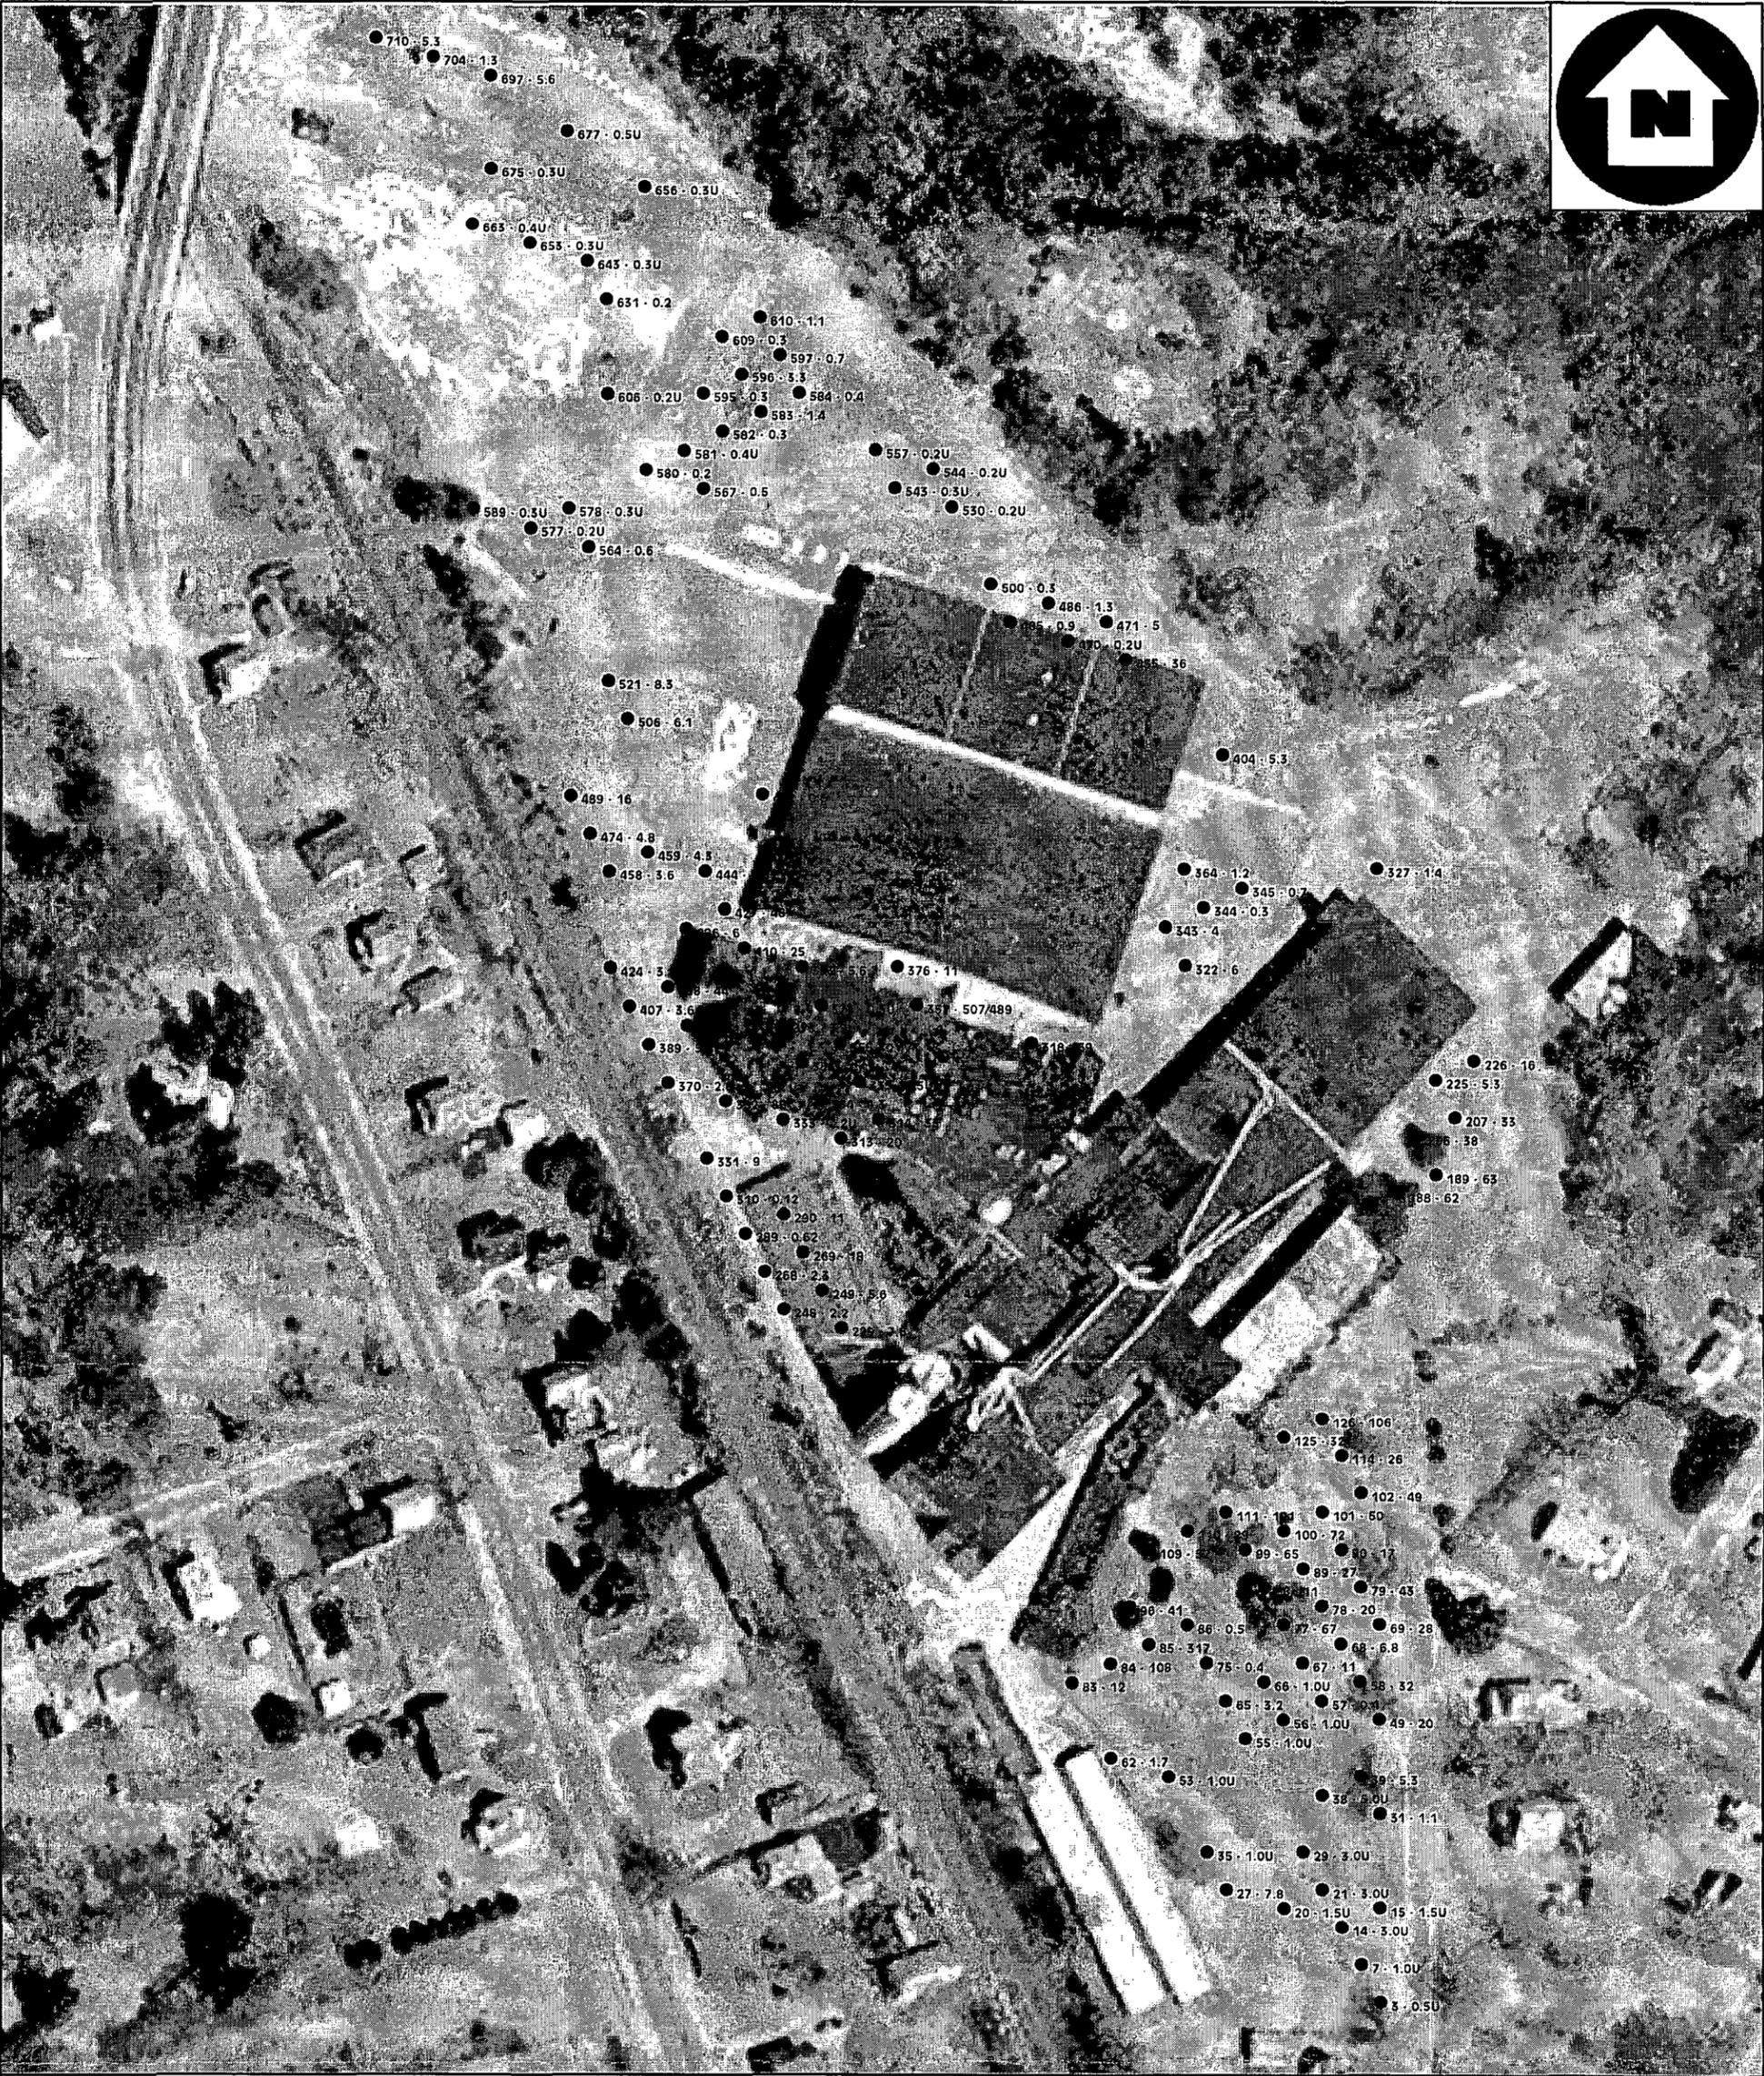
FIGURE 10

Between 14 May and 16 May 2003, SL Brennan and START member Mace collected surface soil samples, labeled SS-100 through SS-176 from the on-site landfill area. Two START Analytical Team members were on site to perform PCB field screening analysis of the samples [see Appendix D - Sampling Diagrams - Landfill Area Perimeter Soil Sampling Diagram (Figure 10)].

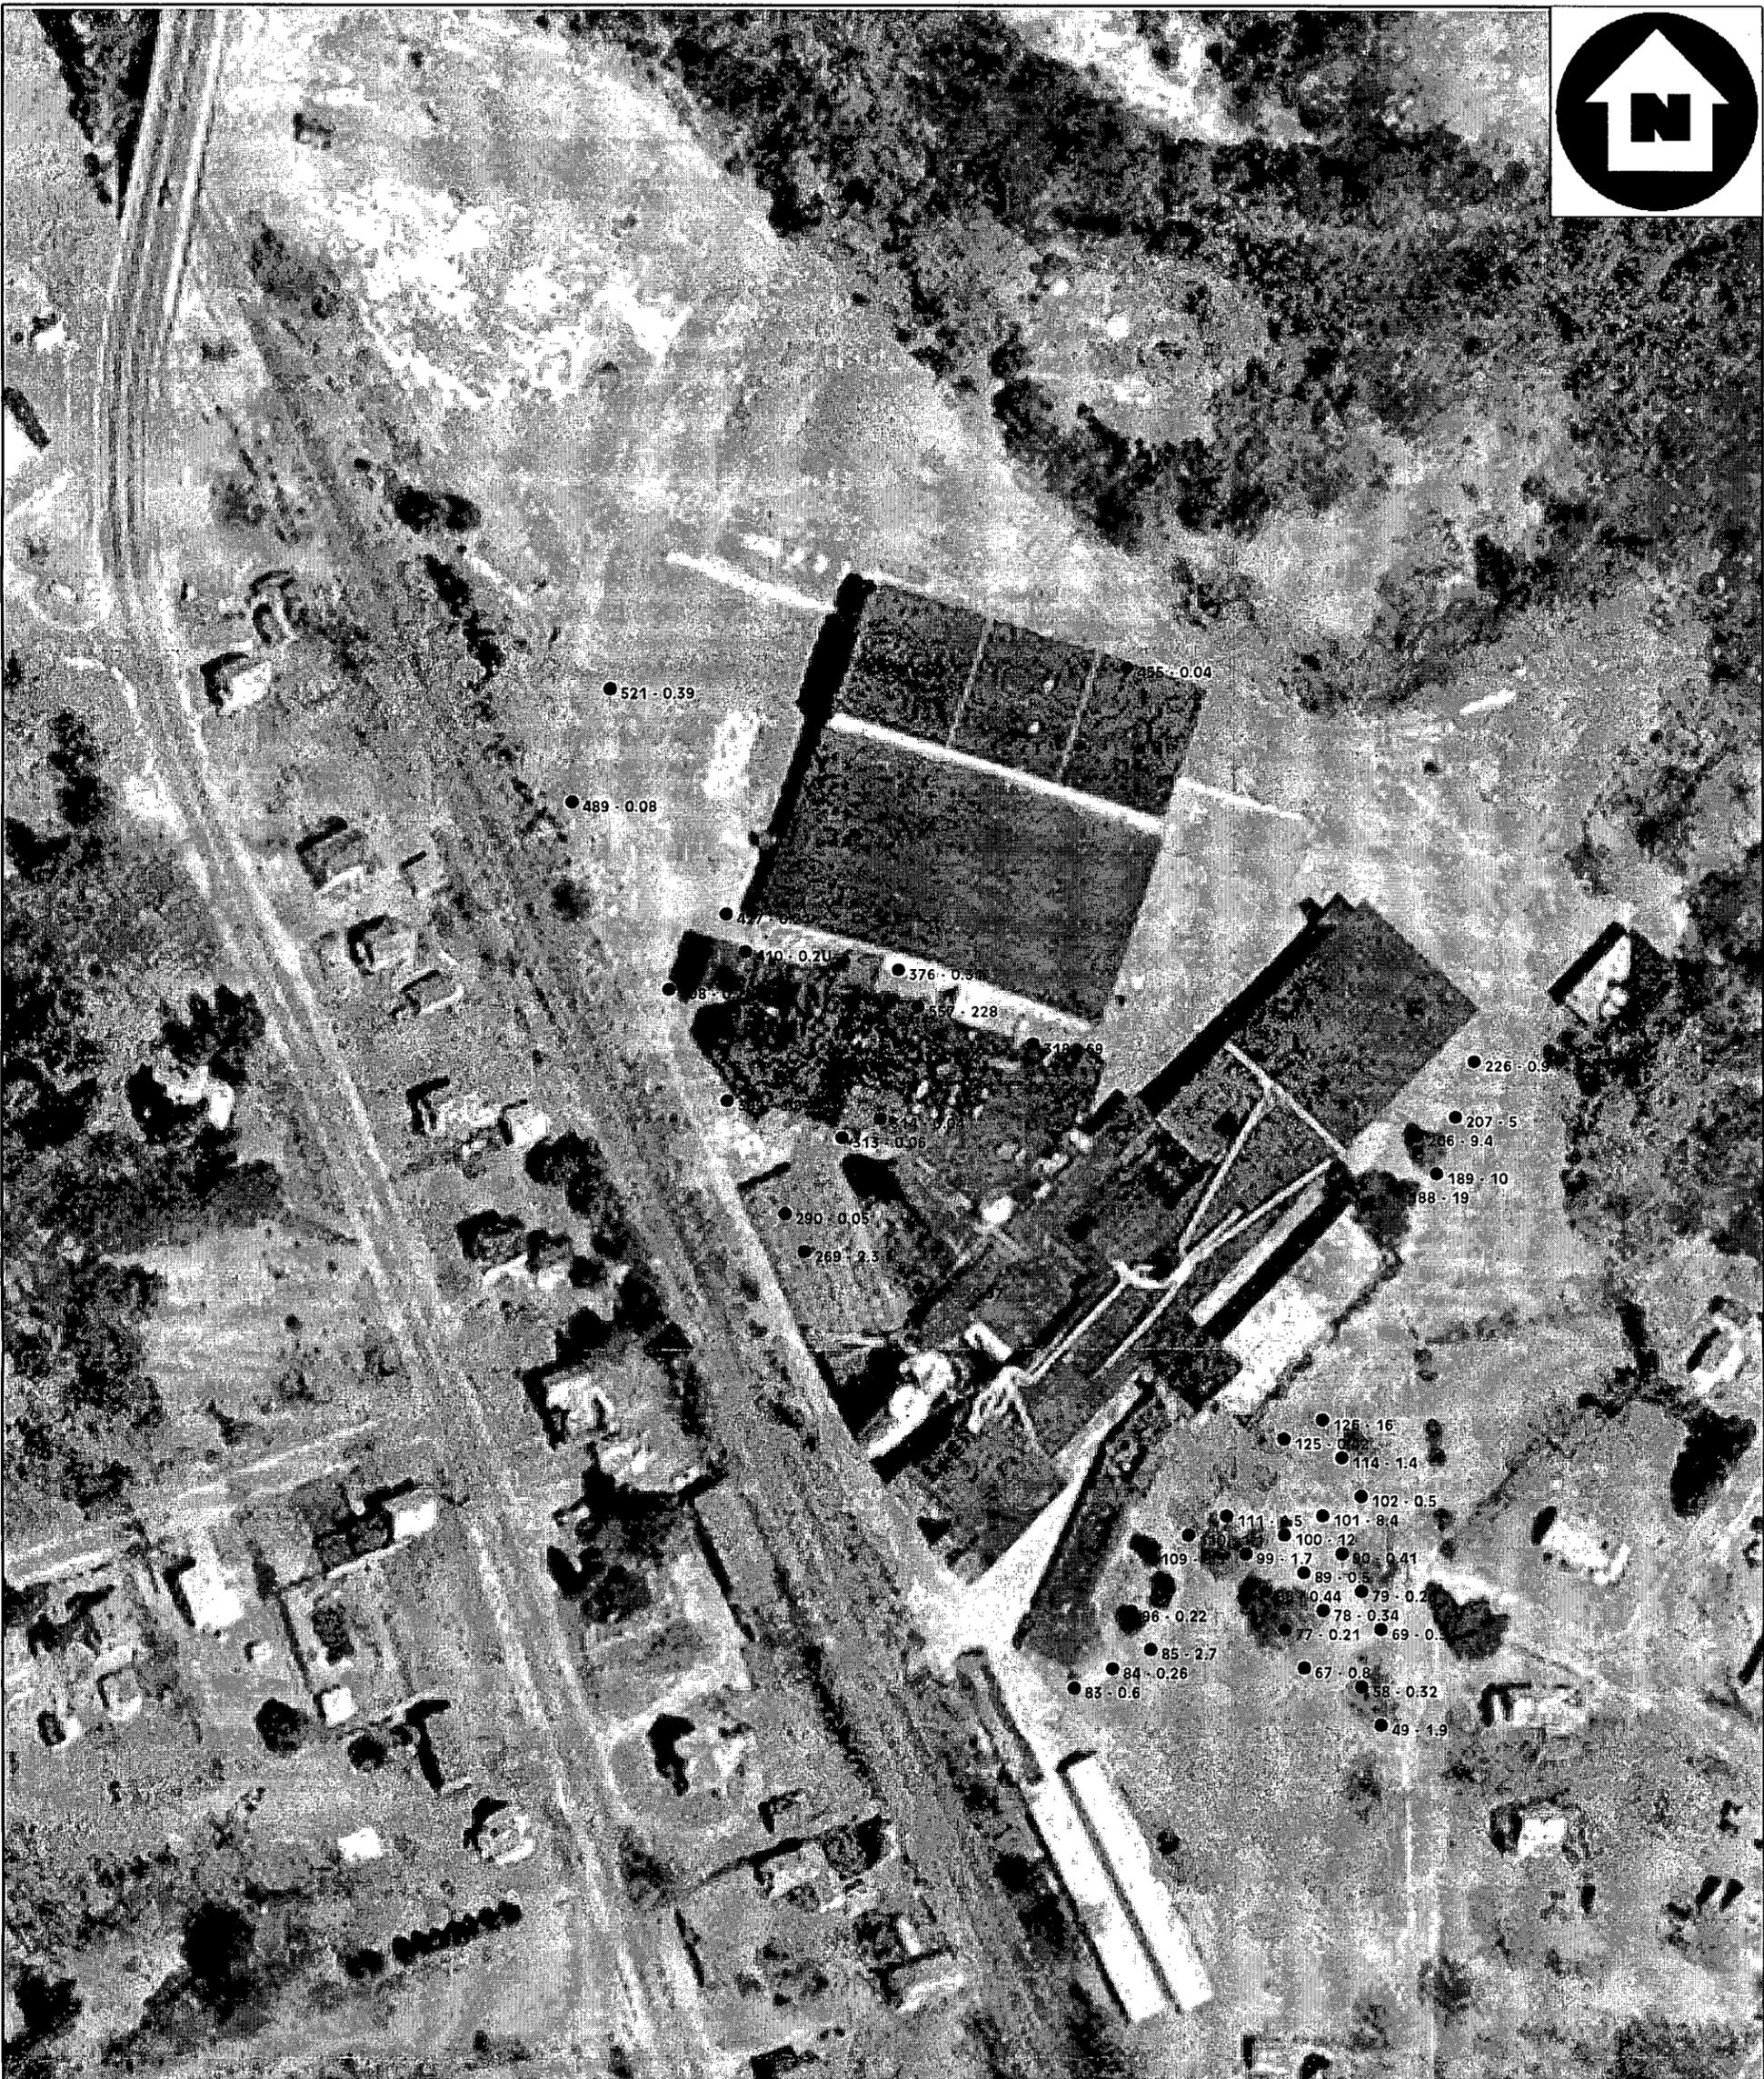
TDD NUMBER: 04-05-0011	CREATED BY: K. BRENNAN	CREATED ON: 09/03/2003
FILE LOCATION: E:\ARC_APRS\START2\TEMPLESTUARTX-X.APR	FIGURE 11

SL Brennan and START member Bill Mahany performed an extent-of-contamination survey of the on-site building area. START personnel established a 30-ft by 30-ft sampling grid over the accessible portions of the building area using GPS waypoint navigation. Surface soil samples were collected from each accessible sample location and relinquished to the EPA Mobile Laboratory for PCB field screening analysis [see Appendix D - Sampling Diagrams - Surface Soil Sample Location Diagram (Figure 11)].

**SURFACE SOIL SAMPLE LOCATION DIAGRAM**
