**REMOVAL PROGRAM  
AFTER ACTION REPORT  
FOR THE  
TEMPLE STUART SITE  
BALDWINVILLE, WORCESTER COUNTY, MASSACHUSETTS  
26 AUGUST 2002 THROUGH 2 AUGUST 2004**

Weston Solutions, Inc.  
Superfund Technical Assessment and Response Team 2000 (START)  
37 Upton Drive  
Wilmington, Massachusetts 01887

April 2005

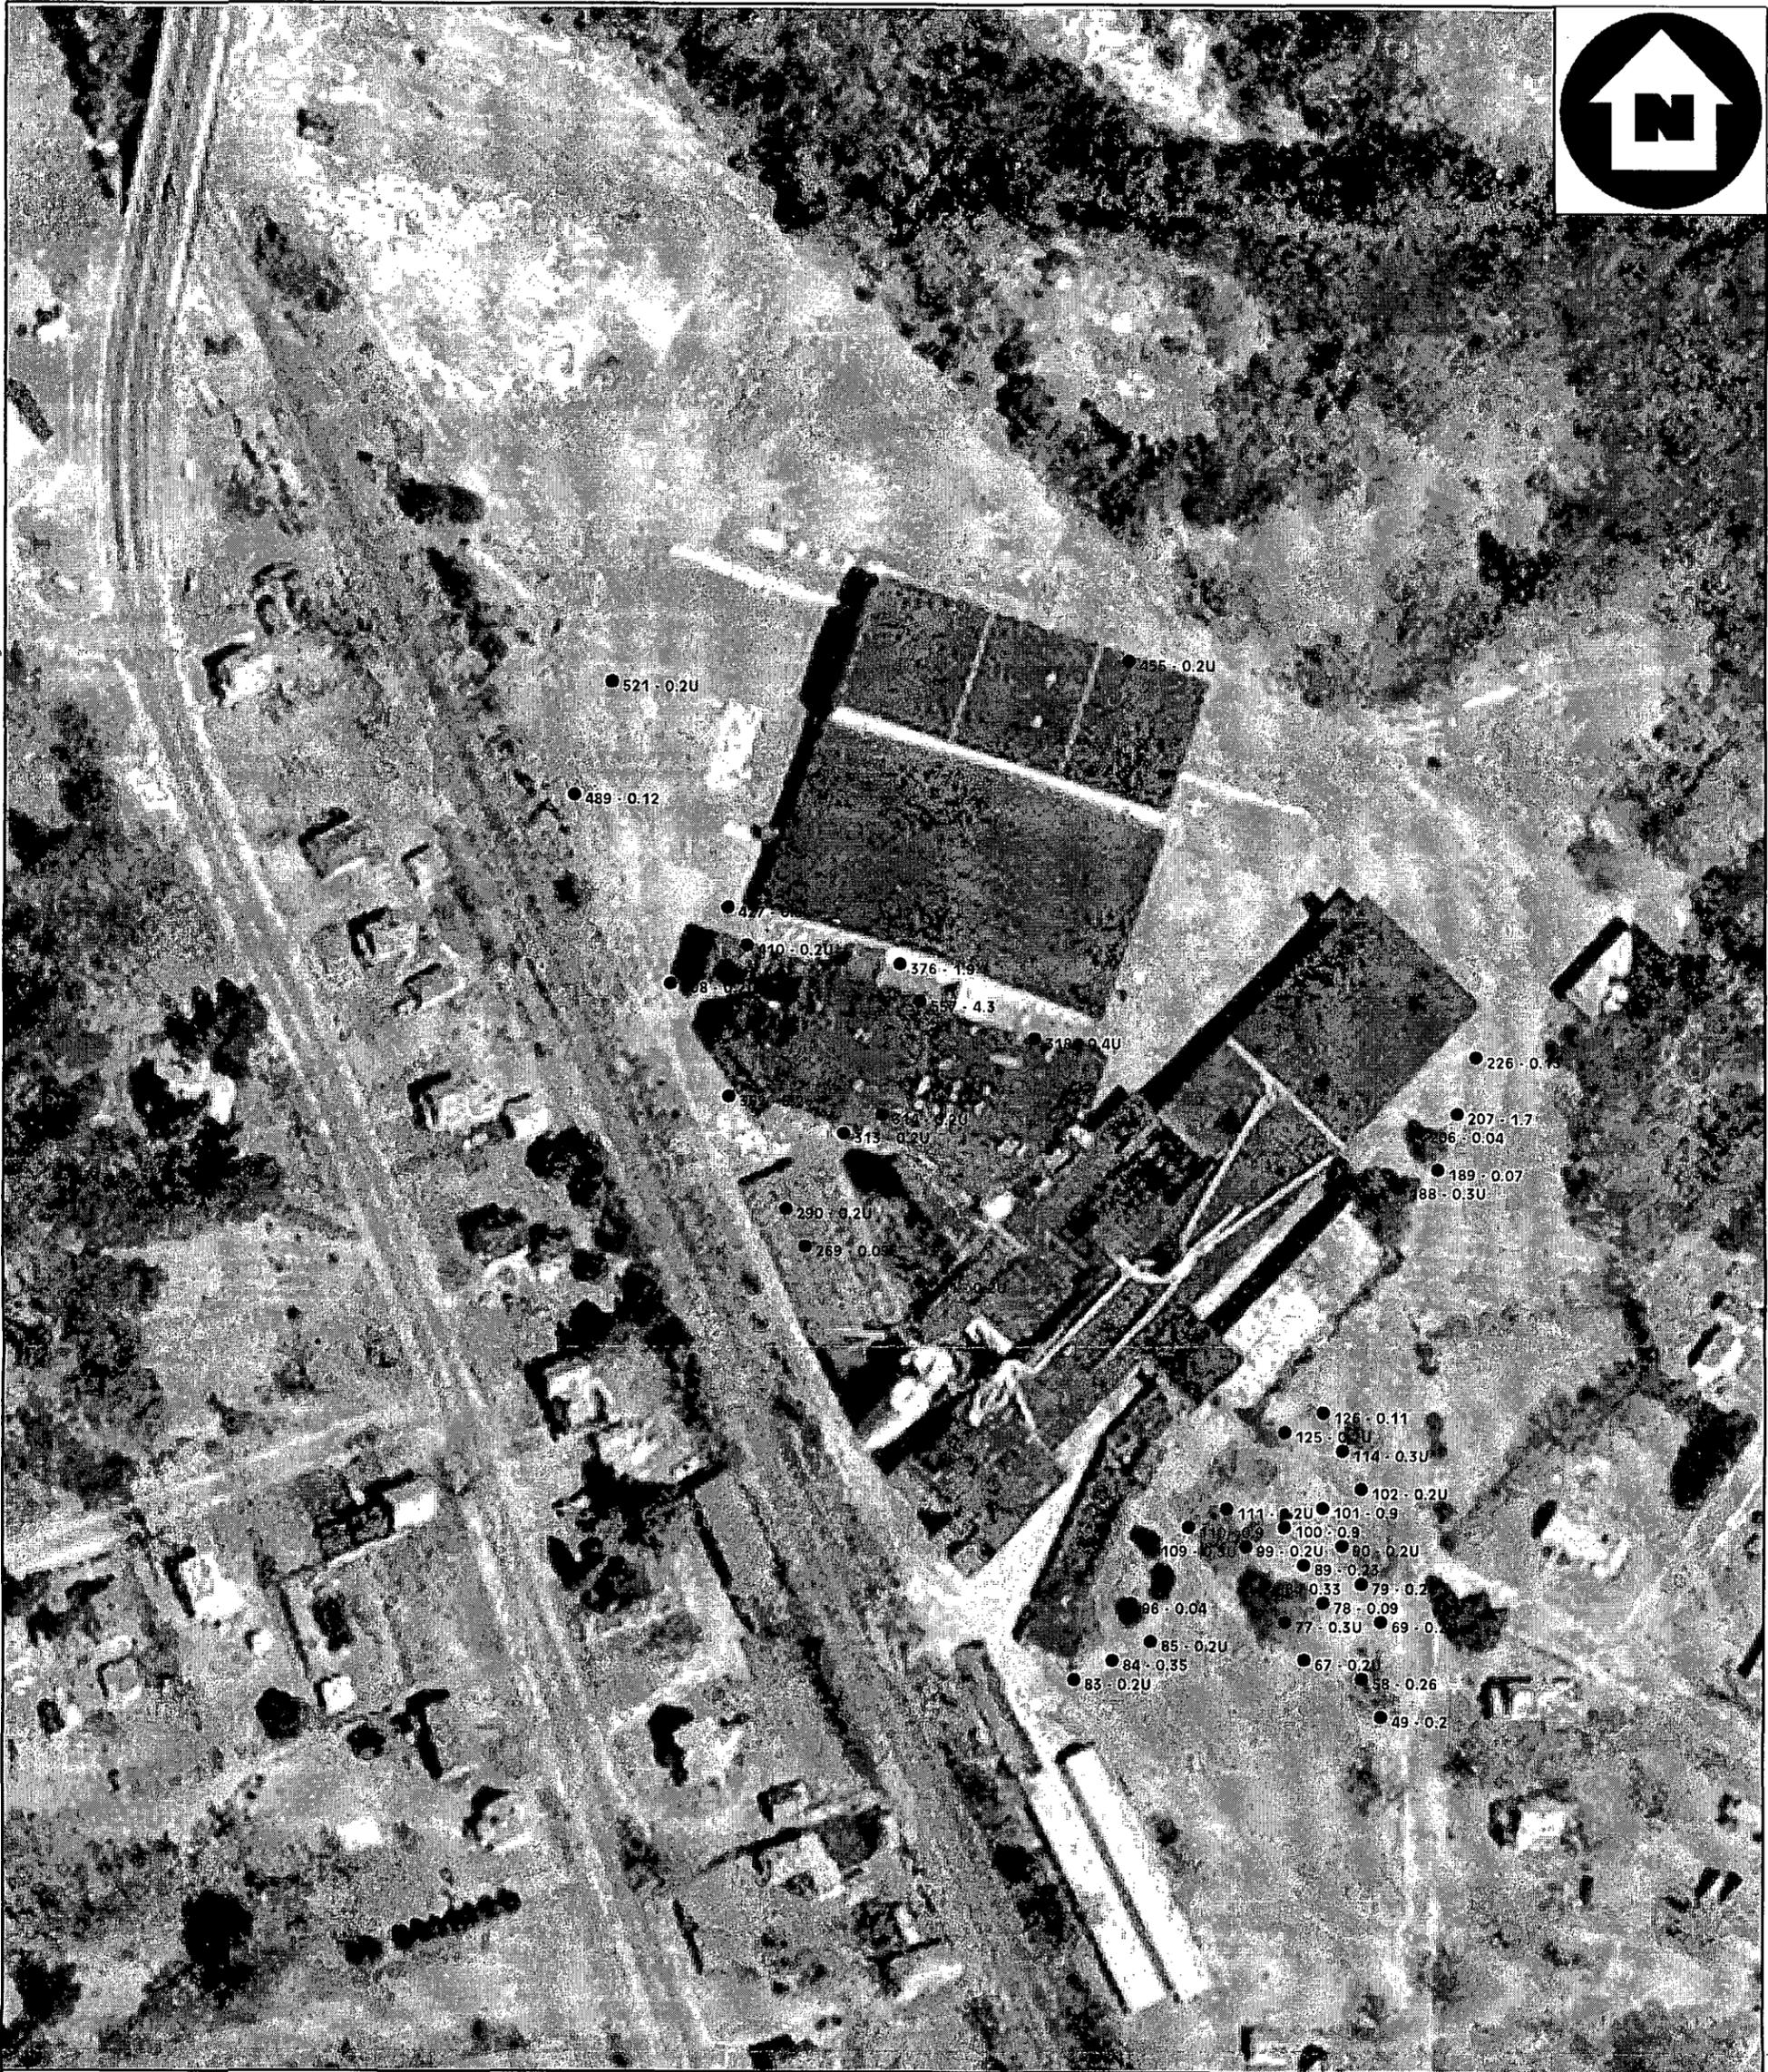
TDD NUMBER: 04-05-0011	CREATED BY: K. BRENNAN	CREATED ON: 09/03/2003
FILE LOCATION: E:\ARC_APRS\START2\TEMPLESTUARTX-X.APR		FIGURE 12

SL Brennan and START member Mahany continued the extent-of-contamination survey of the on-site building area. START personnel collected subsurface soil samples from previously marked grid sample locations as determined by the OSC. Samples were relinquished to the EPA Mobile Laboratory for PCB field screening analysis [see Appendix D - Sampling Diagrams - Soil Sample Location Diagram 0'-1' (Figure 12), Soil Sample Location Diagram 1'-2' (Figure 13), Soil Sample Location Diagram 2'-3' (Figure 14), Soil Sample Location Diagram 3'-4' (Figure 15)].

SOIL SAMPLE LOCATION DIAGRAM 0'-1'

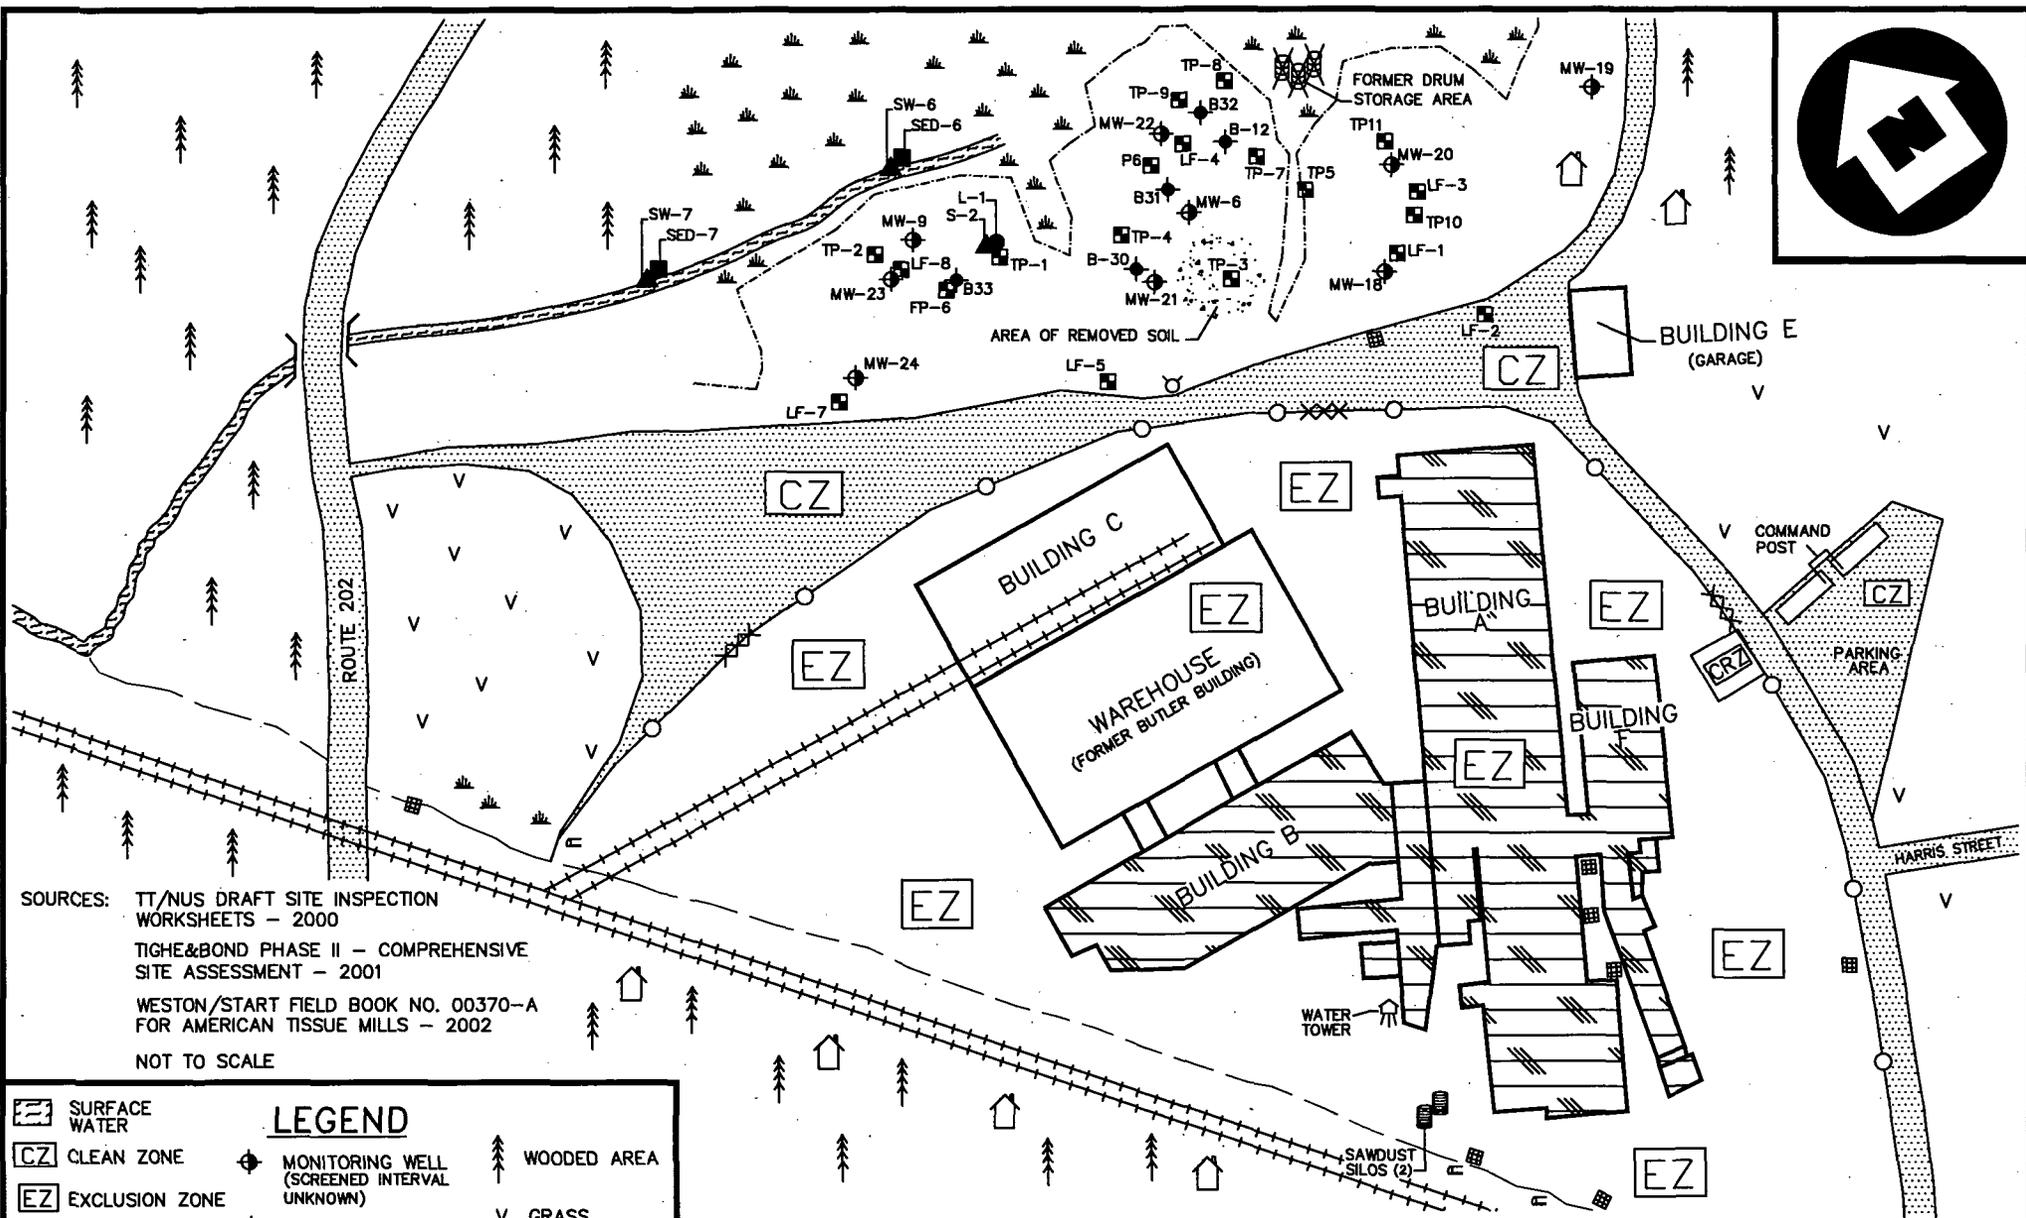
LEGEND	
SURFACE WATER	WOODED AREA
CLEAN ZONE	GRASS
EXCLUSION ZONE	WETLANDS
CONTAMINATION REDUCTION ZONE	GATE
TEST PIT	PAVED AREA
FORMER DRUM	DEMOLISHED STRUCTURES
OUTFALL PIPE	FENCE LINE
FIRE HYDRANT	RESIDENCE
CATCHBASIN	LANDFILL BOUNDARY
CULVERT	RAILROAD TRACKS
MONITORING WELL (SCREENED INTERVAL UNKNOWN)	REMOVED SOIL
SOIL BORING	
SOIL SAMPLING LOCATION	
SURFACE WATER SAMPLING LOCATION	
SEDIMENT SAMPLING LOCATION	
AIR SAMPLING LOCATION
