MAINE DEPARTMENT OF ENVIRONMENTAL PROTECTION
OIL & HAZARDOUS MATERIALS REPORT

Spill Number: P-541-2011

Subject/Owner: CMP - LEWISTON STEAM PLANT SUBSTATION - -

P-541-2011
 UNDERGROUND STORAGE
 TANK INVESTIGATION
 Central Maine Power Substation
 Mill Street, Lewiston

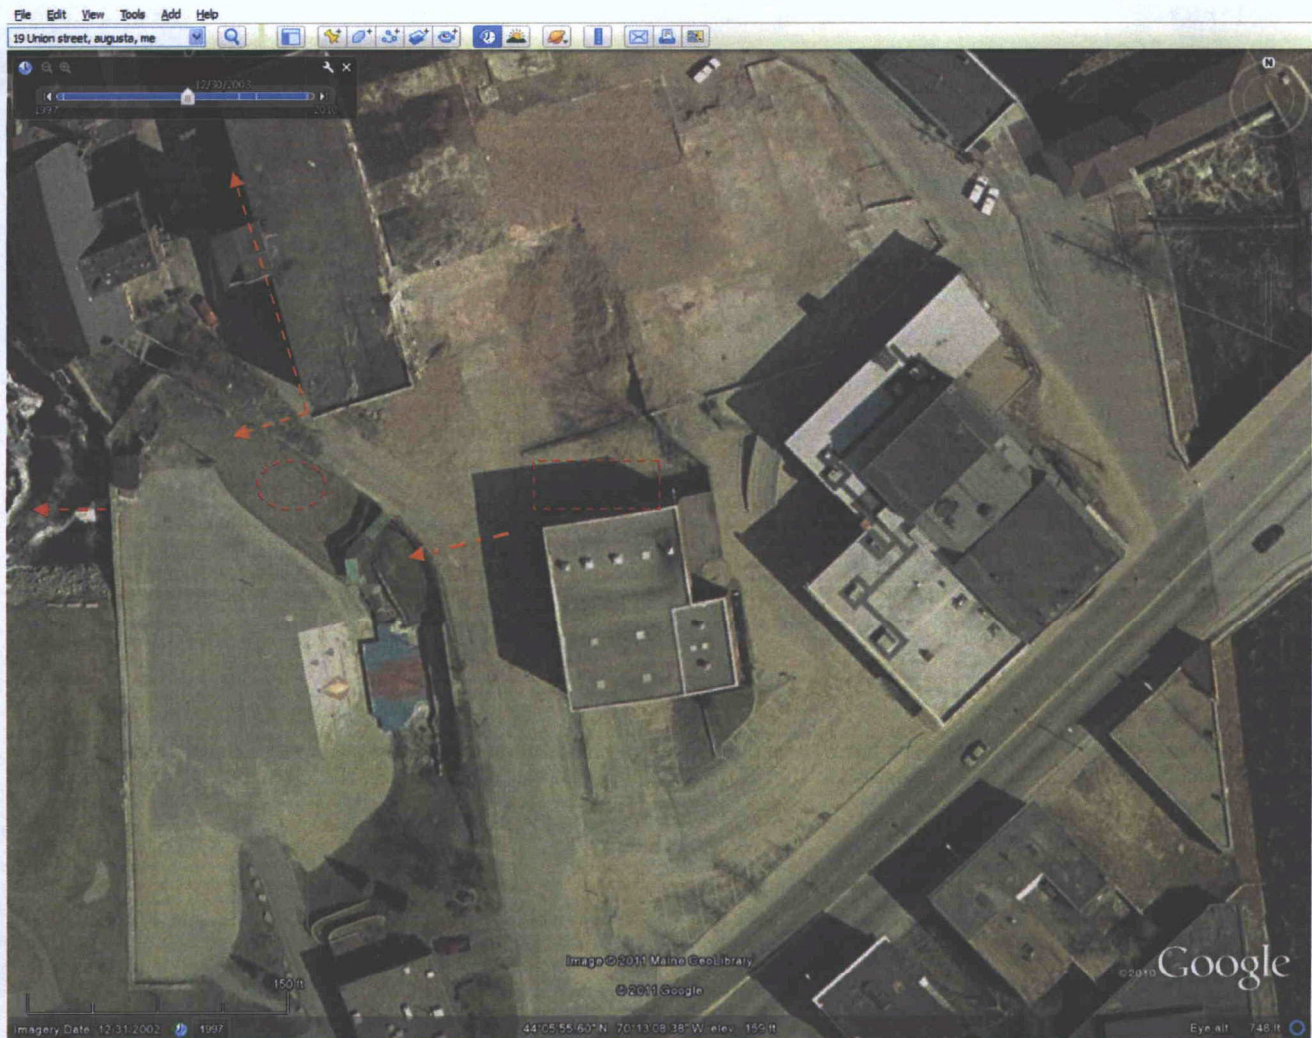
1.
 - a) Aerial view of the CMP LEWISTON STEAM PLANT building in center, now a CMP transformer substation. Directly above is the former WS Libbey Mill location at the time mostly gone except for the Mill No. 1 building left of upper left. All the mill buildings are now gone. At right is a former CMP administration building that had a registered motor fuel UST.

- b) At upper left is the smaller former Cowan Mill which burned about 2009 and underwent a UST abandonment in July 2011 [MDEP spill report P-537-11].

- c) Left of the CMP building the orange dashed line denotes the steel pipe with black oil leaking around (see Photos 7 – 9 below). North of the CMP Steam Plant is the location of the 147,000-gallon concrete #6 oil UST [P-541-11].

- d) At far left is a red arrow showing the location of the #6-oil discharge out the retaining wall into the Androscoggin River [P-534-11]. This is the area of the former Columbia Mill buildings, now known as Heritage Park.

- e) At upper left is an orange arrow denoting a set of underground #6 oil and steam pipes remaining from abandonment-by-removal of a 12,000-gallon #6 oil UST in year 2000, associated with the former Libbey Mill. The Libbey Mill UST location is marked by the red circle.

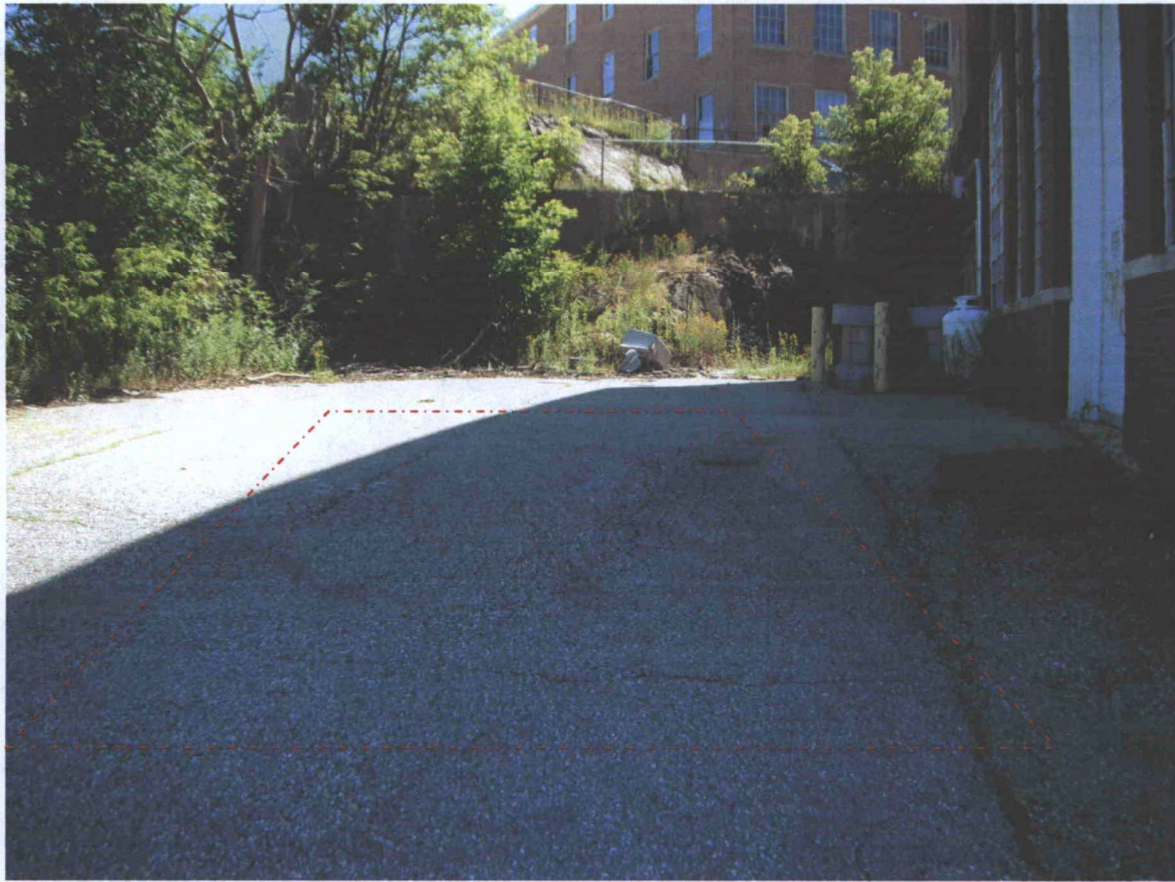
2.

7/14/11: looking east over the location of the 147,000-gallon concrete #6-oil UST, and a later 10,000-gallon UST on the north side of the CMP substation building. The evidence of new pavement at right is perhaps from former uncovering of or work on one or both of the USTs.

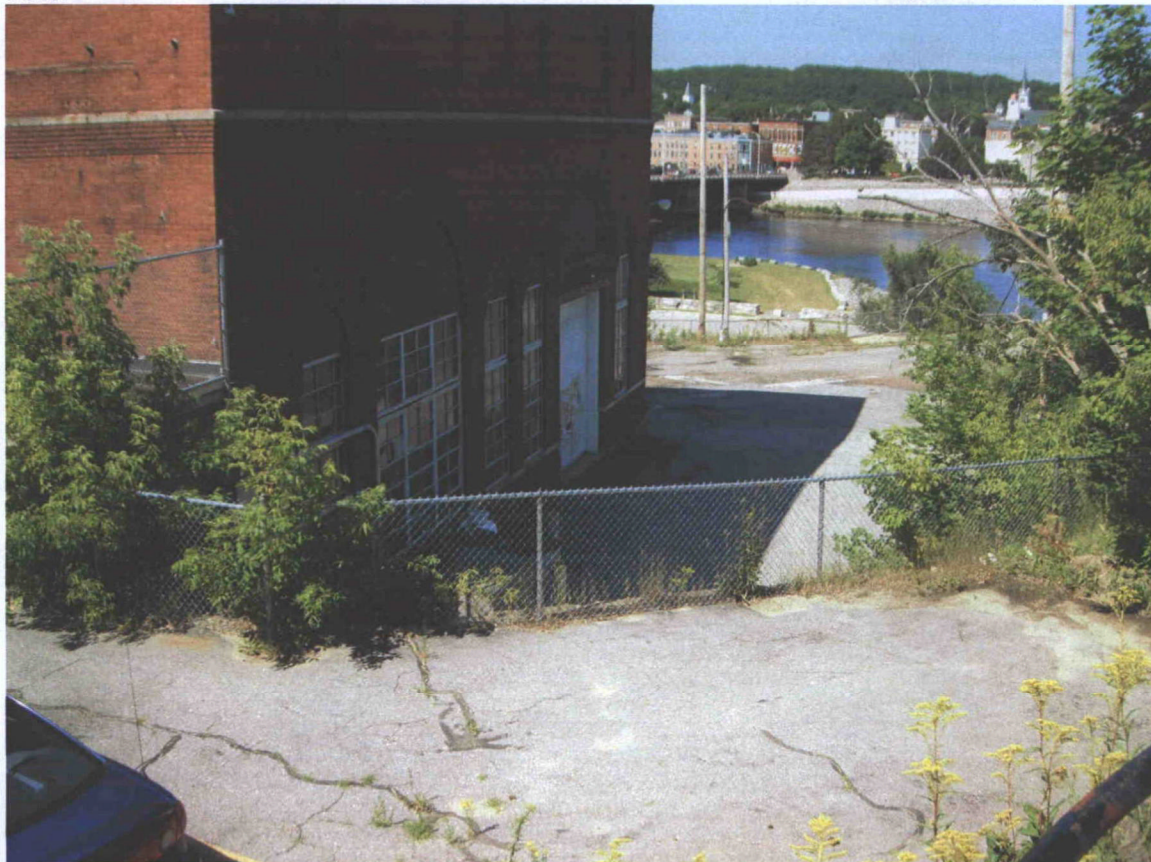
3.

Looking west towards the Androscoggin River and down on the UST location behind the building. No UST vent or fill pipes were noted at this time.

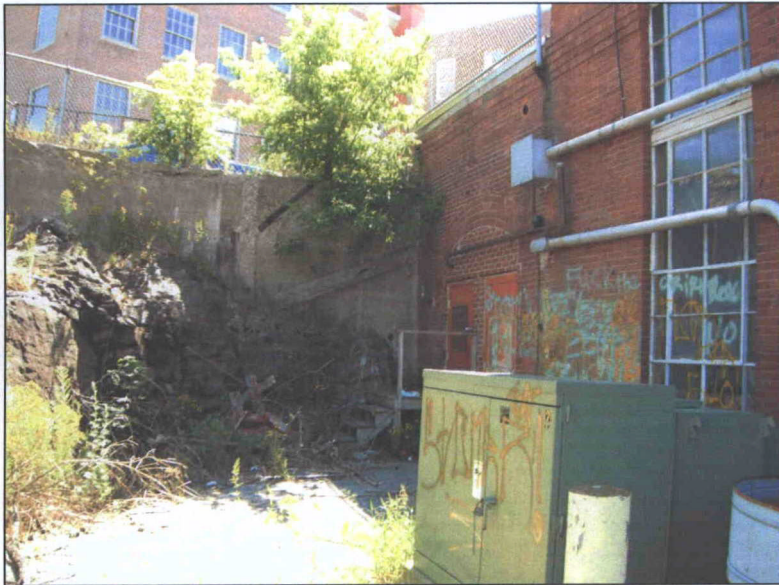
4. Thurs. 7/14/11: Rear, north side, of the substation showing the doors into the 4000-gallon #2-oil AST and a vent pipe on the side of the building above the door [see Photo-6 below].

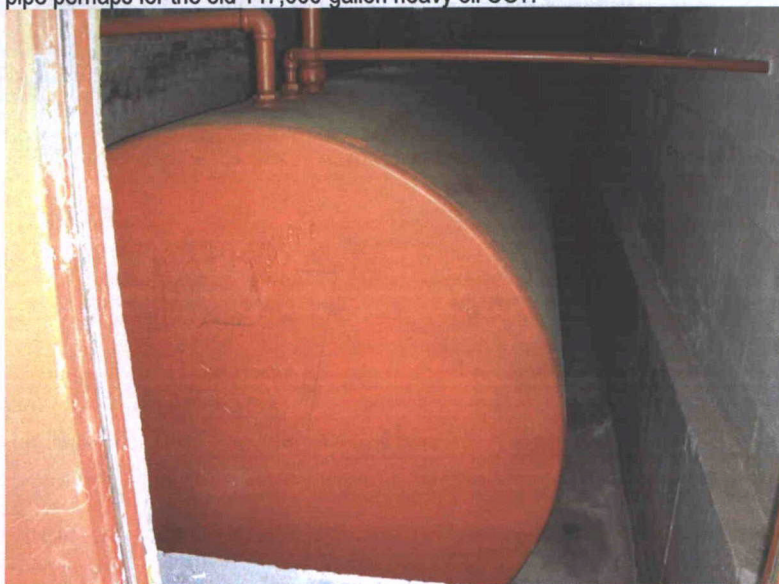
6. Thurs. 7/14/11: Inside view of the active 4000-gallon #2-oil AST with a product line going right into building and fill & vent left out to east side of building. No evidence of leaks.

The facility at this time was a large electrical substation. The area is dense commercial use, formerly industrial use and is served by municipal water and sewer. In the past the building had been a steam powered generator plant with a 147,000-gallon three-compartment, underground storage tank (UST) for #6 oil dating from the 1940s. Sometime prior to 1979 a 10,000-gallon #2 oil UST was installed within one of the chambers of the older tank and it is presumed the 147,000-gallon UST was removed from service. The 10,000-gallon UST appears to have been removed about 1988 and replaced by a 4000-gallon #2 oil aboveground storage tank (AST) presently active and within the building (photo 6).

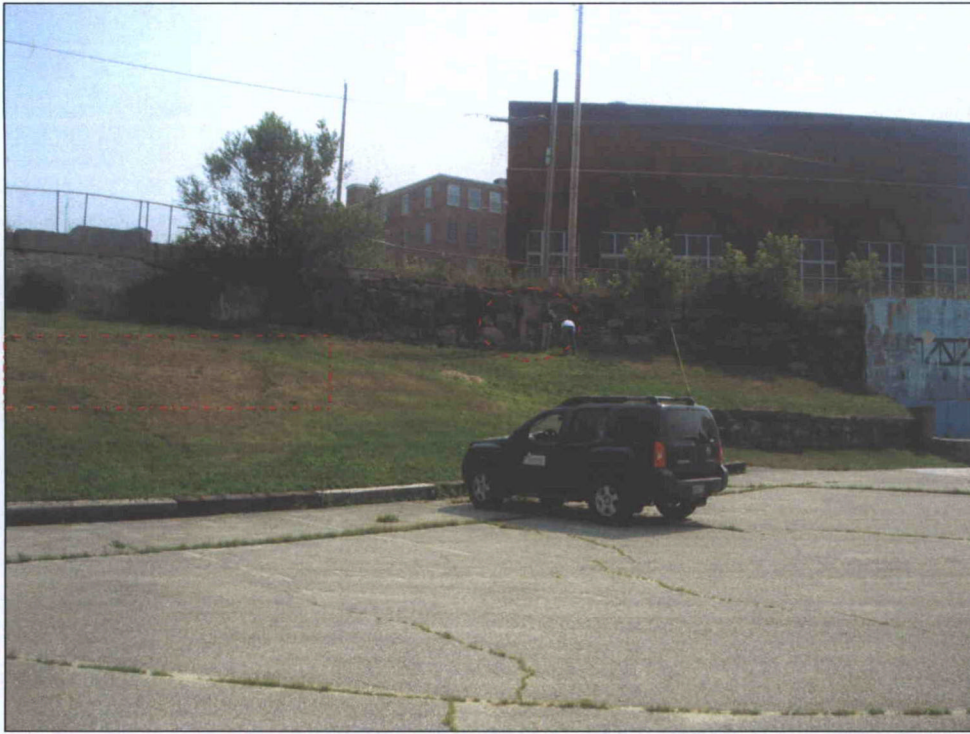
7. Wed. 7/20/11: From the Heritage Park parking lot looking east at the CMP Lewiston Steam Plant building and the 147,000-gallon #6-oil UST location just to the left (north) of the building. In the photo center is a pipe circled in red that looks to be coming from the corner of the CMP building and UST location. This wall used to be part of the former Columbia Mill building.

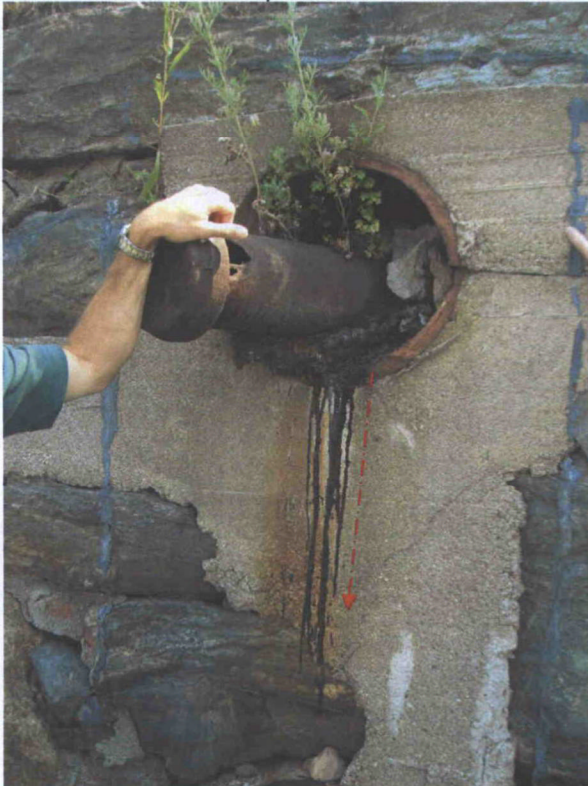
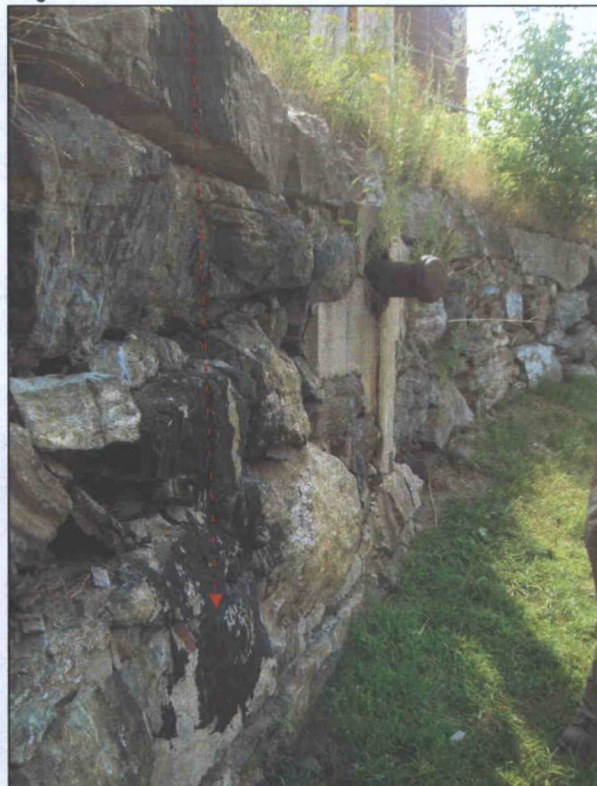
8. Wed. 7/20/11, above left: Close-up photo of the approx. 15" clay drain pipe with an 8" diameter steel pipe that was circled above in Photo-7. An old, black oil leak is visible coming out of the clay pipe and running down the stone wall. Cutting into the black stain we found it too not viscous enough to be asphalt at this day's ambient temperature. This pipe within a pipe was traced across Mill St. to the CMP UST facility. Drumlin Env. found information that this pipe was an offset fill pipe from Main Street that fed both the CMP UST and the Libbey Mill UST.
9. Wed. 7/20/11 above right: Looking south east at the pipe and leak, and another, larger oil discharge down the side of the retaining wall in the foreground. This larger spill appears to perhaps be a surface spill from the top of the wall and could be unrelated to the leak out the pipe.

A set of pipes downgrade of this UST facility protrudes from a retaining wall below Mill Street; old black oil appears to have seeped out of this pipe (photo 8 and 9). Drumlin uncovered information that this pipe was part of an offset fill pipe that ran from the former railroad yard on Main Street and fed both the CMP UST and the Libbey Mill UST facility (see P-561-2011).

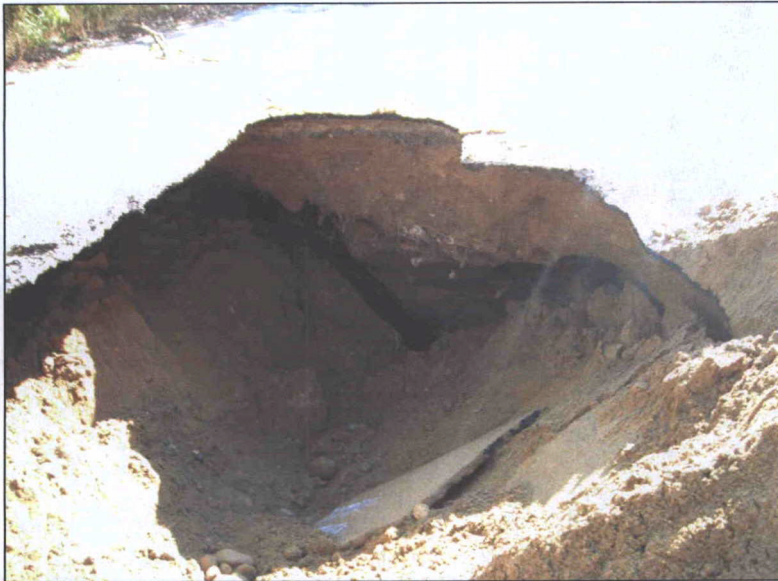
10. Mon. 8/1/11: **Test Pit TP-1** in the north chamber of the CMP 147,000-gallon UST where the later 10,000-gallon steel UST was located. EPI excavated under Drumlin Environmental for CMP. We found the 10,000-gal. UST had been removed, the concrete tank-top had been broken in.

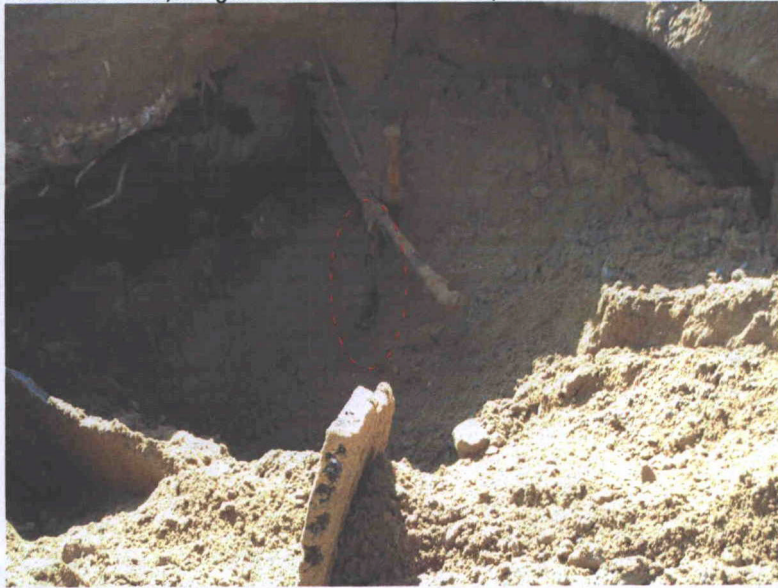
11. Mon. 8/1/11: Exposed in TP-1 old product, return lines and electrical conduit for the former 10,000-gal. UST exposed; one line is leaking what appears to be black oil similar to #4 oil (circled). At bottom left are two pieces of broken concrete tank top. At upper left is the wall separating the east compartment and upper right is the wall separating the south compartment. Soil was loose and slumped making excavation difficult.

Monday 8/1/11: test pits TP-1, TP-4 and TP-5 within the three compartments of the 147,000-gallon tank found the concrete tank had been mostly cleaned out, filled with uncompacted sand and the concrete top broken into the tank as fill. Old fuel and return piping was still within the tank in (photos 11 & 12) and leaked some oil into fill and water below when accidentally broken.

- 3) On 8/1/11 MDEP approved abandonment-in-place of the 147,000-gallon UST facility. EPI drained and removed the old steel piping on 8/1/11. Non-oil-saturated #2-oil contaminated soil and water remains within the concrete UST but I judged not to be cost effective to remove at the time.

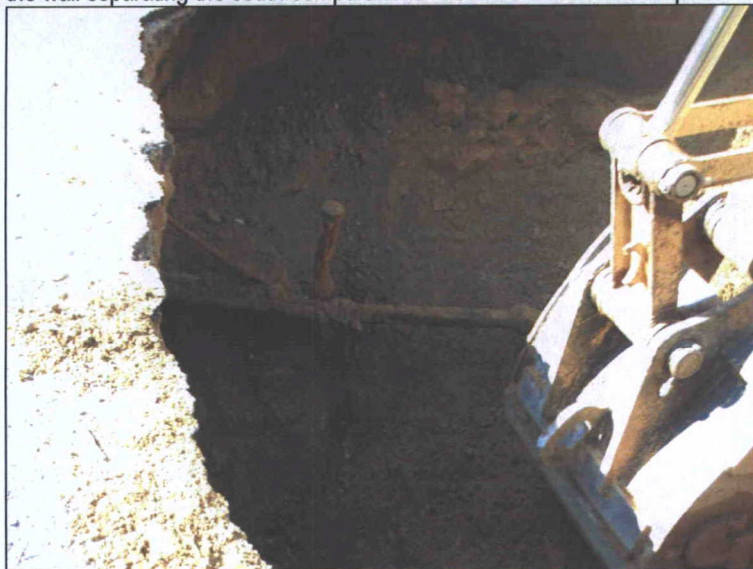
12. Mon. 8/1/11: TP-1, another view of the remaining piping.

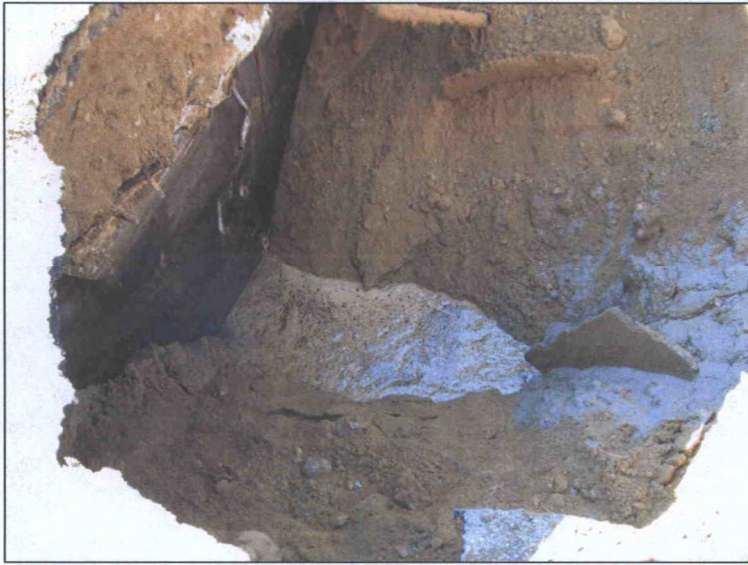
13. Mon. 8/1/11: In TP-1, water in the tank with a discontinuous layer of black oil. The concrete tank's walls appeared reasonable well cleaned. Gray oil-contaminated soil but not oil-saturated soil was found within the bottom several feet depth of the concrete tank (Soil sample SS-1).

Blobs of black oil were noted on the water in the northwest compartment from the pipe leak (TP-1) where the 10,000-gallon tank was located. At the bottom of the tank compartment was gray (not black), wet, oil-contaminated soil with odor of anaerobic degraded oil. I noted no remaining contamination in TP-4 and TP-5. I believe this oil contaminated soil was from the 10,000-gallon #2 oil UST.

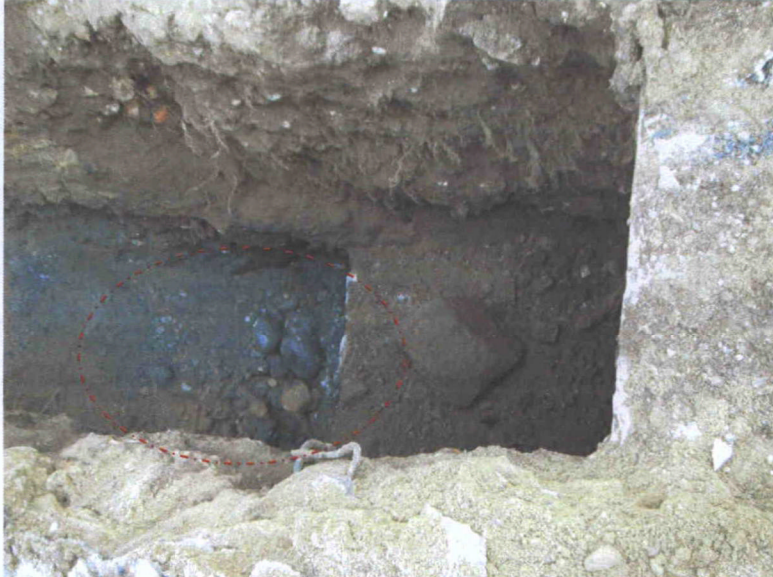
14. Mon. 8/1/11: **Test Pit TP-2** located just outside the west tank wall with black-oil saturated soil below the footer for the concrete UST (circled) on the silt/clay soil layer.

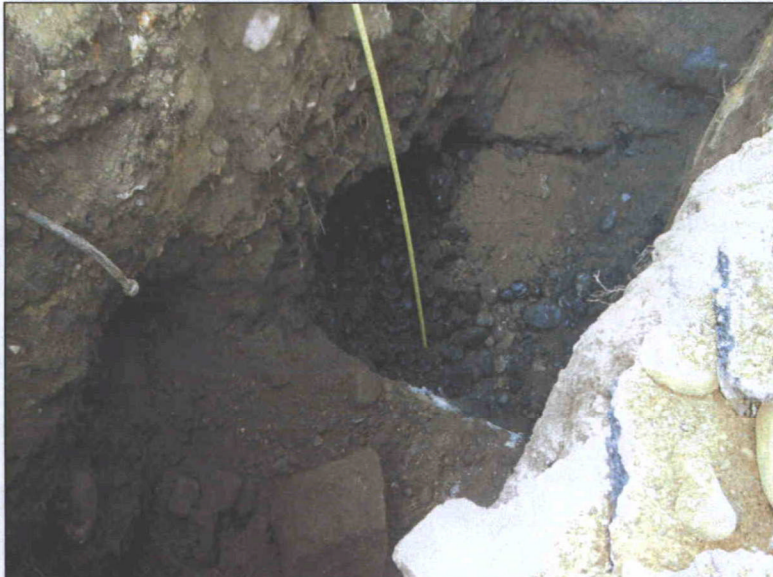
15. Mon. 8/1/11: Another view into oil-saturated soil at the north end of TP-2 @ about 7.5' below grade. At lower left is the concrete footer for the UST.

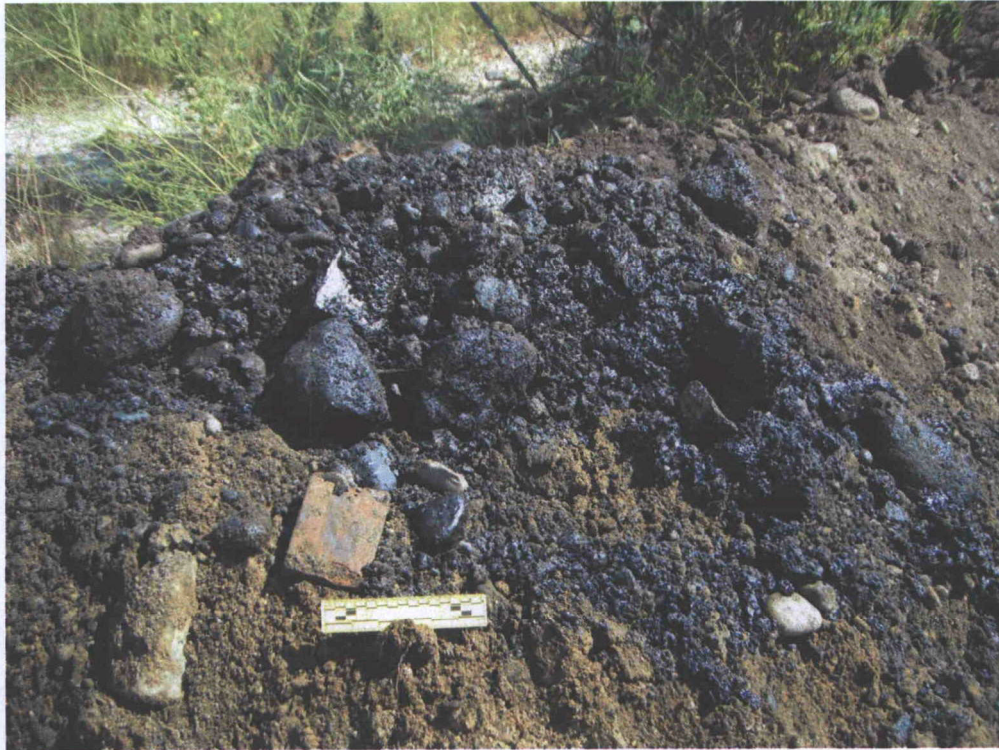
16.

Mon. 8/1/11: Black 6-oil

saturated soil excavated from about 7.5' bg in TP-2. Goopy oil on the cobbles and an oil-saturation test confirmed saturated soil 1.5' to 2' thick. Oil saturated soil and free product was later confirmed in a soil layer under the clay layer and above bedrock.

TP-2 was on the west exterior of the concrete tank. Coal ash, sand fill and bricks were found during excavation with native Preumpscott Formation silt/clay soil. At approximately 7.5 feet below grade we encountered black oil-stained rocks and weathered, anoxic oil-smelling soil that tested to be saturated with black, #6 oil (see photo-16). This confirmed a discharge from the tank. An old north-south 20 inch water pipe was

- 2) At this time no remediation of the confirmed #6 oil contamination has been initiated. I recommend that in the spring of 2012 at the latest this soil be removed to stop or prevent further migration of oil contamination to the river.

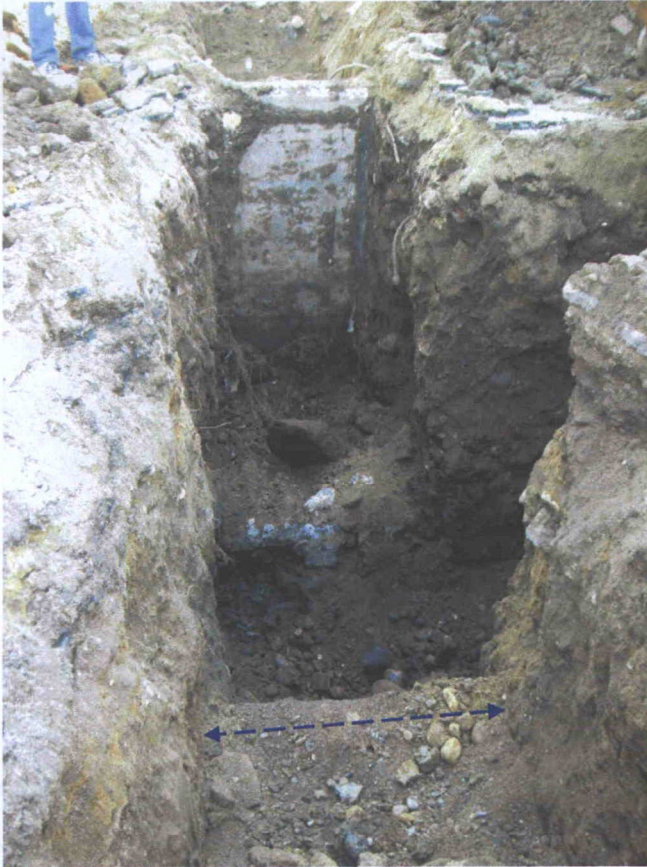
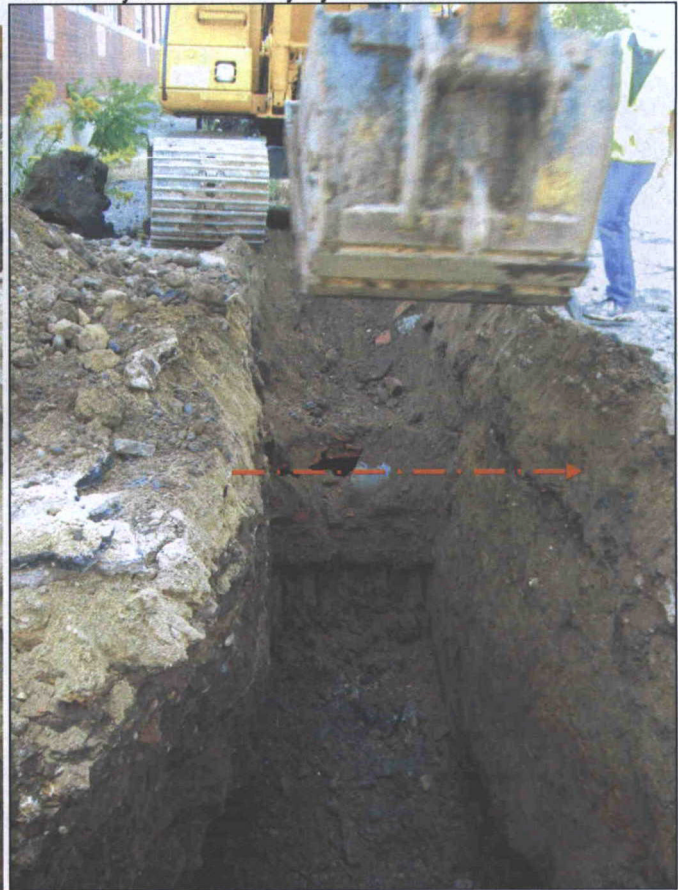
17. Mon. 8/1/11 Left Photo: Looking east down TP-2 toward the outer wall the concrete tank. Soil here was compacted and competent (the location of an old Libbey Mill building?). A branch of TP-2 also extends south (right) toward the building. The arrow near the bottom marks a 20" diameter old water pipe into the substation building basement.
18. Mon. 8/1/11 Right Photo: Looking south along the leg of TP-2 exposing the 15" clay pipe with the 8" iron pipe inside (see Photo-8 above). No oil was found in the pipe. These pipes may have been a perimeter drain for the concrete UST and/or the building, but information indicates an offset fillpipe from main St. feeding the CMP and Libbey Mill USTs. Black oil-saturated soil was found below the pipe.

TP-2 was extended south until we encountered the east-west running 15" clay pipe with the 8' iron pipe within (photos 8 and 18). No oil was found within the pipe which was several feet above the oil contaminated zone. A 20" old water pipe was found to the west (photo 17).

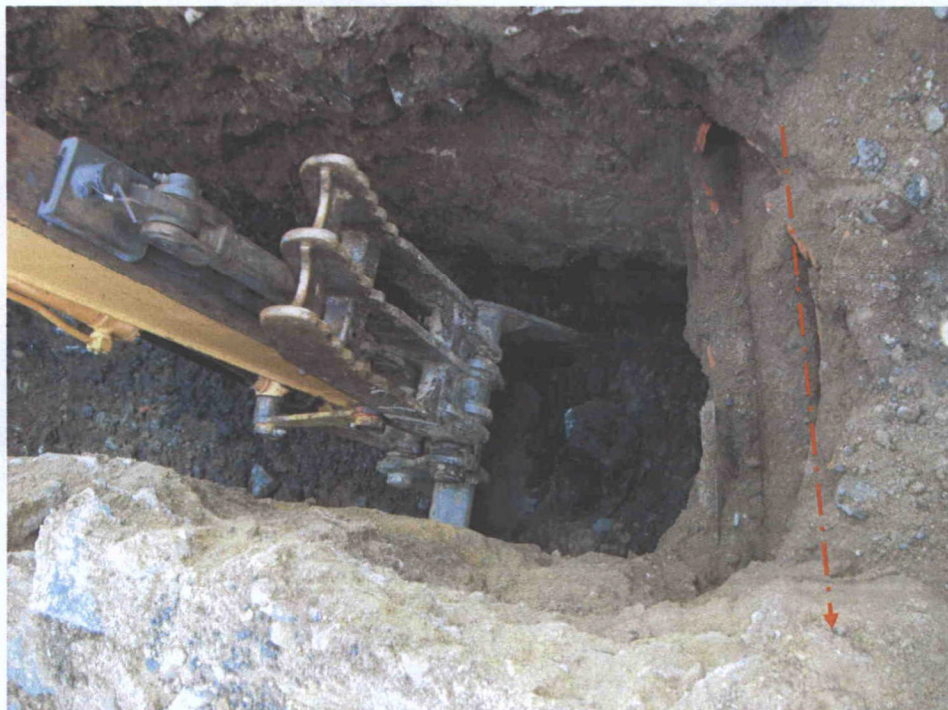
19. Mon. 8/1/11: Looking down into south end of TP-2 over the 15" clay pipe with the 8" iron (offset fill) pipe exposed. That goes west under Mill Street to the location of the Libbey Mill UST facility (see P-561-2011).

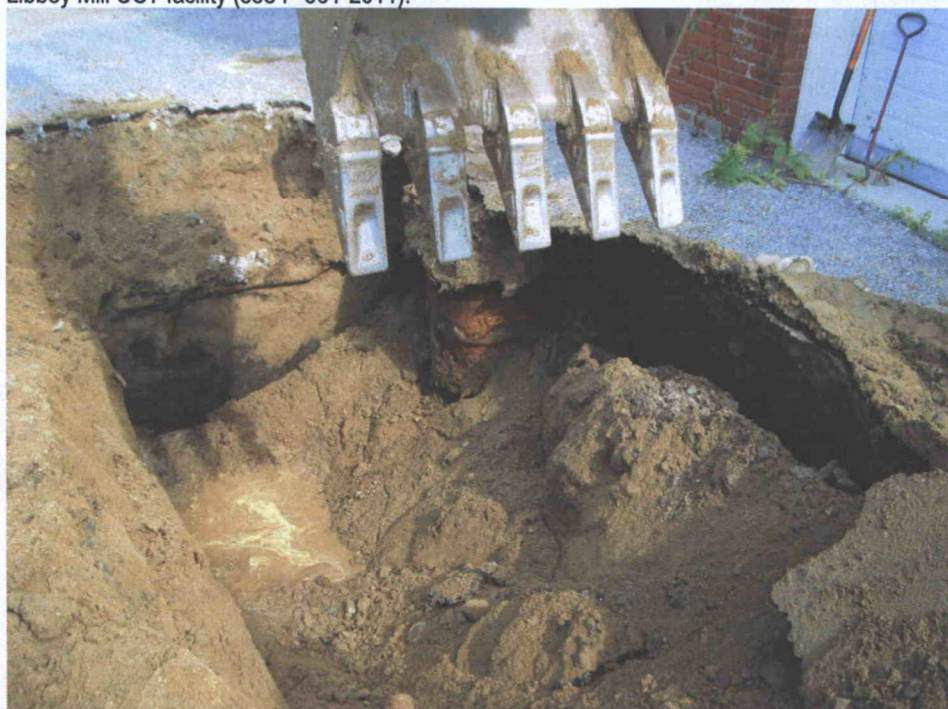
20. Mon. 8/1/11: Excavation of **Test Pit TP-4** within the smaller, south concrete tank compartment. Water was found within the compartment with no evidence of oil saturated soil of free product. In the center is what appears to be a buried 55-gallon drum that may have been a manway.

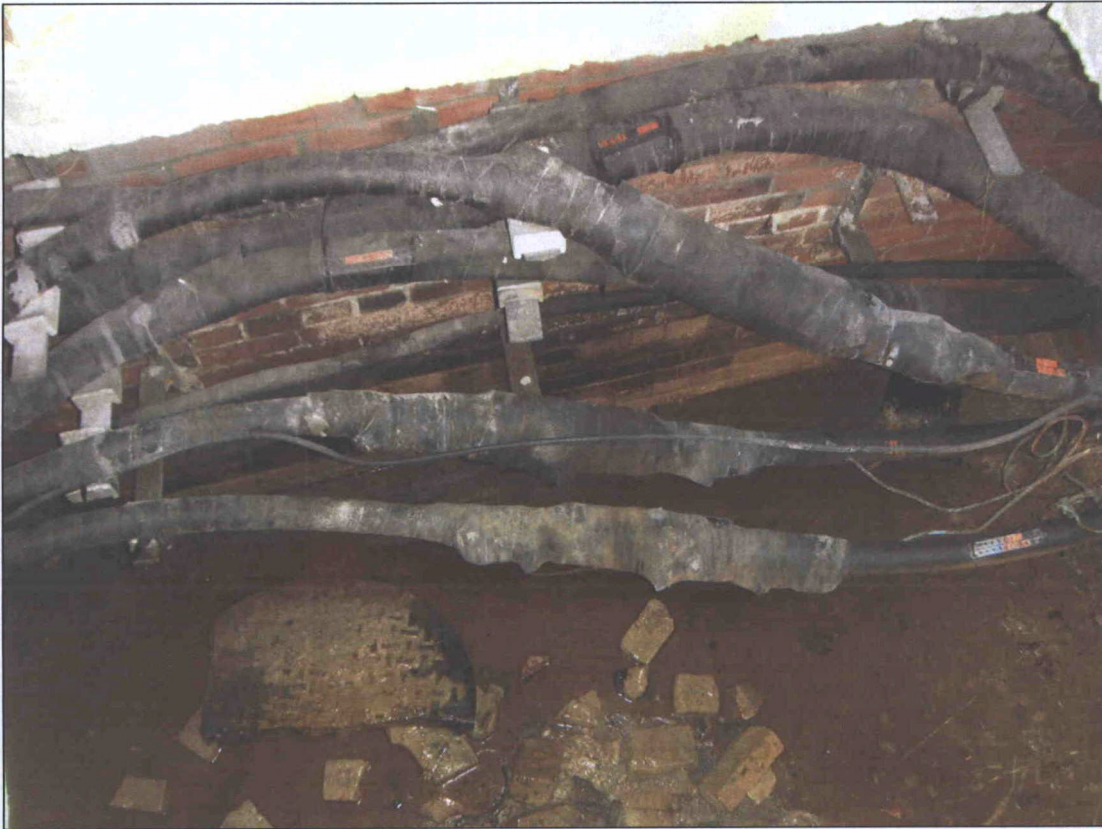
21.

Mon. 8/1/11: Looking

down into a CMP brick constructed vault under Mill Street and north of the CMP UST facility; visible along the SW wall of the vault are the live power lines to the substation. Below is a layer of water and on the water are what appear to be possible sporadic blobs of black and brown oil. Depth to the vault bottom I estimate at 8' to 10', within the range of groundwater depth based on TP-2.

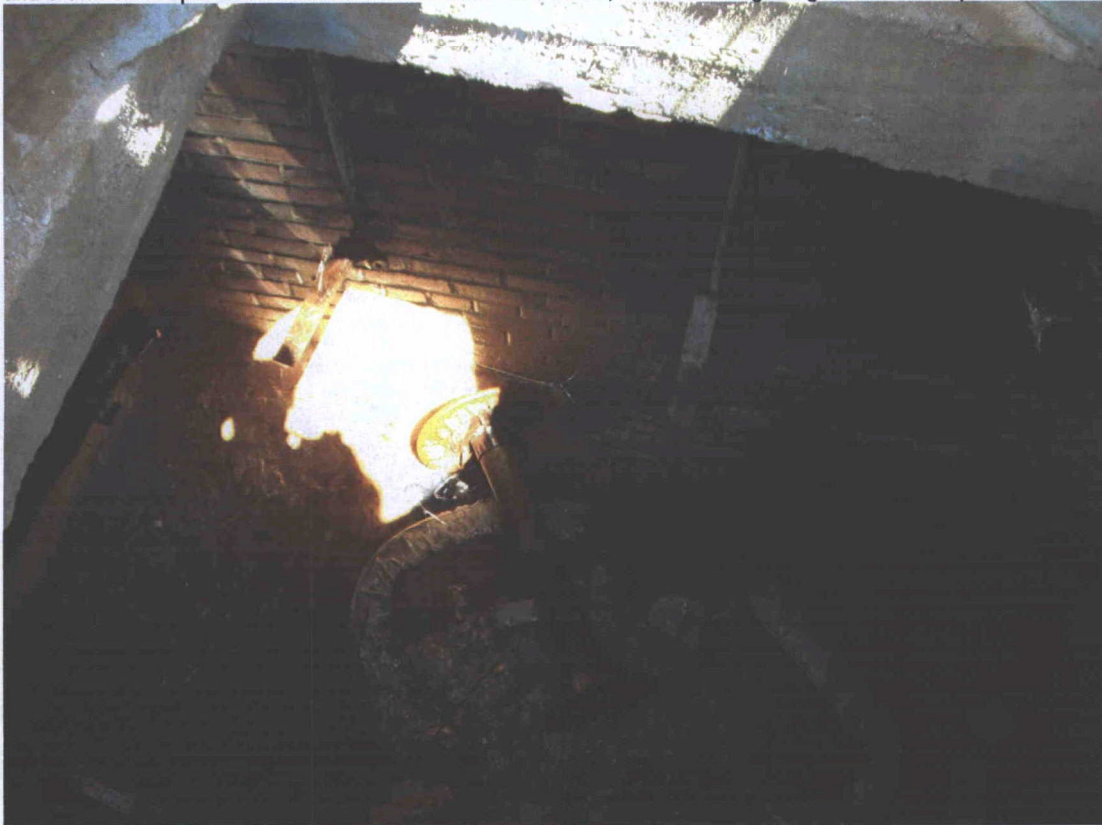
22.

Mon. 8/1/11: The NW

corner and NE wall of the vault. More brown blobs of what appeared to be oil I noted at this end but the lighting does not show them well. We noted no inlet or outlet pipes to the vault; the water may be groundwater or surface water that leaked in.

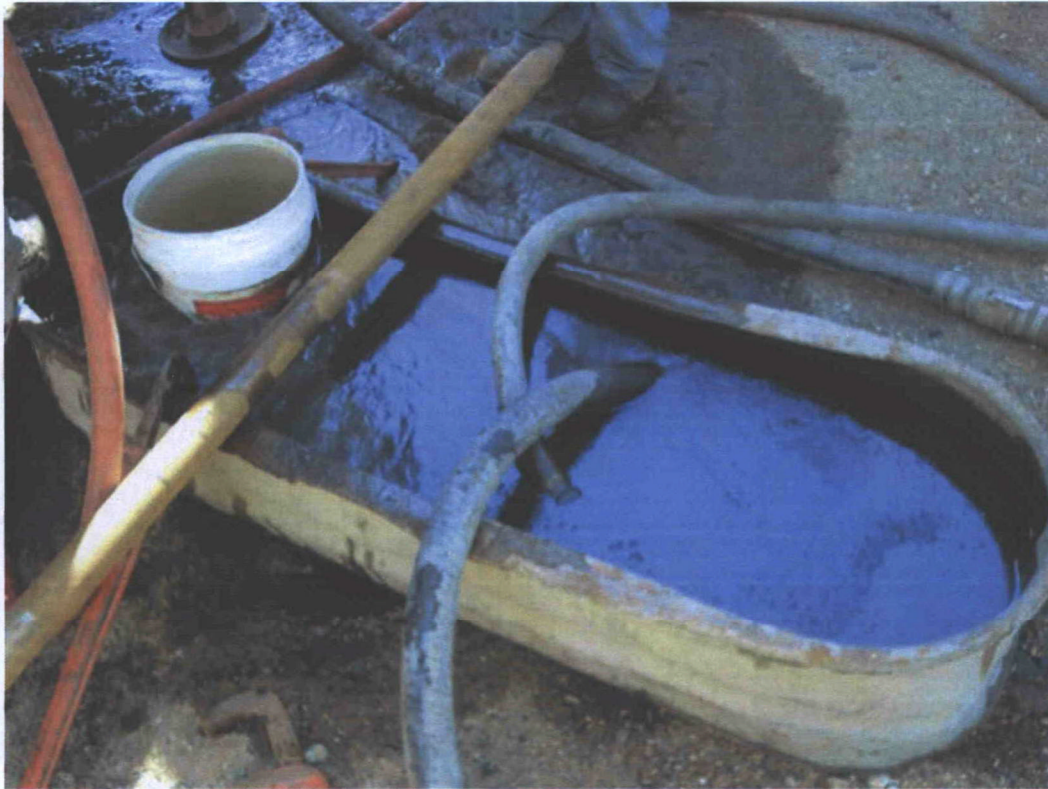
23.

9/19/11 (Photo by Troy

Smith): To check for the possibility of free product oil migrating through the bedrock the bedrock monitoring well BR-2 was drilled just west of the CMP tank. In addition to oil-saturated soil above the silt/clay layer, an oil-saturated layer was found below the clay and above the bedrock. As seen above free product black oil was brought up with the drilling water.

9/19/11: A bedrock monitoring well was installed and found black oil contamination above the silt-clay layer, an oil-saturated layer below the silt-clay and above bedrock. The oil saturated layer below the clay was a possible pathway for oil to the river.

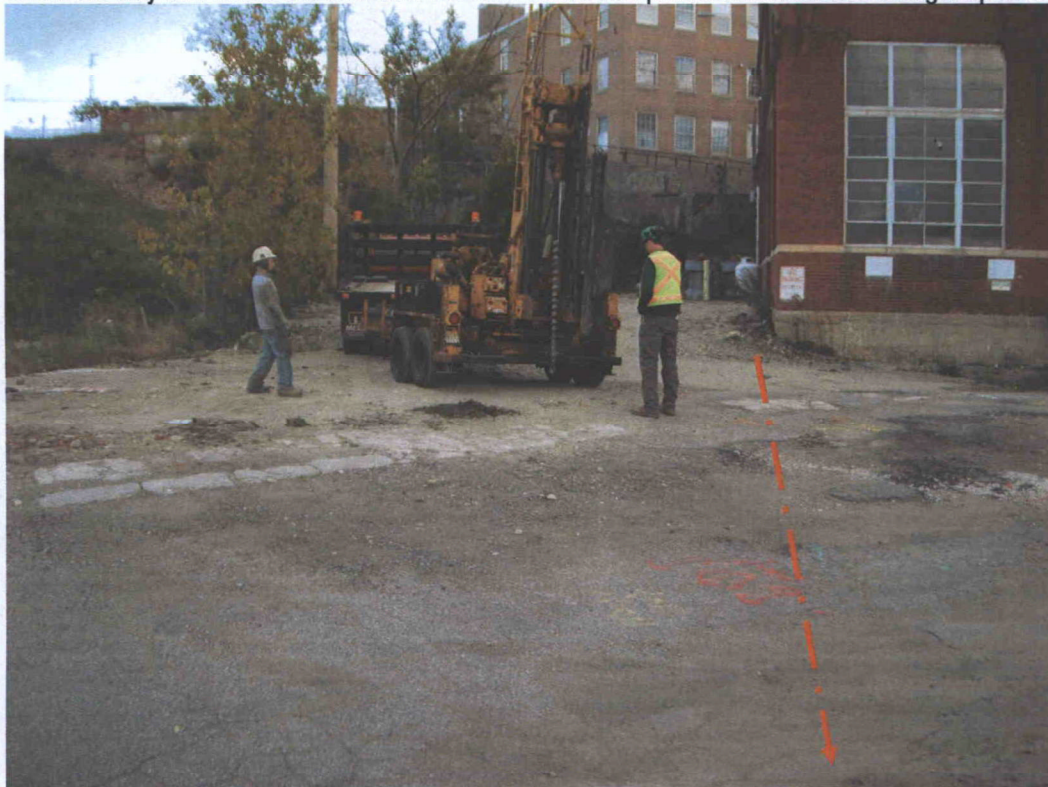
24.

10/17/11: Northern Test

Boring advancing drilling overburden test borings TB-25, TB-26 and TB-27 down to bedrock to check on migration of the oil in BR-2 further west. TB-25 and TB-27 had no evidence of oil contamination; TB-26 had soil with an oil odor but no oil-saturation or staining. Geologist Troy Smith stands to the right of the drill rig. MDEP was not permitted to drill under Mill St. As of 11/30/11, TP-11 showed oil sheen but no free product coming from under Mill St. that could be attributed to the CMP UST (or the offset fill pipe to the Libbey Mill UST denoted by the orange dashed arrow, see Photo 8).

10/17/11: Test Borings TB-25, TB-26 and TB-27 advanced to bedrock and located west of BR-2 found no free oil plume. Maine DEP did not get permission from owner Stanley Sclar to place borings in Mill Street to check for a free product plume migrating toward the river. Confirming a free product plume under Mill St. would have confirmed a contribution of the CMP #6 oil discharge to the oil plume found moving west across the Columbia Mill site (see P-561-2011 and P-534-2011).
