**Transfer Station 1
North Excavation Zone**

**Post Remediation
Surface Gamma Activity**

Cove, Apache County, Arizona

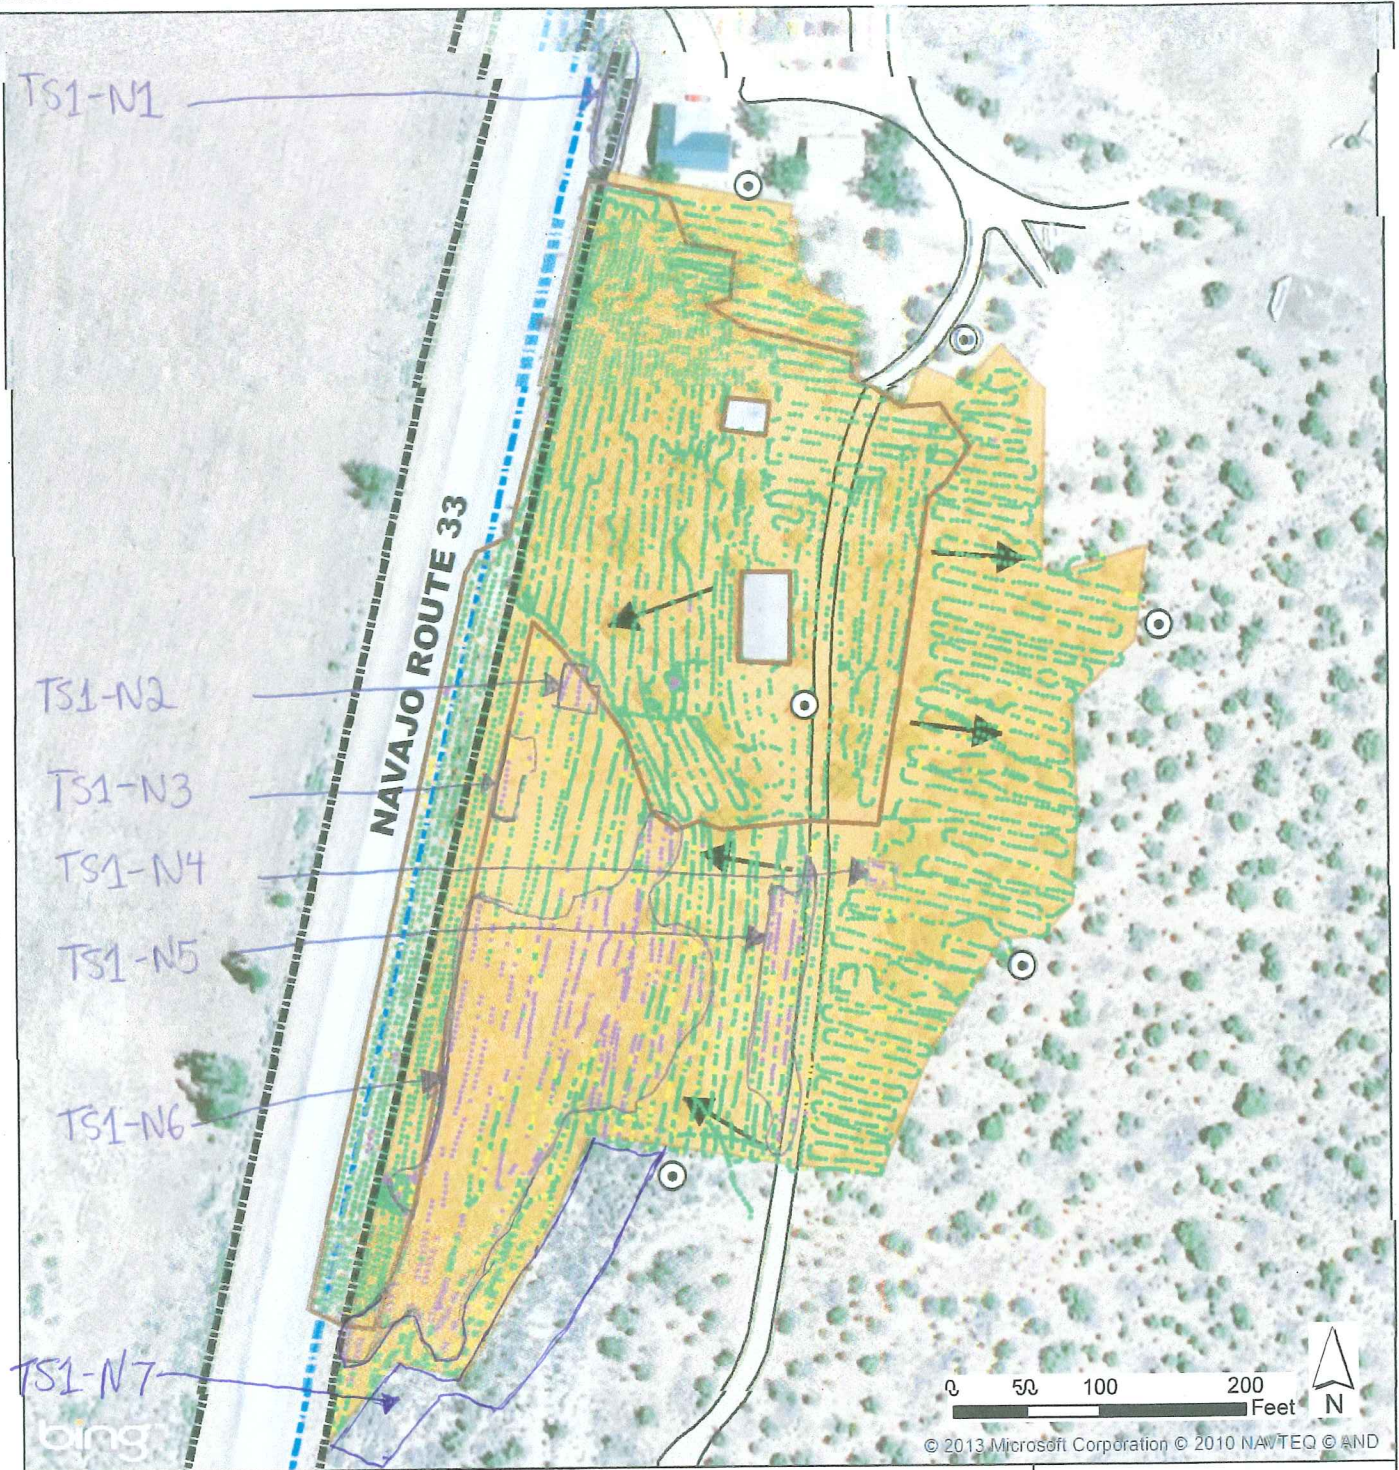
Gamma Activity (Counts Per Minute)	Correlated Radium-226 Concentration (picocuries per gram)
0 to 34,712	0 to 2
34,713 to 40,477	2.1 to 5
40,478 to 59,695	5.1 to 15
> 59,696	> 15
