**FINAL SITE REASSESSMENT REPORT
FOR THE
NEW KENT WOOD PRESERVATIVES, INC. SITE
PROVIDENCE FORGE, VIRGINIA**

May 7, 2012

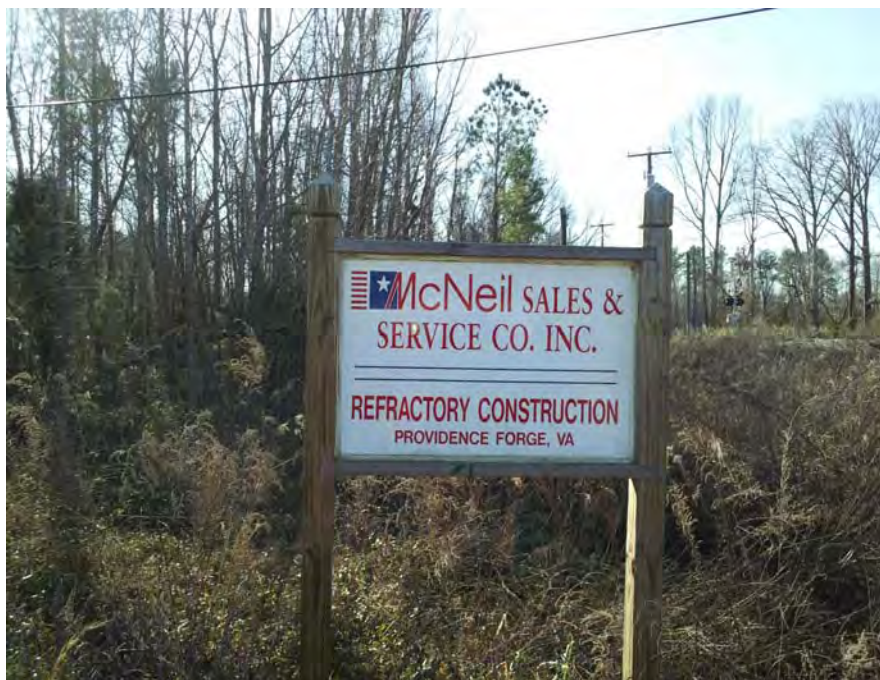
Photograph No. 1

Description: Sign on New Kent
Wood Preservatives site
driveway.

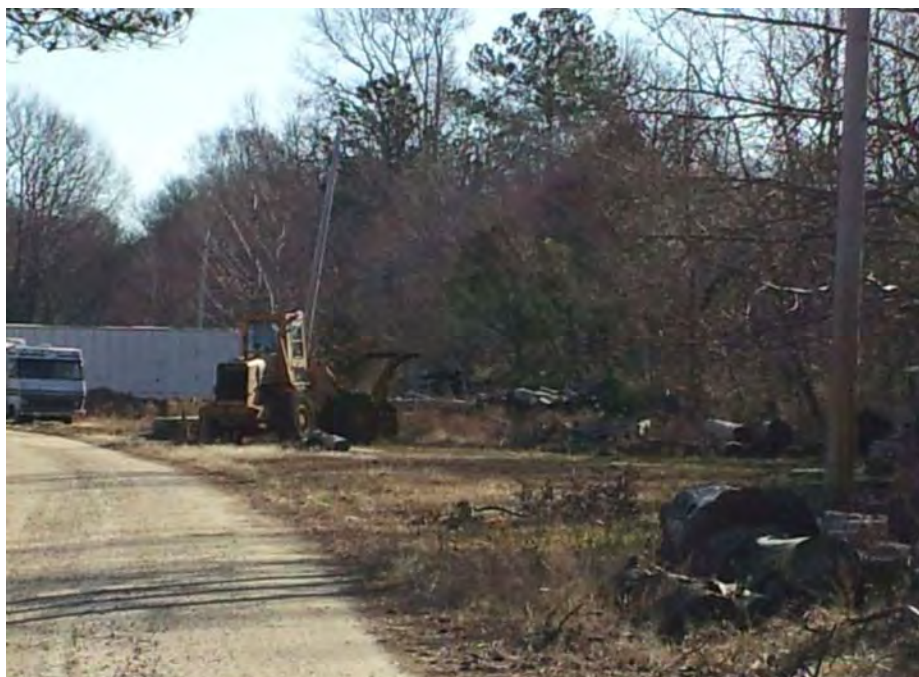
Photograph No. 2

Description: View of site facing
south from driveway.

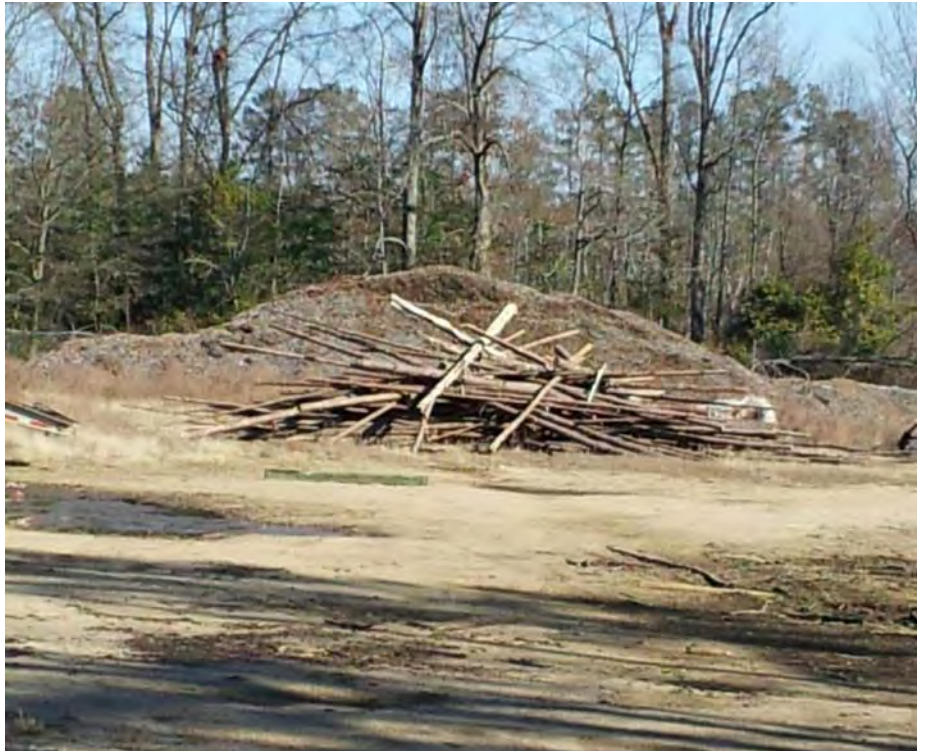
Photograph No. 3

Description: View of wood chip pile and logs along southern fenceline.

Observed pieces of pipe, stacks of
wood, logs, and equipment on S.
fence line.

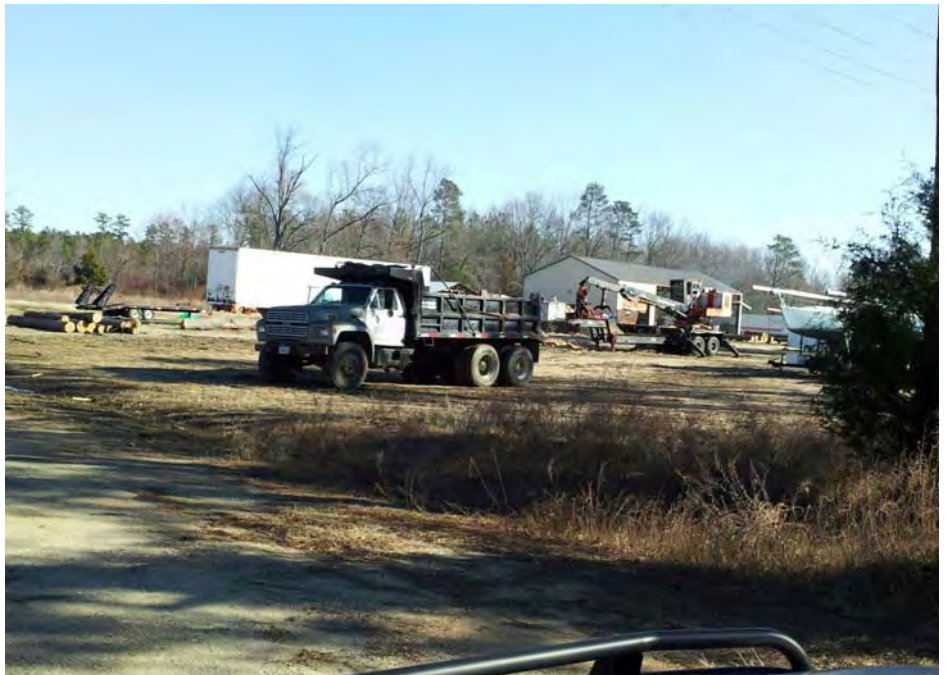
Photograph No. 4

Description: View of site from driveway facing north/northeast.
