Eden Coal Ash Spill  
Eden, North Carolina

Schoolfield Dredge Area  
Pre-Dredge  
Assessment Results Map  
(May 14, 2014)

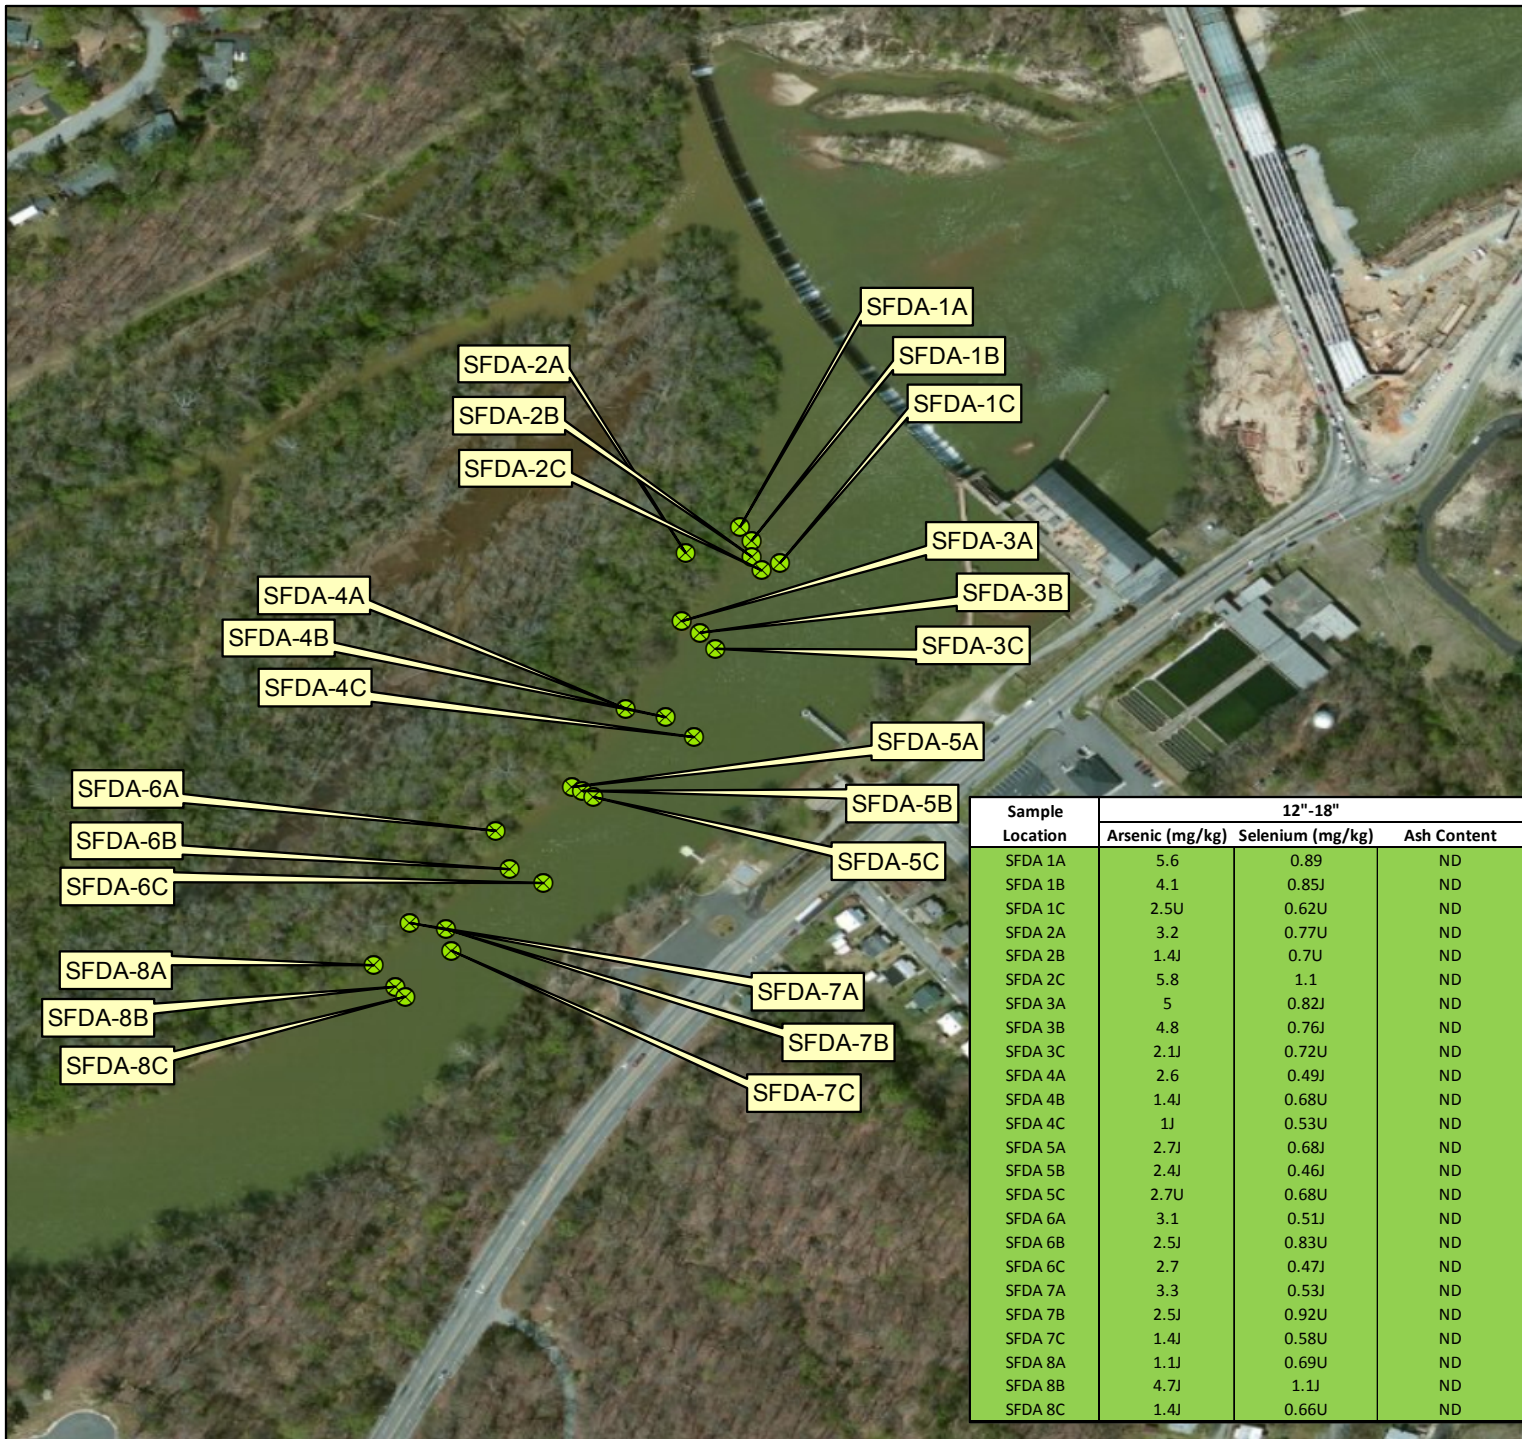
- No exceedances for EPA ecological screening levels (As, Se)
- EPA ecological screening level exceedance (Se), ash content ≤ 1%
- EPA ecological screening level exceedance (Se), ash content > 1%

Notes:  
No exceedances of EPA ecological screening criteria were identified at a depth of 12" – 18".

RED indicates an exceedance of EPA ecological screening levels.

Sample Location	12"-18"		
	Arsenic (mg/kg)	Selenium (mg/kg)	Ash Content
SFDA 1A	5.6	0.89	ND
SFDA 1B	4.1	0.85J	ND
SFDA 1C	2.5U	0.62U	ND
SFDA 2A	3.2	0.77U	ND
SFDA 2B	1.4J	0.7U	ND
SFDA 2C	5.8	1.1	ND
SFDA 3A	5	0.82J	ND
SFDA 3B	4.8	0.76J	ND
SFDA 3C	2.1J	0.72U	ND
SFDA 4A	2.6	0.49J	ND
SFDA 4B	1.4J	0.68U	ND
SFDA 4C	1J	0.53U	ND
SFDA 5A	2.7J	0.68J	ND
SFDA 5B	2.4J	0.46J	ND
SFDA 5C	2.7U	0.68U	ND
SFDA 6A	3.1	0.51J	ND
SFDA 6B	2.5J	0.83U	ND
SFDA 6C	2.7	0.47J	ND
SFDA 7A	3.3	0.53J	ND
SFDA 7B	2.5J	0.92U	ND
SFDA 7C	1.4J	0.58U	ND
SFDA 8A	1.1J	0.69U	ND
SFDA 8B	4.7J	1.1J	ND
SFDA 8C	1.4J	0.66U	ND
