Eden Coal Ash Spill  
Eden, North Carolina

FWS-SF11 Delineation  
Analytical Results Map  
July 1, 2014

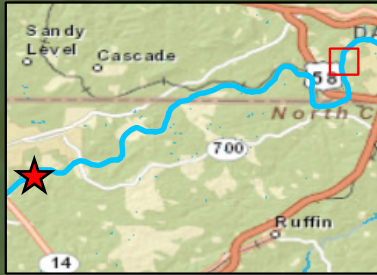
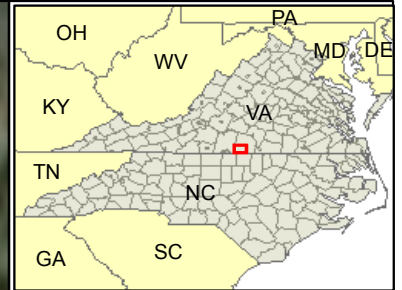
- RED indicates an exceedance of EPA ecological screening levels.
- EPA ecological screening value for As 9.8 mg/kg.
- EPA ecological screening value for Se 2.0 mg/kg.
- All sample locations are FWS-SF11-L-## where ## is the number listed in the label.
- 00 is the location of sample FWS-SF11
