Eden Coal Ash Spill  
Eden, North Carolina

Schoolfield Dredge Area  
Post-Dredge  
Assessment Results Map  
(May 22 - June 12, 2014)

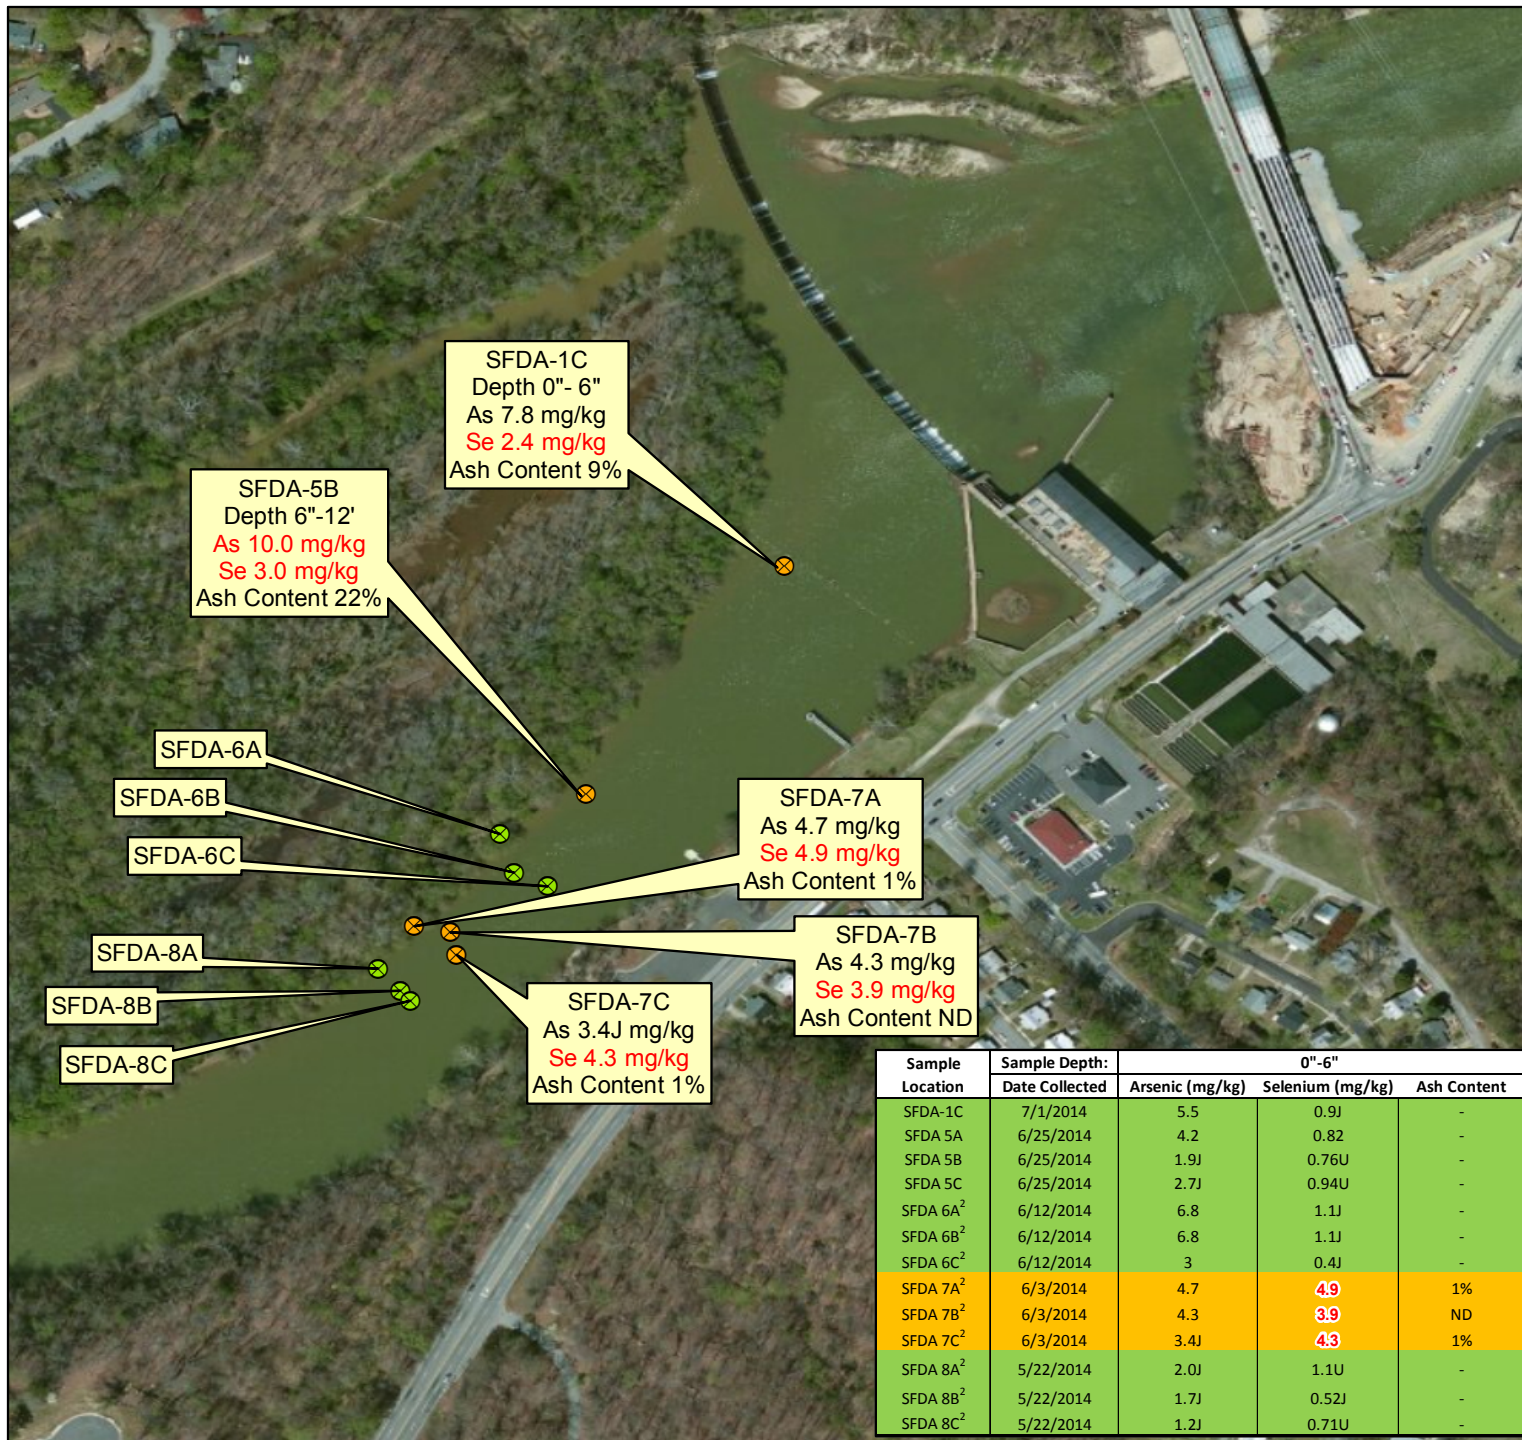
Notes:  
Post-Dredge sediment samples - collected at the 0-6" layer for metals. Splits of those samples were sent for percent ash if there was an exceedance of EPA ecological screening levels

RED indicates an exceedance of EPA ecological screening levels.
