Eden Coal Ash Spill
 Eden, North Carolina

Schoolfield Dredge Area
 Re-assessment Results Map

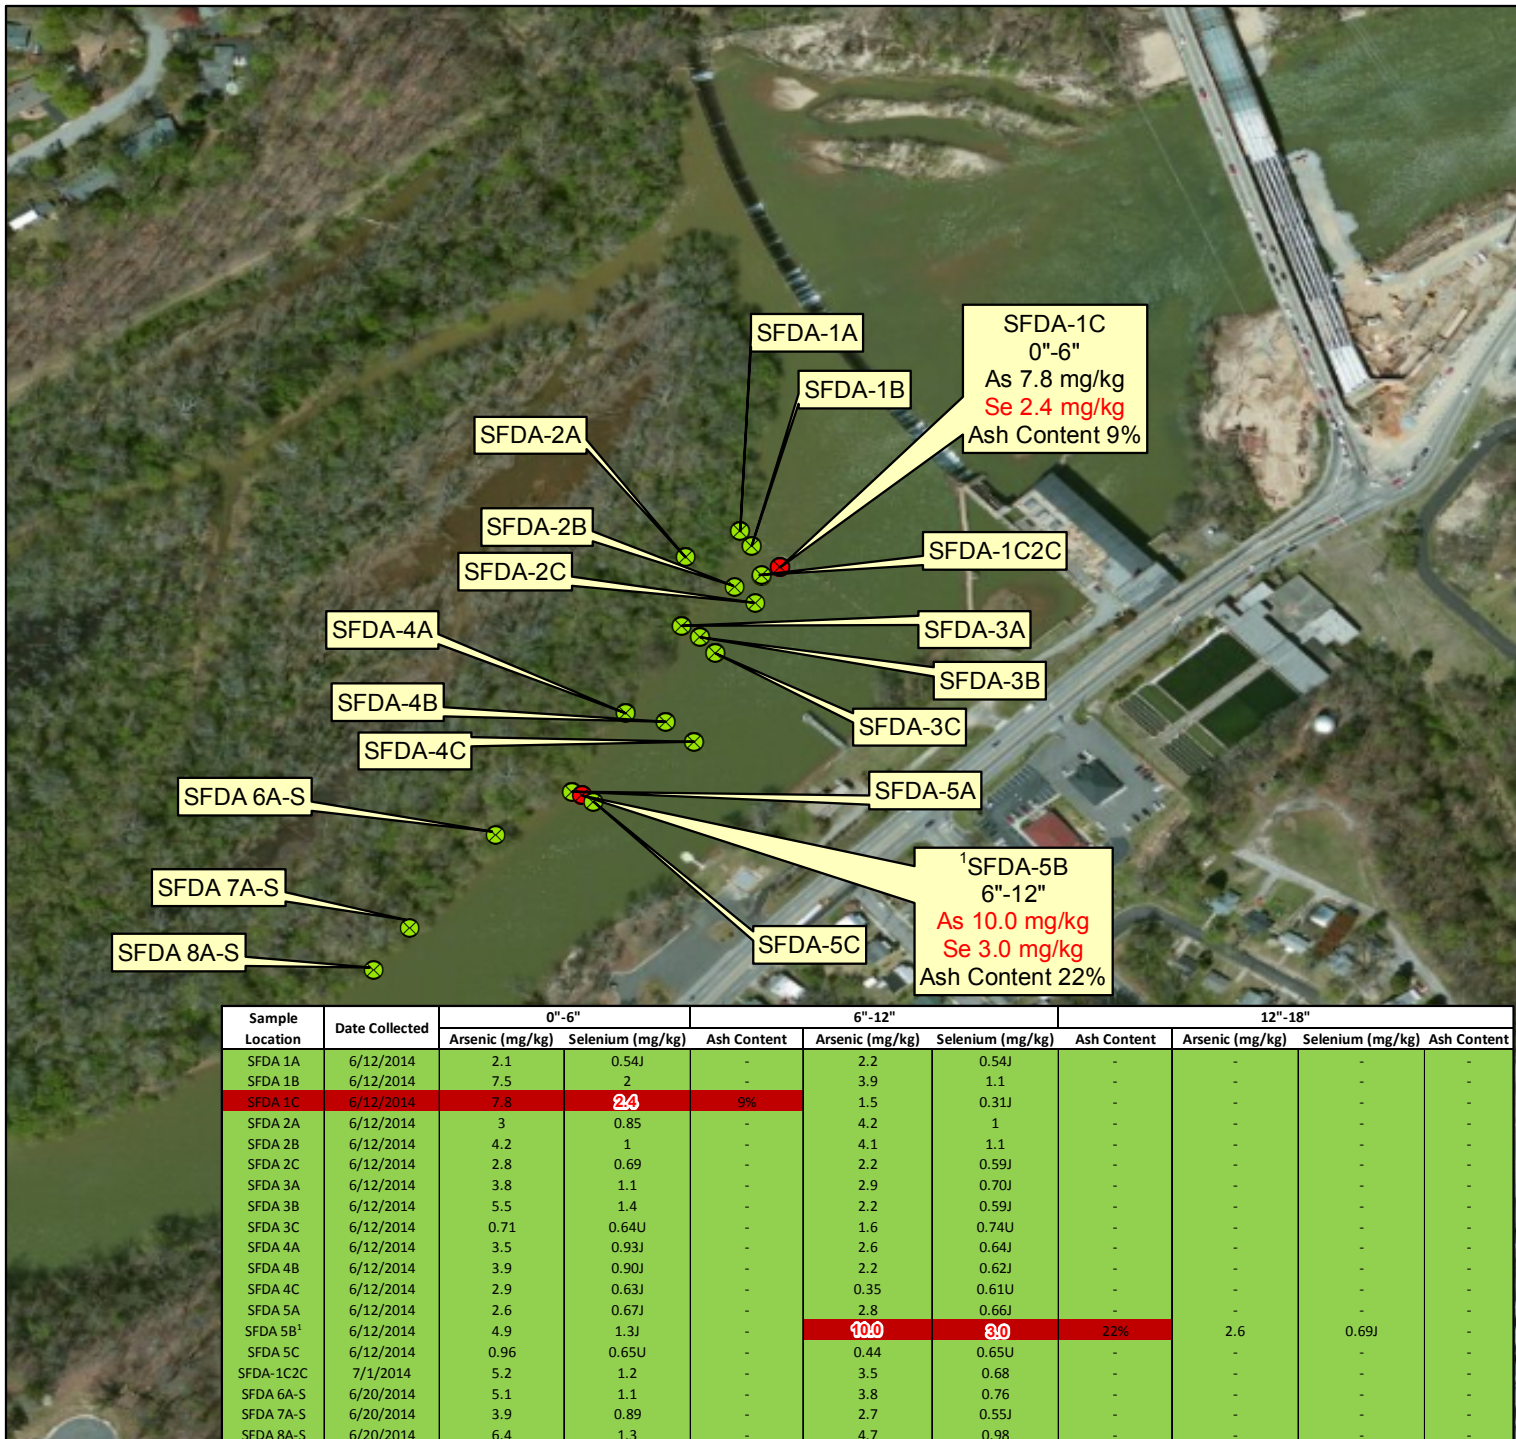
- No exceedances for EPA ecological screening levels (As, Se)
- EPA ecological screening level exceedance (Se), ash content ≤1%
- EPA ecological screening level exceedance (Se), ash content >1%

Notes:
¹Visual suspect ash in the 6"-12" layer at this location warranted sampling of the 12"-16" layer

RED indicates an exceedance of EPA ecological screening levels.

S = sample collected at visible shore line.
