Eden Coal Ash Spill  
Eden, North Carolina

Town Creek  
Post-Removal  
Assessment Results Map  
June 30, 2014

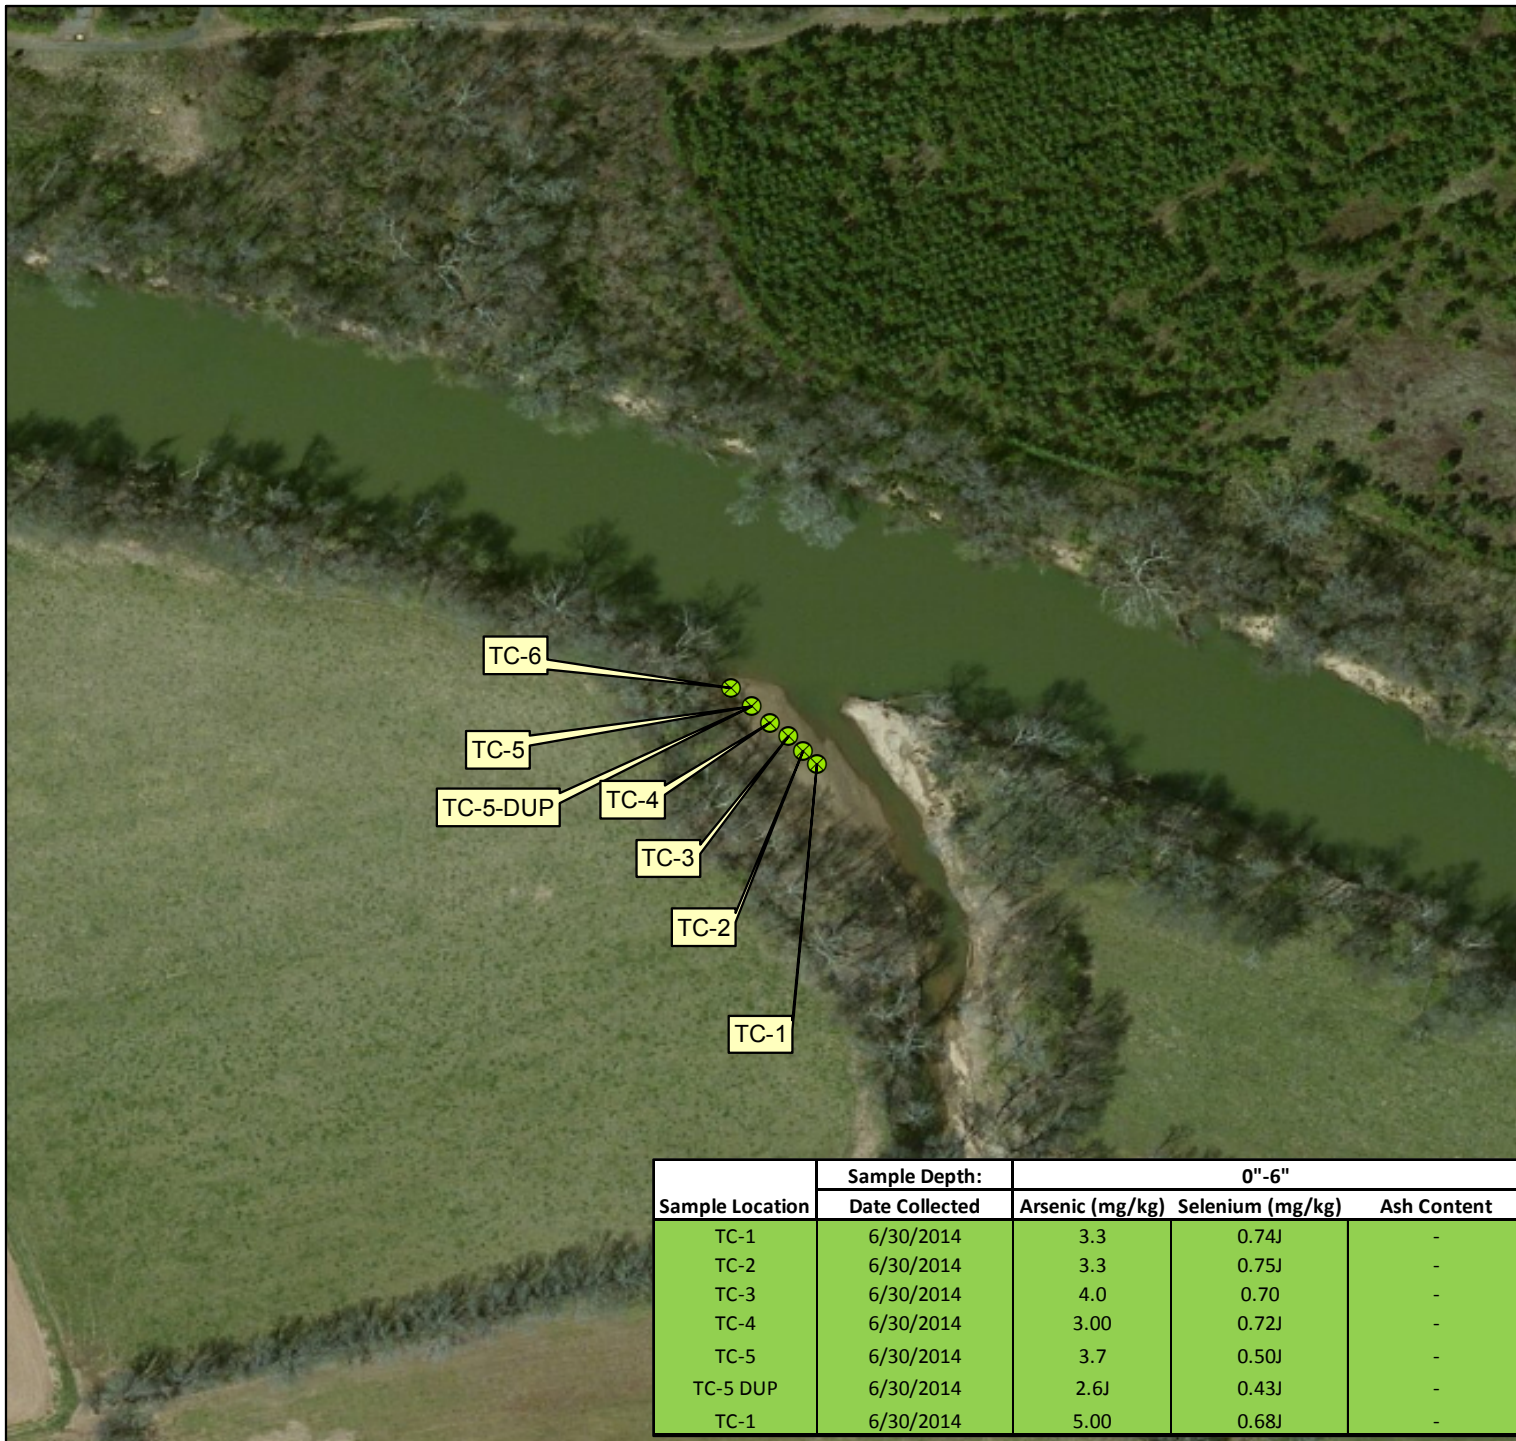
Post-Removal composite surface soil samples were collected for metals analysis.

RED indicates an exceedance of EPA ecological screening levels.

Sample Location	Sample Depth:	0"-6"		
	Date Collected	Arsenic (mg/kg)	Selenium (mg/kg)	Ash Content
TC-1	6/30/2014	3.3	0.74J	-
TC-2	6/30/2014	3.3	0.75J	-
TC-3	6/30/2014	4.0	0.70	-
TC-4	6/30/2014	3.00	0.72J	-
TC-5	6/30/2014	3.7	0.50J	-
TC-5 DUP	6/30/2014	2.6J	0.43J	-
TC-1	6/30/2014	5.00	0.68J	-
