PLAINS
MARKETING, L.P.

Subject: Clean Water Act, Section 311 Information Request
Reference: FPN E14457: Truck Overfilling Operation at the Plains at Stevens Facility in Pachuta, Clarke County, Mississippi on or about September 17, 2014

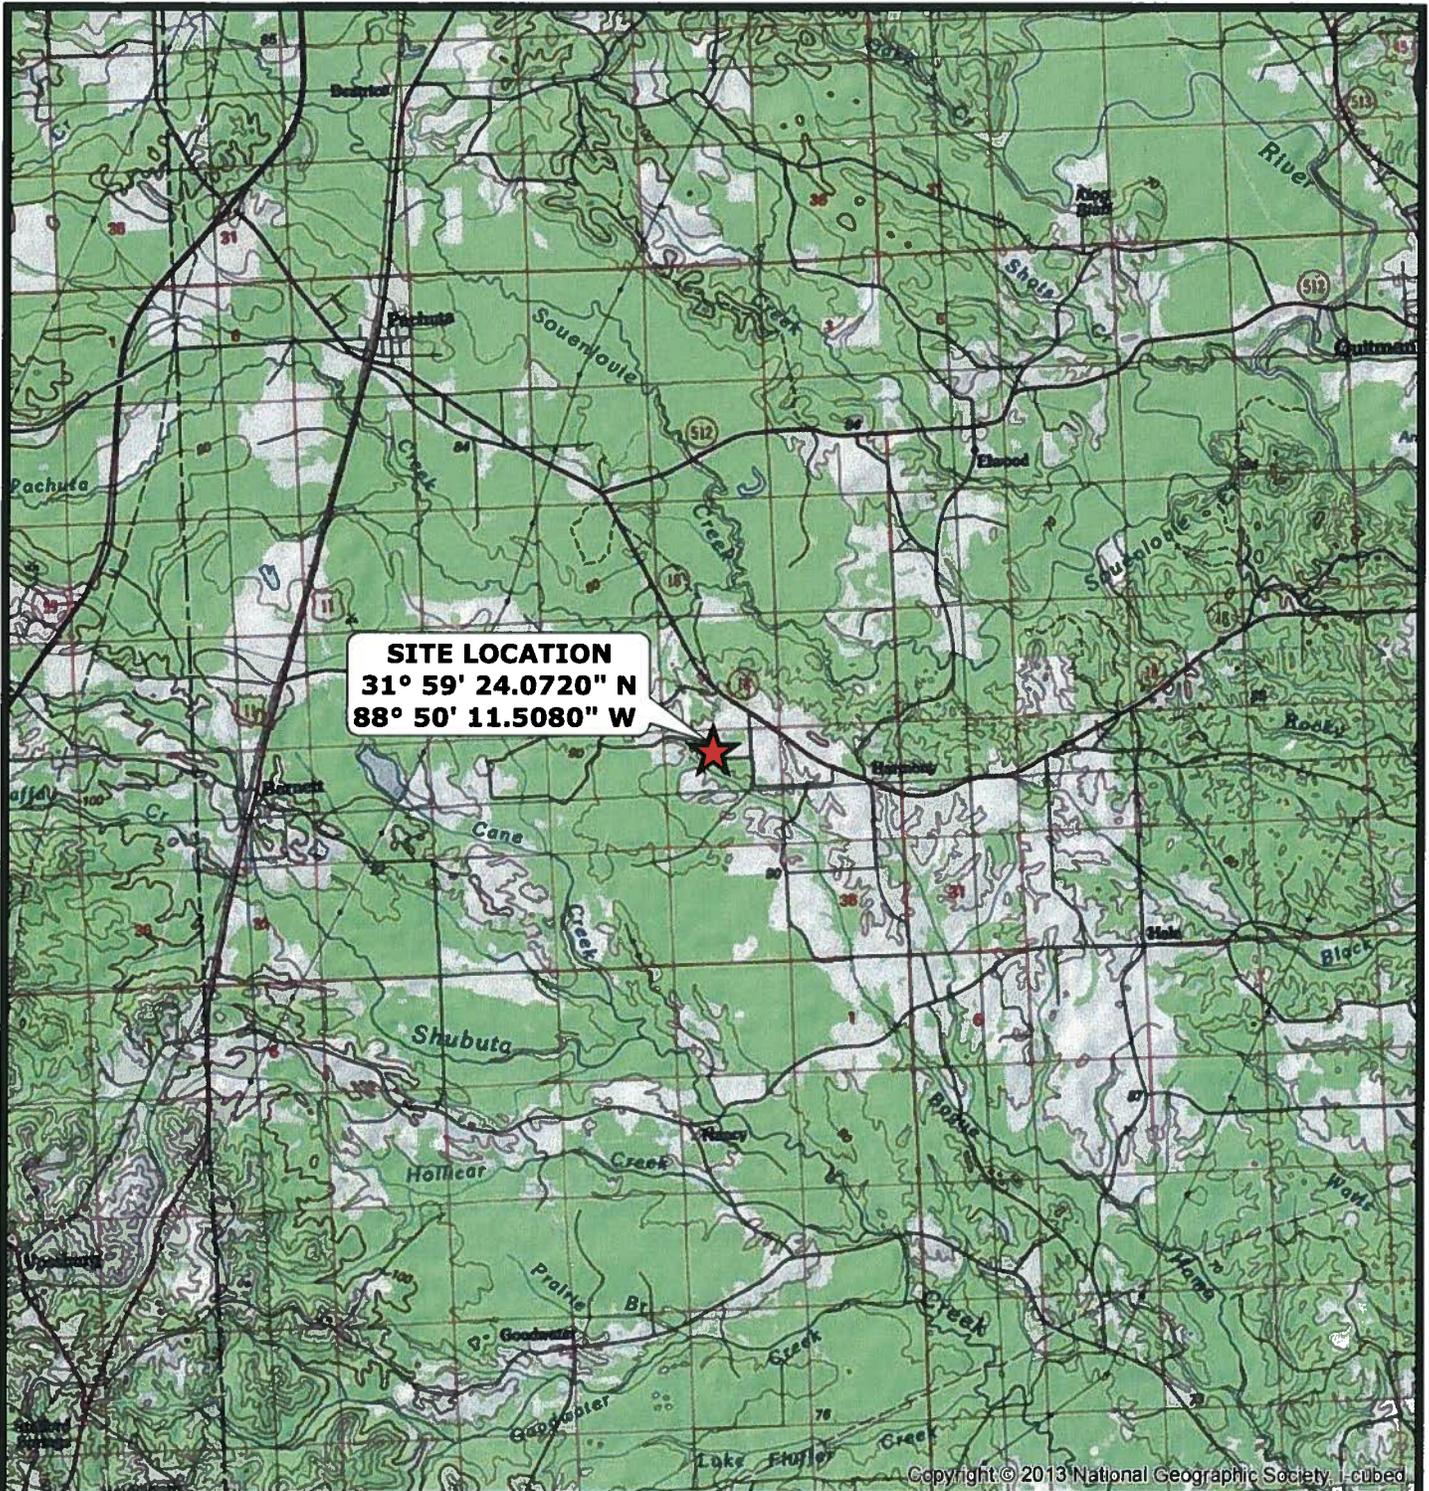
FIGURE 1

The oil was released adjacent to a gravel road / ditch and upland pasture (Figure 1, Division A – 0.21 acres). The slope of the area in Division A coupled with low permeability / infiltration capacity of the soils resulted in the majority of the oil flowing down gradient into an adjacent ephemeral stream bed (Division B – 0.21 acres, @520 linear feet mid-channel). The oil moved down gradient within the ephemeral channel before being deposited in an area with standing water (Division C- 0.36 acres, @ 300 linear feet mid-channel).

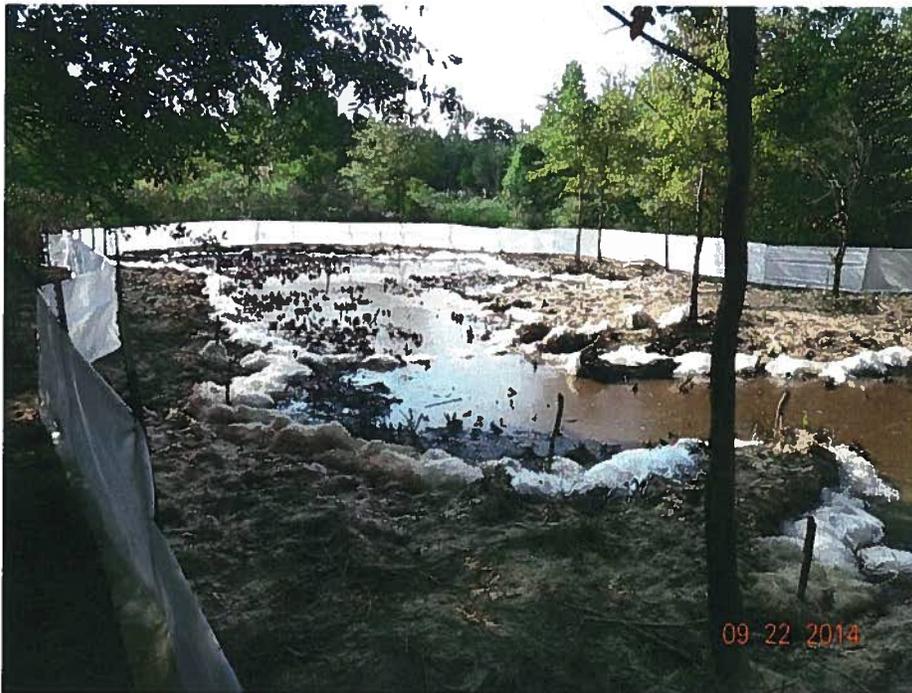
Photo 1: Division C – 9/22/2014 Looking Southwest from Division B transition, note water level drop

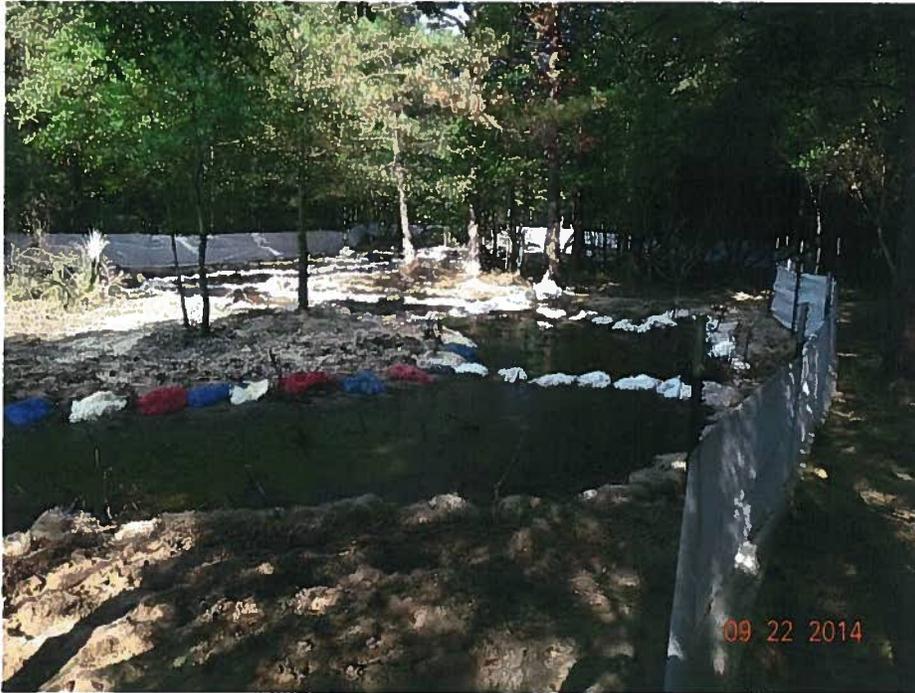
Photo 2: Division C – 9/22/2014 Looking Northwest from Division B transition

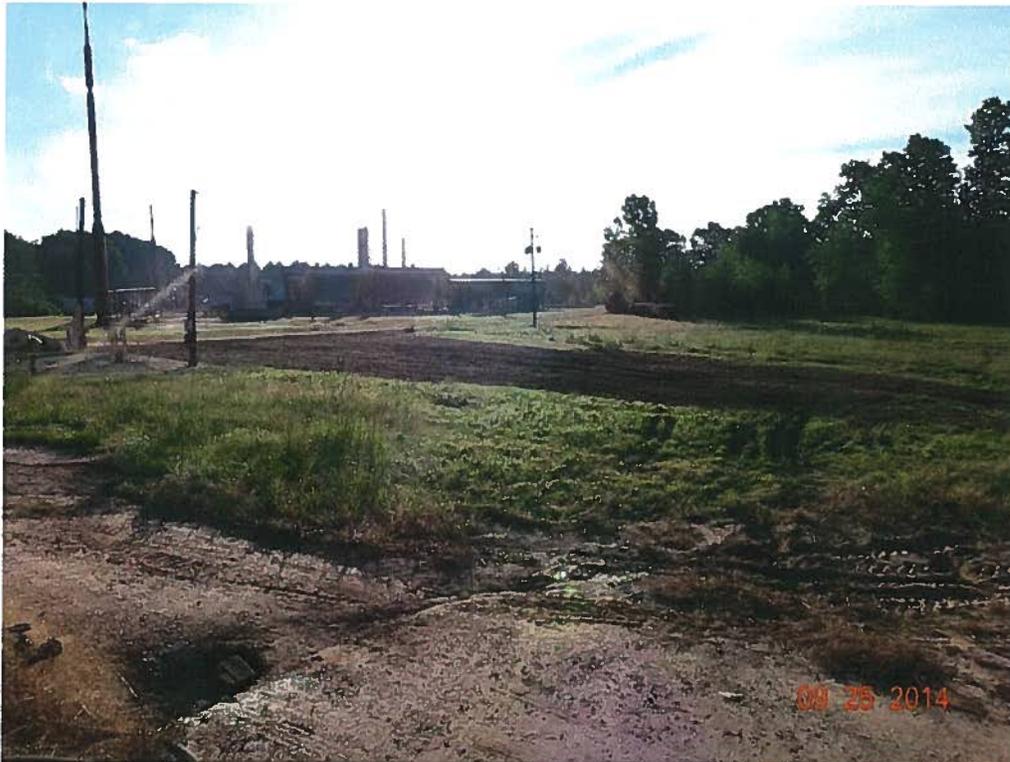
North end of Division A, looking NE

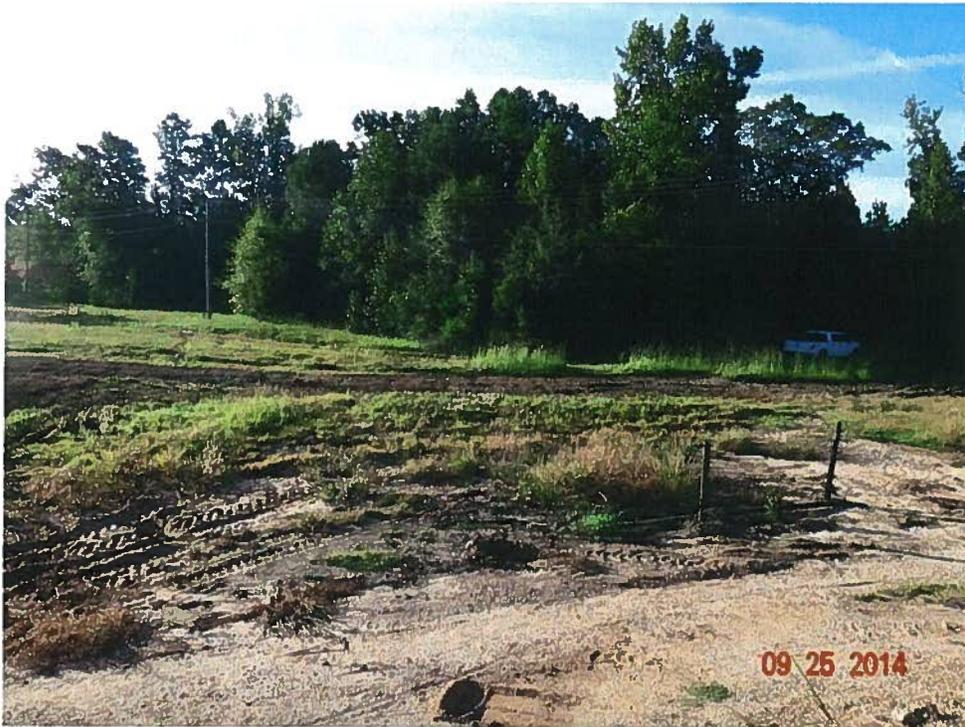
South end of Division A, looking SE

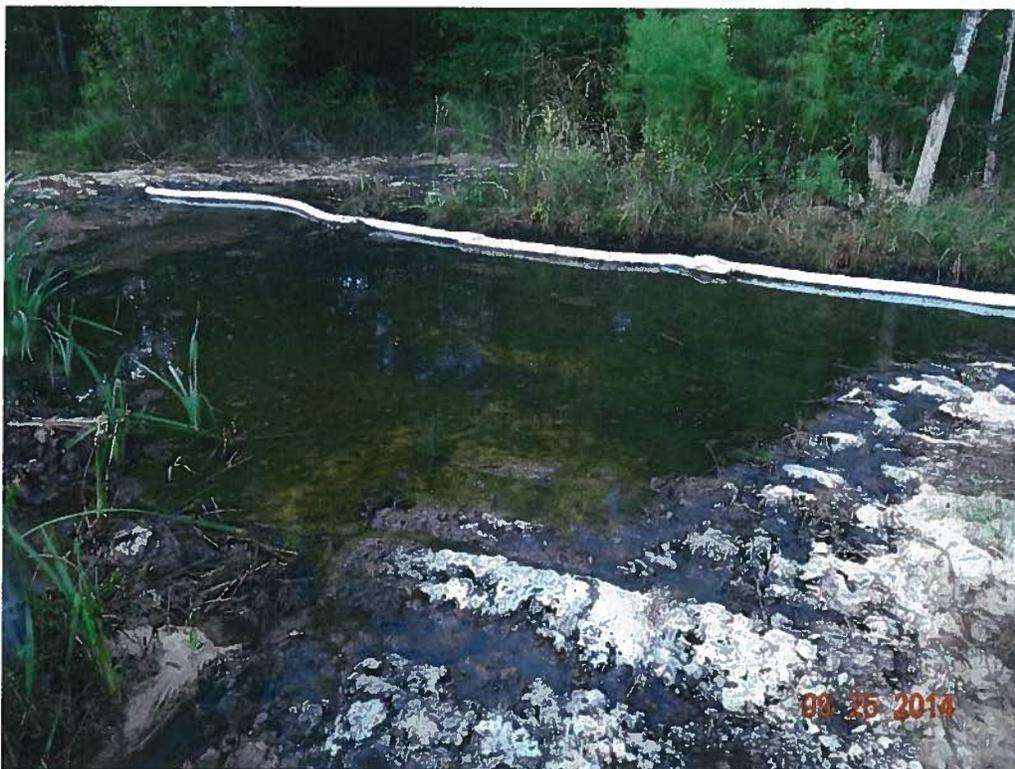
Transition from Division A to Division B, looking SE

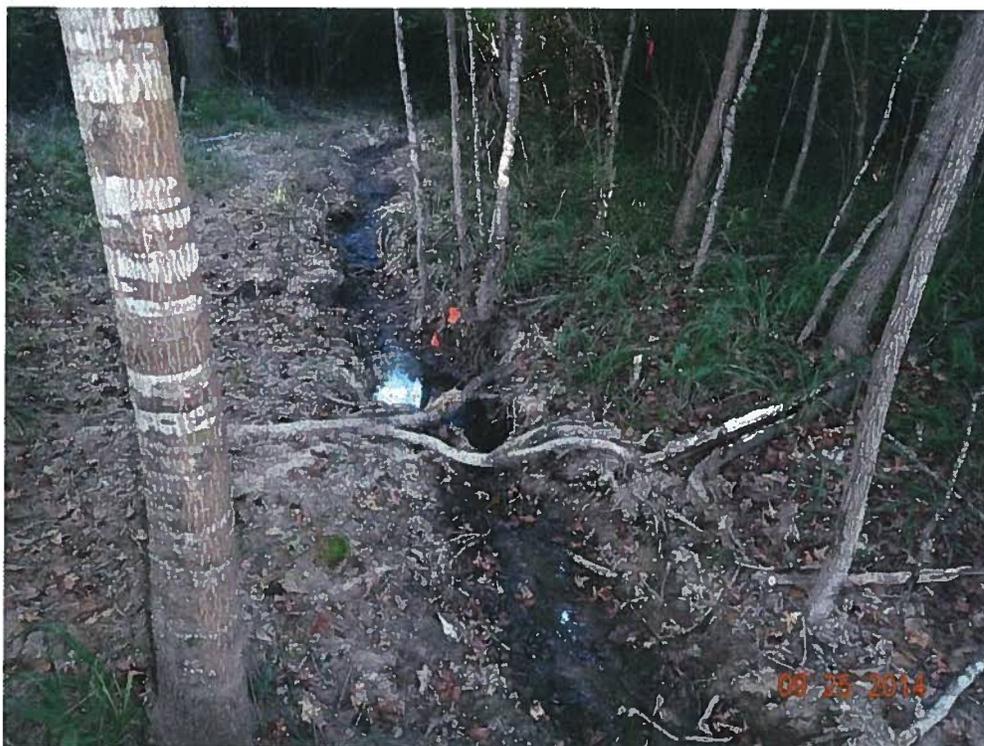
North end Division B up grade, looking S

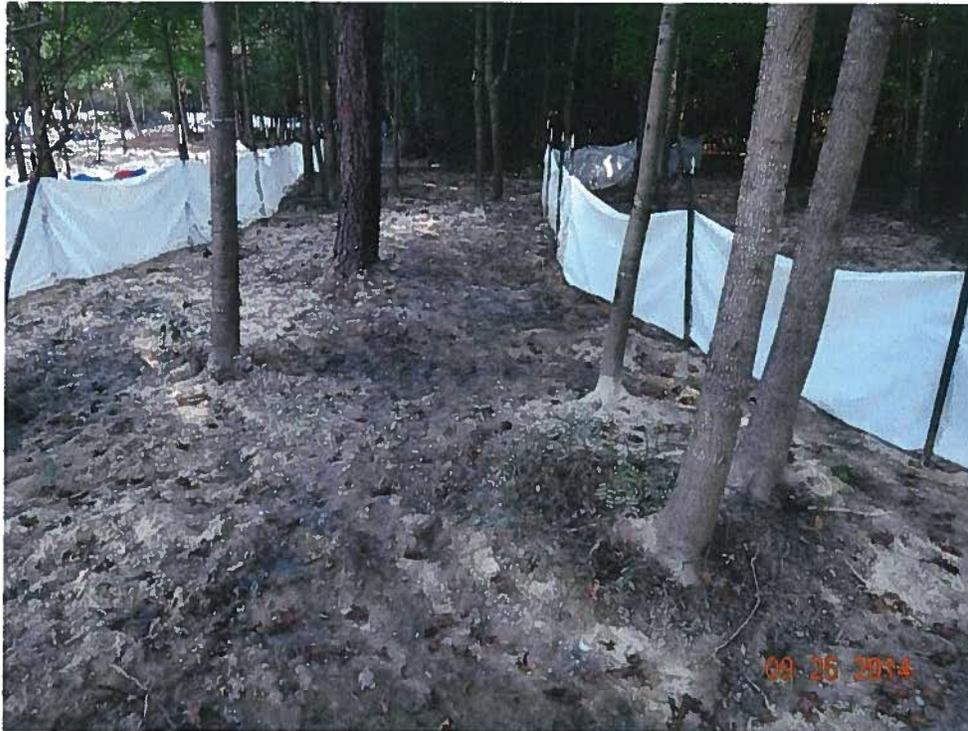
Division B to Division C Transition, looking W

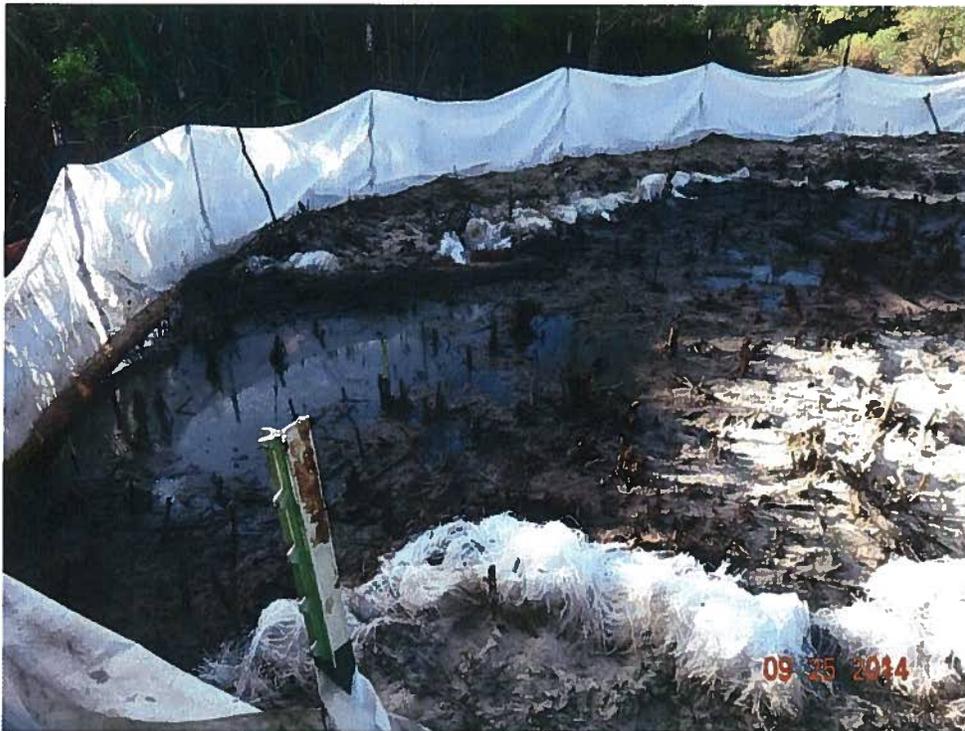
Division C: About 20% of the cat tails stalks are showing signs new as observed. The water level has fallen to an uneven level, since Day 1 of the release. Will continue to monitor the division daily.

East end of Division C, looking SSE (Note there is no water level on puddles)

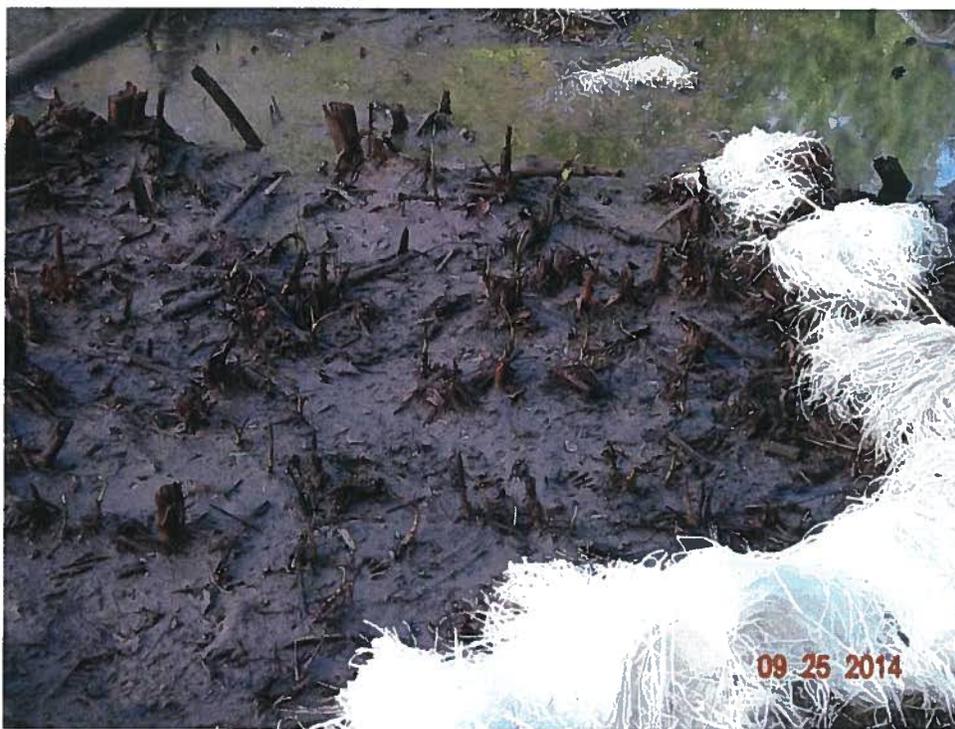
Influent into Division C from Division B, looking S, note that nearly each one of the cat tails are showing new growth.

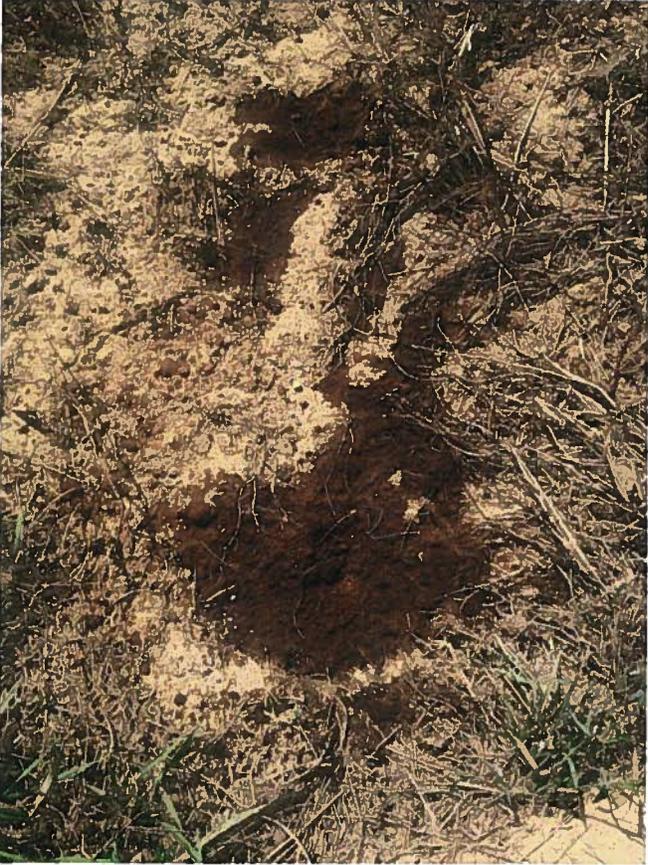
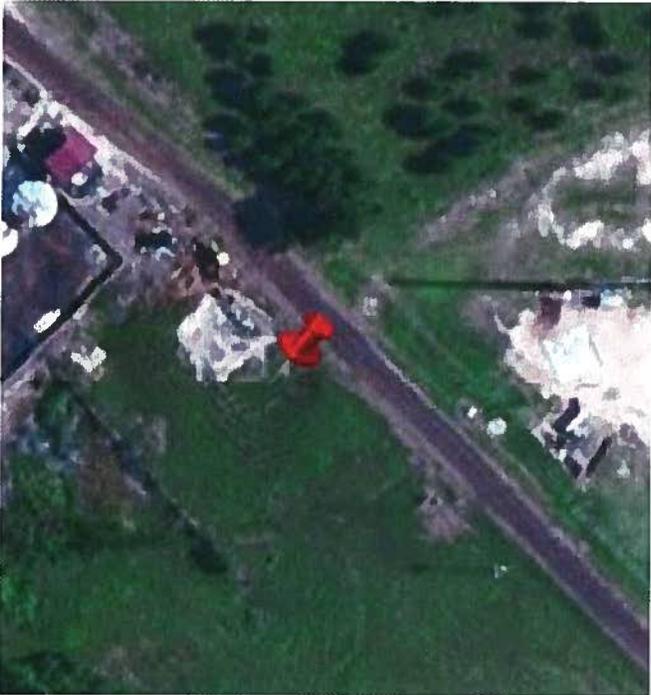
N 31° 59' 22, W 88° 50' 10"

Division A: O&M activity. Small patch of free product was observed about 110' downgrade SW from the point-of-origin. Oil Gator™ was applied to the area (see the attached photograph log). Will continue to monitor the division daily.

Stain 1-Division A – NW Corner

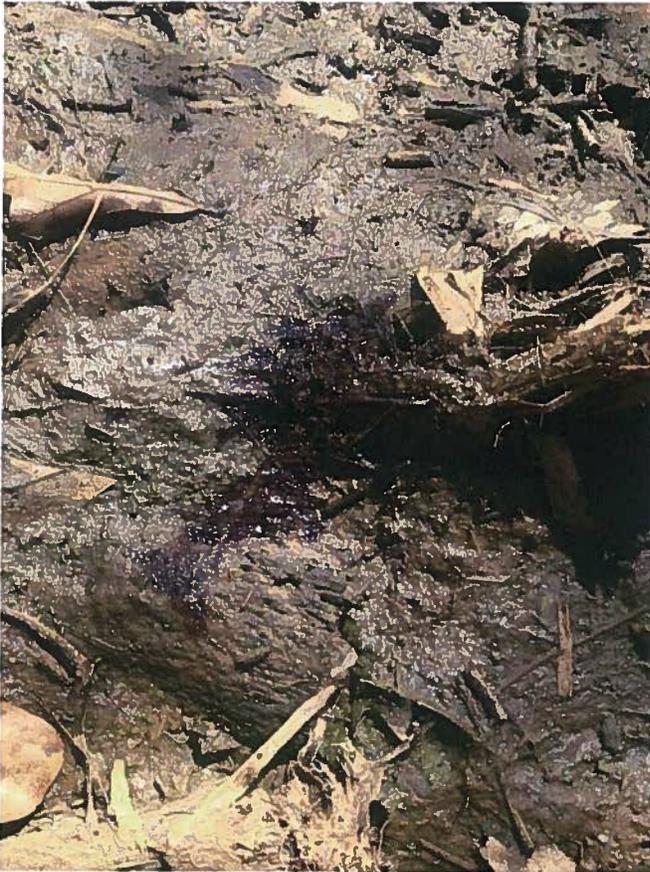
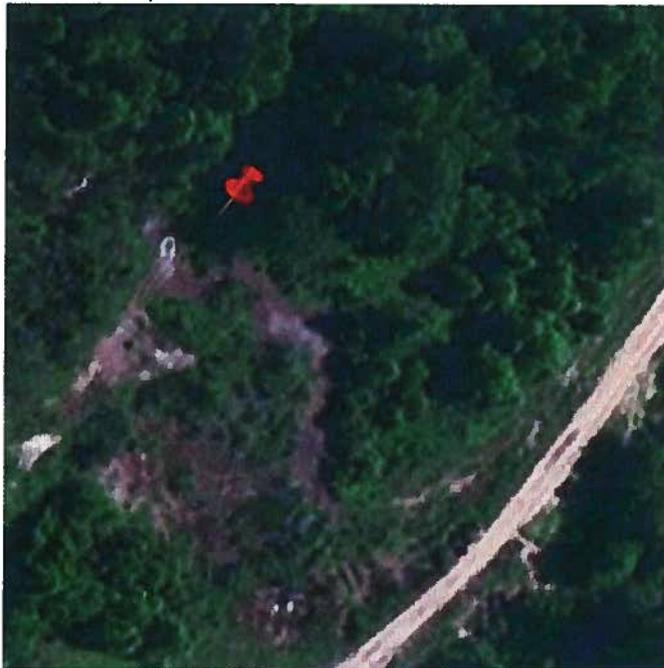
N 31° 59' 16, W 88° 50' 15"

Division C: O&M activity, three patches of free product were observed in the oil "duck bill" vacuum recovery area and Oil Gator™ was applied to the area (see the attached photograph log). Will continue to monitor the division daily.

Stain 2-Division C – NW Corner near vacuum truck recovery

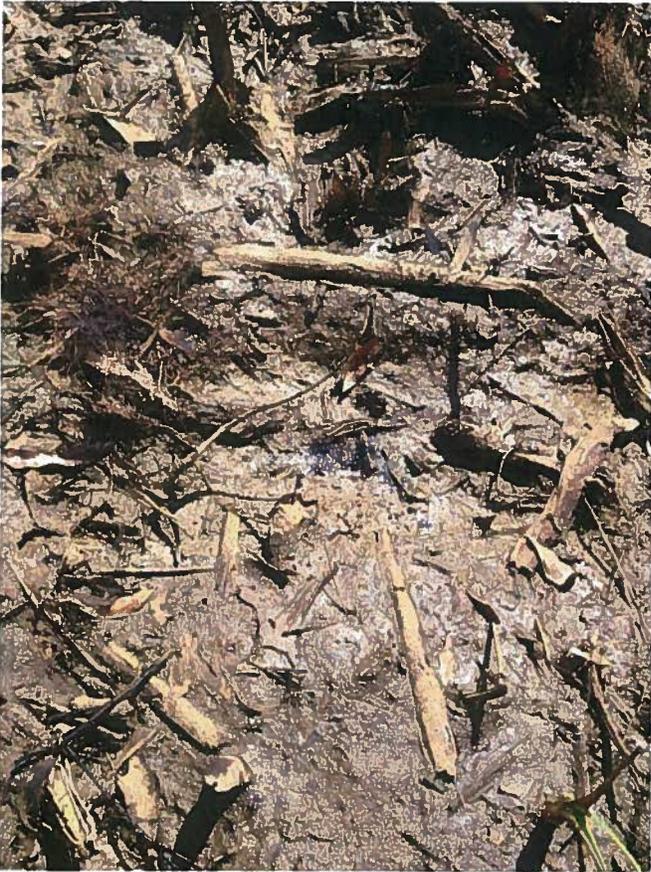
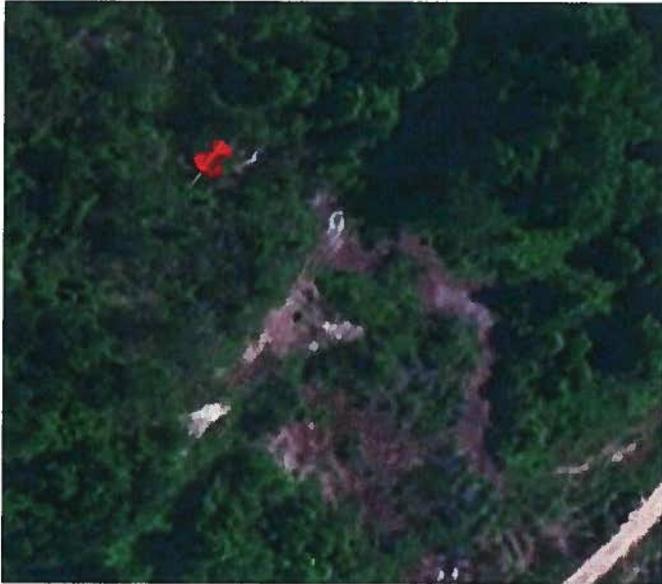
N 31° 59' 16", W 88° 50' 16"

Stain 3-Division C – NW Corner near west boom

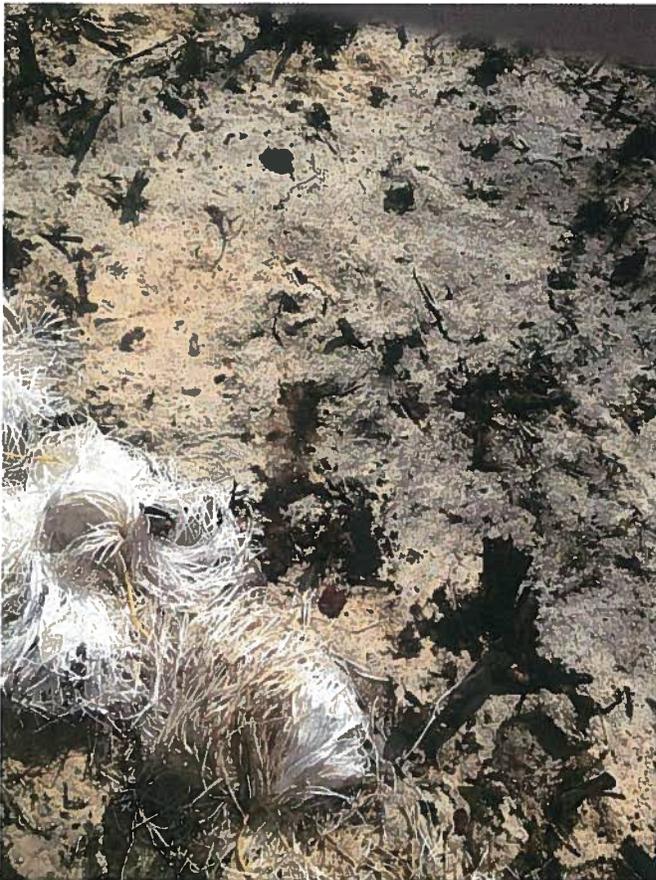
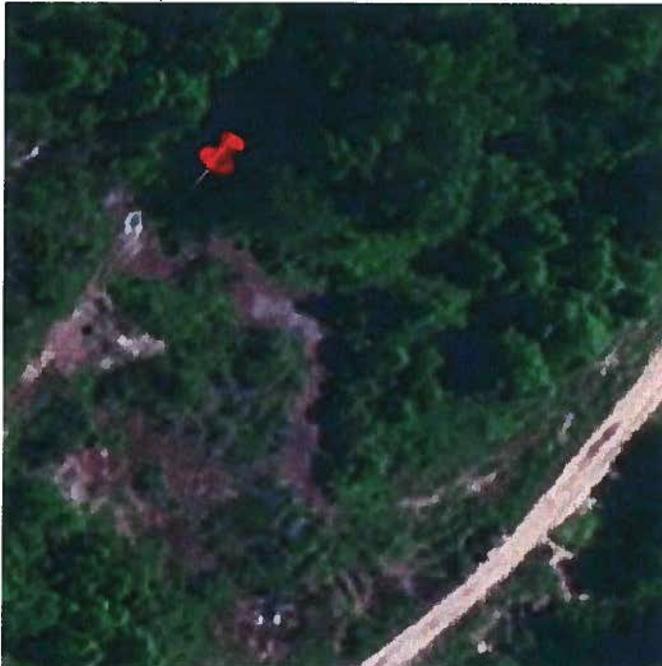
N 31° 59' 16", W 88° 50' 15"

Stain 4-Division C – NW Corner near vacuum truck recovery

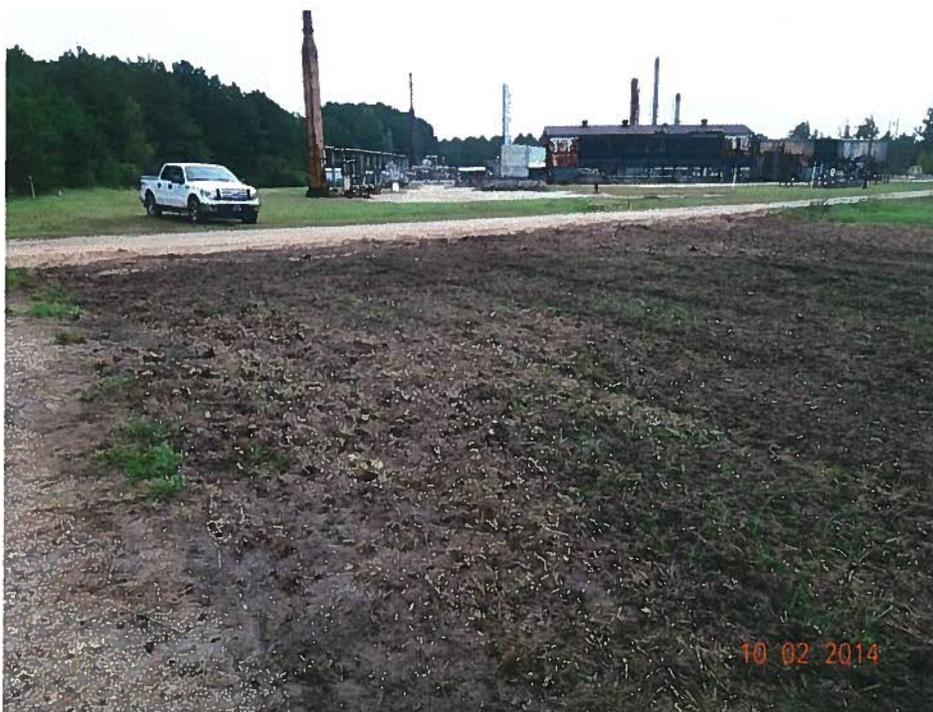
Division A: O&M activity. Fresh well water was observed to be overflowing its tank near the point-of-origin and continuing to flood the NW corner of Division A. No free product observed. Will continue to monitor the division daily.

10-2-2014 Division A – Looking NNW

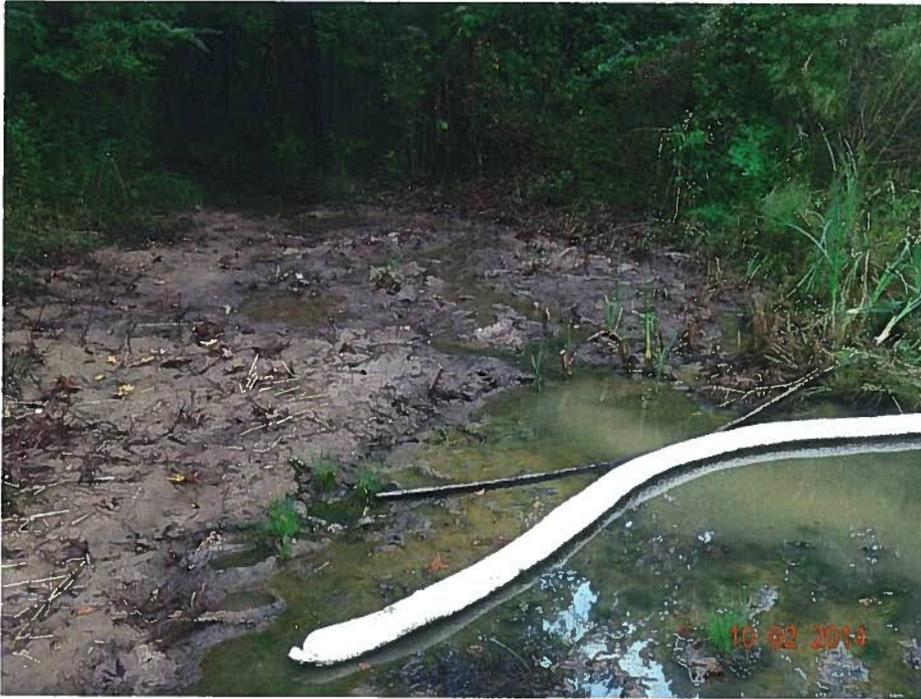
10-2-2014 Division A to Division B Transition – Looking SW

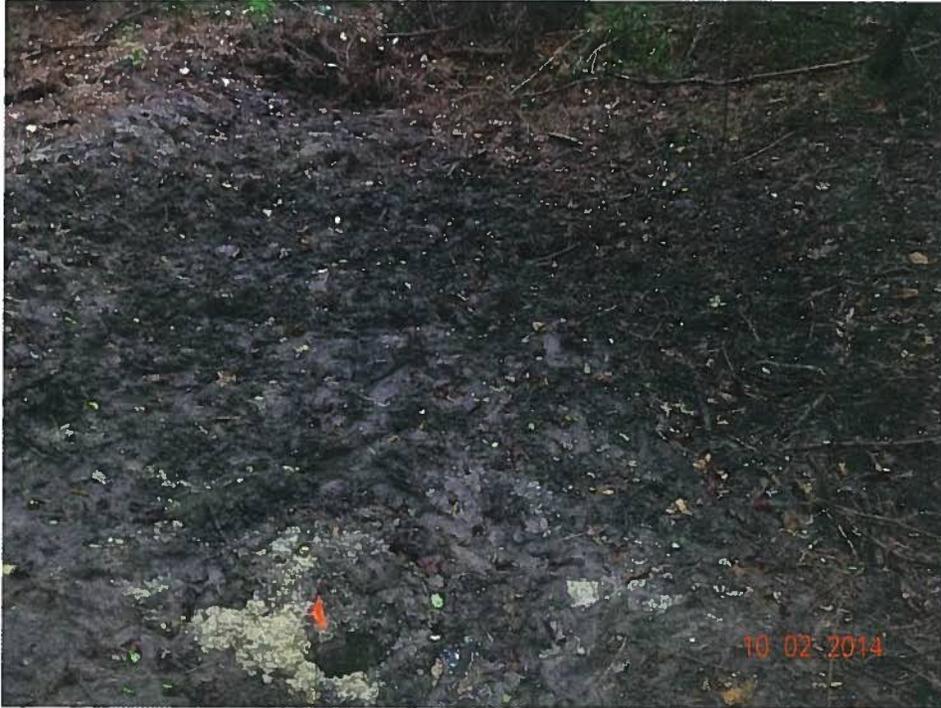
Division B: O&M activity. Fresh well water was observed flowing down about 60% of the distance from the top of the hill and down gradient. A large whitetail doe was observed browsing near the Division B to Division C transition zone. A large feral hog (about 250 lbs) was observed rooting in the dry drainage swale about 100 feet north of Division C. No free product observed. Will continue to monitor the division daily.

10-2-2014 Division B – Hog rooting looking SW

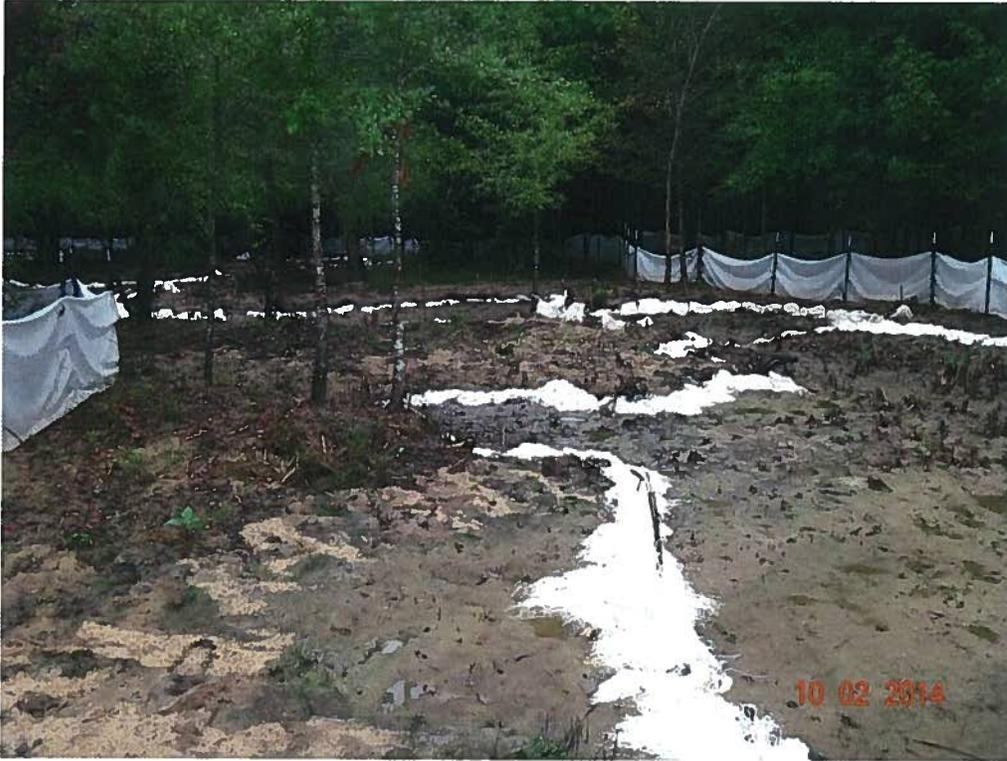
Division C: O&M activity. No effluent water was observed at the east end near the culverts/boom; therefore, no water grab samples were able to taken. No free product observed. Will continue to monitor the division daily.

10-2-2014 Division C – Looking W
