**COMBINED ASSESSMENT
ANALYTICAL RESULTS REPORT
CANYON CREEK WATERSHED
OURAY COUNTY, COLORADO**

OCTOBER 26, 2000

**CANYON CREEK WATERSHED
OURAY COUNTY, COLORADO**

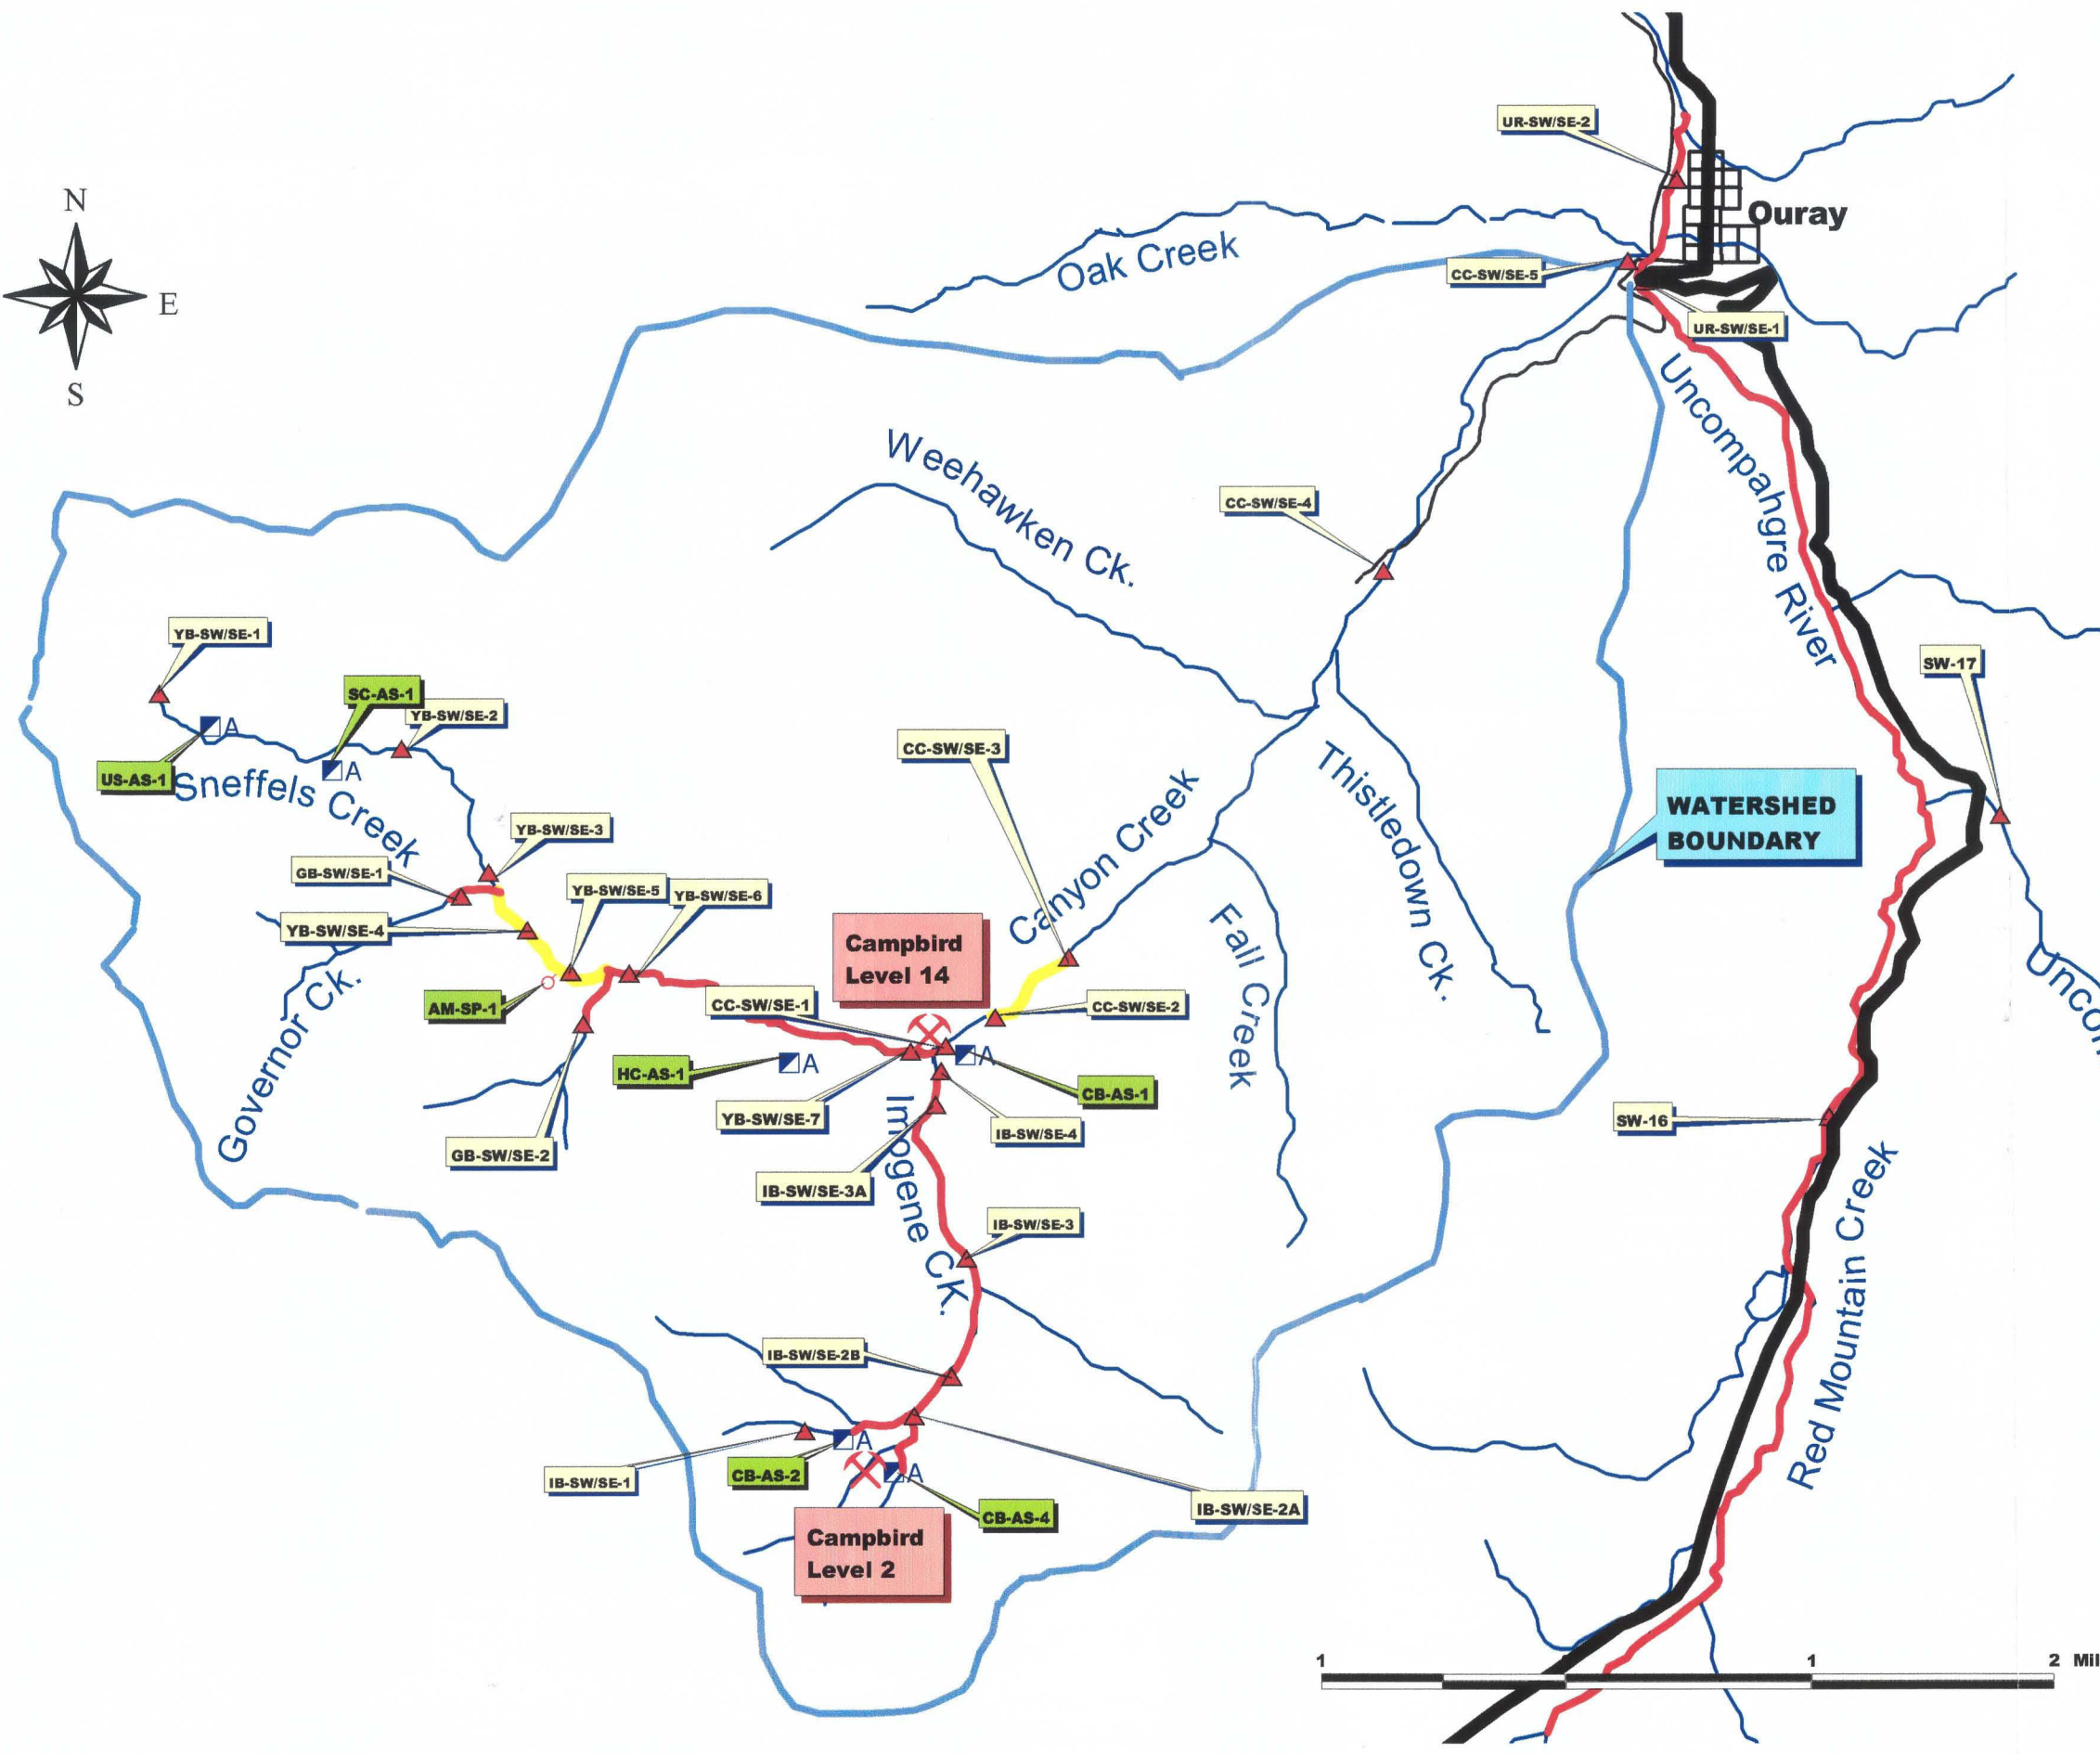
FIGURE 2
SAMPLE LOCATION MAP

- Surface Water/Sediment Sample Location
- Adit Sample Location
- Waste Source Sample Location
- Seep Sample Location
- Stream Segment Exceeds Acute TVS for Zinc
- Stream Segment Exceeds Chronic TVS for Zinc
