Subject: Santa Clara Waste Water Treatment Plant ER
Santa Paula, Ventura County, California
Technical Direction Document (TDD) No.: 0002/1302-T2-R9-14-11-0002
Document Control No.: 0031-08-AAEM
Work Order No.: 20409.012.002.0031.00

This letter report discusses the Site description and history, ER activities, and provides a summary of the ER. **Attachment A** provides the figures for this letter report. **Attachment B** provides a photographic log of site conditions and ER activities.

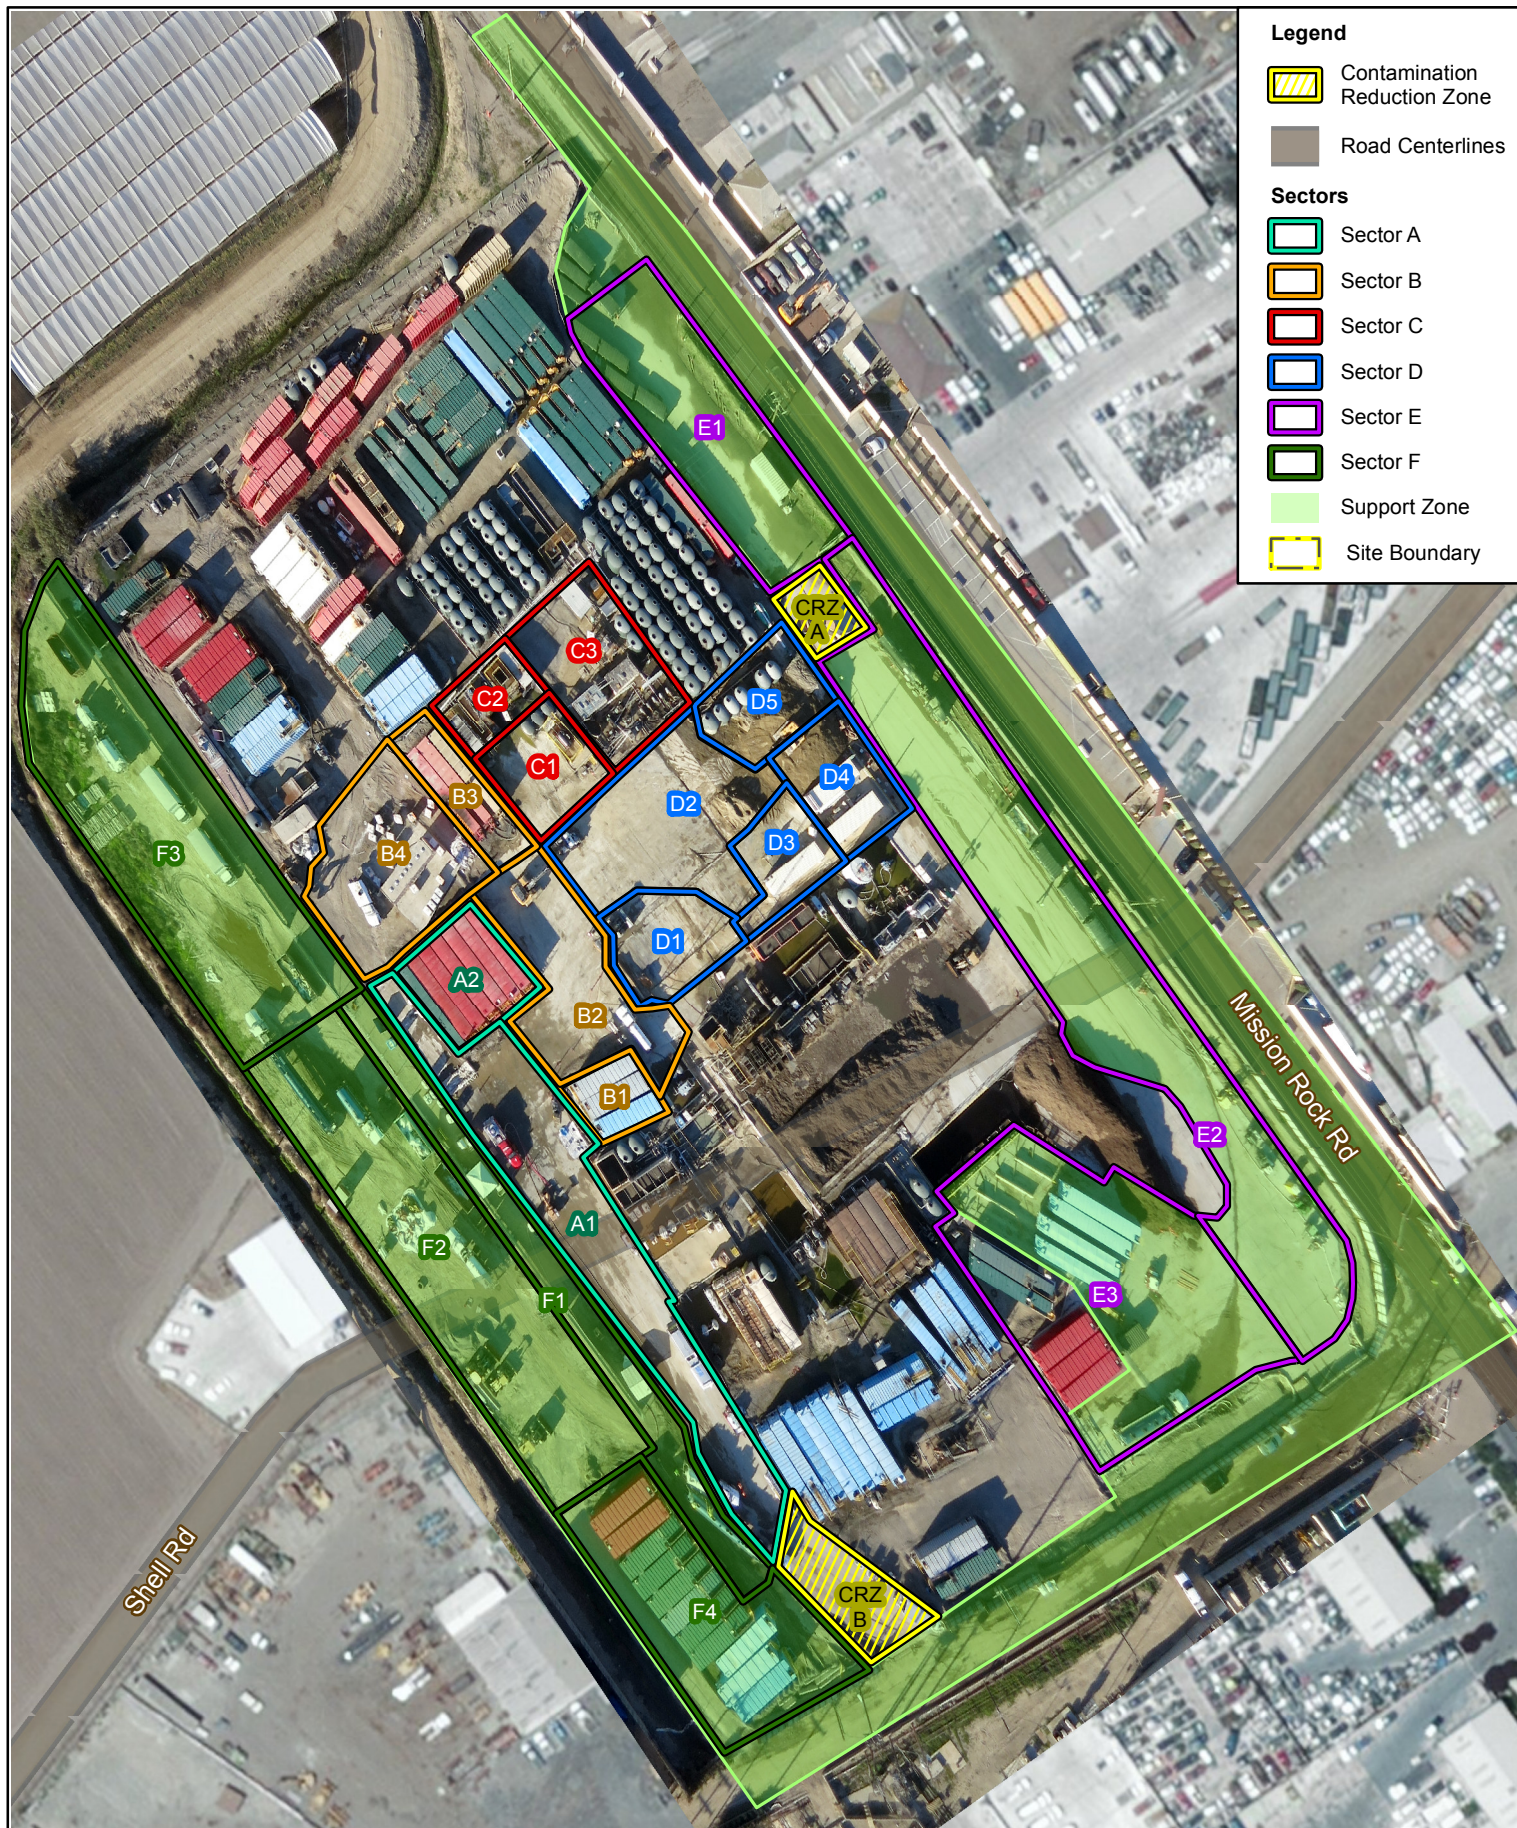
<p>Scale in Feet</p>	<p>PREPARED BY: Region 9, START Weston Solutions, Inc. 1340 Treat Blvd, Ste 210 Walnut Creek, CA 94597</p>	<p>PREPARED FOR: EPA Region 9 Pacific Southwest</p>	<p>FIGURE 2 SITE FEATURES MAP Santa Clara ER Santa Paula, Ventura County, CA</p>
----------------------	---	--	---

divisions A through F (**Figure 2**). Each division, where appropriate, was broken into numerical sectors to sharpen the focus of field work and facilitate communication of activities.

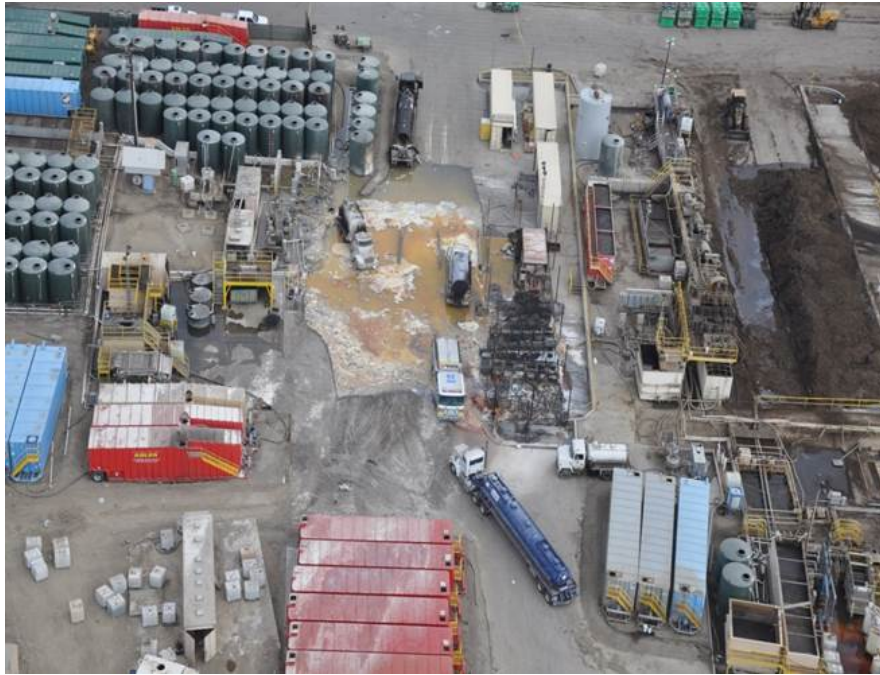
Photograph No.: 1

Subject: A flyover of the Site showing site conditions the day after the fire.

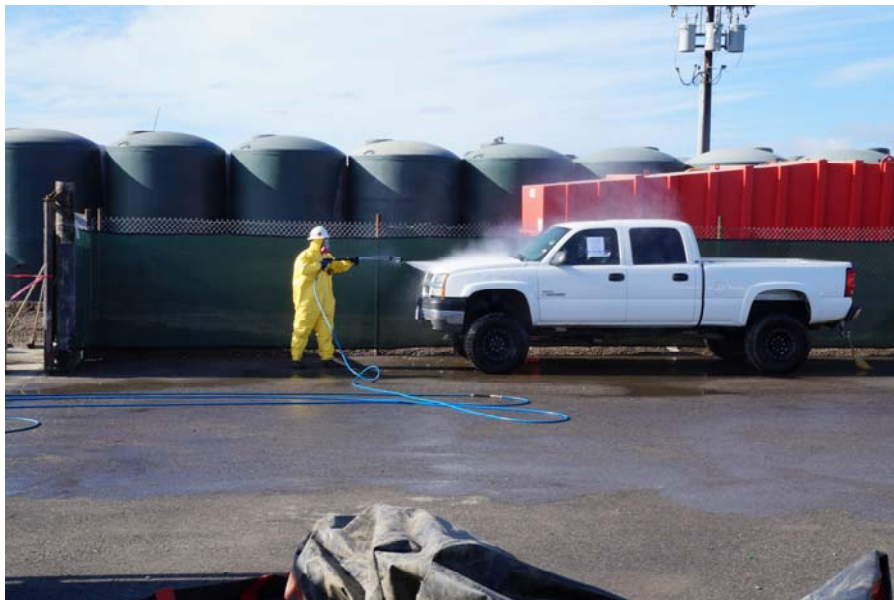
Photograph No.: 2

Subject: Patriot crews decontaminate employee vehicles on Site.

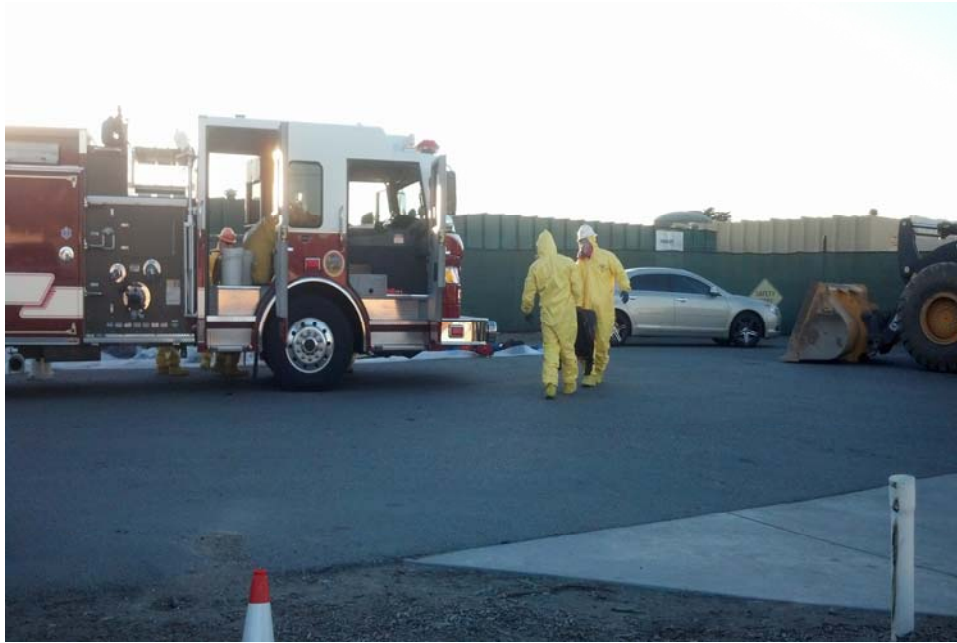
Photograph No.:3

Subject: Patriot/CTEH screen Engine 82 following removal of all soft materials.

- Decontamination of the SPFD Engine 82 continued with the removal of all soft equipment (hoses, headliners, seats). Field screening wipe samples were collected from the engine compartment, air filter, and cab. Additional confirmation wipe samples were collected from the outside of the Engine.

- Laboratory results from the confirmation wipe samples were received by Patriot and reviewed. The sampling results verified the completion of decontamination on Engine 82. The Engine was released from the Site back to SPFD.

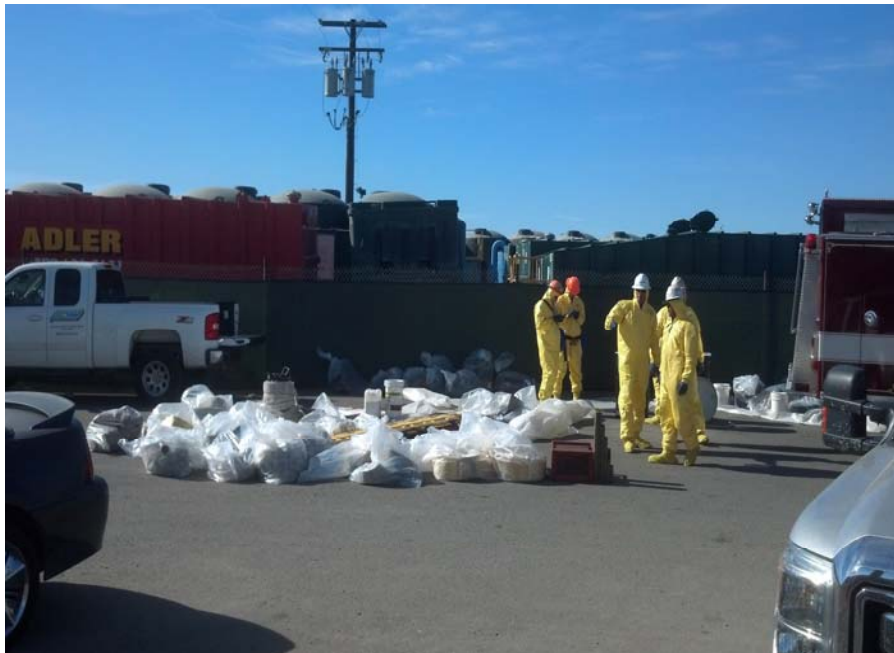
Photograph No.:4

Subject: Patriot/CTEH screen soft materials after removal from Engine 82.

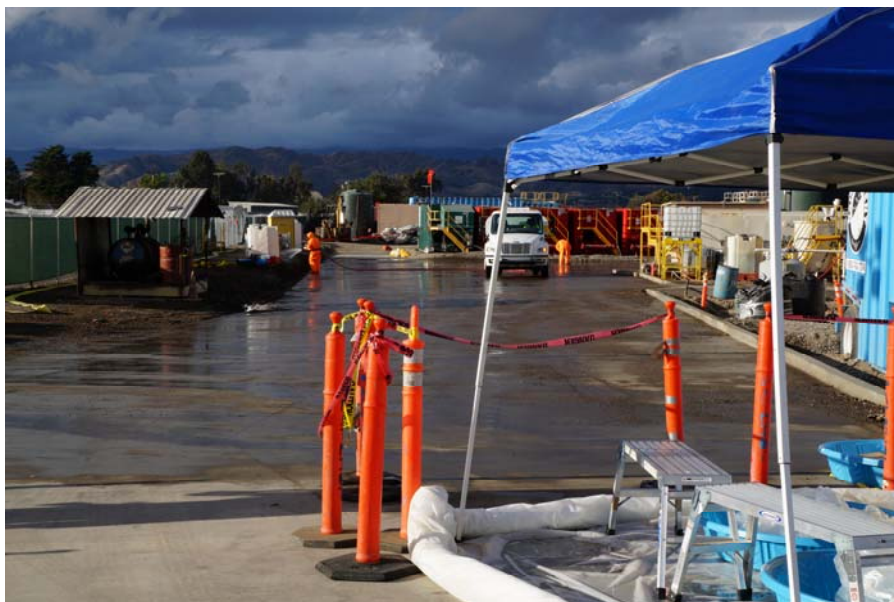
Photograph No.:5

Subject: Patriot/CTEH sample waste from the pooled material.

- CTEH performed a Level B entry into Divisions B, C, and D to collect liquid and solid samples from the pooled material and the vacuum trucks on site. In total, seven samples were collected for hazard categorization (HazCat) and field screening.

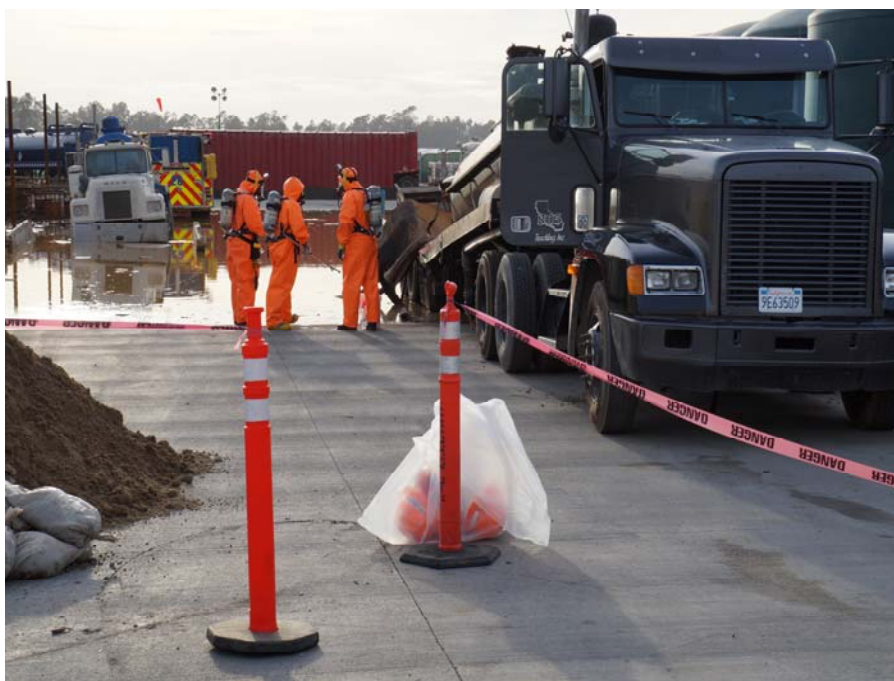
Photograph No.:6

Subject: Patriot/CTEH sample waste from the pooled material.

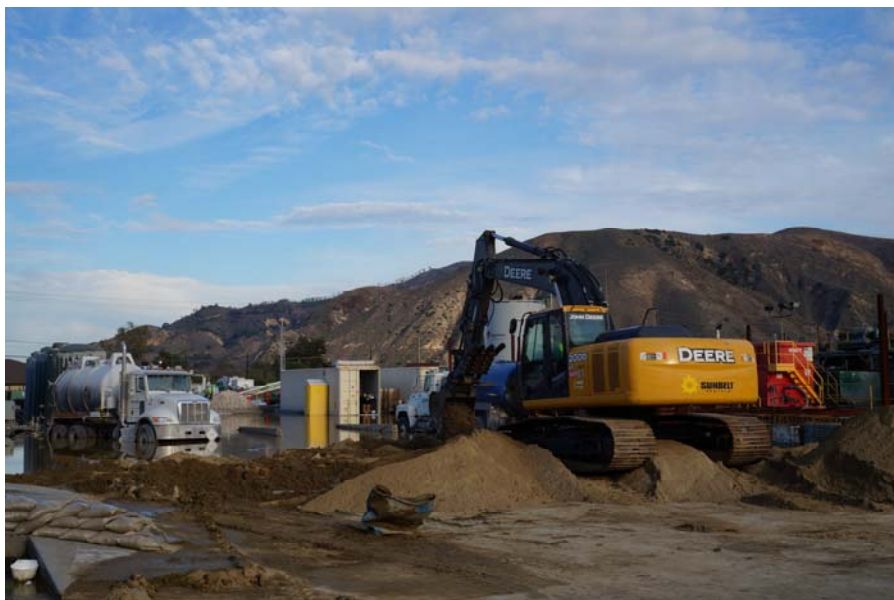
Photograph No.:7

Subject: Patriot begins solidification of pooled material.

- Solidification activities began in Sector D2, with an excavator pushing solidification material into the pooled material. The excavator operator controlled the liquid-solid ratio in the cleared area and then stockpiled the solidified waste to the southwest of the pooled material.

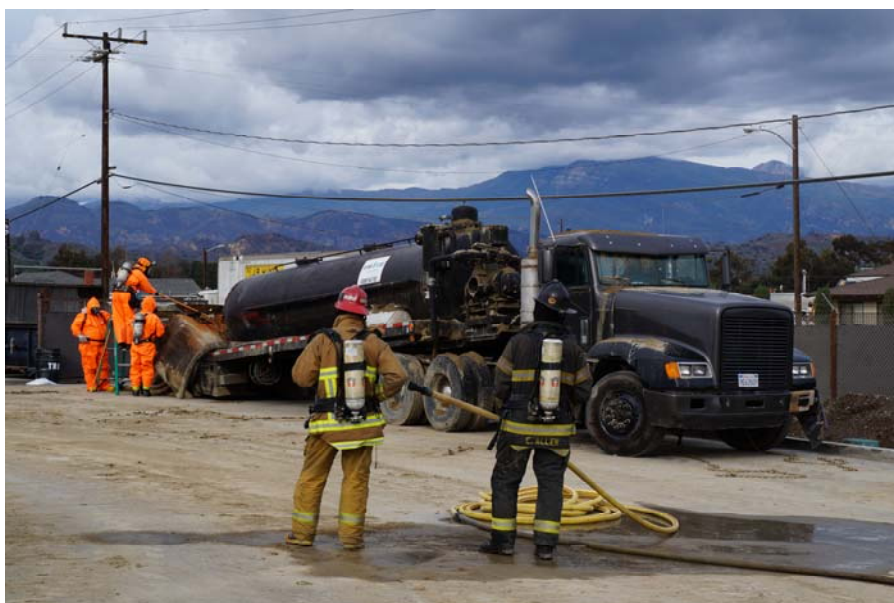
Photograph No.:8

Subject: Patriot/CTEH conduct air monitoring on inlet pipes from “source truck”.

- The 120-barrel vacuum “source truck” was towed out of the pooled material in Sector D2 and into the staging area of Sector E2. During movement, a small plume of white smoke was observed coming from the rear of the truck. Operations were halted as the smoke source was investigated and found to be an accumulation of solid material in the rear inlet pipes. Air monitoring revealed that the material was releasing chlorine gas at a peak value of 4.2 ppm.

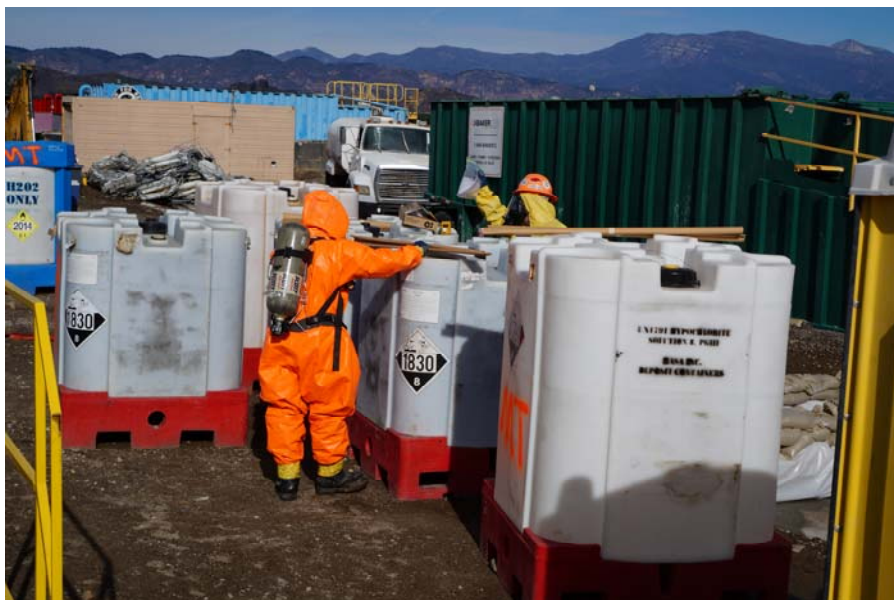
Photograph No.:9

Subject: CTEH collects samples from totes on site.

- Patriot/CTEH collected 13 samples from various totes and tanks on site for HazCat and four samples for laboratory analysis as described in the *Tank and Tote Inventory Sampling and Analysis Plan*. HazCat results indicated that information about tank and tote contents from the potentially responsible party could be considered reliable and utilized in tank and tote identification.

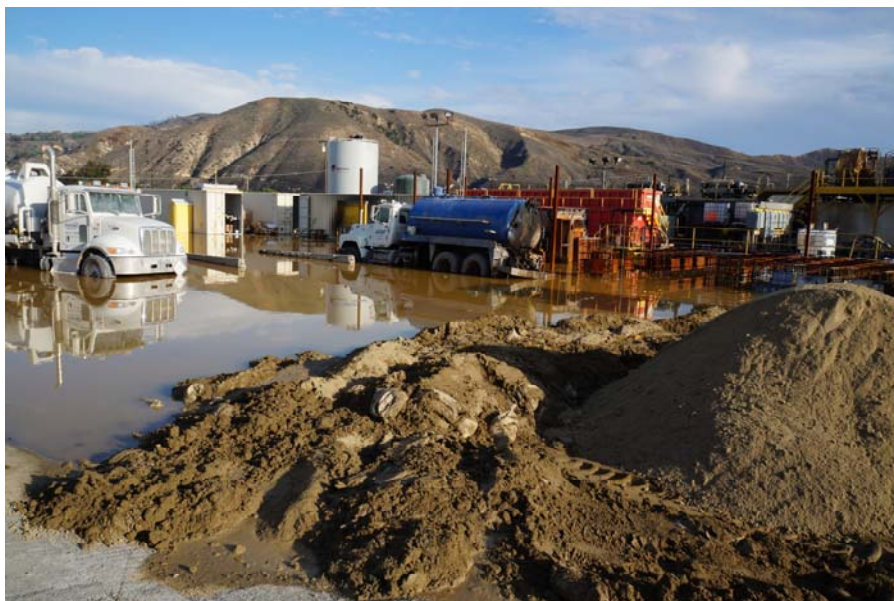
Photograph No.:10

Subject: Solidification materials staged near pool.

- Truckloads of solidification material were delivered to the Site and staged in Sector D2, along the southwest boundary of the pooled material. Loads of solidification materials were delivered consistently to the Site throughout the work days.

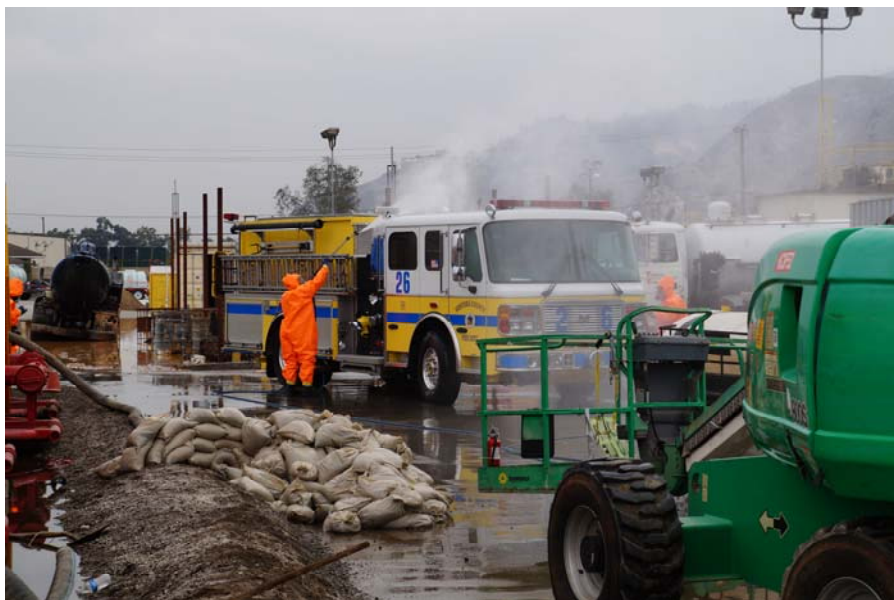
Photograph No.:11

Subject: Removal and gross decon of Engine 26 from pooled area.

- VCFD took possession of Engine 26. The Engine was charged, rinsed one additional time, and then towed off site by VCFD representatives.
- All remaining solidified wastes were removed from the Site and transported for disposal at Chiquita Canyon Landfill by January 9, 2015.

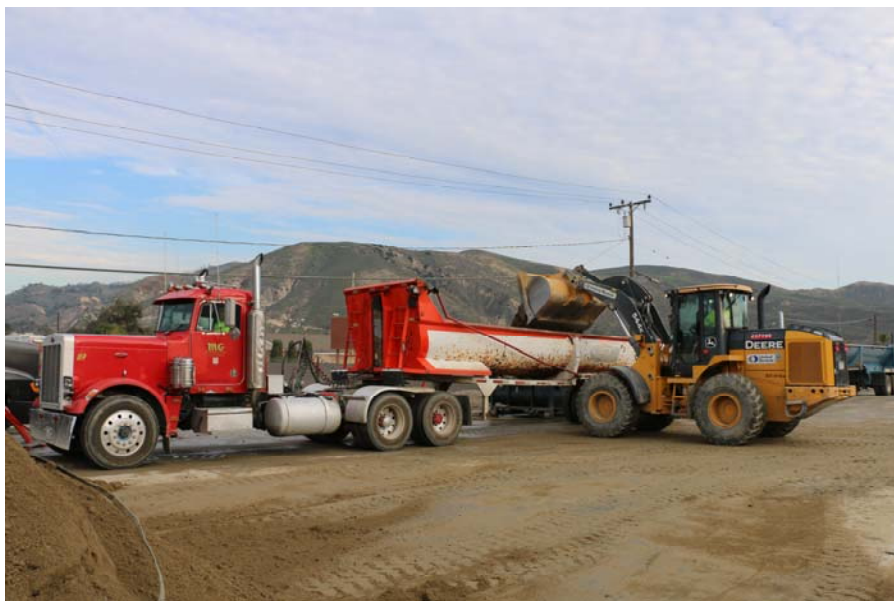
Photograph No.:12

Subject: Solidified waste being loaded into trucks for transportation and disposal.

- On December 31, 2014, transport trucks with tarp covers began transporting stockpiled solidified waste to Chiquita Canyon Landfill in Castaic, CA.
- Patriot/CTEH submitted a plan to scale-back community air monitoring based on changing operations and past results. Perimeter and site air monitoring were proposed to continue as normal. UC reviewed and approved the plan.

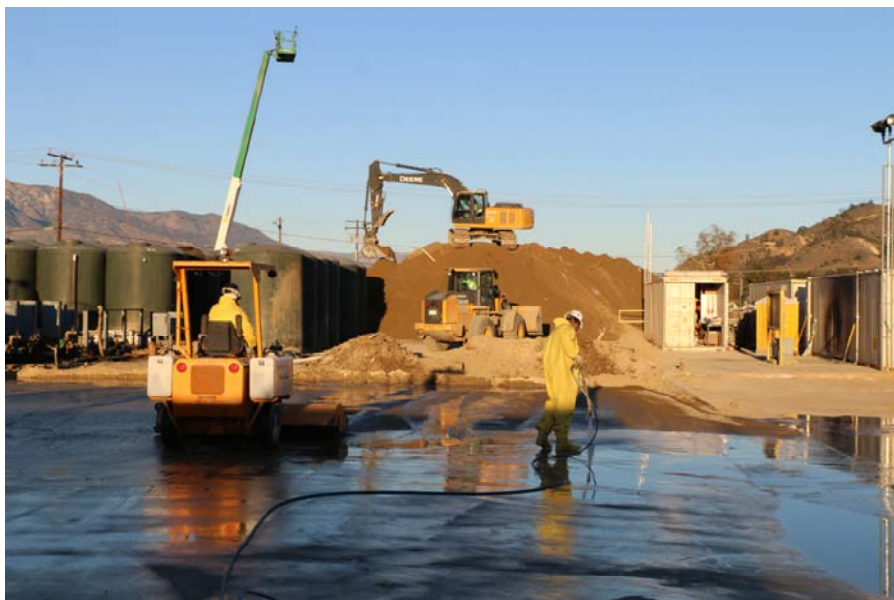
Photograph No.:13

Subject: Pressure washing in Sector D2 following removal of solidified waste.

- Solidification of waste from the pooled area and transport to Chiquita Canyon Landfill continued in Sectors C2, C3, and D2. As each sector was cleared, the area was neutralized with sodium sulfite solution and then power washed clean. The area was finally swipe tested for oxidizers and pH.

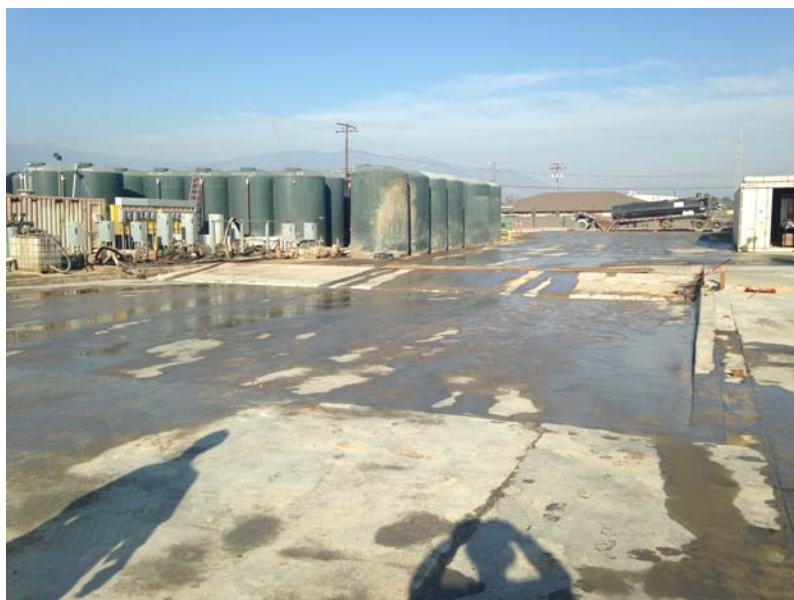
Photograph No.:14

Subject: Division D on final walkthrough of Site.

- A final site walkthrough was conducted by representatives for SCWW, the SCWW consultants, Patriot and CTEH, EPA and START.
- START, EPA, VCEH, and UC demobilized from the Site on January 9, 2015.
