# **Integrated Assessment Report Caney Residential Yards Site**

**March, 2015**

**C3-063-73212**

**INTEGRATED ASSESSMENT**

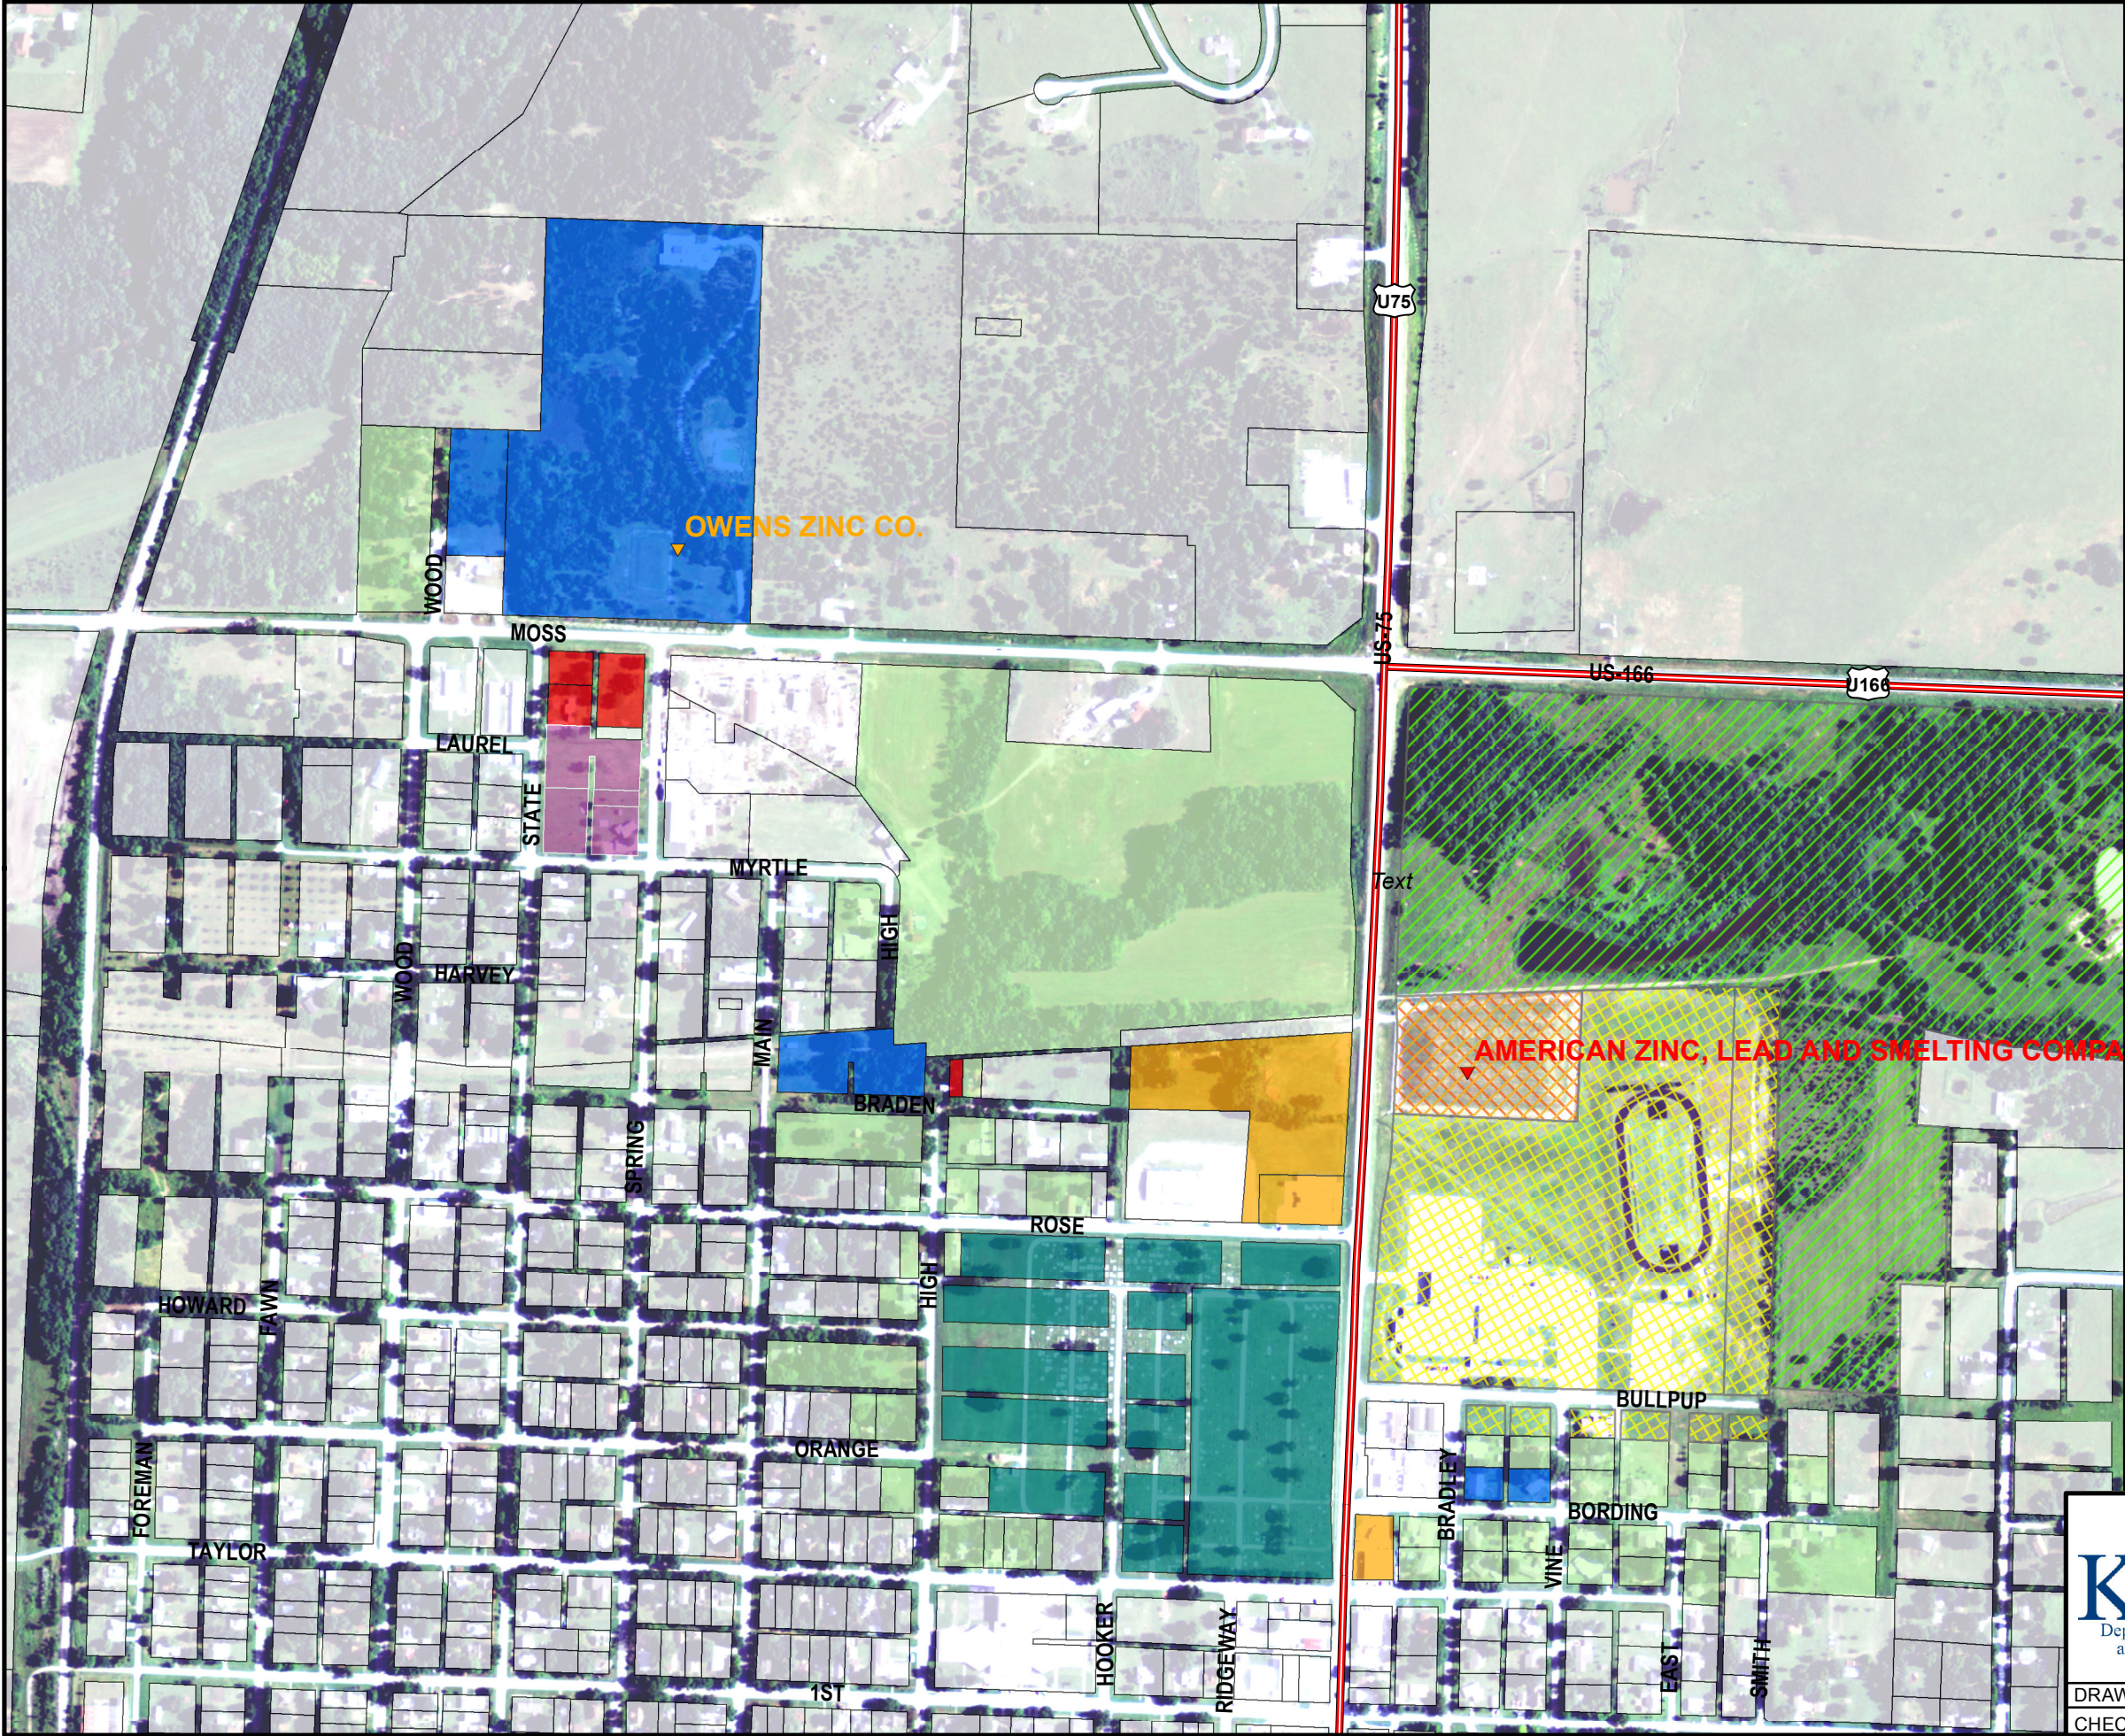
SITE:		Caney Residential Yards Caney, Kansas	
TITLE:		Arsenic Results for Soil Samples on Residential Properties	
PROJECT PHASE:		Integrated Assessment	
DRAWN BY:	NS	3/5/15	BASEMAP DATE: 2013
CHECKED BY:	RB	3/5/15	<b>Figure 5</b>

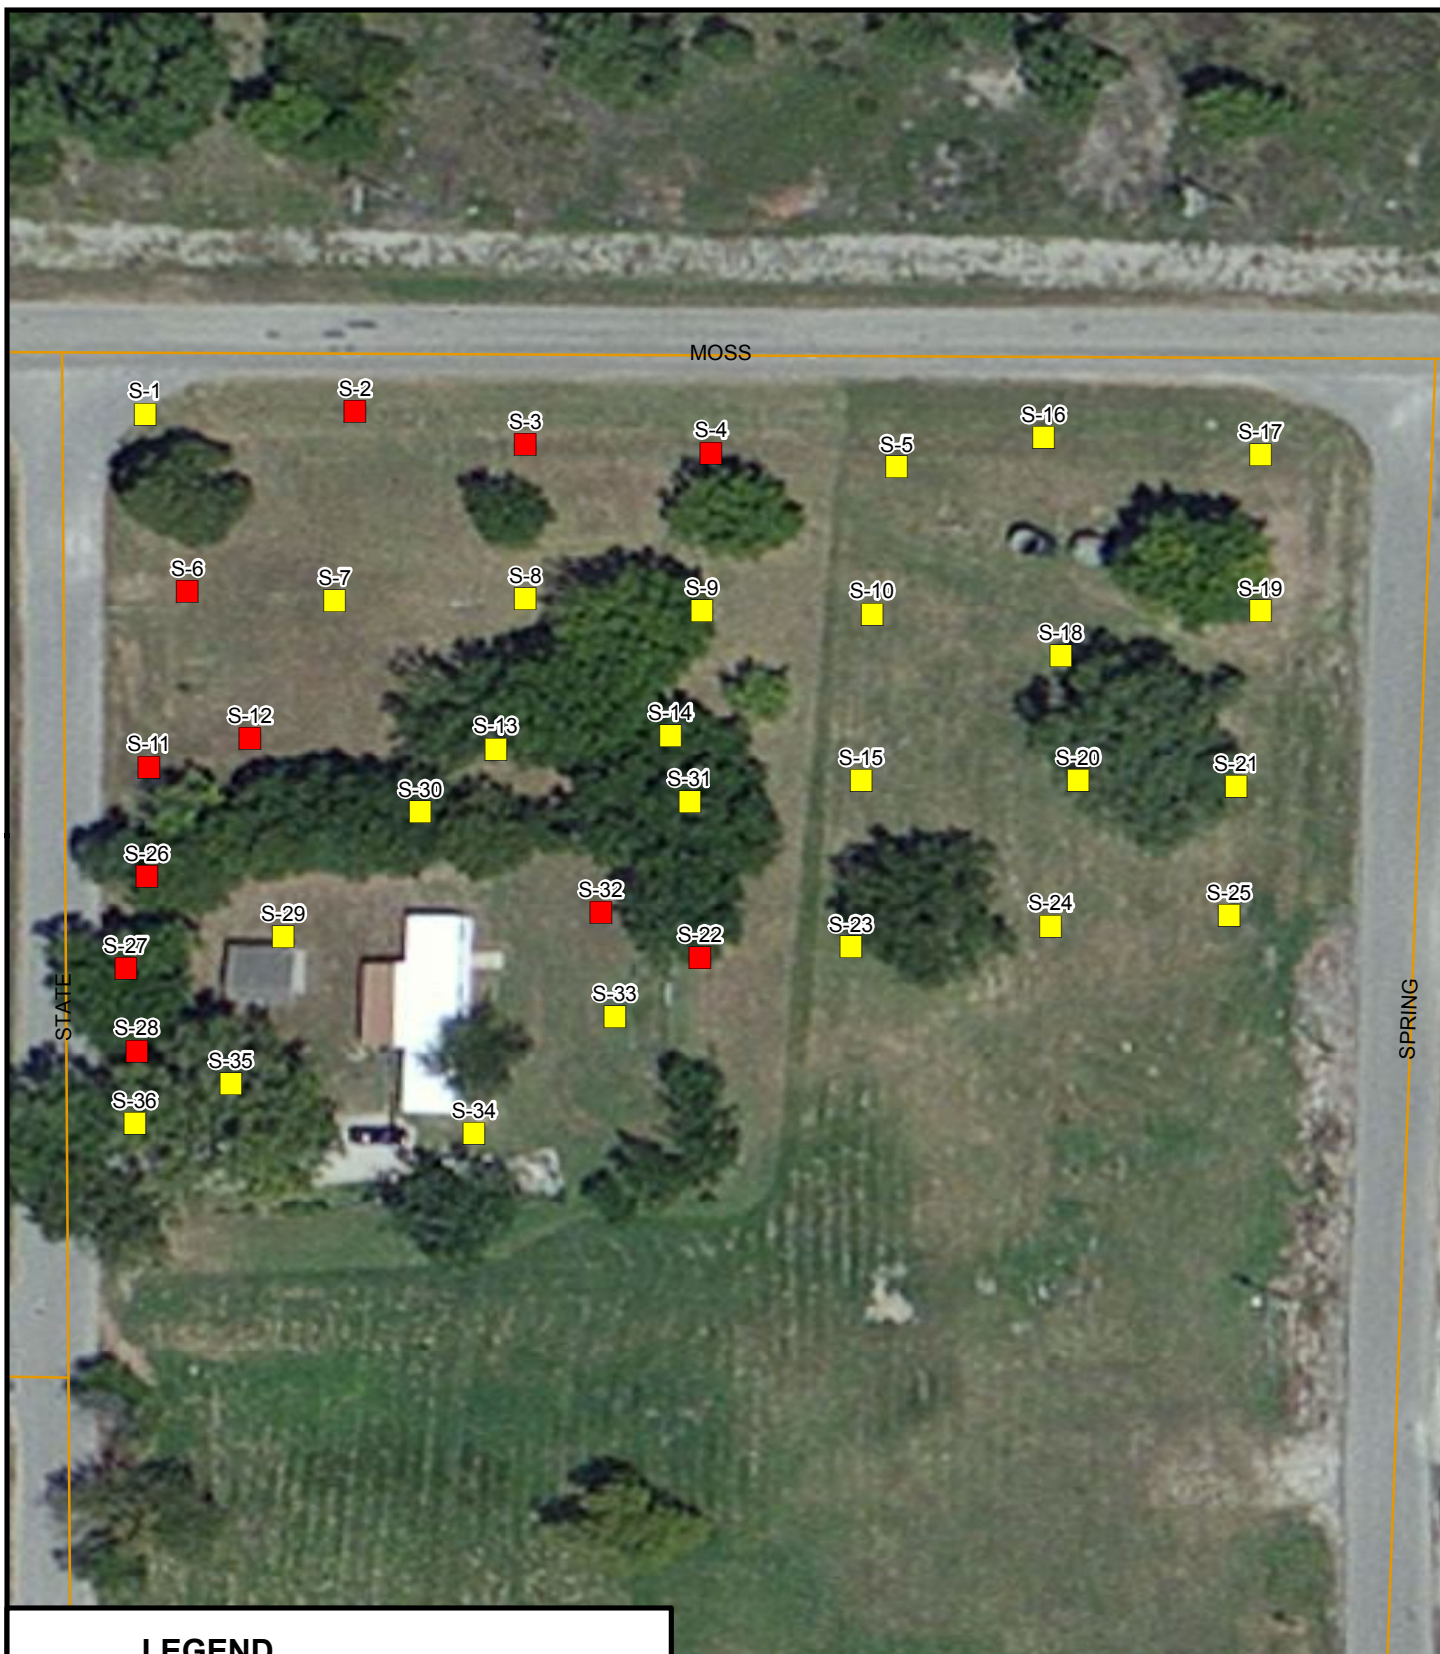
**Figure 3**

The maximum XRF and laboratory lead detections of 3,751 mg/Kg and 5,100 mg/Kg, respectively, were encountered in sample S-32, located near the northern edge of the Bunch residential garden. A total of 11 XRF or laboratory analyses of the 35 surface soil samples exceeded KDHE's residential Tier 2 RSK for lead of 400 mg/Kg (see Figure 3).

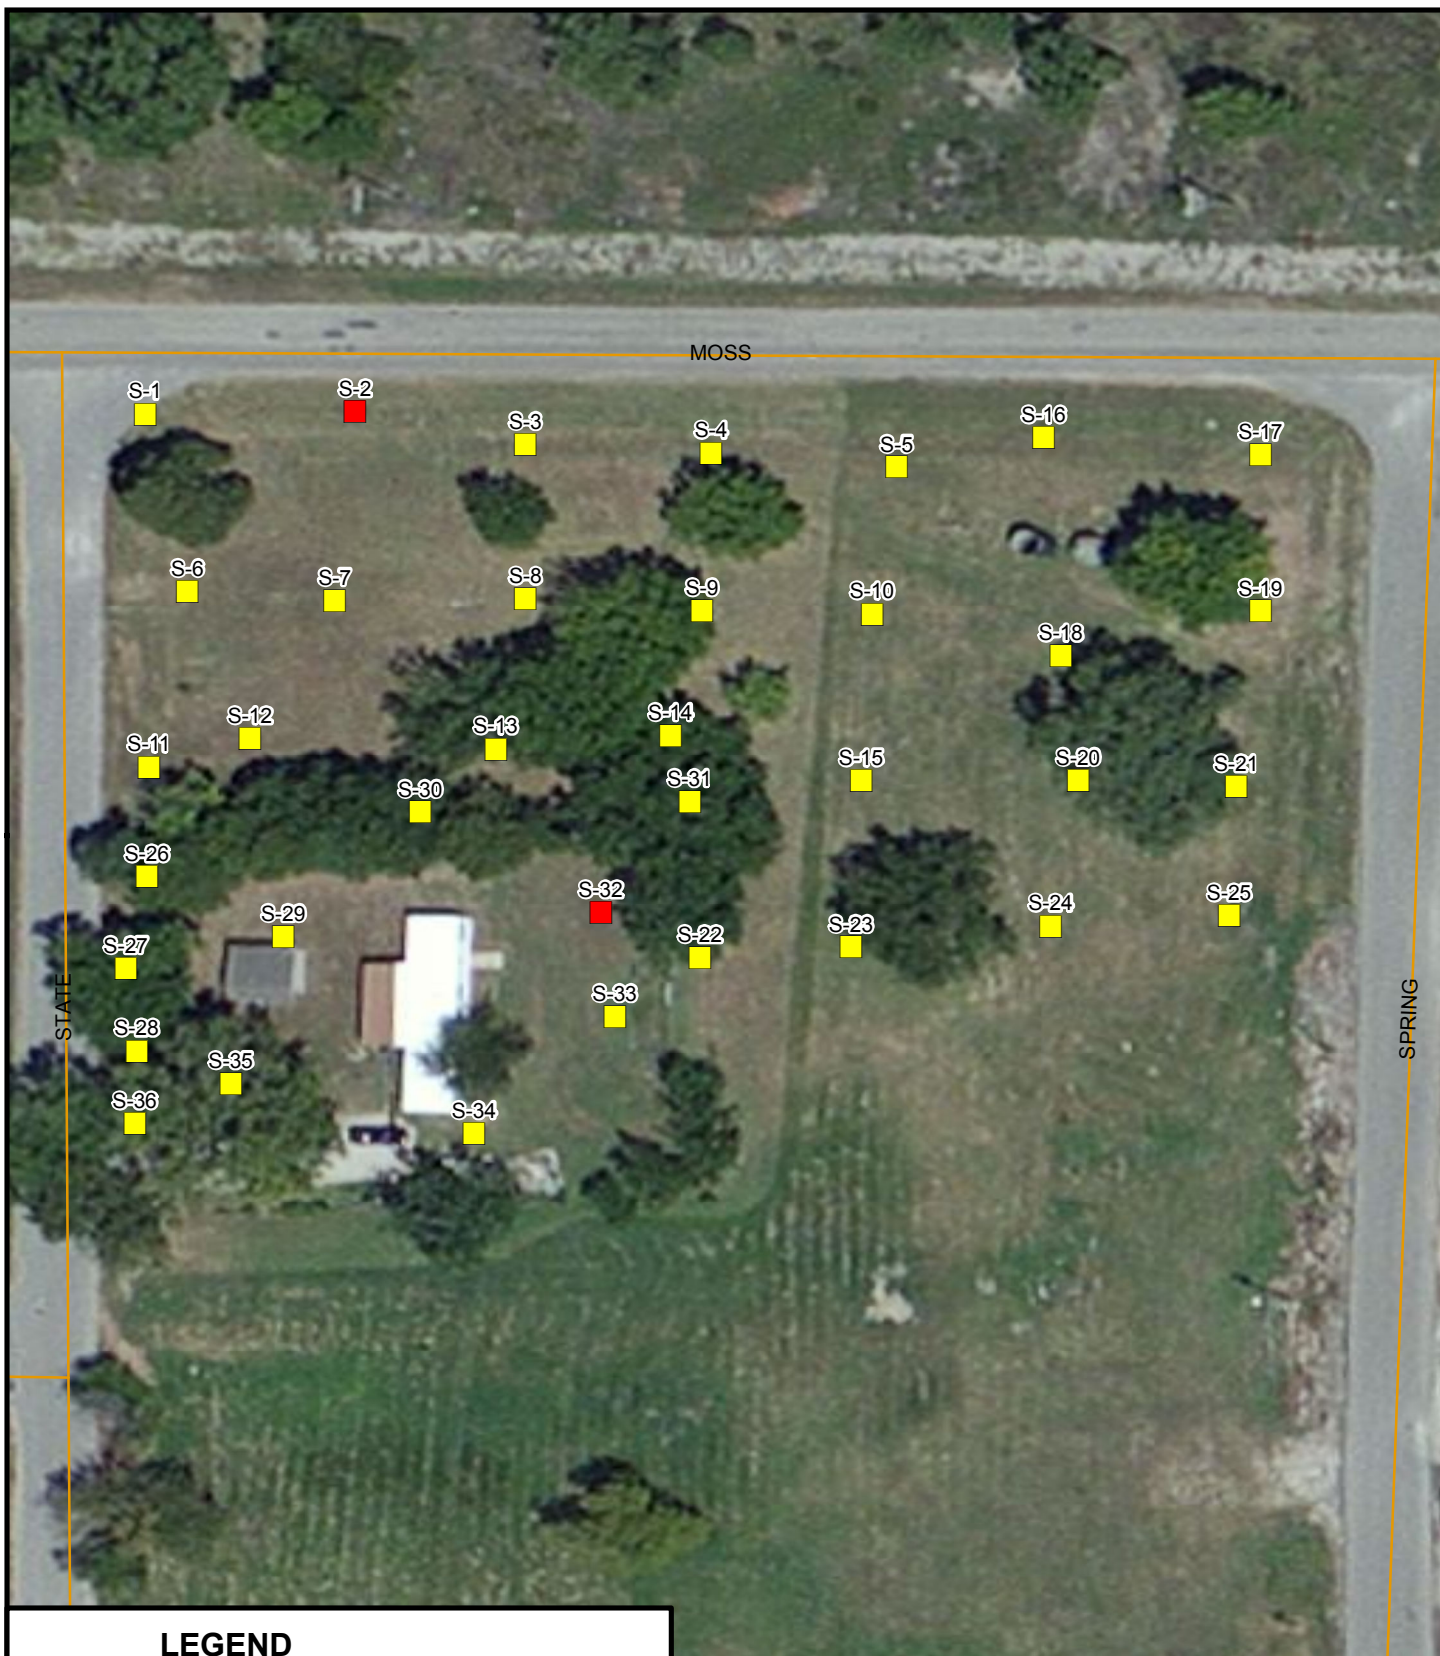
**Figure 5**

Arsenic was detected by laboratory analysis above its residential Tier 2 RSK of 18.9 mg/Kg in samples S-2 and S-36, and both were also above the three times background concentration for arsenic of 20.7 mg/Kg calculated for the Owen Zinc ESI. The arsenic detection in both of these samples was 24 mg/Kg, and each of these locations had a corresponding lead concentration over 400 mg/Kg. Figure 5 includes all arsenic detections above 18.9 mg/Kg.

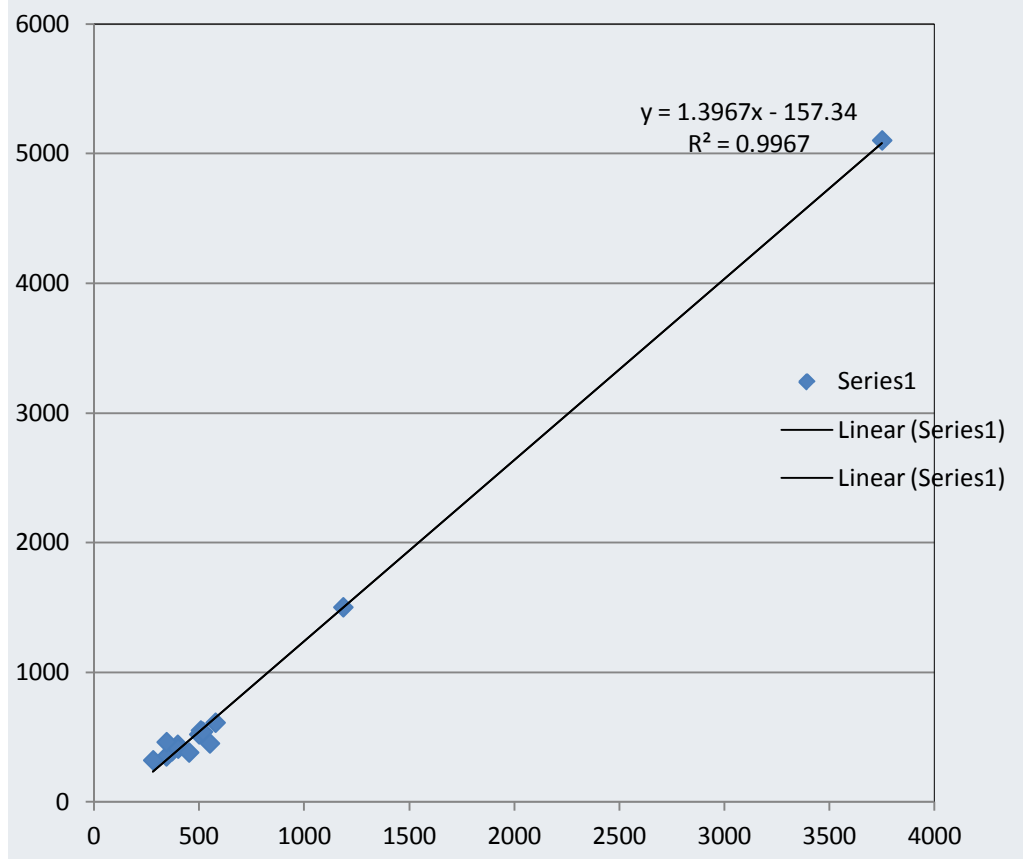
**Laboratory Lead Concentrations (Y Axis) vs. XRF Lead Detections (X Axis) in mg/Kg**

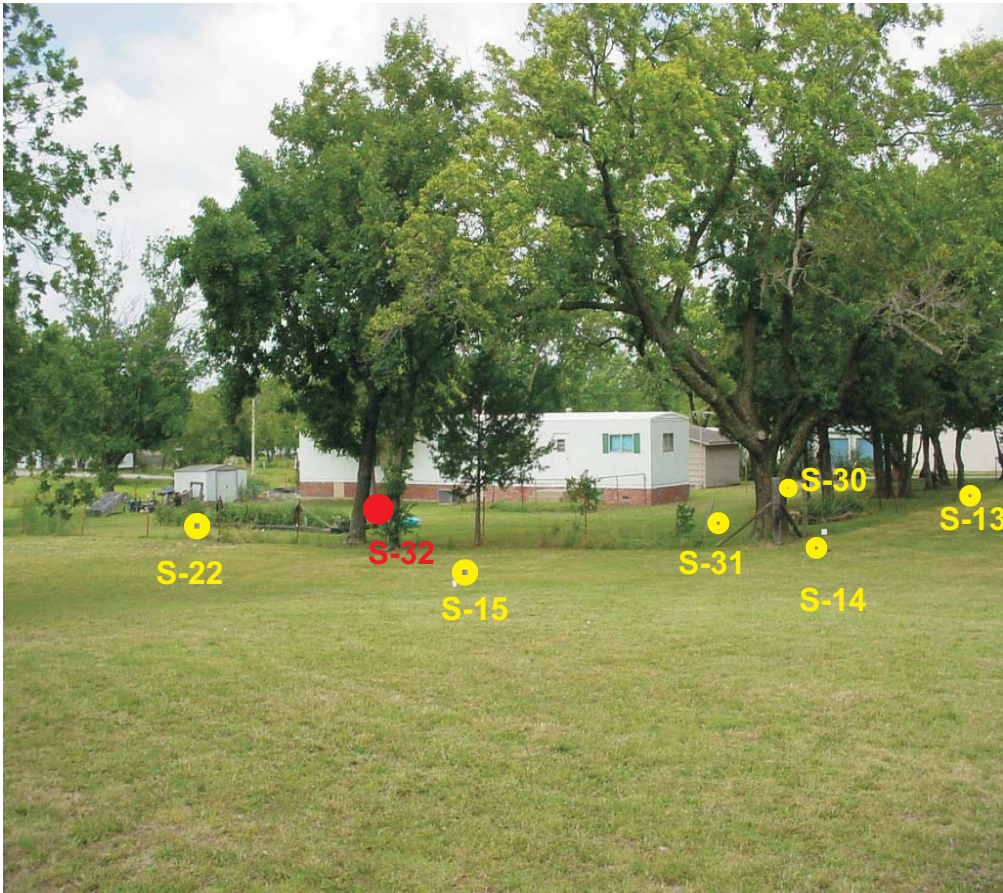
Photo 1

Comments: Bunch residence at 1202 N. State Street. S-32 location with maximum detection of lead is indicated on figure.

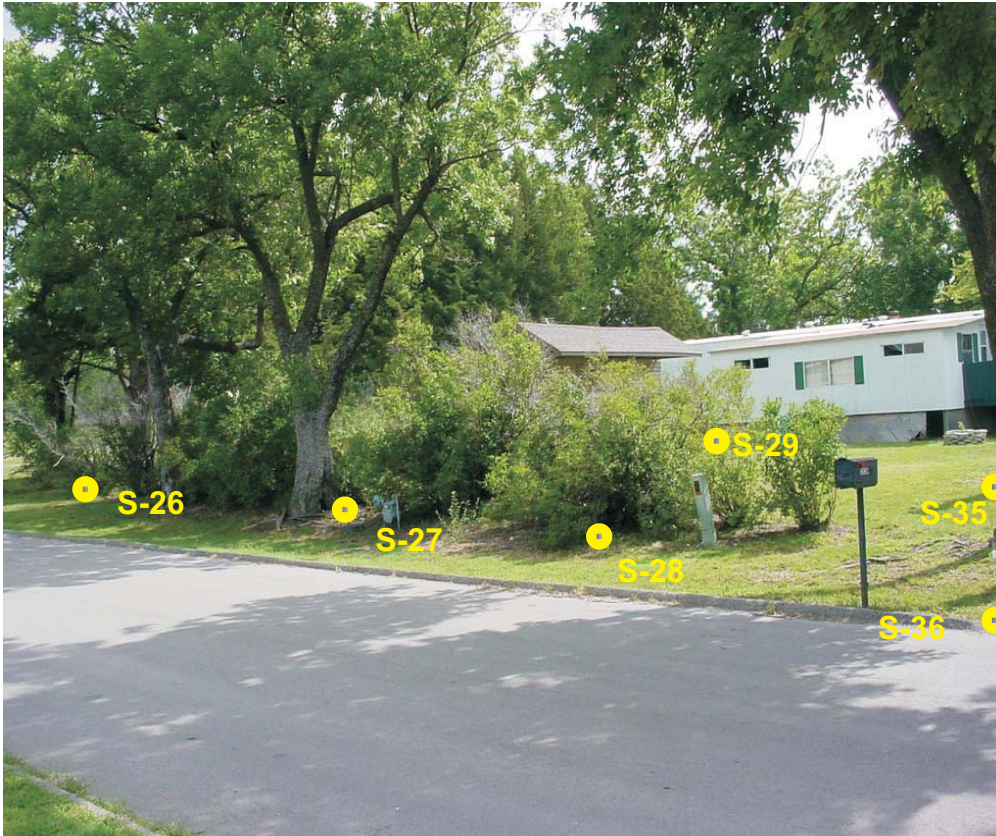
Photo 3  
View: Northeast  
Date: 06/19/2012  
Photo by: Randy Brown  
Comments: Additional sample locations in Bunch residential yard.

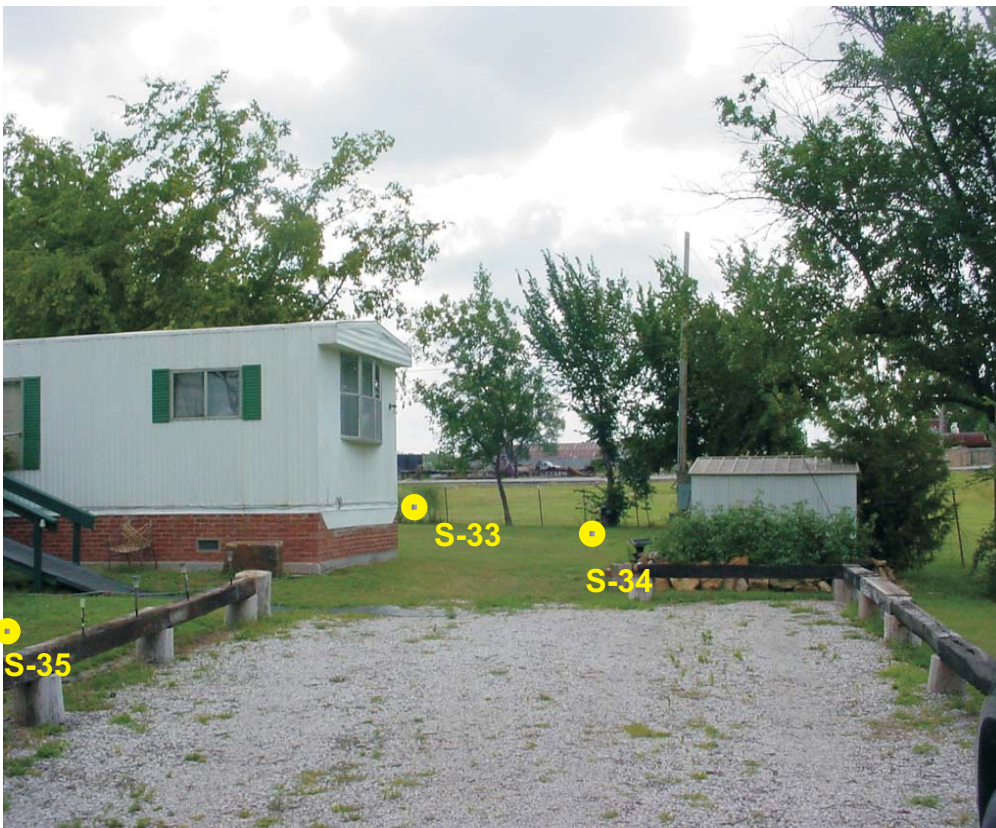
Photo 4  
View: East  
Date: 06/19/2012  
Photo by: Randy Brown  
Comments: Additional sample locations in Bunch residential yard.

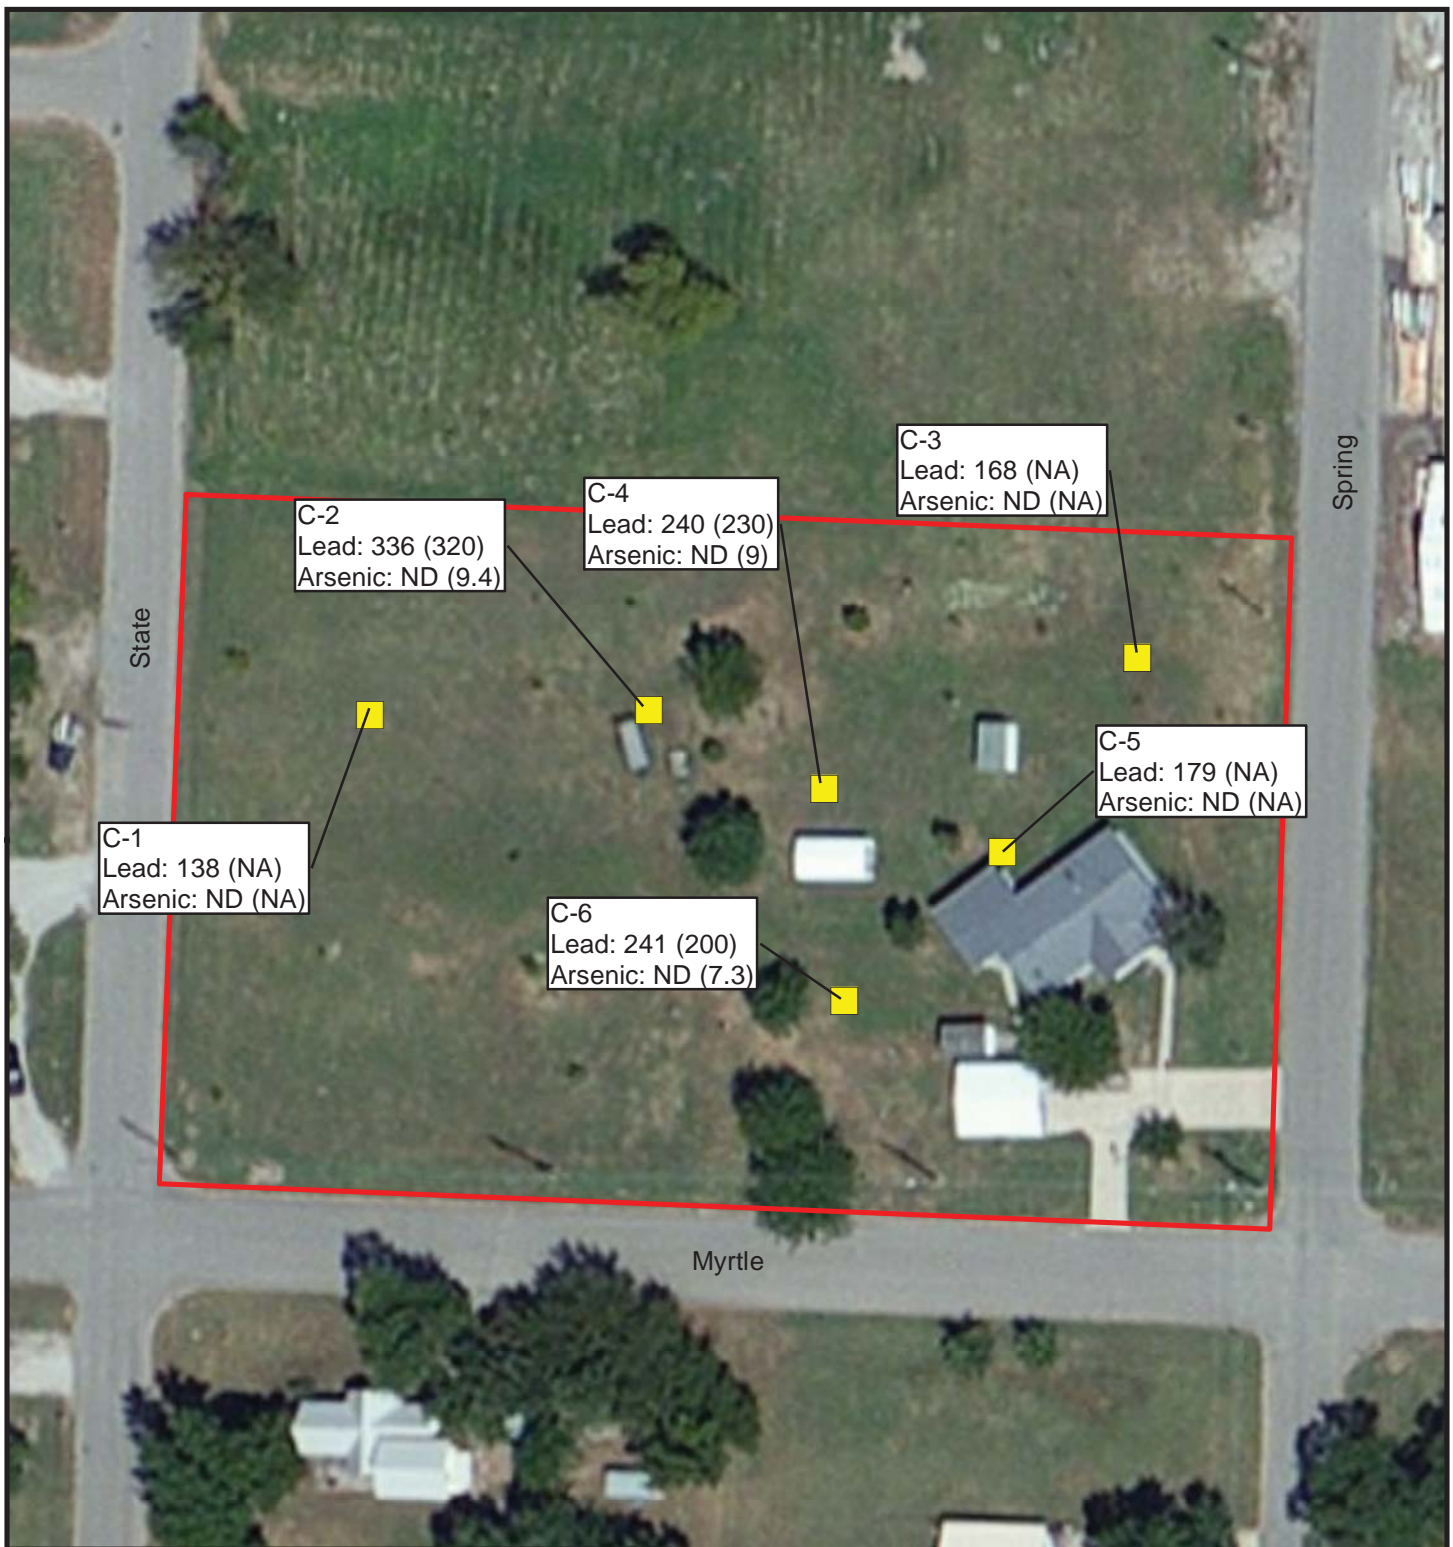
SITE:		<b>Crowe Property Caney, Kansas</b>	
TITLE:		<b>Analytical Results for Surface Soil Samples</b>	
PROJECT PHASE:		Integrated Site Evaluation	
DRAWN BY:	NS	9/23/13	BASEMAP DATE: 2013
CHECKED BY:	RB	9/23/13	<b>Figure 3</b>

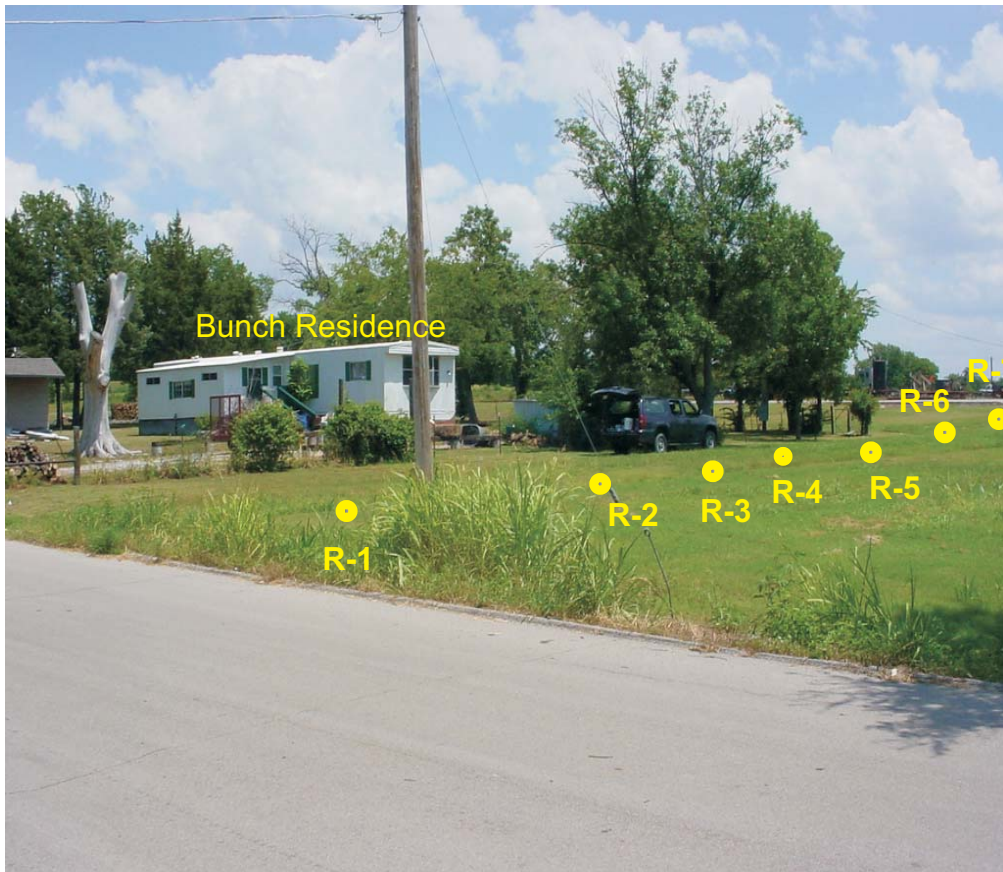
Photo 1

Comments: Bunch residence at 1202 N. State Street and sample locations R-1 through R-7.

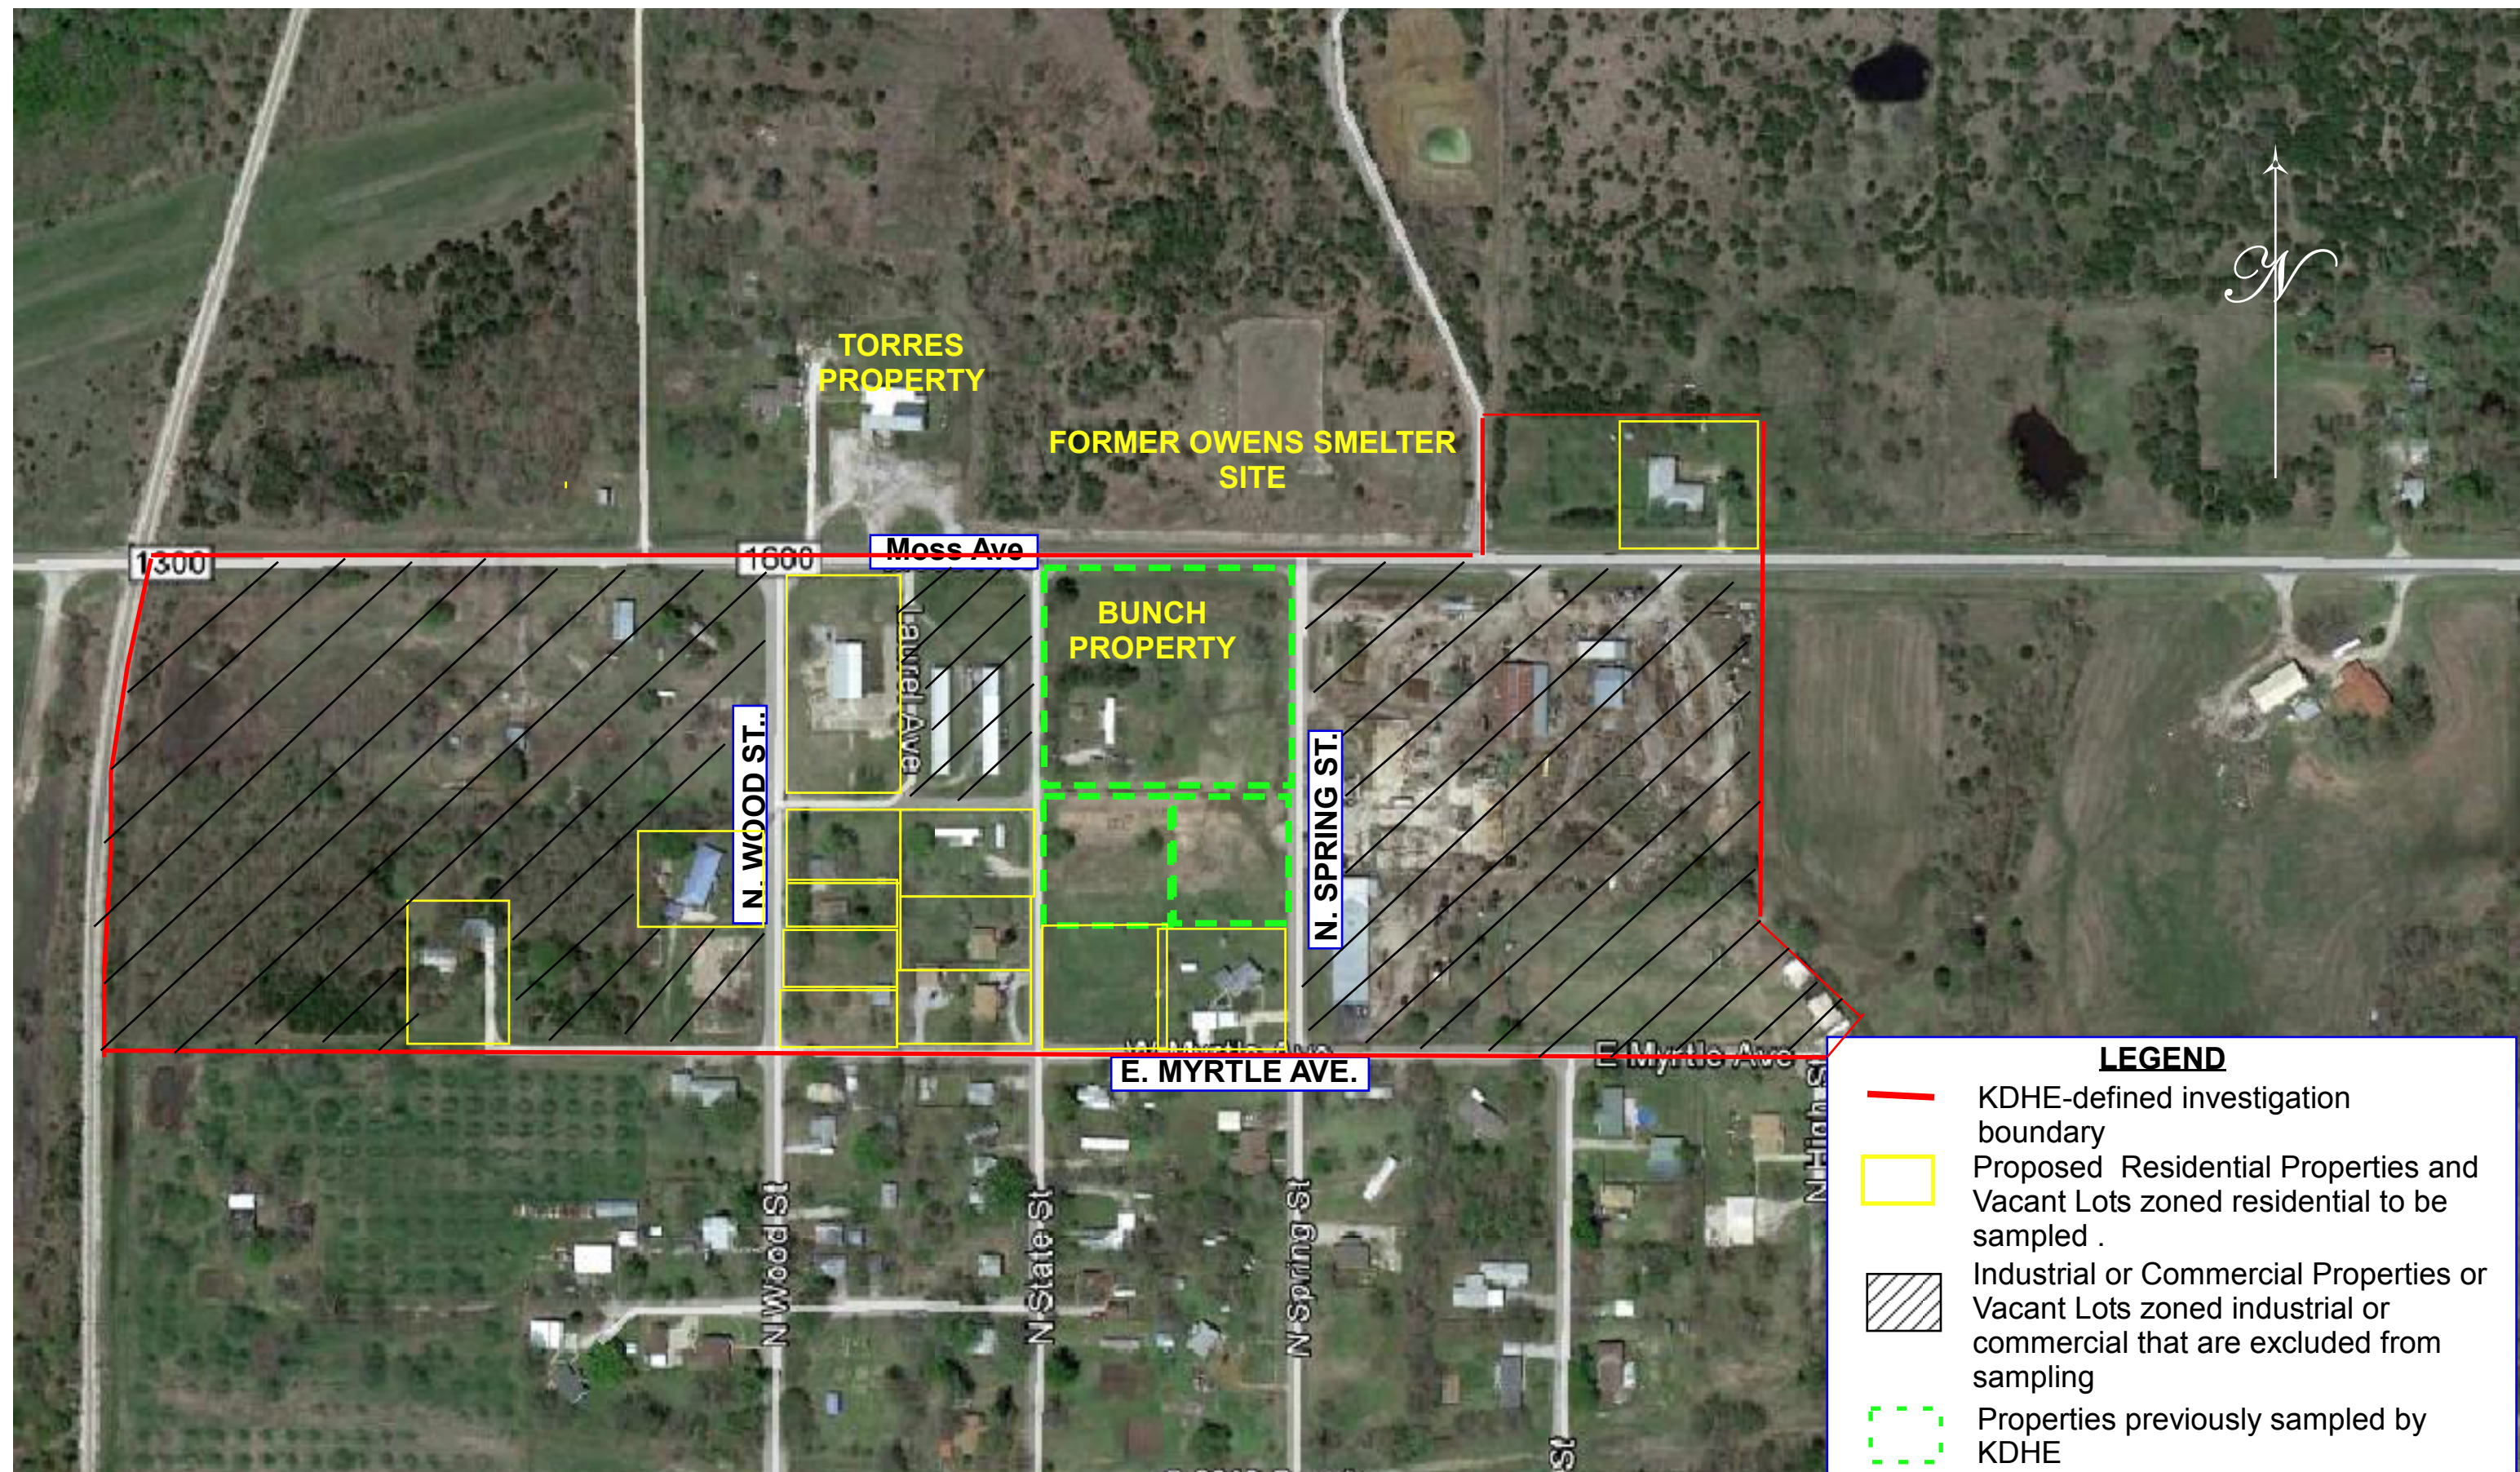
**FIGURE 2**  
**PROPOSED PROPERTIES TO BE SAMPLED AND GENERAL AREA FEATURES**  
**OWEN RESIDENTIAL SAMPLING WORK PLAN**  
**CANEY, KANSAS**

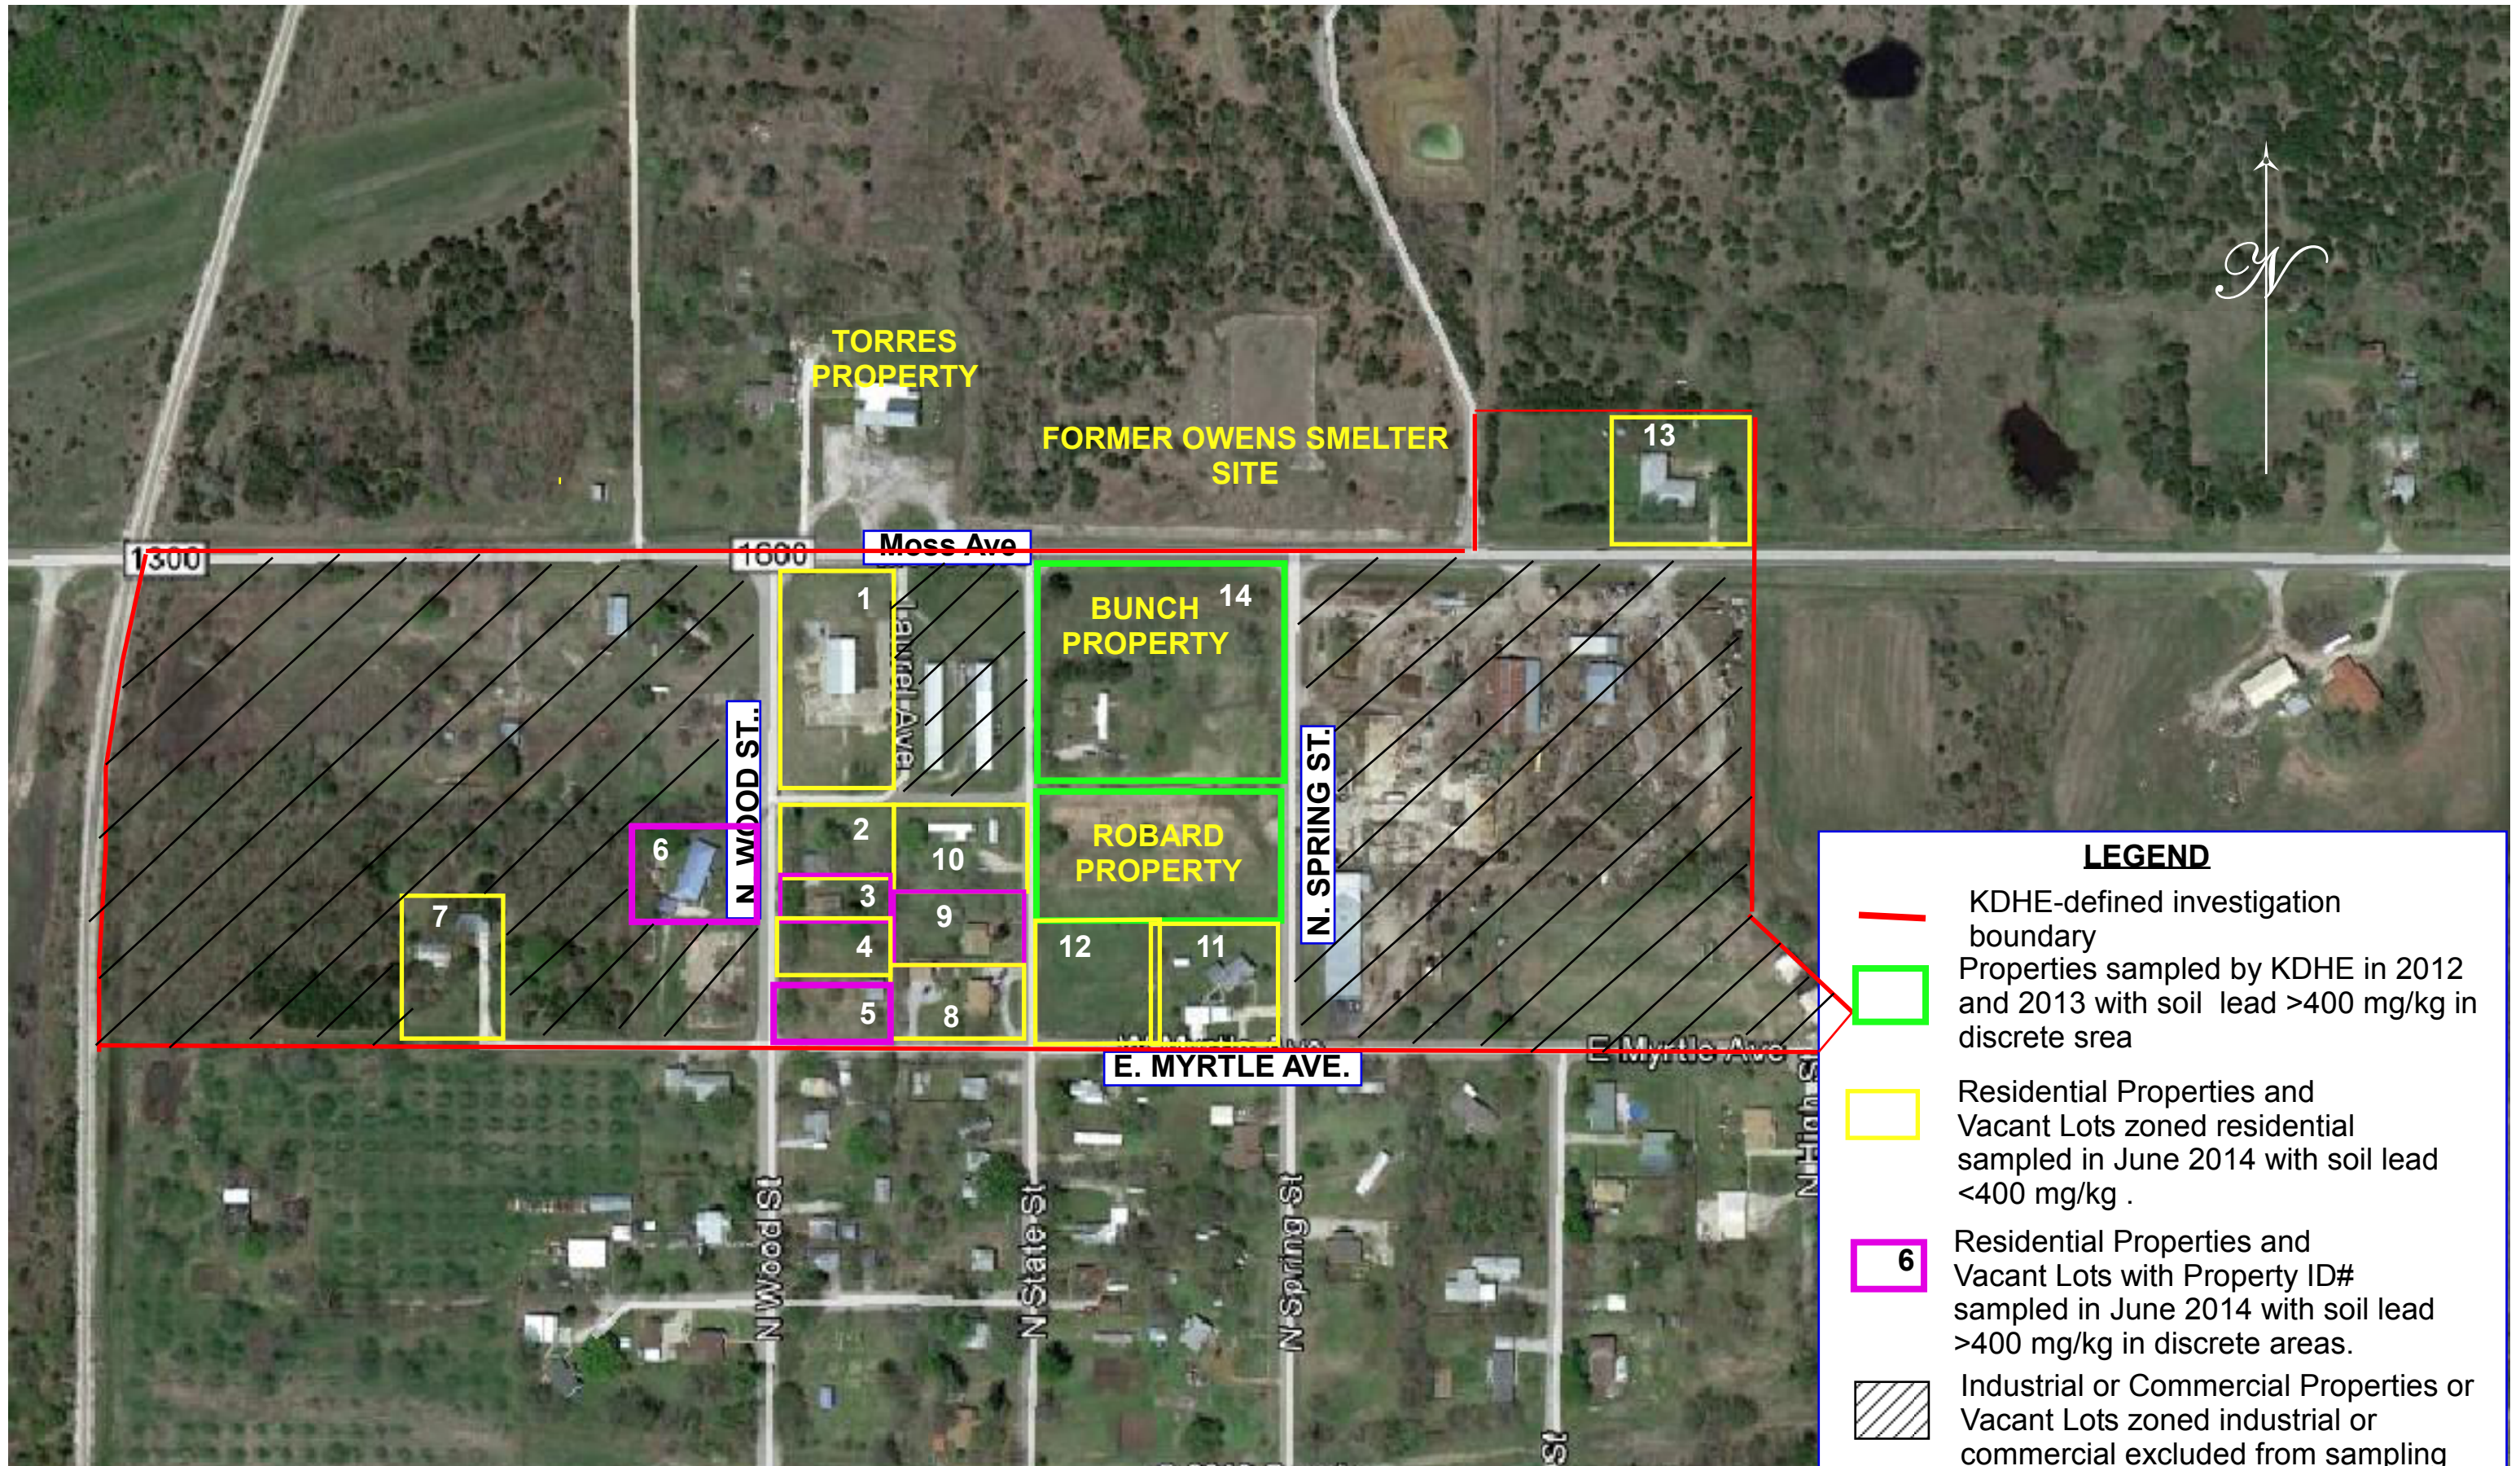
**FIGURE 2**  
**RESIDENTIAL SOIL SAMPLING LOCATIONS AND SURROUNDING AREA FEATURES**  
**RESIDENTIAL SOIL REMOVAL ACTION WORK PLAN**  
**CANEY, KANSAS**
