# **Integrated Assessment Report Caney Residential Yards Site**

**March, 2015**

**C3-063-73212**

**INTEGRATED ASSESSMENT**

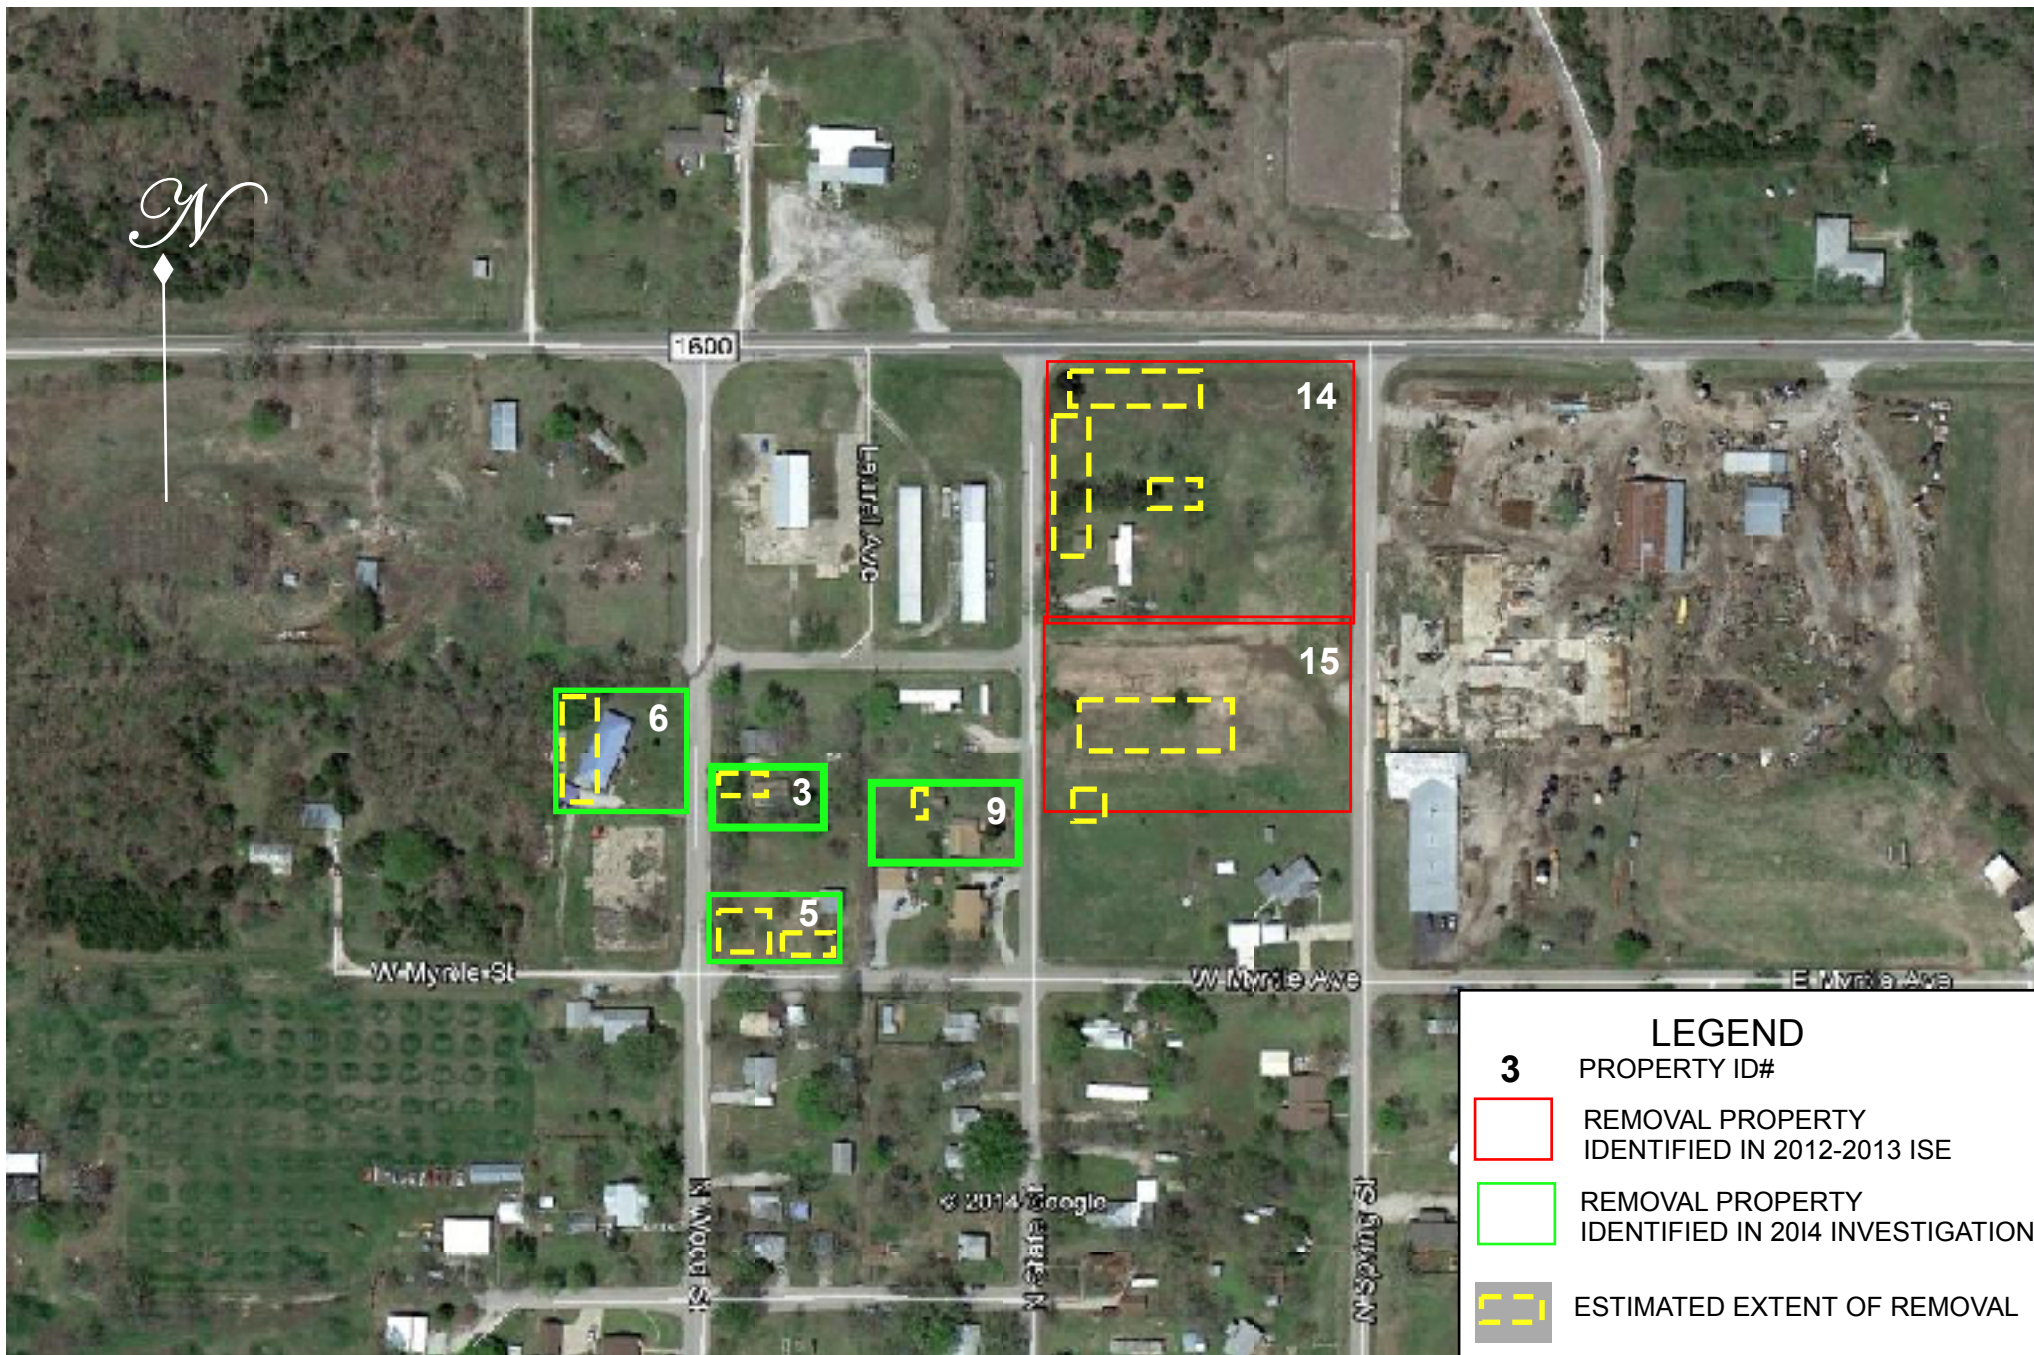
FIGURE 3  
 PROPERTIES SLATED FOR REMOVAL ACTION  
 AND PROPOSED EXCAVATION AREAS

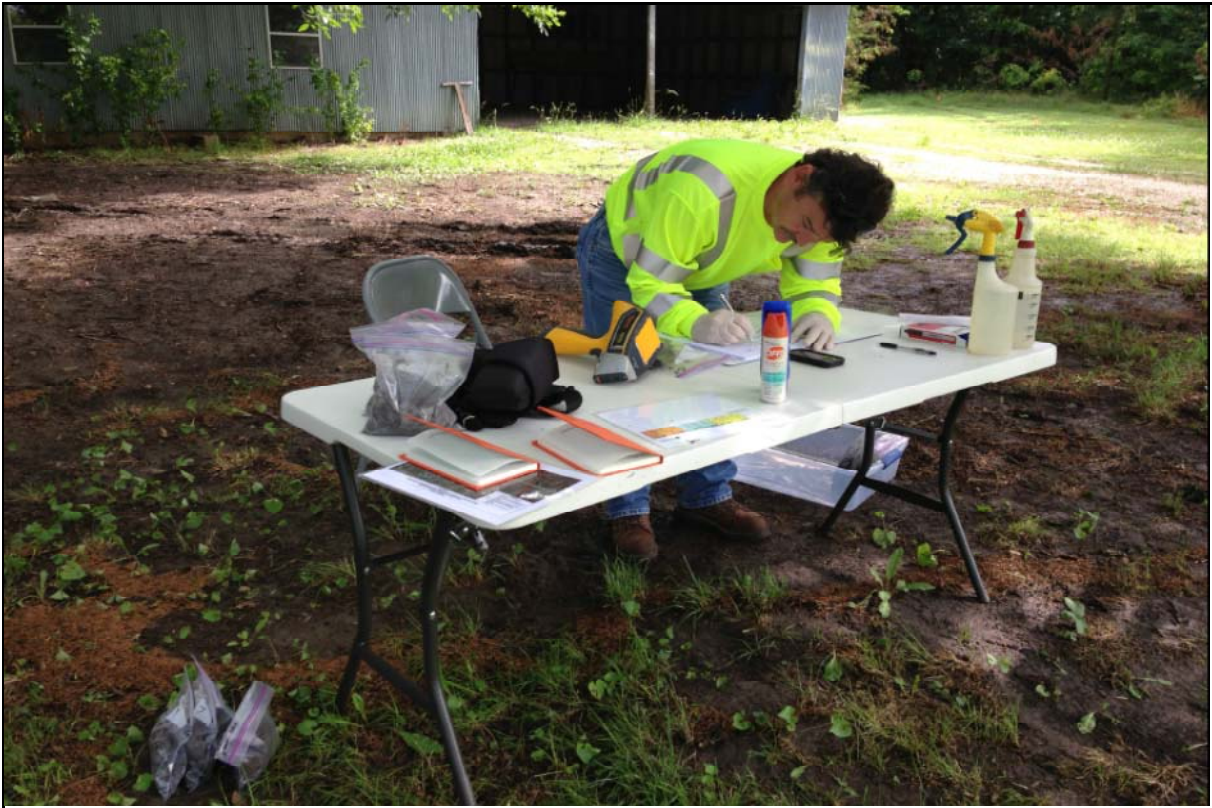
PHOTOGRAPH:	3	PHOTOGRAPHER:	Jenny Self
DATE:	02-Jun-14		
PROJECT:	Owens Residential Sampling Investigation, Former Owens Smelter Site, Caney, Kansas		
SUBJECT:	XRF Sampling Station

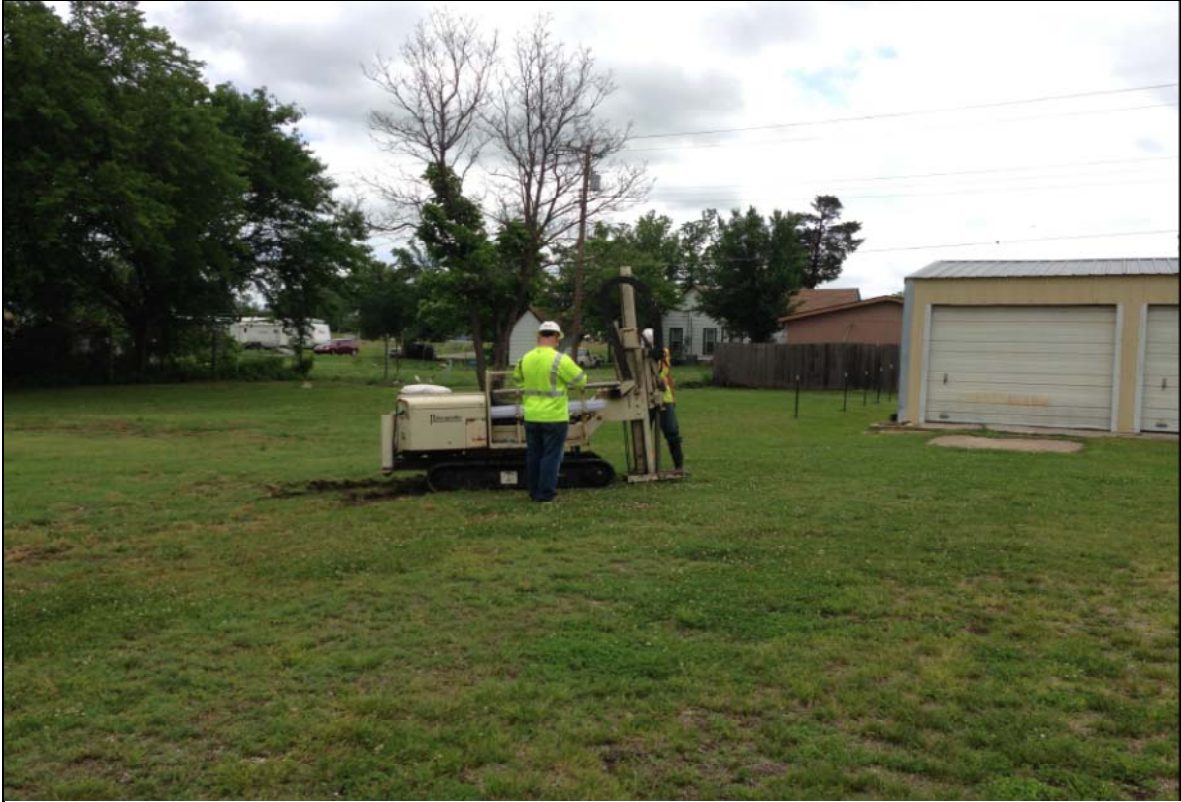
PHOTOGRAPH:	7	PHOTOGRAPHER:	Jenny Self
DATE/TIME:	02-Jun-14		
PROJECT:	Owens Residential Sampling Investigation, Former Owens Smelter Site, Caney, Kansas		
SUBJECT:	Geoprobe Sampling on Property #5

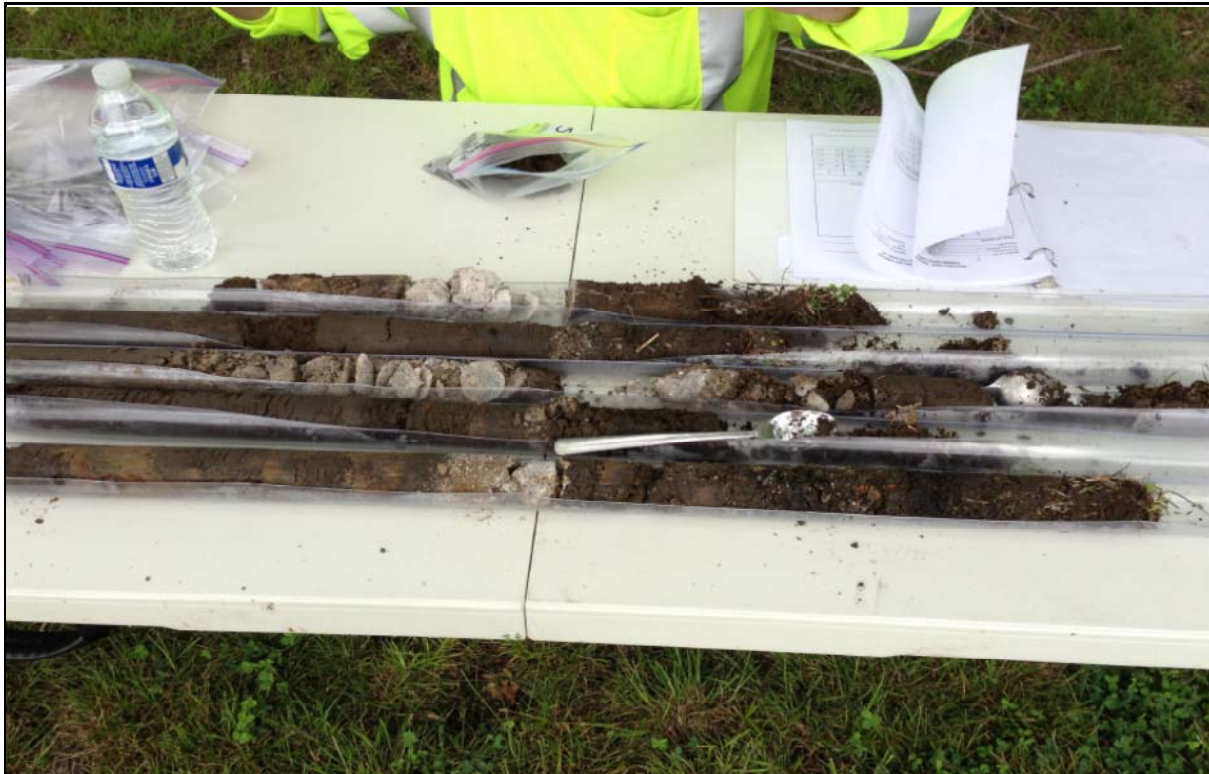
PHOTOGRAPH:	6	PHOTOGRAPHER:	Jenny Self
DATE/TIME:	02-Jun-14		
PROJECT:	Owens Residential Sampling Investigation, Former Owens Smelter Site, Caney, Kansas		
SUBJECT:	Sample MacroCore at Property #5

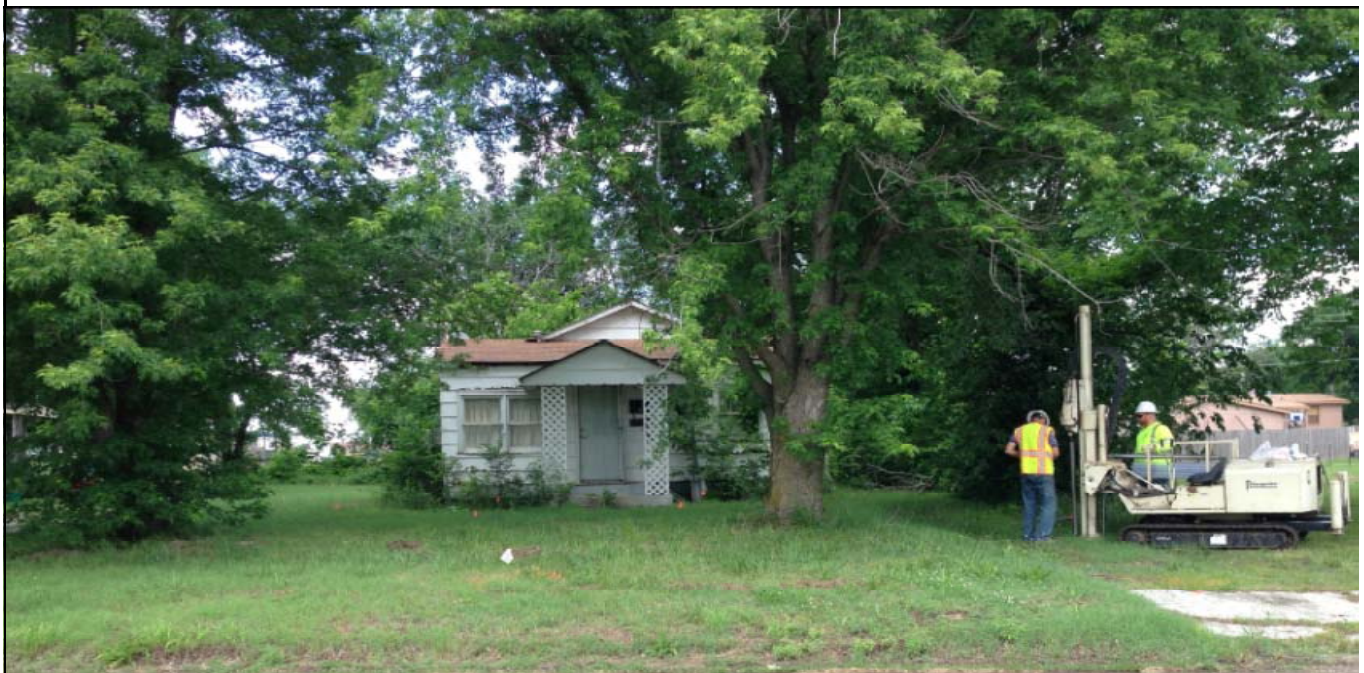
PHOTOGRAPH:	9	PHOTOGRAPHER:	Jenny Self
DATE/TIME:	02-Jun-14		
PROJECT:	Owens Residential Sampling Investigation, Former Owens Smelter Site, Caney, Kansas		
SUBJECT:	Preparing to sample Property #3

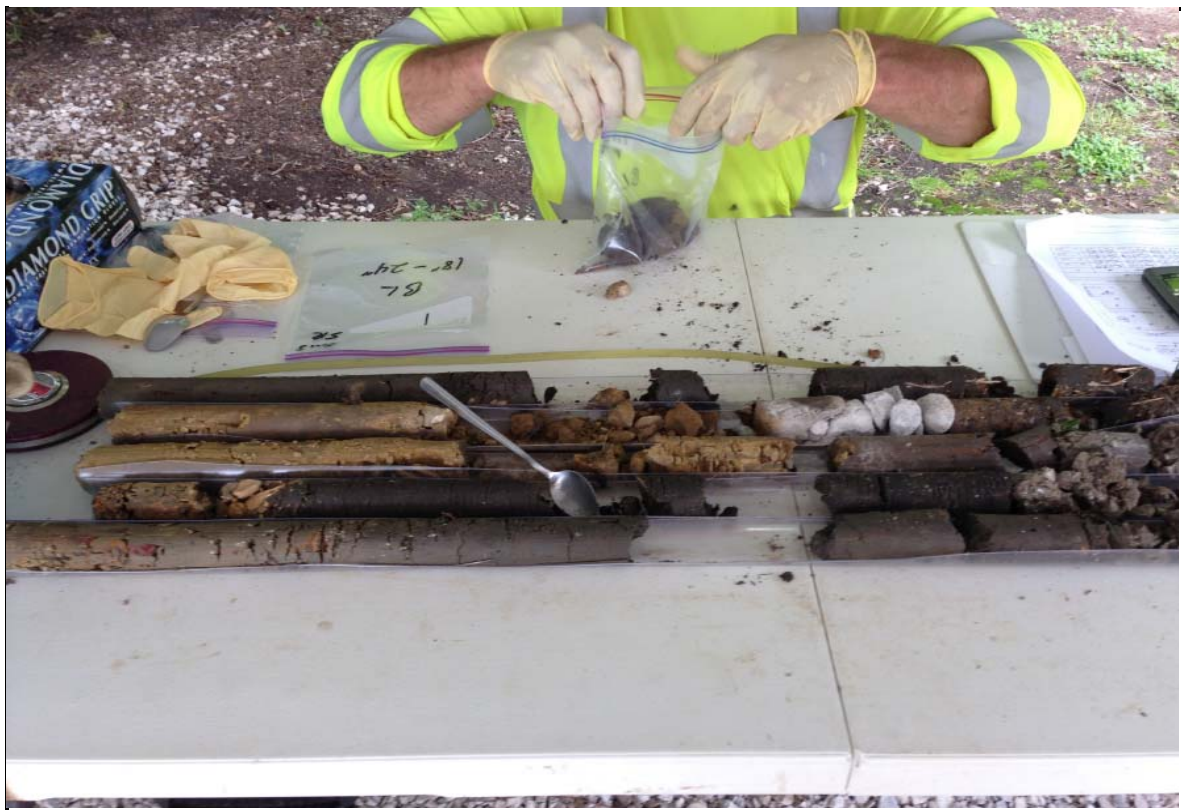
PHOTOGRAPH:	15	PHOTOGRAPHER:	Jenny Self
DATE/TIME:	03-Jun-14		
PROJECT:	Owens Residential Sampling Investigation, Former Owens Smelter Site, Caney, Kansas		
SUBJECT:	Preparing soil samples for XRF analysis

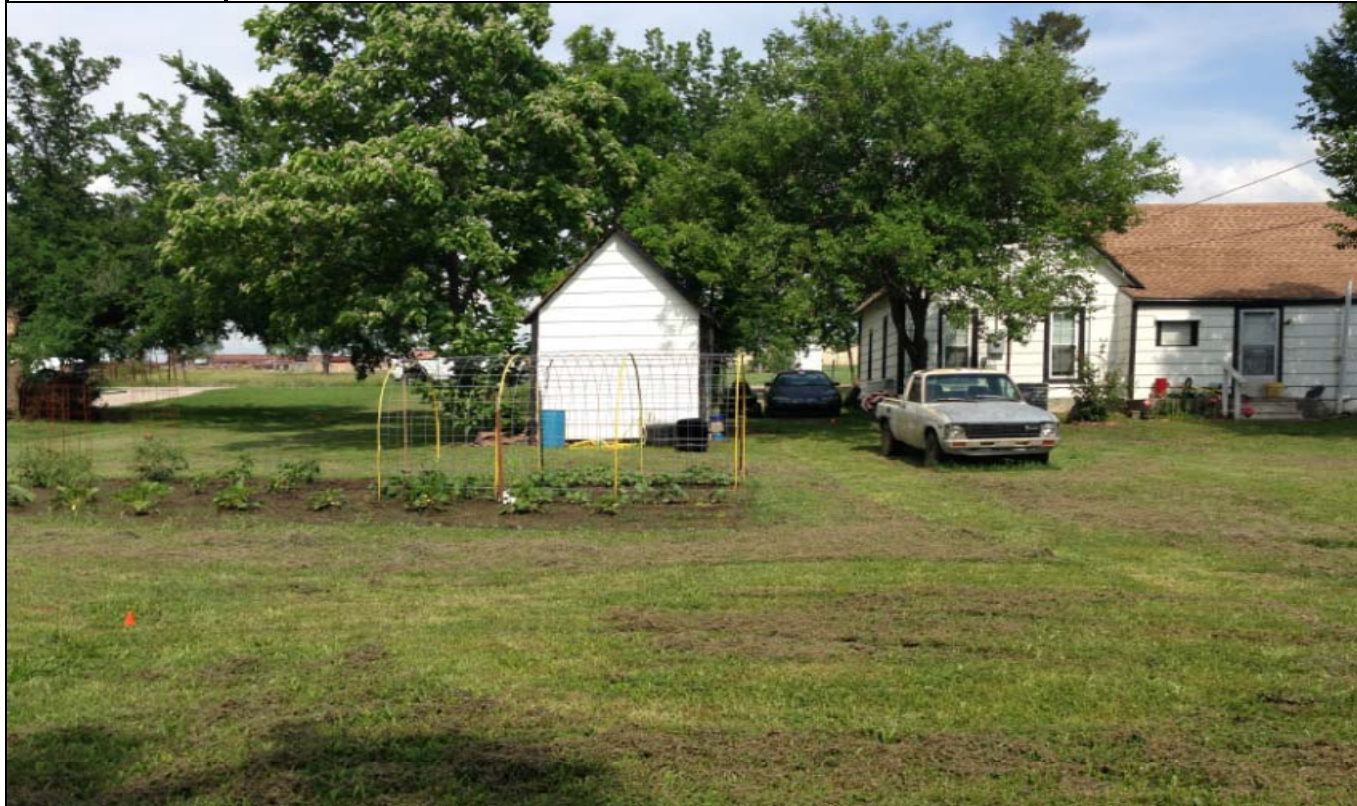
PHOTOGRAPH:	24	PHOTOGRAPHER:	Jenny Self
DATE/TIME:	03-Jun-14		
PROJECT:	Owens Residential Sampling Investigation, Former Owens Smelter Site, Caney, Kansas		
SUBJECT:	Property #9 Garden Area

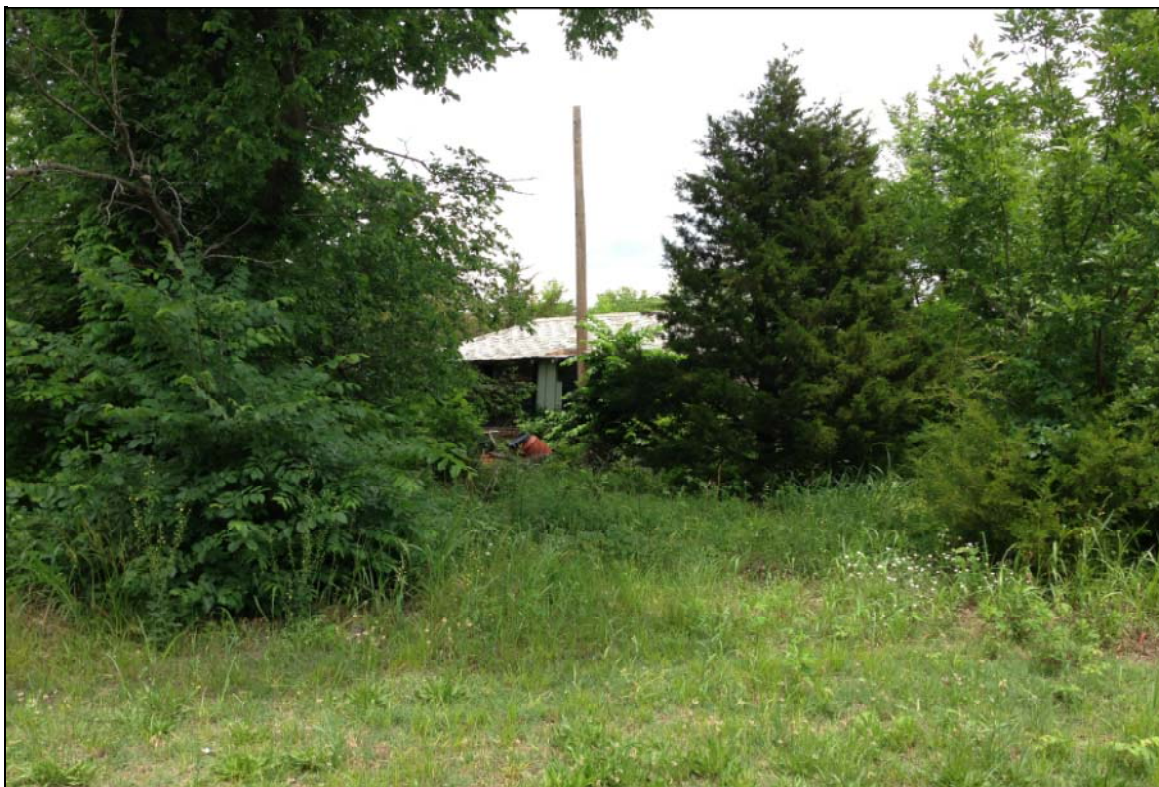
<b>PHOTOGRAPH:</b>	16	<b>PHOTOGRAPHER:</b>	Jenny Self
<b>DATE/TIME:</b>	03-Jun-14		
<b>PROJECT:</b>	Owens Residential Sampling Investigation, Former Owens Smelter Site, Caney, Kansas		
<b>SUBJECT:</b>	Property at corner of Moss and Wood verified to be zoned industrial/commercial with former fuel station structure

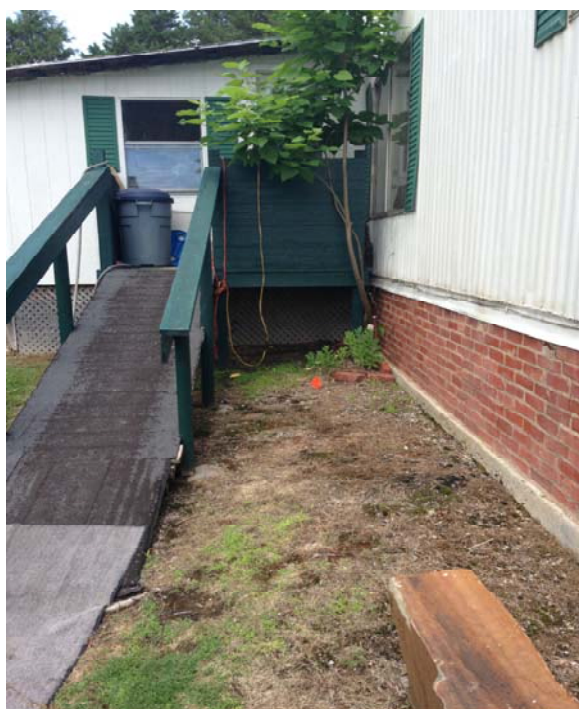
<b>PHOTOGRAPH:</b>	28	<b>PHOTOGRAPHER:</b>	Jenny Self
<b>DATE/TIME:</b>	04-Jun-14		
<b>PROJECT:</b>	Owens Residential Sampling Investigation, Former Owens Smelter Site, Caney, Kansas		
<b>SUBJECT:</b>	Area along house requested to be sampled by Property #14 resident

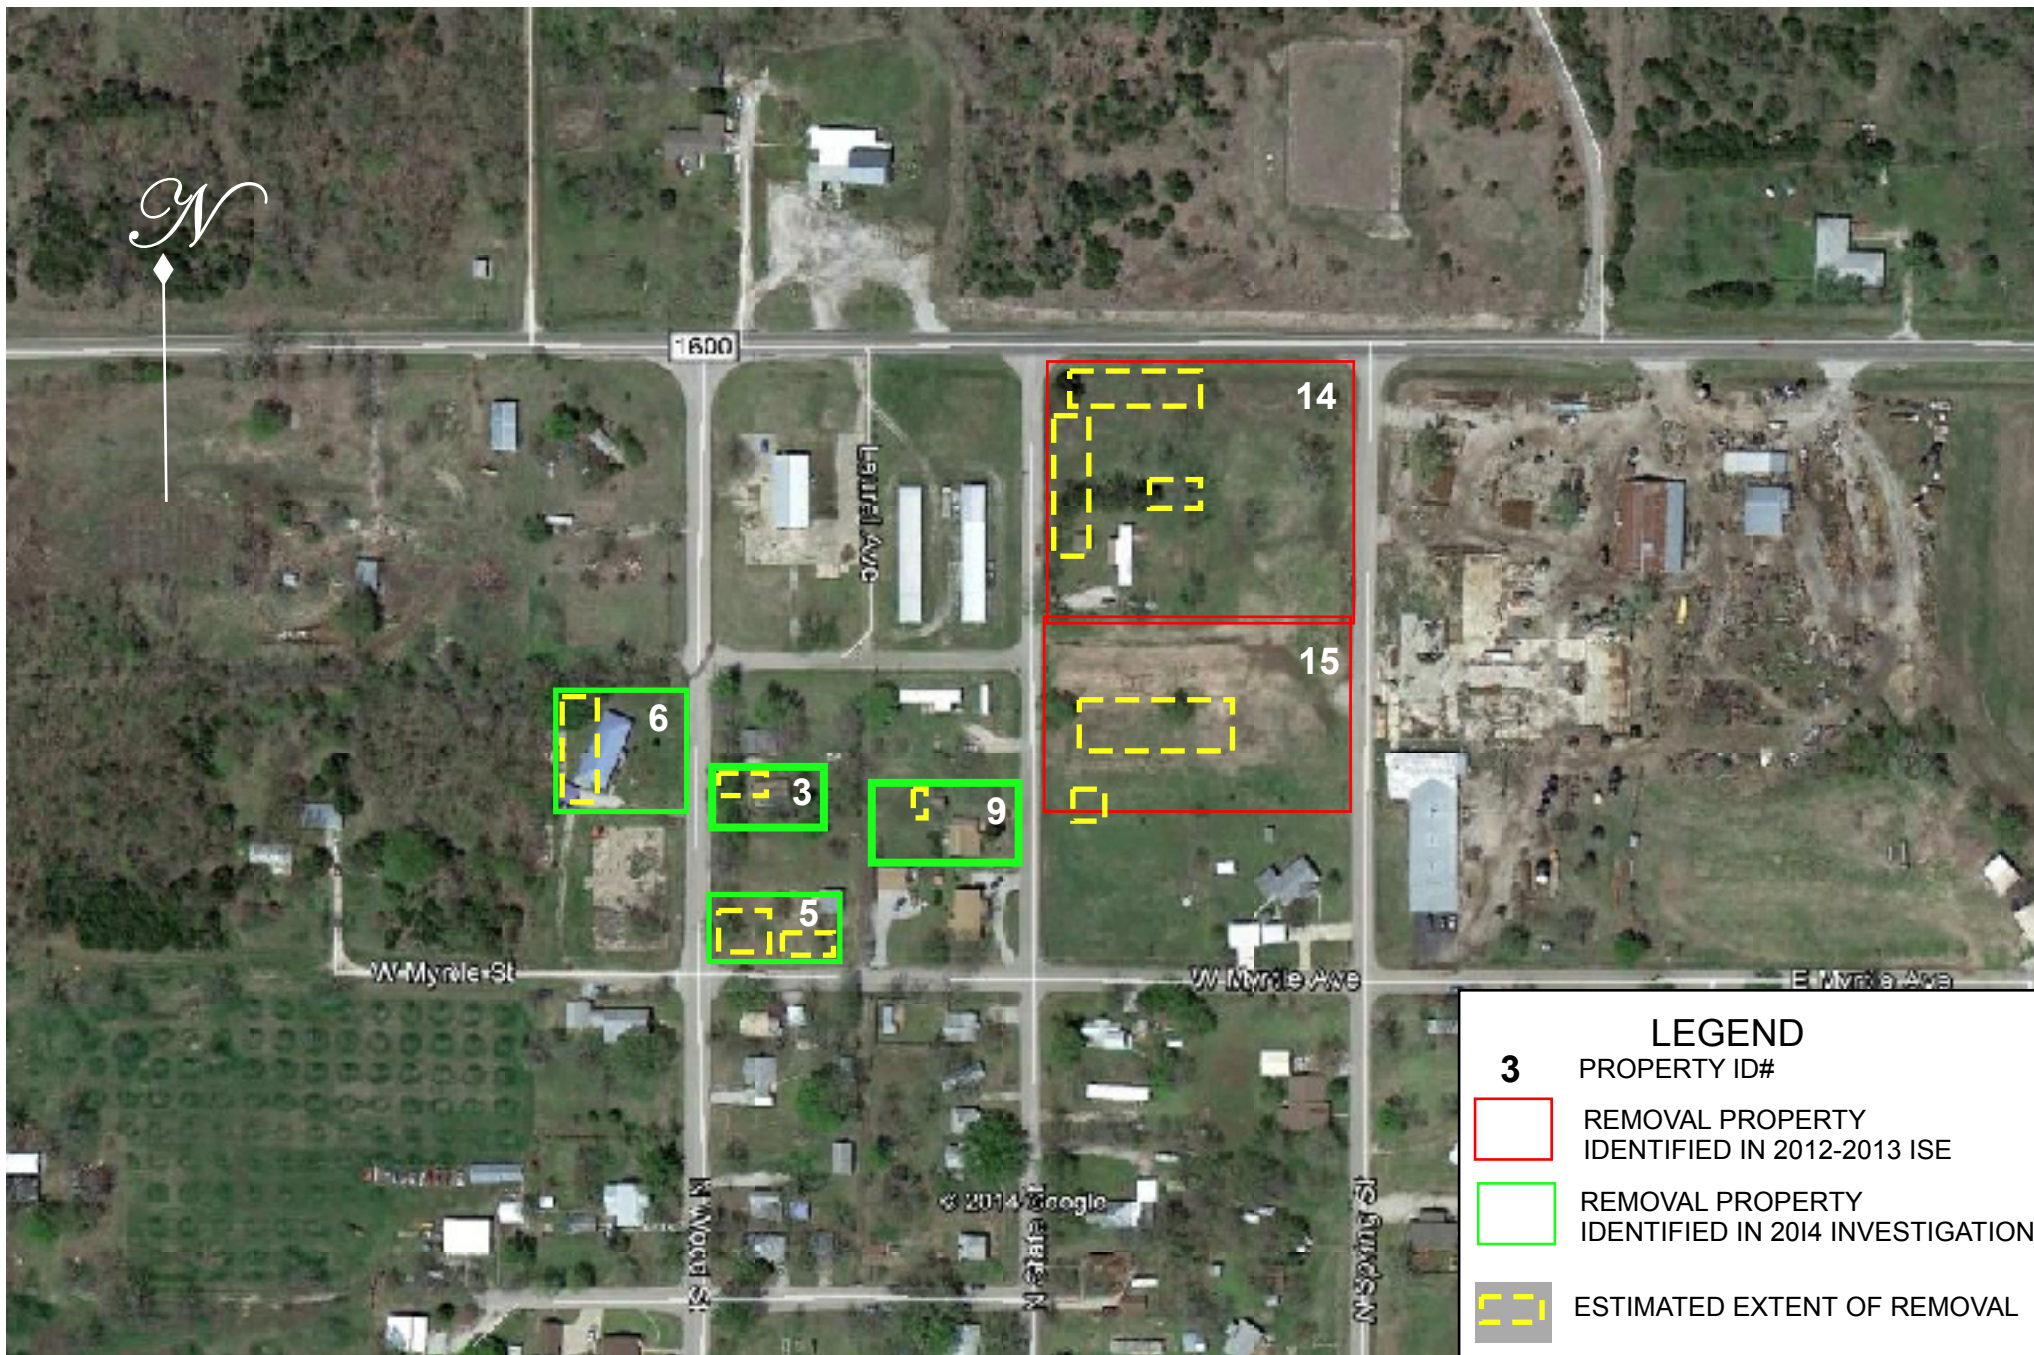
FIGURE 3  
 PROPERTIES SLATED FOR REMOVAL ACTION  
 AND PROPOSED EXCAVATION AREAS
