United States Environmental Protection Agency
Region 8 Emergency Response Unit
Denver, CO

Report: Camp Bird Removal Objectives and Estimated Costs

Site Name: Camp Bird Mine

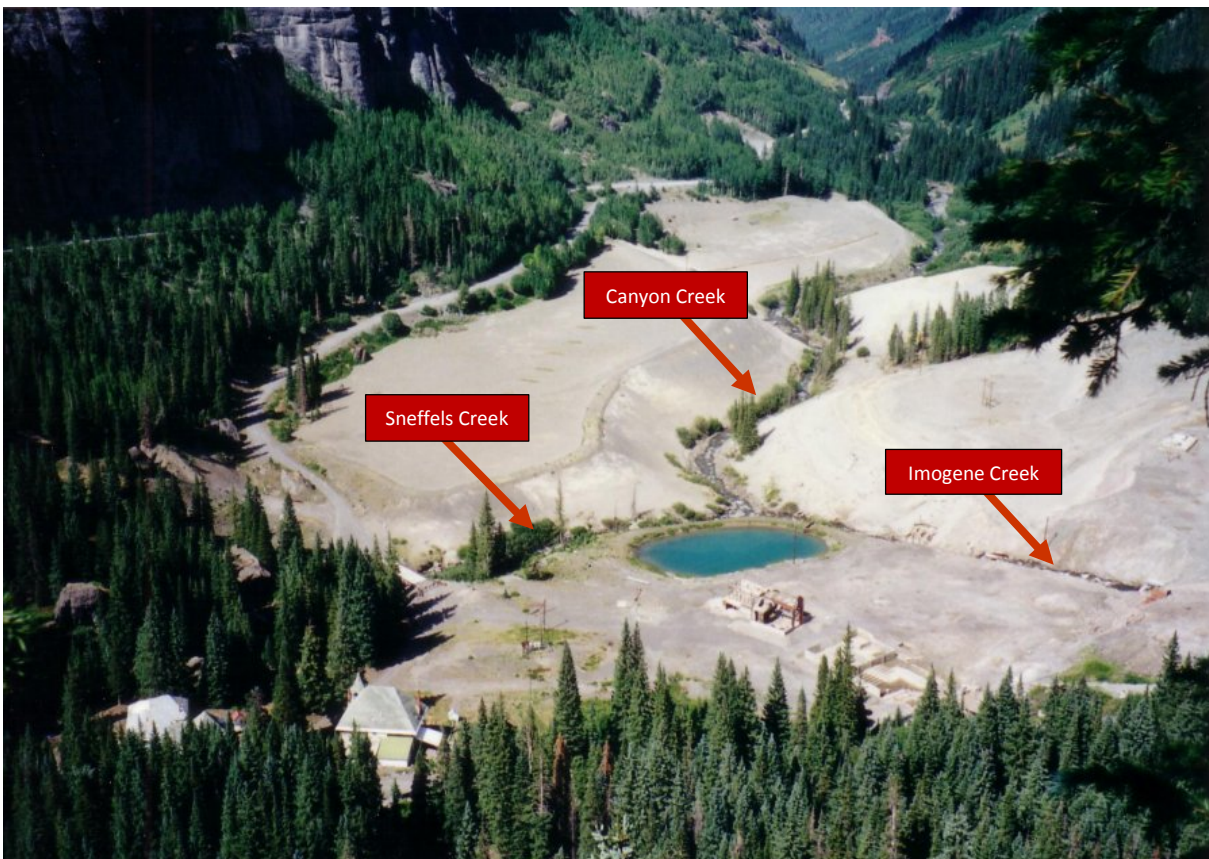
The Camp Bird is a famous gold mine located near Ouray, CO. A large amount of mine waste is located at the entrance to the mine's Level 14. Three water bodies run in direct contact to this mine waste: Sneffels Creek, Imogene Creek and Canyon Creek (which is formed by the confluence of Sneffels and Imogene Creeks).

Aerial View of the Camp Bird Mine at the Entrance to Level 14 in 2002¹

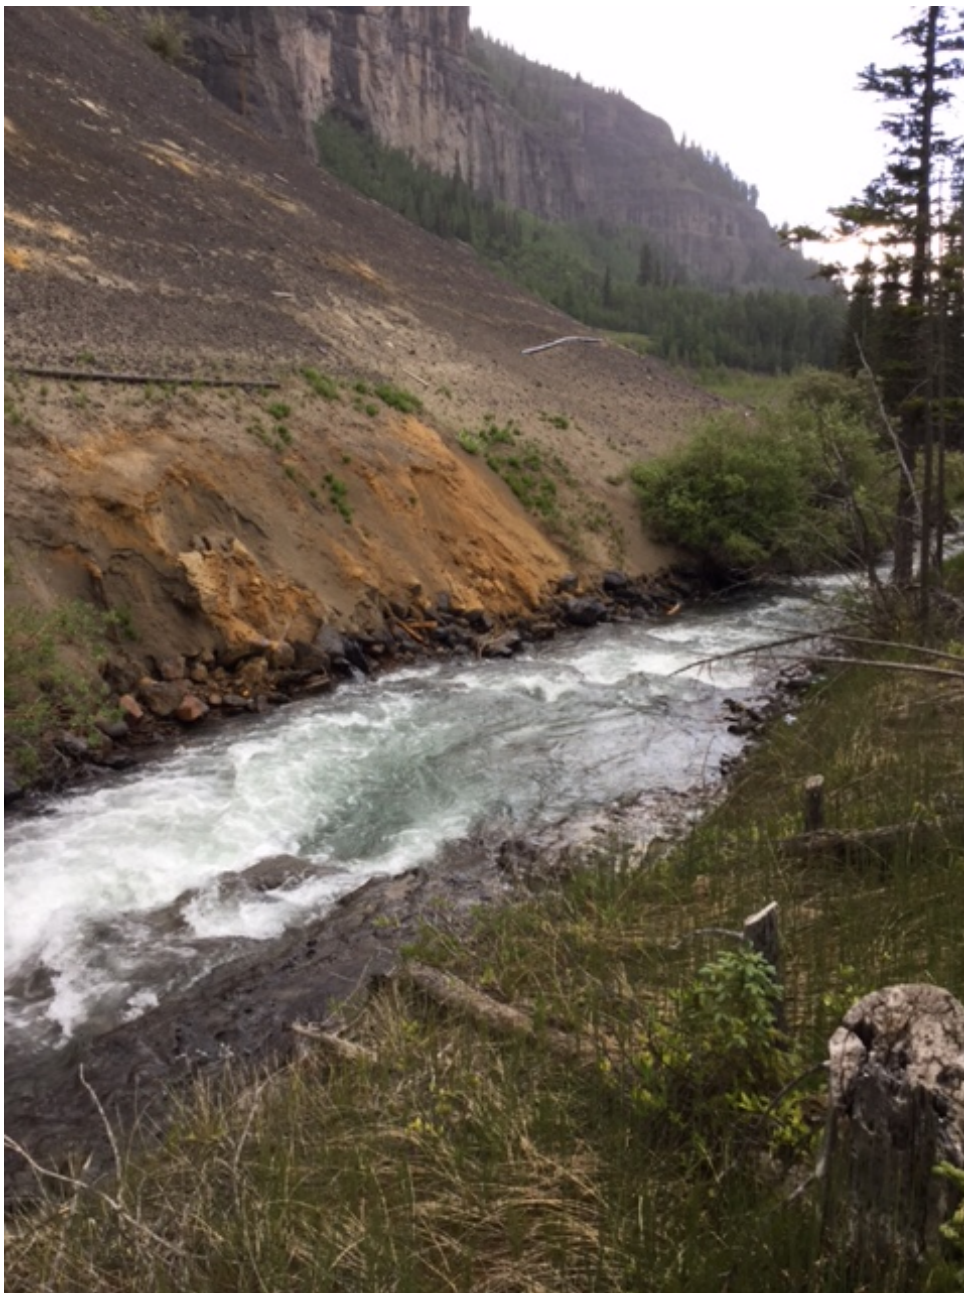
EPA response personnel have visited the site during a variety of stream flow regimes. Mine waste containing heavy metals is being actively eroded into Sneffels Creek, Imogene Creek and Canyon Creek. There is a potential that this erosion may dramatically increase due to increased runoff, streamflow and/or the mass failure of existing slopes. Although some areas at the site are included in an existing mining permit with the State of Colorado, the mine is in bankruptcy and is not being maintained.

Contaminated Material Entering Canyon Creek at the Camp Bird Mine

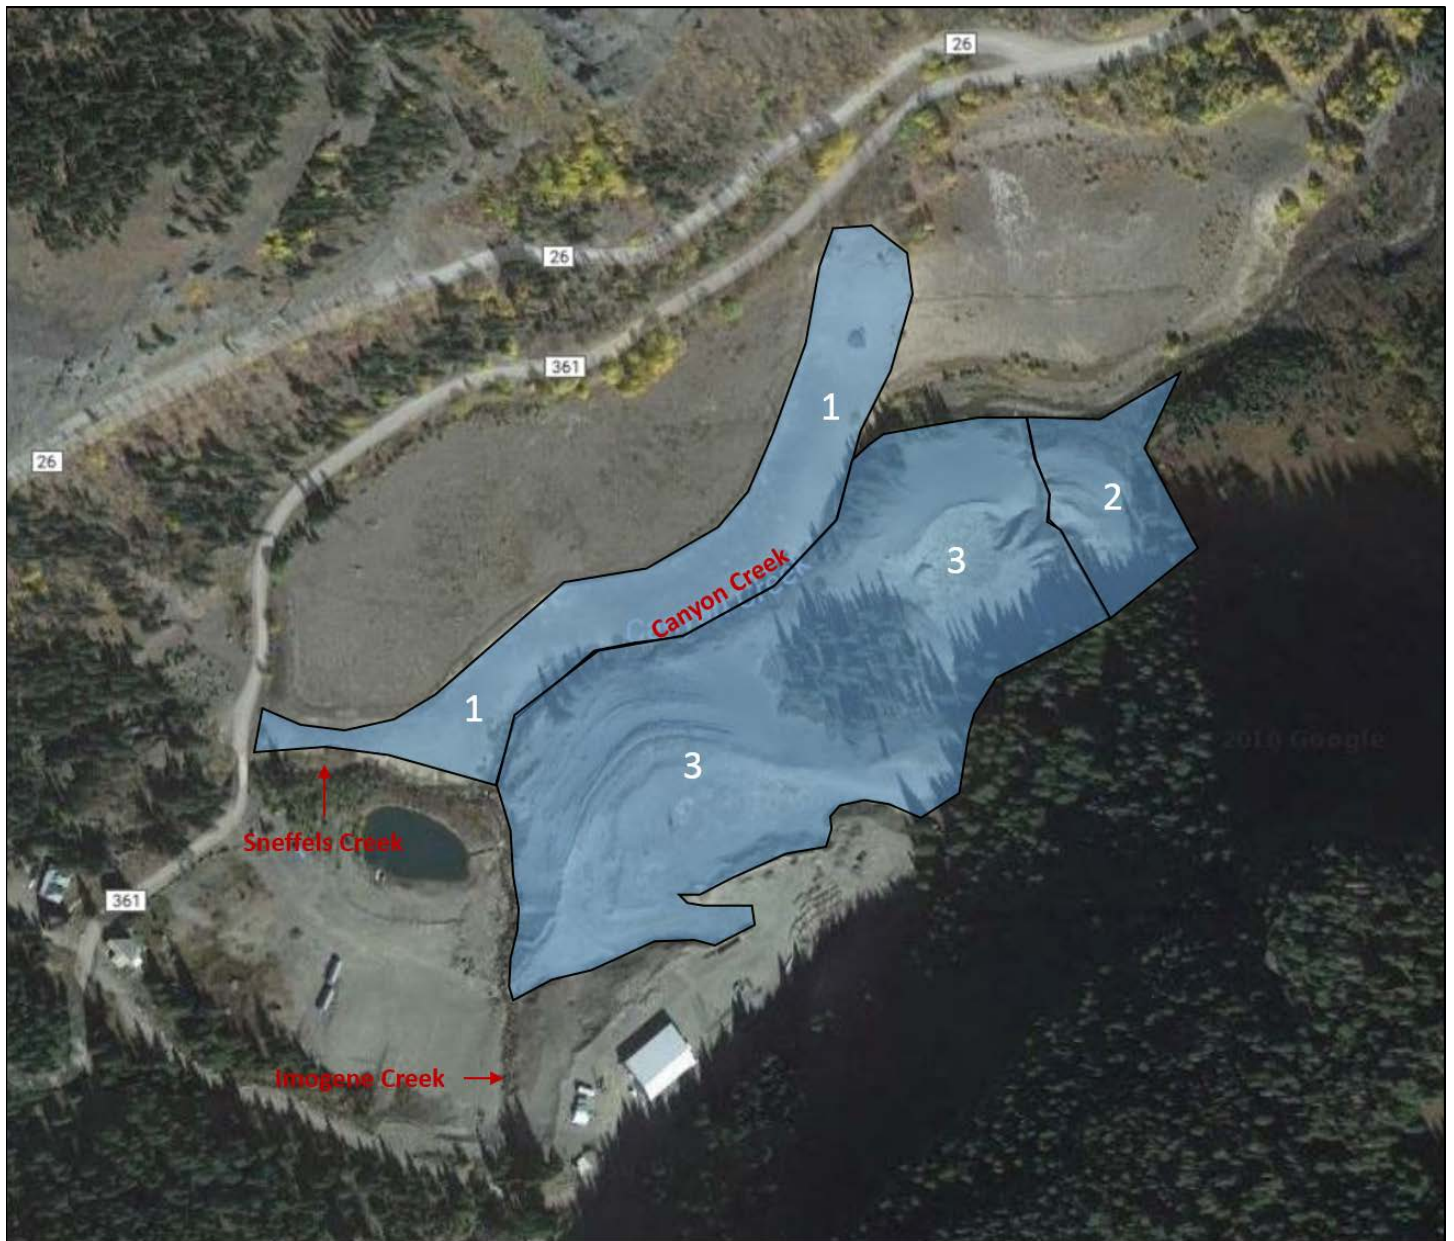
Areas of Interest at the Camp Bird Site

The area to the north of both Sneffels Creek and Canyon Creek is a large tailings deposit. This area is included in an existing mining permit with the State of Colorado but the property is in bankruptcy and the area is not being maintained. The slopes of this tailings deposit are not well covered and are showing signs of instability. These slopes are depicted in Area 1 of the attached diagram.

The waste deposit that is furthest downstream on the south side of Canyon Creek is uncovered and bisected by a side drainage which is actively eroding the deposit. This area is not included in the existing mining permit with the State of Colorado. This area is depicted as Area 2 in the attached diagram.

The large waste deposits south of Canyon Creek and between Imogene Creek and the side drainage (see Objective #2) are uncovered and immediately adjacent to all three drainages. This area is not included in the existing mining permit with the State of Colorado. This area is depicted as Area 3 in the attached diagram.

The slope of the tailings deposit along Sneffels Creek upstream of its confluence with Canyon Creek shall be regraded to pull the toe back away from the creek. Sneffels Creek shall be restored to accommodate flood events.

All slopes in Area 1 shall be stabilized with erosion fabric that is keyed in at the top and bottom. This erosion fabric will be covered with large rip rap at the base of the slopes along the creeks and smaller rip rap towards the top. Much of this rip rap material may be harvested from Level 3 of the Camp Bird Mine workings. *An acceptable alternative approach to the slopes in Area 1 would be to completely regrade them to support the application of topsoil and/or compost and revegetation.*

The waste deposit east of the side drainage shall be removed and consolidated with the waste on the west side of the side drainage. The disturbed area shall be amended with topsoil and/or compost and revegetated. Erosion control features shall be constructed and the side drainage shall be stabilized with rip rap. This rip rap material may be harvested from Level 3 of the Camp Bird Mine workings.

The waste deposits in Area 3 shall be excavated back away from Imogene Creek, Canyon Creek and the side drainage. The choke point in Canyon Creek shall be removed, the banks of the drainages shall be armored with rip rap and the drainages shall be restored with vegetation and erosion control features to accommodate flood events.

The waste deposits shall be regraded. Regraded slopes should not exceed a 3:1 gradient. Waste material shall be consolidated upland away from the creeks. Erosion control features shall be installed across the entire area. Uncovered areas shall be amended with topsoil and/or compost and revegetated.
