**PHASE I
ENVIRONMENTAL SITE ASSESSMENT**

FORMER McLOUTH STEEL FACILITY

**1491 WEST JEFFERSON AVENUE
TRENTON, MICHIGAN 48183**

August 8, 2017

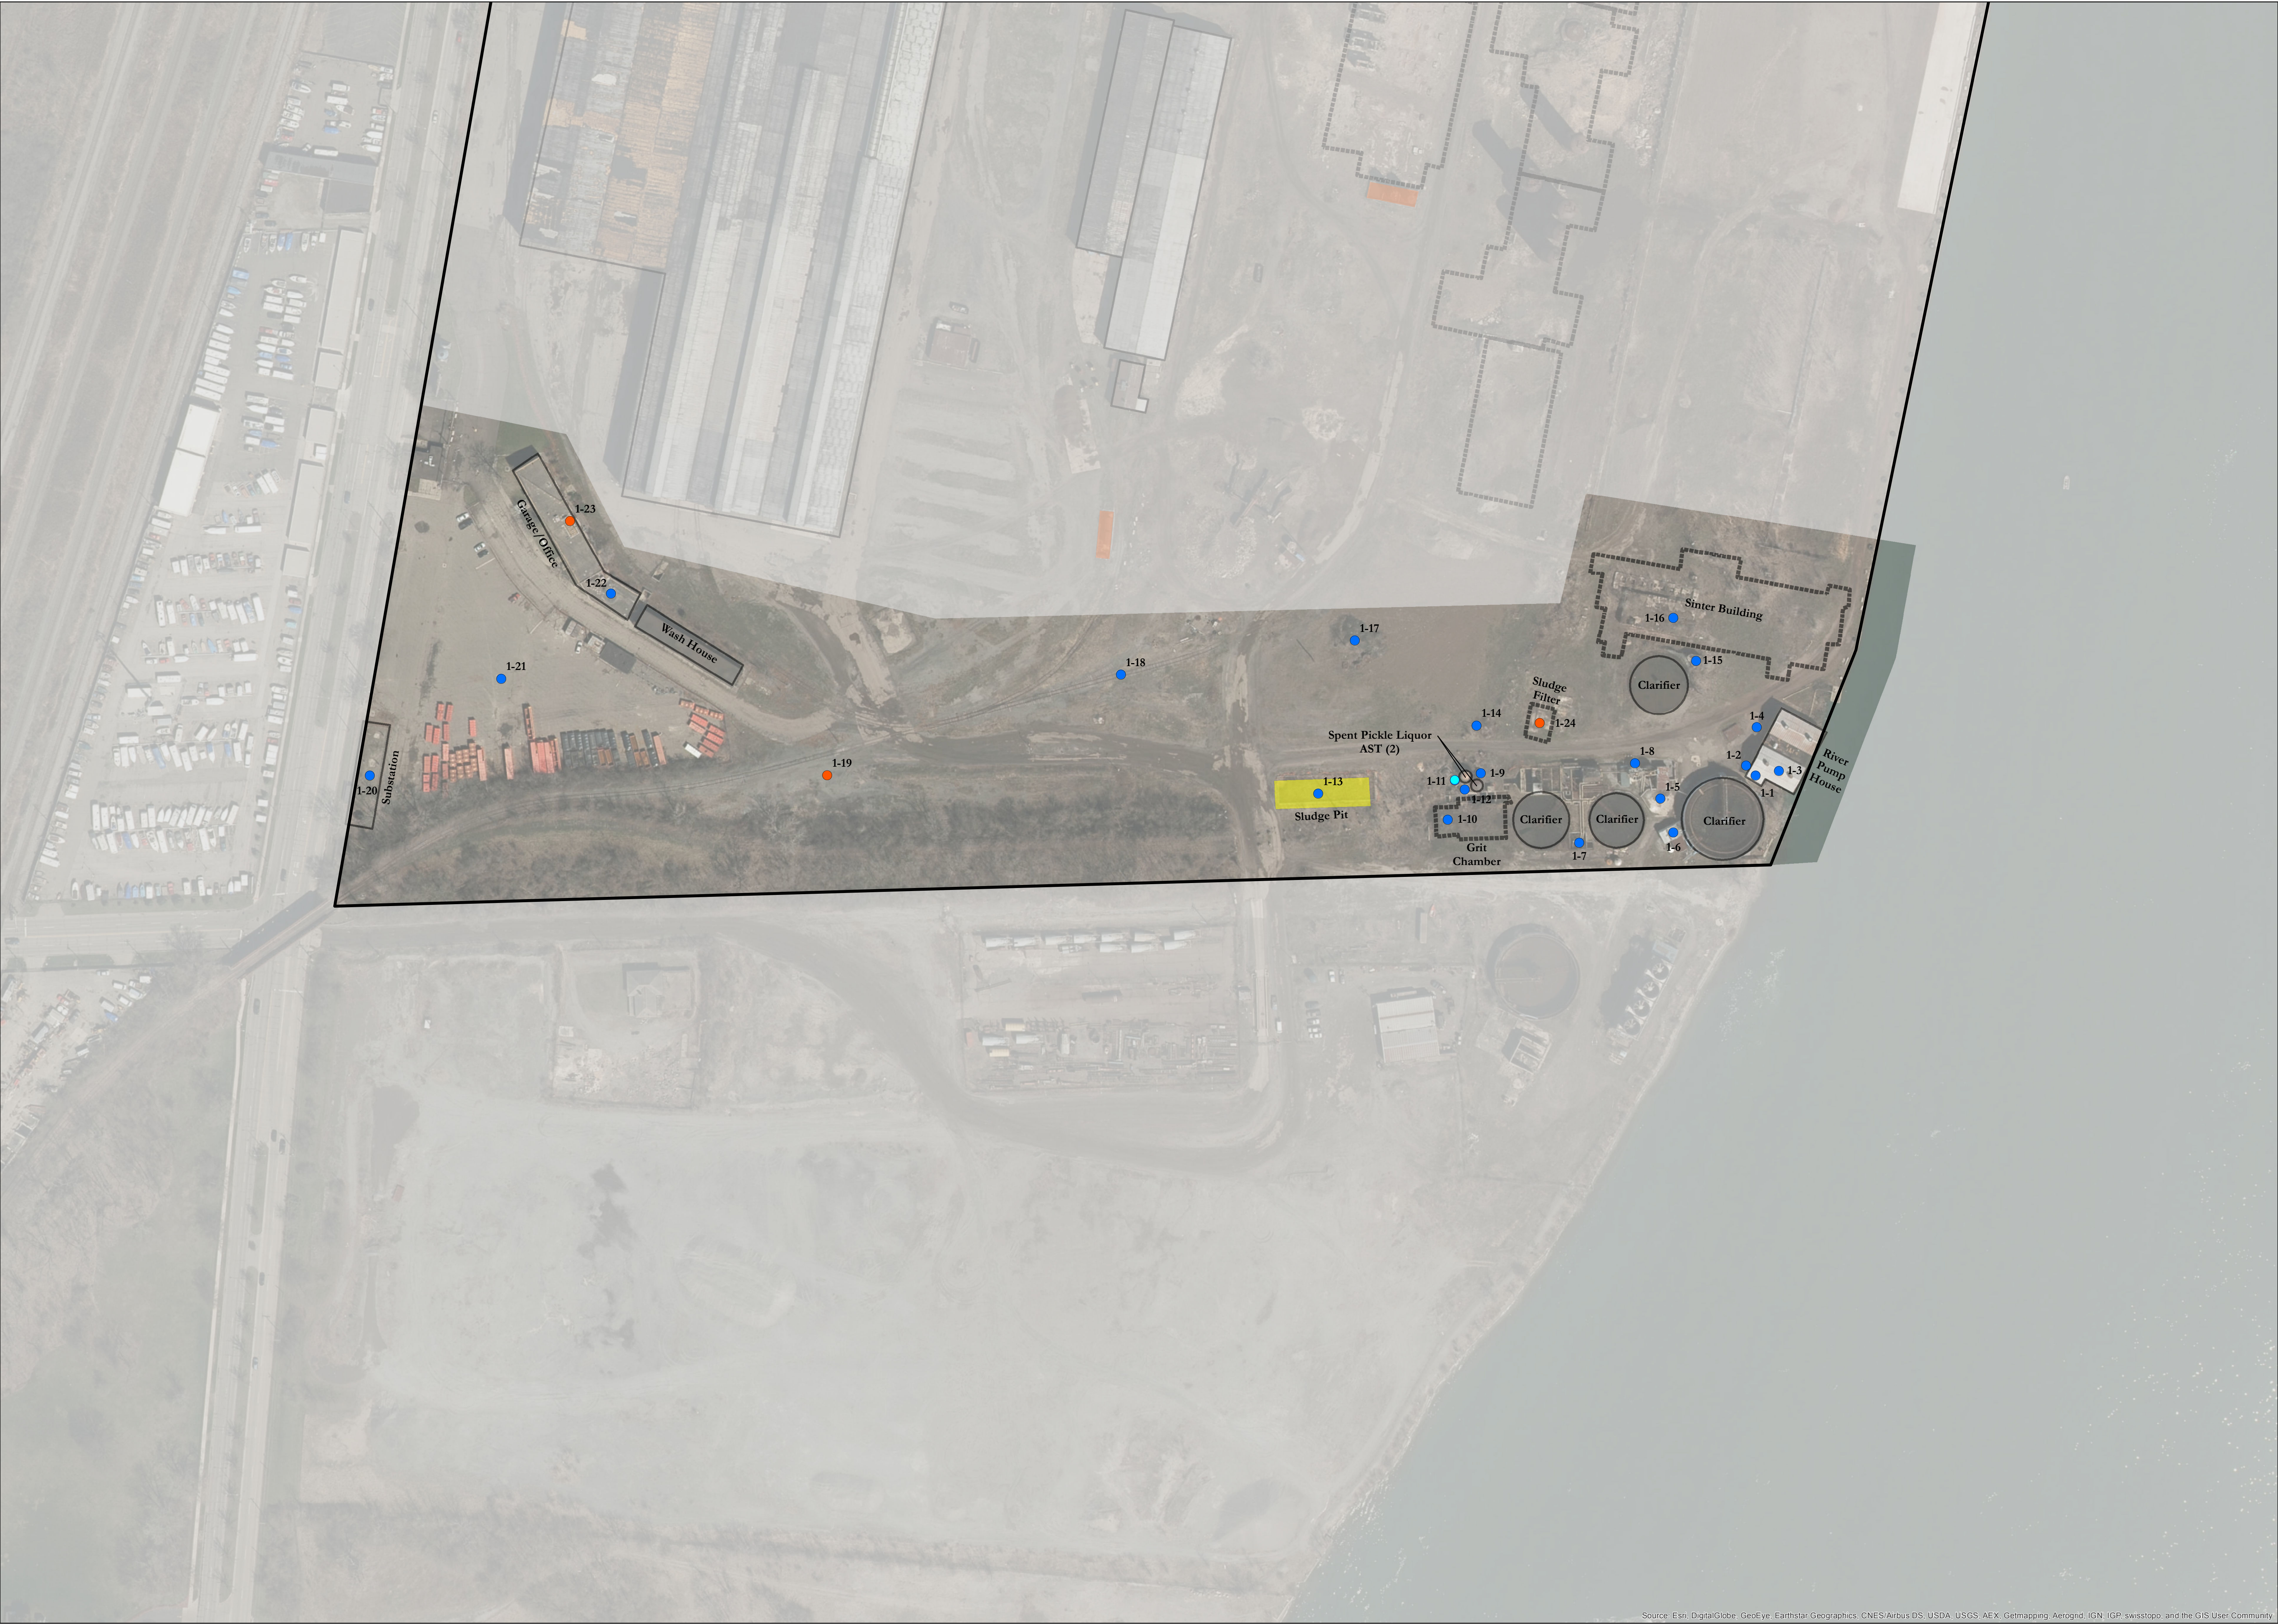
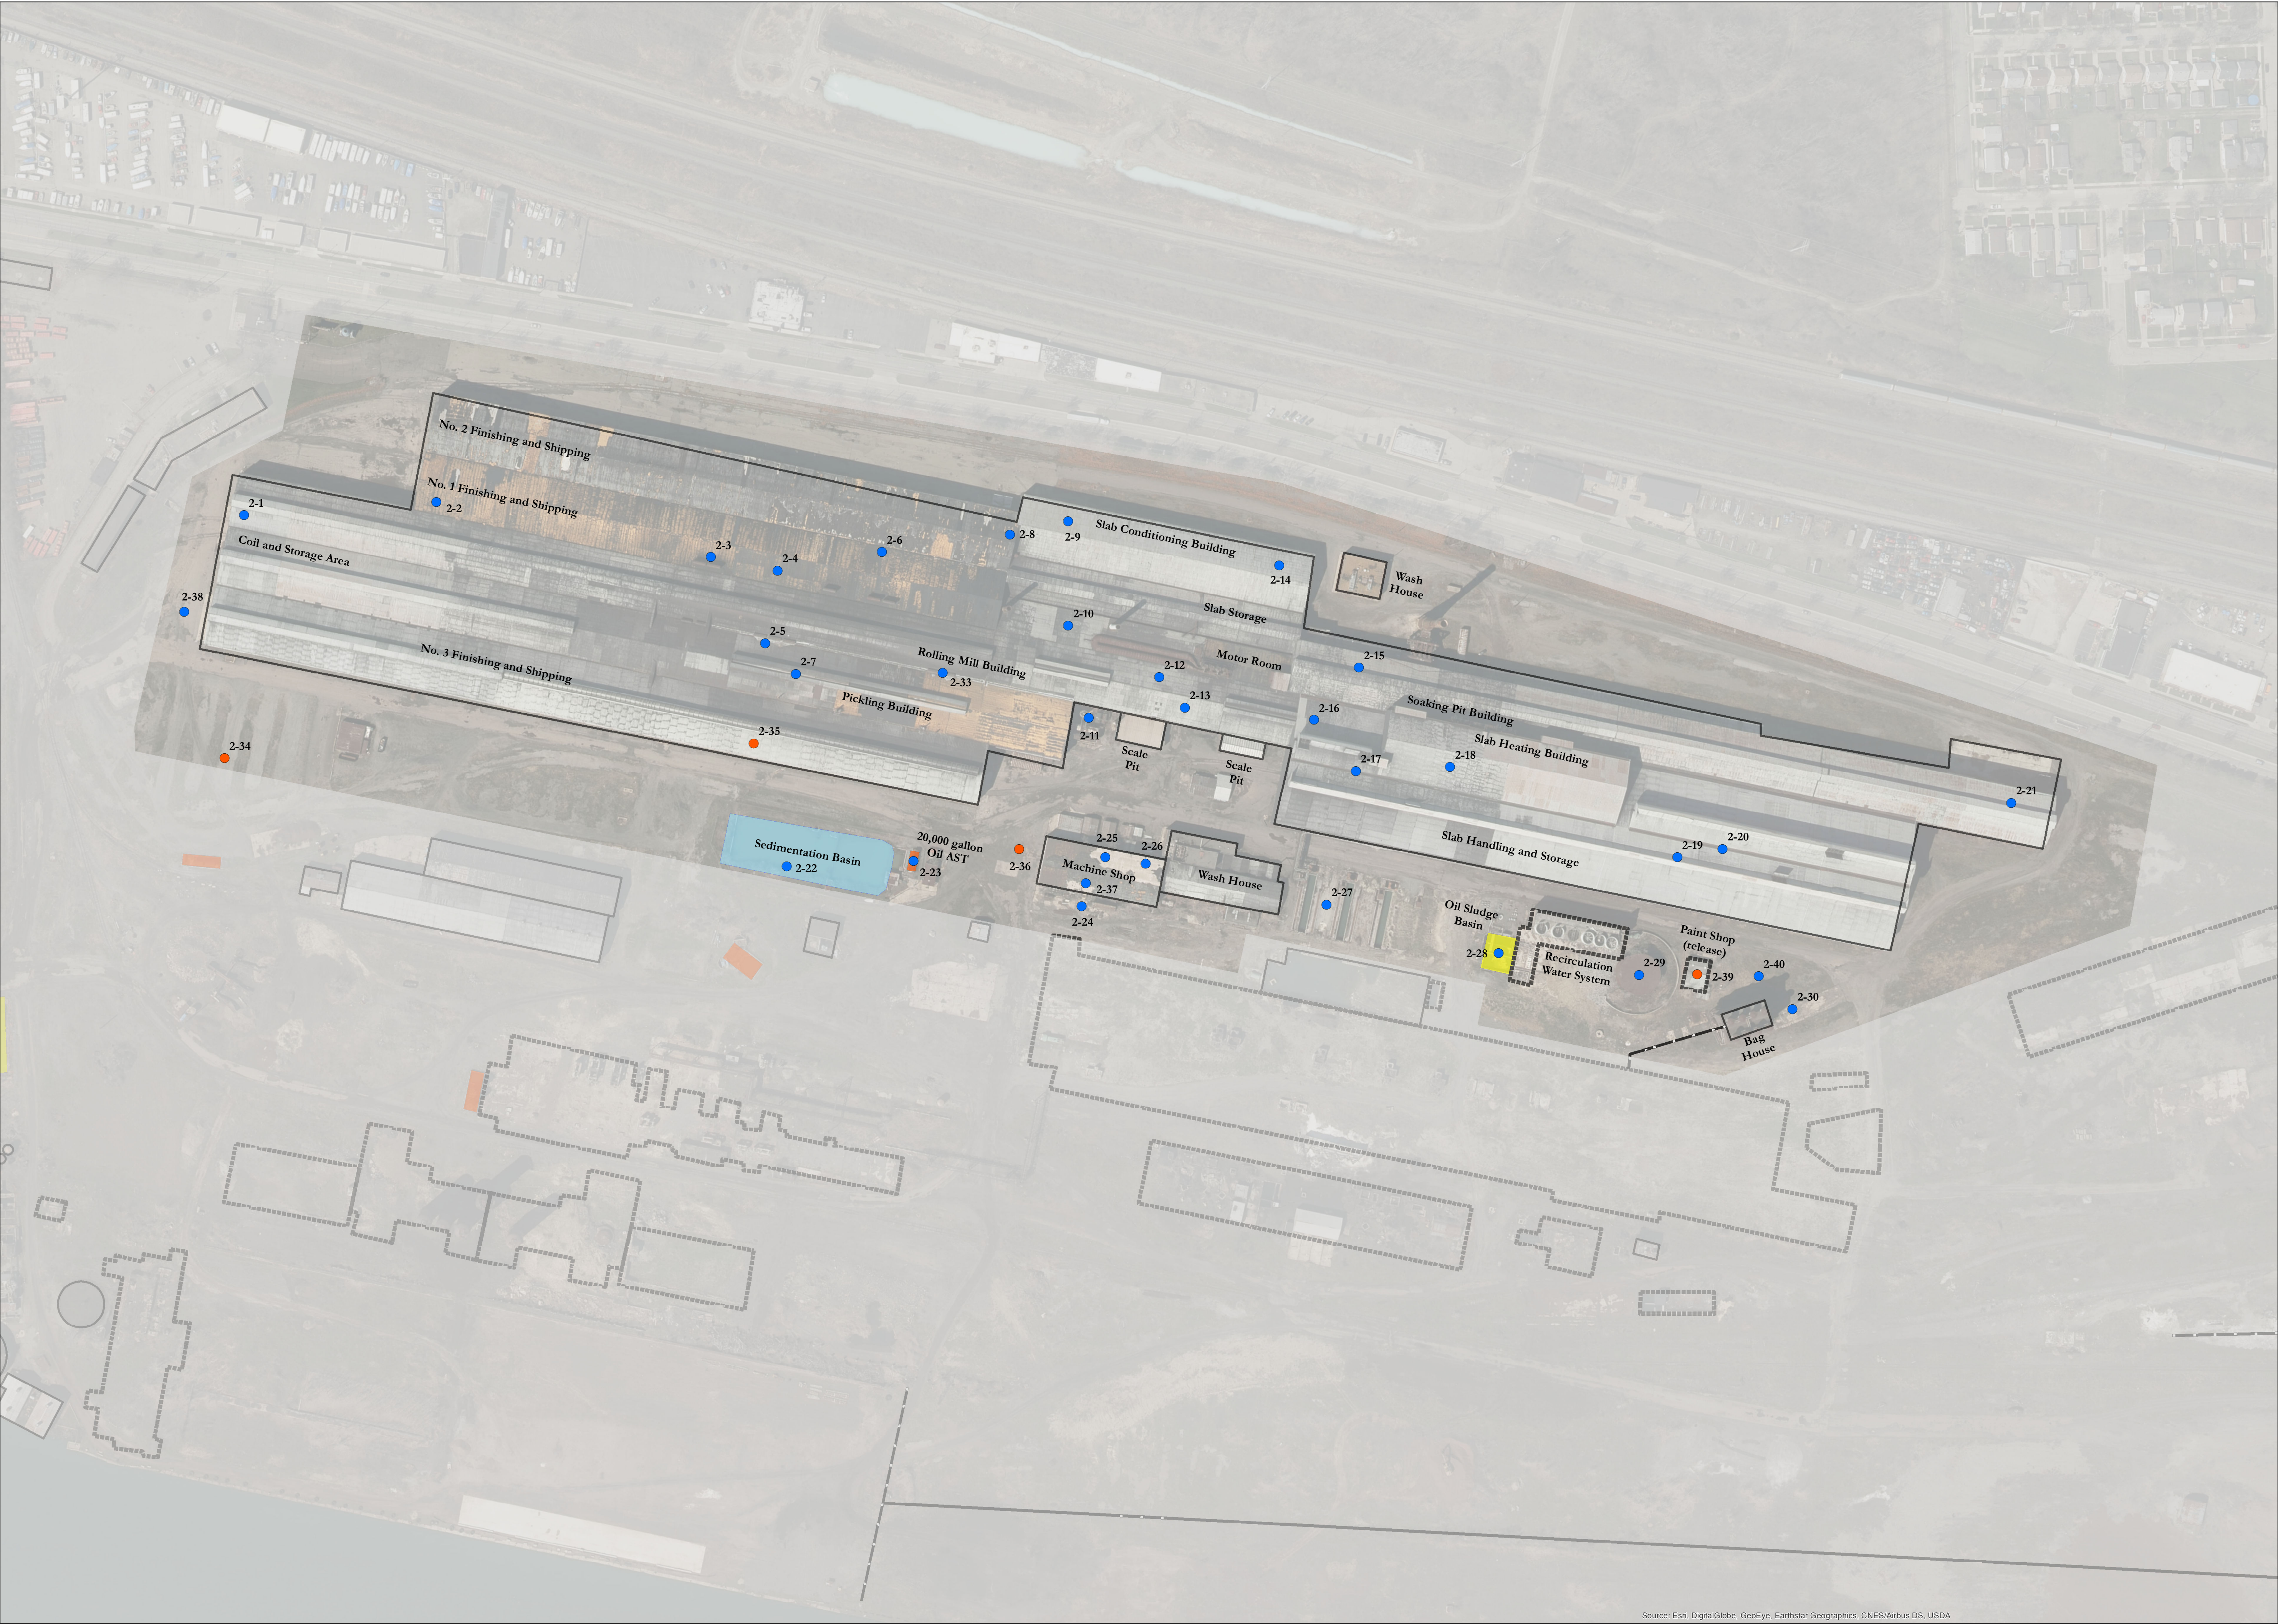
Former McLouth Steel
Figure 4
Area 1 Recognized
Environmental Conditions

A total of (134) RECs were identified during this Phase I ESA. The RECs are divided into five separate tables that provide descriptions of the RECs for each of the five areas. The locations of these RECs are presented in **Figures 4 - 8** respectively. In addition, RECs that were identified through the review of previous investigations and the records review are listed in Table 7.1 below.

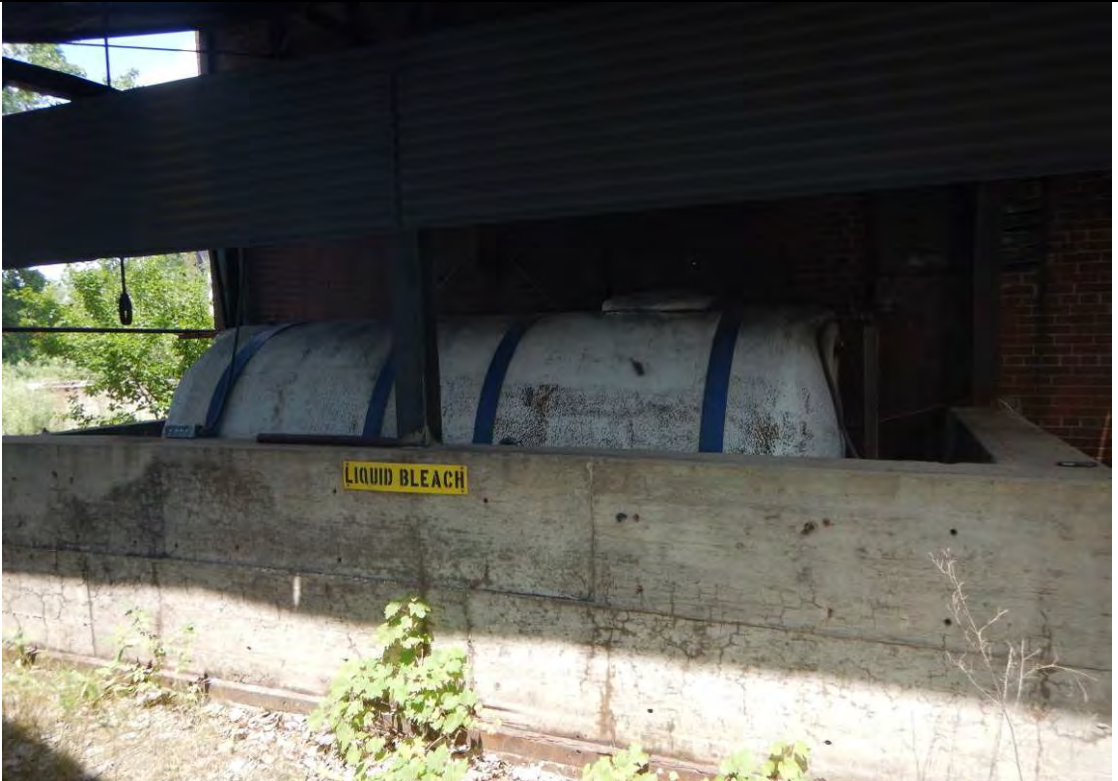
Direction Photo Taken: North			
Description: Area 1 6,000-gallon above ground storage tank, liquid bleach south of River Pump House.

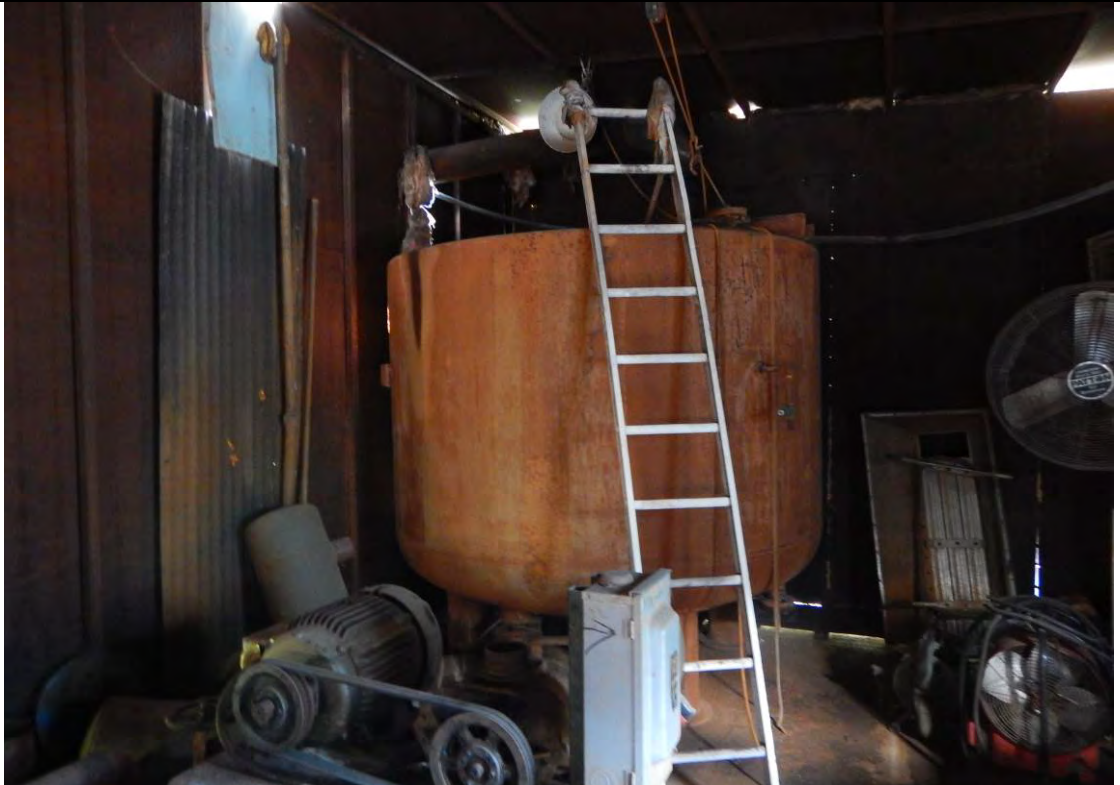
Client Name: City of Trenton		Site Location: 1491 W. Jefferson Avenue, Trenton, MI 48183	Project No. 170443-0100
Photo No. 7	Date: 7/17/17

Direction Photo Taken: N/A			
Description: Area 1 Unknown tank near clarifier at CWWTP.

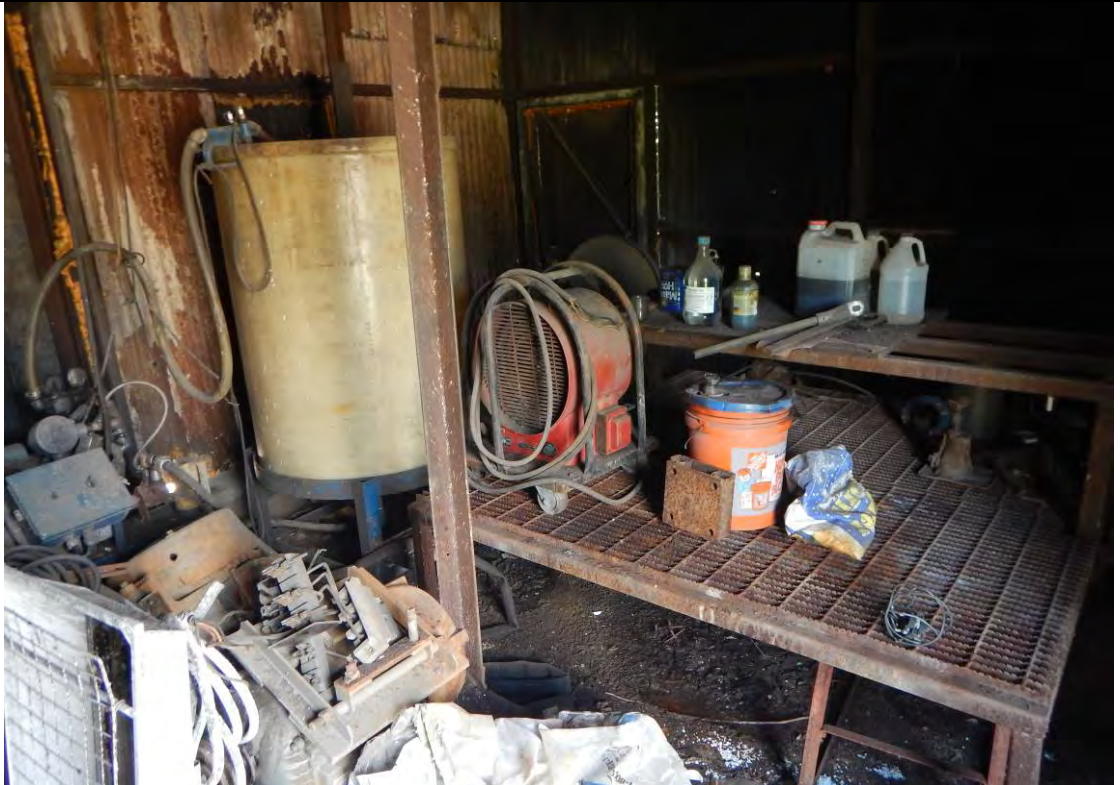
Client Name: City of Trenton		Site Location: 1491 W. Jefferson Avenue, Trenton, MI 48183	Project No. 170443-0100
Photo No. 9	Date: 7/17/17

Direction Photo Taken: West			
Description: Area 1 Unknown tank and acid containers.

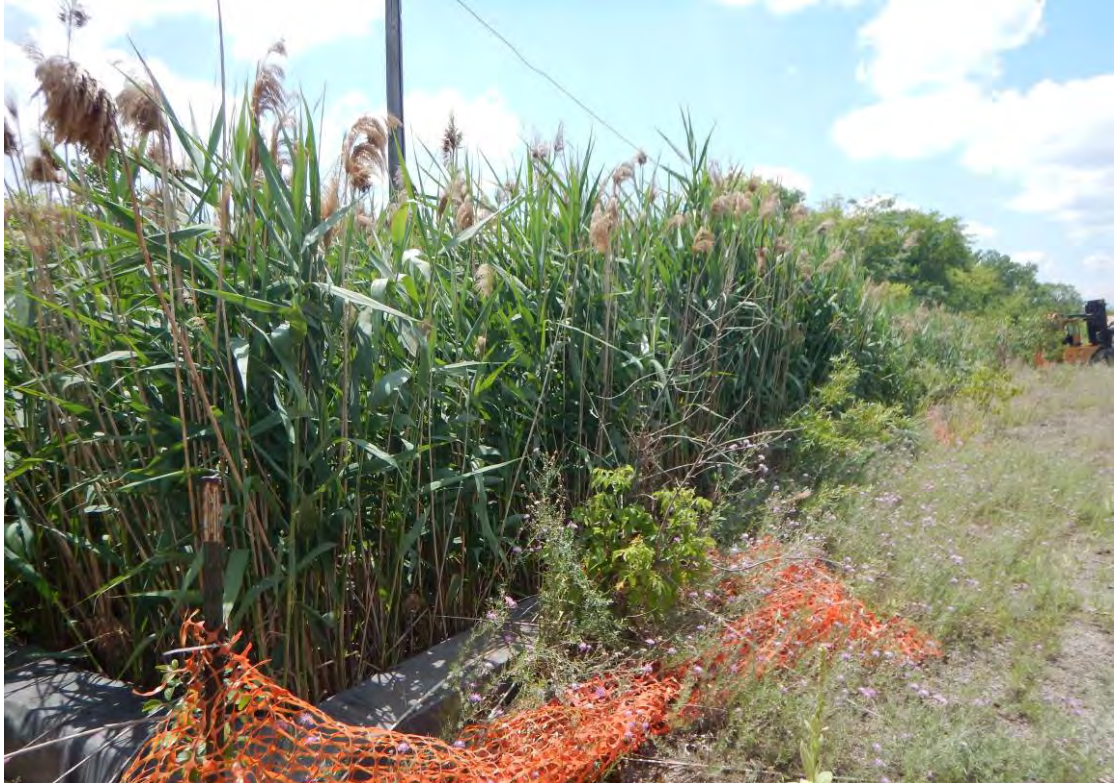
Direction Photo Taken: West			
Description: Area 1 Former sludge pit with overgrown vegetation.

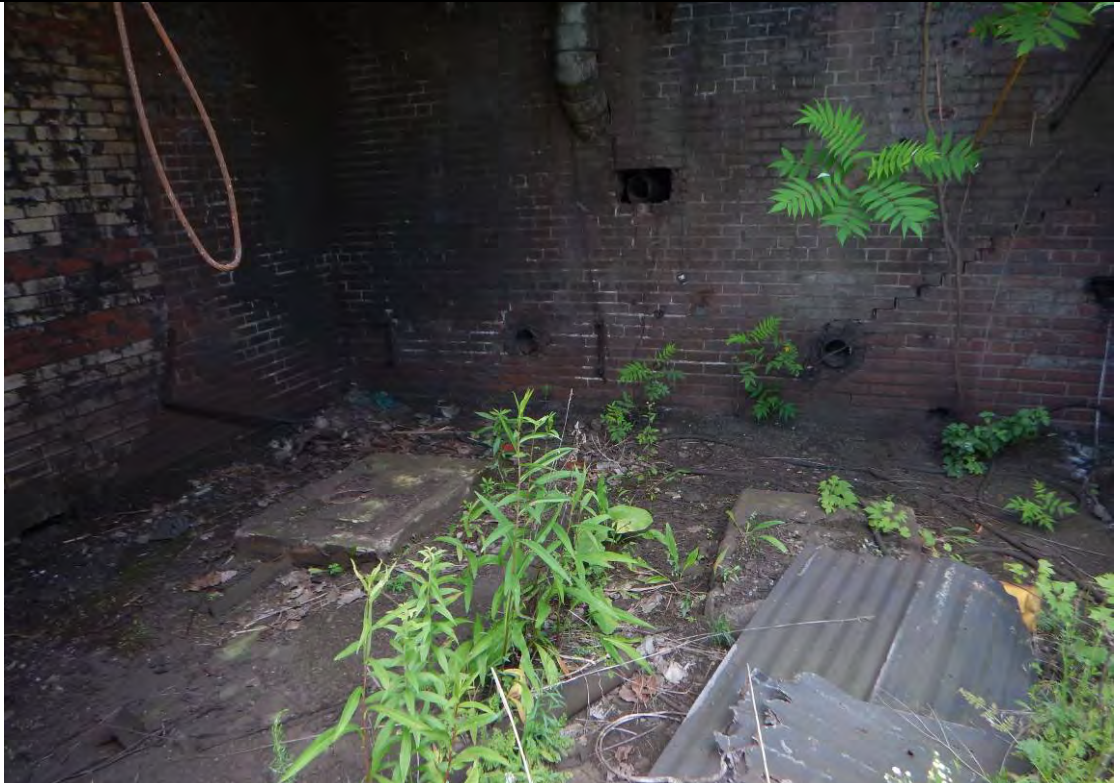
Client Name: City of Trenton		Site Location: 1491 W. Jefferson Avenue, Trenton, MI 48183	Project No. 170443-0100
Photo No. 19	Date: 7/17/17

Direction Photo Taken: South			
Description: Area 1 Eastern portion of former Sinter building, with stained concrete.

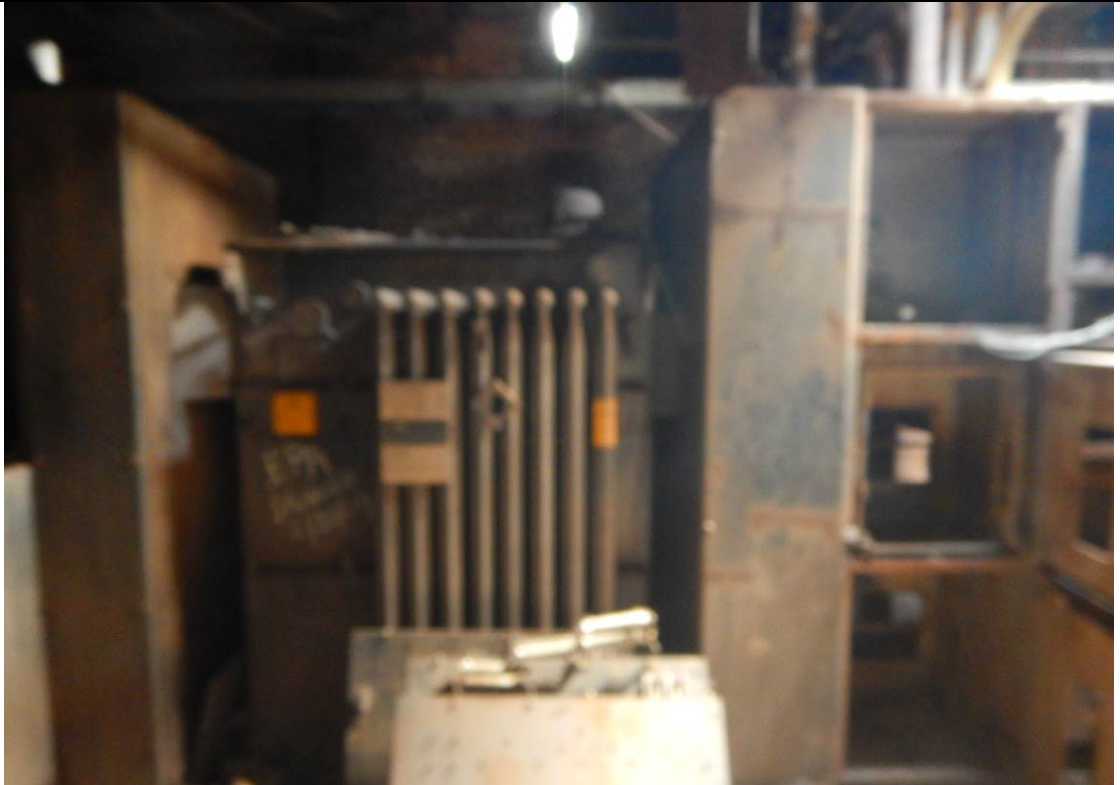
Direction Photo Taken: South			
Description: Area 1 Former Sinter Building interior and EPA drained capacitor.

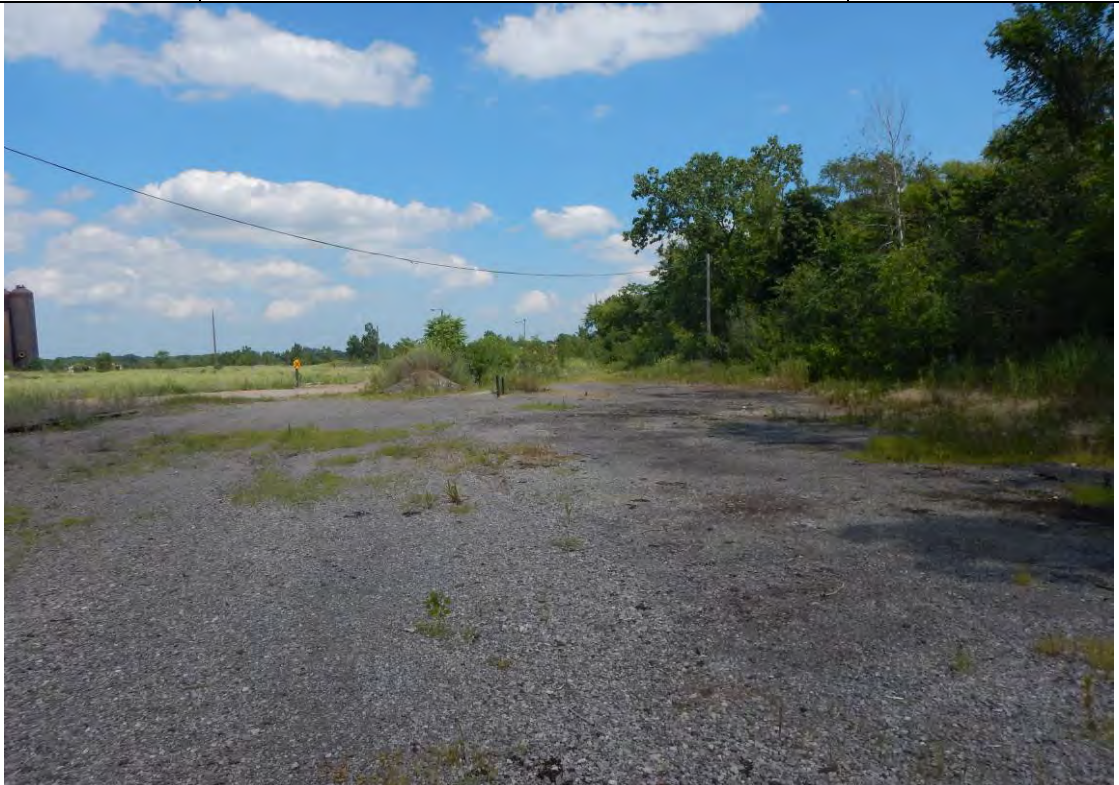
Direction Photo Taken: East			
Description: Area 1 Former drum storage area in central portion of Area 1.

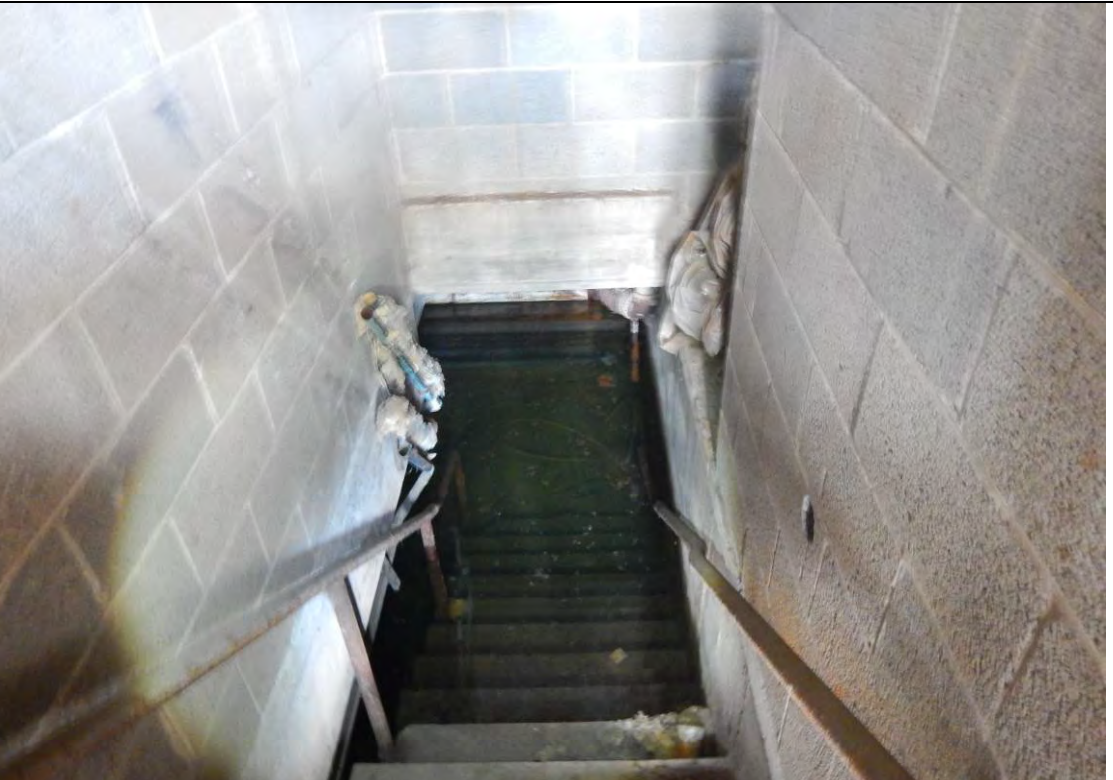
Photo No. 30	Date: 7/17/17

Direction Photo Taken: North		
Description: Area 1 Wash House basement full of water.

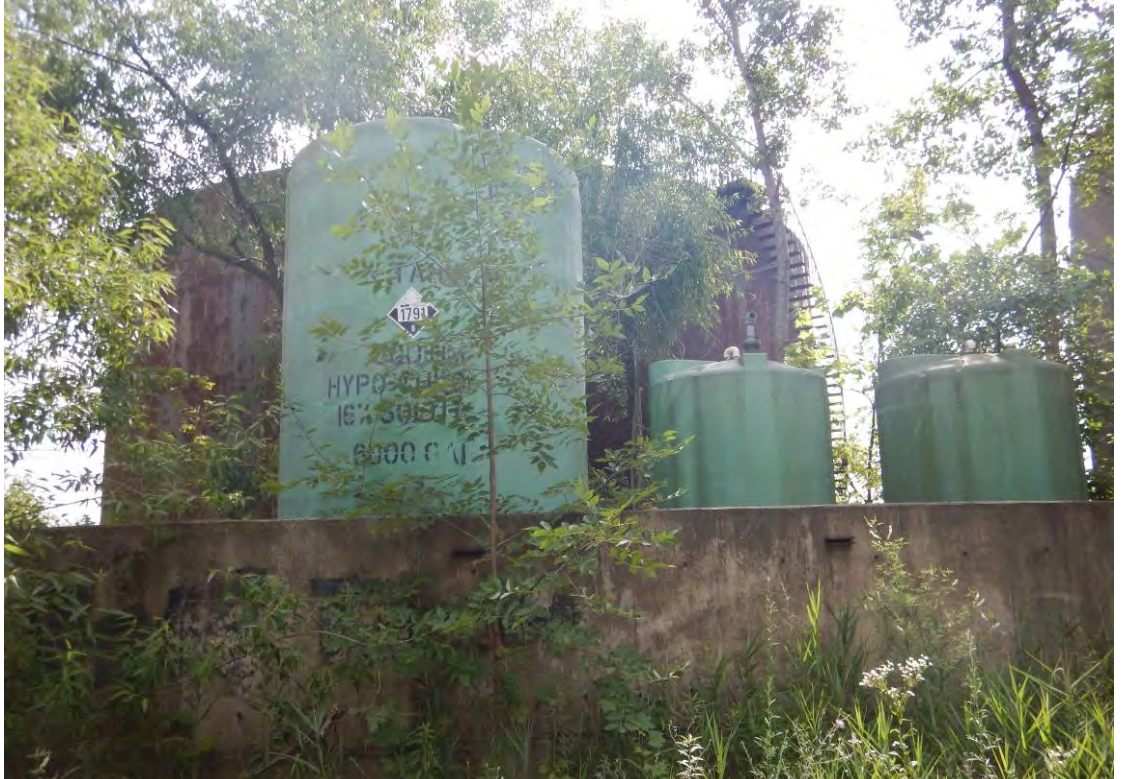
Direction Photo Taken: East			
Description: Area 2 6,000-gallon sodium hypochlorite AST and other tanks inside 1-million-gallon fuel oil tank secondary containment.

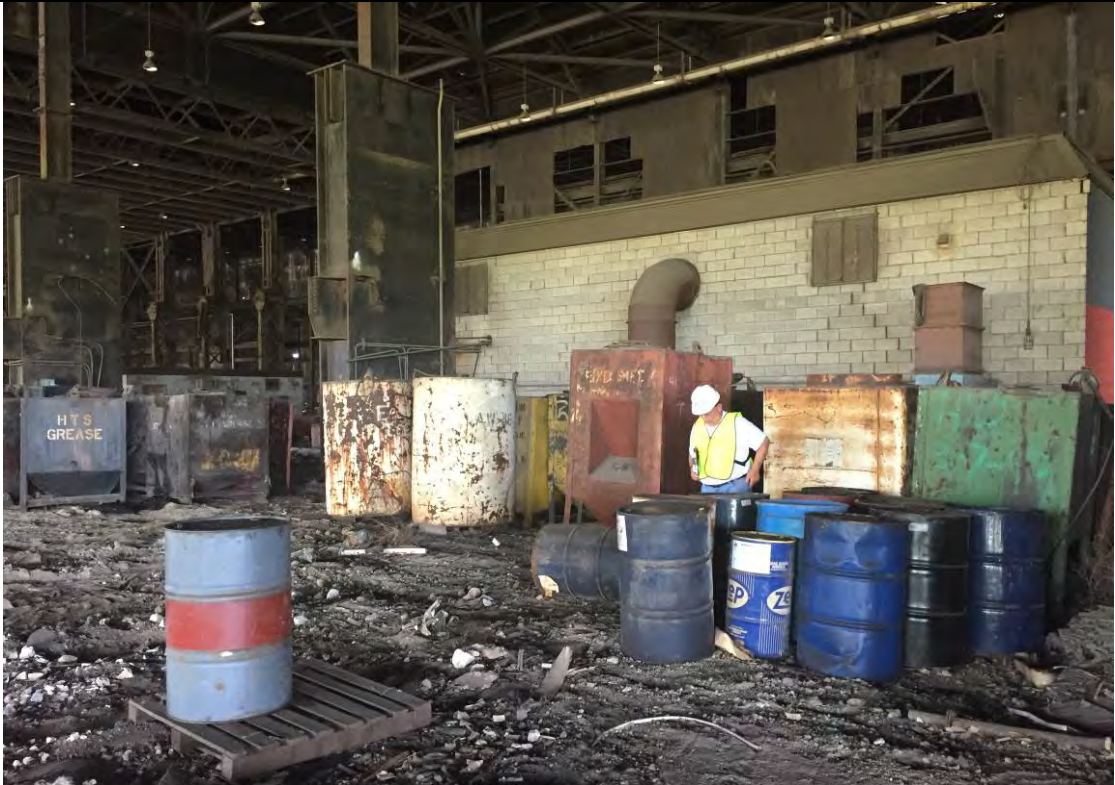
Direction Photo Taken: Southwest			
Description: Area 2 AST and drum staging area in Slab Handling and Storage Bldg..

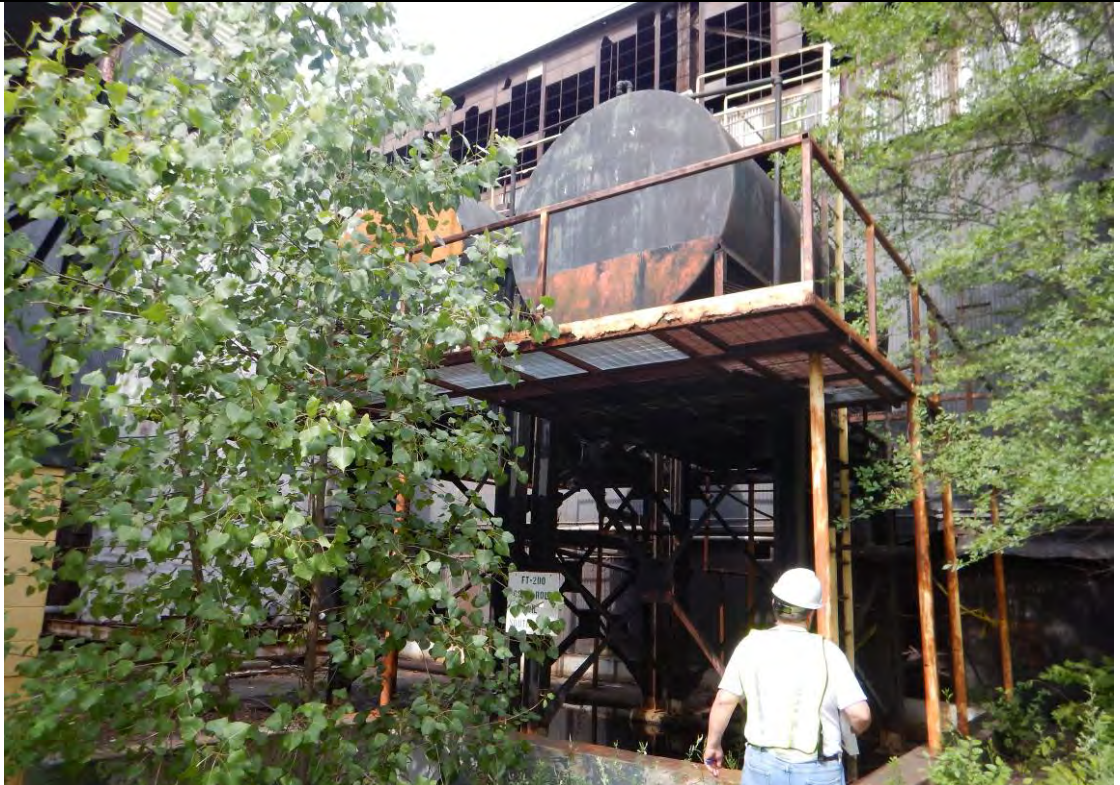
Direction Photo Taken: Southwest			
Description: Area Cold roll oil tanks in pickling acid AST storage area.

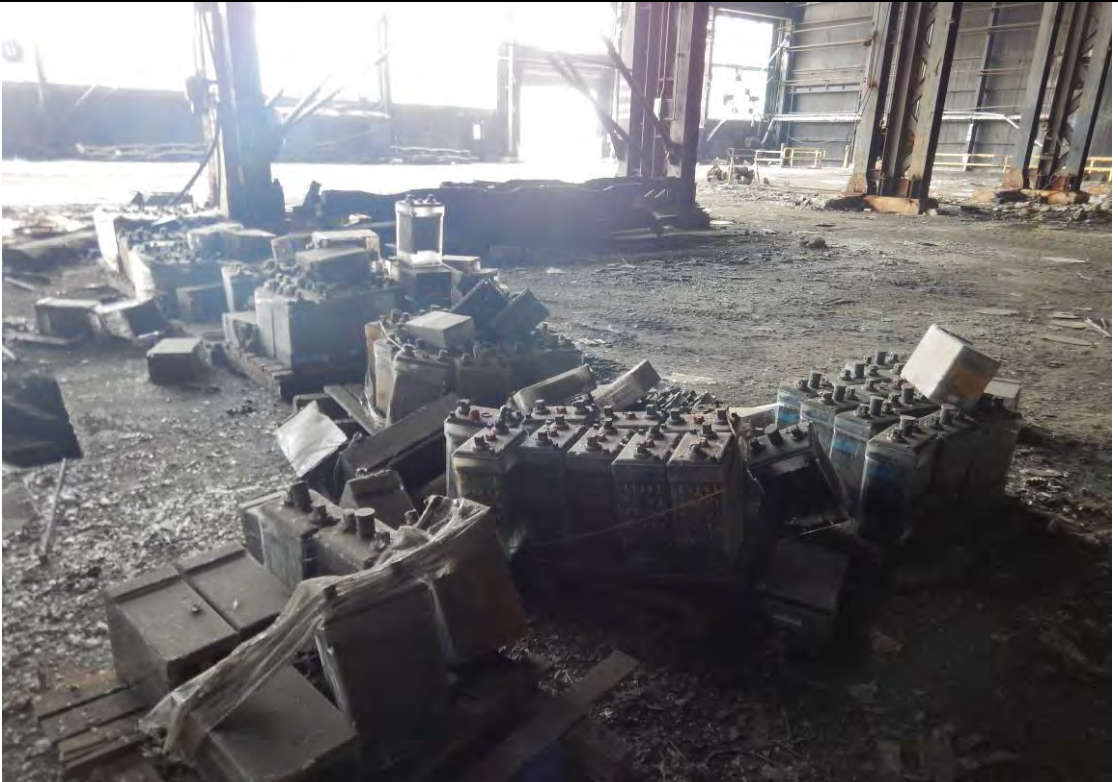
Direction Photo Taken: Northwest			
Description: Area 2 Pallets of "Exide" batteries.

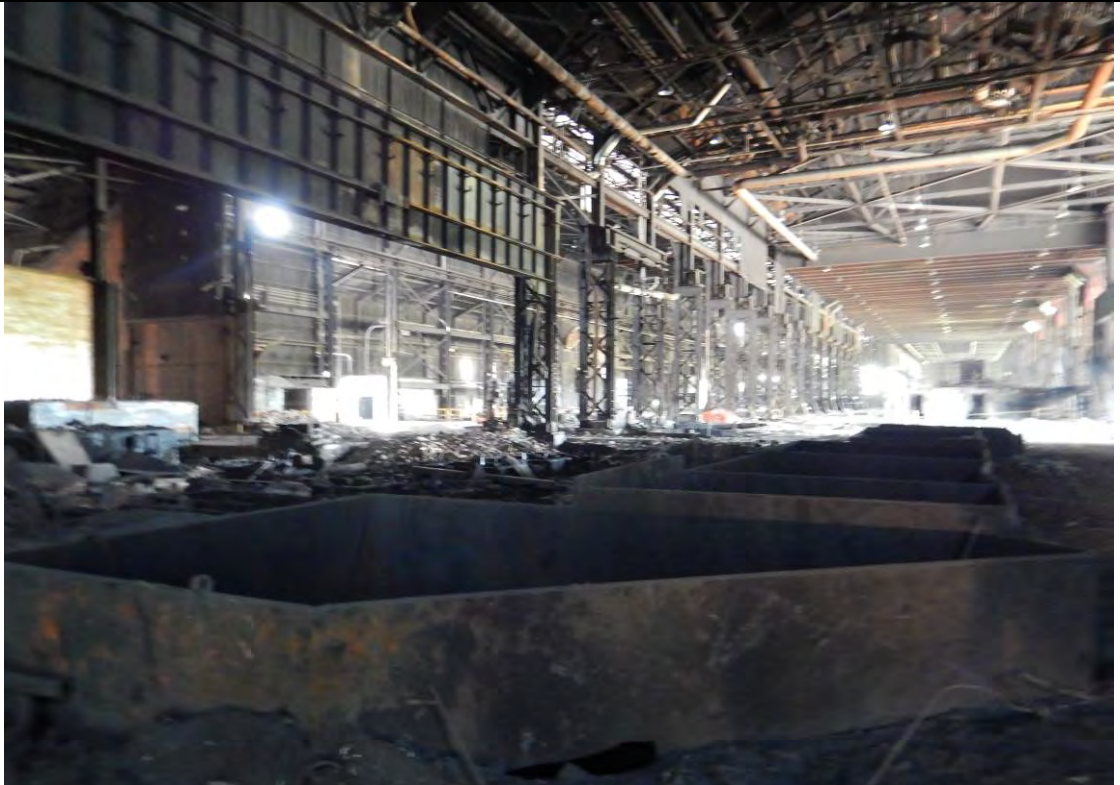
Direction Photo Taken: North			
Description: Area 2 Blooming Mill Scale Pits.

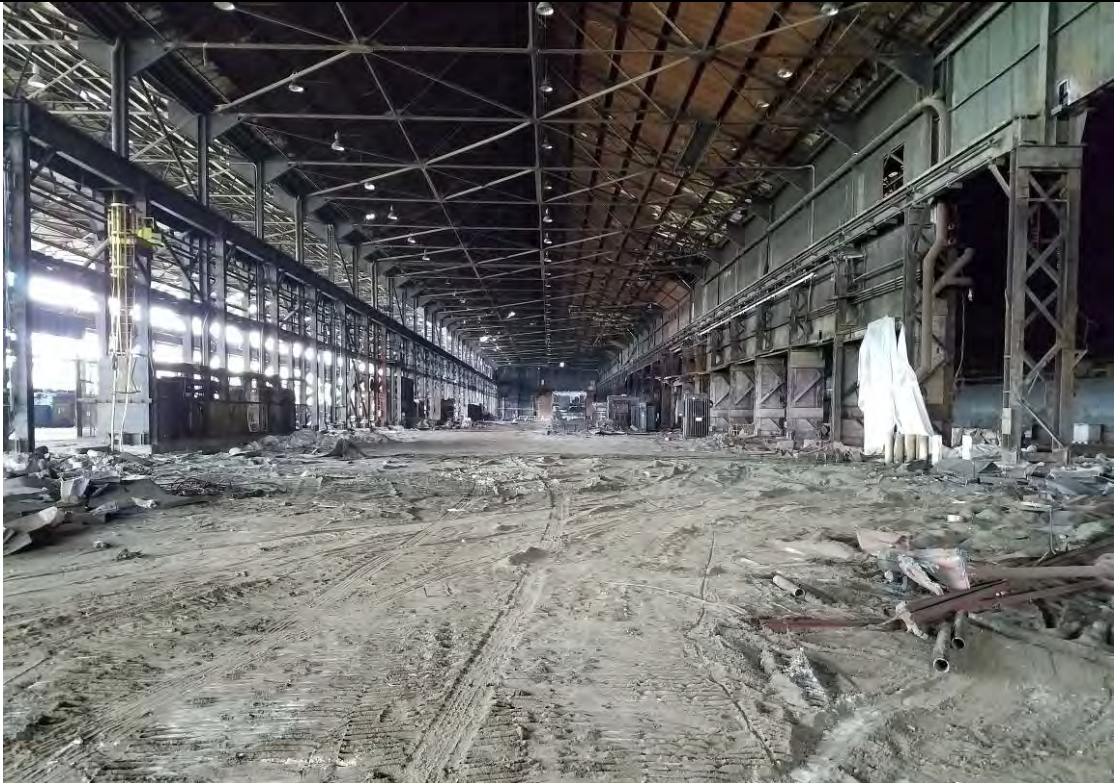
Direction Photo Taken: North			
Description: Area 2 General building interior of No. 1 Finish and Shipping Building.

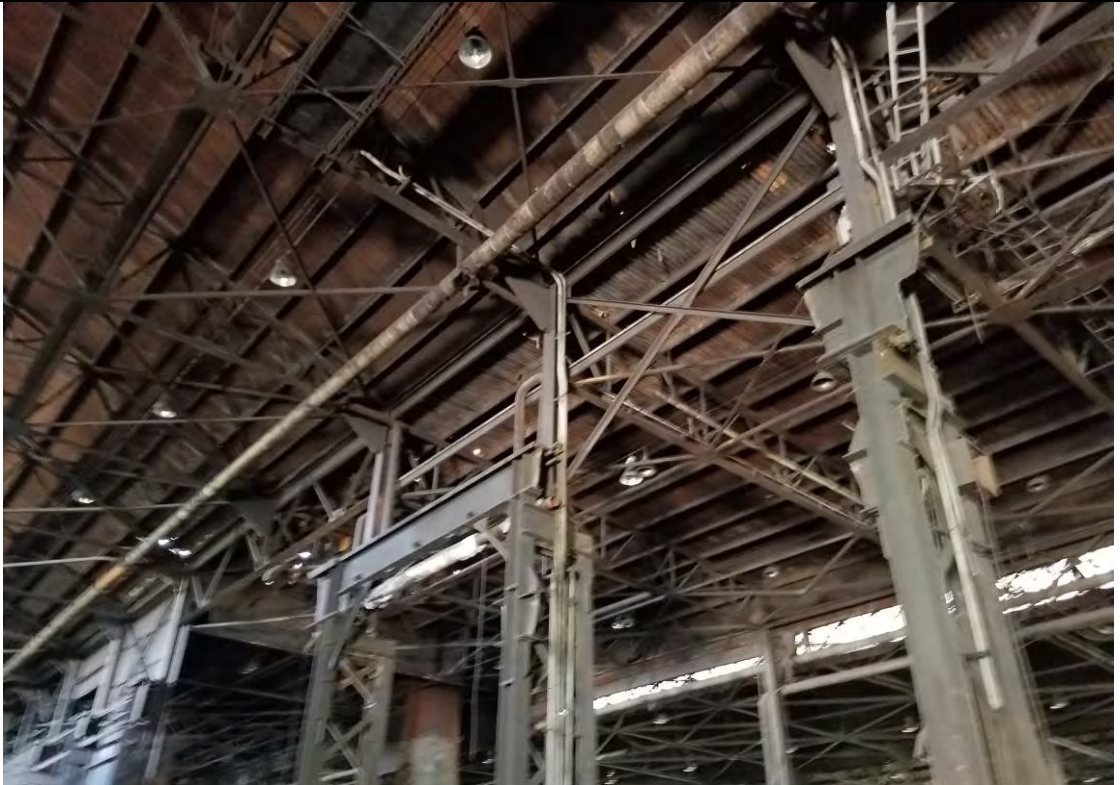
Direction Photo Taken: Southwest			
Description: Area 2 General interior view of ceiling trusses, with potential ACM covered pipes. Stack for "old furnace" visible in background.

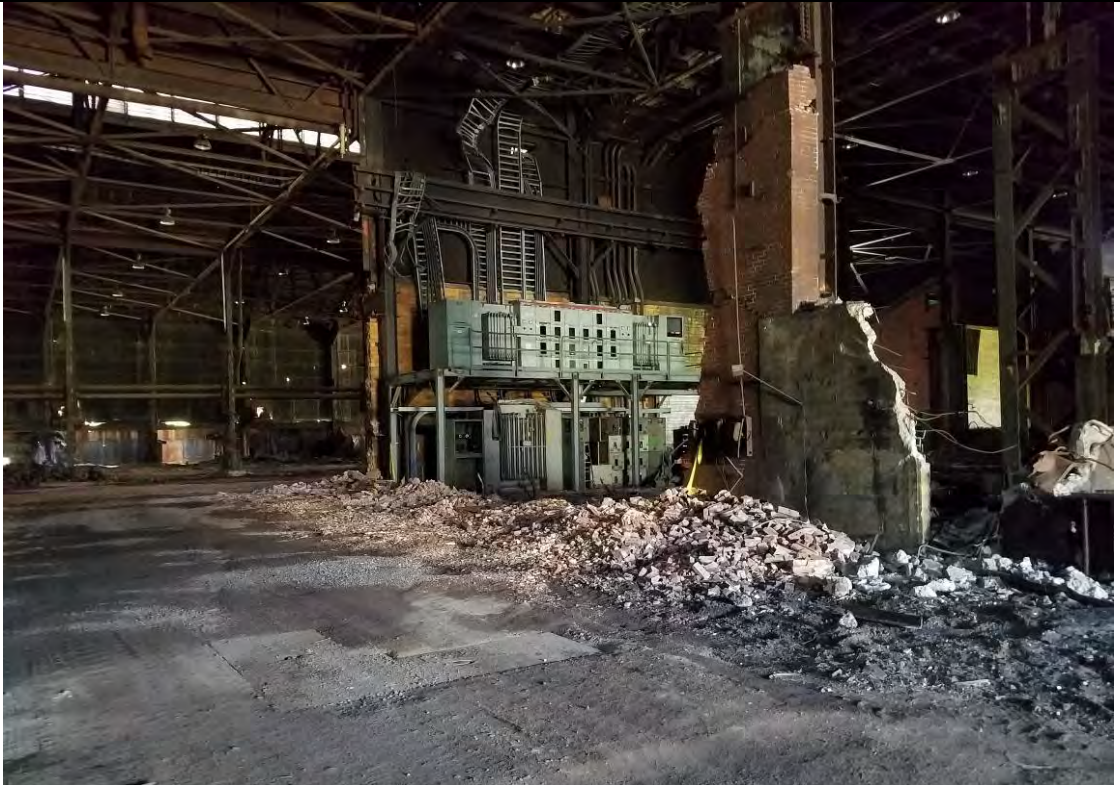
Direction Photo Taken: Northeast			
Description: Area 2 Same area as Photo No. 22 showing transformer banks. Photo taken on 7/17/2017. By 7/21/2017 upper level equipment and steel platform had been removed.

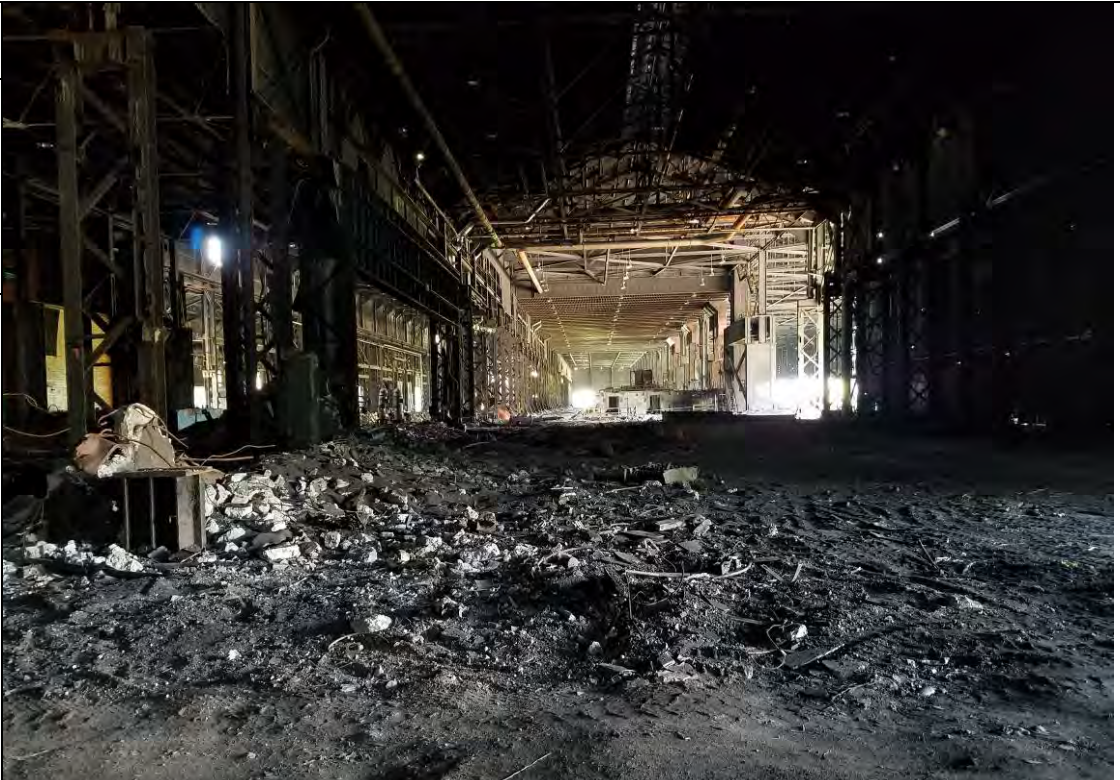
Photo No. 24	Date: 7/17/17

Direction Photo Taken: North		
Description: Area 2 From same location as Photo No. 23 toward Slab Heating Building (left) and Slab Handling and Storage Building (right).
